Mega Denim Ltd. (Extension)

88/1, B.K Bari, Taltoli, Mirjapur, Gazipur sadar, Gazipur.

10 September 2023

Observations

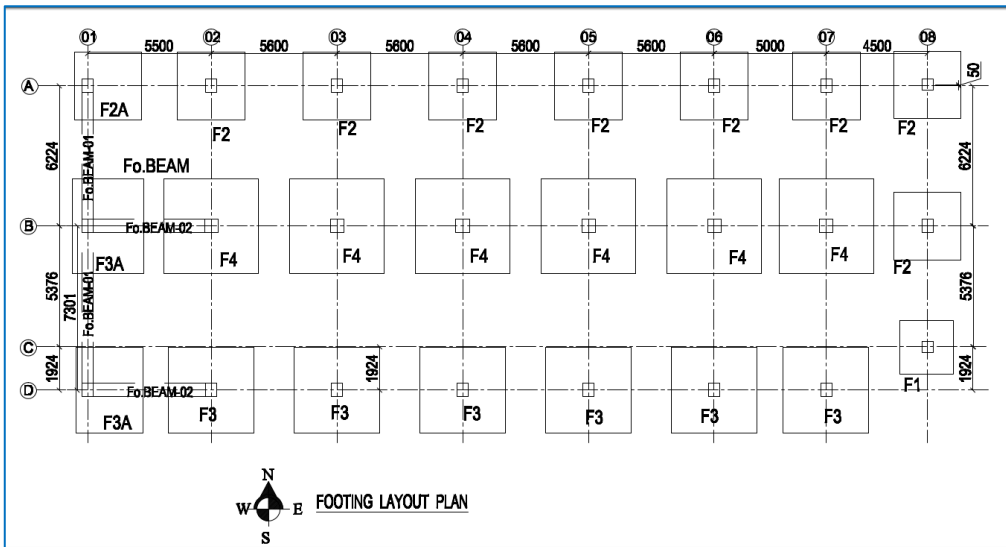
Foundation stress exceeds normal design limit

Cursory calculation indicates that bearing of internal footings exceeds the normal design limit considering ultimate Bearing Capacity of soil 3.25 tsf for 6 kPa live load on 1st floor & 3 kPa on typical floors. The building engineer to review design, loads and foundation stresses.

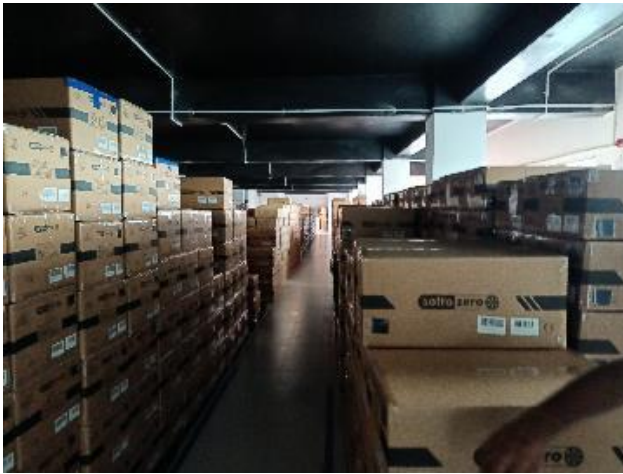
Storage on first floor

Currently, the first floor of the building is being used for finished cartoon store. As per BNBC, the minimum floor live load for light storage is 6 kN/m² (125 psf). But the storage area of the building is designed for 3 kN/m² live loads. Moreover, the factory has provided only 2 sets of concrete cylinder test report from column & slab, which doesn't comply the frequency of testing requirement of BNBC (section- 5.12.2).

Building engineer is required to revise the floor live load plan following BNBC storage live load requirement and revise the design documents based on in-situ material strength. Verify the in-situ material strength by taking 100 mm core from lower tier columns of the building.

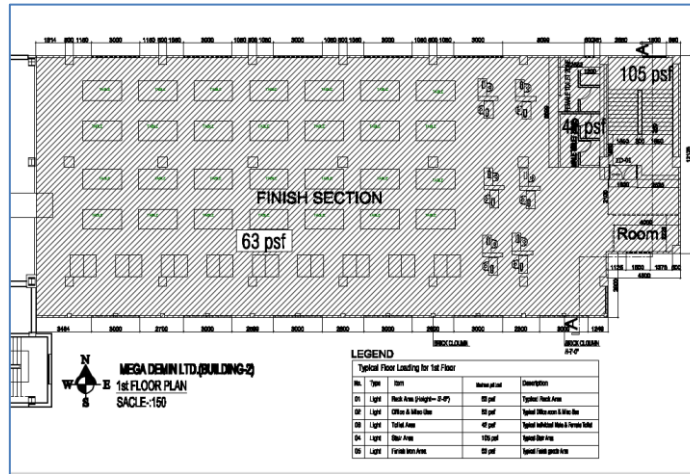
Load plan: 3 kPa live load for 1st floor

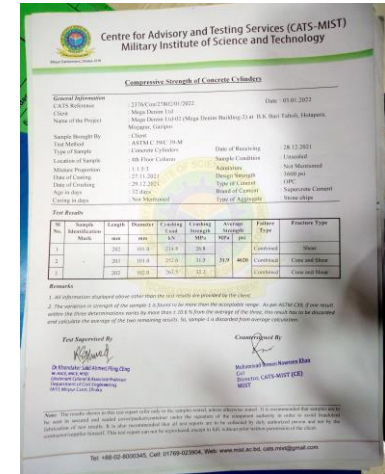
Test report

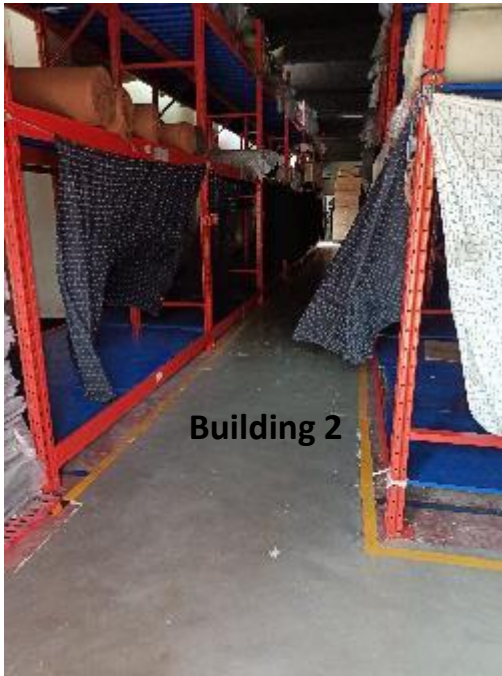
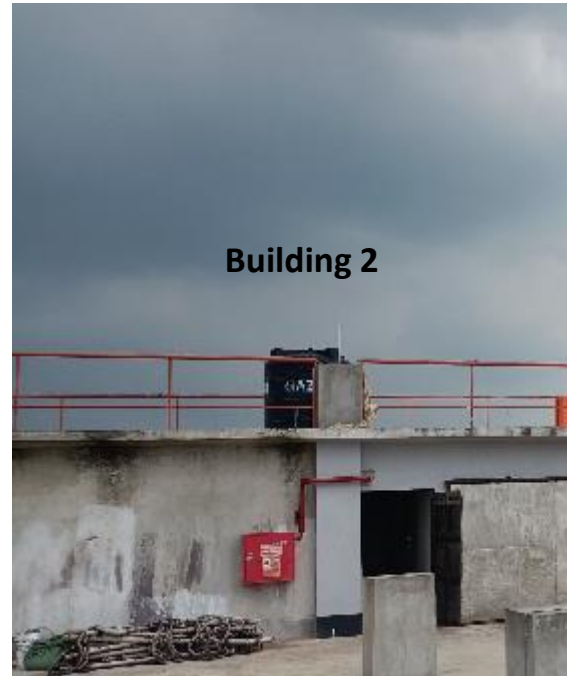
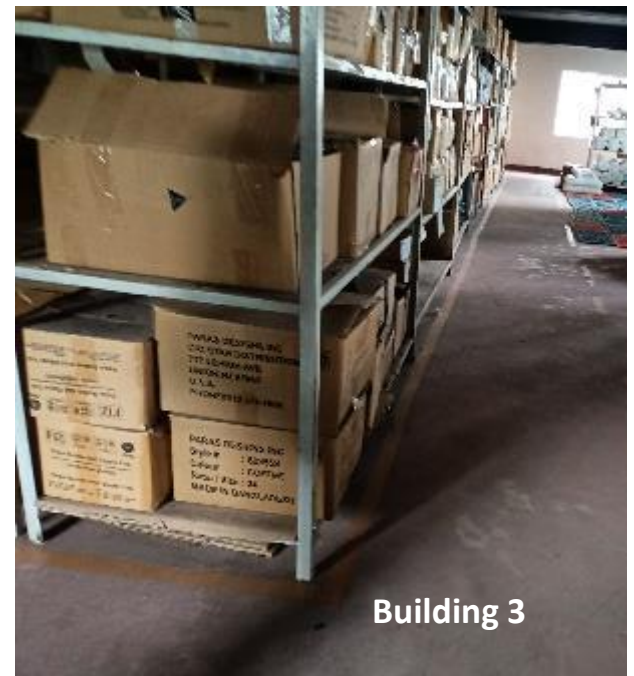
Plastic water tank & storage racks not anchored or braced

Non-structural element including plastic water tank & storage racks not anchored or braced to resist lateral (earthquake) forces. The factory is required to anchor/brace all non-structural elements adequately to resist earthquake forces.

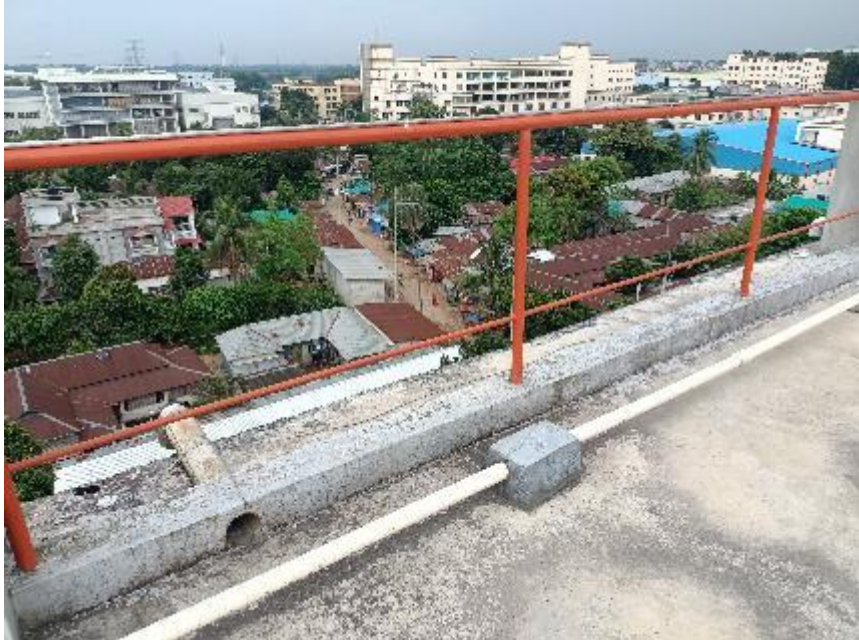
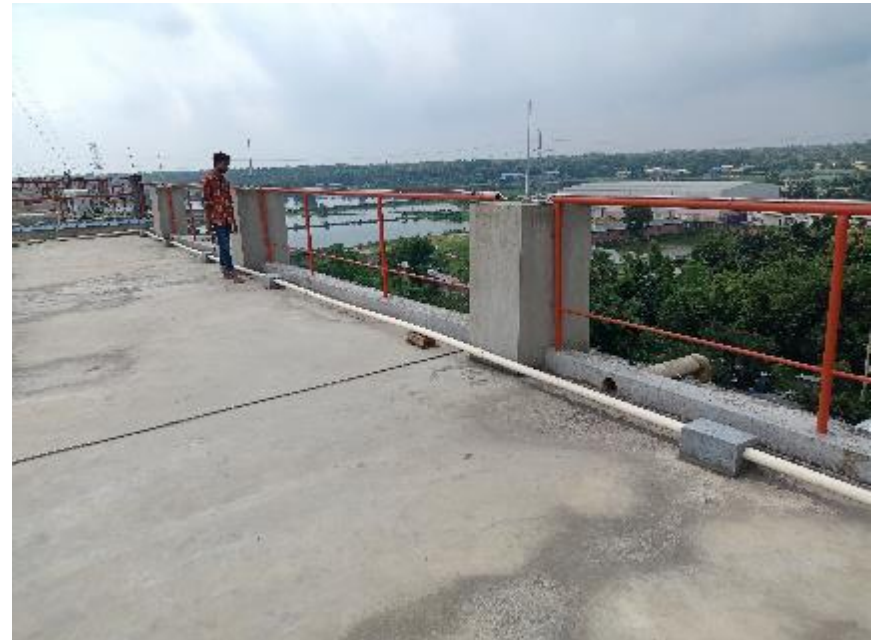
Inadequate protection in the handrail of the roof parapet

The partial hand railing of the parapet was found inadequate to protect falling hazards. Building engineer is required to provide more steel members at the handrail to avoid possible falling hazard.

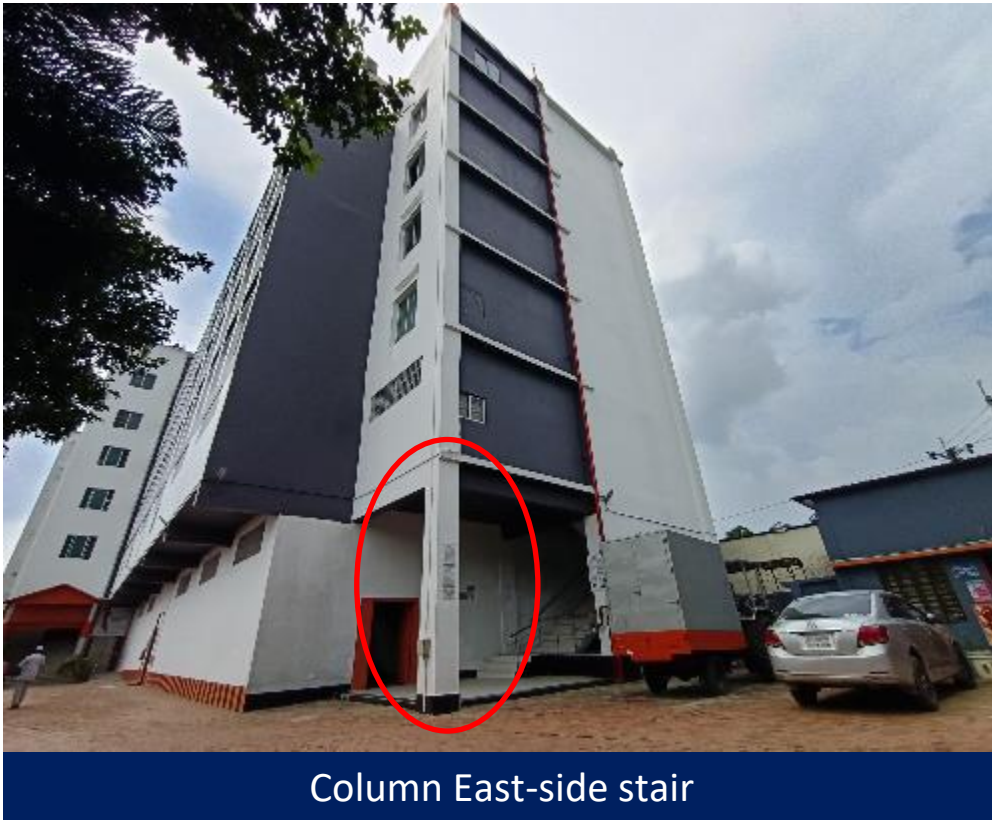
Column susceptible to vehicle impact

Column East-side stair is susceptible to vehicle impact. The factory is required to provide separate barrier around the column to avoid possible vehicle impact.

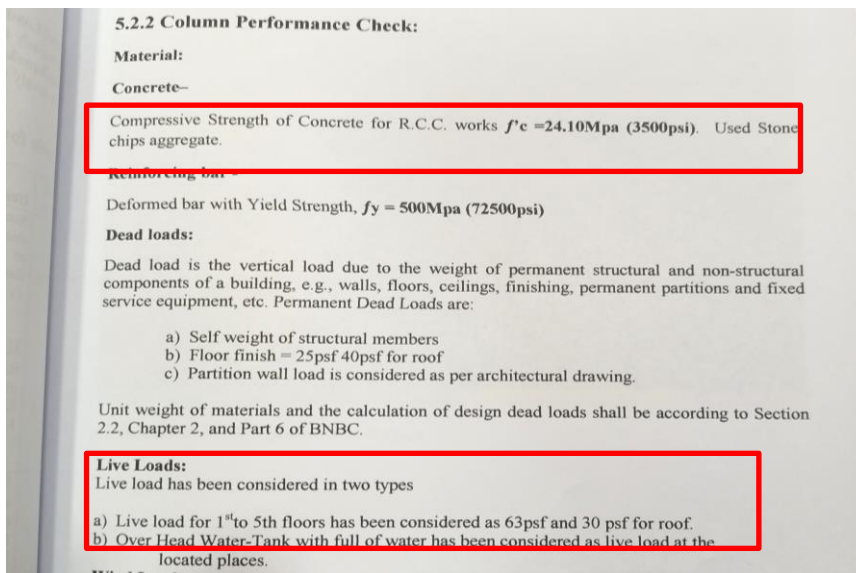
Provided design report

As per BNBC, the minimum floor live load for light storage is 6 kN/m² (125 psf). But the storage area of the building is designed for 3 kN/m² live loads.

Building engineer is required to revise the floor live load plan following BNBC storage live load requirement and revise the design documents based on in-situ material strength.

Verify the in-situ material strength by taking 100 mm core from lower tier columns of the building.

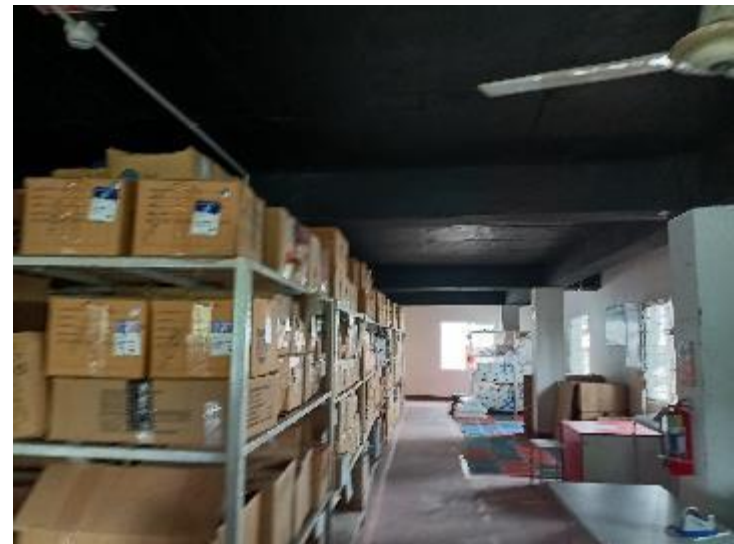
Accessories Store on suspended floor

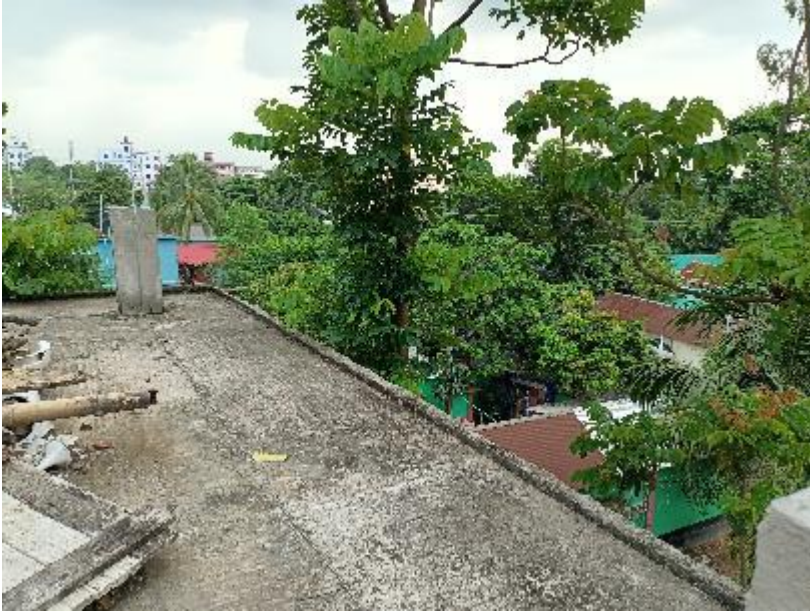
Lack or parapet wall on the existing roof

No parapet wall was found to protect falling hazards on the existing roof. Building engineer is required to provide adequate parapet wall to avoid possible falling hazard.
