Rahmat Sweaters (BD) Ltd. (Extension)

Jogirchala, Mouchak, Kaliakoir, Gazipur-1751.

11-Sep-2023

Building Information

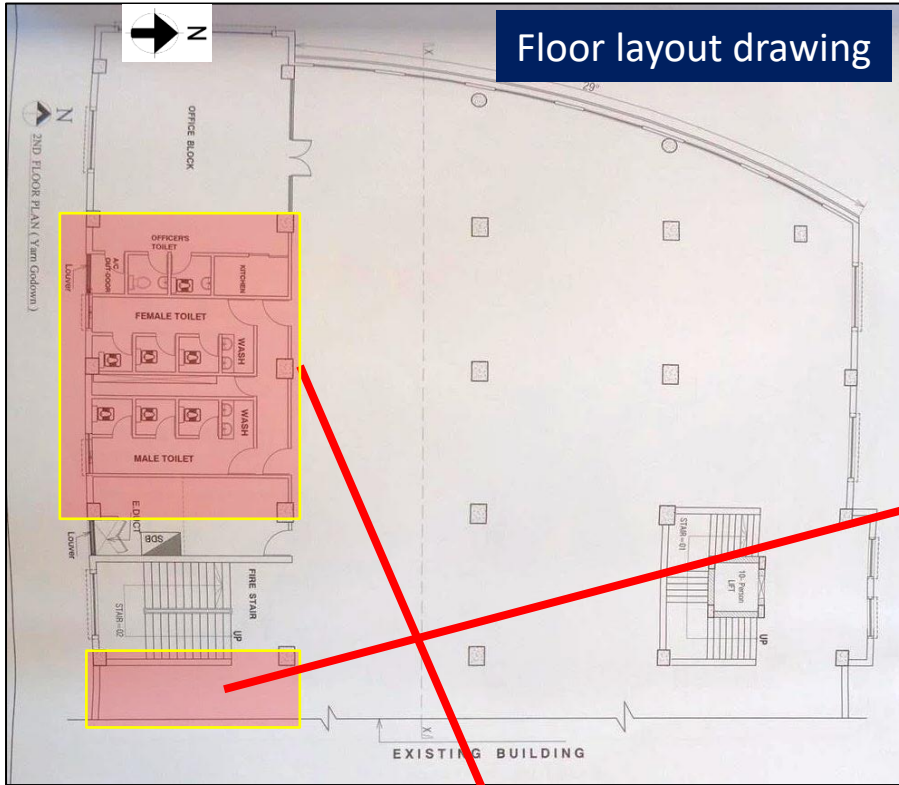
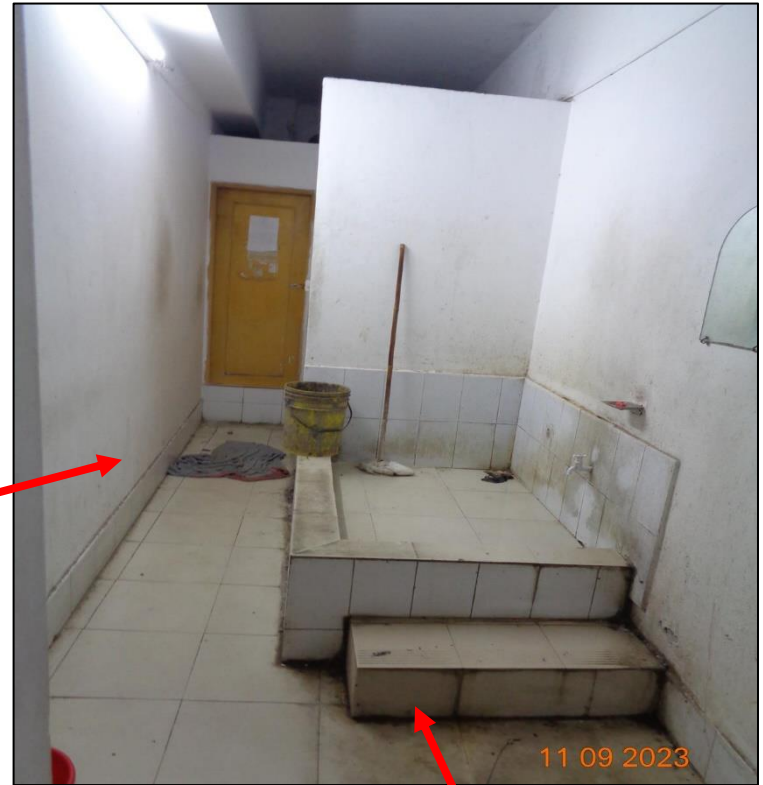
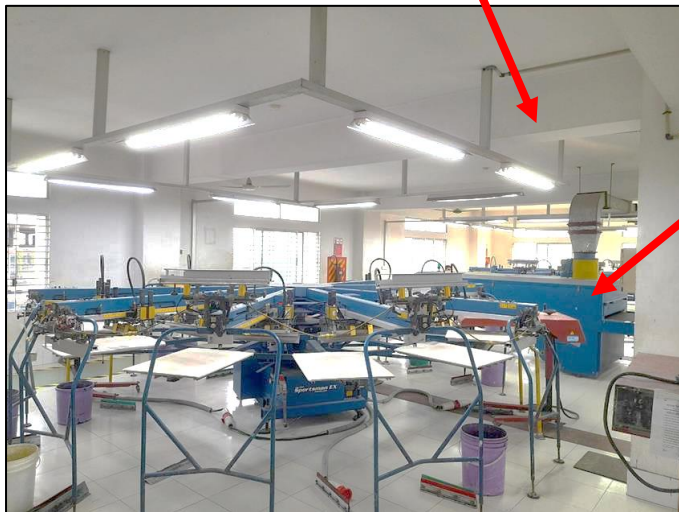
Toilet block in drawing but production floor on-site.

Toilet with build-up was found at cantilever portion as marked in layout plan.

Building engineer is required to survey the structures and update as-built drawings.

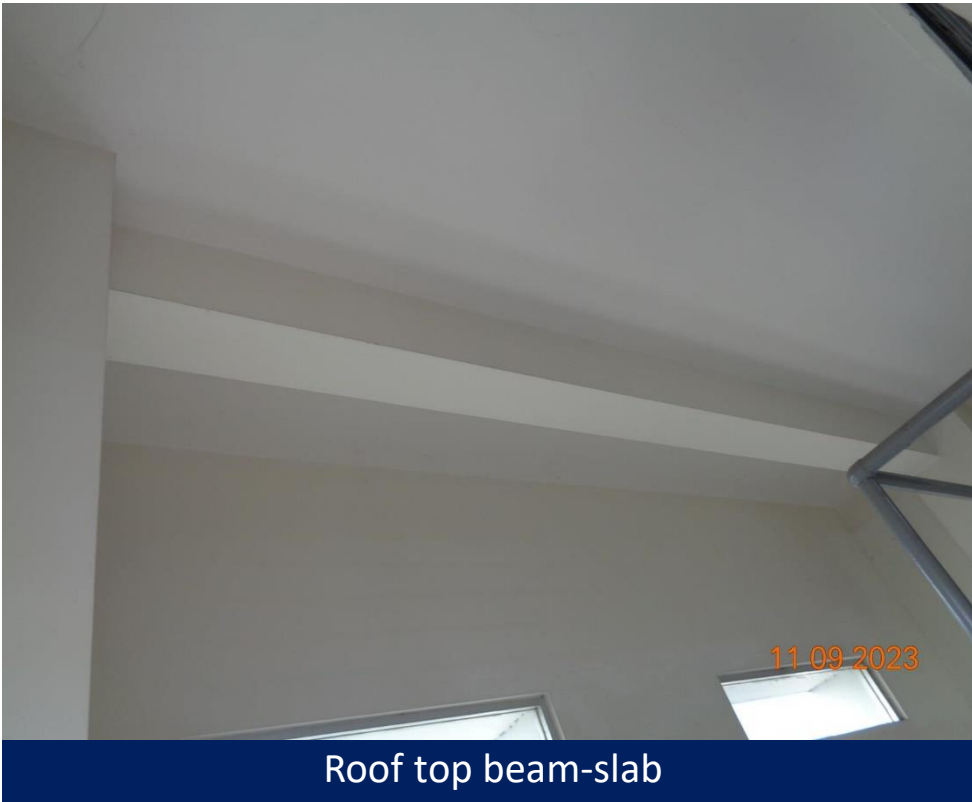
Roof top beam-slab

The details of the roof top beam & slab over the stairs & lift core has not been provided in as built drawing.

Building engineer is required to survey the structures and prepare accurate as-built drawings.

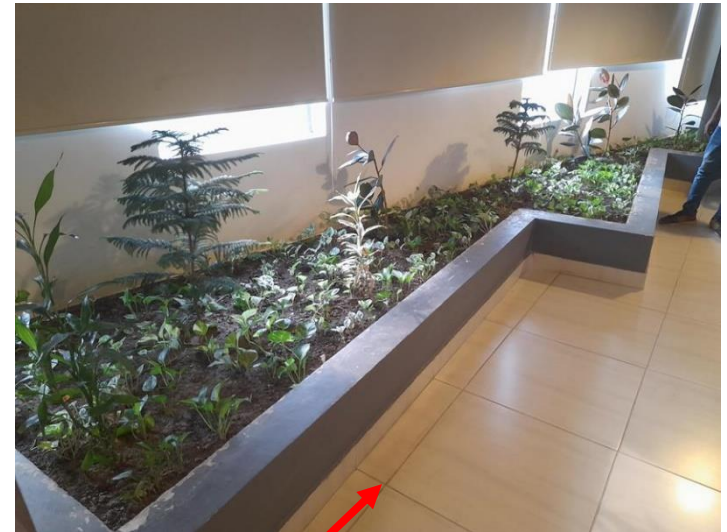
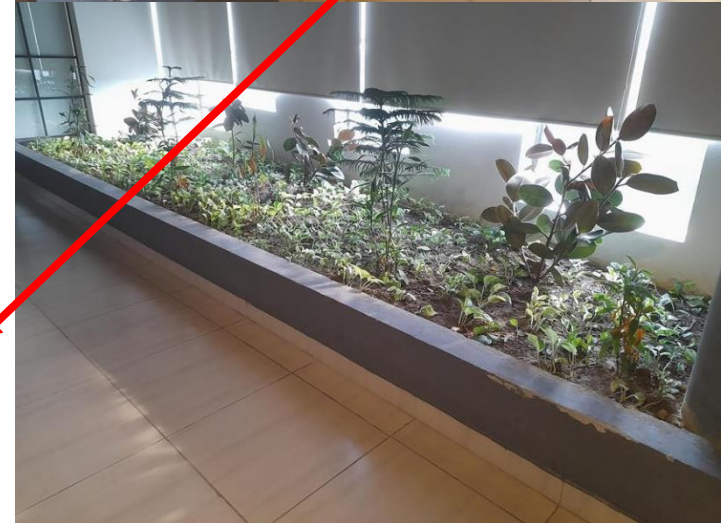
Soil bed found at 4th floor which has not been shown in drawing.

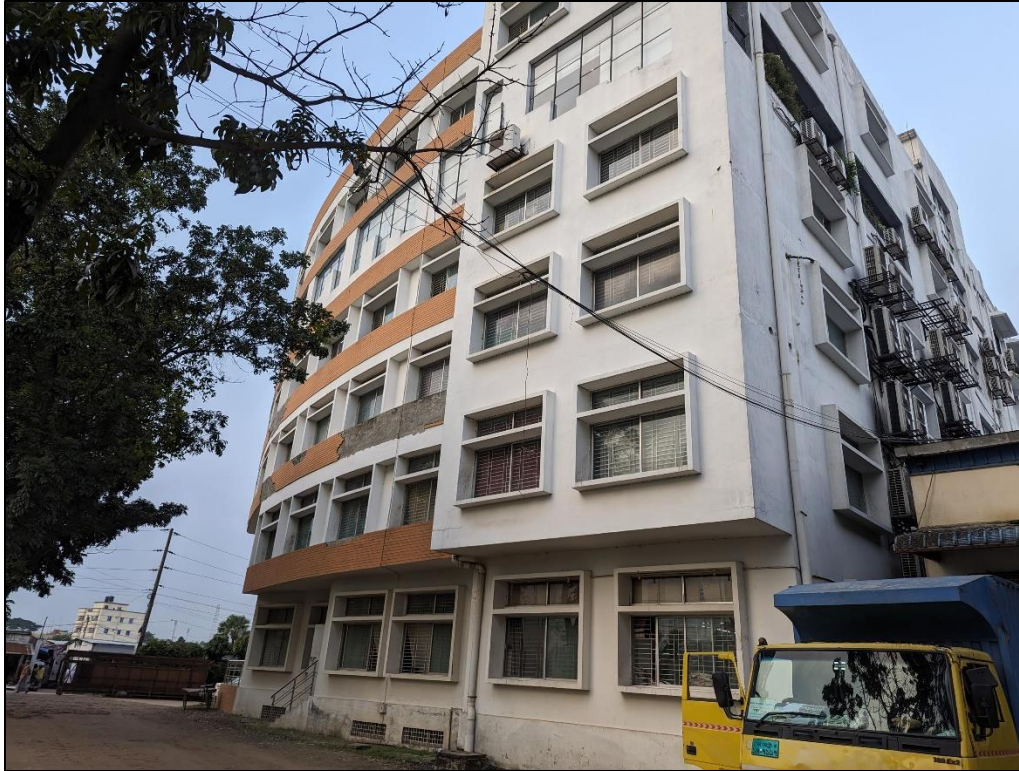
Design report needs to be prepared

As per BNBC, every building or structure designed shall have its design documents prepared in accordance with the provision of Section 1.9.1. The design document shall include a design report, and a set of structural drawings, which shall be prepared in compliance with section 1.9.1.1 and section 1.9.1.2 as per BNBC. At the time of inspection, no design report was available. Building engineer is required to prepare a set of design documents in compliance with section 1.9.1 of BNBC (part-6).

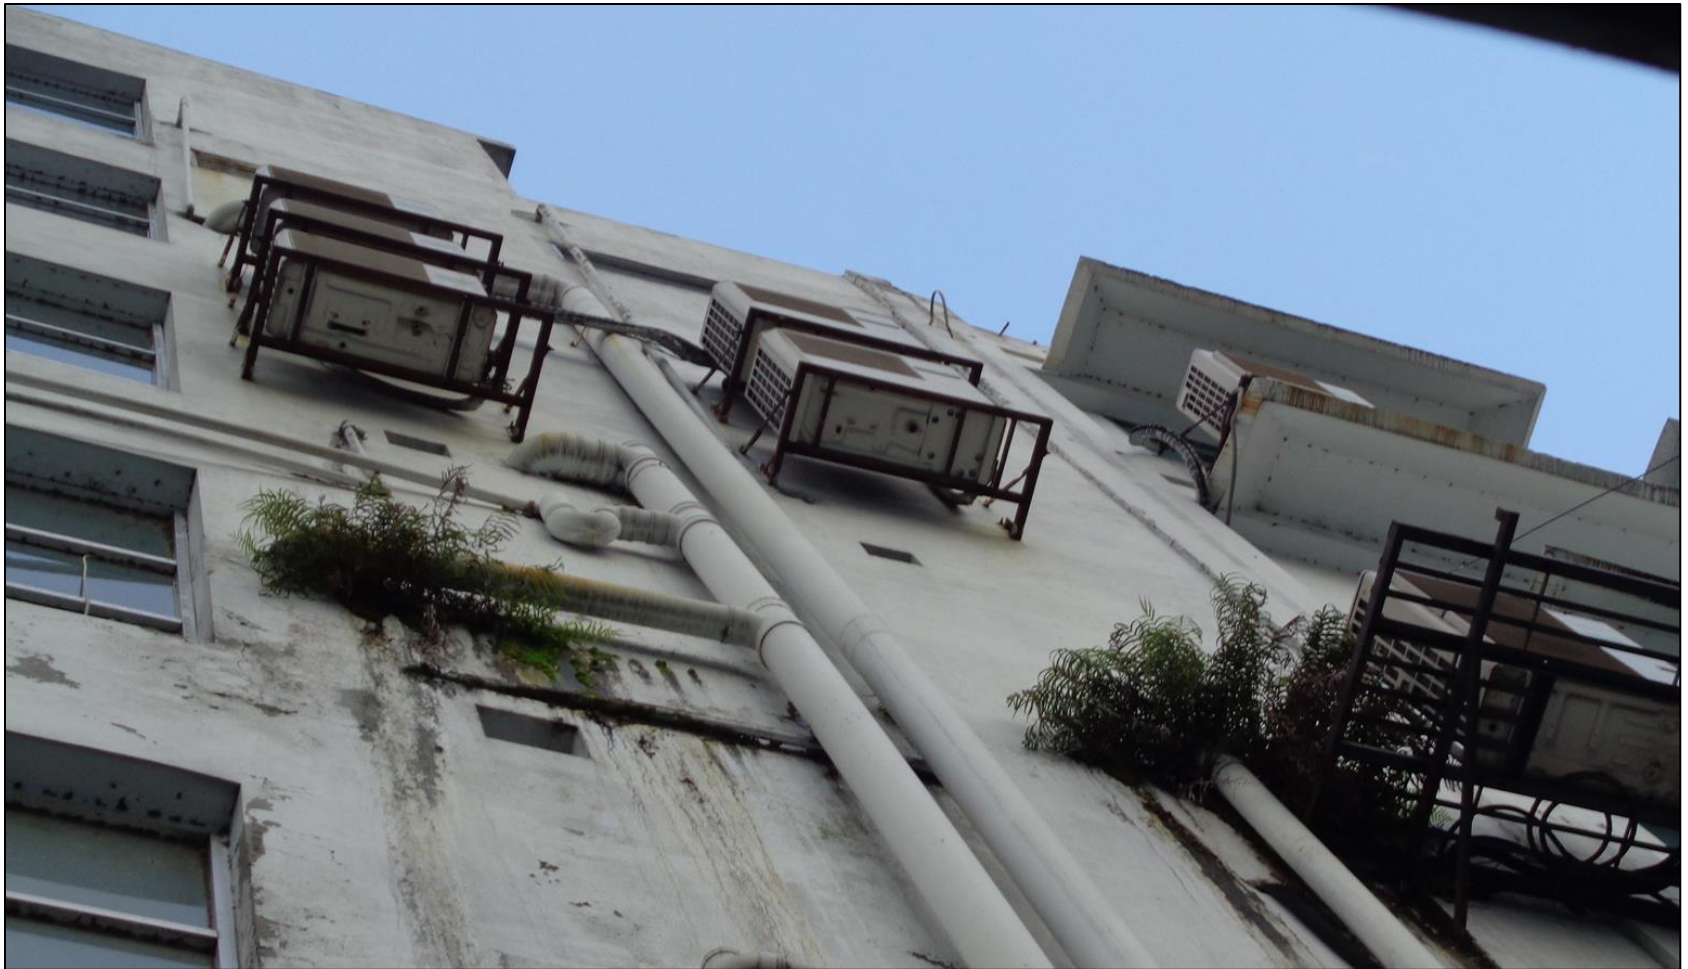
Dampness and vegetation on building façade.

Dampness and vegetation was found on façade. The factory is required to clean the vegetation, identify the source of moisture and seal the sources & repair the damp areas accordingly.

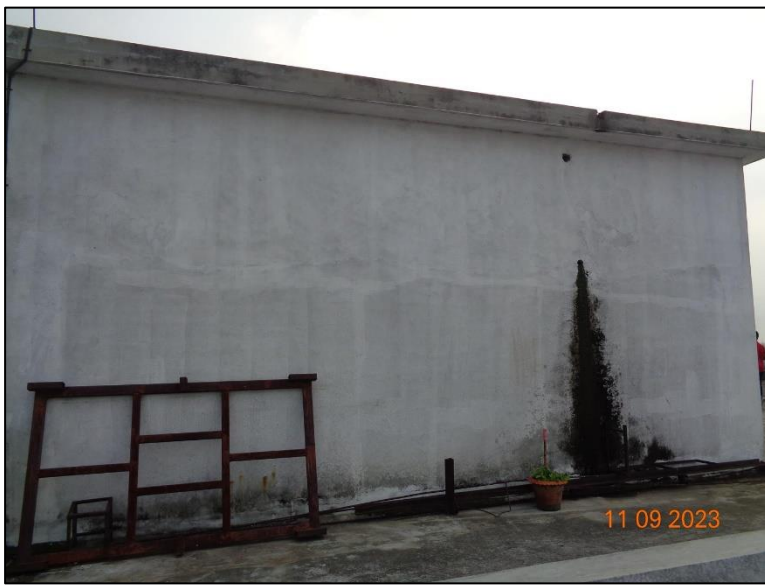
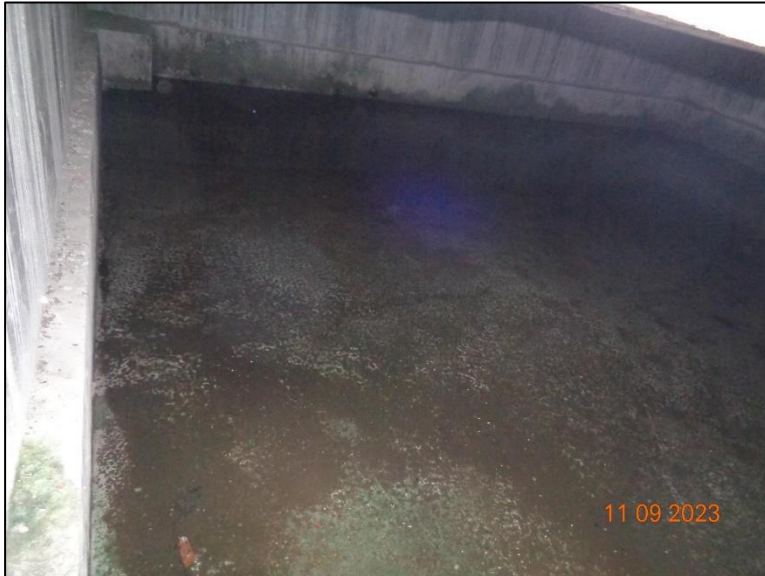
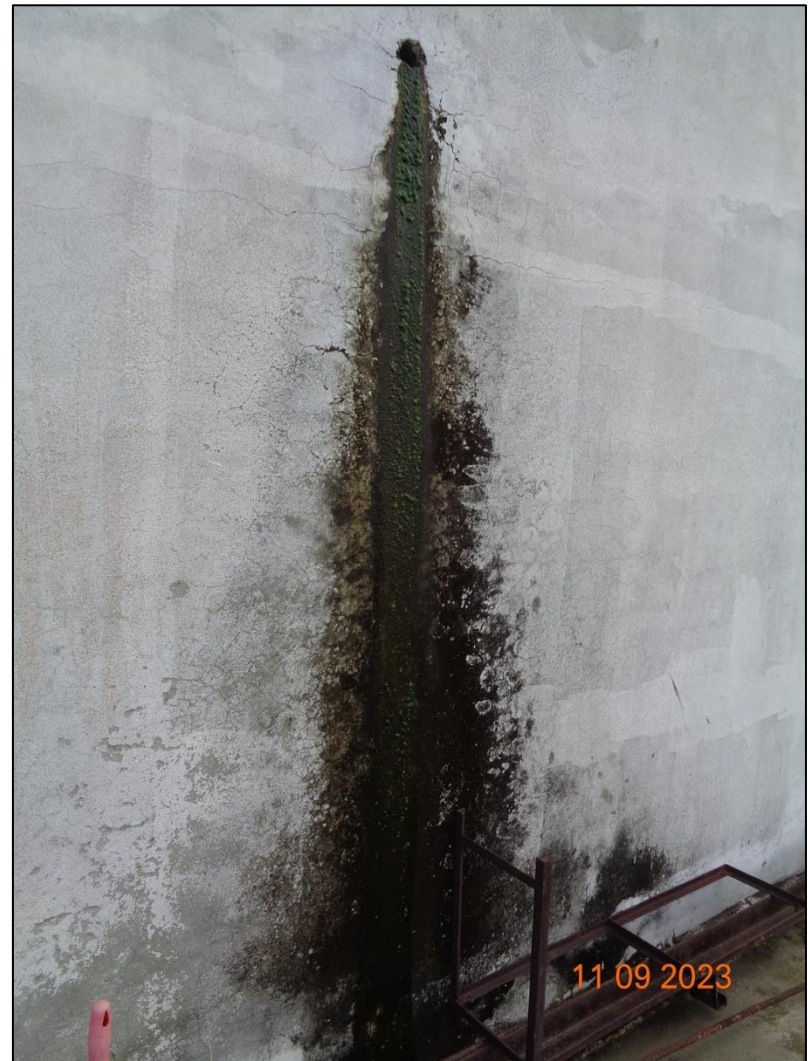
Dampness was found at wall below the overhead water tank due to the leakage from the unused water tank. Factory is required to repair the dampness and stop the source of the dampness.

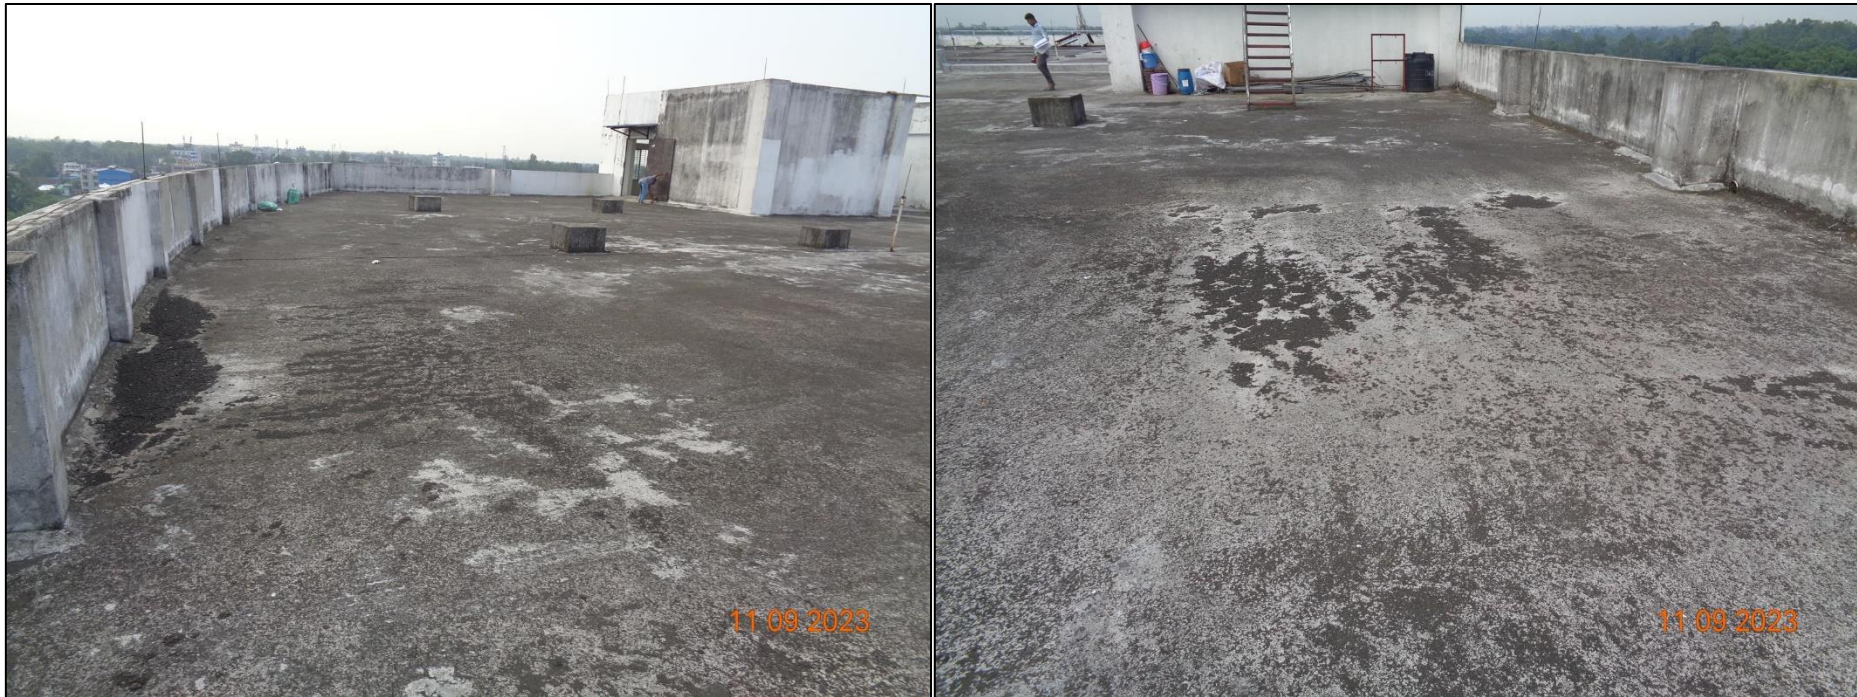
Signage of water ponding on roof slab

Signage of water ponding on roof slab due to poor drainage system. Factory is required to improve drainage system with proper slope and adequate number of water outlet to prevent the water ponding on the roof slab.

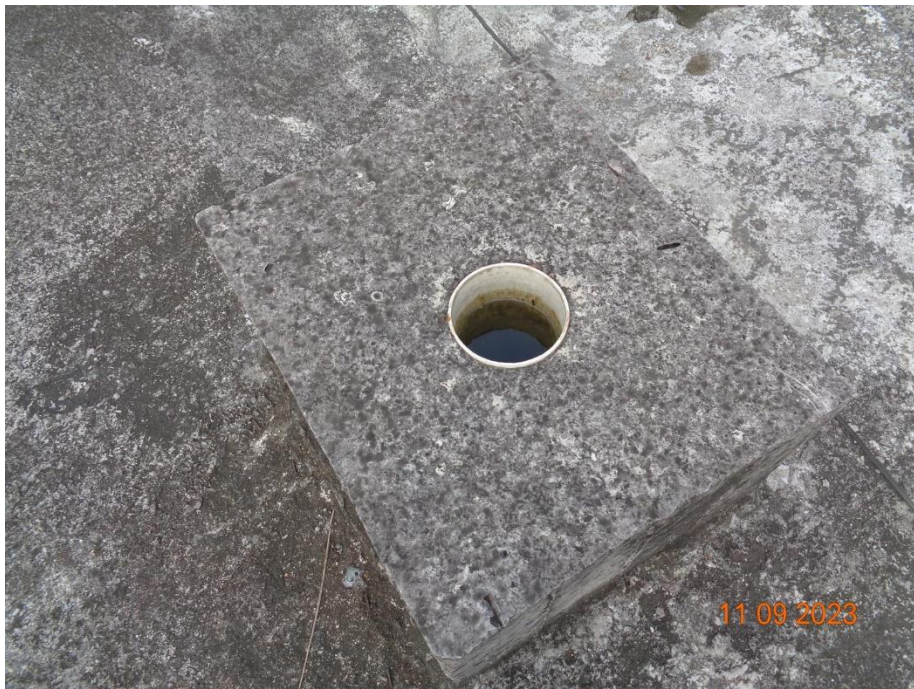
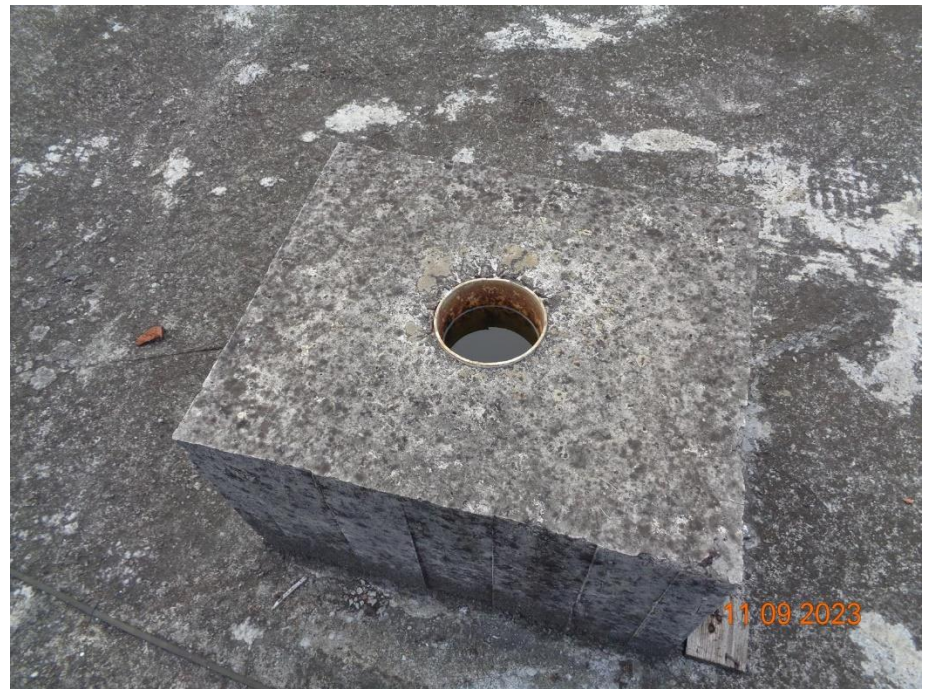
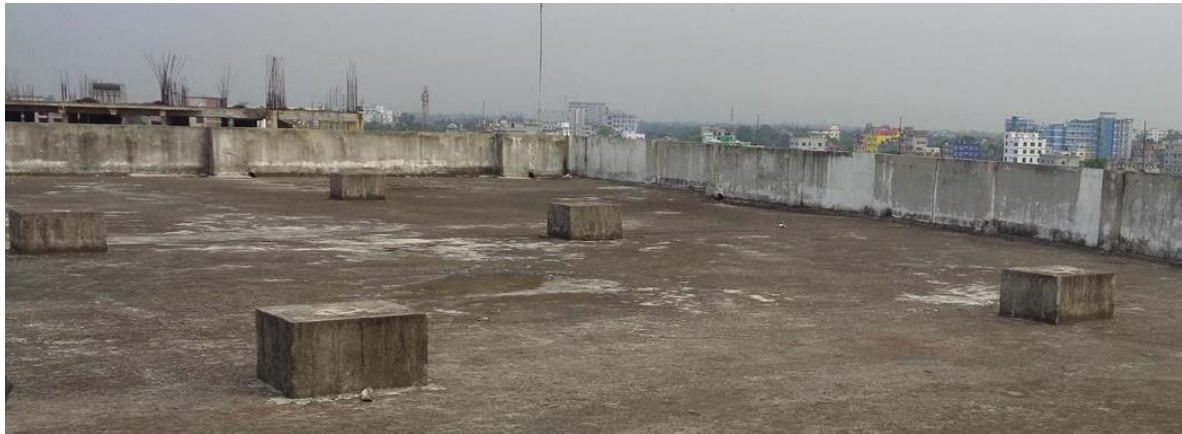
Stagnant of water in concrete is susceptible of re-bar corrosion and damage of column. Factory is required to fill the hole or cover the hole to prevent the intrusion of water.

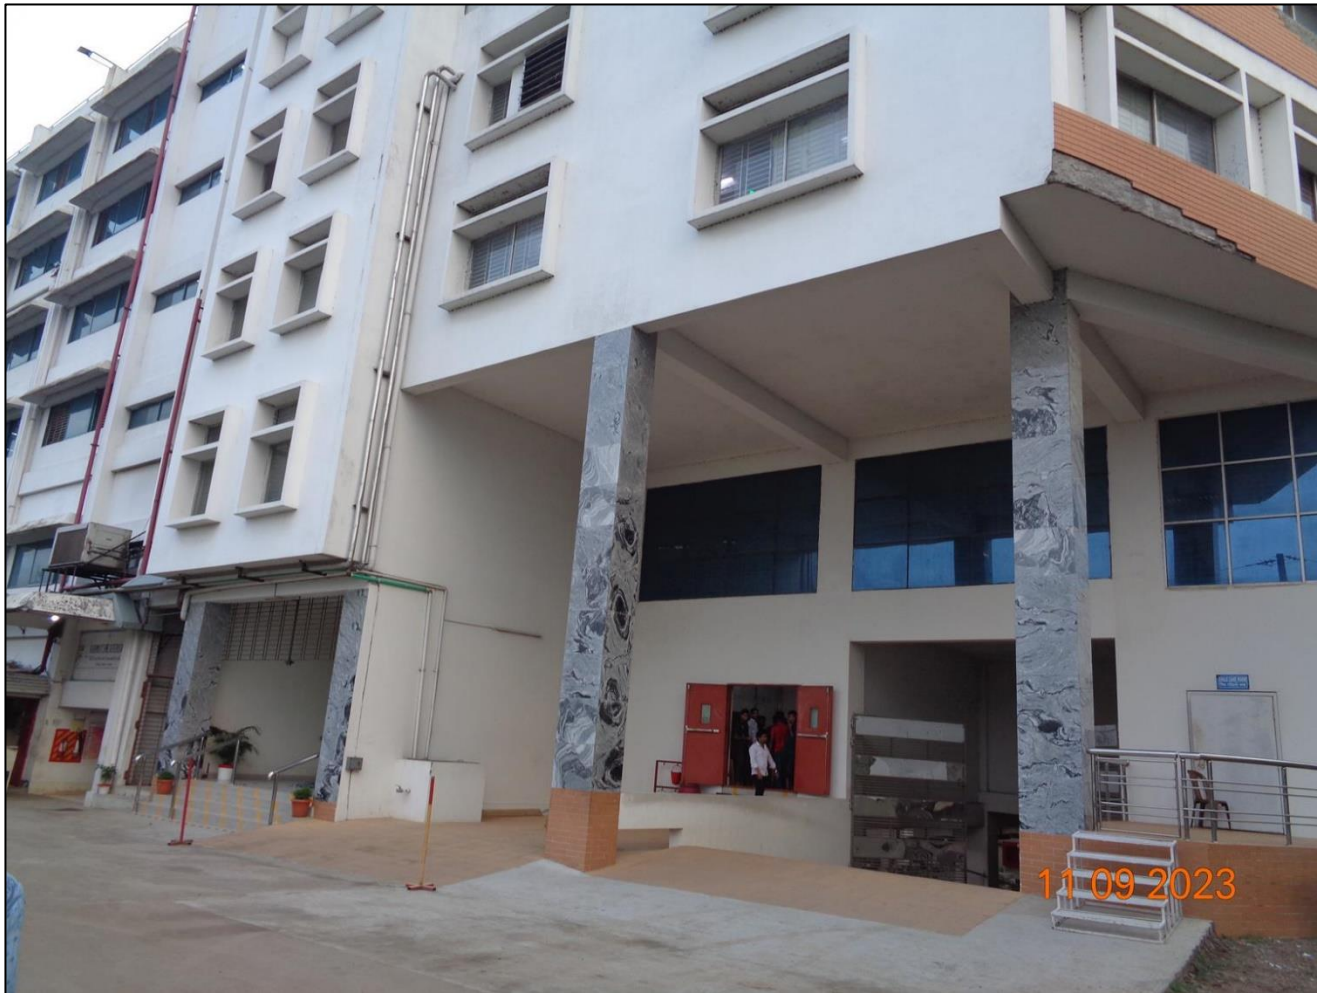
Columns having no barrier/protection at ground floor

Columns at ground floor are susceptible to vehicle impact. The factory is required to provide separate barrier around the columns to avoid vehicle impact on column.

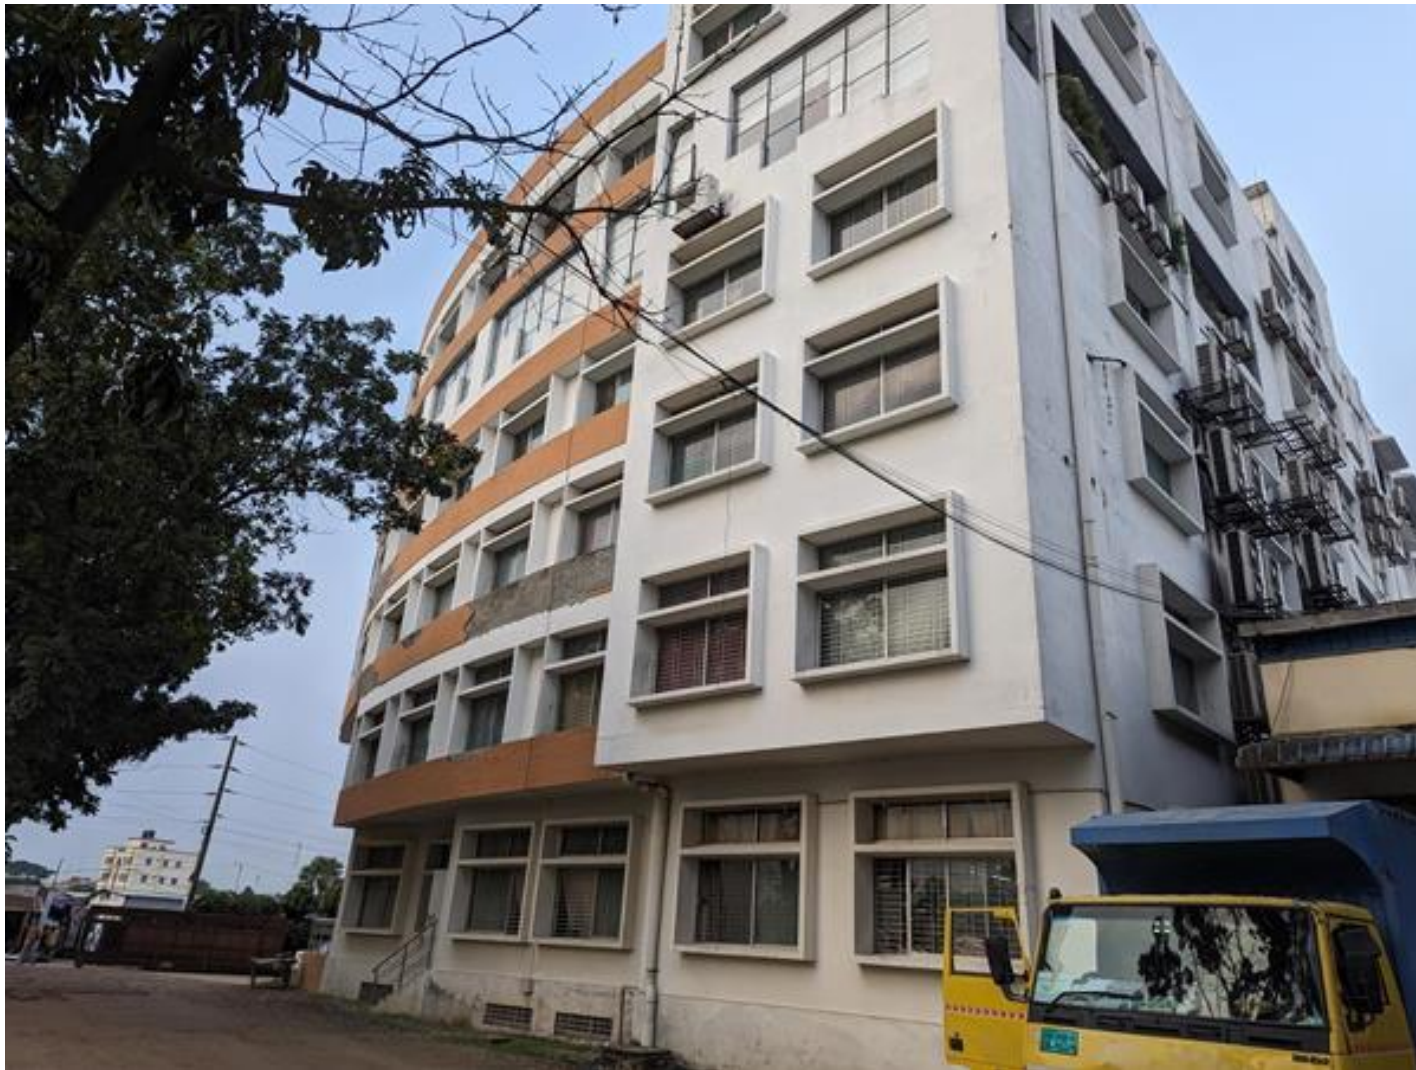
Permit drawing unavailable

Building permit was not available for this building. The factory is required to collect building permit from government approved local authority.
