# Fashion Forum Ltd (Extension 2)

53, 54 Diakhali, Zamgora Asulia Savar

17 September 2023

# Observations

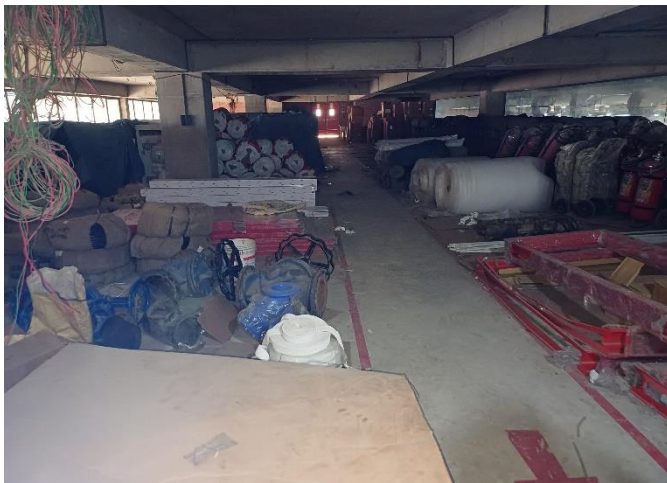
Storage on mezzanine floor

Currently, the mezzanine floor of the building is being used for a warehouse. As per BNBC, the minimum floor live load for light storage is 6 kN/m<sup>2</sup> (125 psf). But the building is being designed for 3 kN/m<sup>2</sup> live loads.

The building engineer is required to revise the floor live load plan following BNBC storage live load requirement and revise the design documents based on in-situ material strength. Verify the in-situ material strength by taking 100 mm core from lower tier columns of the building. The

| Item No. | Observation | Recommended Action Plan | Recommended Timeline |
|---|---|---|---|
| 02 | Load plan & material strength not comply with BNBC requirements. (Building 3) | Building engineer is required to revise the storage live load limit and related design documents based on BNBC requirements. | 6-weeks |
| 05 | Load plan & material strength not comply with BNBC requirements. (Building 3) | Implement the floor load plan. | 6-months |

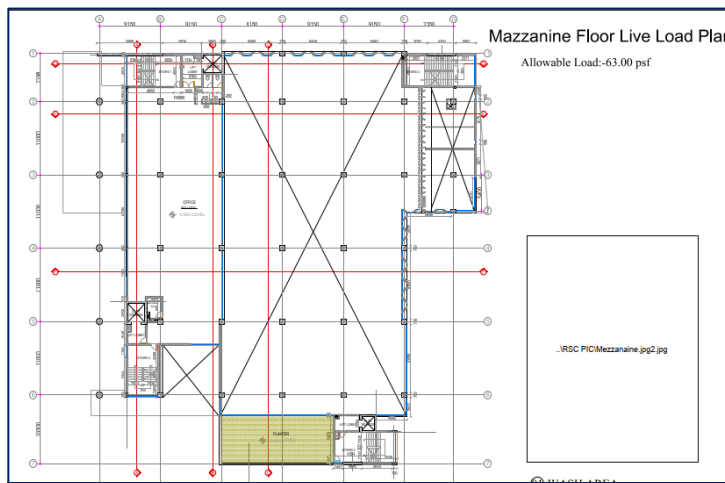
3 kPa live load for mezzanine

Moreover, the factory has provided only 4 sets of concrete cylinder test reports from the column, which doesn't comply with the frequency of testing requirement of BNBC (section-5.12.2).

| Item No. | Observation | Recommended Action Plan | Recommended Timeline |
|---|---|---|---|
| 03 | Load plan & material strength not comply with BNBC requirements. (Building 3) | Verify the in-situ material strength by taking 100 mm core from lower-tier columns. | 6-weeks |

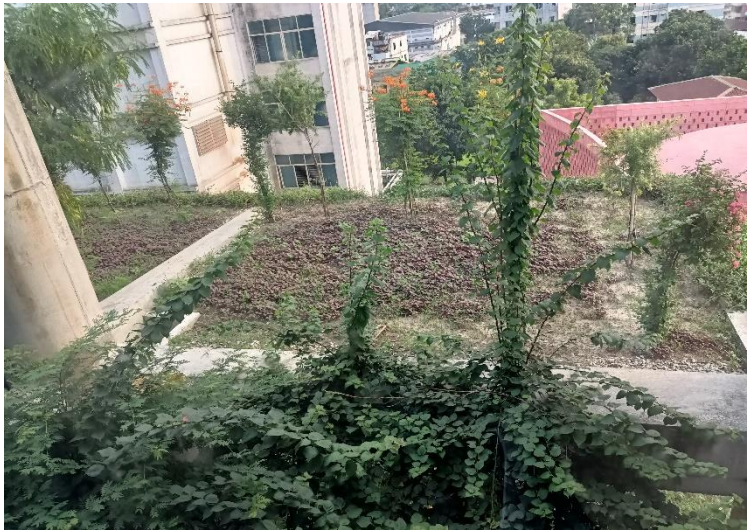
Almost 5 m cantilever porch was observed at the South and East sides of the building. The cantilever is being used for gardening purposes. The building engineer is required to check the adequacy & and deflection of the cantilever slab.

Garden at cantilever portion

| Item No. | Observation | Recommended Action Plan | Recommended Timeline |
|---|---|---|---|
| 06 | Large cantilever at South & East. (Building 3) | Building engineer is required to check the adequacy & deflection limit of the cantilever slab. | 6-weeks |
| 07 | Large cantilever at South & East. (Building 3) | Implement any remediation work if required. | 6-months |

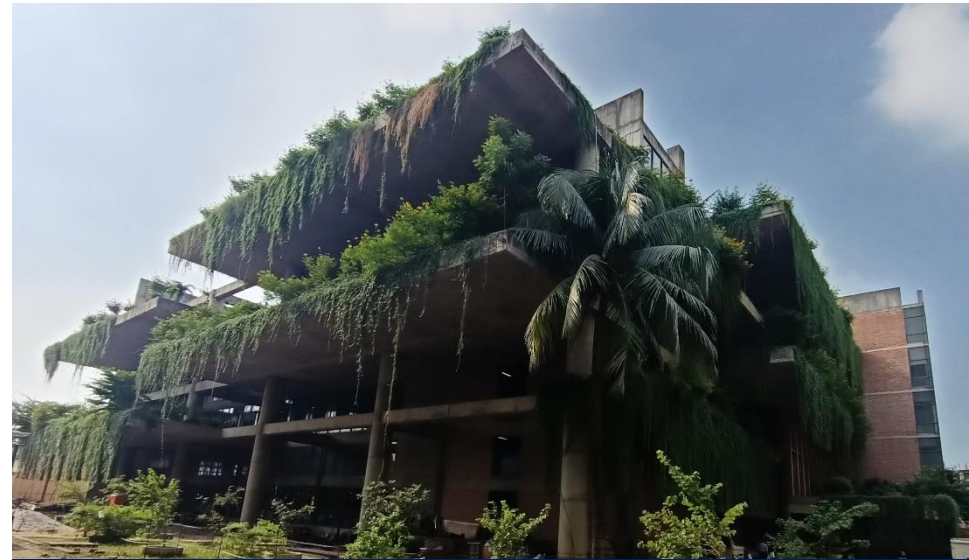
Cantilever Porch at South & East

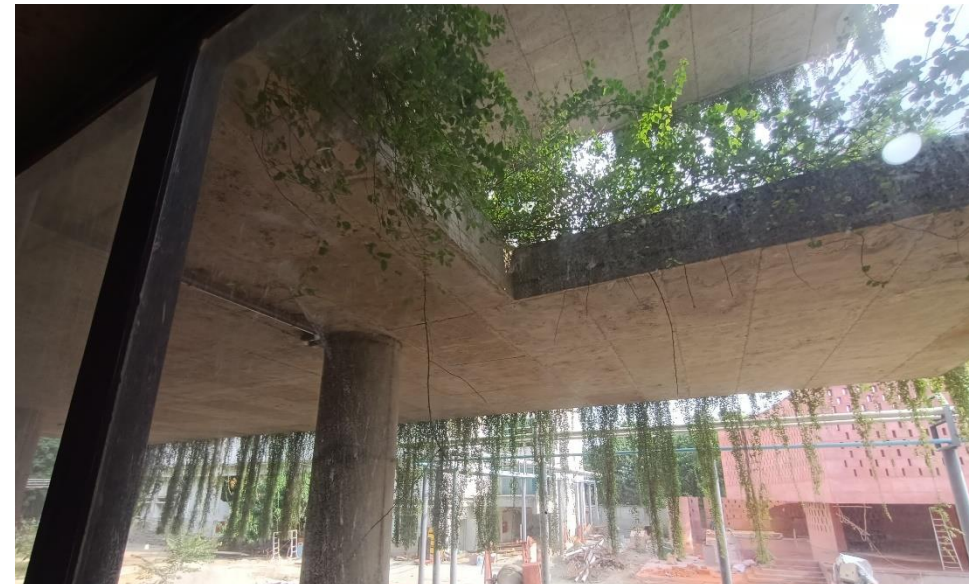
Cantilever slab

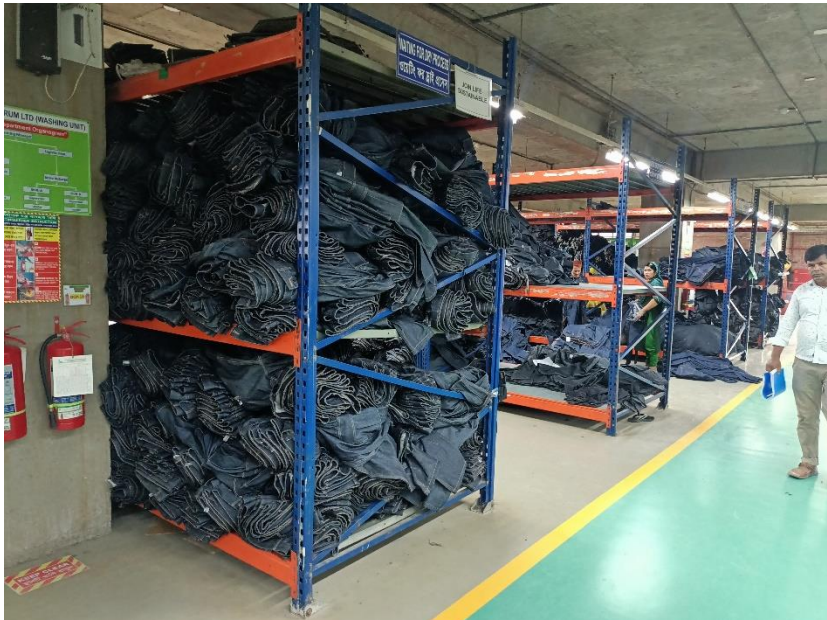
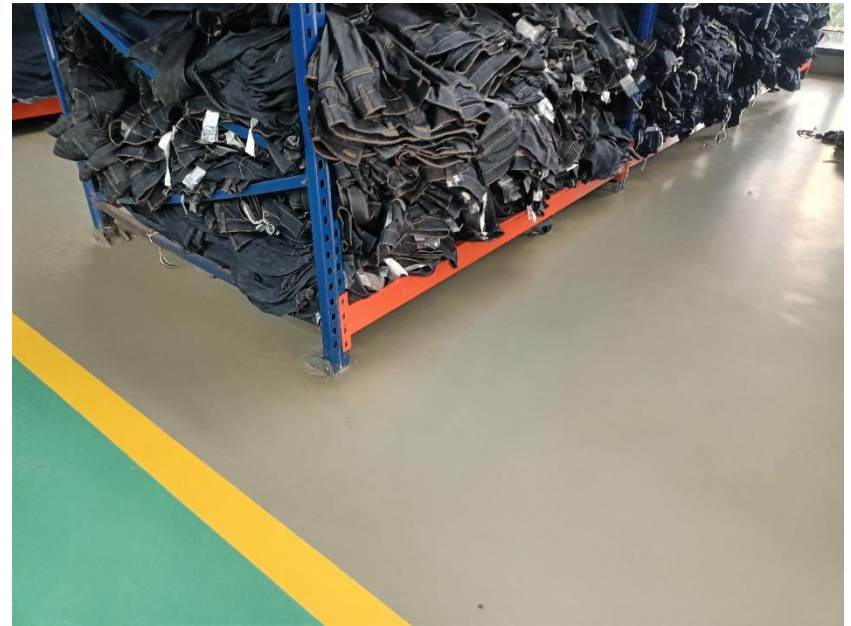
Storage racks not anchored or braced

Non-structural element storage racks not anchored or braced to resist lateral (earthquake) forces. The building engineer is required to anchor/brace all non-structural elements adequately to resist earthquake forces.

| Item No. | Observation | Recommended Action Plan | Recommended Timeline |
|---|---|---|---|
| 08 | Racks and plastic water tanks not anchored or braced. (Building 3) | Building is required to adequately anchor/brace all non-structural elements to resist earthquake forces to comply with the BNBC. | 6-months |

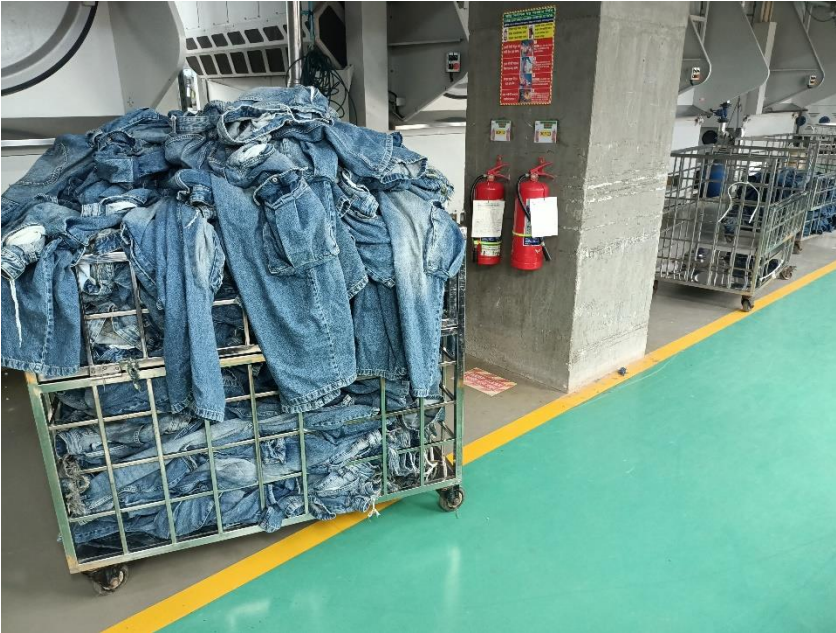
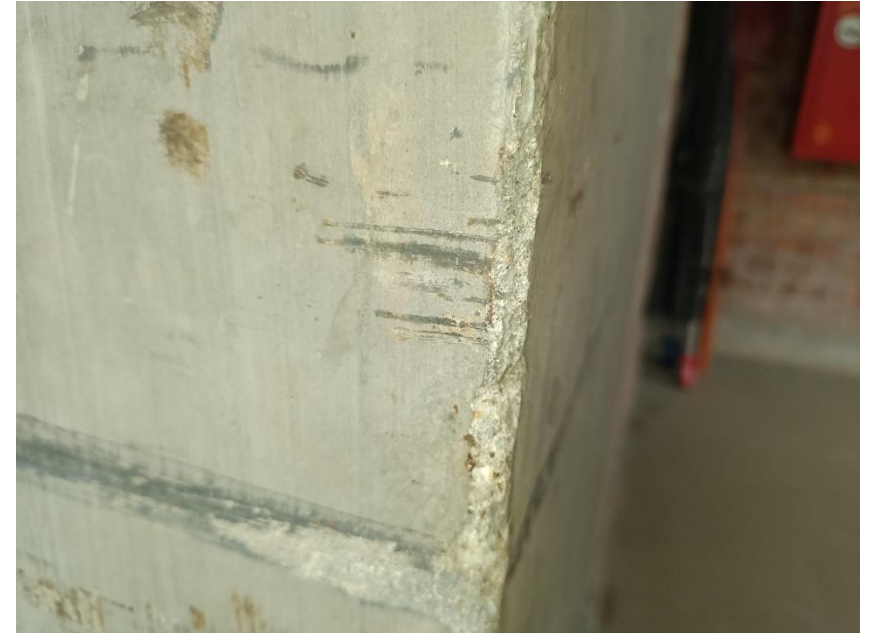
Susceptive column on floor

Column on different floors level are susceptible to trolley impact. The factory is required to provide separate barrier around the column to avoid possible trolley impact.

| Item No. | Observation | Recommended Action Plan | Recommended Timeline |
|---|---|---|---|
| 09 | Column susceptible to trolly impact. (Building 3) | Building engineer is required to provide a safety barrier around the column to avoid possible trolly impact. | 6-months |

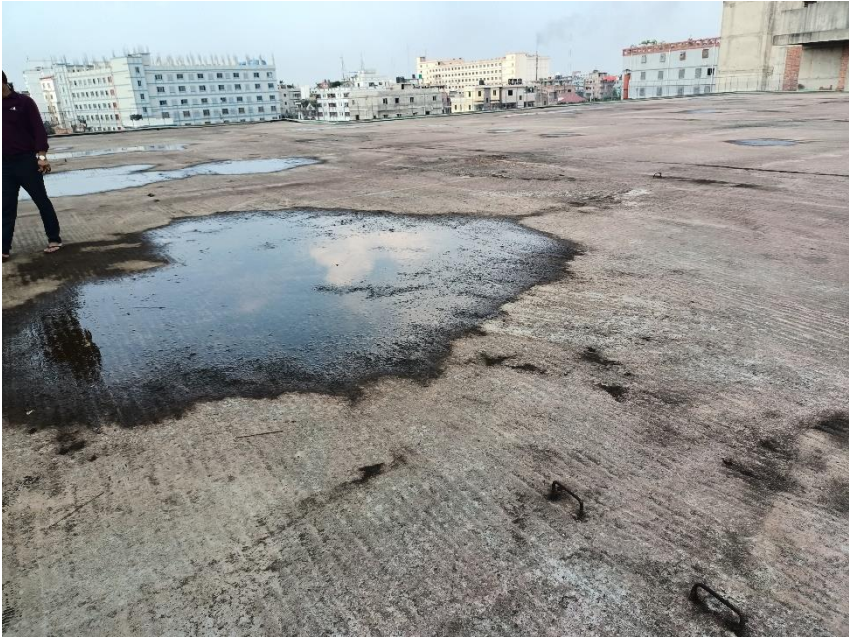
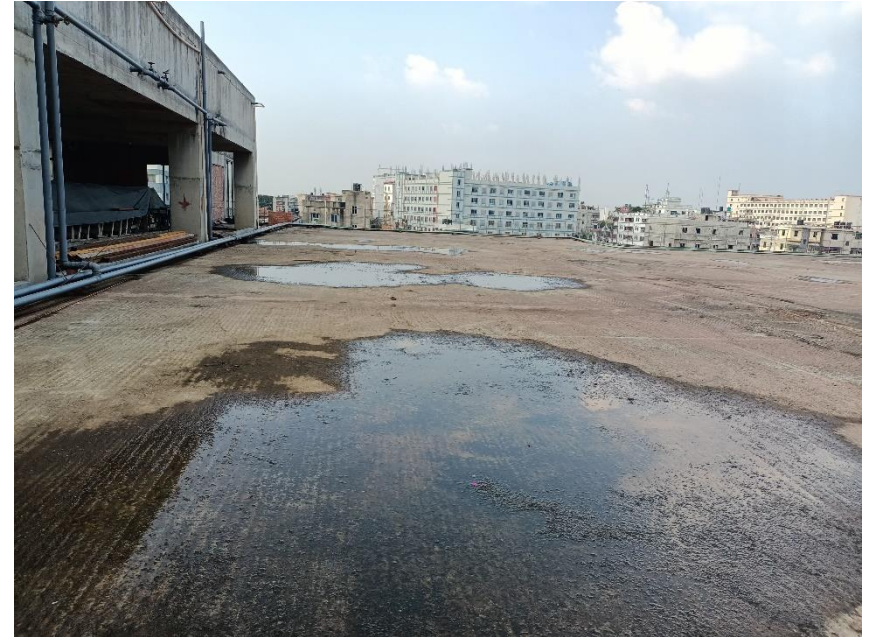
Sign of water clogging on the roof

Sign of water clogging on the roof was observed that indicates improper drainage system. Building engineer is required to provide proper slope and sufficient discharge point on the roof.

| Item No. | Observation | Recommended Action Plan | Recommended Timeline |
|---|---|---|---|
| 10 | Improper drainage on the roof. (Building 3) | Building engineer is required to provide a proper slope and the adequate number of discharge points on the roof. | 6-months |
