Reaz Knitwear Ltd.

Holding#163, Block-B, Hatimara, Kashempur, Gazipur
(23.990488, 90.298408)
11 September 2023

Observations

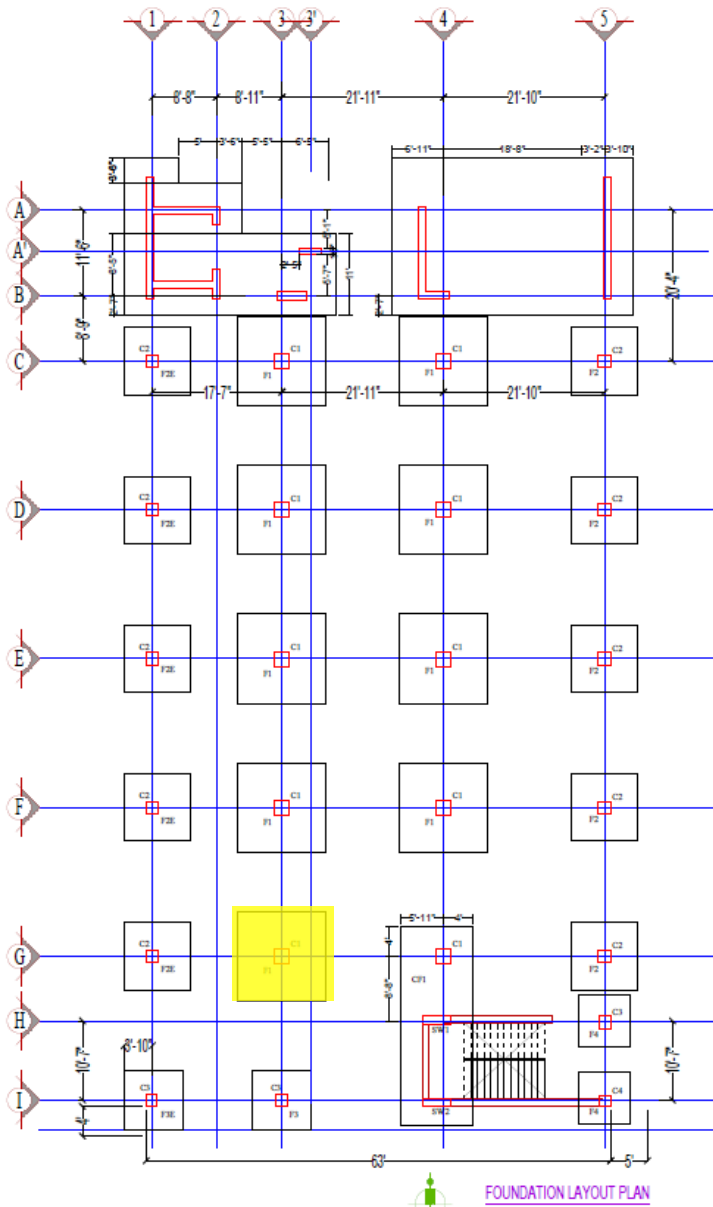
Foundation layout.

Stress in foundation above normal design limit

Cursory calculation indicates that stress in foundation exceeds normal design limit in highlighted foundation (marked in the layout) considering live load as per BNBC 2006 and bearing capacity from geotechnical investigation report. Building engineer is required to review the design, load and

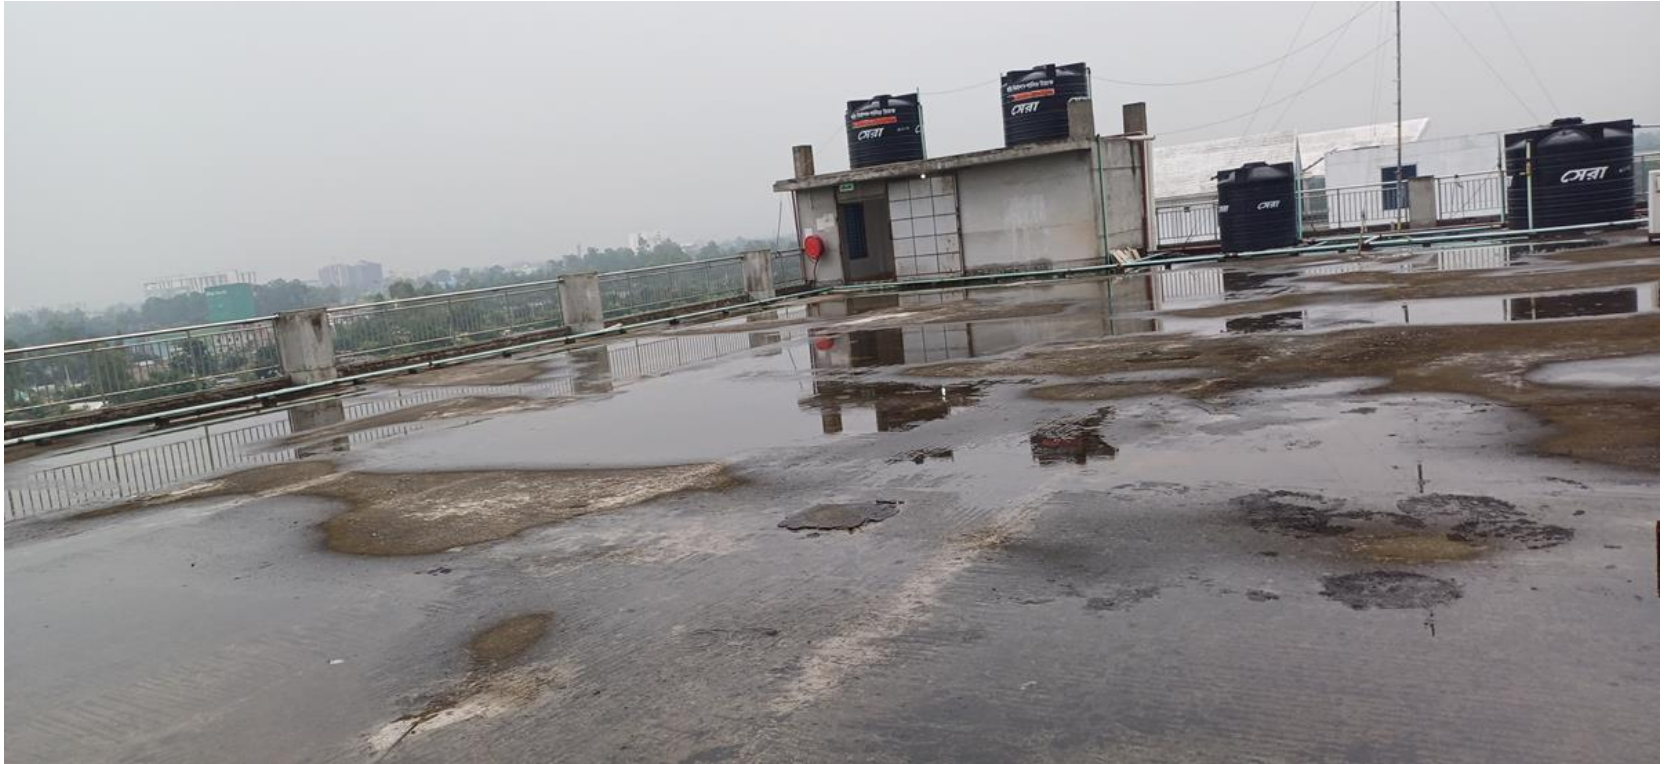
Water ponding on the roof

Water ponding observed on the roof slab due to poor drainage system. The building engineer is required to develop proper drainage system with adequate sloping on

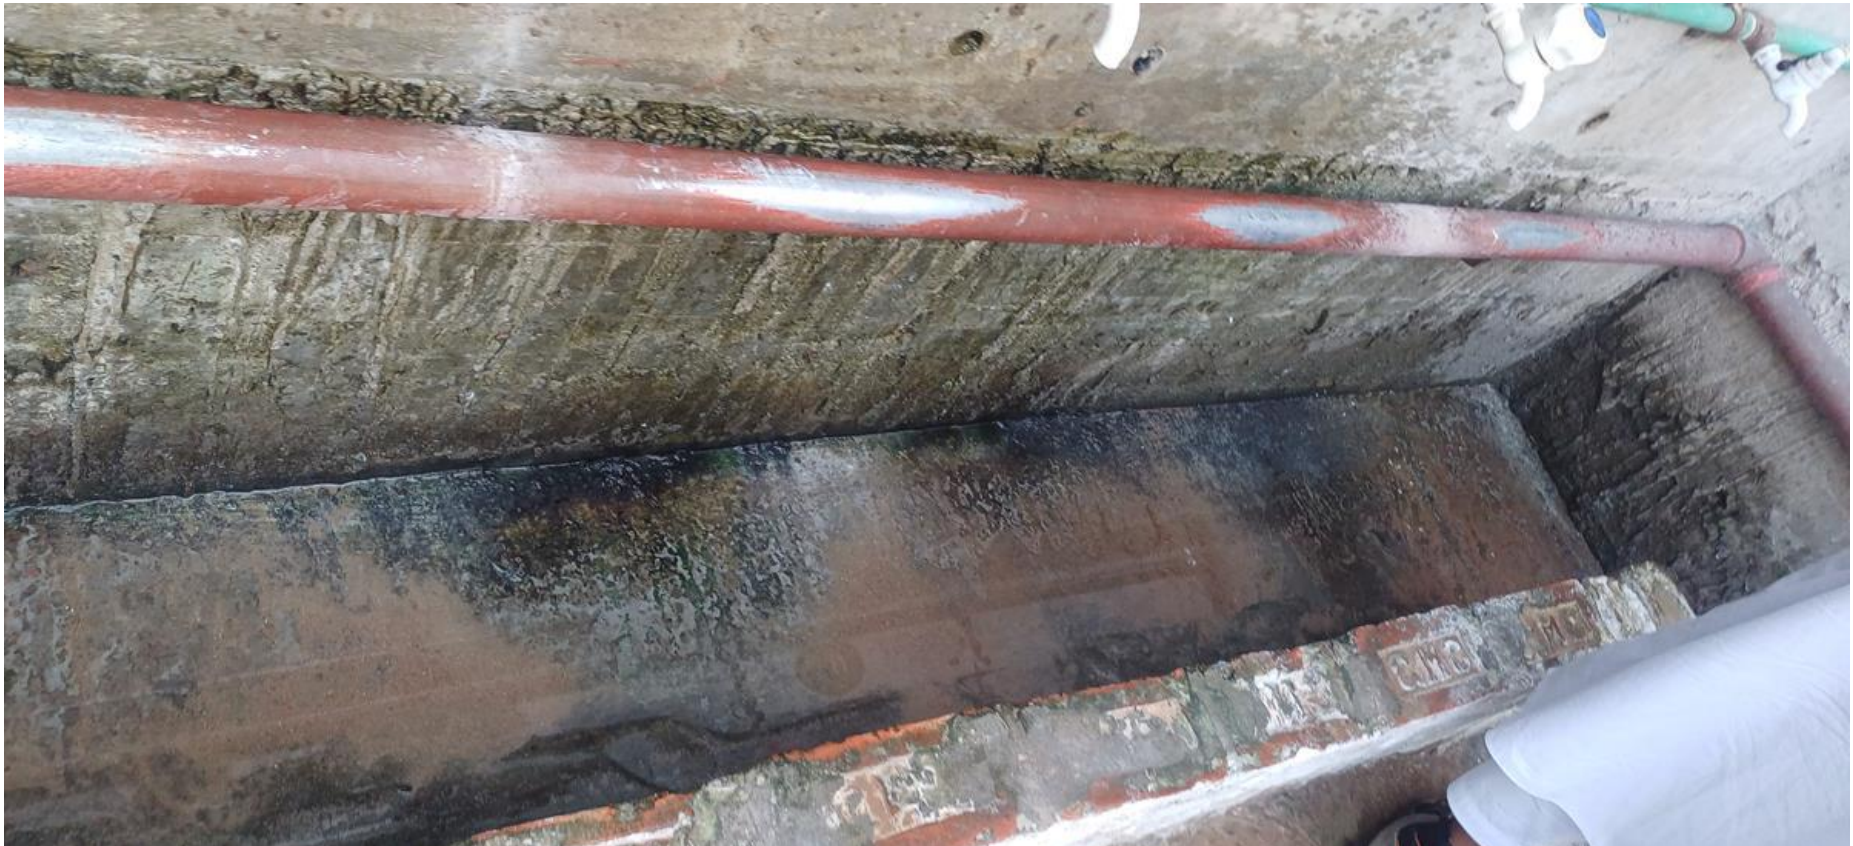
Dampness in shear walls

Dampness on outer face of shear walls

The building engineer is required to investigate the source of dampness and suggest proper remedial actions accordingly.

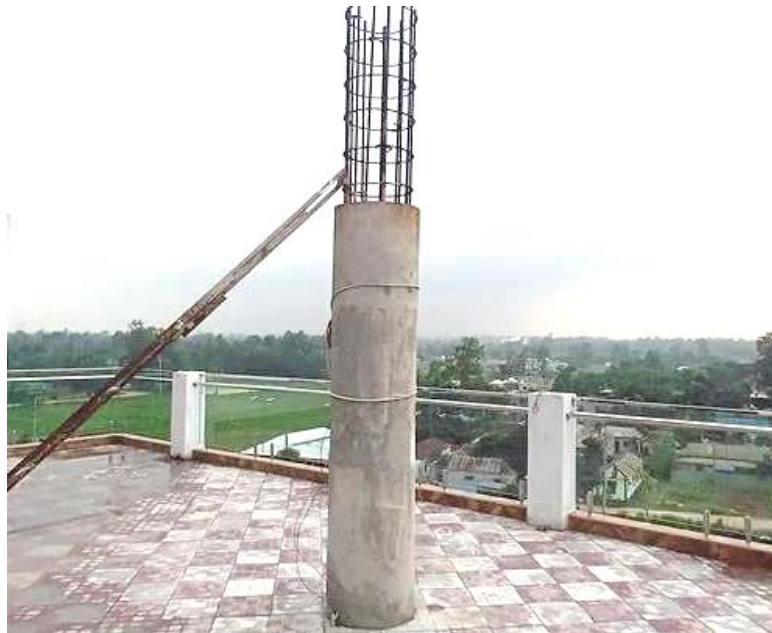
Expose rebar at roof top column

Exposed rebar at roof top column

Exposed rebars were found at roof top column. Building engineer is required to take proper measure to protect the rebar.

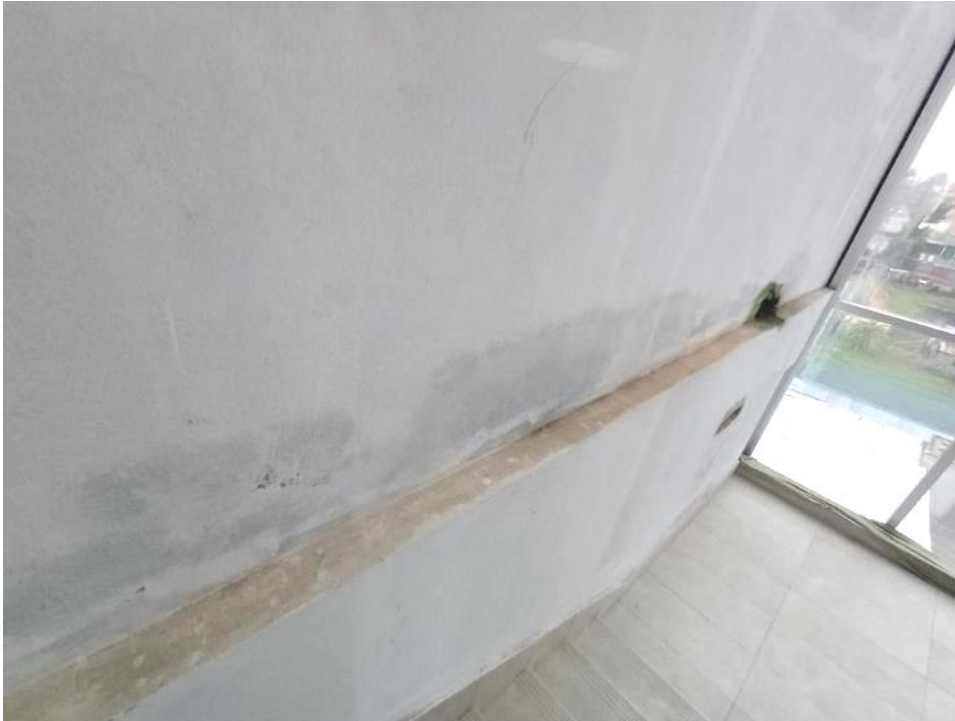
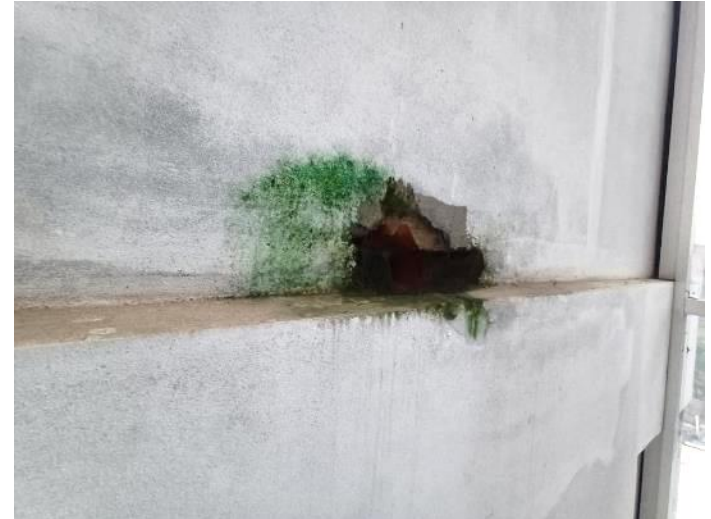
Dampness on exterior walls

Dampness on brick wall

Building engineer is required to seal the source of water and repair the damped area with suitable method.

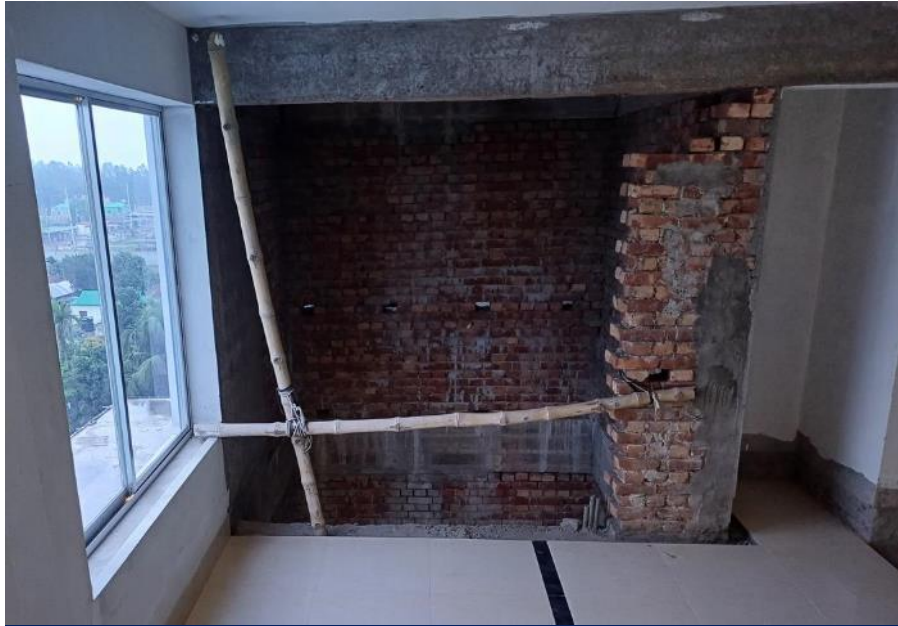
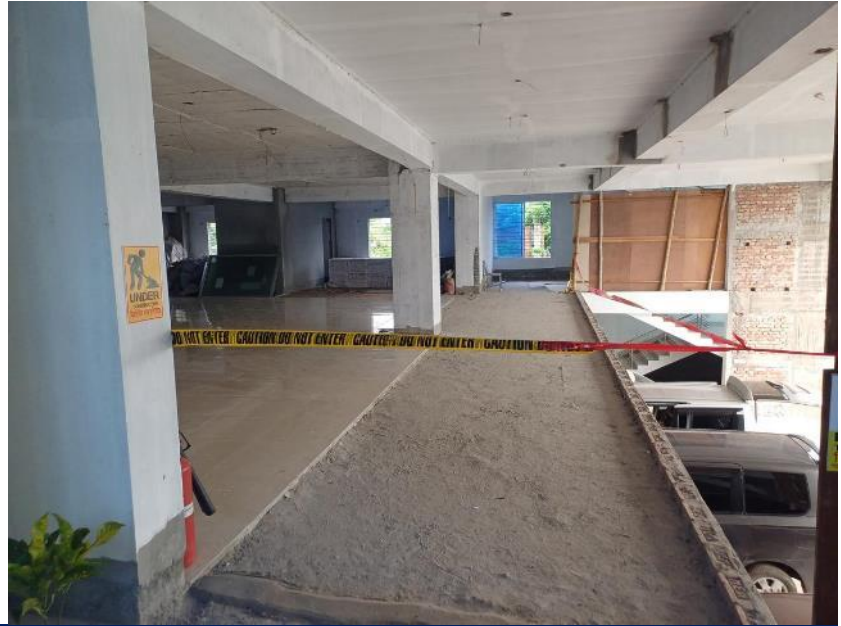
Falling Hazard

Falling hazard from lift core & 1st floor

Falling hazard observed in the lift core & 1st floor. Building engineer is required to take necessary measures to avoid possible falling hazard.

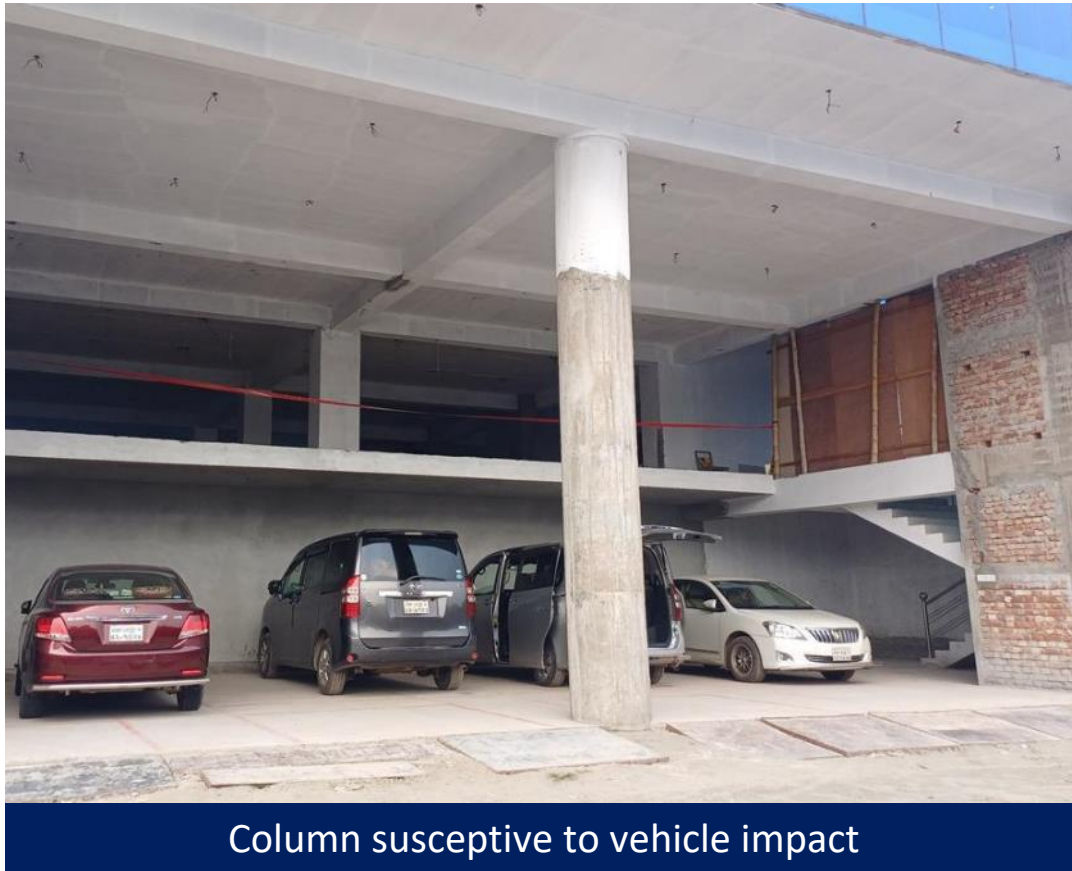
Column susceptible to vehicle impact

A column in the west direction of the building was found adjacent to the driveway of parking. This column is susceptible to vehicle impact. The factory engineer is required to take necessary measures to prevent the vehicle impact by providing the barrier around the column.

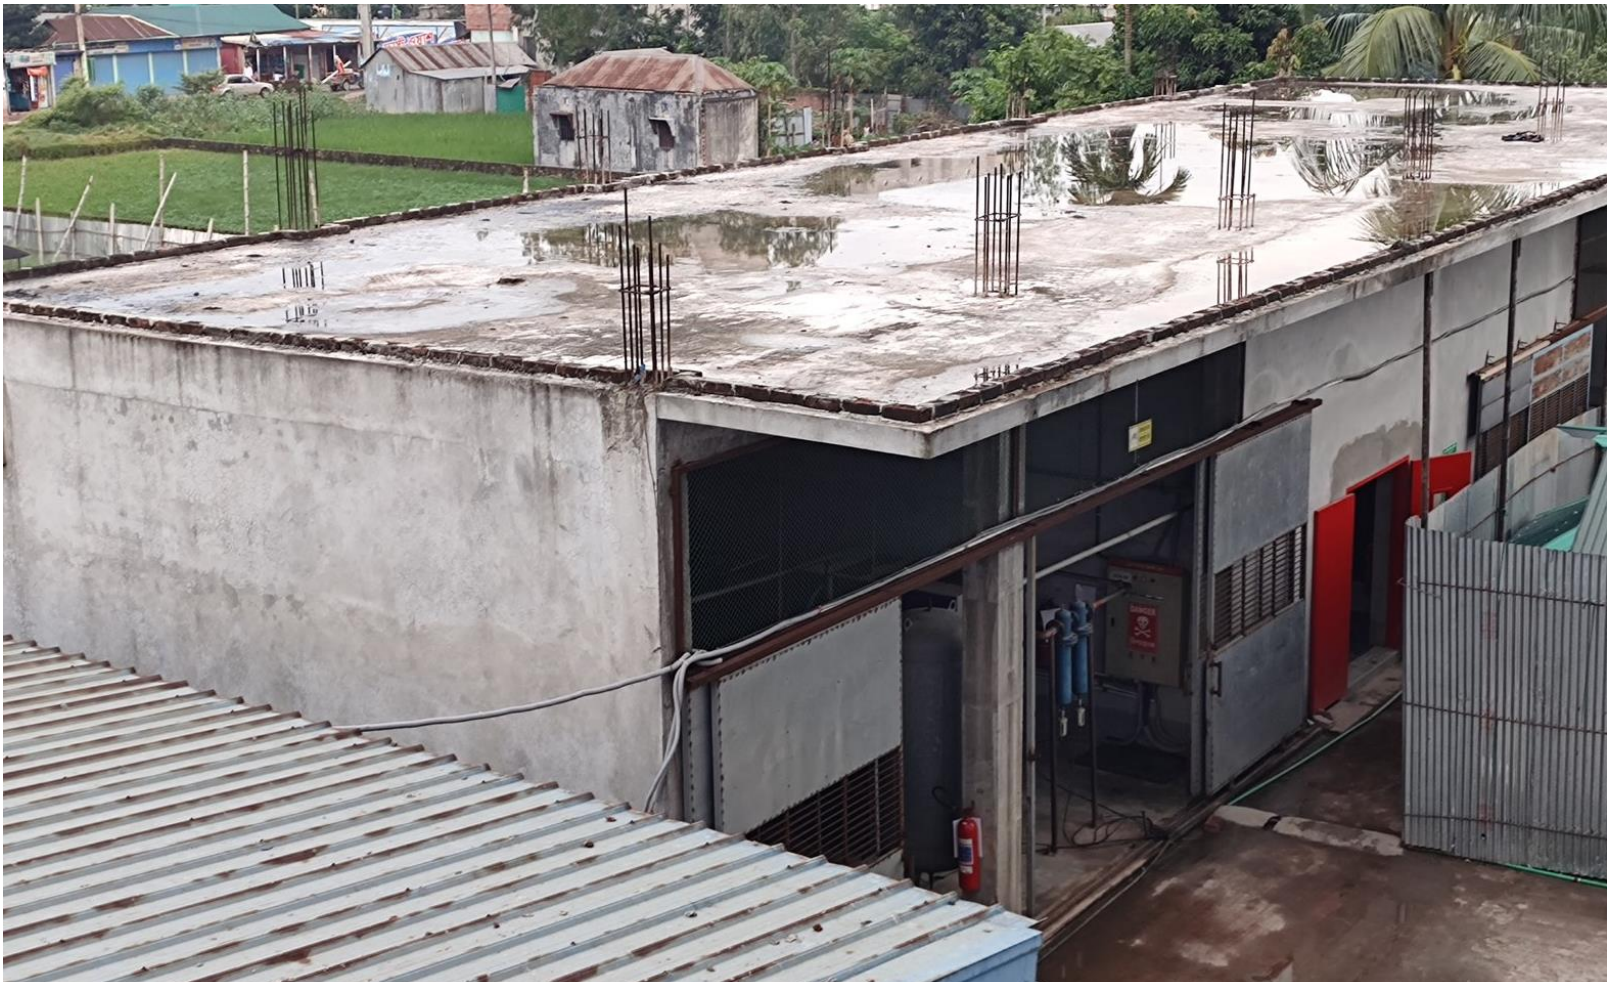
Water ponding and exposed rebar on the roof

Water ponding and exposed rebar on the roof.

Exposed rebars were found at roof top column. Building engineer is required to take proper measure to protect the rebar. Also, develop proper drainage system to remove water ponding on roof.

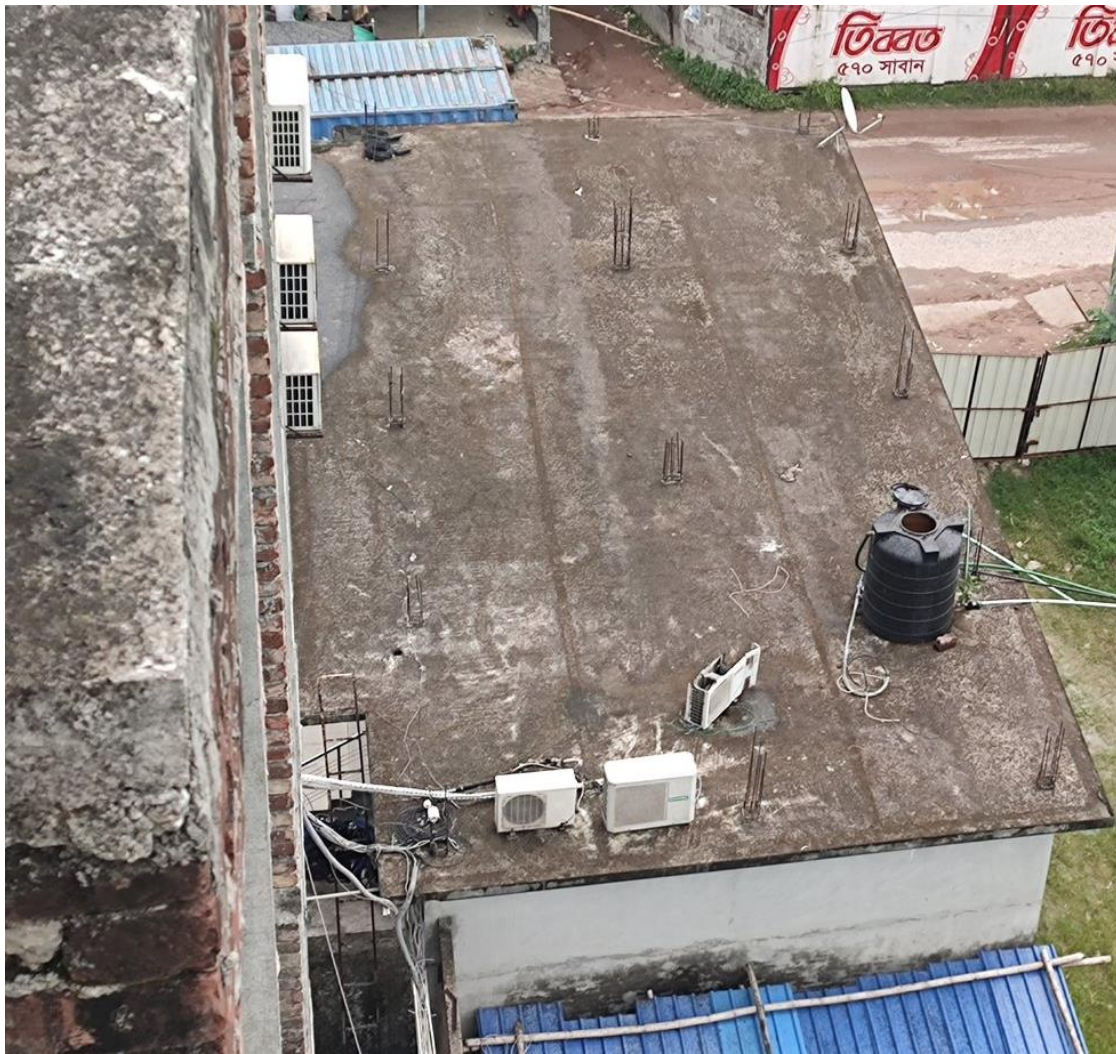
Exposed rebar at roof top column

Exposed rebar on roof

Exposed rebars were found at roof top column. Building engineer is required to take proper measure to protect the rebar.

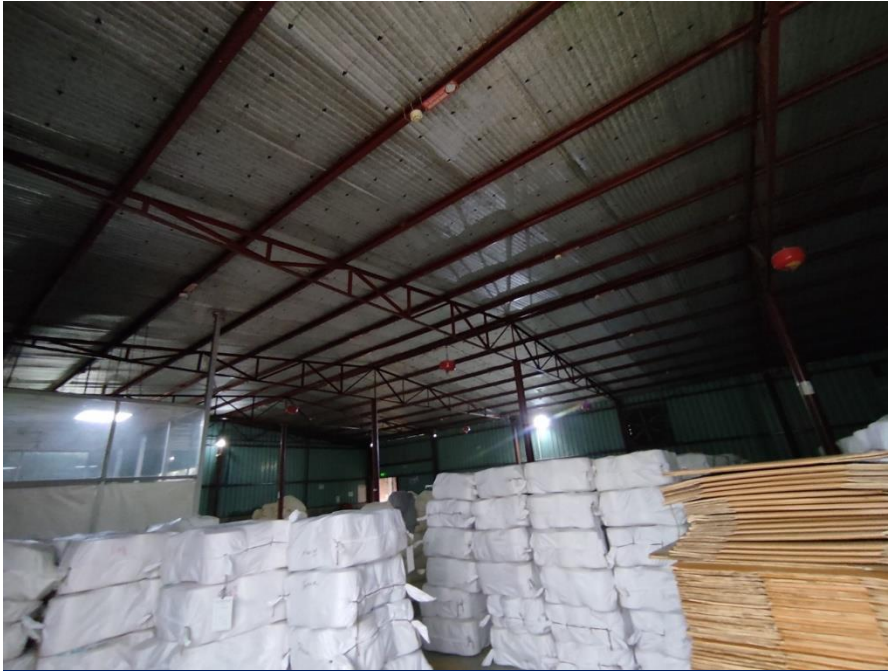
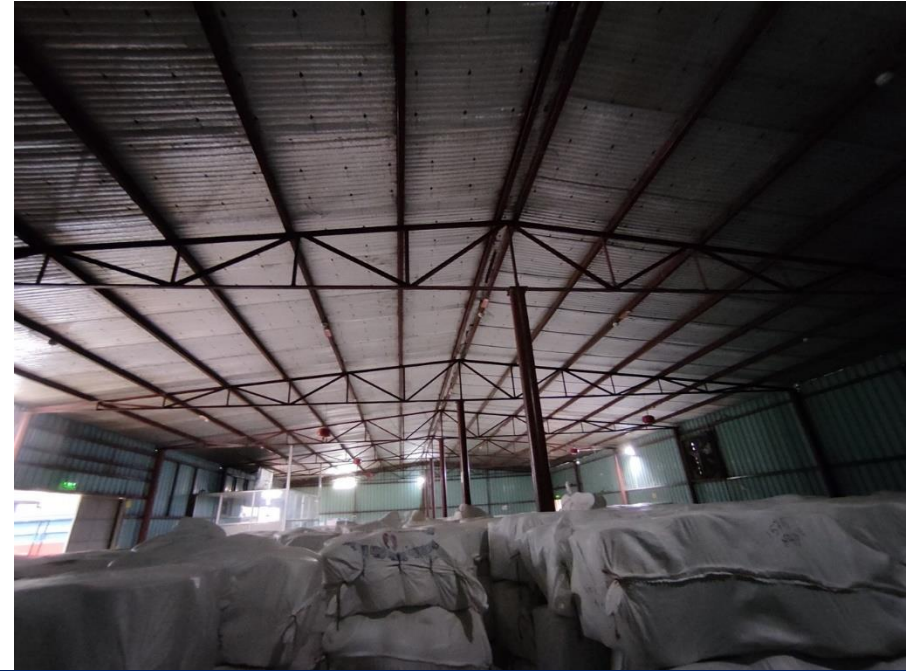
Lack of lateral stability system

No compression or vertical bracing observed

No vertical bracing and compression strut was observed in the structure that indicates the lateral load path is not logical in long direction against lateral loading. Building engineer is required to check the lateral stability of the structure and connection adequacy.

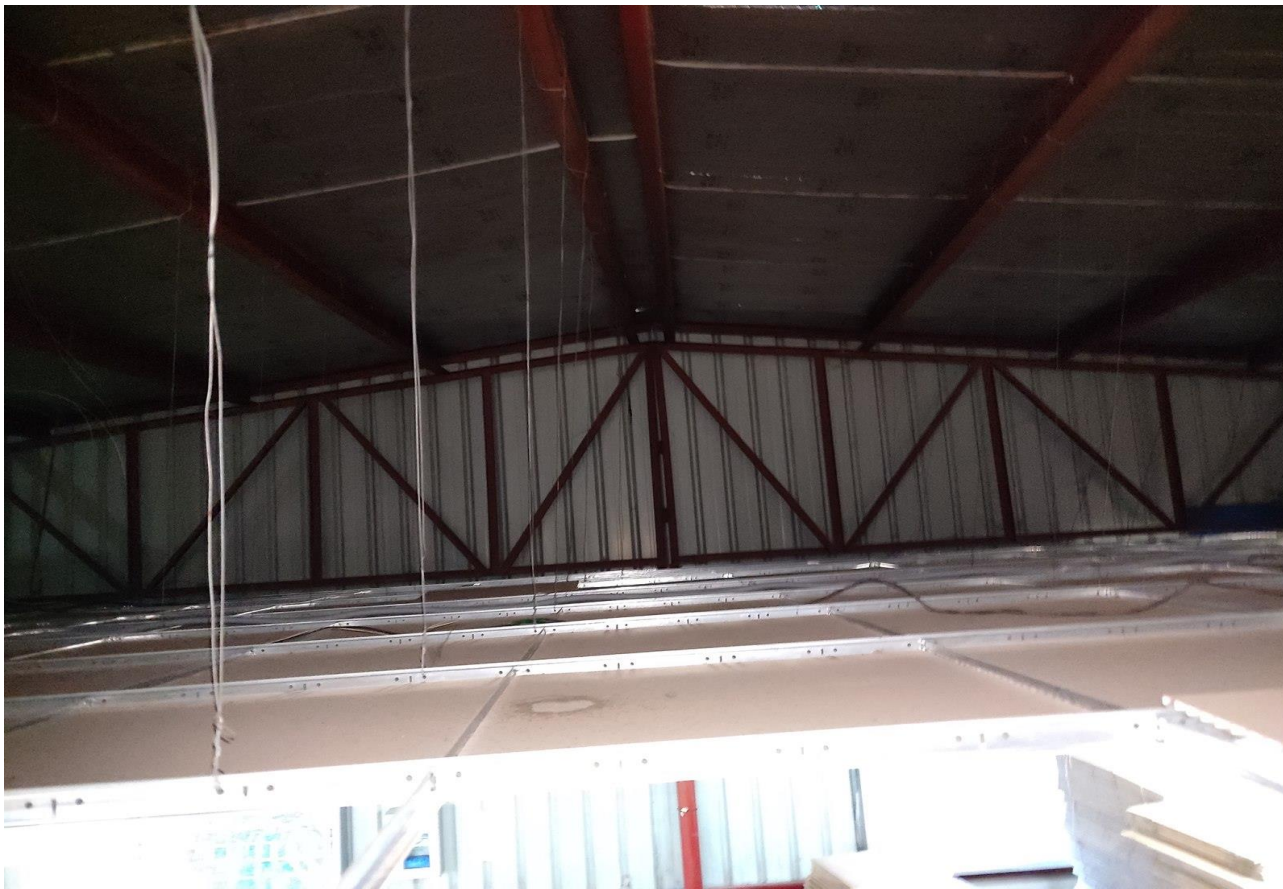
Lack of stability of roof truss

Absence of load transfer media (strut) and load resisting (bracing) system

No horizontal bracing and compression strut was observed in the roof which indicates the lack of lateral stability of the roof trusses. Also, the truss member sizes seems to be inadequate. The building engineer is required to check the overall stability of the structure for lateral loading and suggest necessary remedial action accordingly.

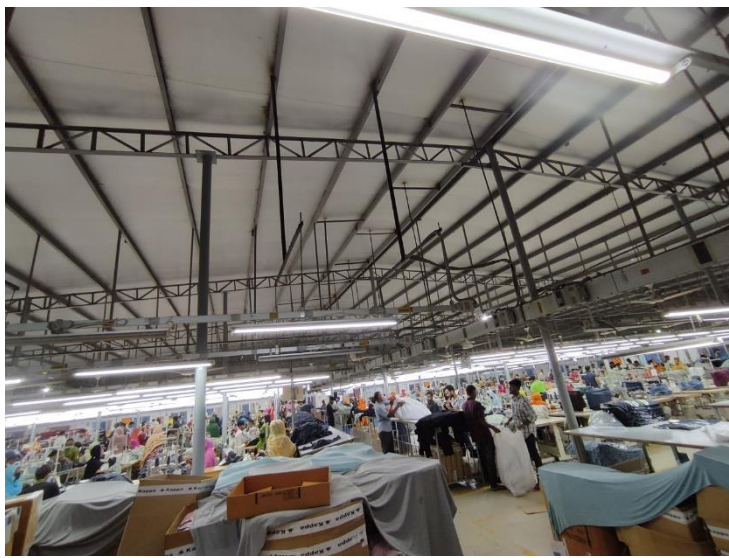
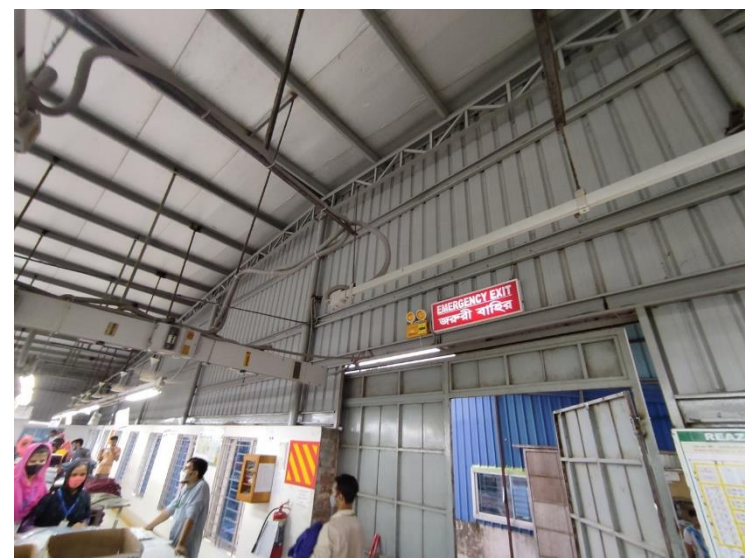
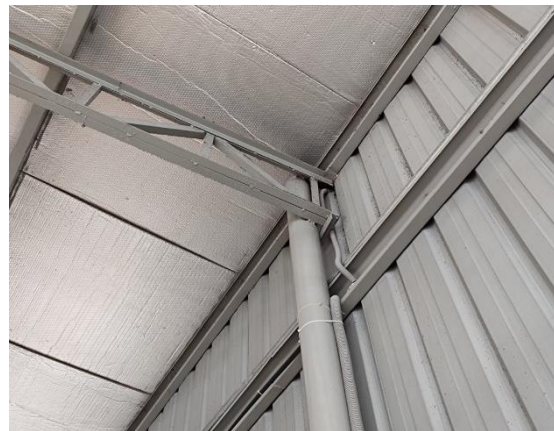
Lack of stability of roof truss

Absence of load transfer media (strut) and load resisting (bracing) system

No horizontal bracing and compression strut was observed in the roof which indicates the lack of lateral stability of the roof trusses. Also, the truss member sizes seems to be inadequate. The building engineer is required to check the overall stability of the structure for lateral loading and suggest necessary remedial action accordingly.

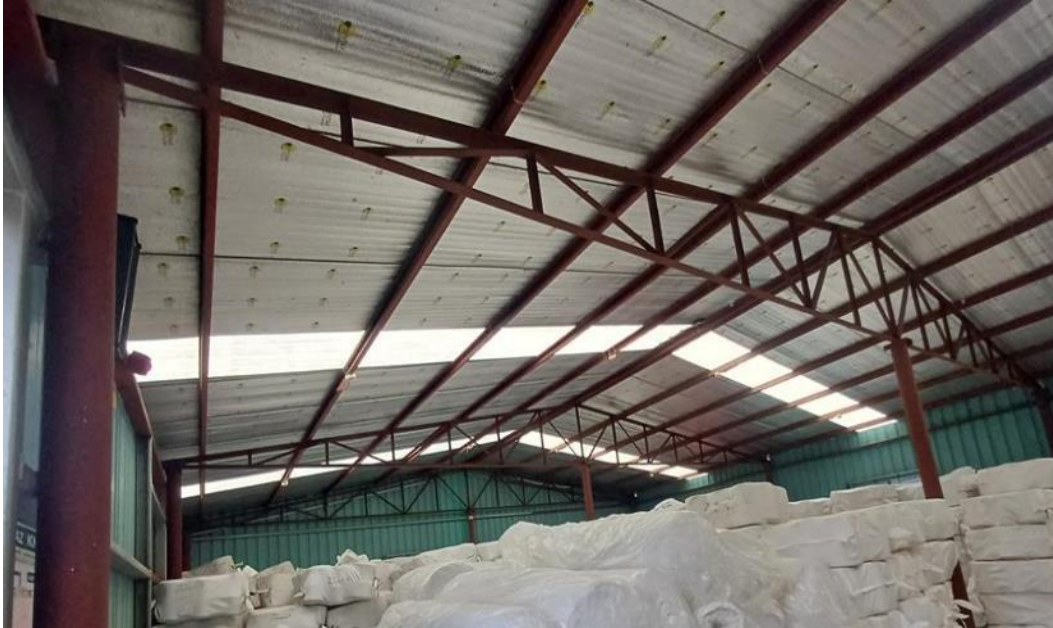
Lack of lateral stability of roof truss

No load transfer media & bracings at roof

No bracing system was observed along transverse direction of roof truss. Also, the connection between steel column and steel roof truss was improper. The building engineer is required carry out Engineering Assessment (EA) to check the connection & lateral stability of the structure and suggest proper remedial actions accordingly.

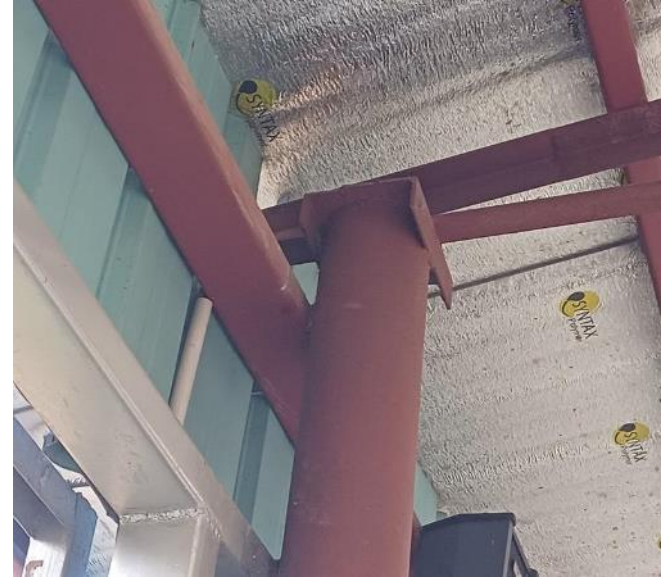
Improper connection between steel column and steel roof

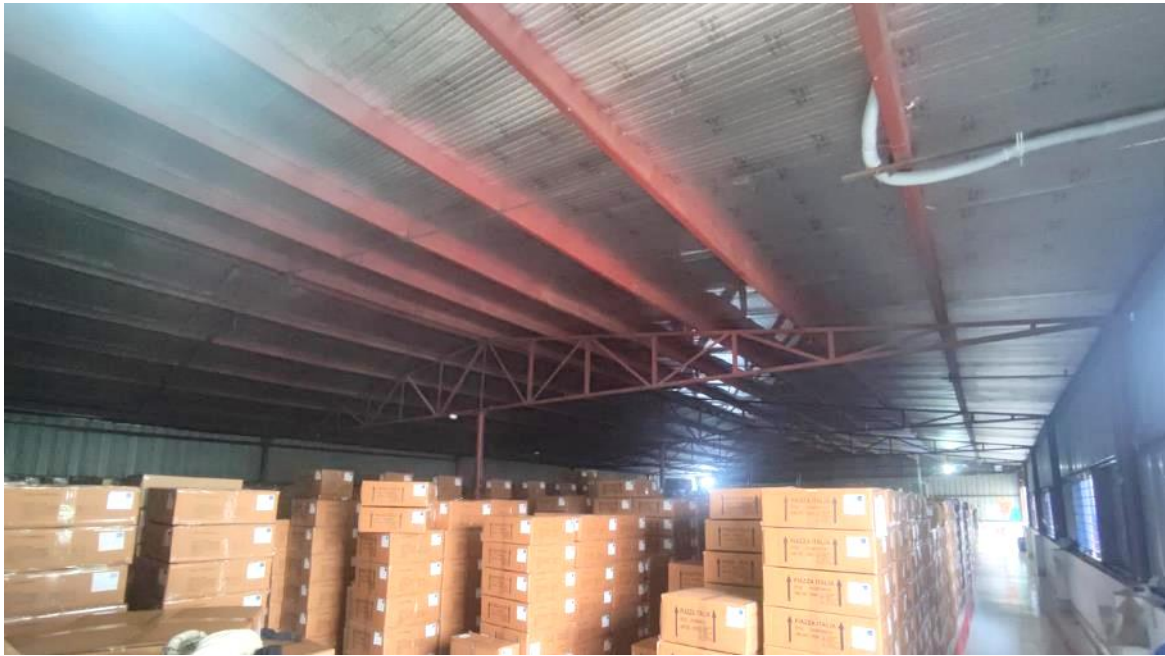
Lack of lateral stability system

Absence of load transfer media along transverse direction and absence of bracing

No bracing system was observed along transverse direction of roof truss. Also, the connection between steel column and steel roof truss was improper. The building engineer is required carry out Engineering Assessment (EA) to check the connection & lateral stability of the structure and suggest proper remedial actions accordingly.

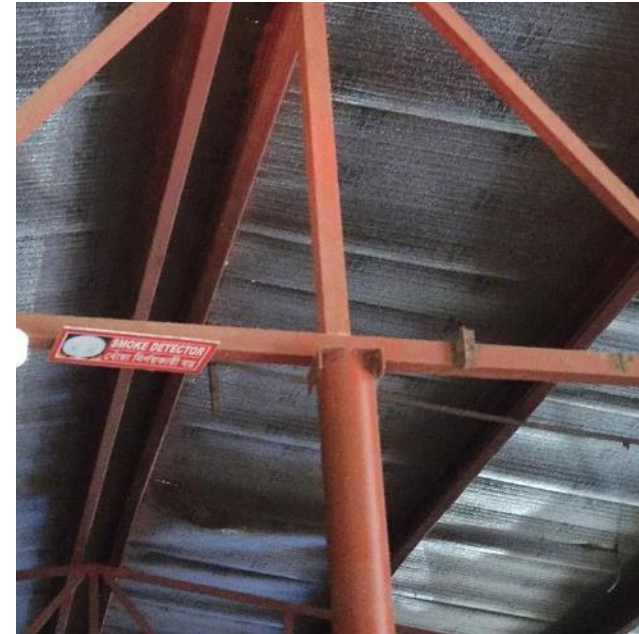
Improper connection between steel column and steel roof

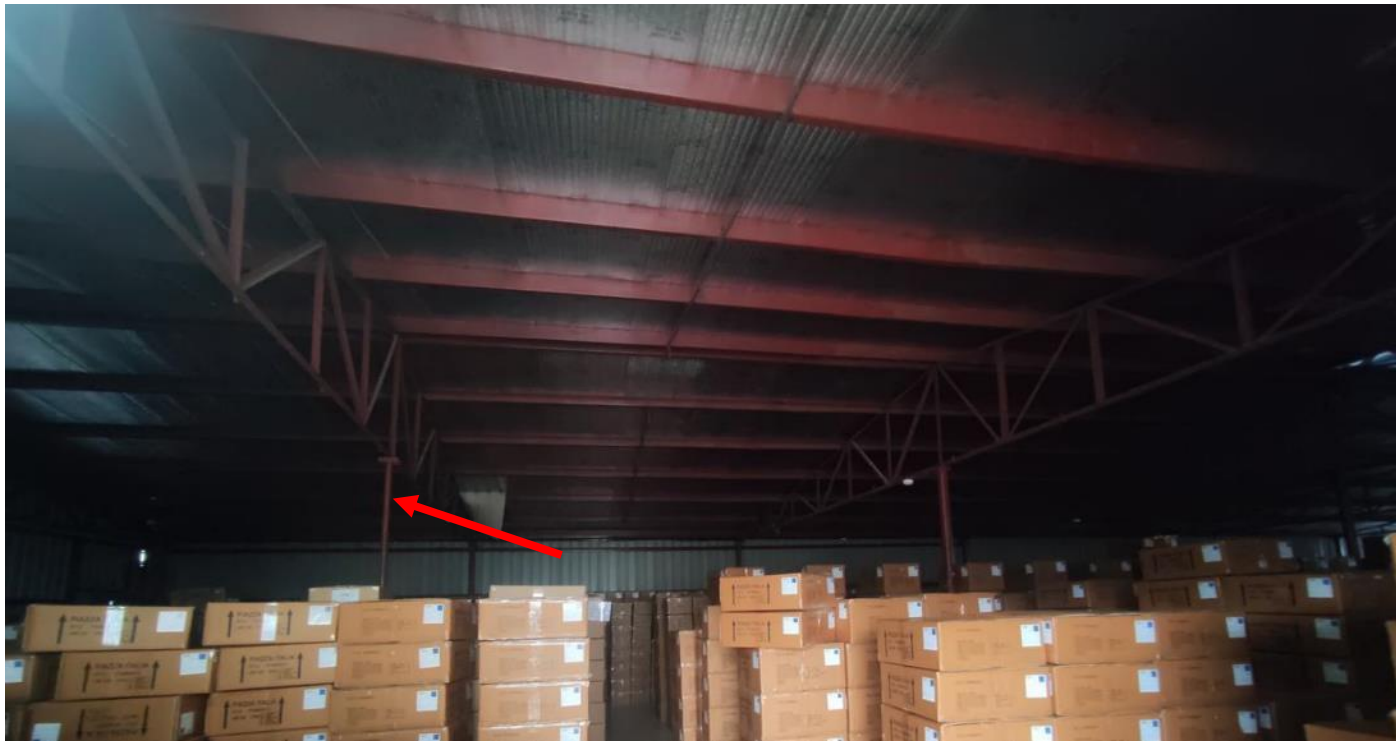
Slender pipe column (63mm steel pipe) at the center of truss

Slender pipe column (63mm steel pipe) was observed at the center of roof truss. The building engineer is required to carry out Engineering Assessment (EA) to check the adequacy of slender pipe column and suggest proper remedial actions accordingly.

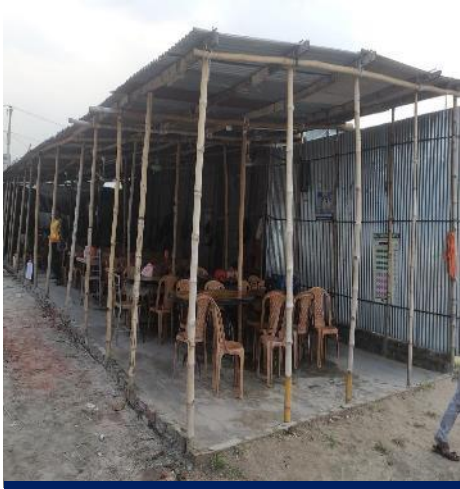
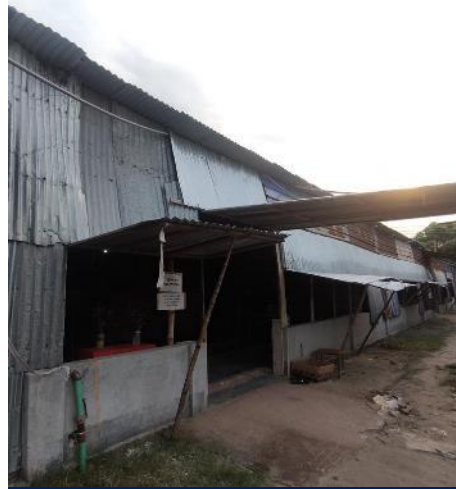
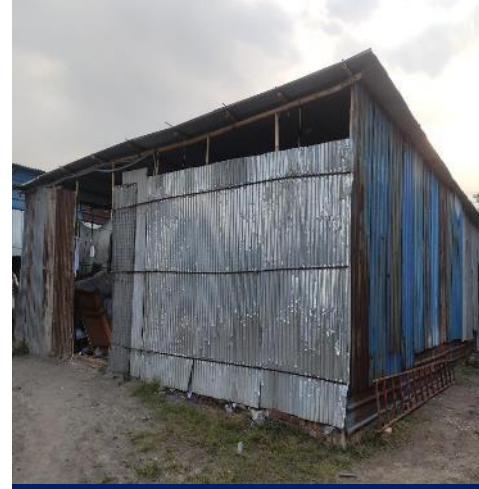
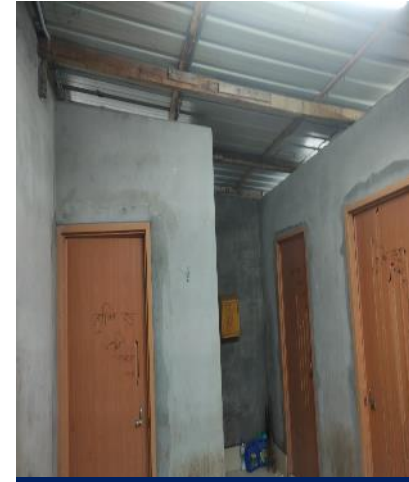
Apparently non-engineered structure

Ancillary 2,3,4 & 5 are bamboo structure & the stability system of these structures are apparently non-engineered. The building engineer is required to suggest proper alternatives to make the structure adequate and prepare necessary design documents accordingly. Otherwise, the factory is required to replace the building with well-designed structure.

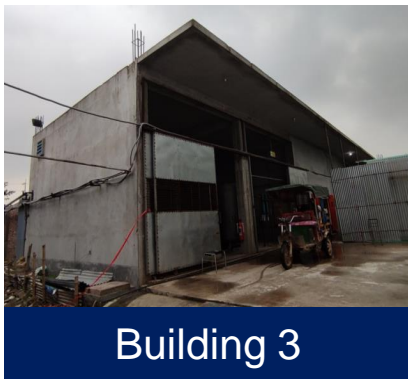
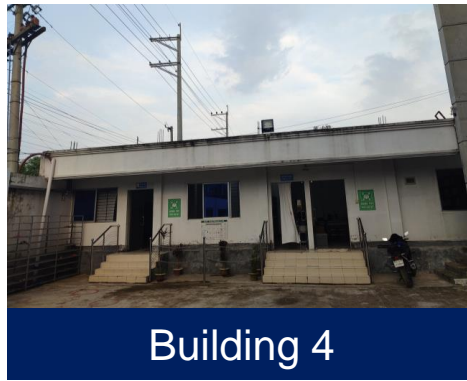
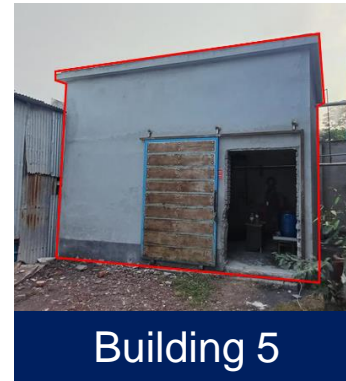
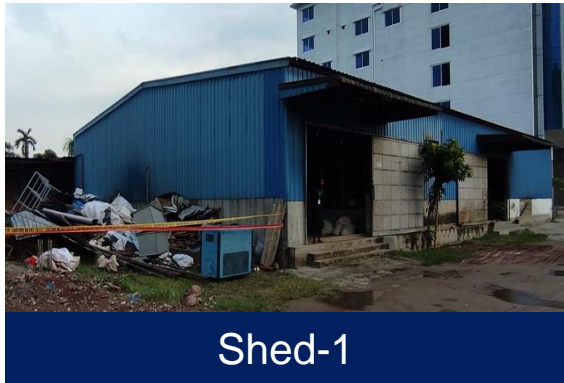
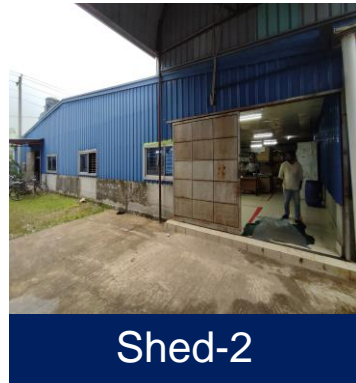
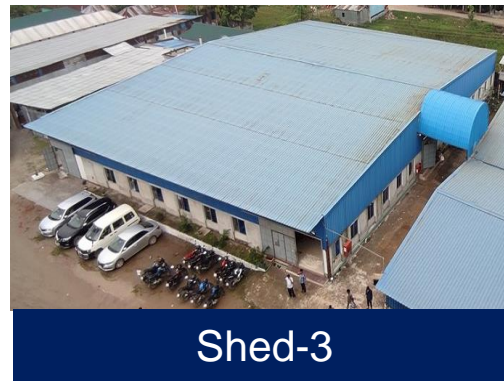
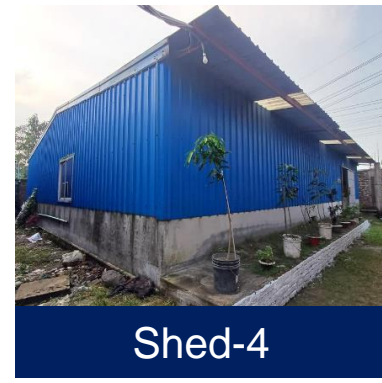
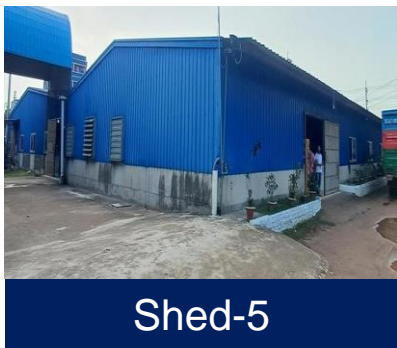
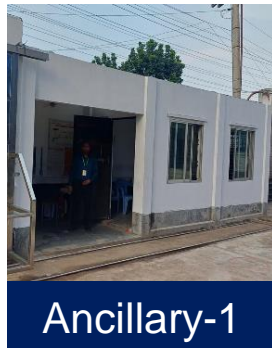
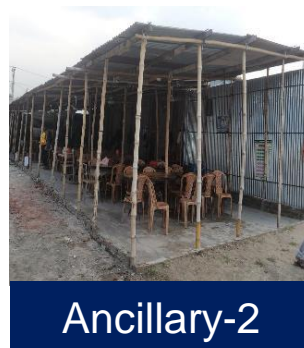
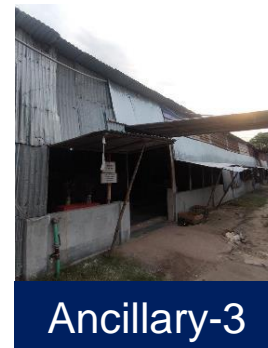
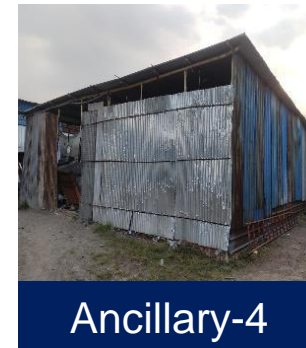
Lack of building permit

Building permit drawing was not available for the mentioned structure. The factory is required to collect building permit from BNBC prescribed local building permit authority.

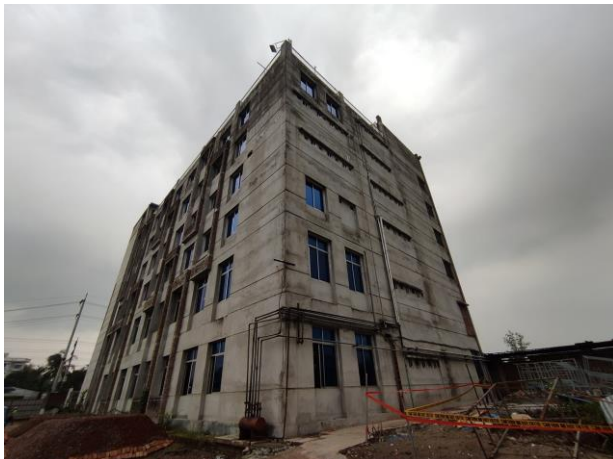
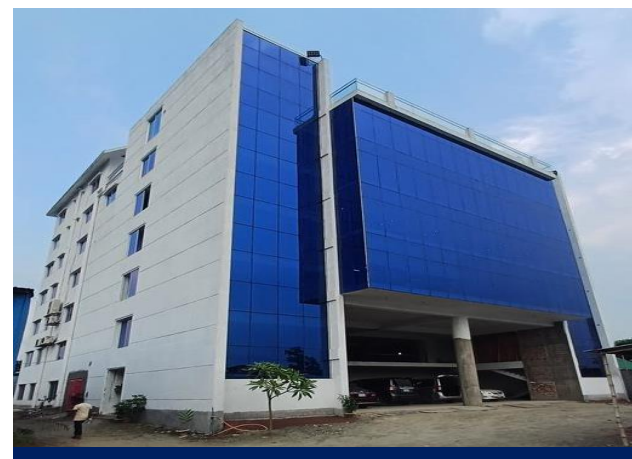
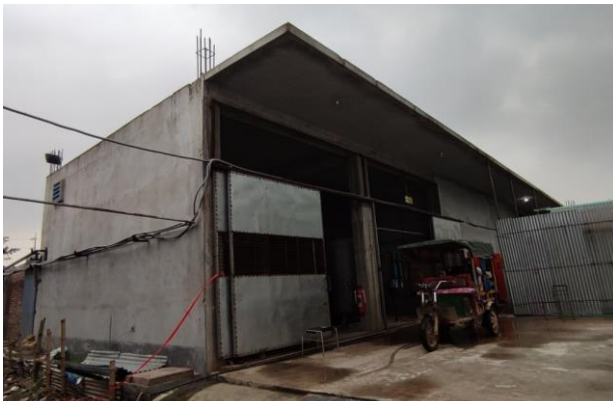
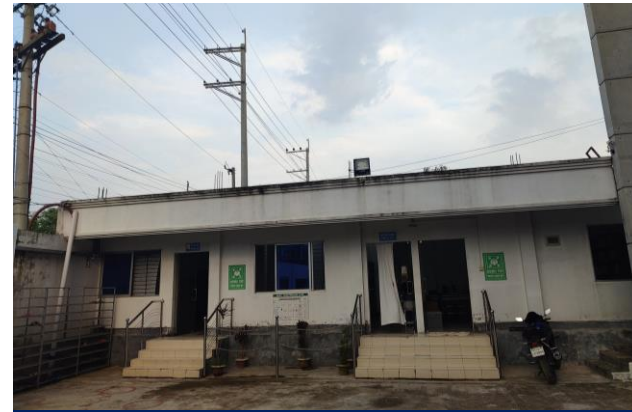
Absence of design documents

As per BNBC, every building or structure designed shall have its design documents prepared in accordance with the provision of Section 1.9.1, part-6 of BNBC. The design document shall include a design report, and a set of structural drawings, which shall be prepared in compliance with section 1.9.1.1 and section 1.9.1.2 as per BNBC. During inspection design report was not found which is required to be prepared in compliance with section 1.9.1.1 (part-6, BNBC).
