# Life Textile Pvt. Ltd (Extension)

BSCIC Industrial Estate, Konabari, Gazipur  
(24.009262N, 90.322270E)

18-Sep-2023

# Observations

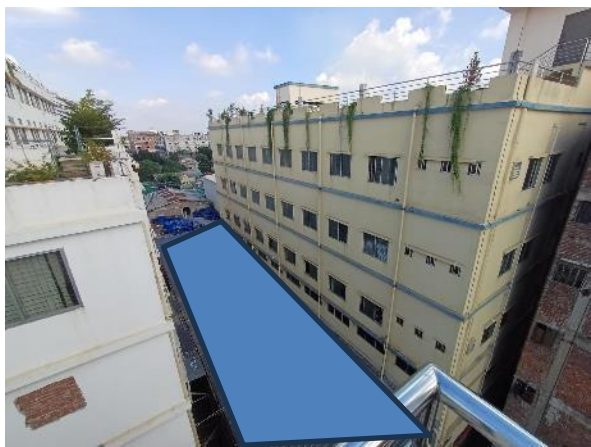
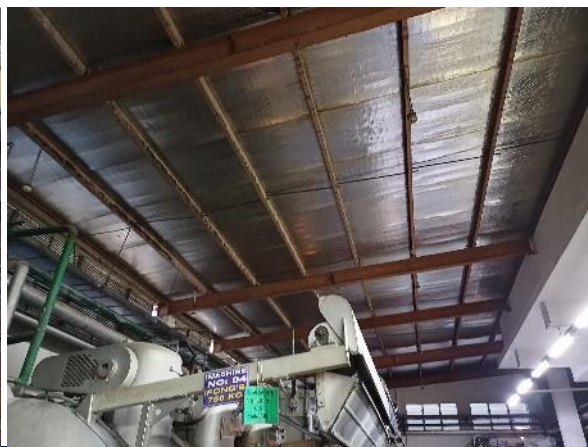
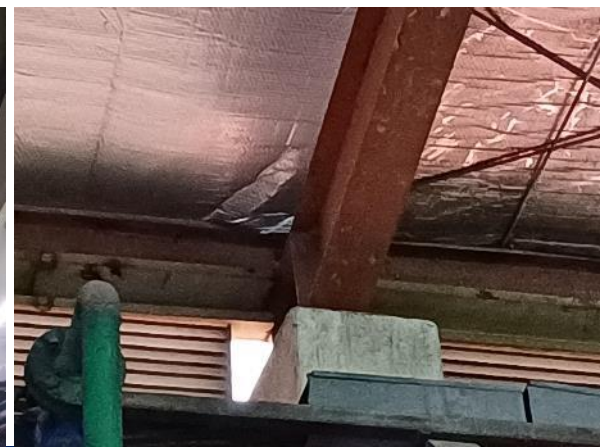
Ground floor shed of knitting building

The steel shed is supported by the RC column of the knitting building. The connection between RC column & steel rafter is not clear. The shed does not have lateral load resisting system along the long direction. Factory engineer is required to perform Engineering Assessment (EA) to check the lateral stability & connection adequacy of the shed and prepare as-built drawing with connection details.

| Item No. | Observation | Recommended Action Plan | Recommended Timeline |
|---|---|---|---|
| 01 | Lack of lateral Stability of the steel shed (Knitting Building) | Building engineer is required to produce full set of as-built drawing including the actual connection details. | 6-weeks |
| 02 | Lack of lateral Stability of the steel shed (Knitting Building) | Factory engineer is required to perform Engineering Assessment (EA) to check the lateral stability & connection adequacy | 6-weeks |
| 03 | Lack of lateral Stability of the steel shed (Knitting Building) | Implement remedial work if required. | 6-months |

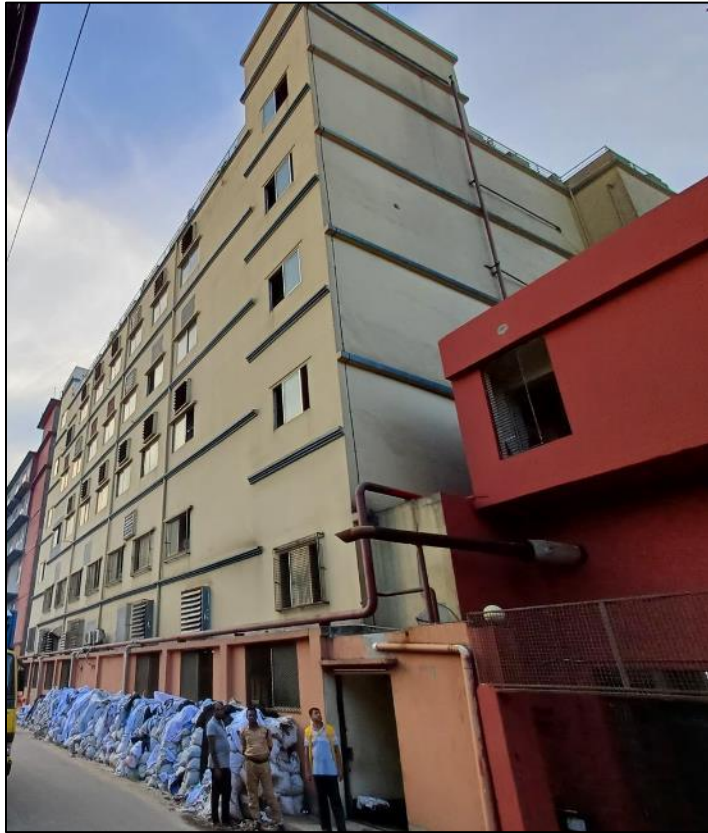
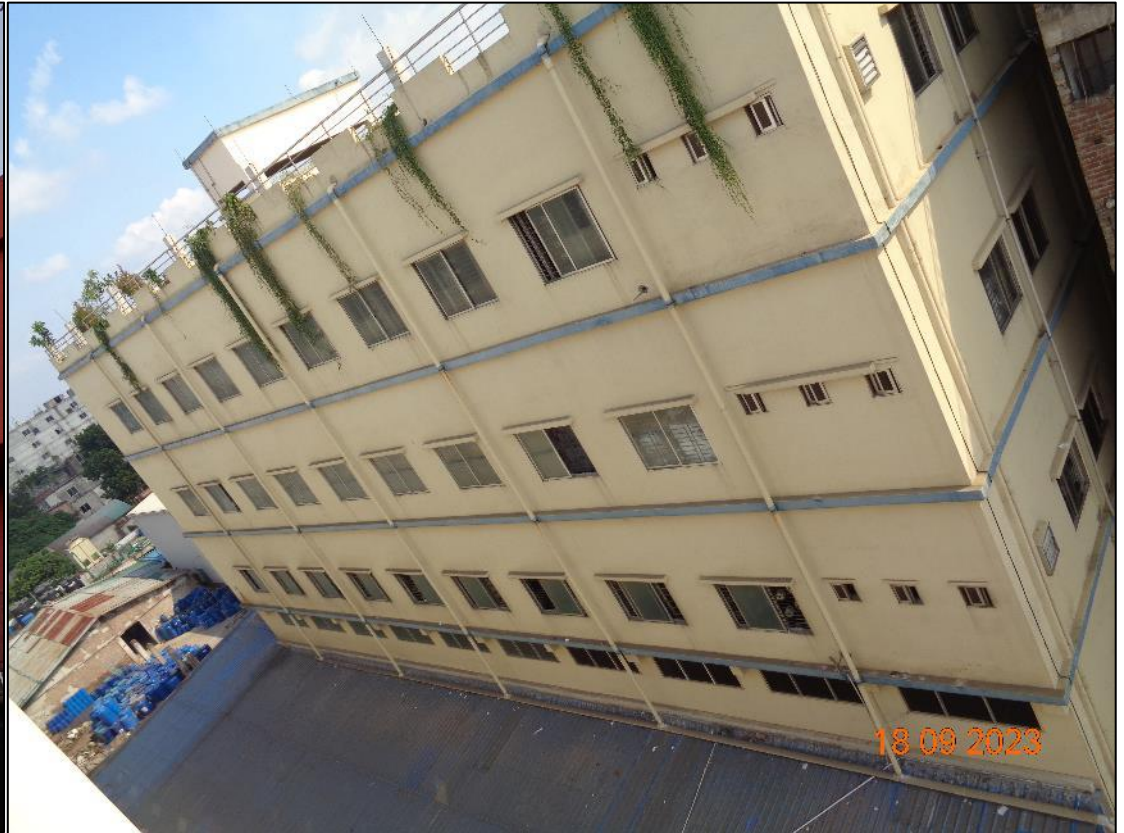
Knitting Building

As per BNBC (part-6), every building or structure designed shall have its design documents prepared in accordance with the provision of Section 1.9.1. The design document shall include a design report, and a set of structural drawings, which shall be prepared in compliance with section 1.9.1.1 & section 1.9.1.2 of BNBC (part-6).

At the time of inspection, no design report was available. Building engineer is required to prepare a set of design documents in compliance with BNBC.

| Item No. | Observation | Recommended Action Plan | Recommended Timeline |
|---|---|---|---|
| 04 | Design report needs to be prepared (Knitting Building) | Building engineer is required to prepare a design documents in compliance with section 1.9.1 of BNBC (part-6). | 6-weeks |
| 05 | Design report needs to be prepared (Knitting Building) | Implement remedial work if required. | 6-months |

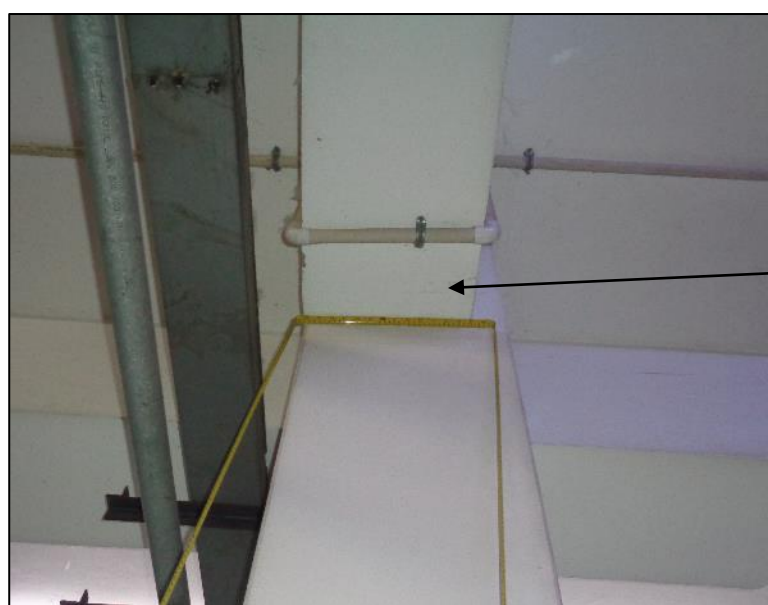
Beam width 300 mm onsite

Size of the beam width was found 300 mm instead of 375 mm.

Building engineer is required to survey the whole structure and update the as-built drawings and perform Engineering Assessment (EA)

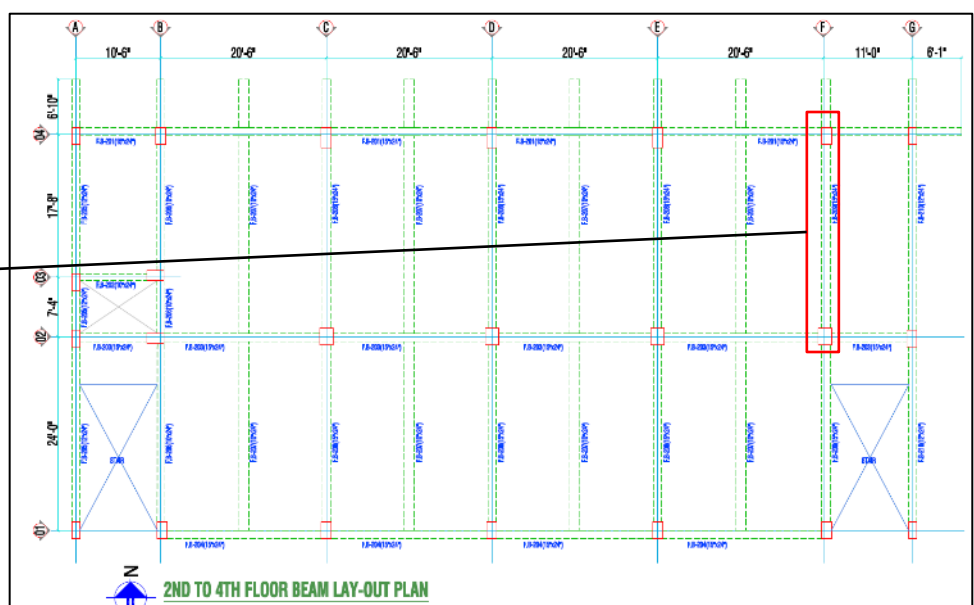
Beam Layout plan: beam width shown 375 mm

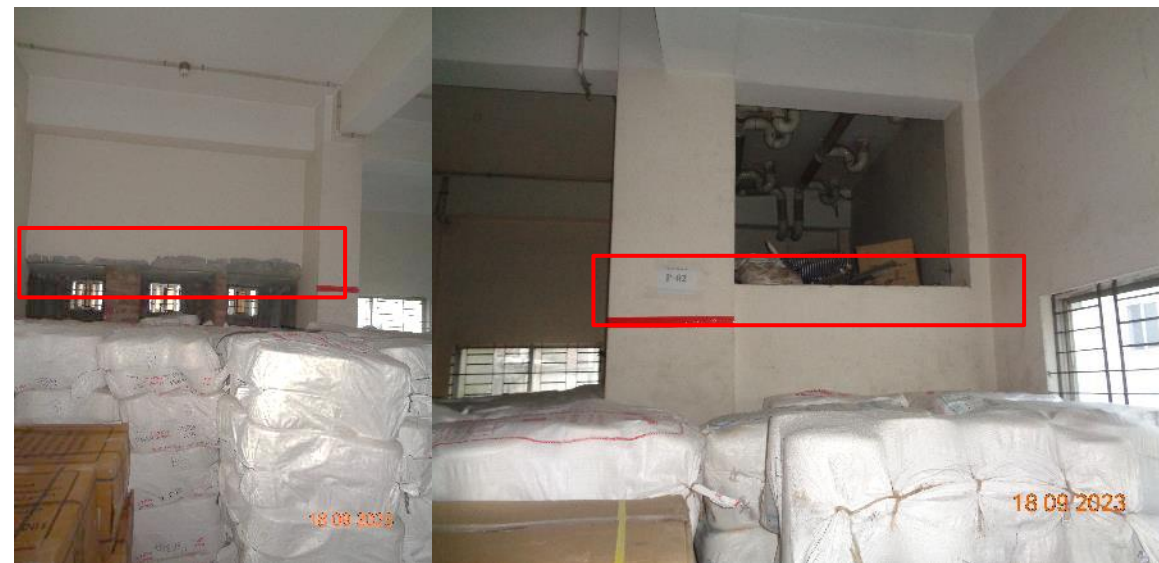
False slab in toilet zone area

False slab was found in toilet zone area which was not shown in as-built architectural drawing.

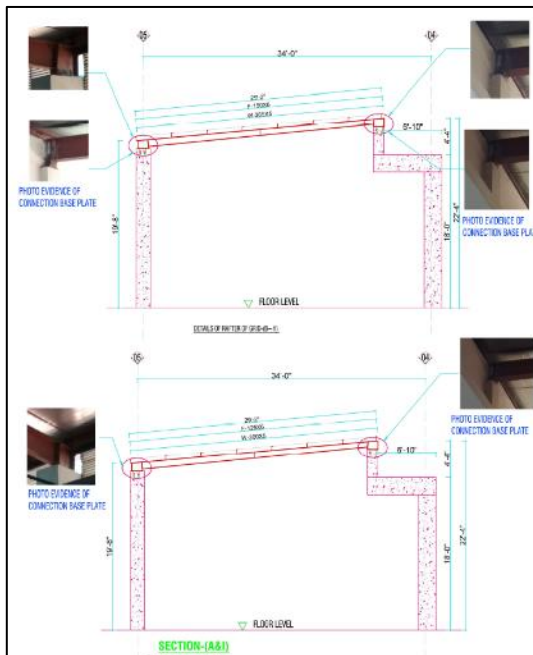
Fame in drawing

Connection details has not been provided in as-built drawing.

Building engineer is required to survey the whole structure and update the as-built drawings with structural connection details.

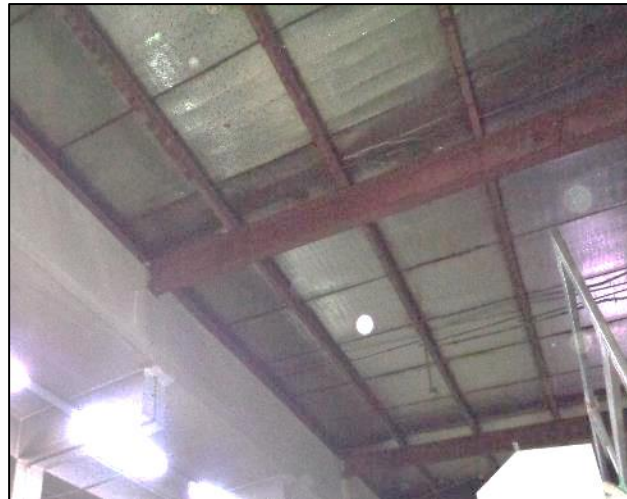
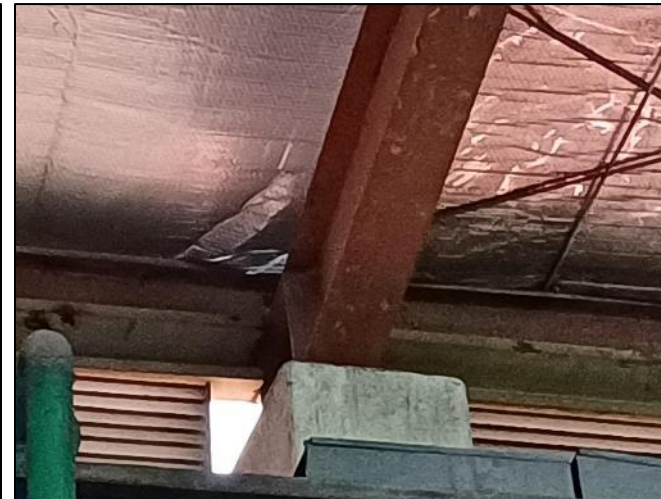
Connection of rafter with RC column

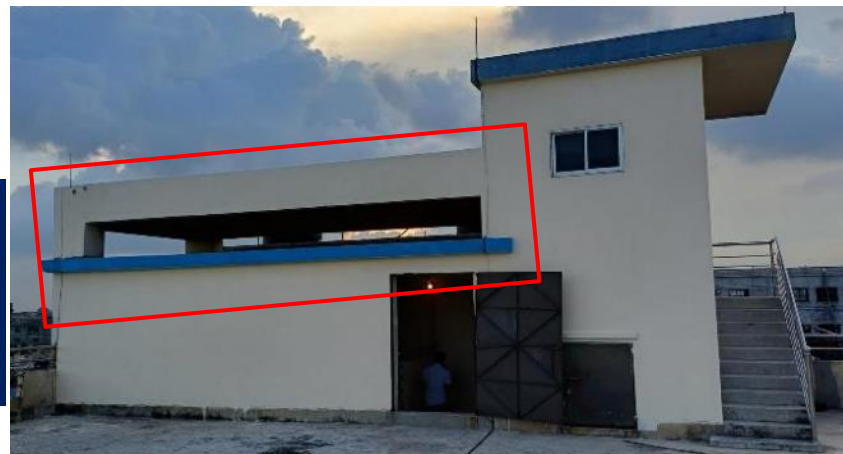
Additional slab at the roof of the stair top

No details was found in as-built drawings for the additional slab.

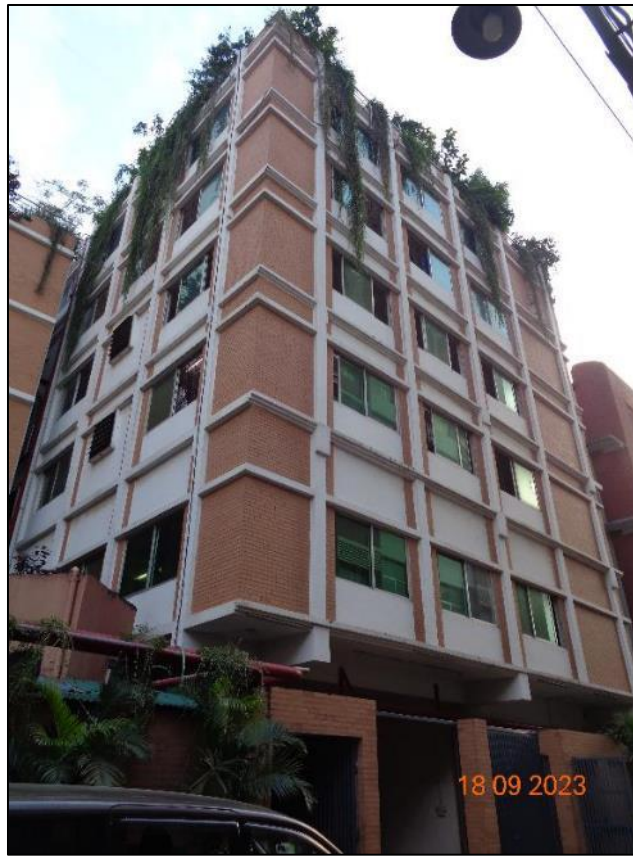
Printing Building

As per BNBC (part-6), every building or structure designed shall have its design documents prepared in accordance with the provision of Section 1.9.1. The design document shall include a design report, and a set of structural drawings, which shall be prepared in compliance with section 1.9.1.1 & section 1.9.1.2 of BNBC (part-6).

At the time of inspection, no design report was available. Building engineer is required to prepare a set of design documents in compliance with BNBC.

| Item No. | Observation | Recommended Action Plan | Recommended Timeline |
|---|---|---|---|
| 09 | Design report needs to be prepared (Printing Building) | Building engineer is required to prepare a design documents in compliance with section 1.9.1 of BNBC (part-6). | 6-weeks |
| 10 | Design report needs to be prepared (Printing Building) | Implement remedial work if required. | 6-months |

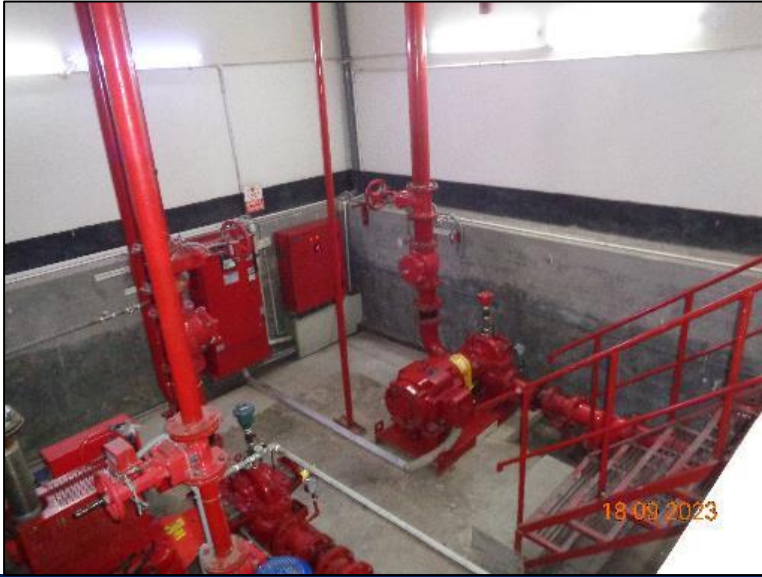
Fire pump room below ground level

Fire pump room construed below ground floor level. But no structural details has been provided in as-built structural drawing.

Building engineer is required to survey the whole structure and update the as-built drawings and perform Engineering Assessment (EA).

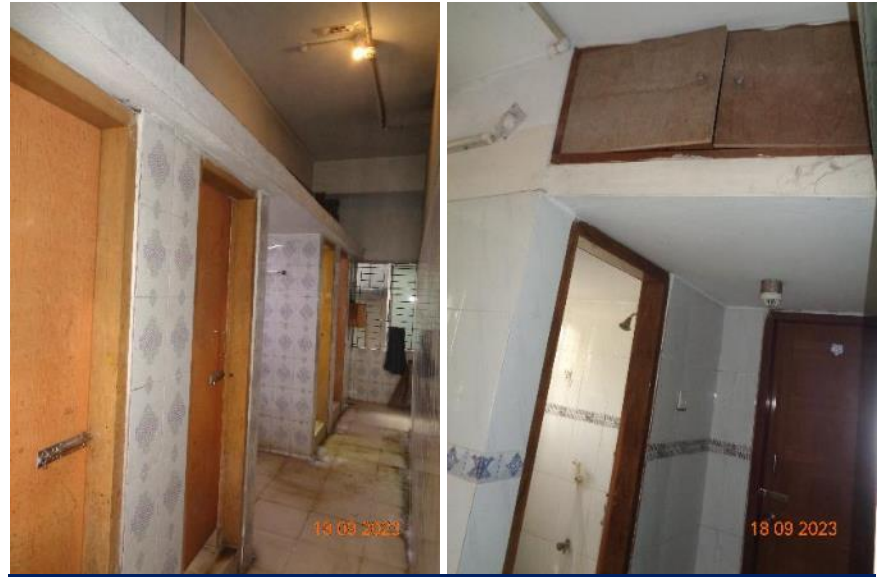
False slab in toilet zone area

False slab was not shown in as-built drawing.

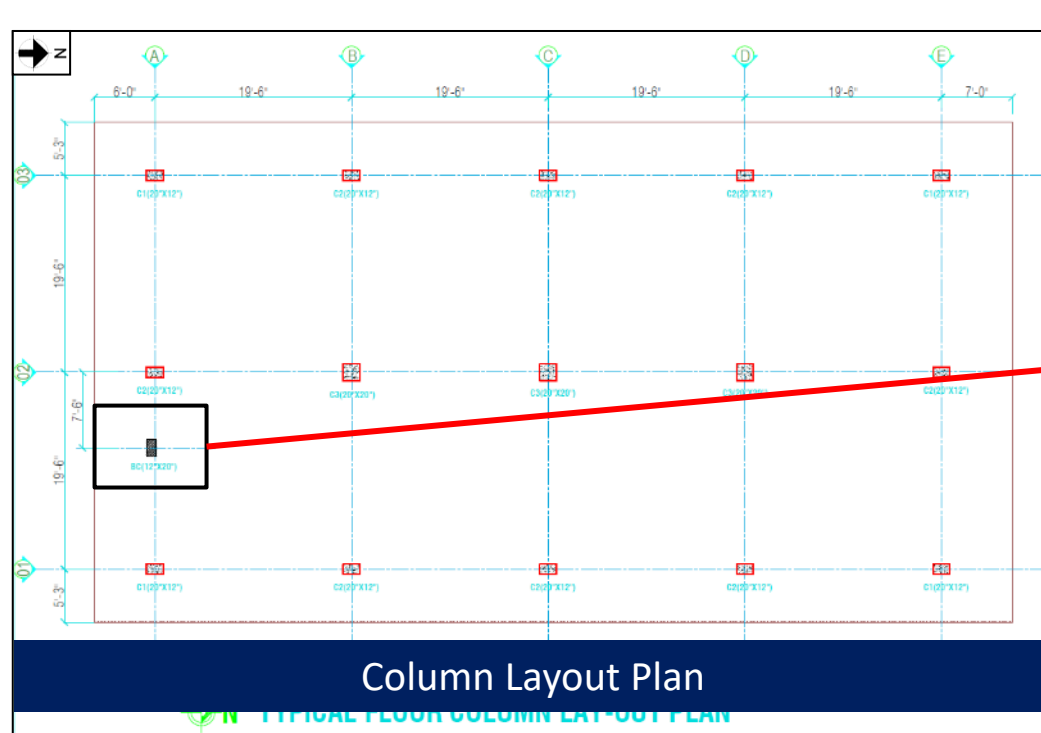
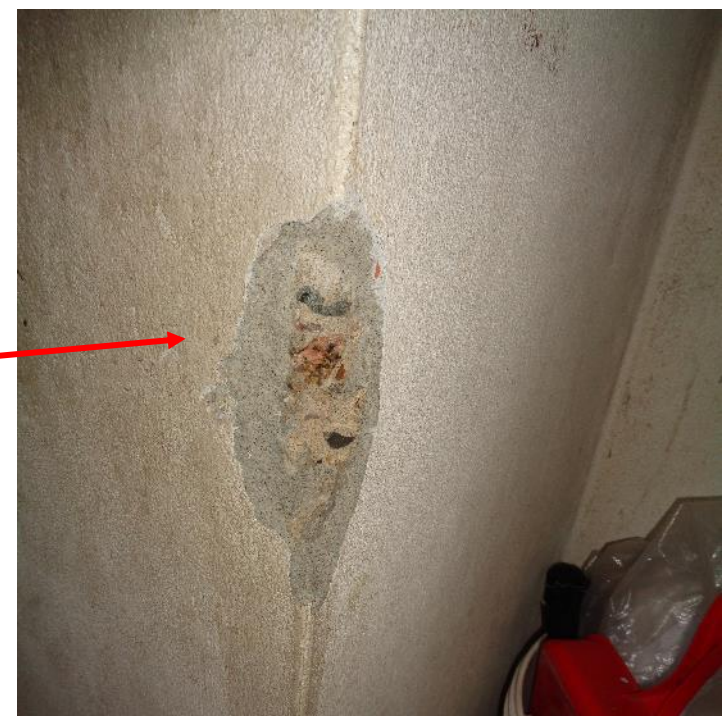
Stone chips Aggregate in column

Stone chips aggregate found in column instead of brick chips aggregate.

Building engineer is required to survey the whole structure and update the as-built drawings.

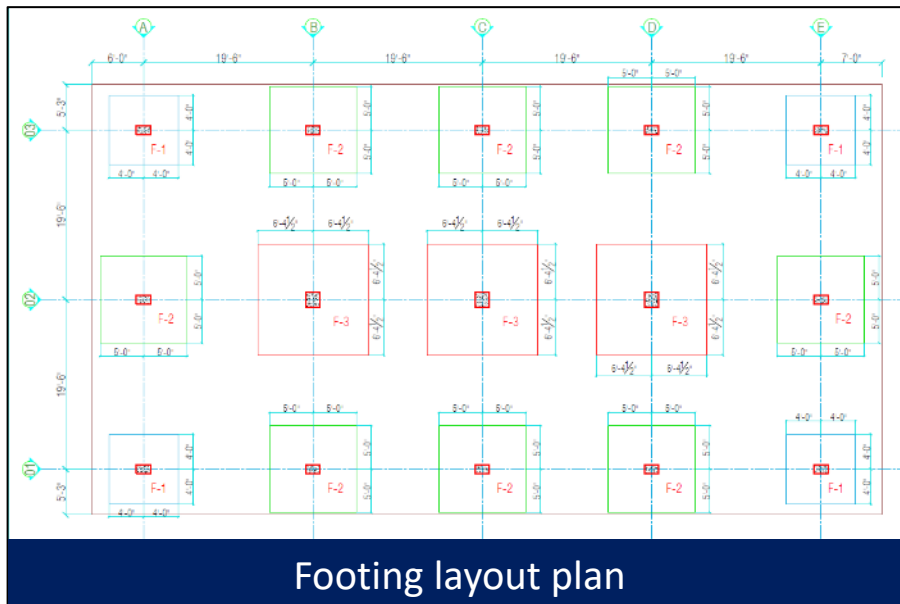
The foundation position of the lift core has not been shown in foundation layout plan.

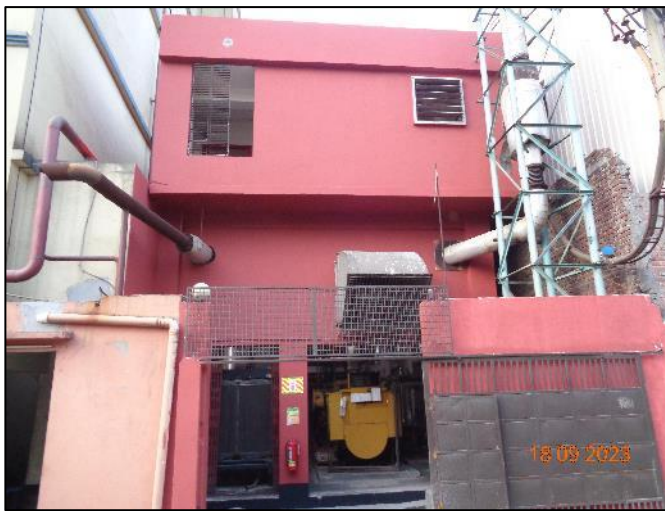
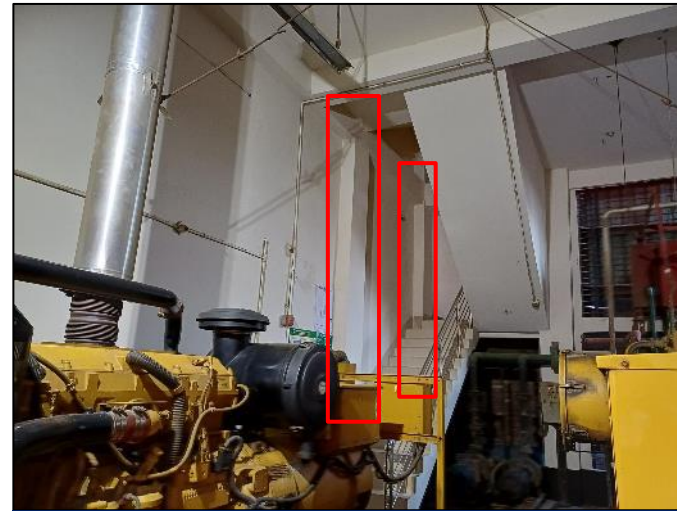
Retrofitted column

Column has been retrofitted for the generator building. Building engineer is required to submit the Detail Engineering Assessment (DEA) documents to the RSC for the further review to justify the capacity of foundation, column and beam & slab against the lateral & vertical loading.

| Item No. | Observation | Recommended Action Plan | Recommended Timeline |
|---|---|---|---|
| 14 | Retrofitting documents needs to be reviewed (Generator Building) | Building engineer is required to submit the Detail Engineering Assessment (DEA) documents to RSC for the further review to justify the capacity of column and foundation for lateral & gravity loading. | 6-weeks |
| 15 | Retrofitting documents needs to be reviewed (Generator Building) | Implement remedial work if required. | 6-months |
