# DELUXE FASHIONS LTD. (Extension)

178,179 Baizid Bostami Road, Nasirabad Industrial Area, Chittagong.

20 September 2023

**Utility Building:** Five (G+4) storied building.

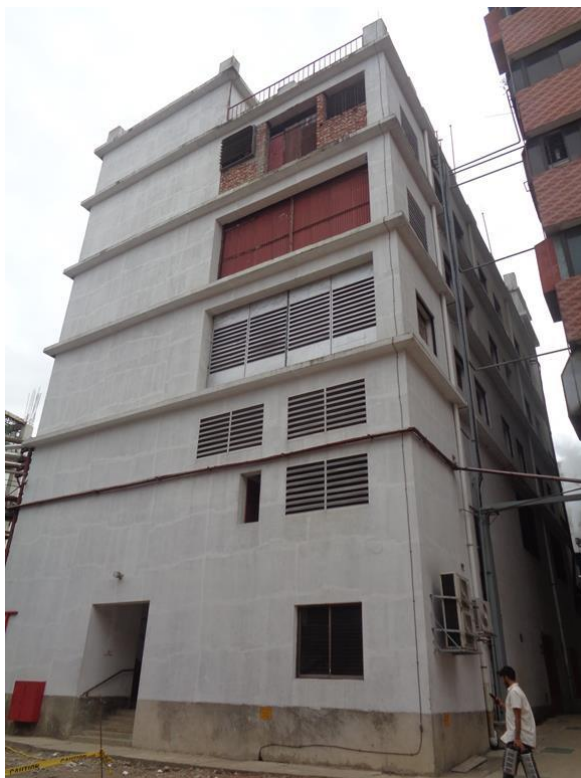
Utility Building

**Lack of design report & floor load plan**

As per BNBC (part-6), every building or structure designed shall have its design documents prepared in accordance with the provision of Section 1.9.1. The design document shall include a design report, and a set of structural drawings, which shall be prepared in compliance with section 1.9.1.1 & section 1.9.1.2 of BNBC (part-6).

At the time of inspection, design report, floor load plan & material test report was not available. Building engineer is required to prepare a set of design documents in compliance with BNBC based on current floor load and in-situ material strength.

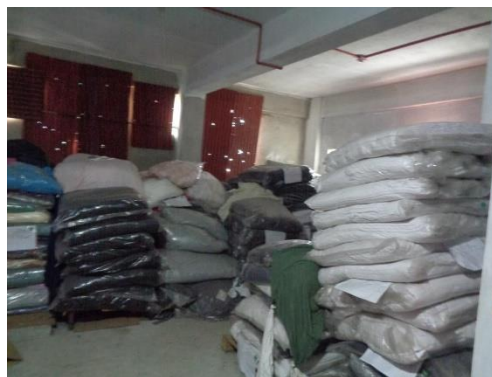
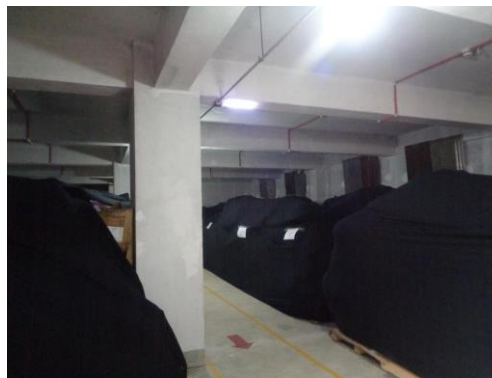
Storage on 2<sup>nd</sup> & 3<sup>rd</sup> floor

| Item No. | Observation | Recommended Action Plan | Recommended Timeline |
|---|---|---|---|
| 01 | Lack of design report & floor load plan (Utility Building) | Produce floor live load plan for all floor plates following BNBC requirements and based on column & foundation capacity. | 6-weeks |

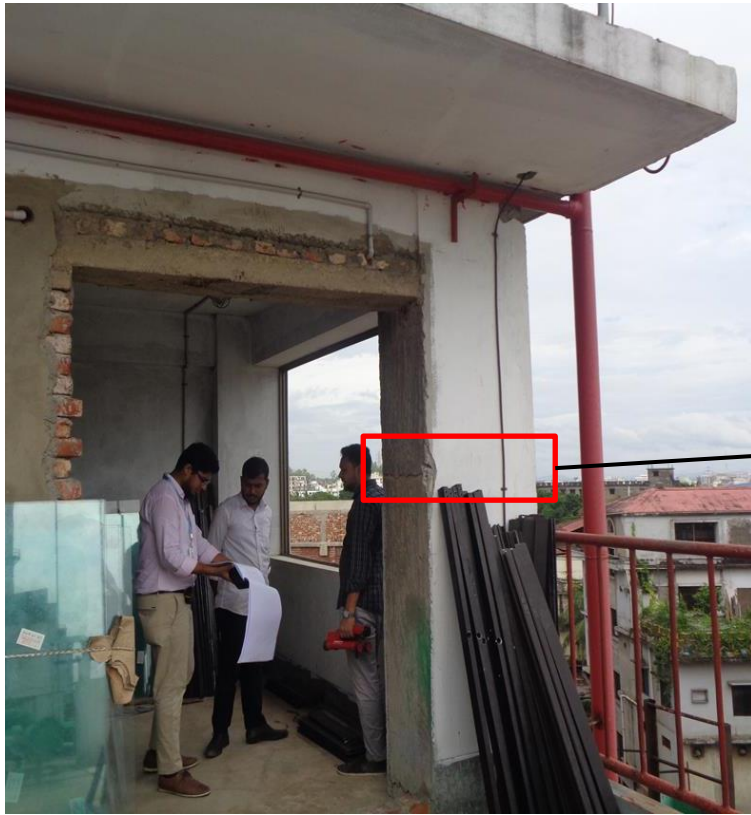
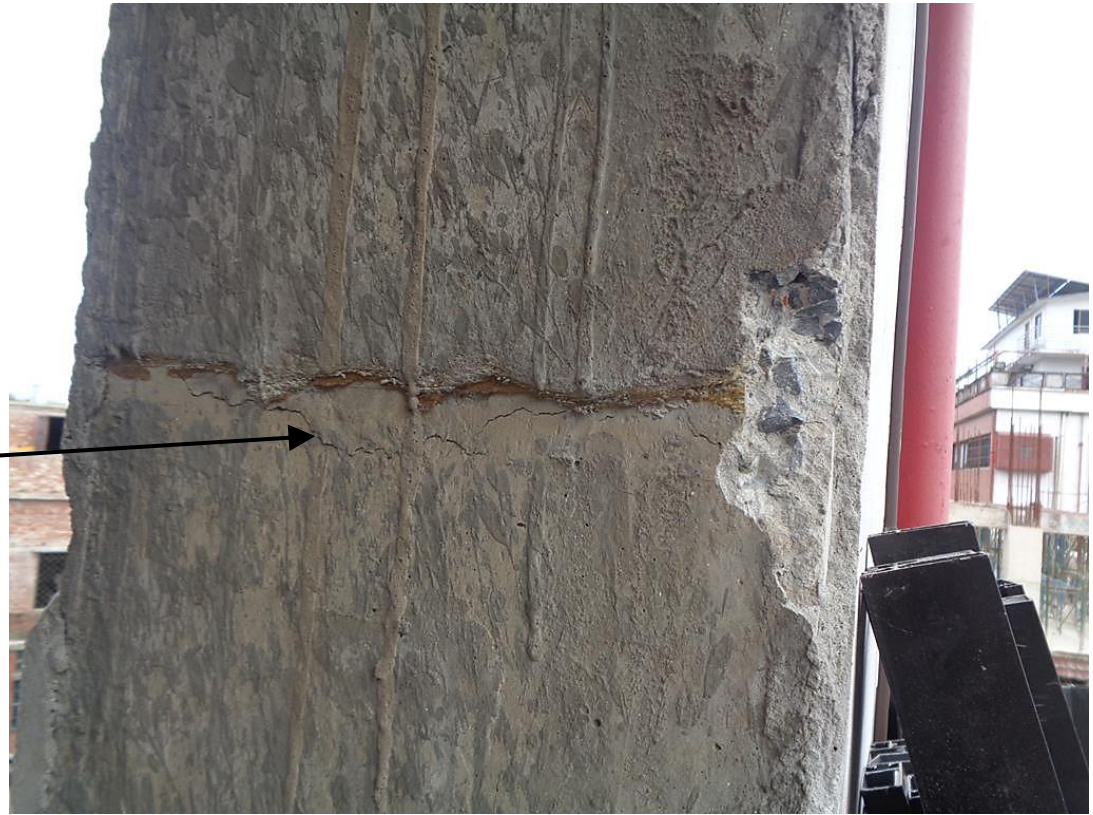
Crack in stair column at roof level

The building engineer is required to prepare an investigation report with necessary pictorial evidence and provide proper remedial action.

| Item No. | Observation | Recommended Action Plan | Recommended Timeline |
|---|---|---|---|
| 07 | Crack in stair column at roof level. (Utility Building) | The building engineer is required to prepare an investigation report with necessary pictorial evidence and provide proper remedial actions for the crack. | 6-weeks |
| 08 | Crack in stair column at roof level. (Utility Building) | Carry out suggested remedial works. | 6-months |
