Karim Textiles Limited(Extension)

Noorbag, Kaliakor, Gazipur, Bangladesh
Geographic Coordinates: 24.019730N, 90.300313E
07 September 2023

Building Information

1. **Building-3:** This structure is a nine storied (B+G+8) reinforced concrete (RC) building with one basement.

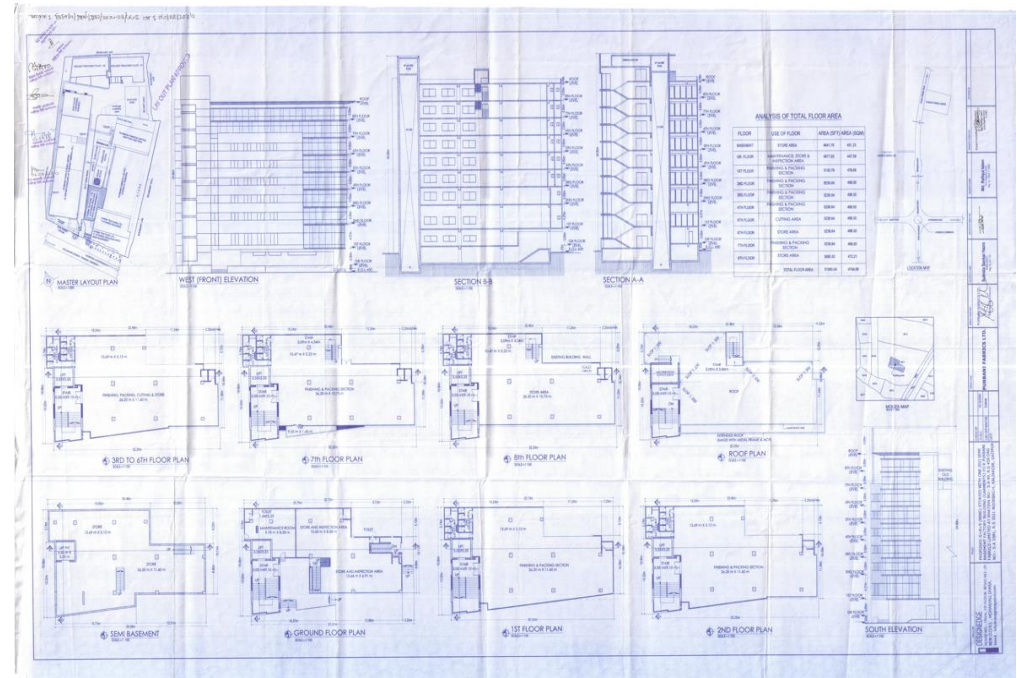
NTPA Load and Combination used for structural integrity

The building construction was started in April 2013 and ended in November 2014. Approval from local authority from April 2013. The factory occupied the structure since December 2014. But in the design report software-based analysis load combination had been considered as NTPA which doesn't comply with BNBC part-6.

Building engineer is required to revised the prepared design report as per BNBC part-6.

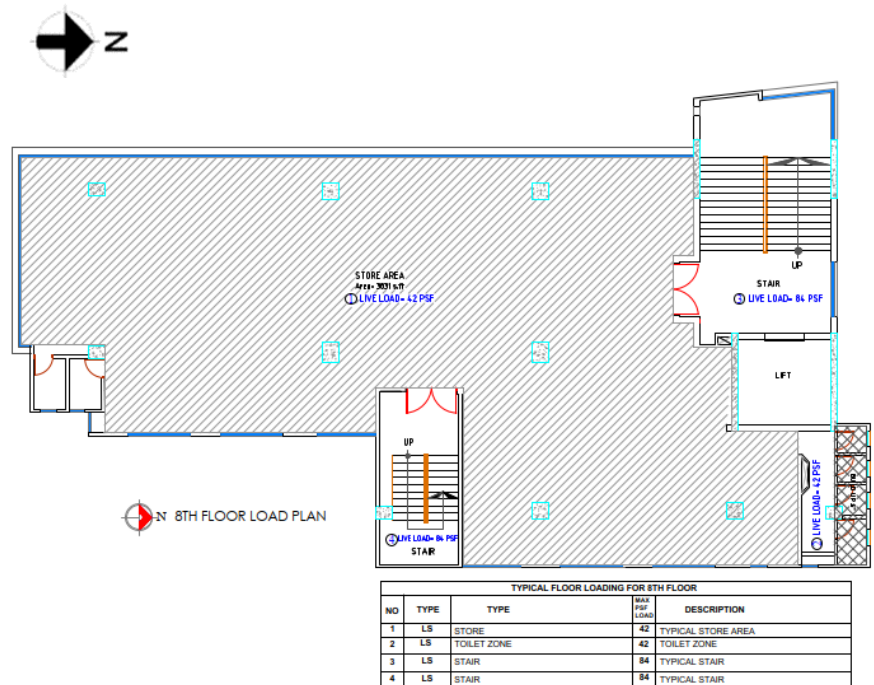
Typical Live load considered as 2 KPa

Typical live load considered as 2 kPa in all floors. As per BNBC- Part 6, live load for light workroom area is required to be considered minimum 3 kPa and light storage to be considered minimum 6 kPa . Building engineer is required to revise the load plan as per BNBC requirement.

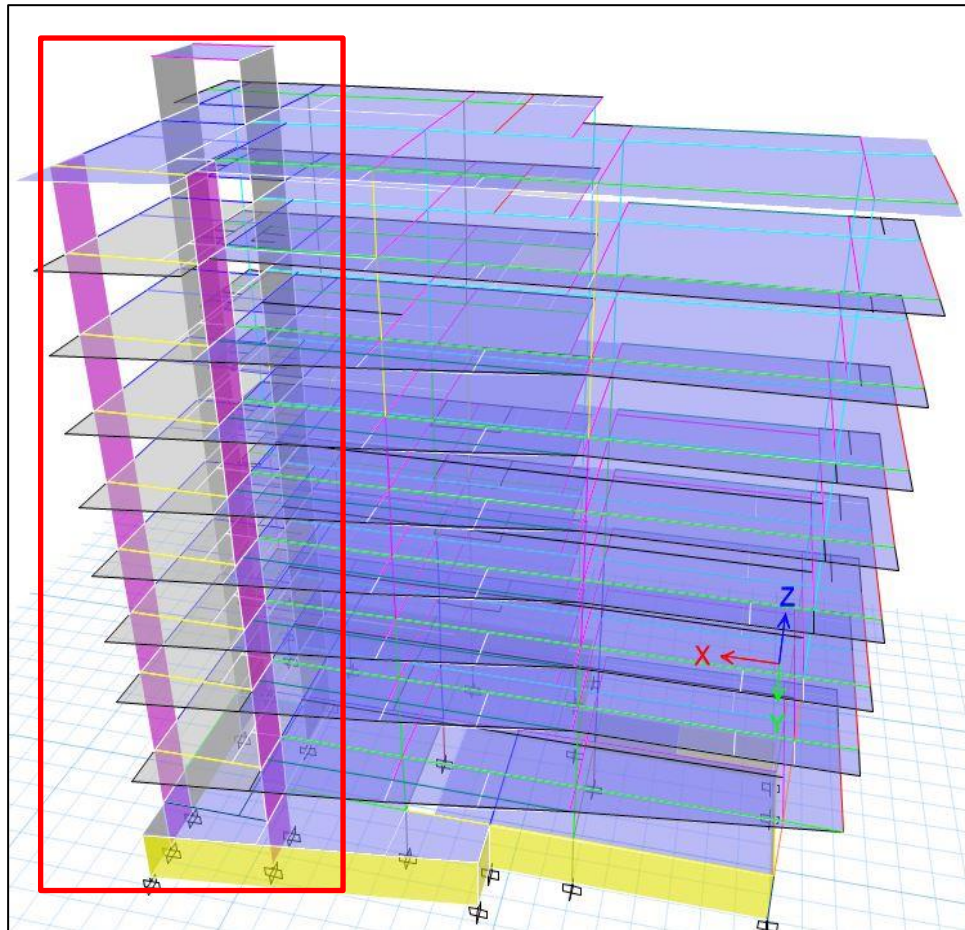
RC wall adequacy checks missing in the design report

In the design report RC wall (stair & lift) adequacy checks were not incorporated at all. Building engineer is required to incorporate all type of design check for the RC wall adequacy as per the BNBC.

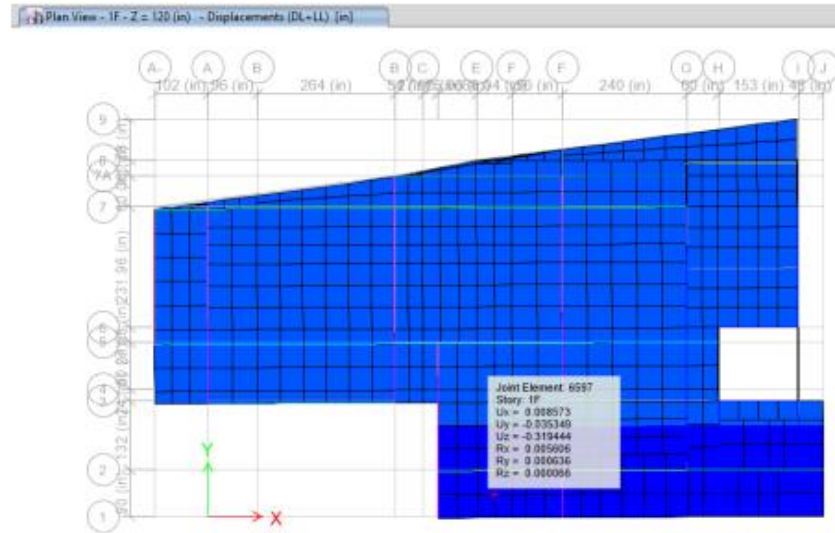
Deflection contour due to service load at typical story

Deflections contour has been considered to study the maximum deflection. The deflection contour shows that the maximum vertical deflection is 0.32 inch or 8.2 mm for interior beam/slab panel for a span length. The allowable limit for simply supported for span length 20 feet of beam/slabs is $L/360 = 0.67$ inch. Therefore, it can be concluded that the **compliance for deflection is adequate for all beams as well as for slabs.**

Deflection and drift study shall be added against lateral loading also. Building engineer is required to incorporate the deflection, drift and building separation study as per NBC-2006 part-6 section-1.5.6.

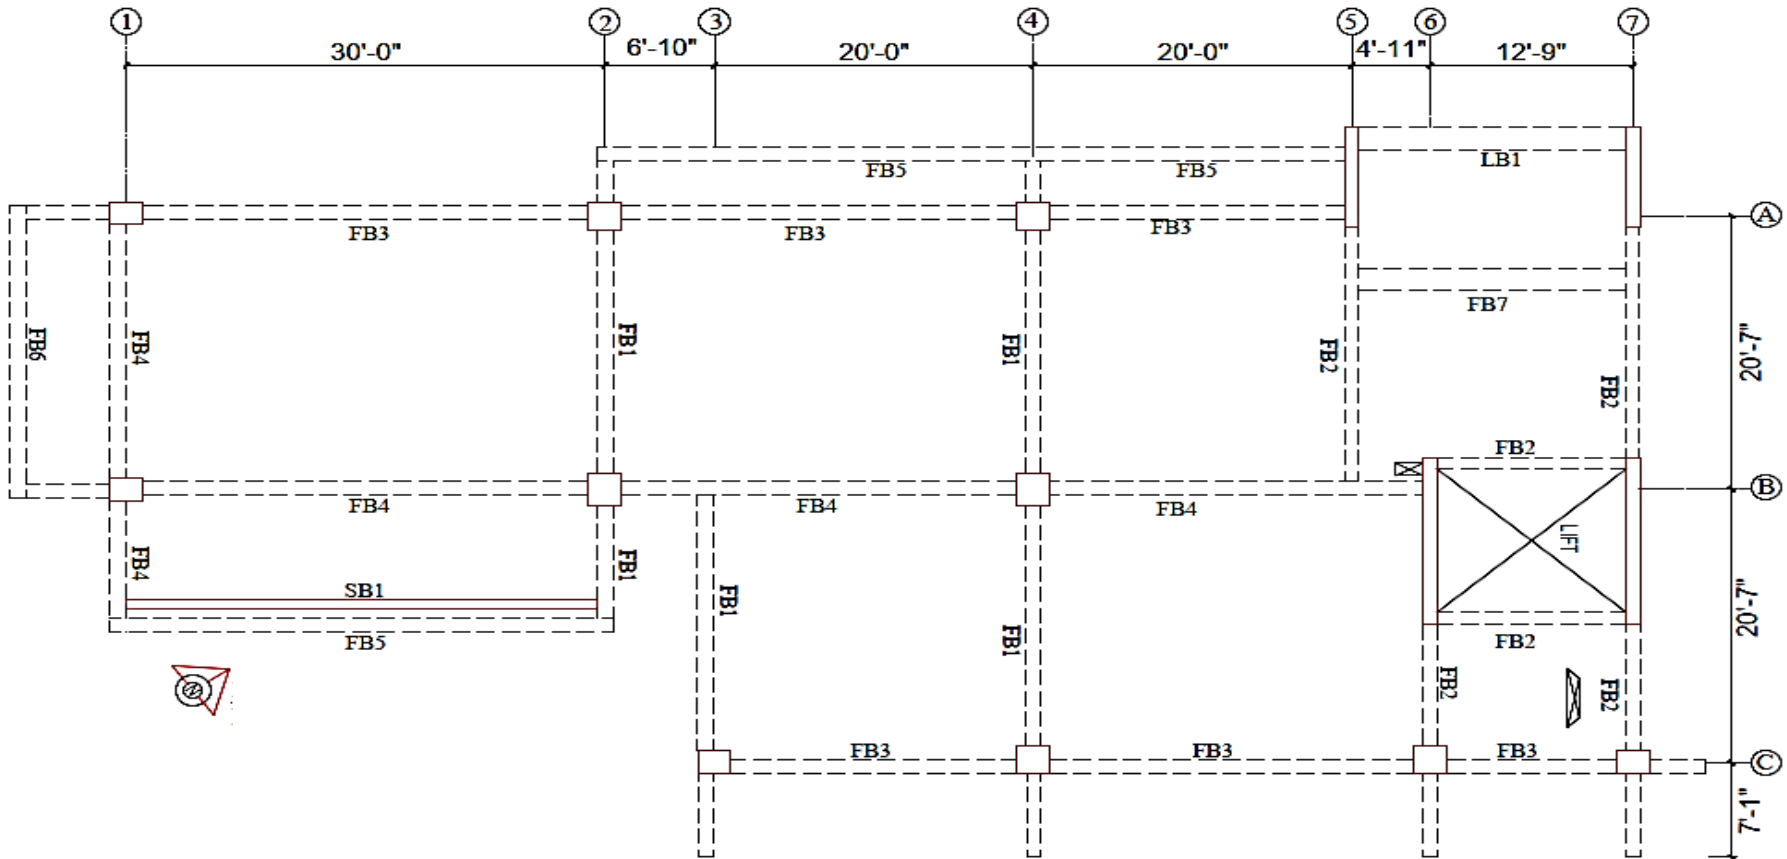
Floor Beam Layout Plan

Lack of information of cantilever beams in as-built drawing

Lack of information of cantilever beam found in the as-built drawing. Building engineer is required to provide details of cantilever beams (Dimension, Size).

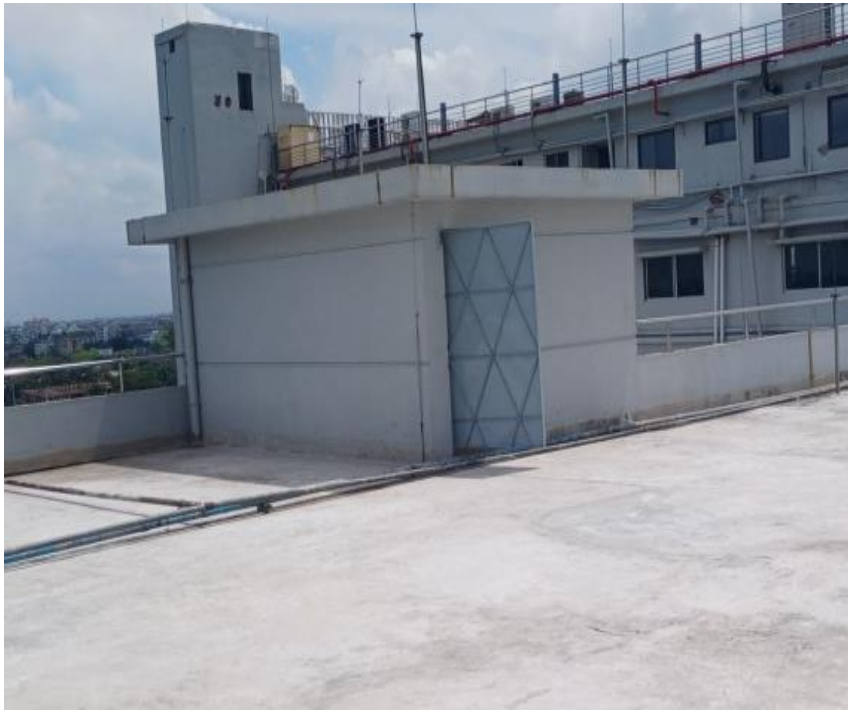
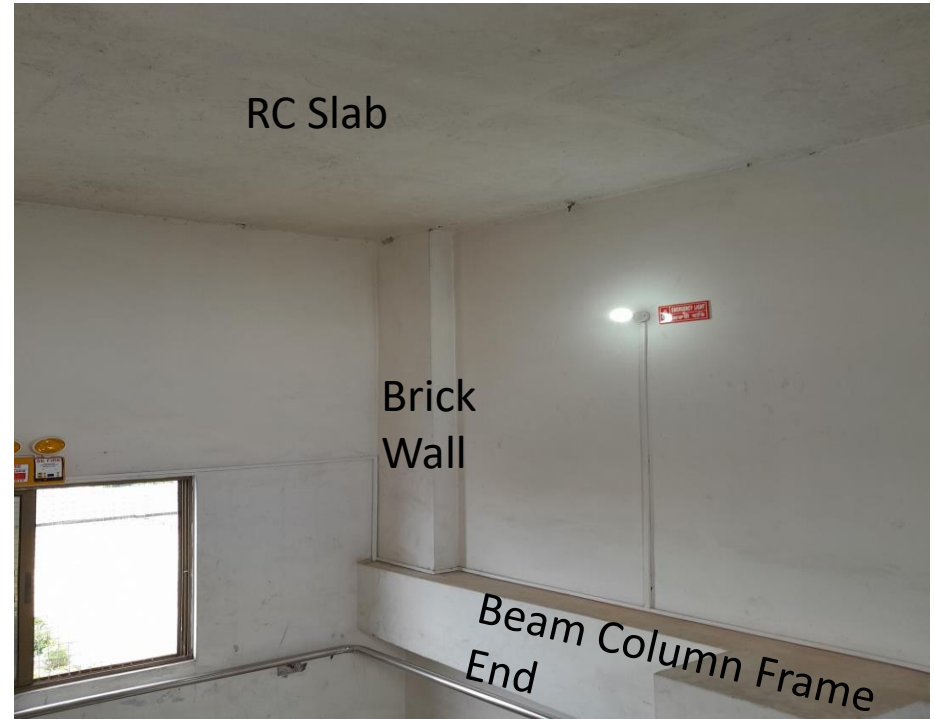
Rooftop staircase slab rested on brick wall

Rooftop staircase slab found rested on brick wall. Building engineer is required check the adequacy of the rooftop staircase structure.

Item No.	Observation	Recommended Action Plan	Recommended Timeline
01	Inconsistencies in design report.	Building engineer is required to prepare the design report considering BNBC 1.9.	6-weeks
02	Inconsistencies in design report	Building engineer is required to incorporate all adequacy check in the design report.	6-weeks
03	Inconsistencies in design report	Carry out the remedial works if required.	6-months
04	Lack of information of cantilever beams in as-built drawing.	Building engineer is required to survey the whole structure and update the as-built drawing.	6-weeks
05	Rooftop stair slab rest on brick wall.	Building engineer is required check the adequacy of the rooftop staircase structure.	6-weeks
06	Rooftop stair slab rest on brick wall.	Carry out the remedial works if required.	6-months
