Green Smart Shirts Ltd (Extension)

Tapirbari, Mawna, Sreepur, Gazipur
(24.2373838, 90.4342180)
18 September 2023

Observations

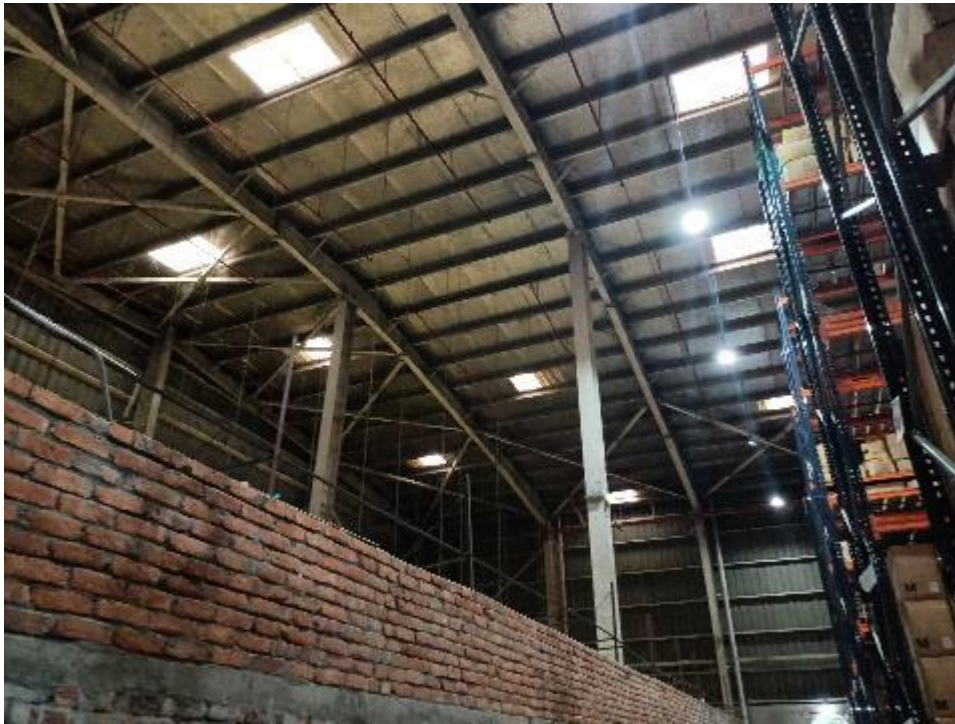
Incomplete lateral stability system

No compression strut was found along the ridge lines of the long direction. So lateral stability in the long direction is incomplete. The building engineer is required to check the stability system of the existing structure.

Item No.	Observation	Recommended Action Plan	Recommended Timeline
01	Incomplete lateral stability system. (Finished Good Warehouse)	Building engineer is required to check the lateral stability of the structure.	6-weeks
02	Incomplete lateral stability system. (Finished Good Warehouse)	Implement remediation work if required.	6-months
03	Mismatches in as built drawings. (Finished Good Warehouse)	Building engineer is required to survey the structure and prepare accurate as-built drawings.	6-weeks
04	Inclined steel column. (Finished Good Warehouse)	Building engineer to review design of distorted steel column considering the as-built condition of the column.	6-weeks
05	Inclined steel column. (Finished Good Warehouse)	Carry out remedial works (if any) after review by RSC.	6-months

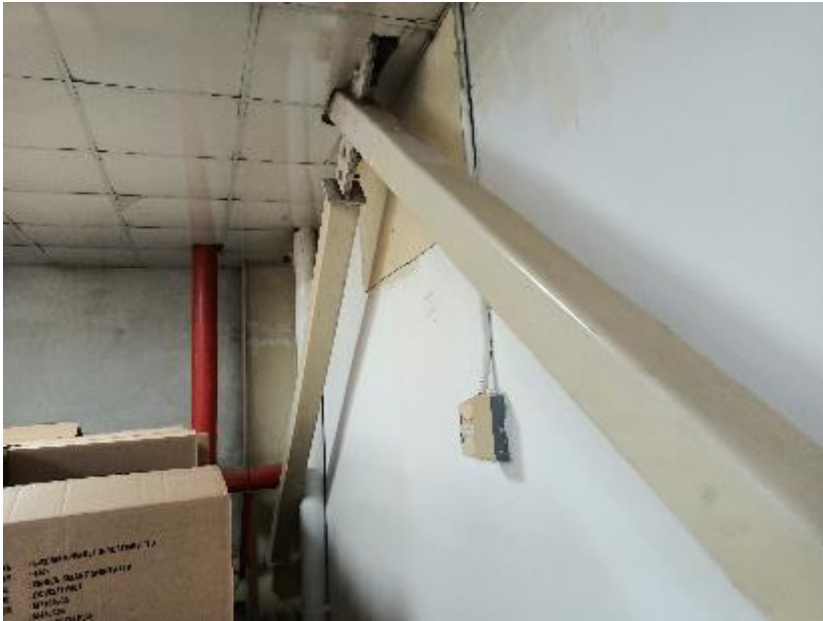
Bracing joint

Paucity in as-built drawing

Column splice and connection details were not found in the provided as-built drawings. Building engineer is required to incorporate the connection details in the as-built drawing.

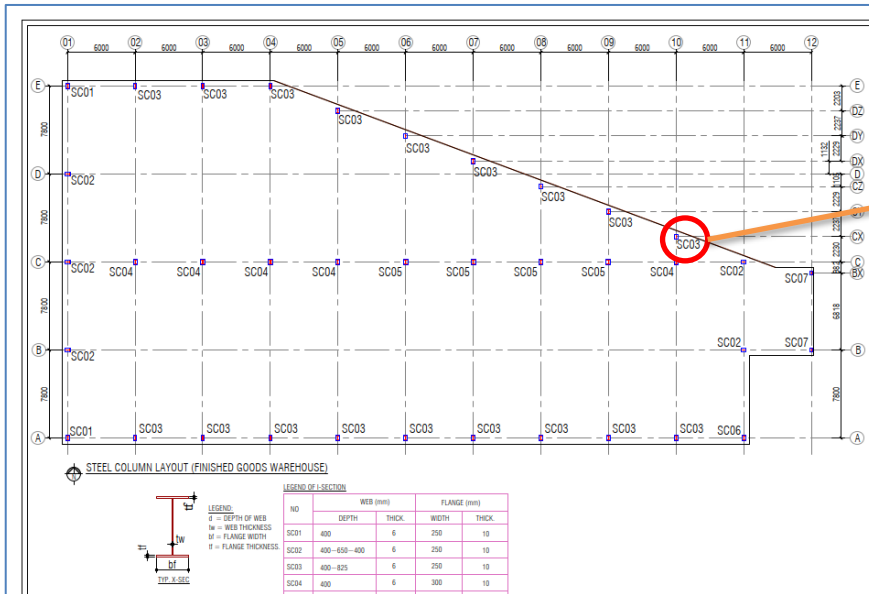
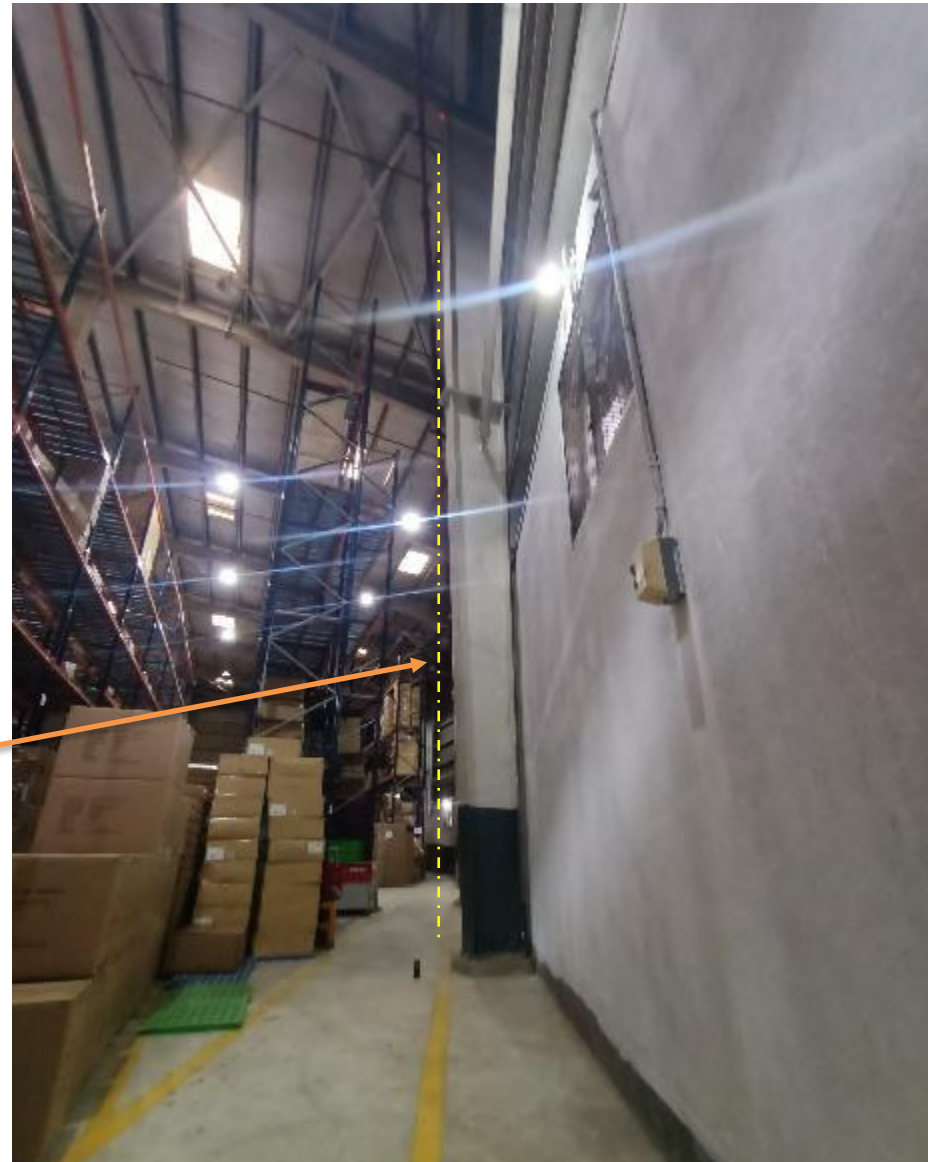
Inclined steel column

An inclined steel web column was found on the North side of the shed. The stability of the distorted columns and related elements need to be checked.

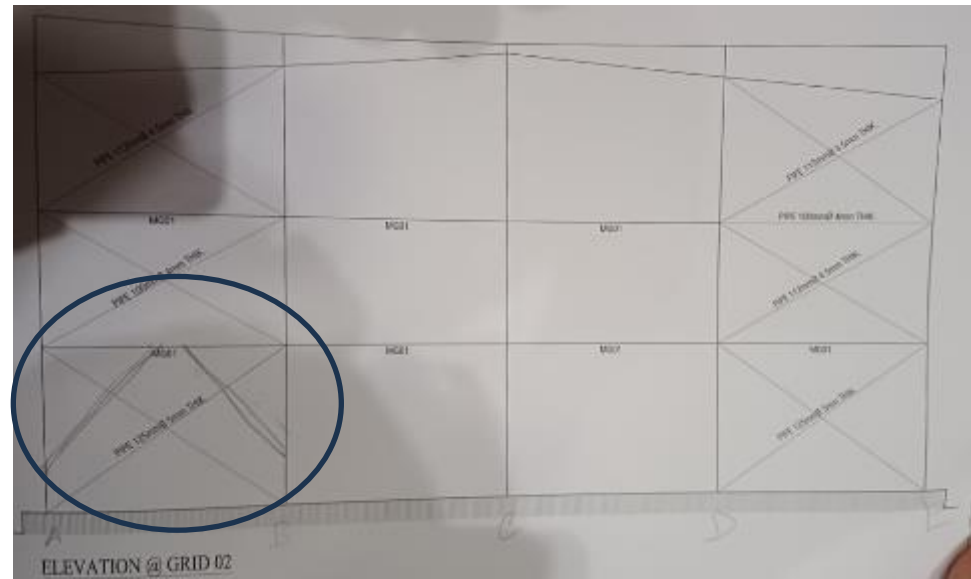
Column joint

Inverted V bracing was found instead of cross bracing at grid 2. Column splice detail is not found in the provided as-built drawings. Moreover, all connection details are not found in the drawings.

Building engineer is required to revise the as-built drawing showing connection details with complete information.

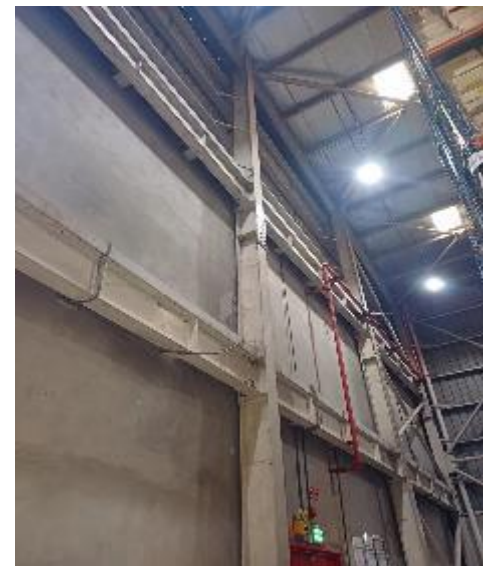
connection details not shown in the drawing

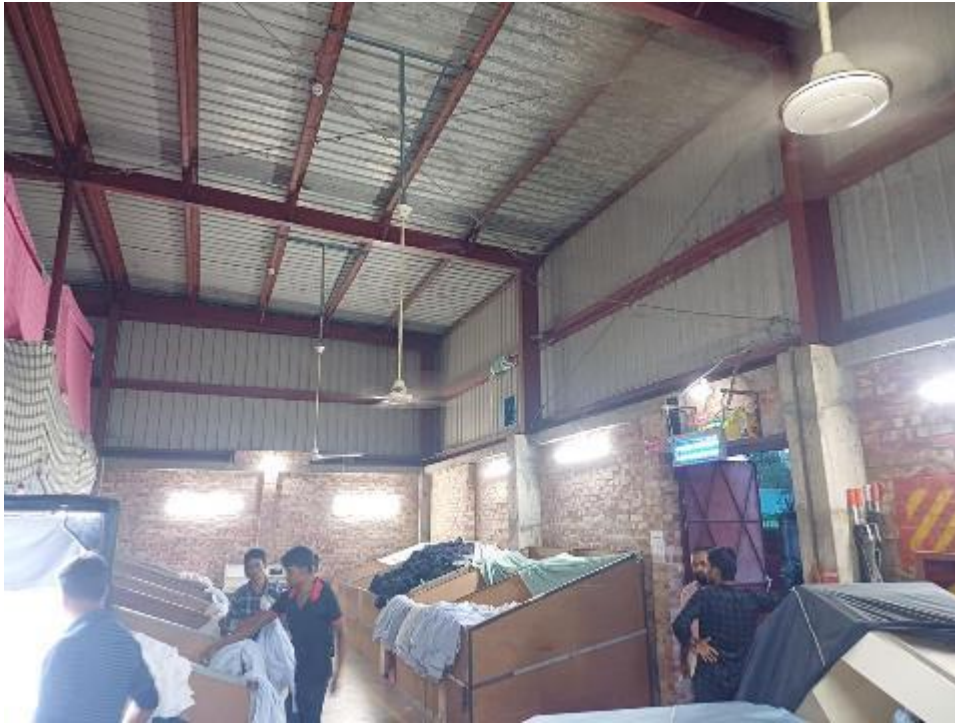
No load transfer media along long direction

Load transfer media is not provided along long direction for this shed. Therefore, lateral stability system of the shed is apparently incomplete. Building engineer is required to check the lateral stability of the structure.

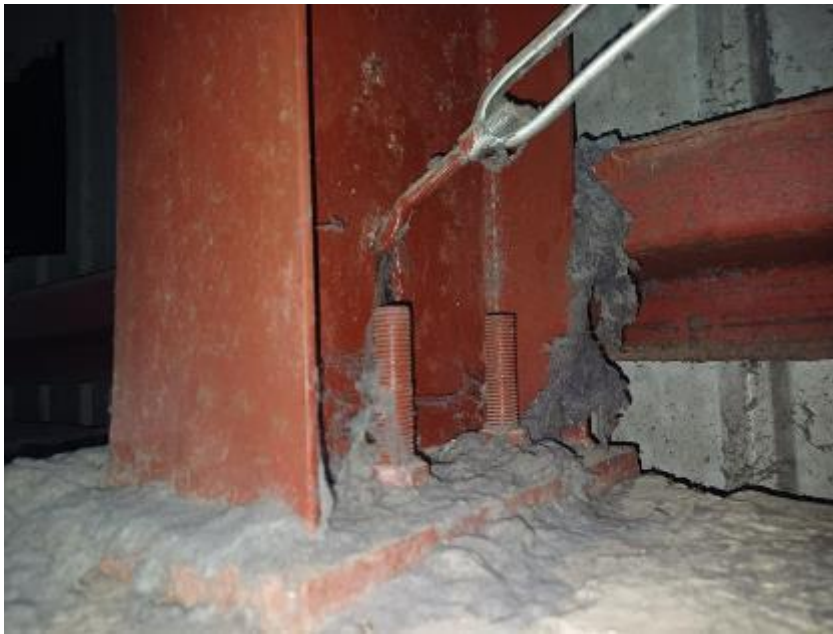
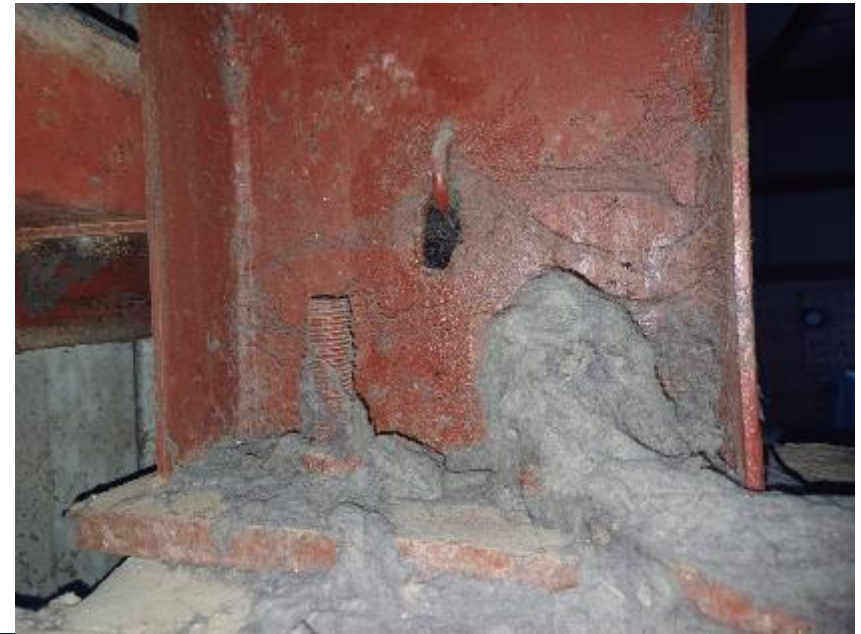
Bracings connection on site

Improper bracing connection

Bracings are not connected as per drawings. Only hooks are used for connection. Building engineer is required to replace the connection as per drawings.

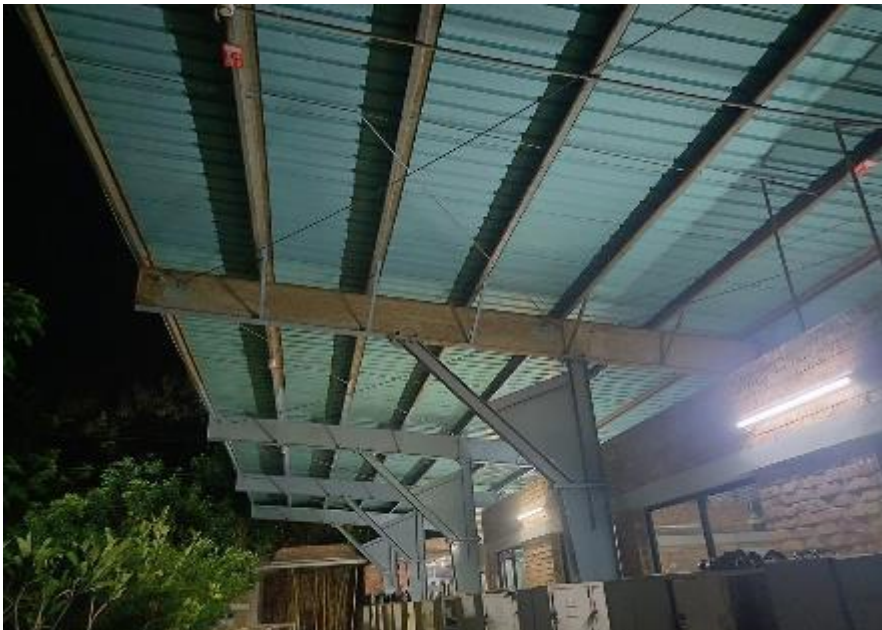
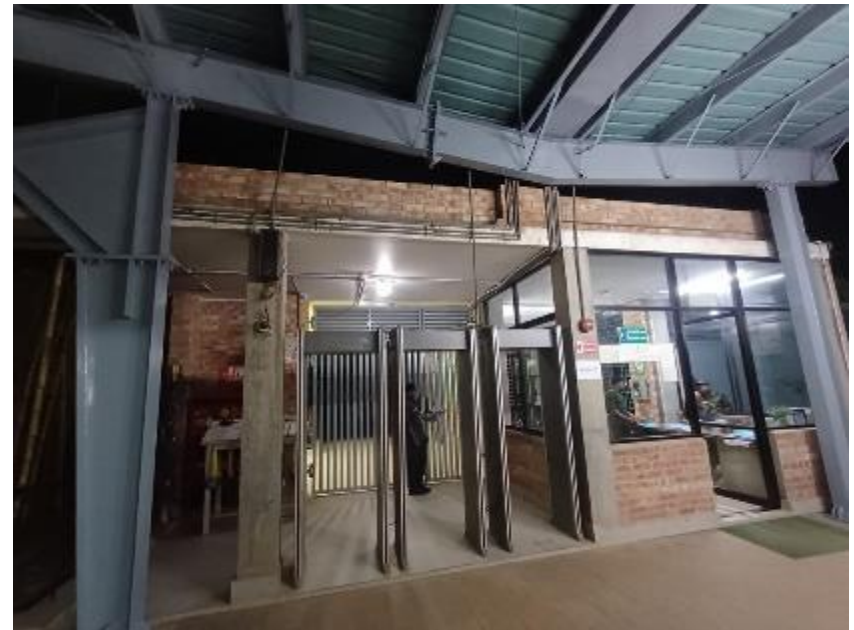
Load transfer media is not provided along long direction for this shed. Only cable bracings were found but strut member has not been provided. Therefore, lateral stability system of the shed is apparently incomplete. Building engineer is required to check the lateral stability of the structure.

No load transfer media along long direction

Item No.	Observation	Recommended Action Plan	Recommended Timeline
12	Lack of lateral stability system. (Gate House)	Building engineer is required to check the lateral stability of the structure.	6-weeks
13	Lack of lateral stability system. (Gate House)	Implement remediation work if required.	6-months
14	Corrosion in steel member (Gate House)	Building engineer to remove the corrosion and apply suitable corrosion resistance coating.	6-weeks
15	Lack of drawings. (STP Shed)	Building engineer is required to prepare the as-built structural drawing in compliance with section 1.9.1.1 as per BNBC.	6-weeks
16	Apparently non-engineered connection. (STP Shed)	Building engineer is required to check the connection of the steel roof for the uplift pressure of wind.	6-weeks
17	Apparently non-engineered connection. (STP Shed)	Complete implementation of remedial works if required.	6-months

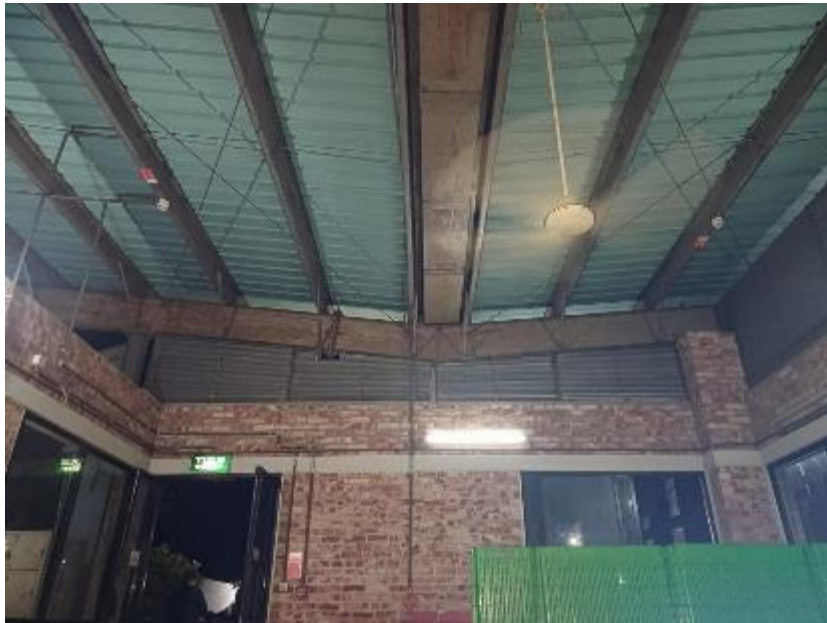
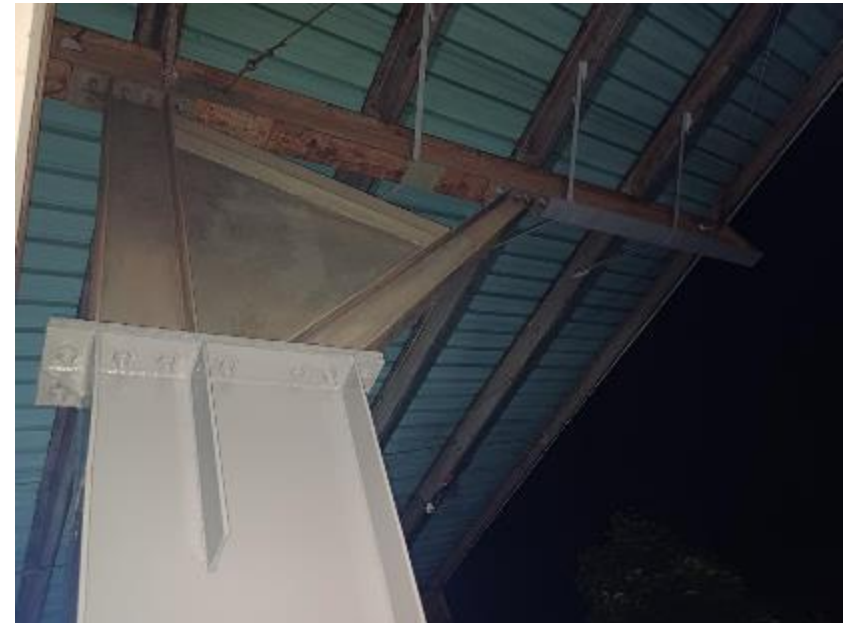
Corrosion in steel member

Corrosion in steel member of Gatehouse were observed in several locations. The building engineer is required to suggest proper remedial measures accordingly

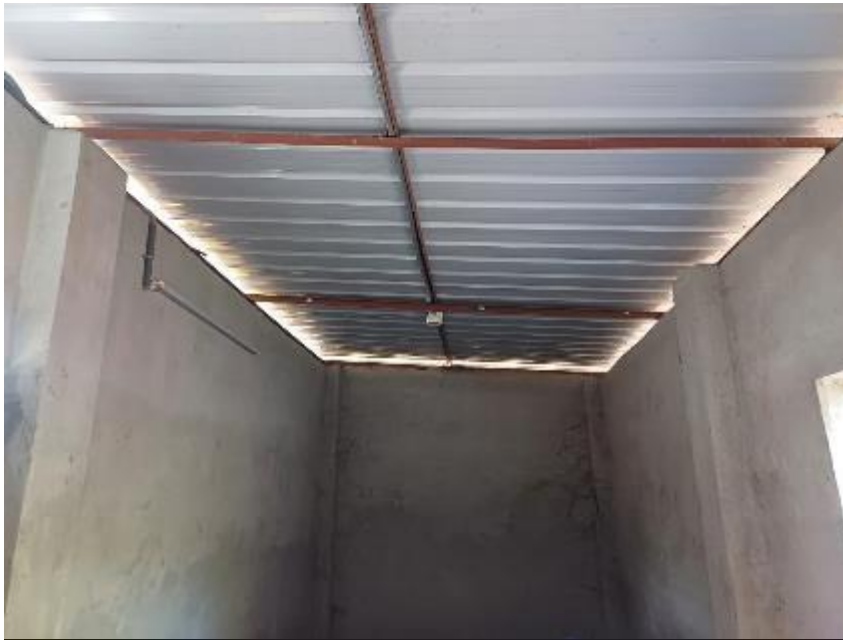
Steel angel

Apparently non-engineered connection

Apparently inadequate connections were observed at the lightweight roof of the single storied Sheds. The building engineer to check the connection adequacy of the lightweight roof against the uplift pressure of wind.

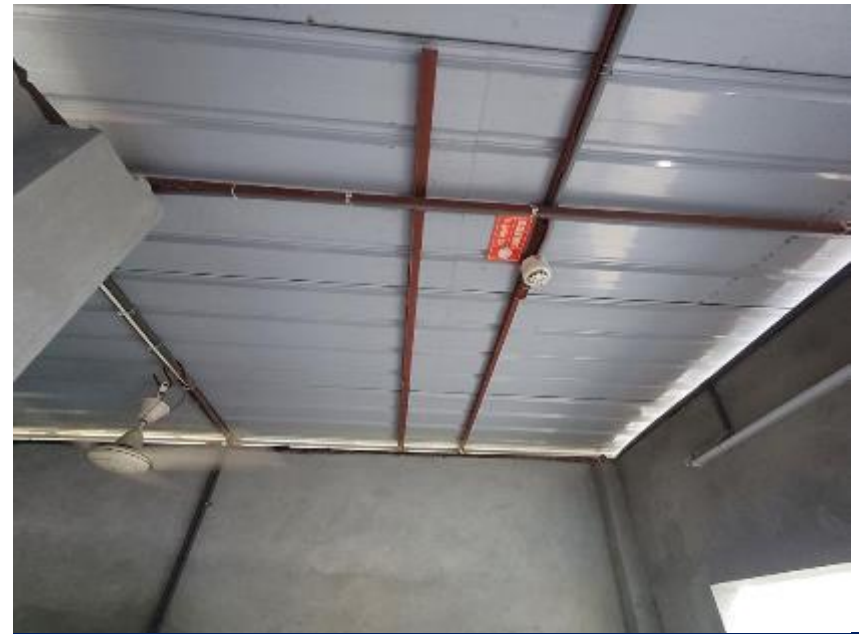
Steel angel connection with wall
