# TED Bernhardt Textile Industry Ltd.

Gazipura, Ershadnagar, Tongi, Gazipur-1704, Bangladesh

7 September 2023

# Observations

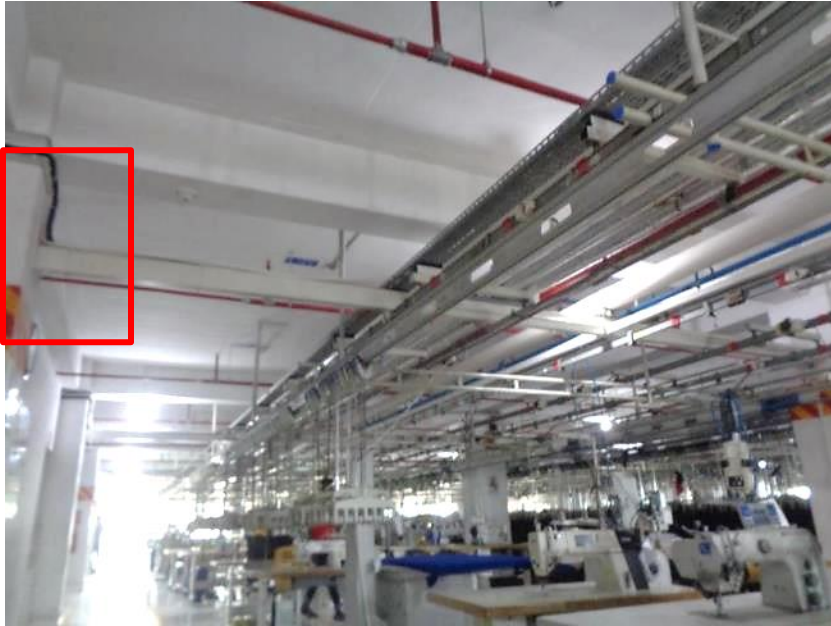
Cable tray and several utility service pipes are supported on steel box beam.

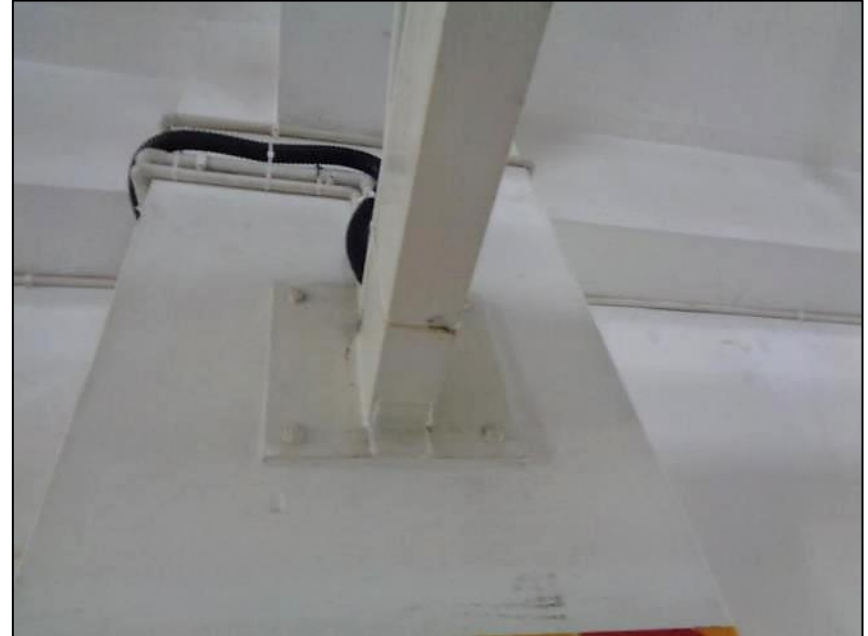
End connection of steel box

Adequacy of steel box member and its end connection did not include in the DEA report. The building engineer is required to incorporate the steel member & connection adequacy check in the DEA report.

| Item No. | Observation | Recommended Action Plan | Recommended Timeline |
|---|---|---|---|
| 03 | Design report to be revised for in-situ material strength.<br>Building-1 (Main Building) | Incorporate the steel member & connection adequacy check in the design report. | 6-weeks |

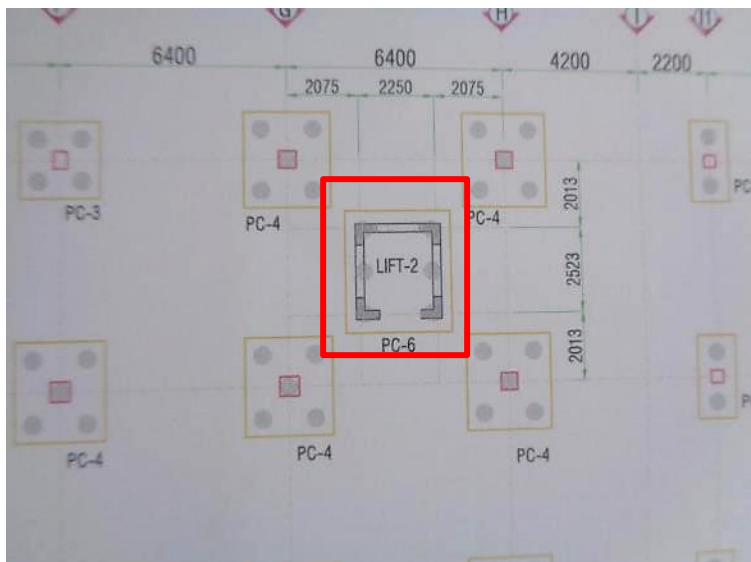
Drawing: L-shape column in lift core

As-built drawings doesn't match with as-built condition. The building engineer is required to survey the structures and prepare accurate as-built drawings.

| Item No. | Observation | Recommended Action Plan | Recommended Timeline |
|---|---|---|---|
| 07 | Discrepancies in as-built drawings. Building-1 (Main Building) | The building engineer is required to survey the structure and produce accurate as-built drawings. | 6-weeks |

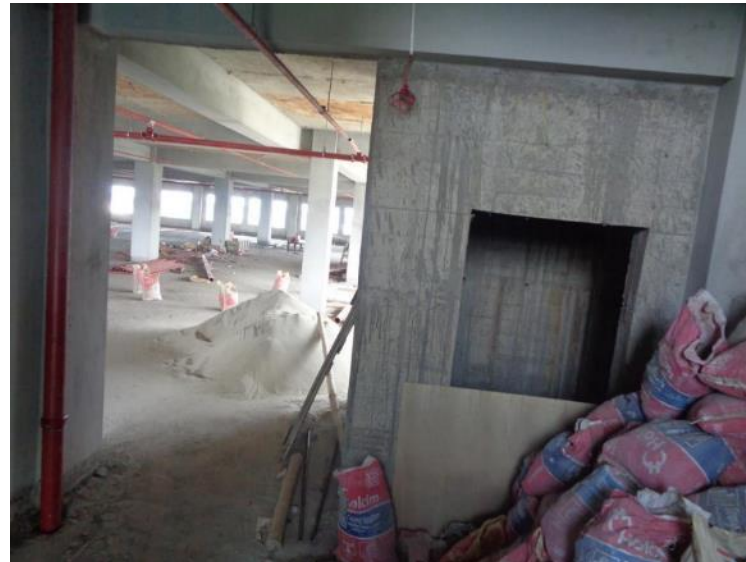
Onsite: Shear wall in lift core

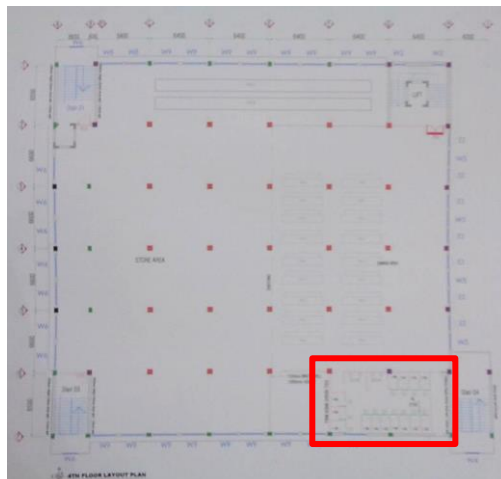
Drawing: 6 toilets

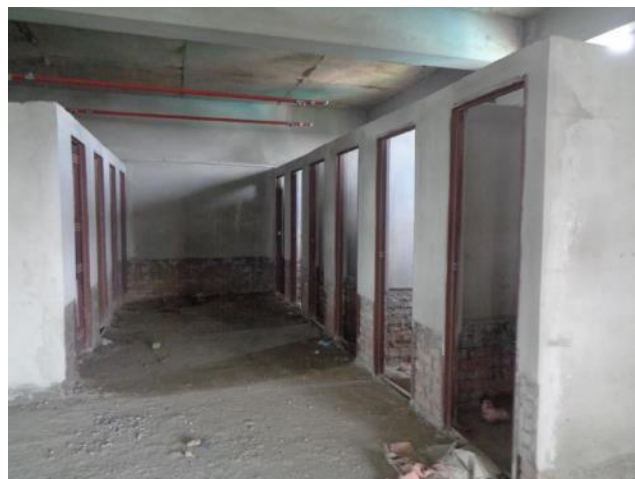
Onsite: 7 toilets

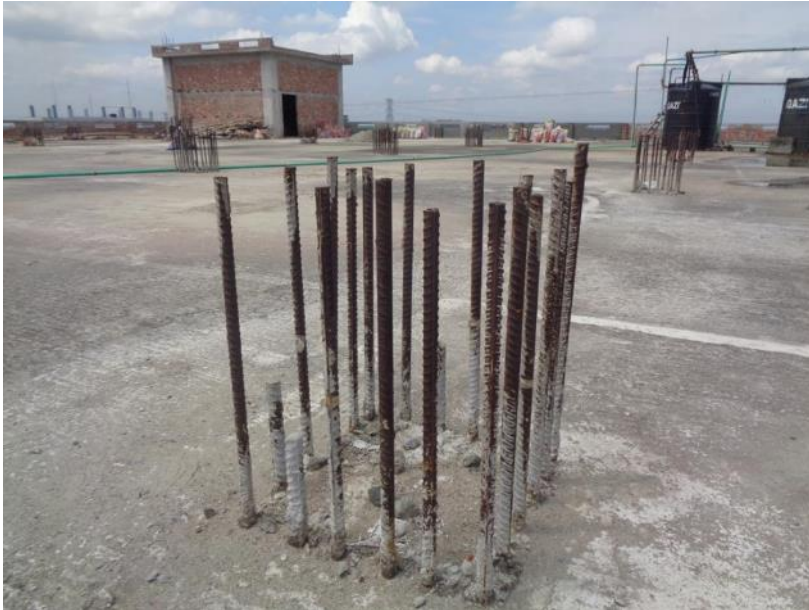
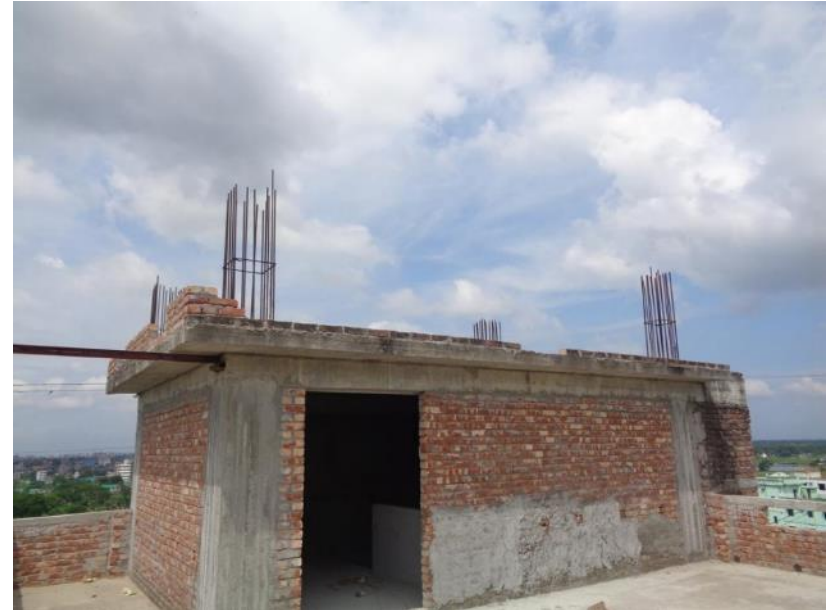
Exposed rebar on roof

Exposed rebar observed on roof which is prone to corrosion. The factory is required to provide anti-corrosive coating on the exposed rebar.

| Item No. | Observation | Recommended Action Plan | Recommended Timeline |
|---|---|---|---|
| 08 | Exposed rebar at roof. Building-1 (Main Building) | The factory is required to provide anti-corrosive coating on the exposed rebar. | 6-months |

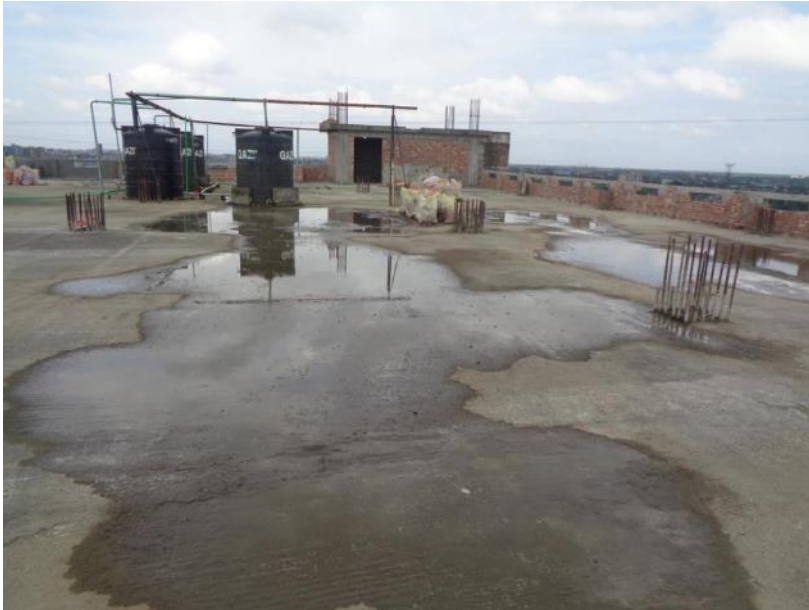
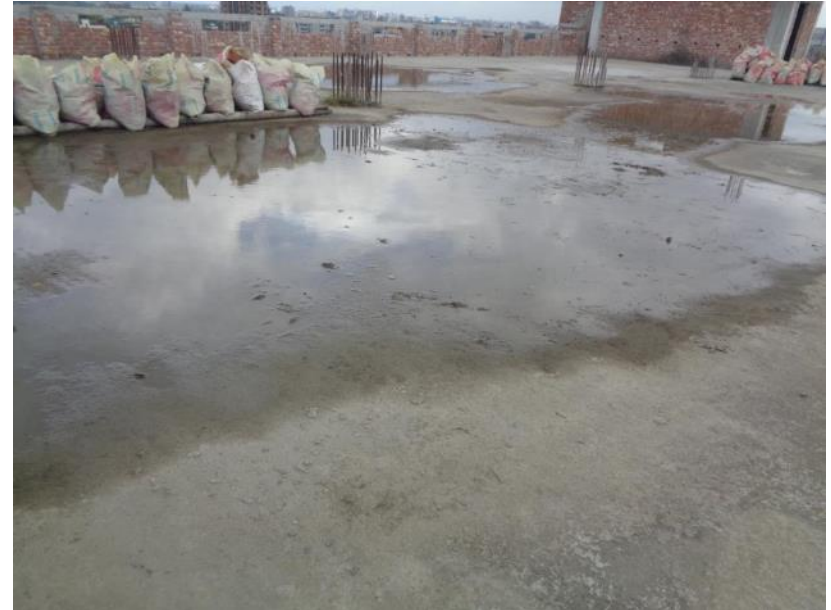
Water ponding on the roof

The factory is required to improve roof drainage system with adequate slope and provide sufficient water outlets to drain out water.

| Item No. | Observation | Recommended Action Plan | Recommended Timeline |
|---|---|---|---|
| 09 | Water ponding on roof. Building-1 (Main Building) | The factory is required to improve roof drainage system with adequate slope and provide sufficient water outlets to drain out water. | 6-months |

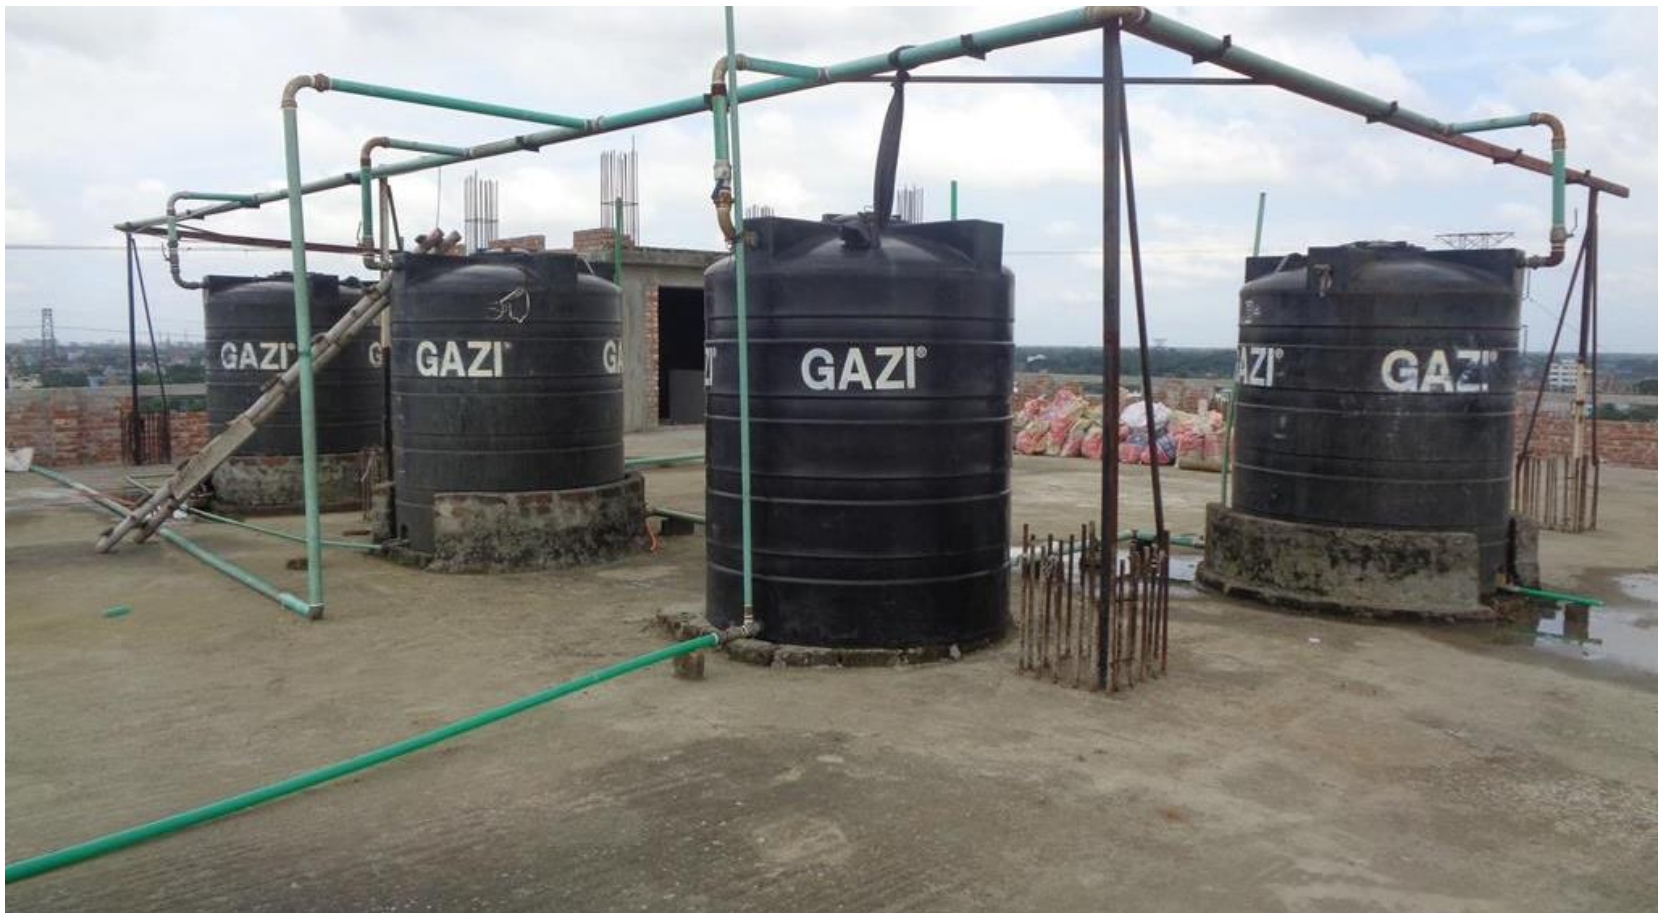
Water tank on the roof has no lateral brace

The factory is required to provide lateral bracing for water tanks to resist seismic forces.

| Item No. | Observation | Recommended Action Plan | Recommended Timeline |
|---|---|---|---|
| 10 | Lack of anchorage of non-structural elements. Building-1 (Main Building) | The factory is required to provide lateral bracing for water tanks to resist seismic forces. | 6-months |

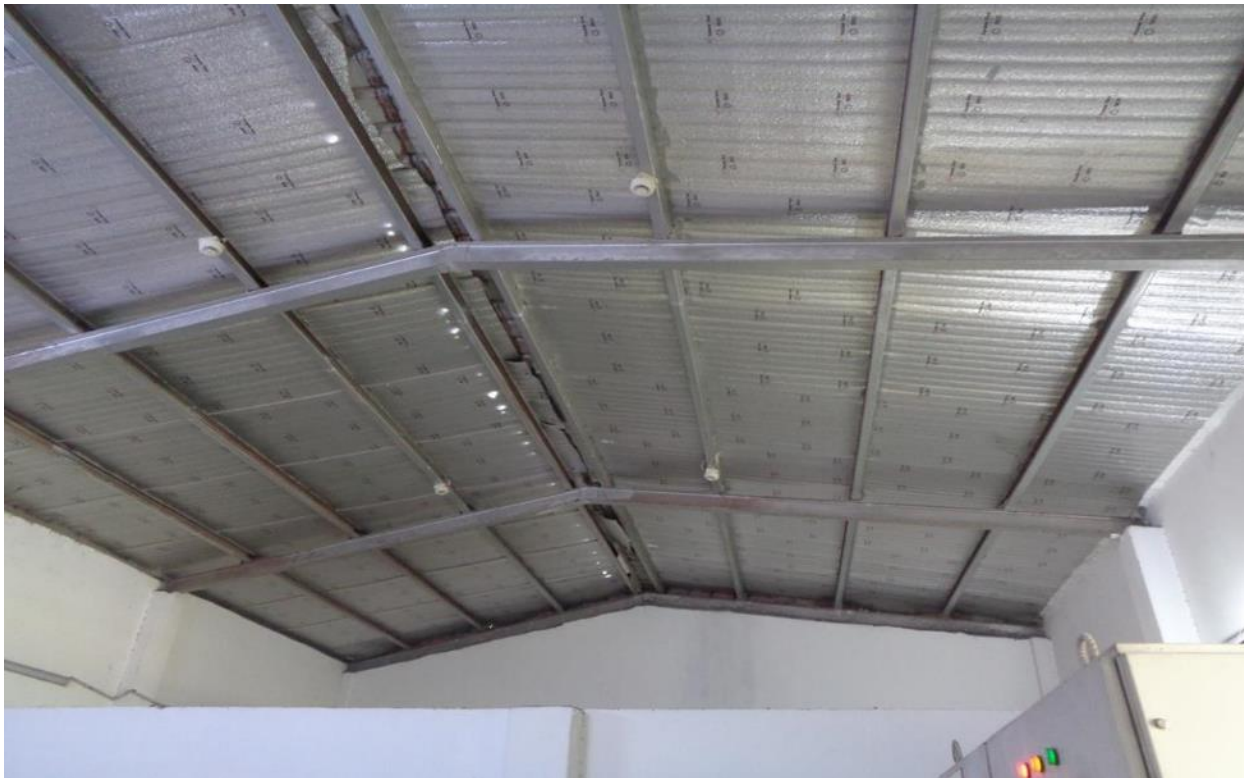
Absence of load transfer media along transverse direction of rafter and absence of horizontal bracing at roof

Lack of lateral stability system (bracing & compression strut) was observed in the structure. Also, the column and rafter size seems to be inadequate. The building engineer is required carryout Engineering Assessment (EA) to check the lateral stability of the structure and suggest proper remedial actions accordingly. Submit the EA documents to the RSC for review.

| Item No. | Observation | Recommended Action Plan | Recommended Timeline |
|---|---|---|---|
| 11 | Lack of design documents for lateral stability. Building-2 (Generator, Security and Substation Shed) | The building engineer is required carryout Engineering Assessment (EA) to check the lateral stability of the structure and suggest proper remedial actions accordingly. | 6-weeks |

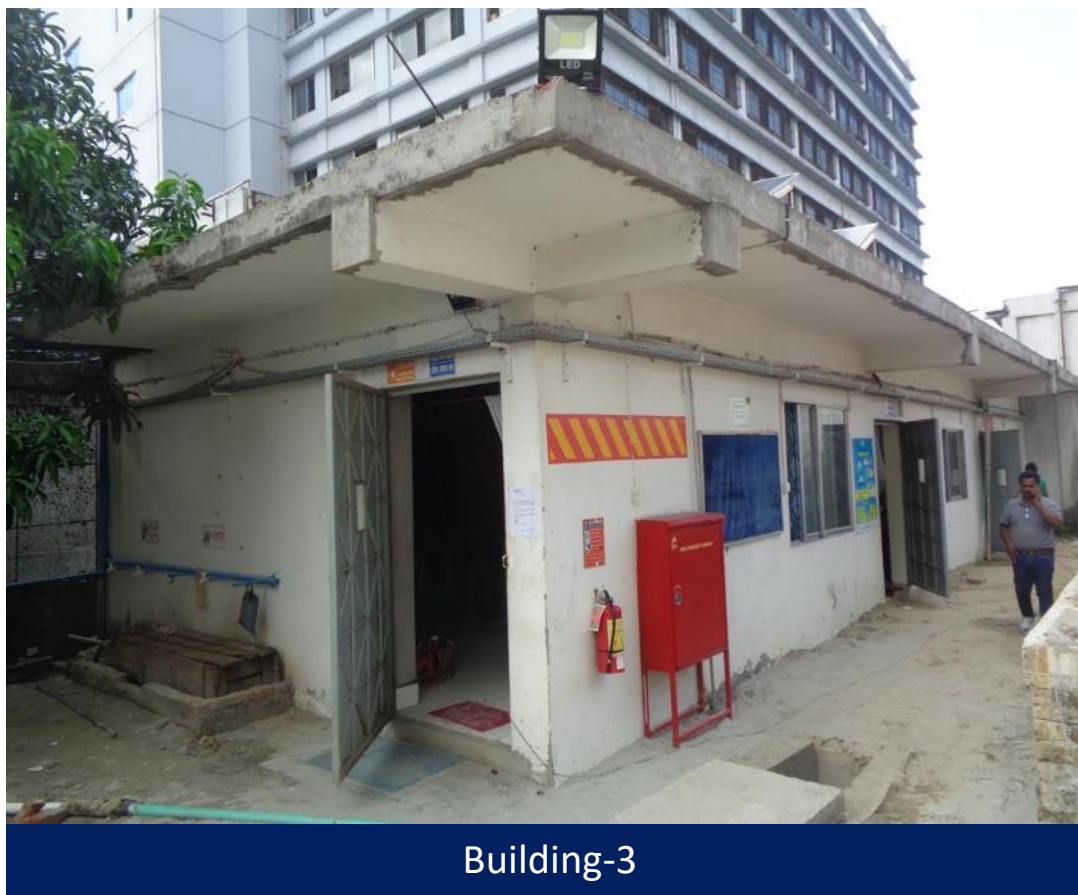
During inspection design report was not found which is required to be prepared in compliance with section 1.9.1.1 (part-6, BNBC).

| Item No. | Observation | Recommended Action Plan | Recommended Timeline |
|---|---|---|---|
| 13 | Lack of design report. Building-3 (Childcare, Medical & Fire Control Building) | The building engineer is required to prepare design documents in compliance with section 1.9.1.1 (part-6, BNBC). | 6-weeks |

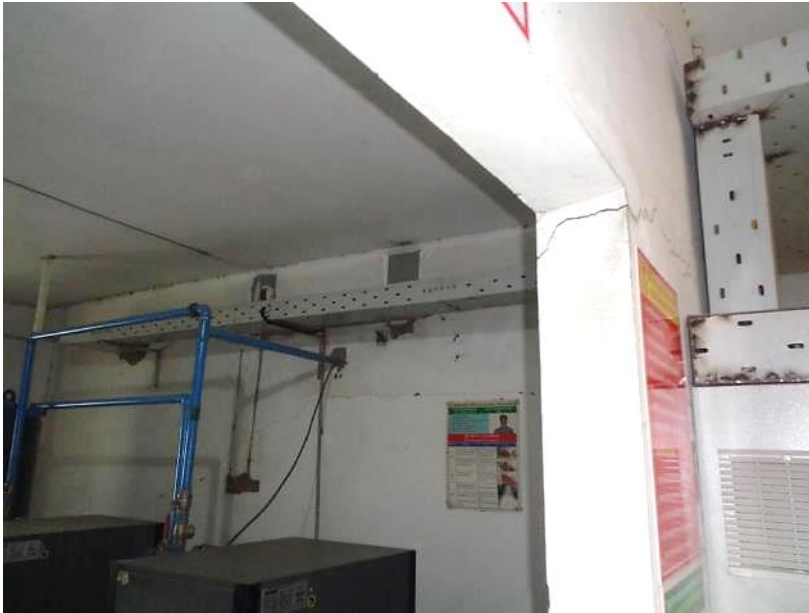
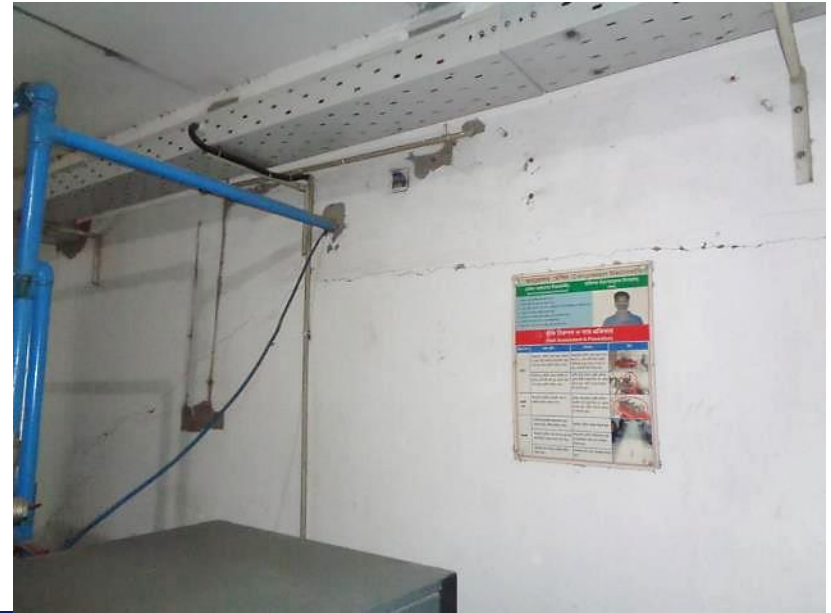
Crack in brick walls & floors

The building engineer is required to investigate the reason of crack and prepare an investigation report with proper remedial methodology.

| Item No. | Observation | Recommended Action Plan | Recommended Timeline |
|---|---|---|---|
| 15 | Crack in brick wall and ground floor. Building-3 (Childcare, Medical & Fire Control Building) | The building engineer is required to investigate the reason of crack and prepare an investigation report with proper remedial methodology. | 6-weeks |

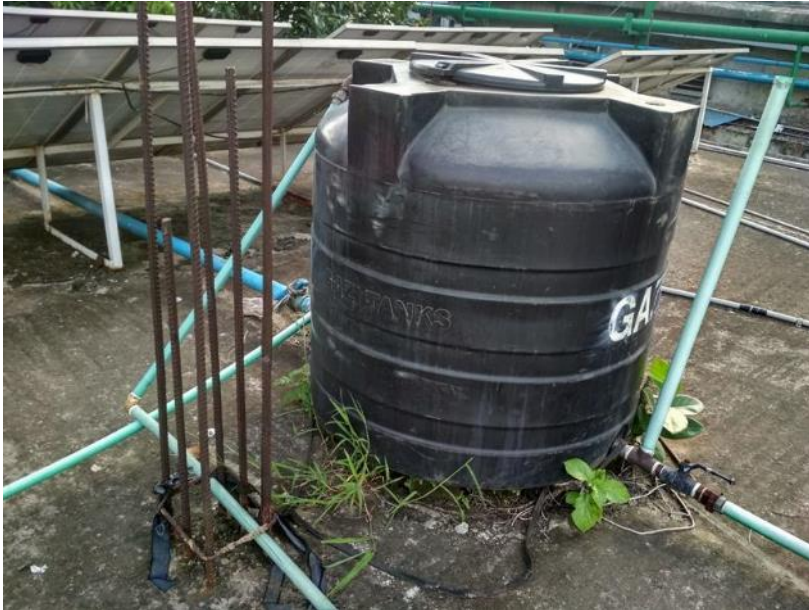
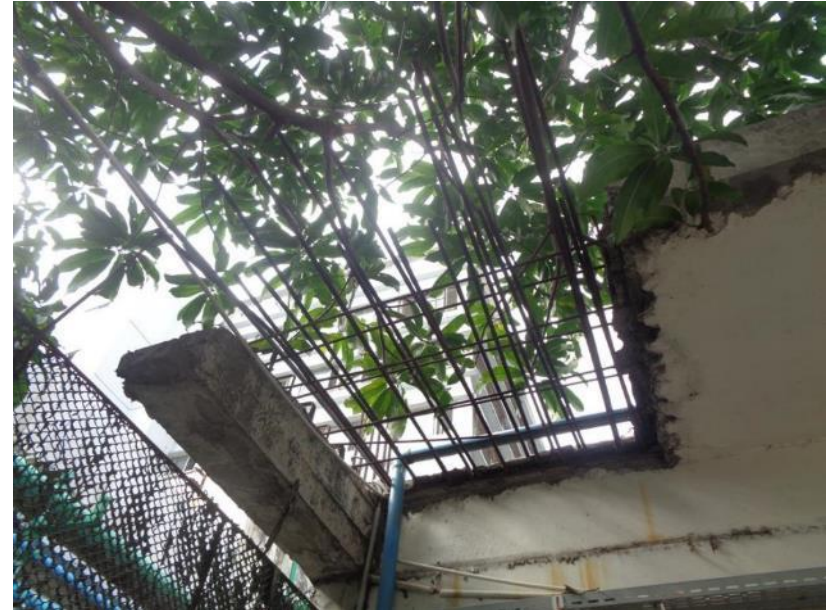
Exposed rebar on roof

Exposed rebar observed on roof which is prone to corrosion. The factory is required to provide anti-corrosive coating on the exposed rebar or remove the rebars & seal the exposed areas.

| Item No. | Observation | Recommended Action Plan | Recommended Timeline |
|---|---|---|---|
| 17 | Exposed rebar on roof. Building-3 (Childcare, Medical & Fire Control Building) | The factory is required to provide anti-corrosive coating on the exposed rebar or remove the exposed rebars. | 6-months |

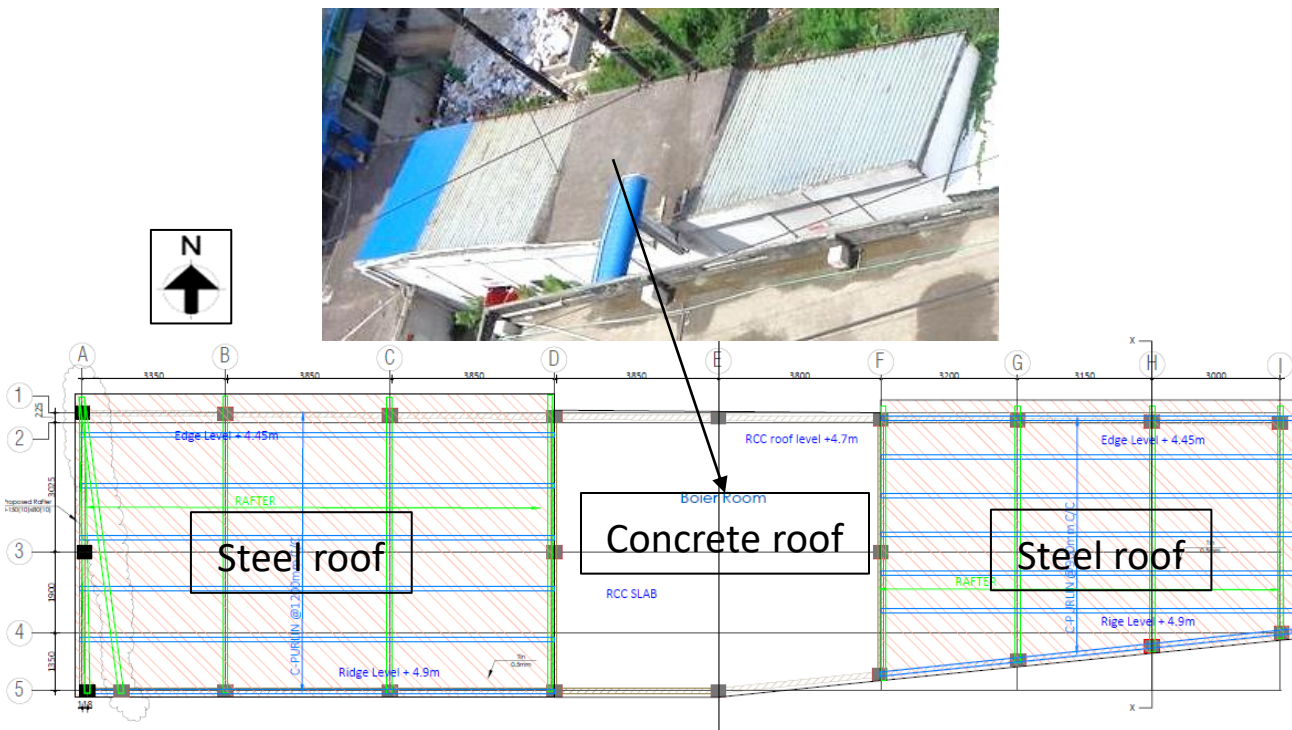
Roof layout: Combination of concrete & steel frames

The rafter size and connection seems to be inadequate. And there is combination of concrete & steel frames. So, the building engineer is required carryout Engineering Assessment (EA) to verify the lateral stability of the structure and suggest proper remedial actions accordingly. Submit the EA documents to the RSC for review.

| Item No. | Observation | Recommended Action Plan | Recommended Timeline |
|---|---|---|---|
| 18 | Lateral stability system to be verified. Building-4 (Boiler Shed) | The building engineer is required carryout Engineering Assessment (EA) to verify the lateral stability of the structure and suggest proper remedial actions accordingly. | 6-weeks |

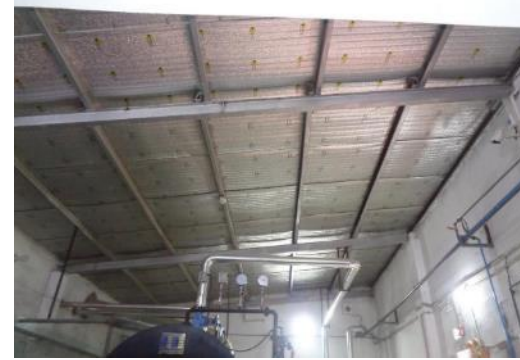
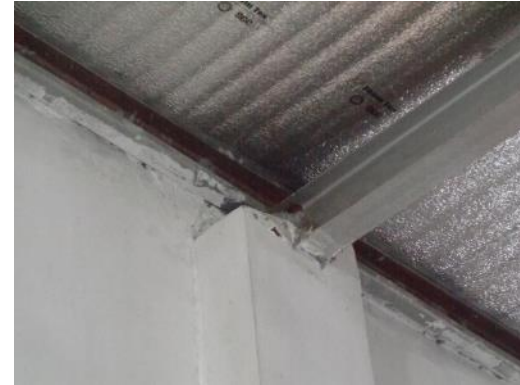
Apparently inadequate member & connection

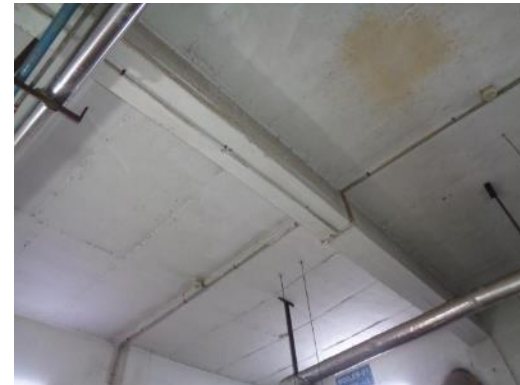
Single panel RC frame

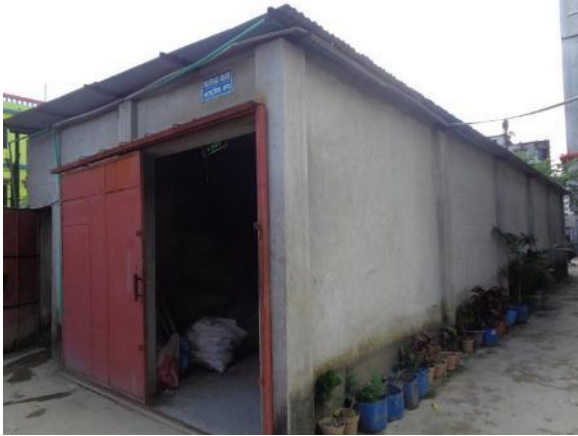
Peripheral brick walls

The building engineer is required carryout Engineering Assessment (EA) to check the lateral stability & connection of the structure and suggest proper remedial actions accordingly. Submit the EA documents to the RSC for review.

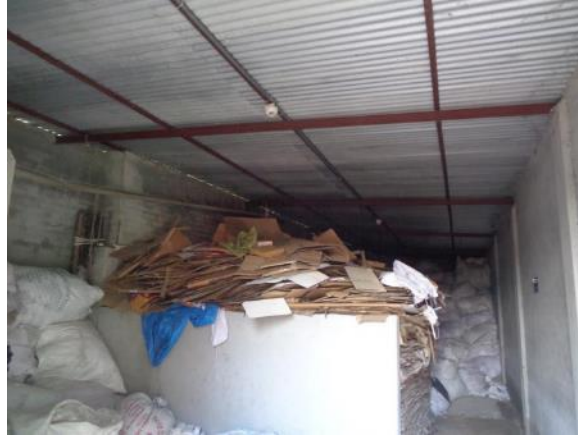
Apparently inadequate rafter

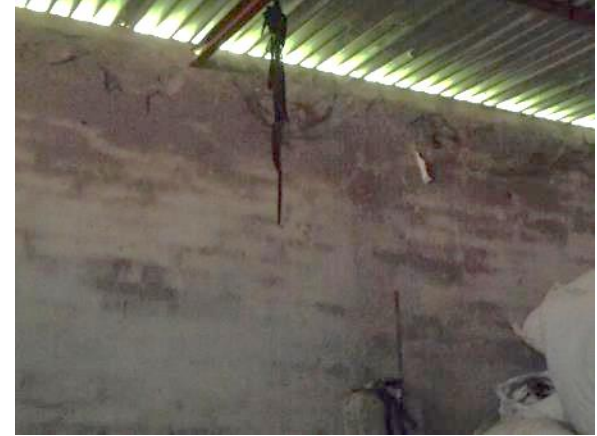
Non-engineered connection

| Item No. | Observation | Recommended Action Plan | Recommended Timeline |
|---|---|---|---|
| 20 | Apparently inadequate connection and lateral stability system. Building-5 (Wastage Shed) | The building engineer is required carryout Engineering Assessment (EA) to check the lateral stability & connection of the structure and suggest proper remedial actions accordingly. | 6-weeks |

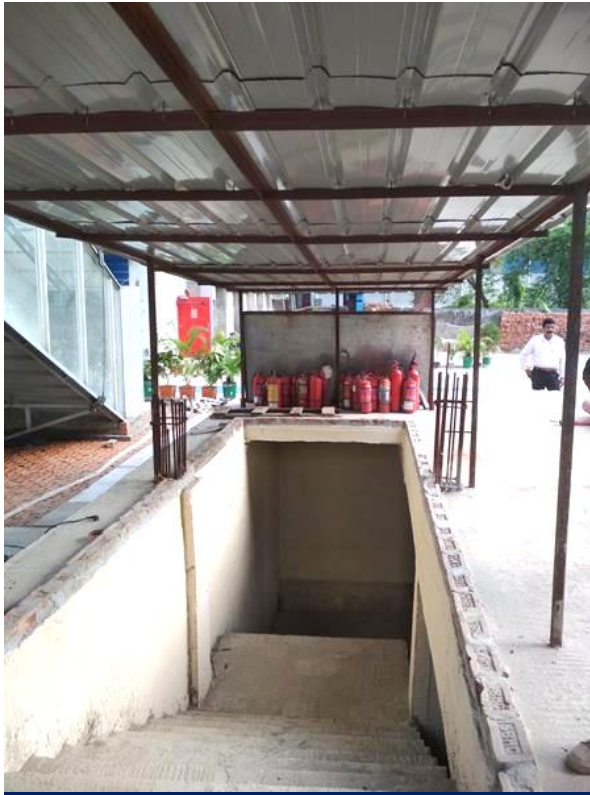
Lightweight steel shed above staircase

Building engineer is required to check the adequacy of steel roofing for lateral forces and top slab of fire pump for heavy vehicle loads.

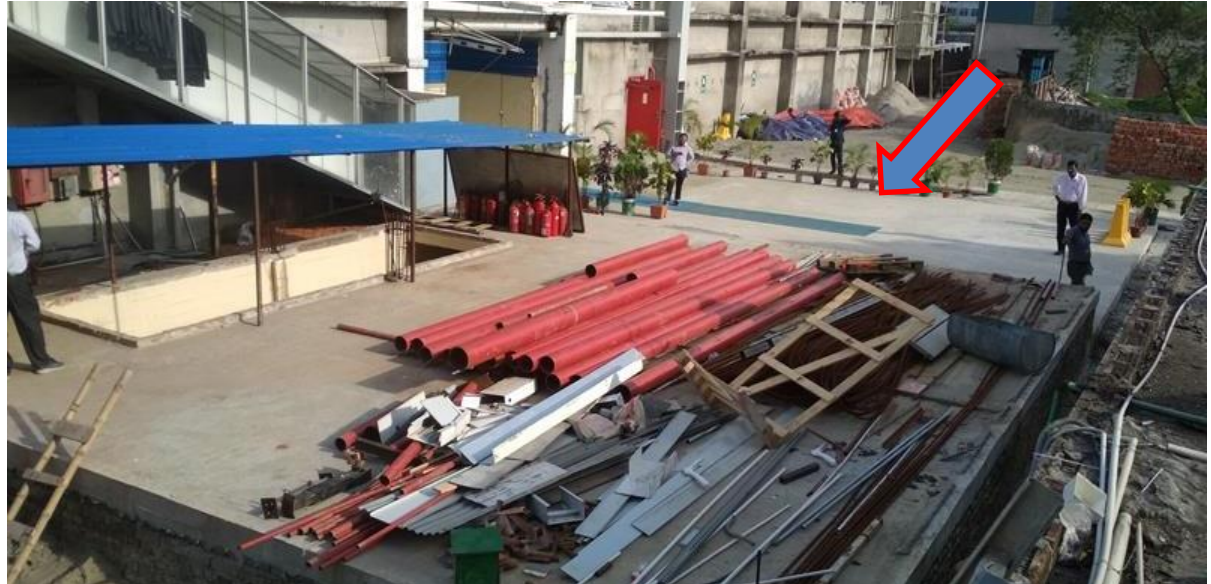
Roof of fire pump room used for loading unloading zone

| Item No. | Observation | Recommended Action Plan | Recommended Timeline |
|---|---|---|---|
| 22 | Lack of design documents for ground floor loading-unloading zone & steel roofing. Building-6 (Fire Pump Room) | Building engineer is required to check the adequacy of steel roofing for lateral forces and top slab of fire pump for heavy vehicle loads. | 6-weeks |

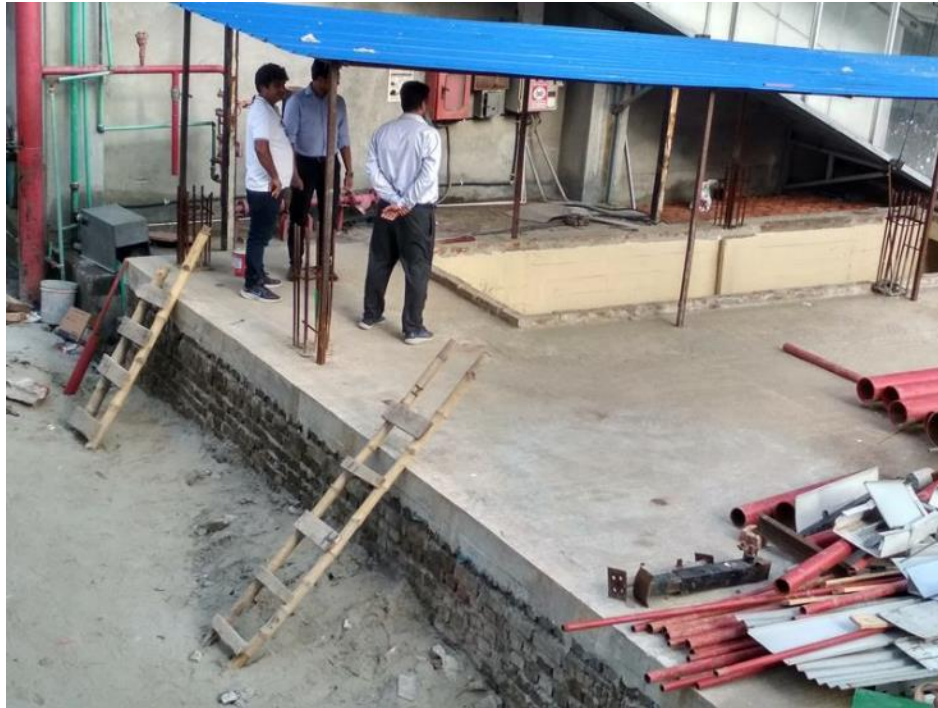
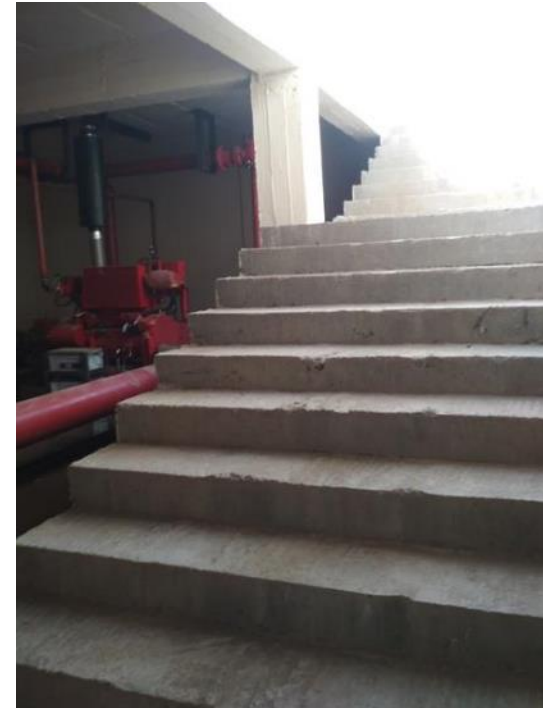
Falling hazards

The factory is required to provide adequate barrier to avoid possible falling hazards.

| Item No. | Observation | Recommended Action Plan | Recommended Timeline |
|---|---|---|---|
| 24 | Falling hazard in raised platform and stair. Building-6 (Fire Pump Room) | The factory is required to provide adequate barrier to avoid possible falling hazards. | 6-weeks |

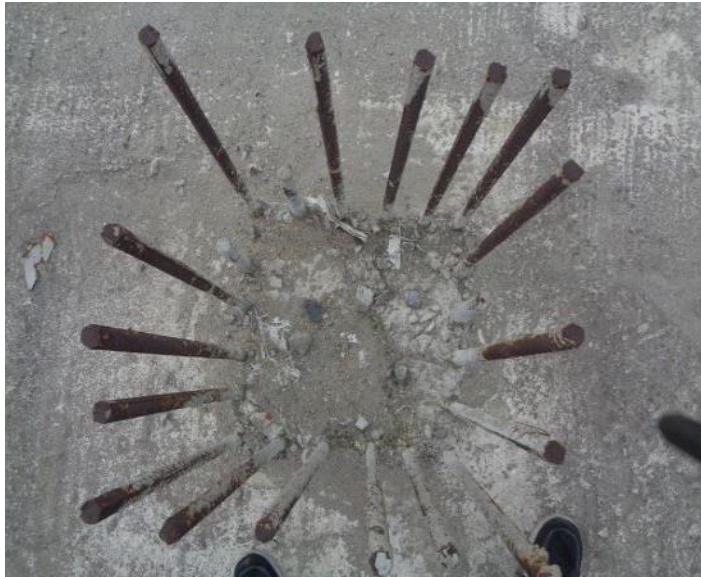
Exposed rebar on roof
