Murad Apparels Ltd (Extension)

South Gouripur Ashulia, Savar, Dhaka-1341

21-Sep-2023

Buildings Information

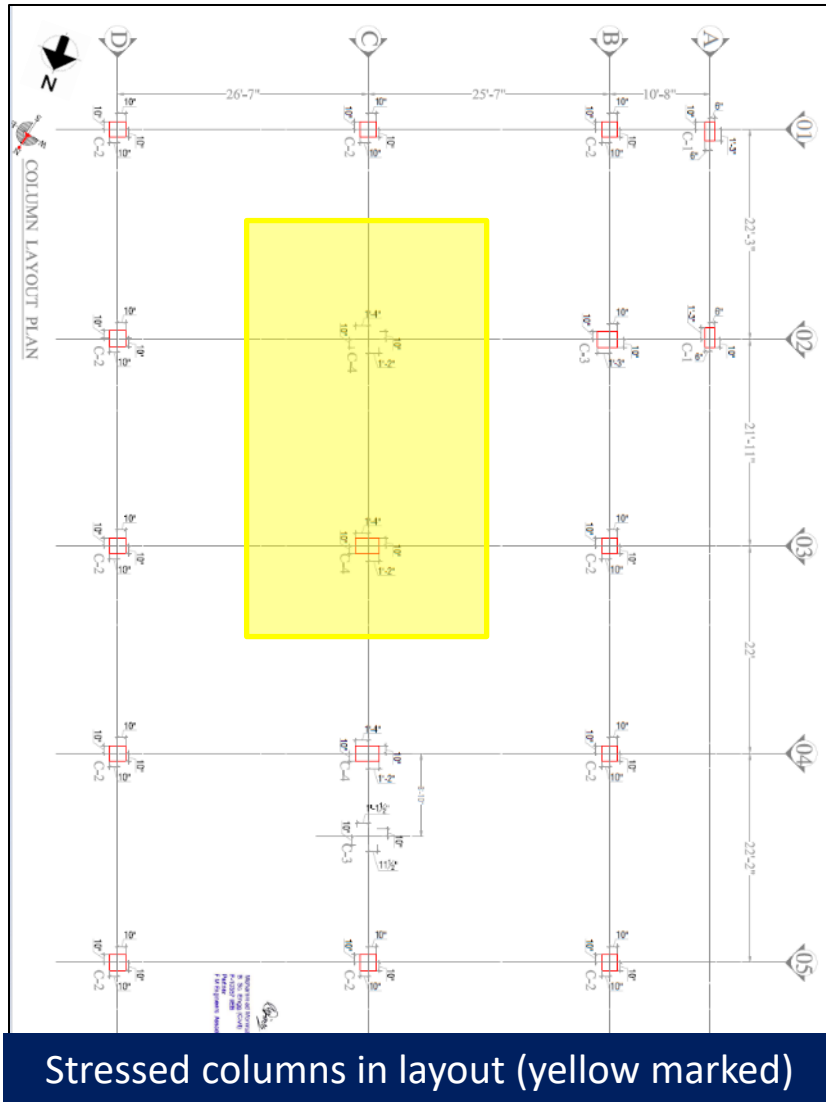
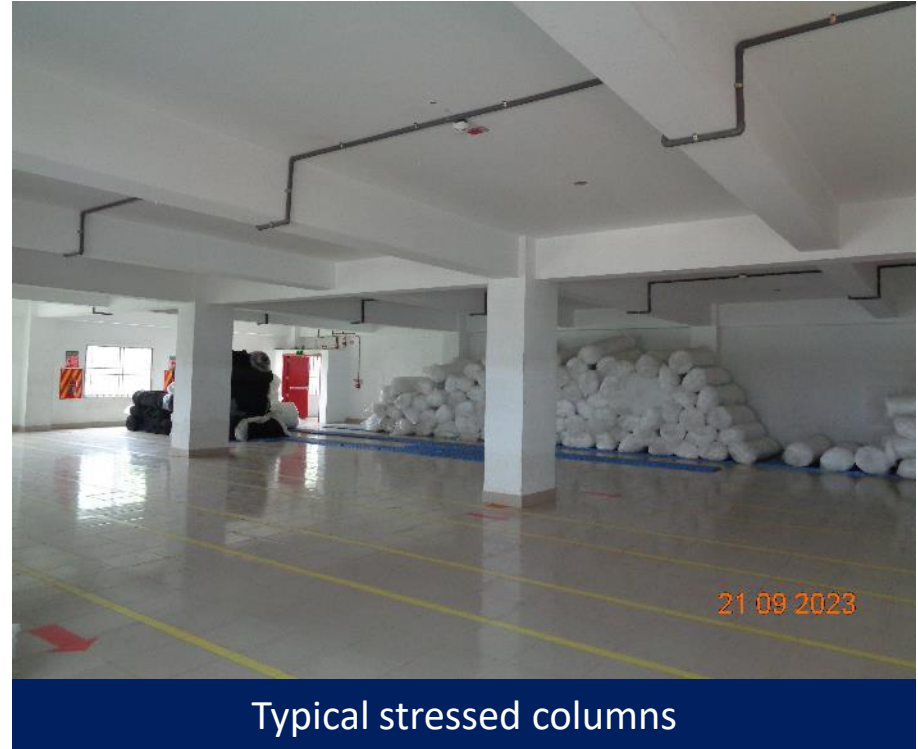
Stress in column exceeds normal design limit

The cursory calculation indicates that column stress exceeds the normal design limit considering a typical floor live load of 6kPa, roof live load of 1.5 kPa, and concrete strength of 16.31 MPa. The building engineer is required to review the design, loads, and column stresses for the marked columns based on in-situ material strength.

Item No.	Observation	Recommended Action Plan	Recommended Timeline
01	Stress in column exceeds normal design limit (Godown Building-1)	Building Engineer to review design, loads and column stresses in the area identified above.	6-weeks
02	Stress in column exceeds normal design limit (Godown Building-1)	Verify in-situ concrete stresses by 100mm dia. cores from a minimum 4 nos from lower tier columns.	6-weeks
03	Stress in column exceeds normal design limit (Godown Building-1)	Produce and actively manage a loading plan for all floor plates considering floor and column capacity.	6-weeks
04	Stress in column exceeds normal design limit (Godown Building-1)	Carry out remedial works where required.	6-months
05	Stress in column exceeds normal design limit (Godown Building-1)	Continue to implement floor loading plan.	6-months

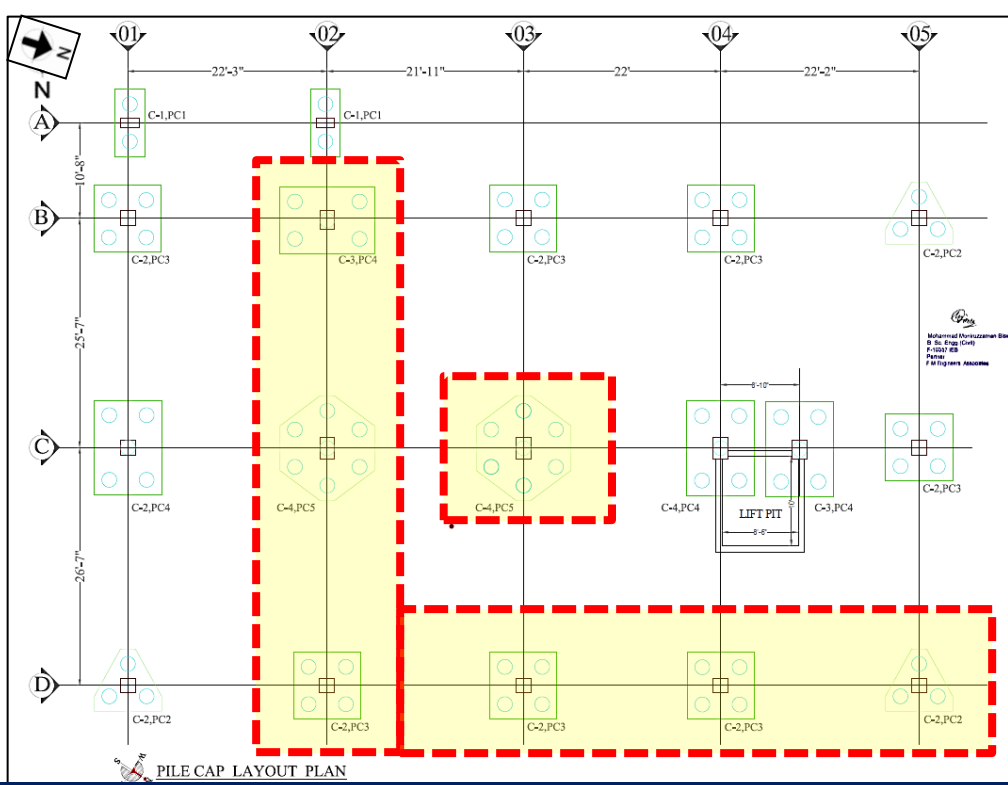
Pile layout plan

Stress in pile foundations exceed normal design limit

Cursory calculation indicates that Factor of Safety of some pile foundations below the allowable limit considering pile capacity from the soil test report and 6 kPa (63psf) live load on for storage. Building engineer is required to review the design load and stress in the pile foundations.

Item No.	Observation	Recommended Action Plan	Recommended Timeline
06	Stress in pile foundations exceed normal design limit (Godown Building-1)	Building engineer is required to review the design load and adequacy of the pile foundations and suggest necessary remedial actions accordingly.	6-weeks
07	Stress in pile foundations exceed normal design limit (Godown Building-1)	Carry out suggested remedial works where necessary.	6-months
08	Live load consideration and assignment. (Godown Building-1)	Building engineer to revise the Engineering Assessment (EA) including a design report, and a set of structural drawings in compliance with section 1.9.1.1 and section 1.9.1.2 as per BNBC.	6-weeks
09	Live load consideration and assignment. (Godown Building-1)	Produce and actively manage a loading plan for all floor plates within the factory, considering floor, column and foundation capacity.	6-weeks
10	Live load consideration and assignment. (Godown Building-1)	Continue to implement loading plan.	6-months

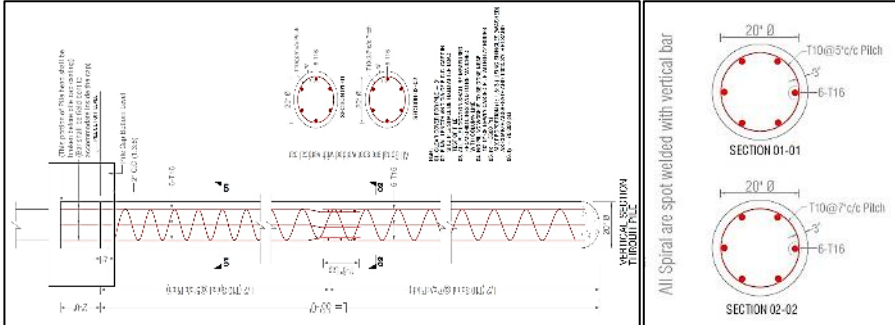
Allowable pile capacity from Soil Test report

The pile length- 55ft and pile dia- 20 inch.

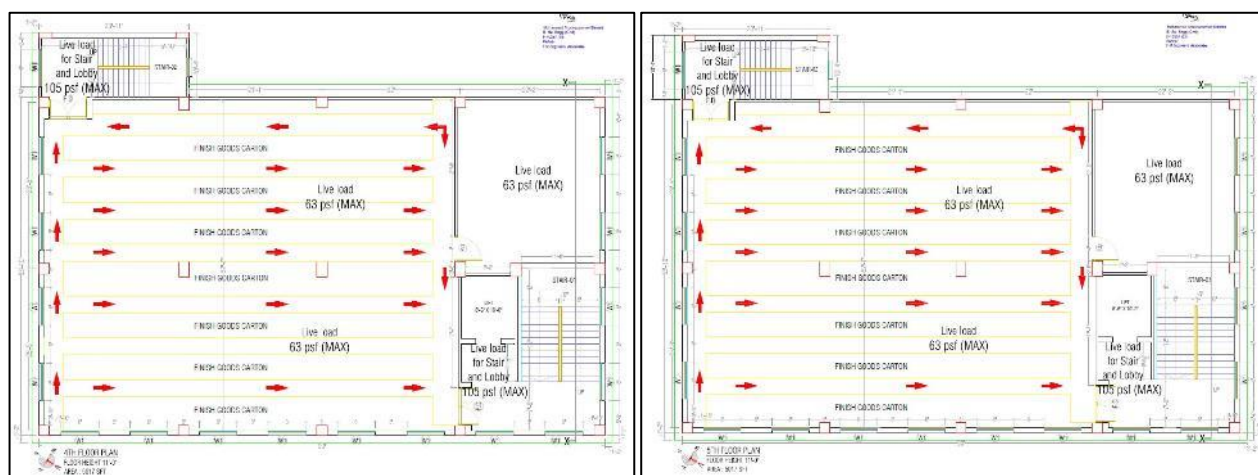
Prepared load plan for 4th and 5th floors. Floor loading has been considered 3kPa (63 psf) instead of 6kPa (125 psf) for storage areas.

As per BNBC, 6 kPa is required to consider as floor loading for the light storage facilities. During inspection, load plan was found posted considering (63 psf) 3kPa at 5th floor. Revise the software-based analysis model, Engineering Assessment (EA) report and load plan following BNBC requirements.

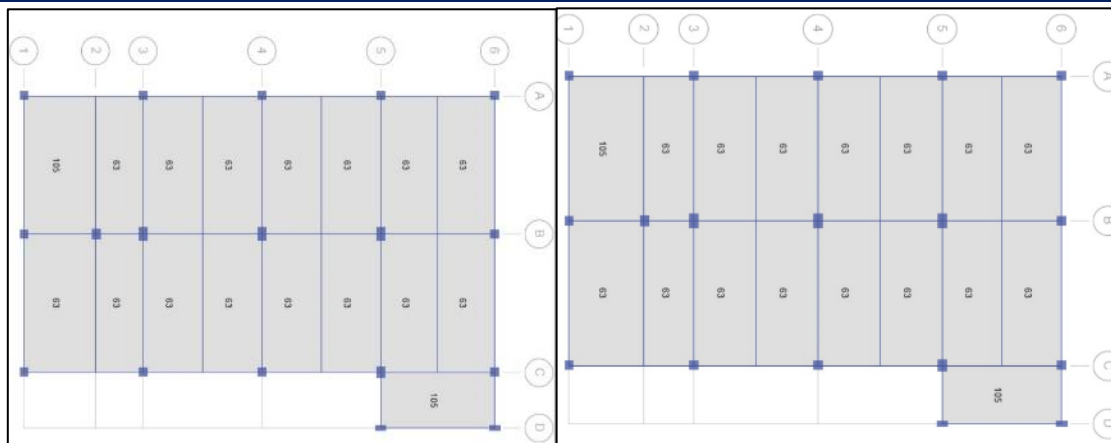
Loading at 4th & 5th Floor loading has been assigned 3 kPa (63 psf) in FEA model instead of 6kPa (125 psf).

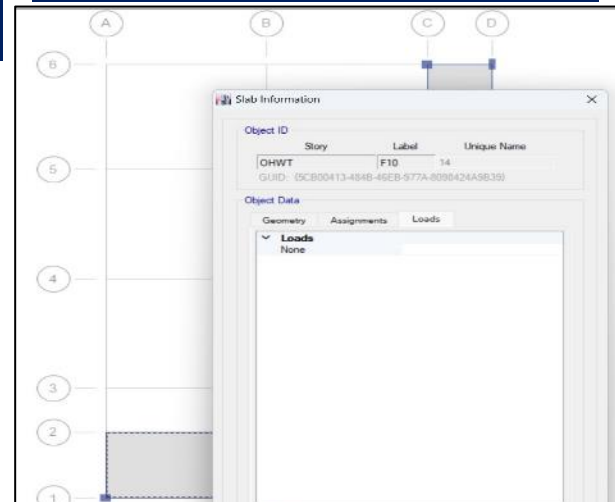
The stair roof top loading has not been assigned in FEA model.

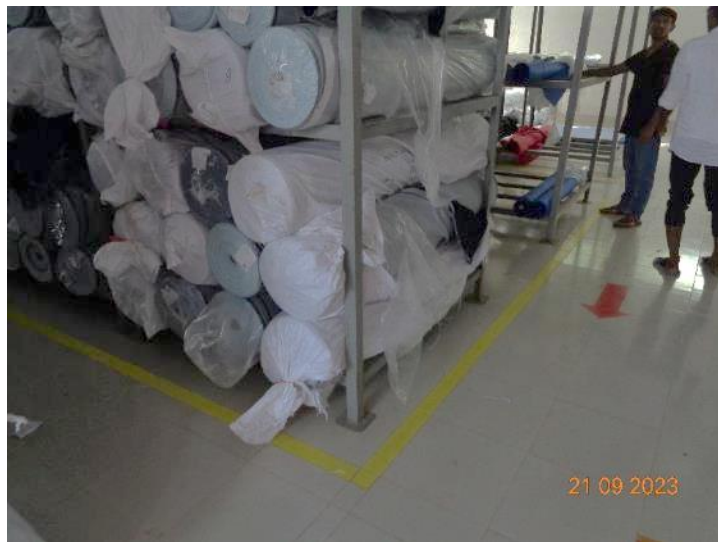
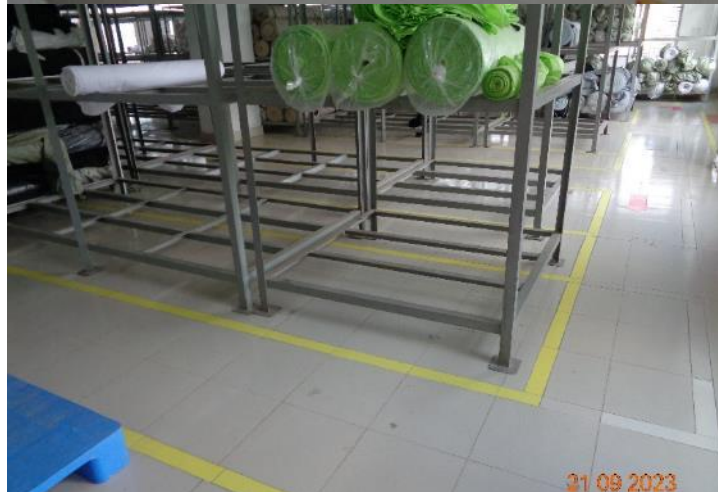
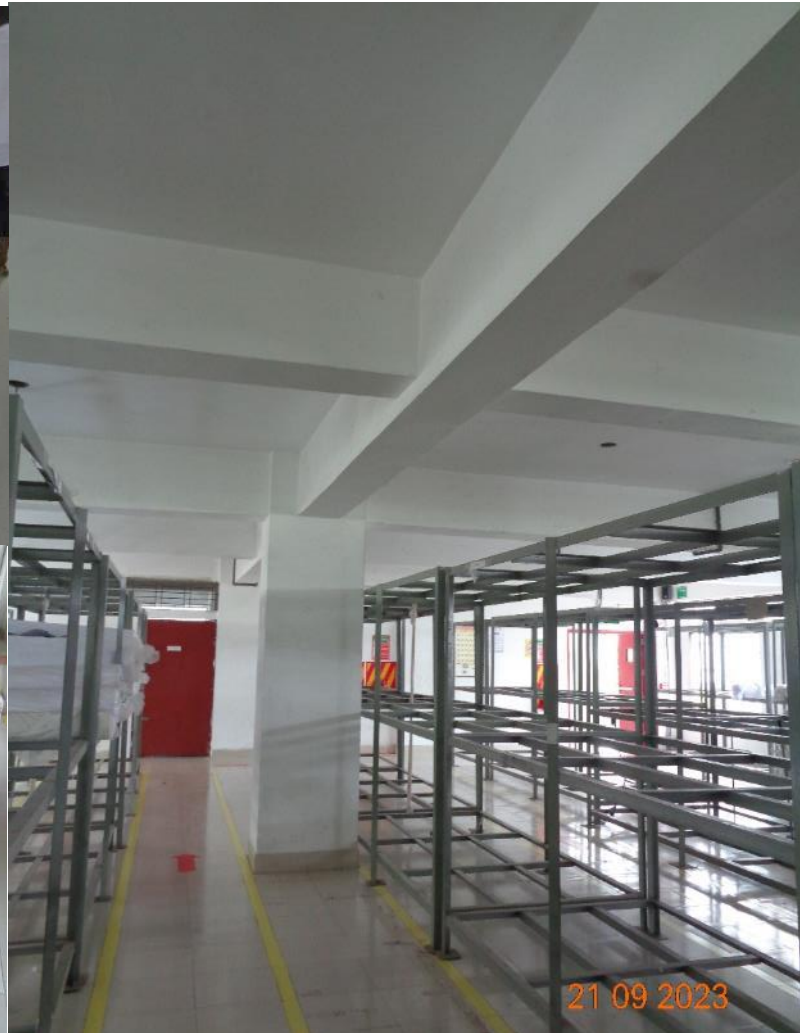
Rack on floor level

Non-structural elements not anchored or braced

Racks on different floors are not adequately anchored or braced to resist lateral (earthquake) forces. Building is required to adequately anchor and brace all non-structural elements to resist earthquake forces to comply with the BNBC.

Item No.	Observation	Recommended Action Plan	Recommended Timeline
11	Non-structural elements not anchored or braced (Godown Building-1)	Building engineer is required to adequately anchor and brace all non-structural elements to resist earthquake forces to comply with the BNBC.	6-weeks
12	Detail Engineering Assessment (DEA) needs to be performed before Future Vertical Extension (Godown Building-2)	Prior to the vertical extension, building engineer is required to produce a Detailed Engineering Assessment(DEA) of the structure according to BNBC and submit it to RSC for review.	6-weeks
13	Detail Engineering Assessment (DEA) needs to be performed before Future Vertical Extension (Godown Building-2)	Carry out recommendation as outcome of the DEA.	6-months
14	Lack of edge protection (Godown Building-2)	Building is required to provide edge protection on the roof and stair to avoid falling hazard.	6-weeks

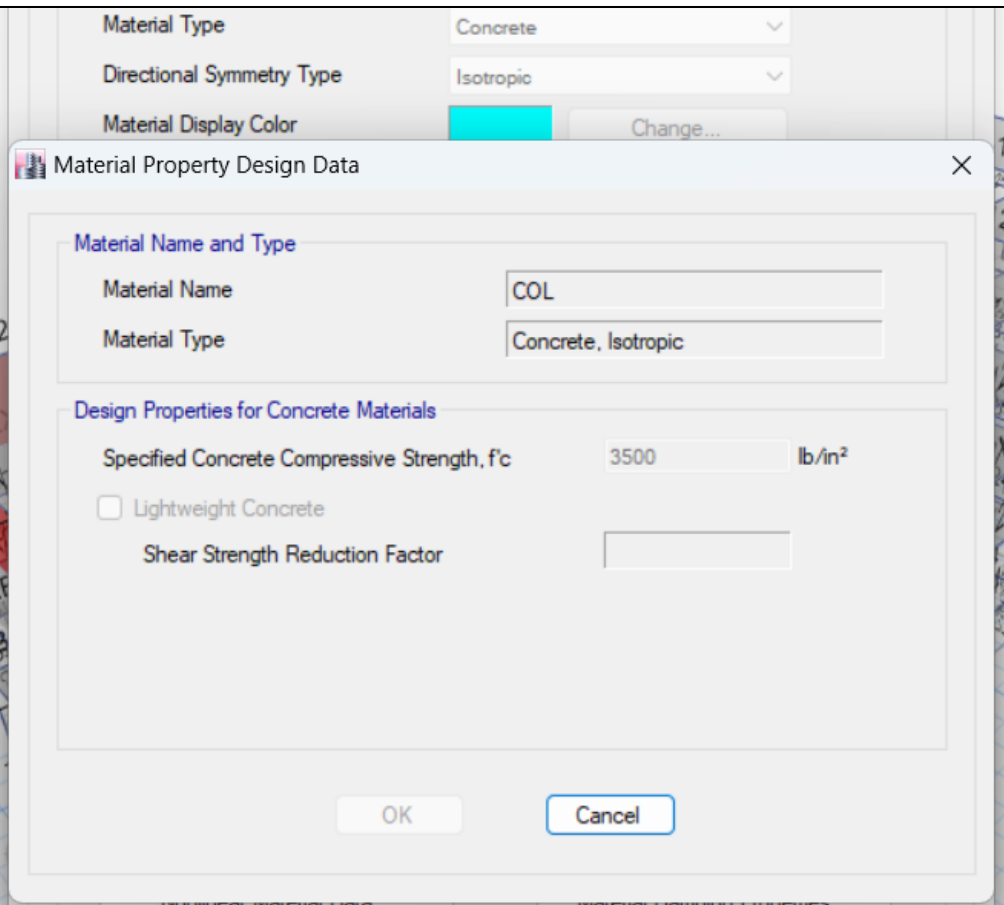
In software analysis, the concrete strength of columns considered $f'c=3500$ psi.

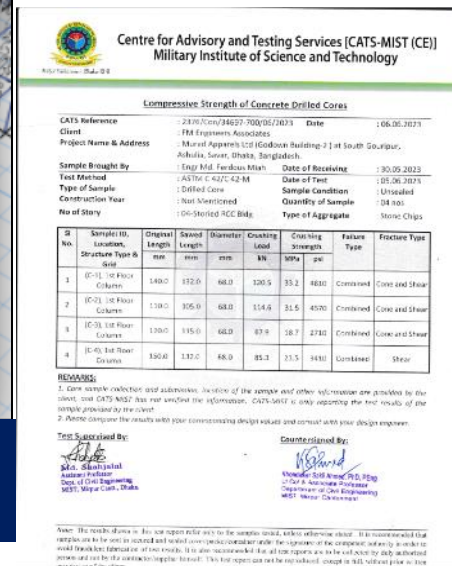
Compressive strength of concrete cores are 4810 Psi, 4570Psi, 2710 Psi, 3410 Psi

Building engineer has taken the concrete core from the column. The equivalent concrete strength was found 2739 psi following ACI-562 and considering ACI-214 correction the equivalent concrete strength was found 3068 psi which is below the design strength 3500 psi. Building engineer is required to perform a detailed engineering assessment considering the equivalent concrete strength of the column concrete core.

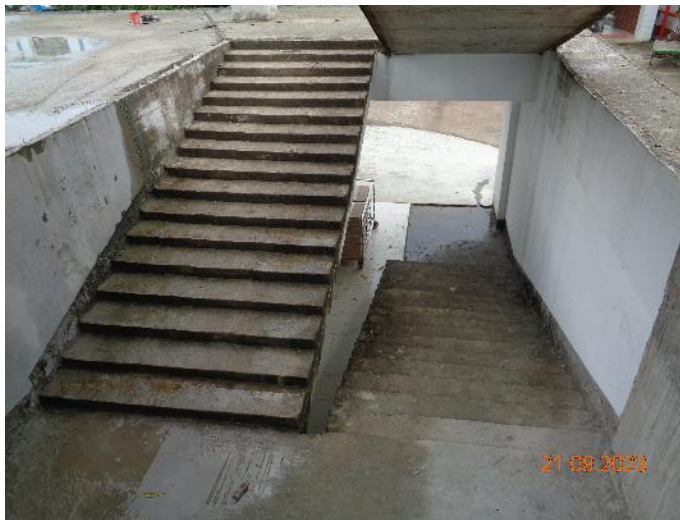
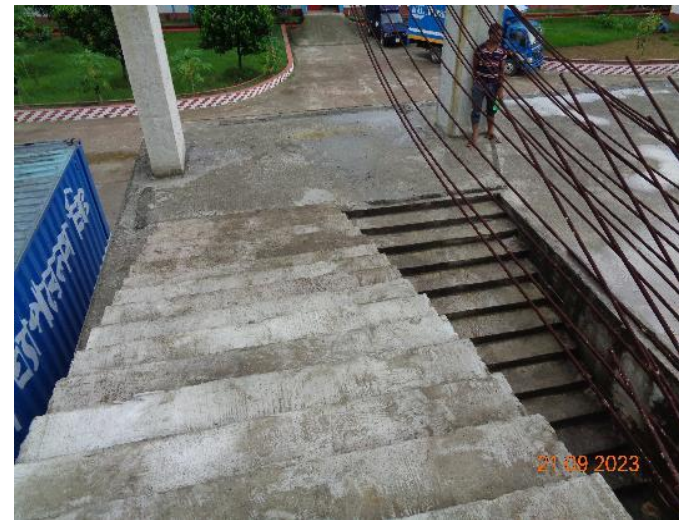
Missing railing at stair

During the inspection, Edge protection (Parapet wall/Railing) was not observed on the roof and stairs. Building is required to provide edge protection to avoid falling hazards.

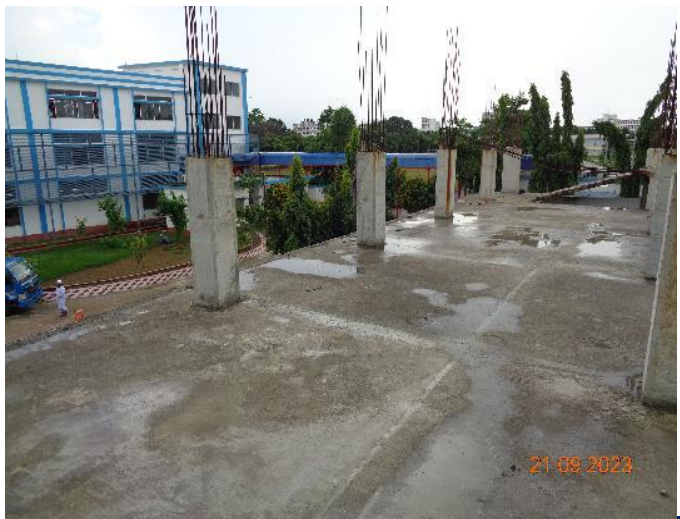
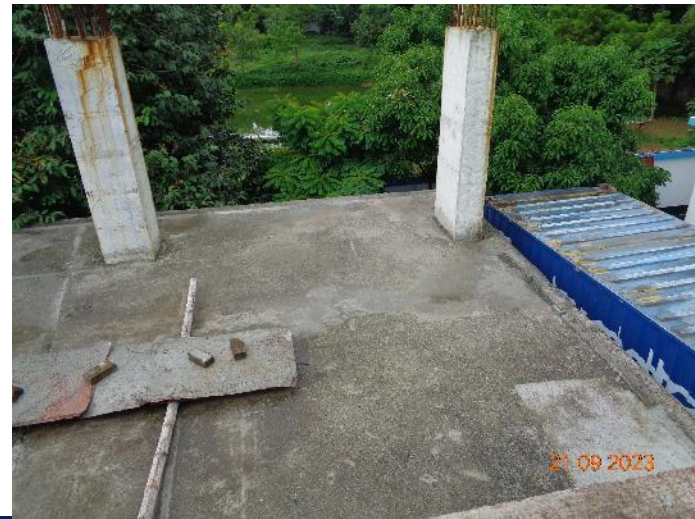
Parapet wall missing at roof

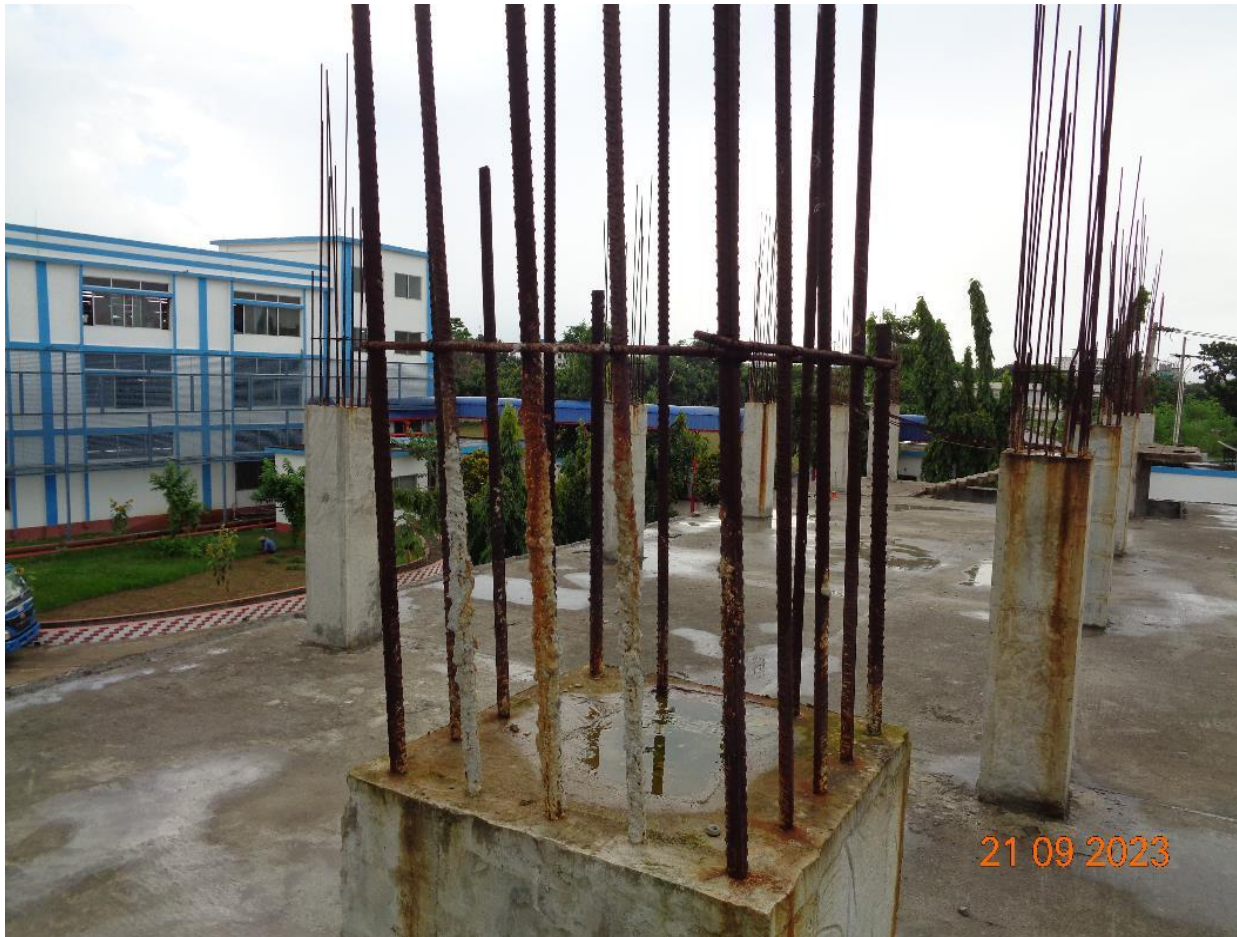
Exposed rebar of Column

Exposed reinforcement was found on rooftop columns. Building engineer is required to take necessary measures to prevent corrosion in exposed rebar.

15	Exposed re-bar at roof (Godown Building-2)	All exposed reinforcement is to be protected from corrosion which may cause degradation of the concrete.	6-weeks

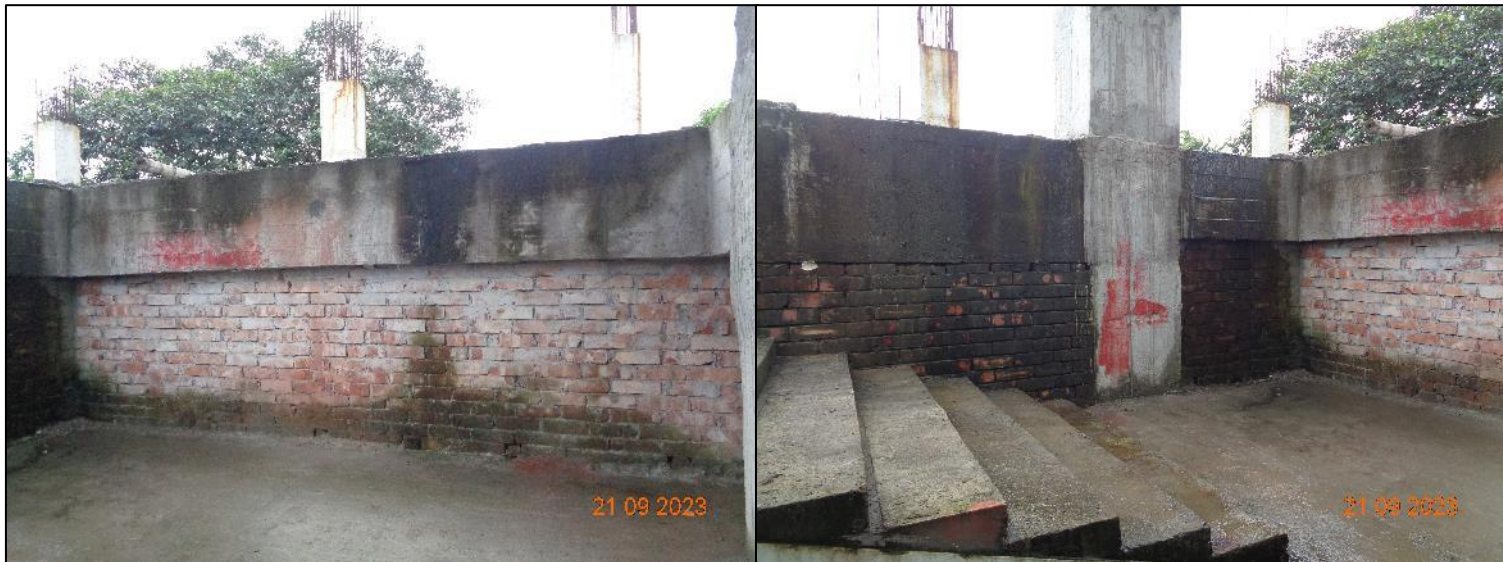
Dampness on beam

Dampness was found in several locations of the structure. Building engineer is required to investigate the source of dampness and take necessary measures to prevent the dampness.

Item No.	Observation	Recommended Action Plan	Recommended Timeline
16	Dampness at several locations (Godown Building-2)	Building Engineer is required to investigate the reason of dampness & apply suitable method to repair dampness.	6-weeks
17	Dampness at slab & wall (RMS Room)	Building Engineer is required to investigate the reason of dampness and carry out suitable repair of dampness.	6-weeks

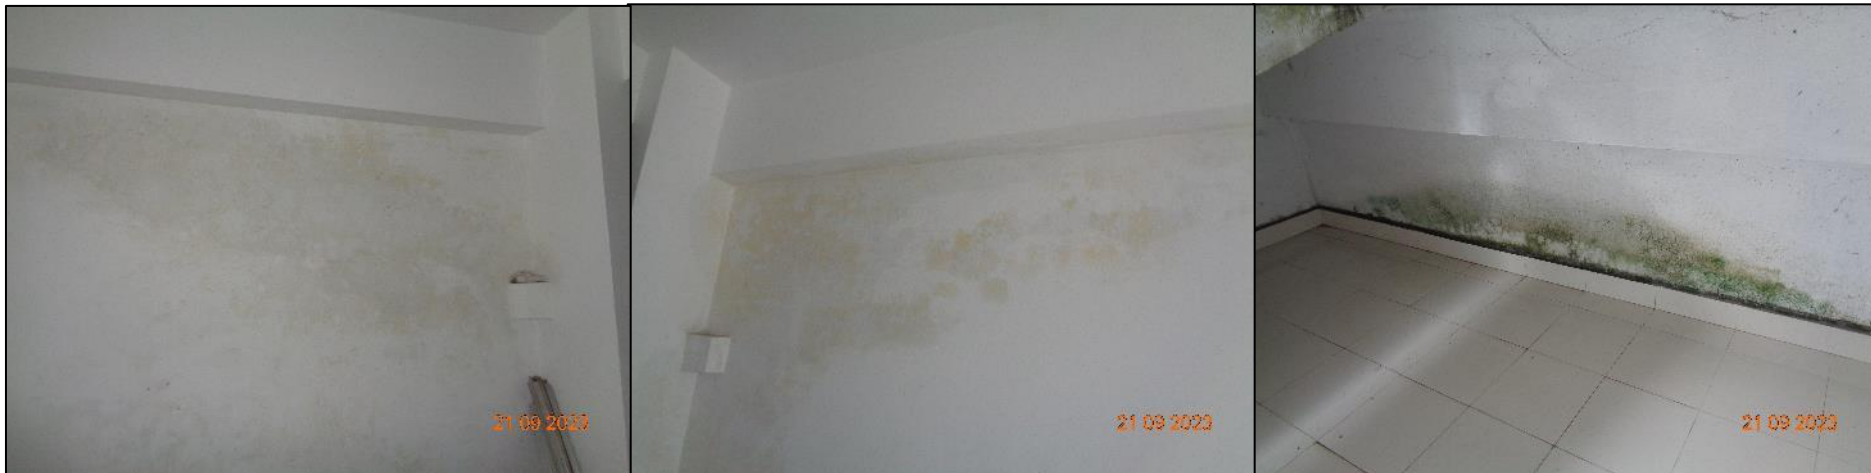
Dampness on Wall

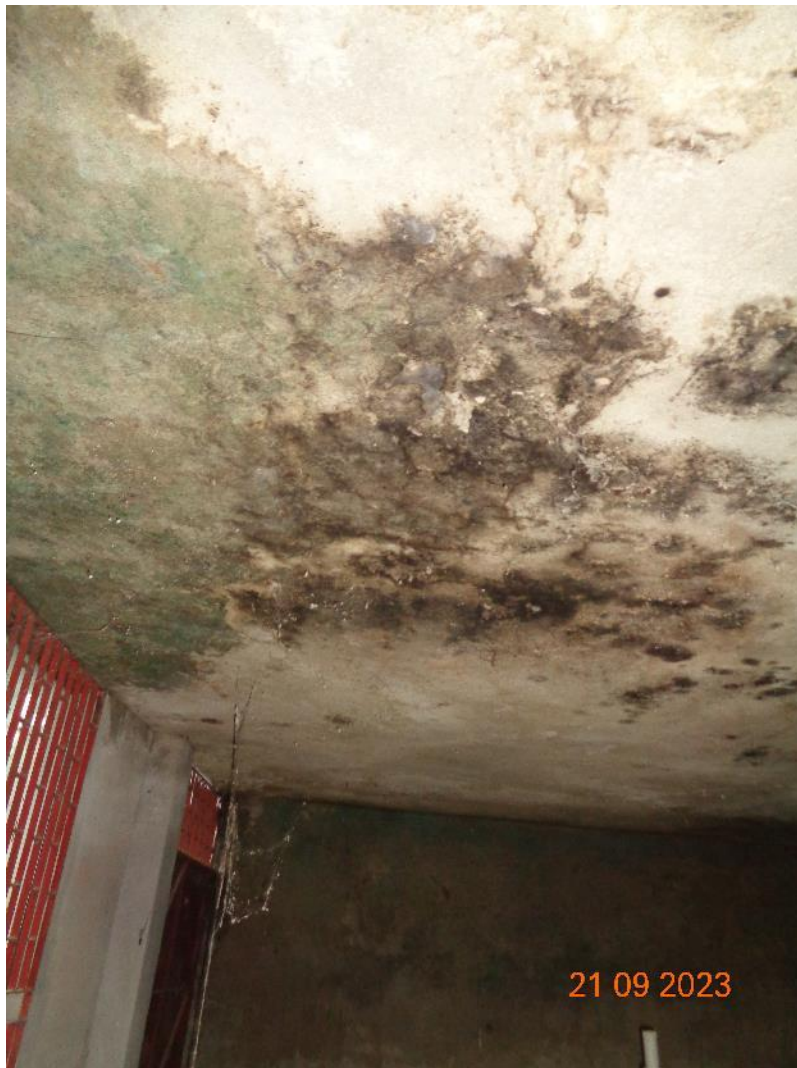
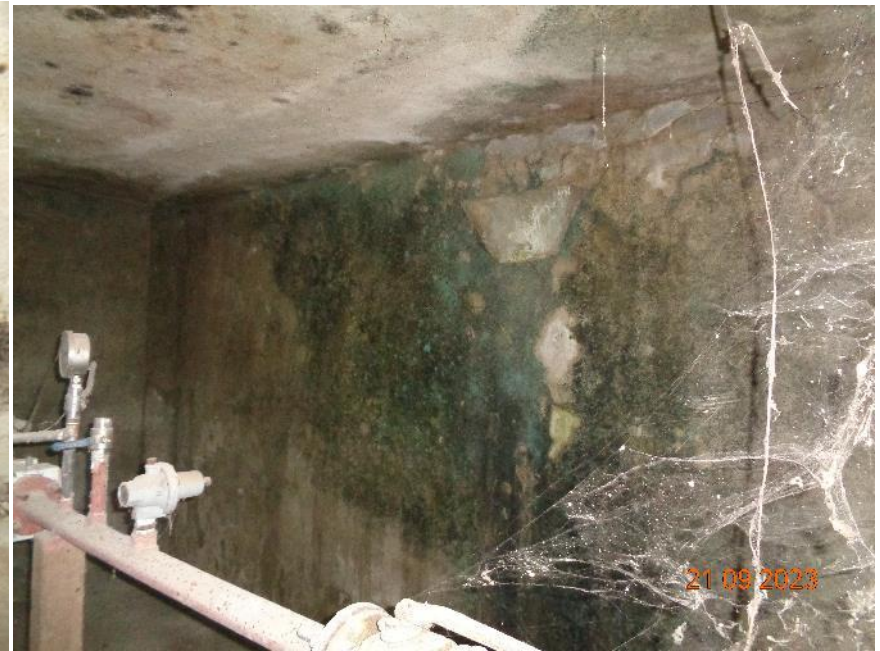
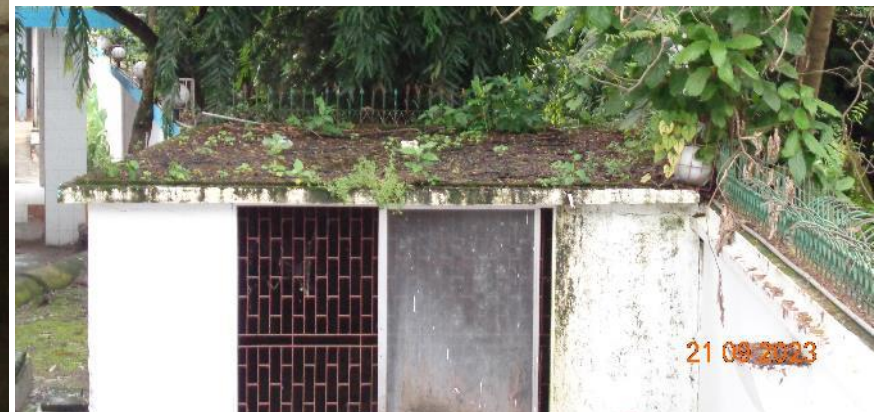
Dampness on Wall & slab

Dampness was found at the wall and slab of the RMS Room. Building engineer is required to investigate the source of dampness and take necessary measures to prevent the dampness.
