# Park Bangladesh Company Ltd

Plot# 94-95, Sector# 03, Karnaphuli EPZ, North Patenga, Chattogram

13 September 2023

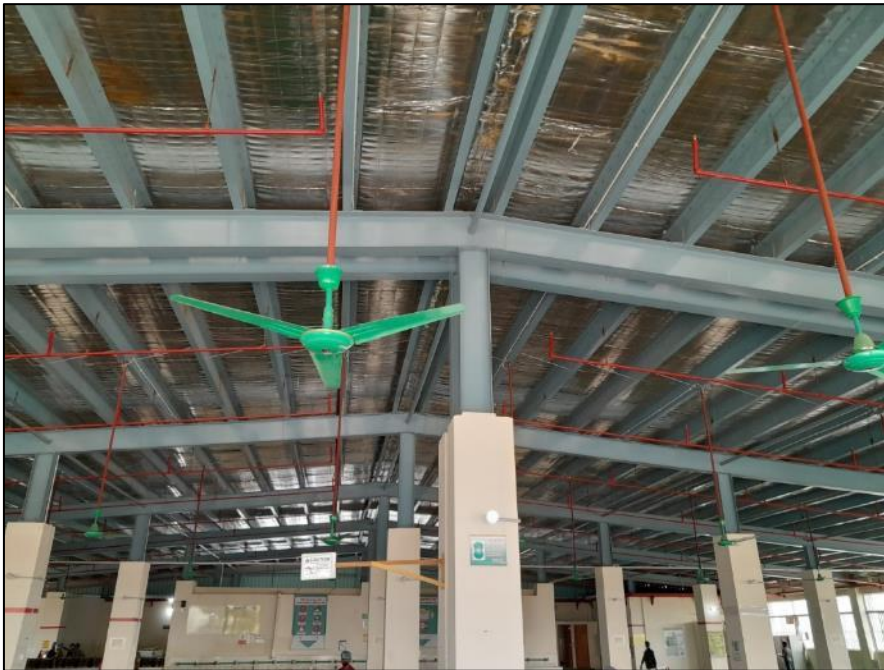
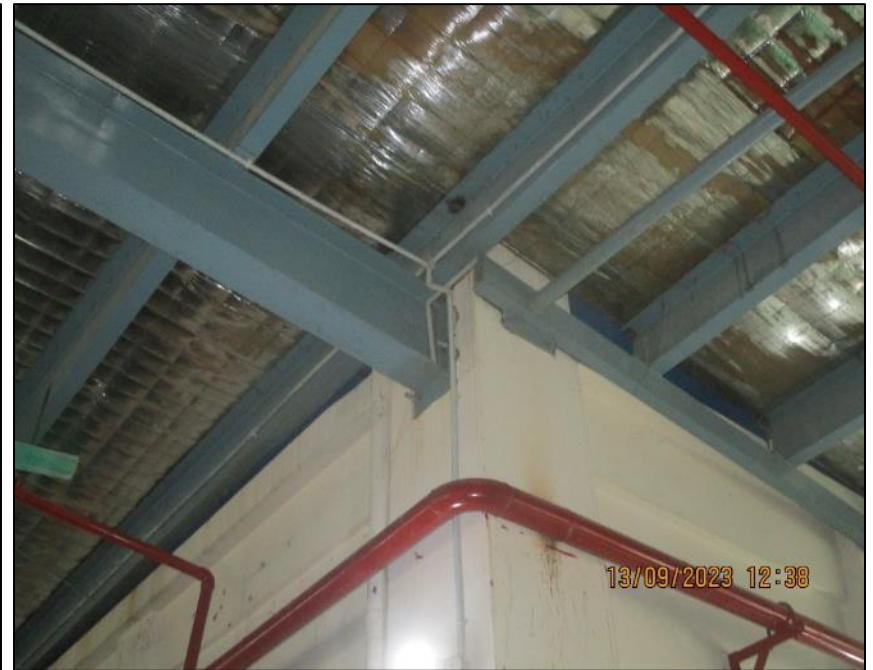
**Observation: Rooftop shed (Main Building)**

## **Lack of lateral stability of the roof shed**

Apparently inadequate compression strut and lack of lateral stability system. Also, connection details was not provided in the drawing. Building engineer to check the stability of roof structure against lateral loading and prepare necessary design documents.

| Item No. | Observation | Recommended Action Plan | Recommended Timeline |
|---|---|---|---|
| 01 | Lack of lateral stability of the roof shed. (Building-1 (Main Building) ) | Building engineer to check the stability of roof structure against lateral loading and prepare necessary design documents. | 6-weeks |
| 02 | Lack of lateral stability of the roof shed. (Building-1 (Main Building) ) | Carry out remedial works where necessary. | 6-months |

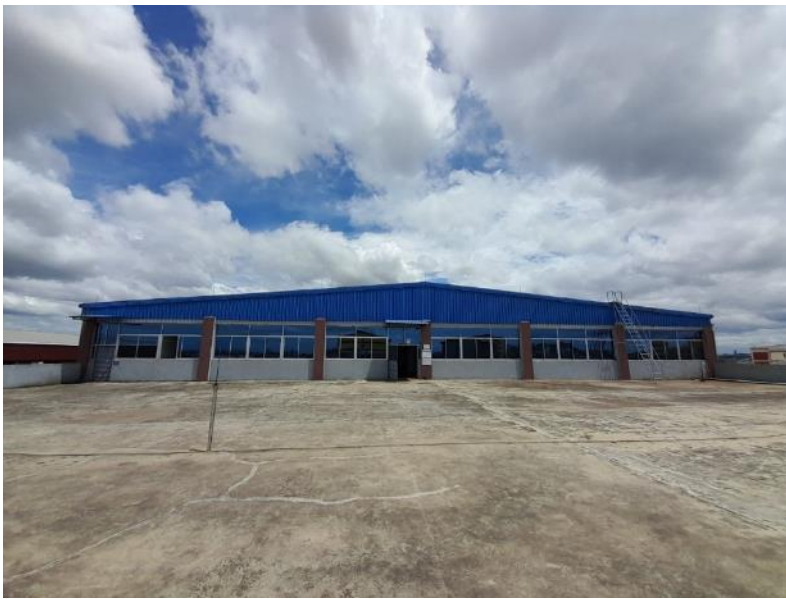
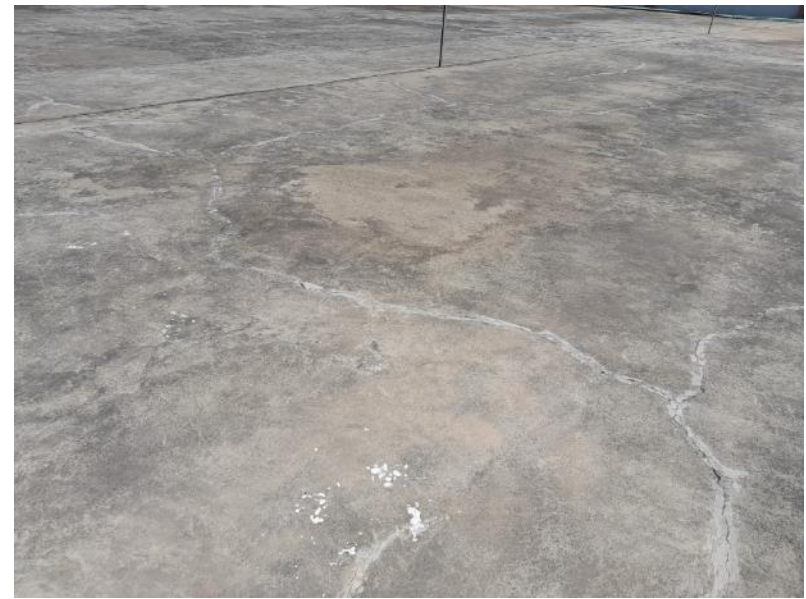
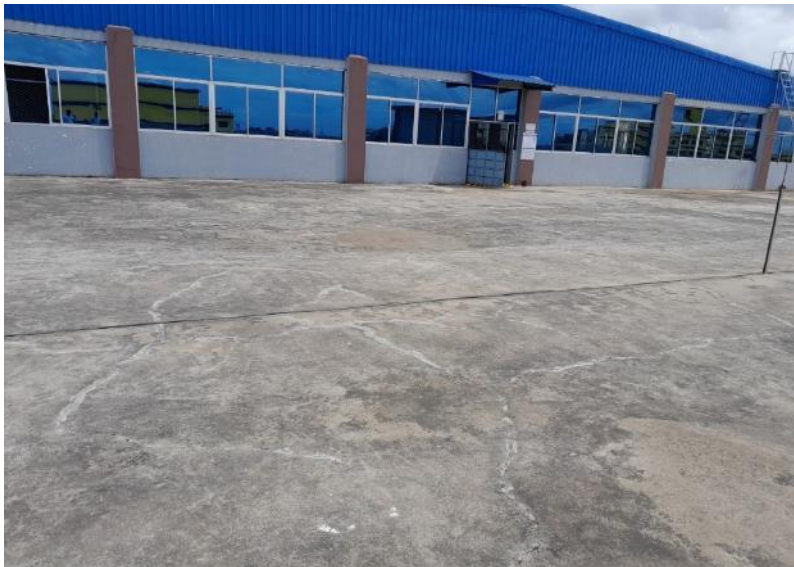
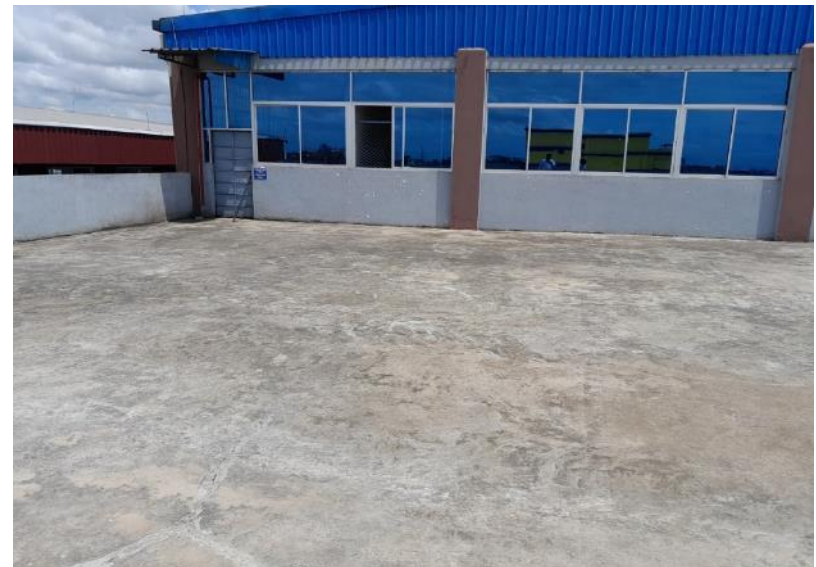
**Crack on the floor finish of roof**

Crack on the rooftop screeding. Building engineer is required to repair the crack with suitable repair method.

| Item No. | Observation | Recommended Action Plan | Recommended Timeline |
|---|---|---|---|
| 03 | Crack on the floor finish of roof. (Building-1 (Main Building) ) | Building engineer is required to repair the crack with suitable repair method. | 6-months |

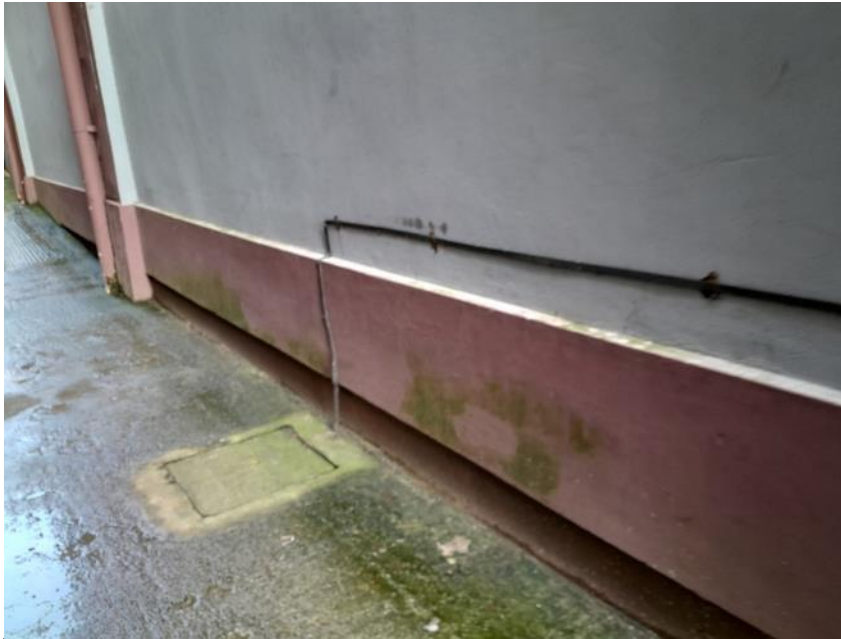
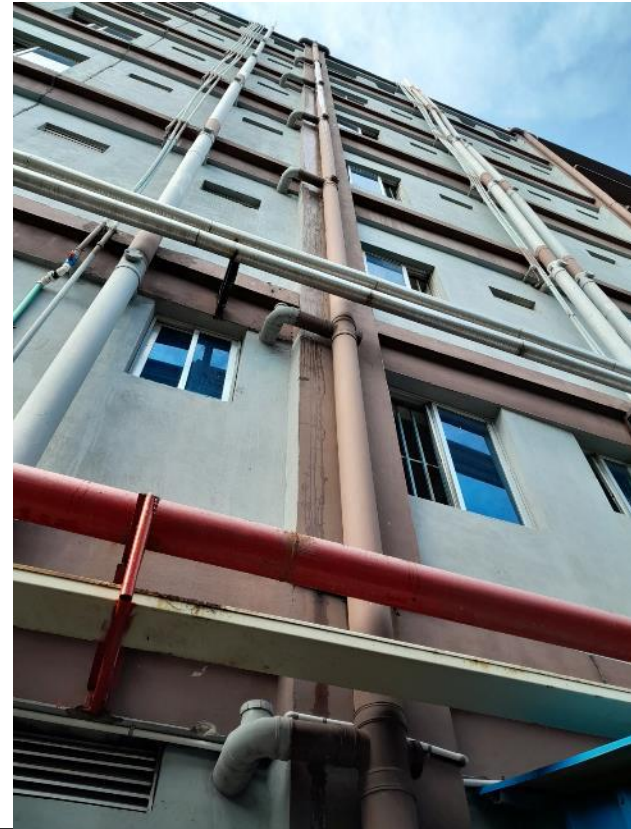
**Observation: Building-1 (Main Building)**

Dampness and leaked rainwater downpipe close to the columns were observed. Building engineer is required to repair the leaked downpipe and repair the dampness.

| Item No. | Observation | Recommended Action Plan | Recommended Timeline |
|---|---|---|---|
| 04 | Dampness and leakage of water. (Building-1 (Main Building) ) | Building engineer is required to repair the leaked downpipe and repair the dampness. | 6-months |

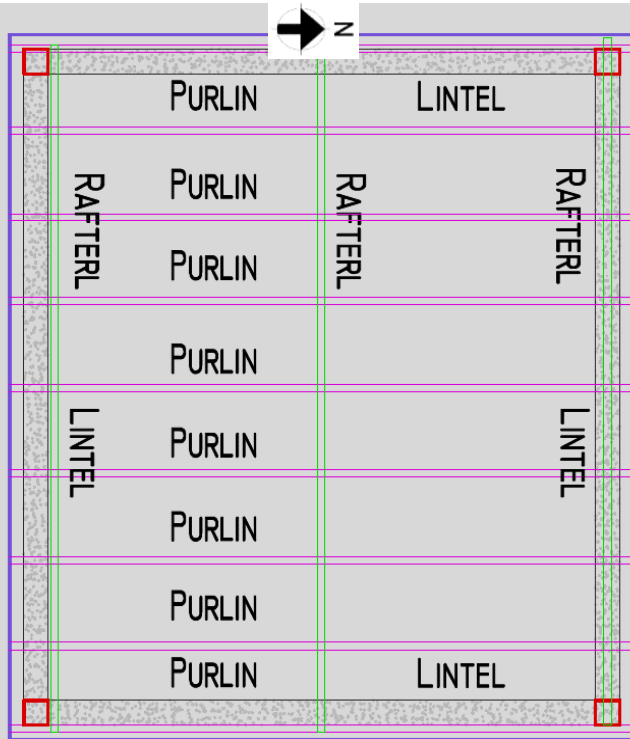
Rafter & Purlin layout plan

Rafter section did not match with on site condition. In drawing 'I' section was shown, but 'C' channel was provided on site.

| Item No. | Observation | Recommended Action Plan | Recommended Timeline |
|---|---|---|---|
| 05 | Discrepancies in provided drawing. (Building-3 (Ancillary-2)) | Building Engineer to survey the structure and update the as-built drawings with connection details. | 6-weeks |

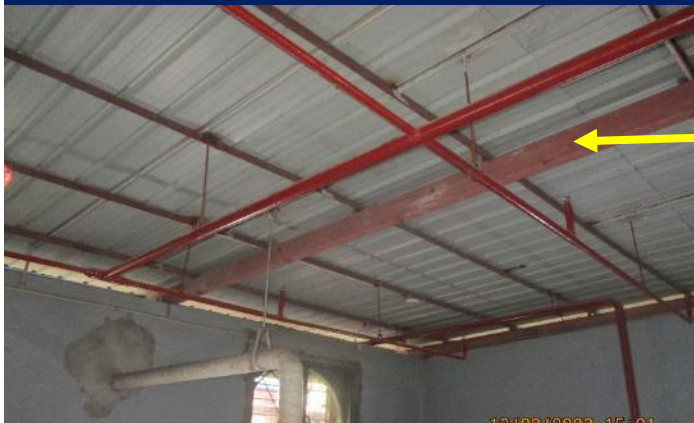
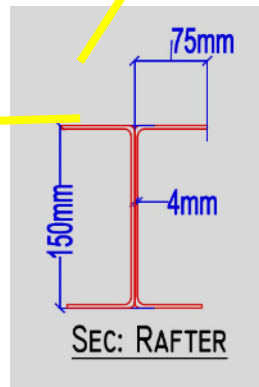
C-channel rafter at roof

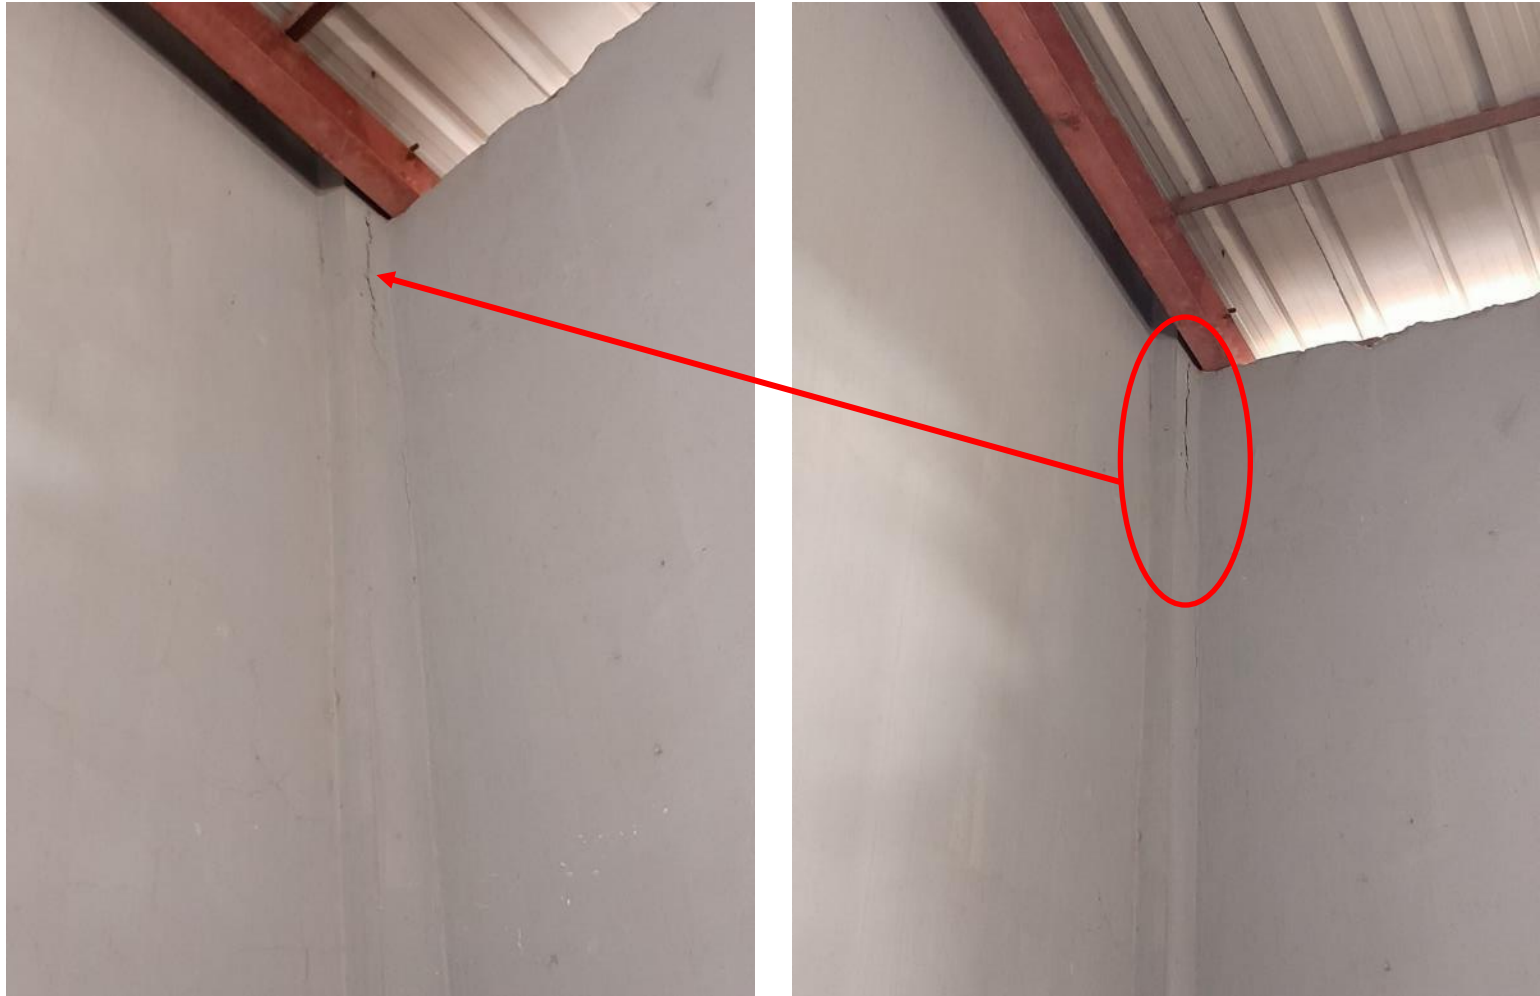
Crack on column surface at column-wall joint

Crack was observed on column surface. Building engineer is required to check the extent of crack and prepare an investigation report with necessary remedial measure.

| Item No. | Observation | Recommended Action Plan | Recommended Timeline |
|---|---|---|---|
| 06 | Crack on of column surface.<br>(Building-3 (Ancillary-2)) | Building engineer is required to check the extent of crack and prepare an investigation report with necessary remedial measure. | 6-weeks |
| 07 | Crack on of column surface.<br>(Building-3 (Ancillary-2)) | Carry out remedial works. | 6-months |

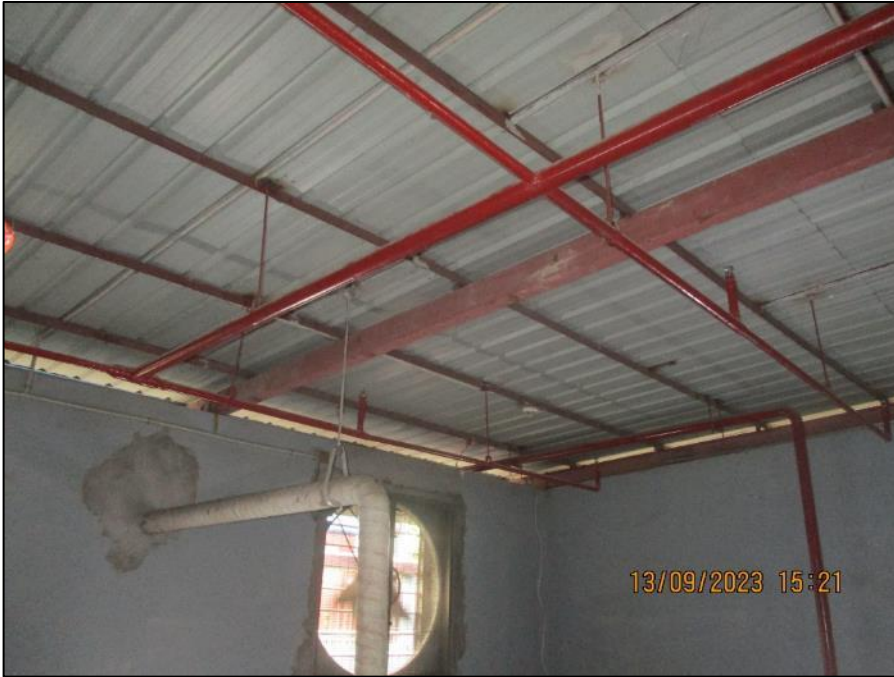
Light weight roof supported on peripheral wall

Roof of pump room is apparently non-engineered. Building engineer to check the stability of the lightweight roof structure against uplift forces.

| Item No. | Observation | Recommended Action Plan | Recommended Timeline |
|---|---|---|---|
| 08 | Apparently non-engineered roof.<br>(Building-3 (Ancillary-2)) | Building engineer to check the stability of the lightweight roof structure against uplift forces. | 6-weeks |
| 09 | Apparently non-engineered roof.<br>(Building-3 (Ancillary-2)) | Carry out remedial works if necessary. | 6-months |

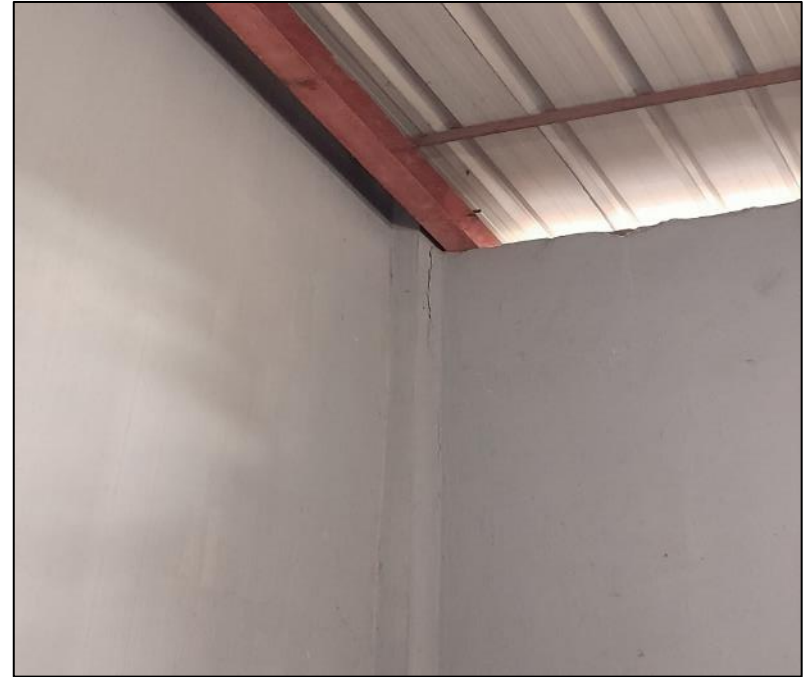
Non-engineered connection
