# AL-Ittefaq Textiles Limited

Plot: 11, Mohara CDA I/A, Chandgaon, Chattogram.

26 September 2023

# Observations

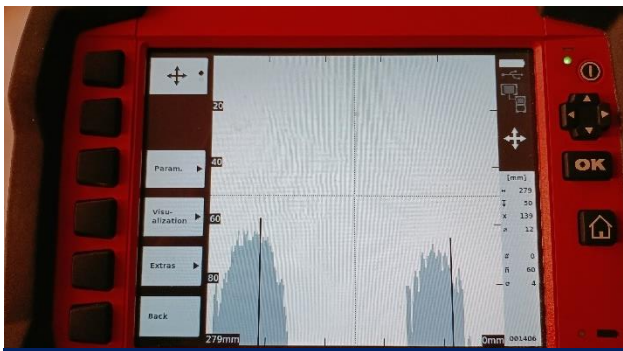
Ferro-scanning: 2 rebar at short face

Rebar at C-1 type column not matched with drawings. Two rebars were found at short face on 4<sup>th</sup> floor level instead of three. Moreover, some beams are found in different level at mezzanine level.

Building engineer is required to confirm the amount of rebar in column and update the drawing with connection details.

| Item No. | Observation | Recommended Action Plan | Recommended Timeline |
|---|---|---|---|
| 01 | Mismatches in structural drawings. (Main Building) | Building engineer is required to confirm the amount of rebar in column and prepare accurate as-built structural drawing with necessary connection details. | 6-weeks |

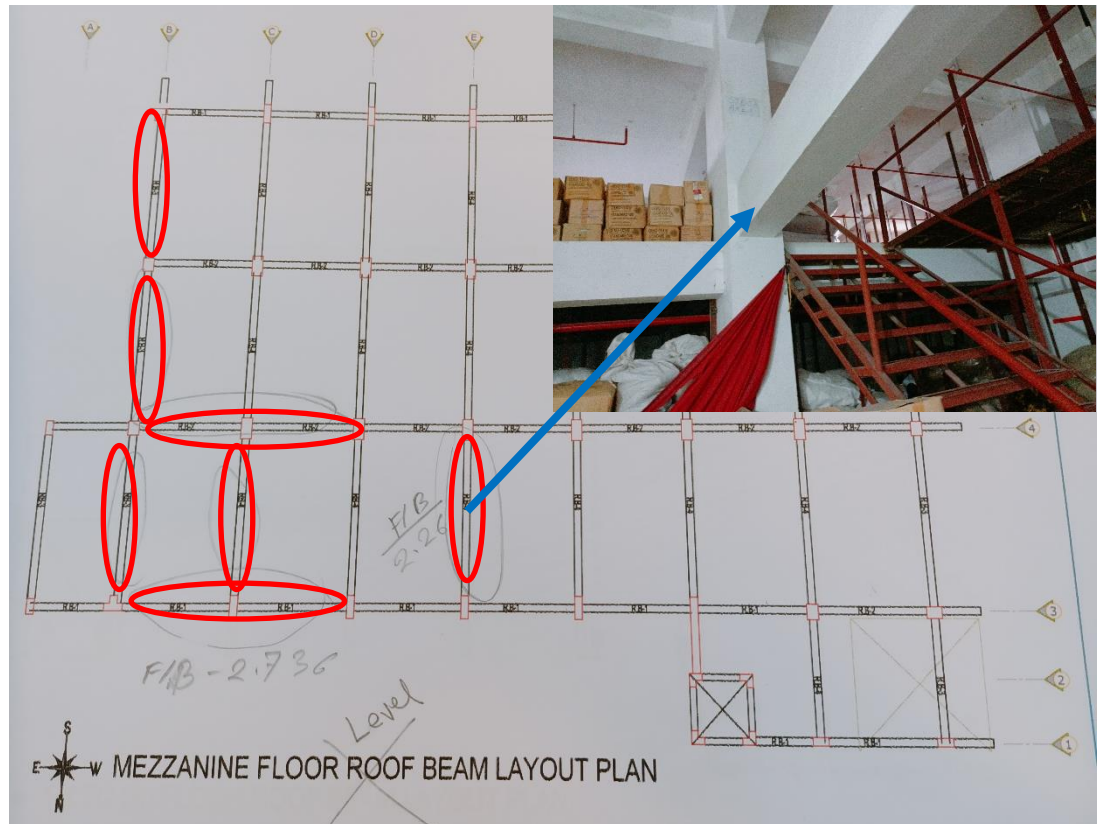
Marked beams are found at different level

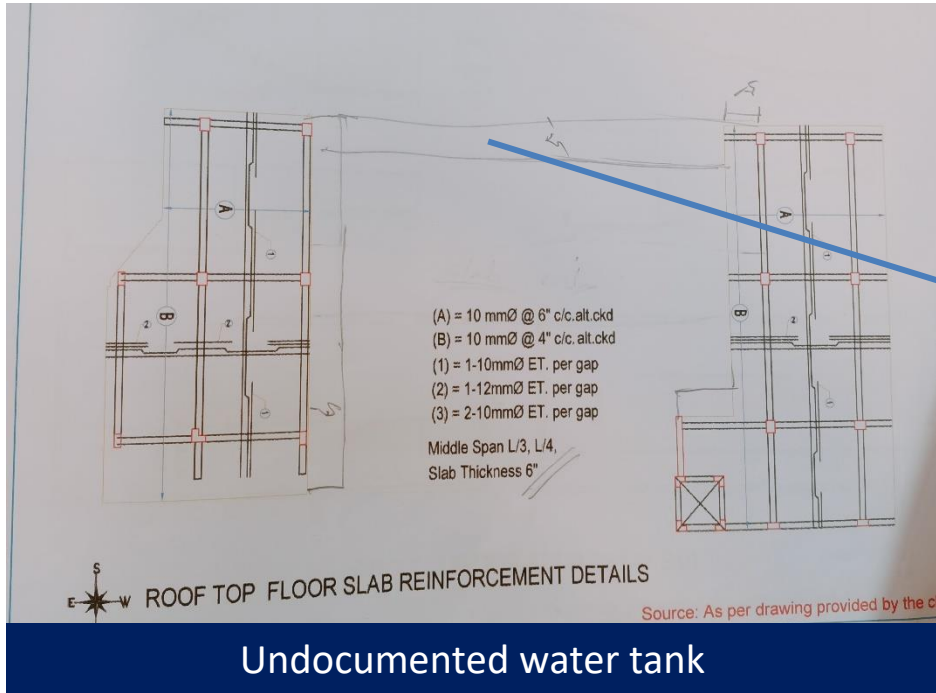
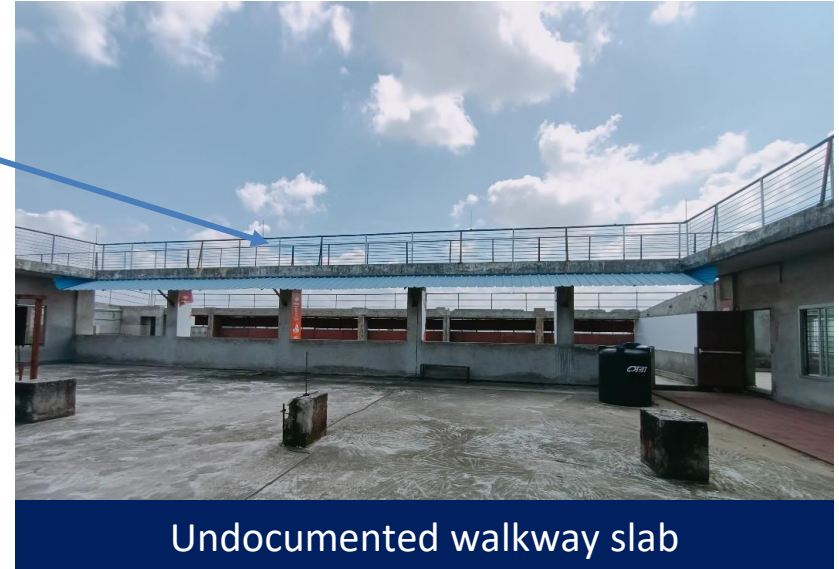
Undocumented walkway slab was found at the roof. Building engineer is required to confirm the amount of rebar in column and prepare accurate as-built structural drawing with necessary connection details.

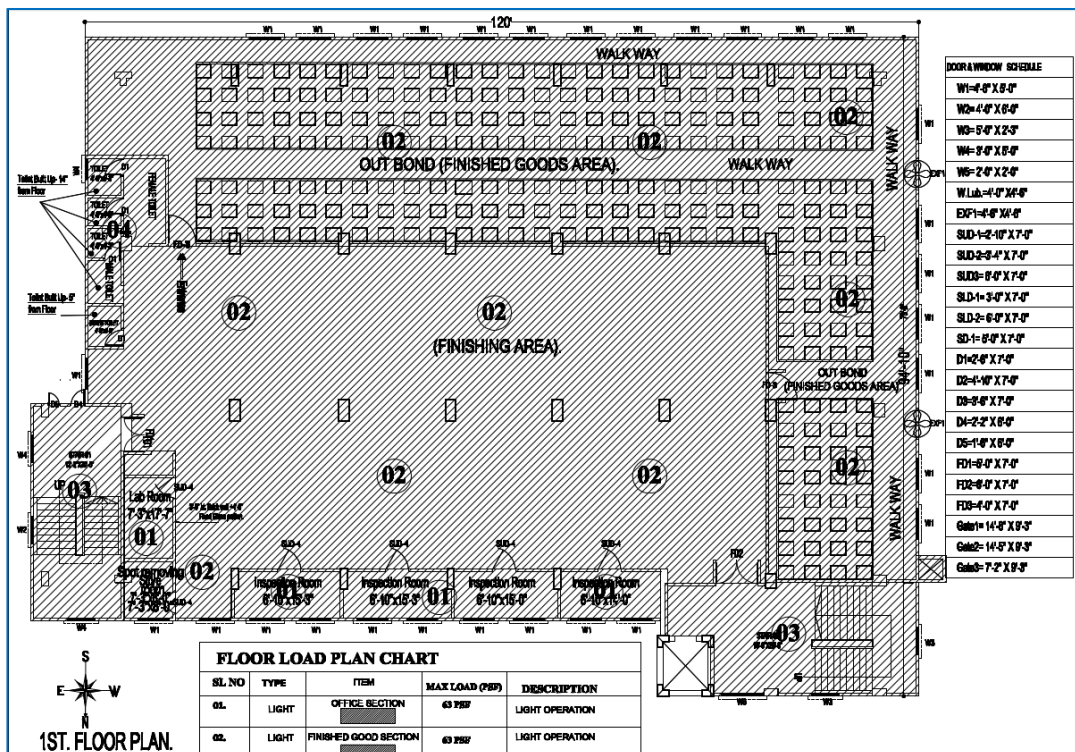
1<sup>st</sup> floor load plan: finishing area with 3 kN/m<sup>2</sup> live load

The first floor of the building is allotted for storage. As per BNBC, the minimum floor live load for storage is 6 kN/m<sup>2</sup> (126 psf). But the first floor of the building is designed for 3 kN/m<sup>2</sup> live loads.

Moreover, core cutting layout required was missing.

Factory engineer is required to revise the load plan and related design documents based on BNBC requirement.

| Item No. | Observation | Recommended Action Plan | Recommended Timeline |
|---|---|---|---|
| 03 | Load plan not comply with BNBC requirements. (Main Building) | Factory engineer is required to revise the load plan and related design documents based on BNBC requirement. | 6-weeks |

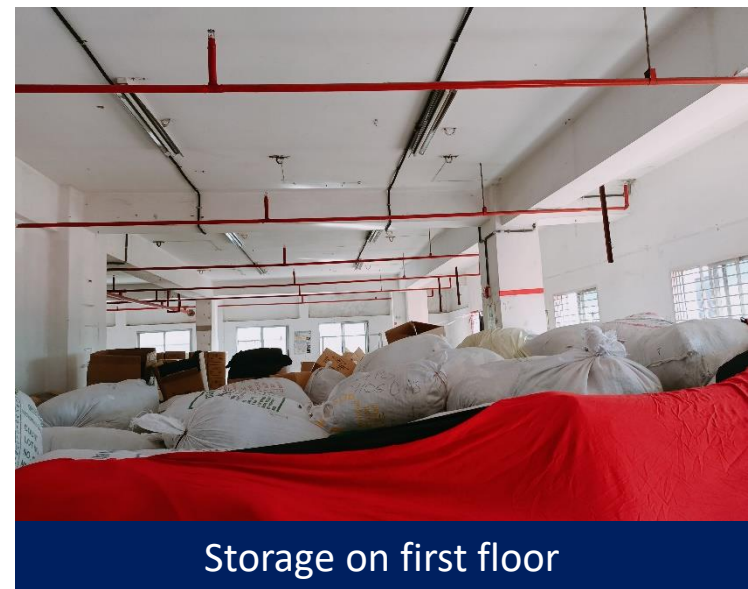
Storage on first floor

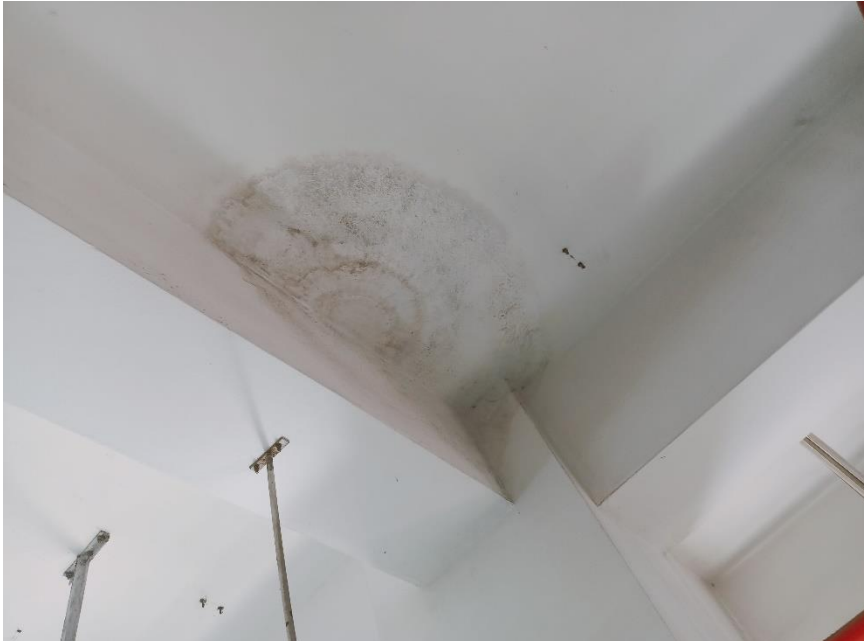
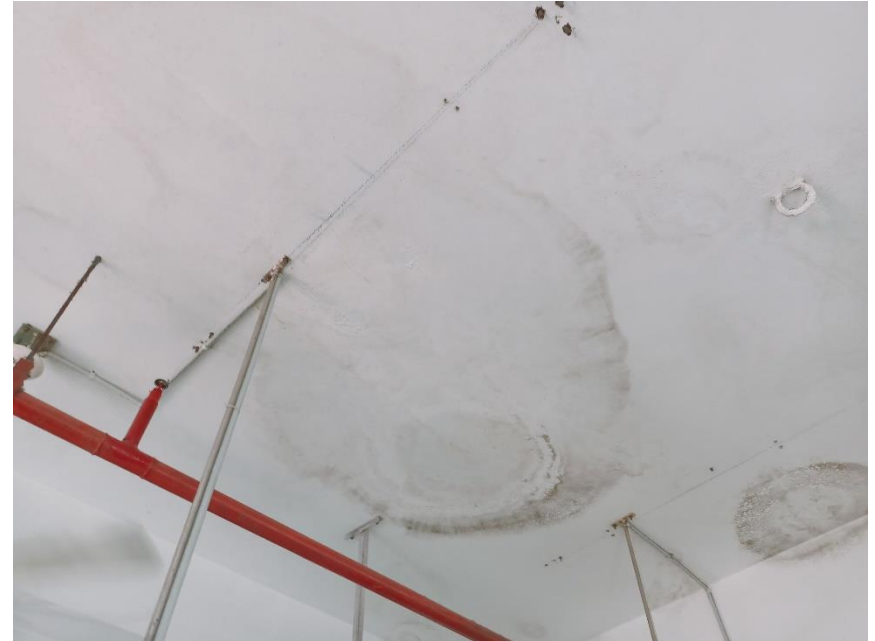
Dampness on slab soffit

Dampness on ceiling of 5<sup>th</sup> floor was observed. Factory engineer is required to seal the source of water and repair the damp areas with suitable method.

| Item No. | Observation | Recommended Action Plan | Recommended Timeline |
|---|---|---|---|
| 06 | Dampness at ceiling of 5th floor. (Main Building) | Factory engineer is required to seal the source of water and repair the damp areas with suitable method. | 6-weeks |

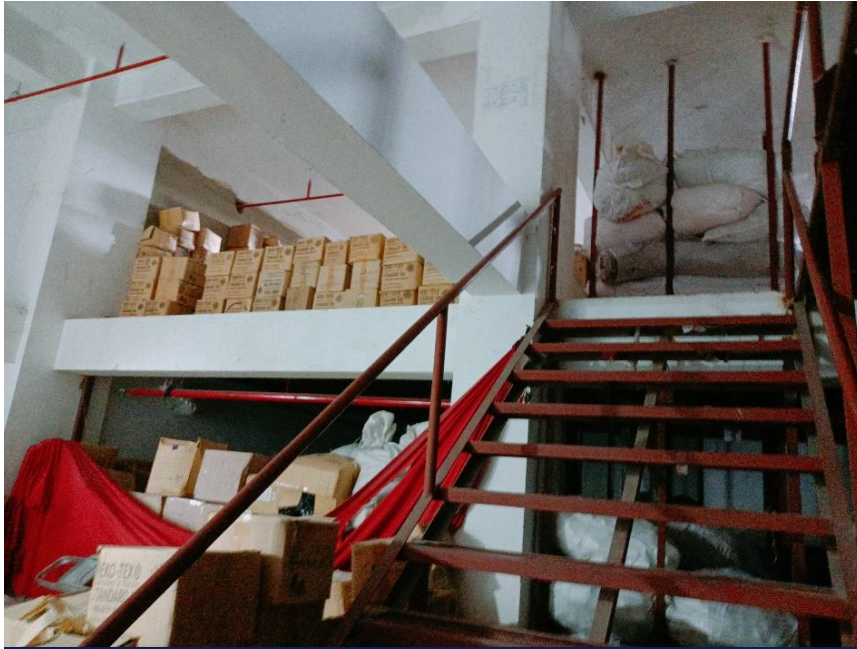
Racking platform on ground floor

Apparently non engineered racking platform was found on ground floor. The platform is being used for storage purpose. The member size and connection seems to be inadequate. Building engineer is required to check the adequacy of member & connection of the structure and suggest necessary remedial actions.

| Item No. | Observation | Recommended Action Plan | Recommended Timeline |
|---|---|---|---|
| 07 | Apparently non engineered racking system on ground floor. (Main Building) | Building engineer is required to check the member and connection adequacy of the structure and suggest necessary remedial works. | 6-weeks |

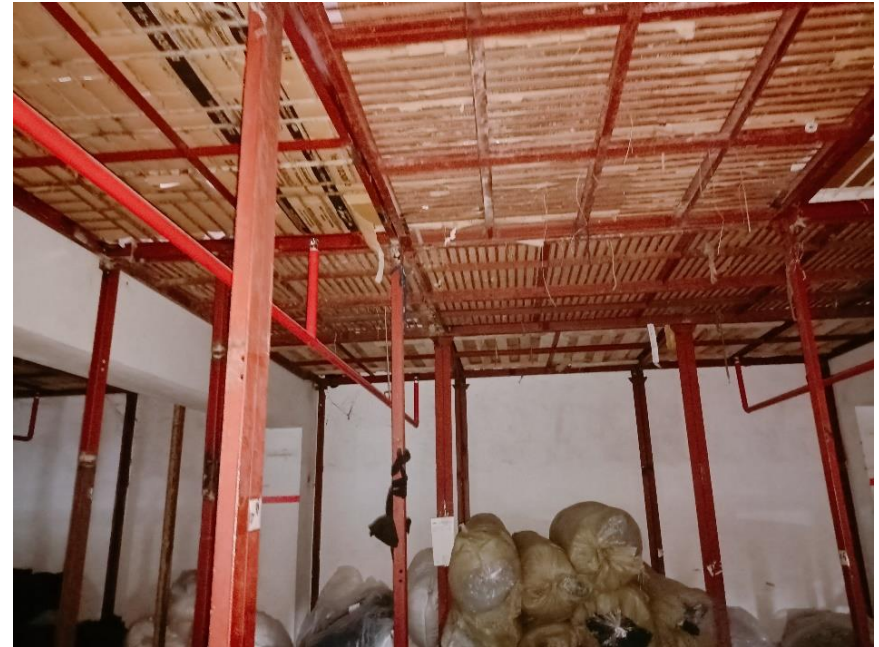
Apparently inadequate member & connection

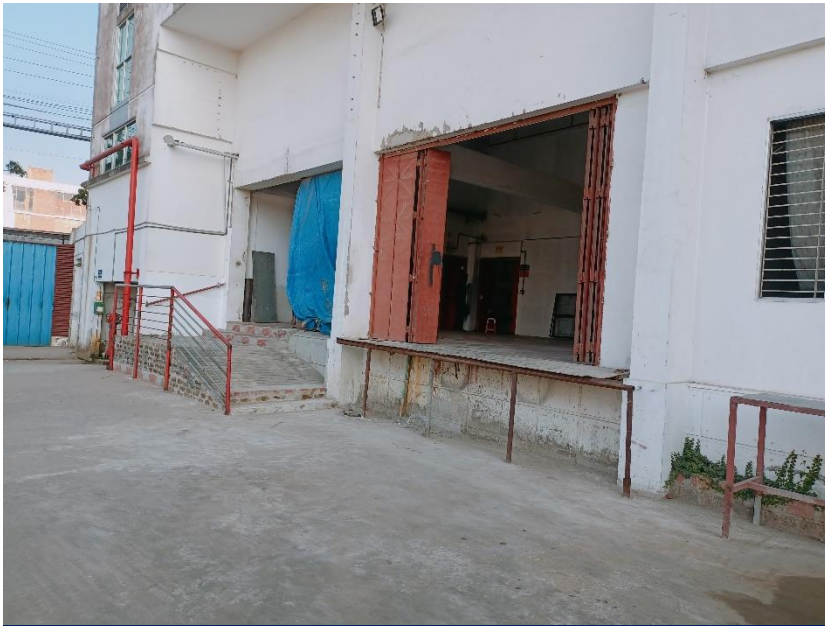
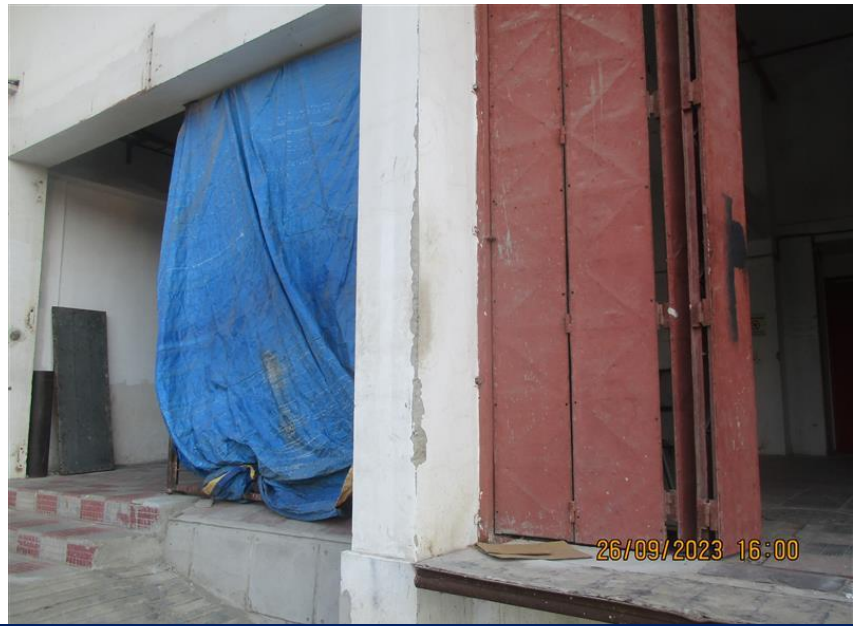
Column and beams adjacent of driveway of loading unloading zone

Column and beams adjacent to the driveway of loading unloading area is susceptible to vehicle impact. The building engineer is required to provide separate barrier and signage to avoid possible vehicle impact on column & beam.

| Item No. | Observation | Recommended Action Plan | Recommended Timeline |
|---|---|---|---|
| 09 | Column and beam susceptible to vehicle impact. (Main Building) | The building engineer is required to provide separate barrier and signage to avoid possible vehicle impact on column & beam. | 6-months |

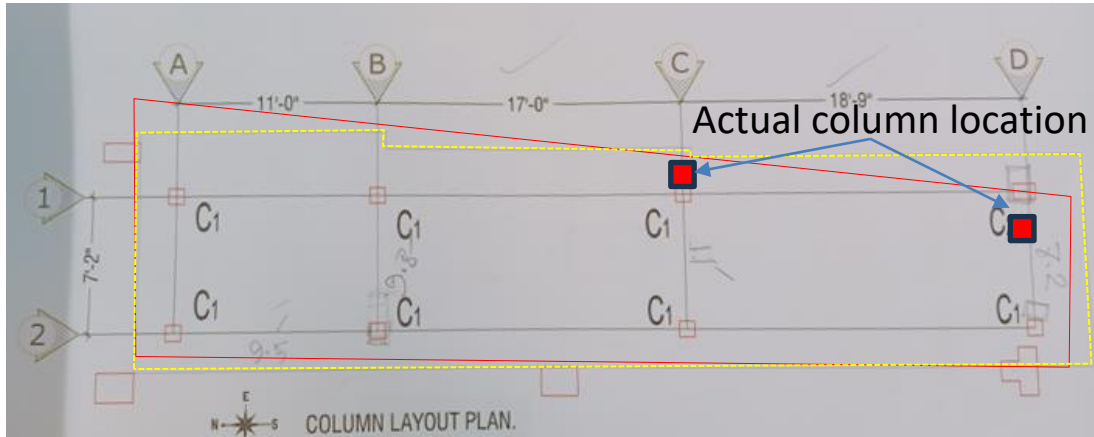
Grid dimension and slab layout did not match with as-built condition. Also, core cutting location has not been prepared and all core cutting location could not be verified. Building engineer is required to survey the structure and prepare accurate as-built drawings showing all structural details. Also, revise the design report based on as-built drawing and submit to RSC.

As per drawing column & slab layout marked in yellow

| Item No. | Observation | Recommended Action Plan | Recommended Timeline |
|---|---|---|---|
| 10 | Inconsistencies in as-built drawing. (Sub-station Building) | Building engineer is required to survey the structure and prepare accurate as-built drawings showing all structural details. | 6-weeks |

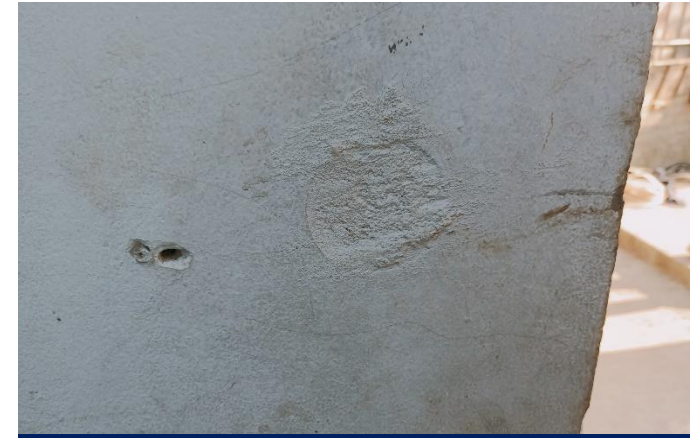
Core cutting location

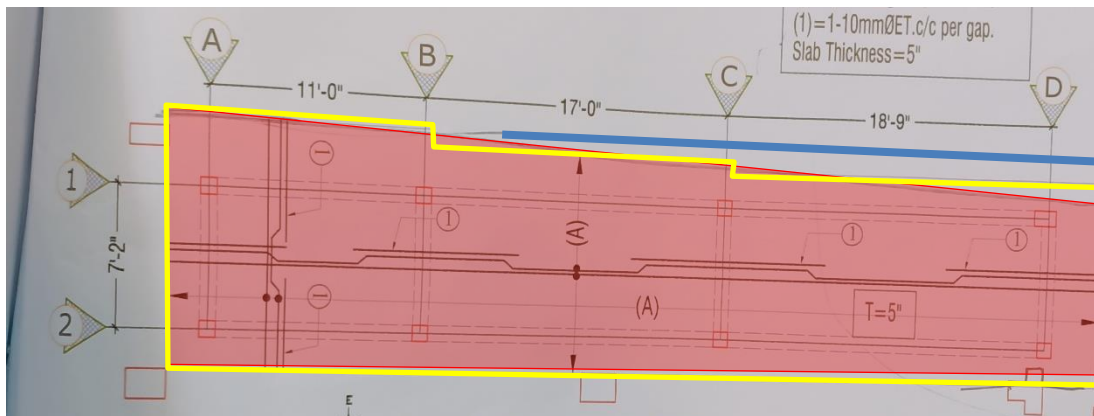
Actual slab layout mentioned in red

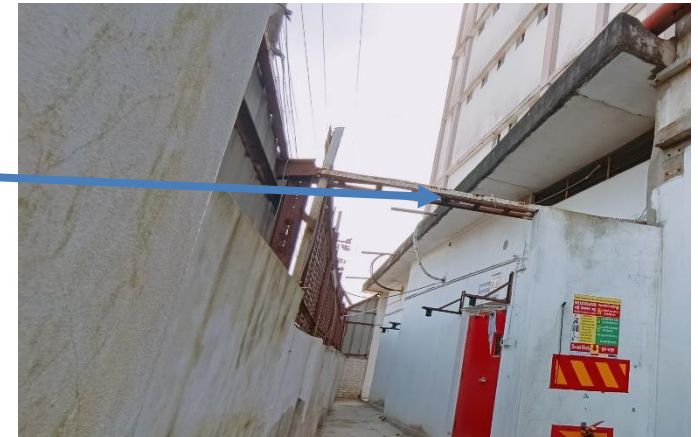
Slab of sub-station

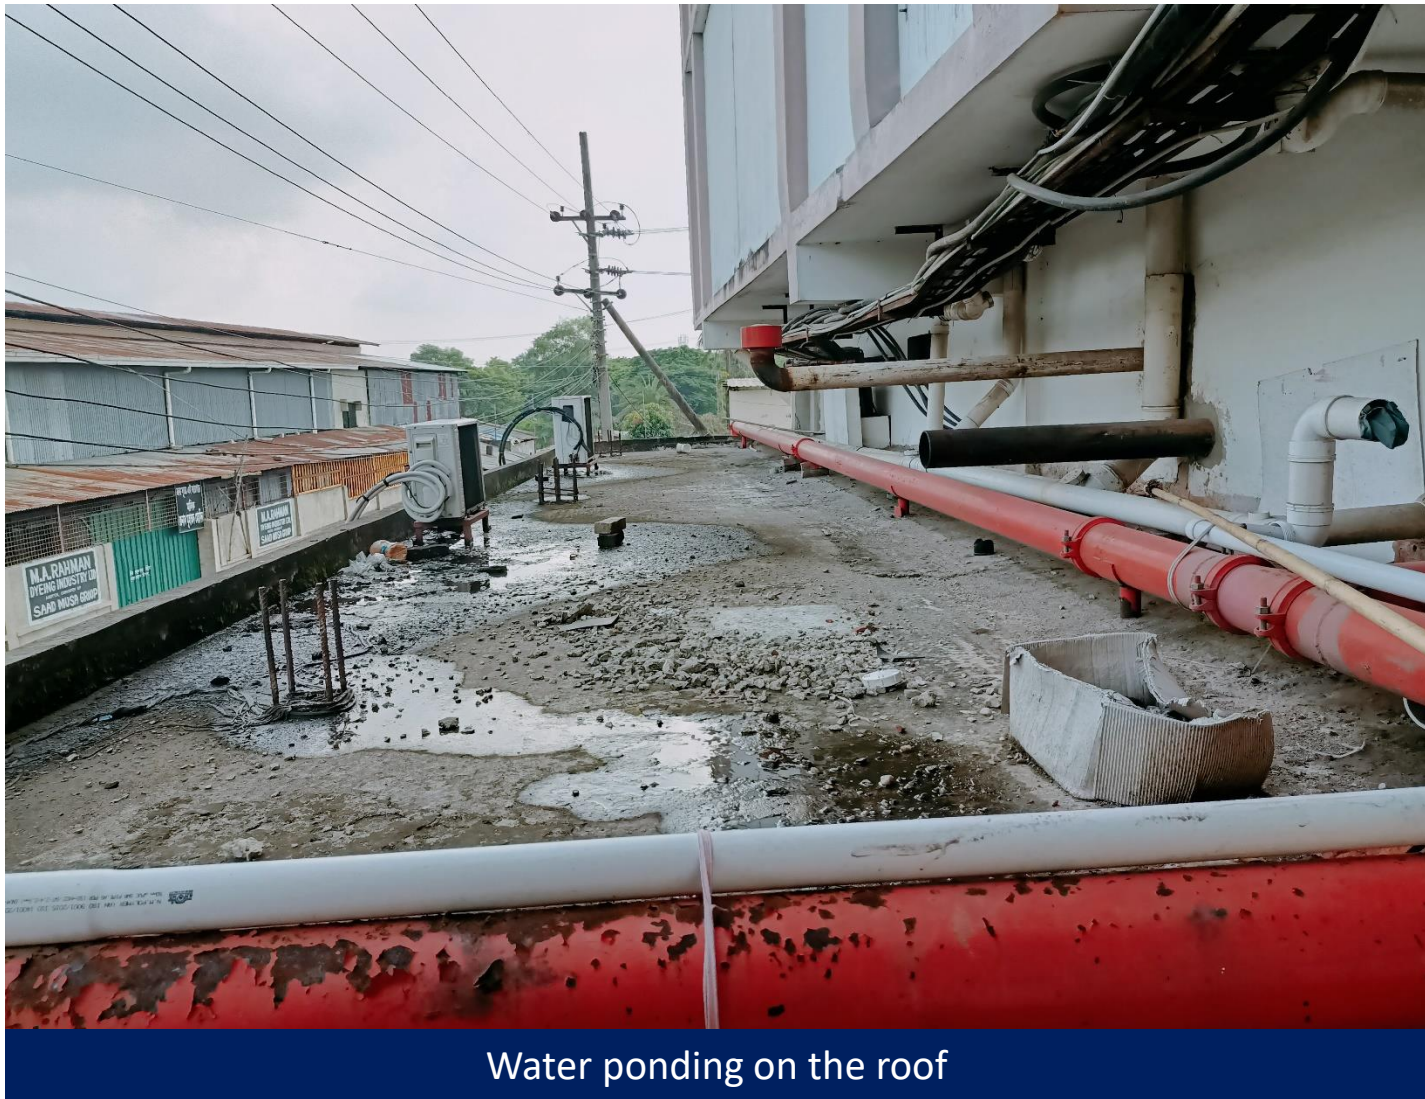
Water ponding on the roof

The factory is required to improve roof drainage system with adequate slope and provide sufficient water outlets to drain out water.

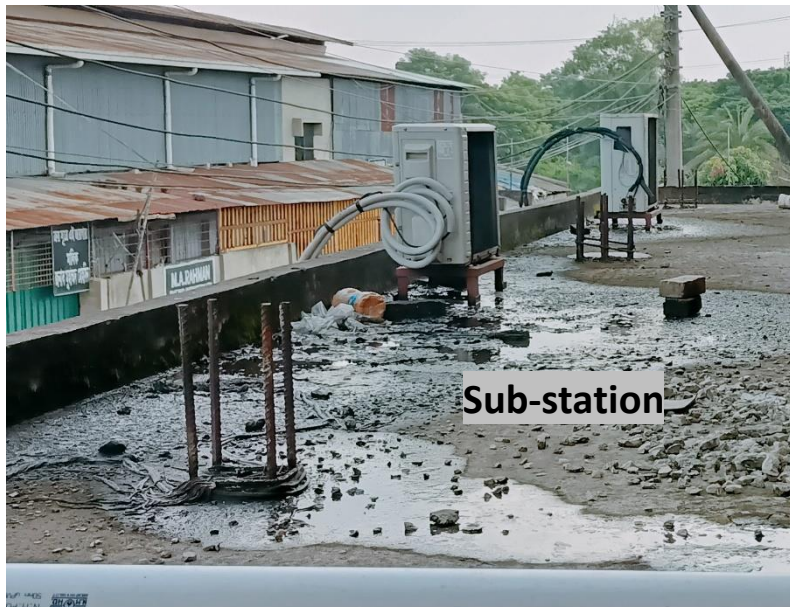
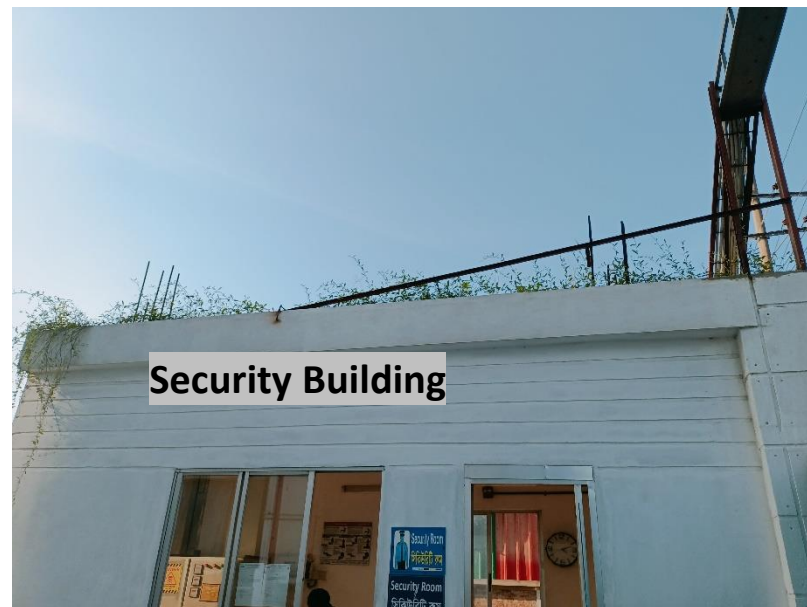
Exposed rebar on roof

Exposed rebar observed on roof which is prone to corrosion. The factory is required to provide anti-corrosive coating on the exposed rebar.

| Item No. | Observation | Recommended Action Plan | Recommended Timeline |
|---|---|---|---|
| 14 | Exposed rebar at roof. (Substation & Security Building) | The factory is required to provide anti-corrosive coating on the exposed rebar. | 6-months |
