# Fakir Knitwears Ltd. (Extension)

Kayempur, Fatullah, Narayanganj

22 August 2023

# Observations

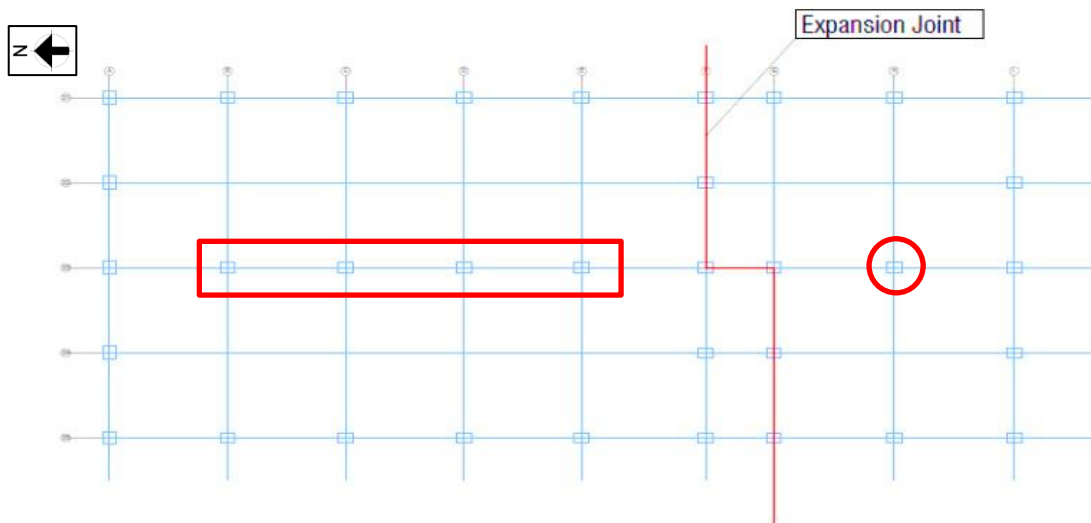
Column layout plan

**High stress in the column**

Cursory calculation indicates that the marked columns are highly stressed based on 3 kPa typical floor live load, and observed machinery loads with minimum concrete (14.1 MPa) and rebar strength (415 MPa). The source of loadings are chiller machine of the floors and cooling tower on the roof. The building engineer is required to carry out Detail Engineering Assessment (DEA) to review the design, loads and column stress based on in-situ material strength, actual machinery loads and minimum floor live loads.

| Item No. | Observation | Recommended Action Plan | Recommended Timeline |
|---|---|---|---|
| 04 | High stress in the column Building-4 (Generator Building) | Produce and actively manage a floor live load plan for all floors of the building based on floor, column & foundation capacity. The floor load plan must include machinery weight and specifications | 6-weeks |

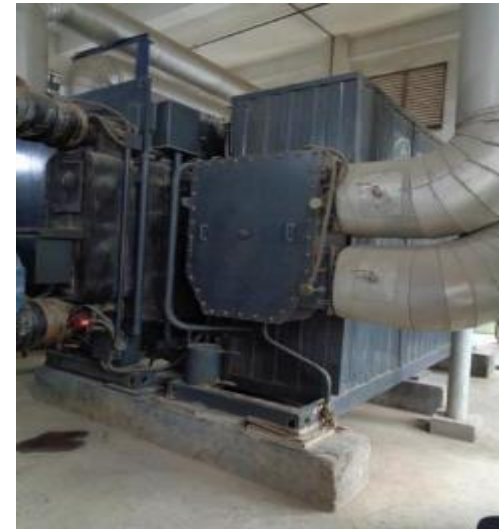
Source of loading: Chiller

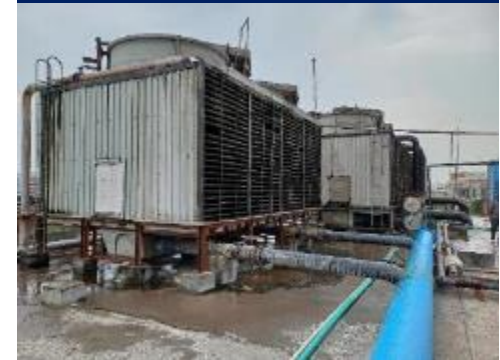
Source of loading:  
Cooler

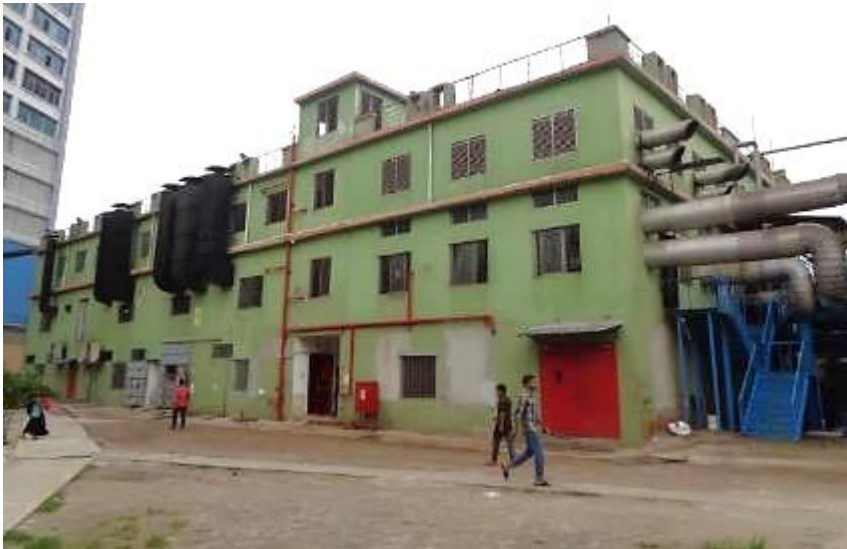
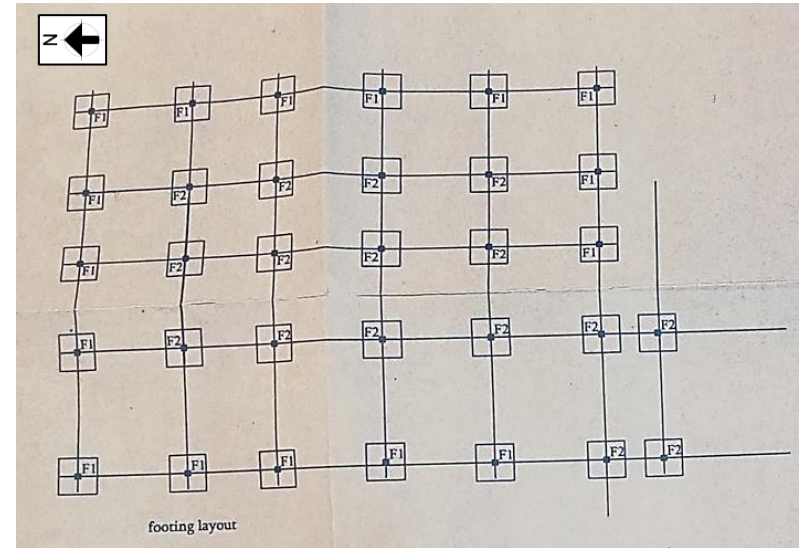
Footing layout (Old part)

## **Lack of foundation details**

Foundation layout drawing was available for the old part of the Building-4. But foundation size and other details were not available. In addition, geotechnical investigation report was not available for both part. However, as part of DEA, the building engineer is required to prepare as-built drawings for foundations with necessary details; carry out geotechnical investigation; check the foundation adequacy of the building and suggest proper remedial actions.

| Item No. | Observation | Recommended Action Plan | Recommended Timeline |
|---|---|---|---|
| 07 | Lack of foundation details<br>Building-4 (Generator Building) | Carry out geotechnical investigation to close vicinity of the building to determine the soil properties. | 6-weeks |
| 08 | Lack of foundation details<br>Building-4 (Generator Building) | As part of DEA, the building engineer is required to investigate the actual foundation sizes, prepare as-built structural drawings of foundations, check the foundation adequacy of the building and suggest proper remedial actions. Submit DEA documents to the RSC for review. | 6-weeks |
| 09 | Lack of foundation details<br>Building-4 (Generator Building) | Carry out necessary remedial works as per DEA. | 6-months |

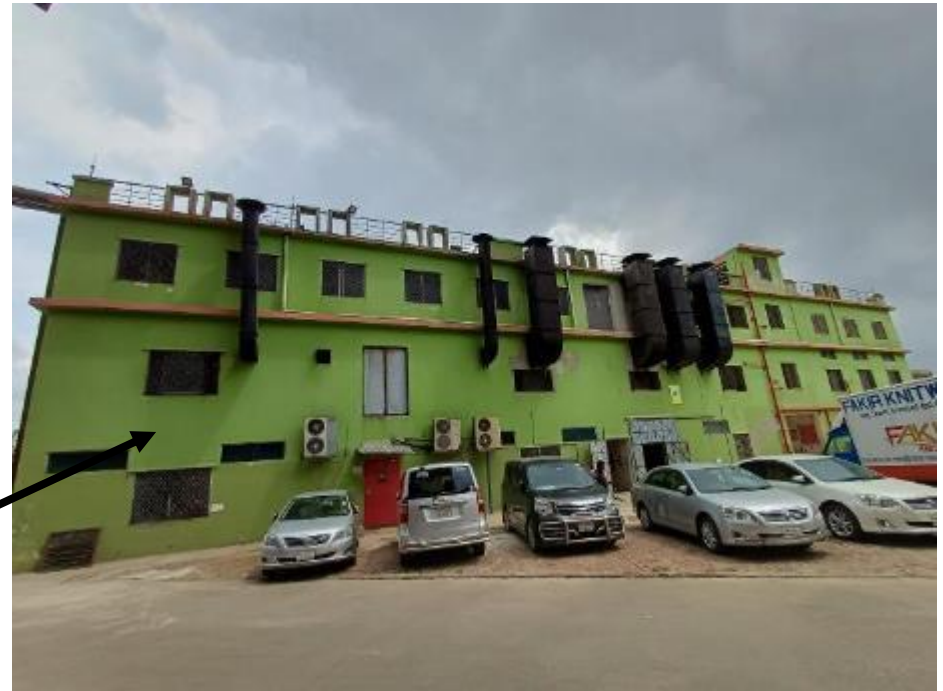
As-built construction of Building-4: 3 storey

Factory had a building permit drawing for proposed 2 storied Powerhouse Building (Building-4). However, the building was found as three storied. Also, the existing building plan and column layout doesn't reflect the permit drawing. The factory is required to collect revised building permit drawing for the structure from the local authority.

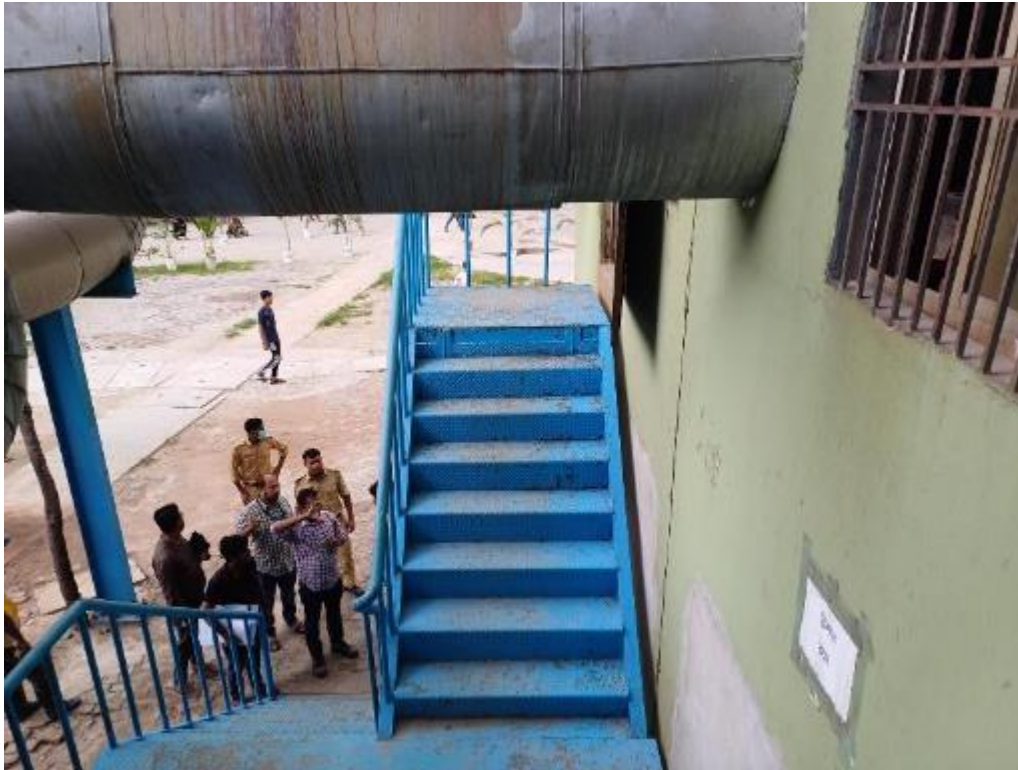
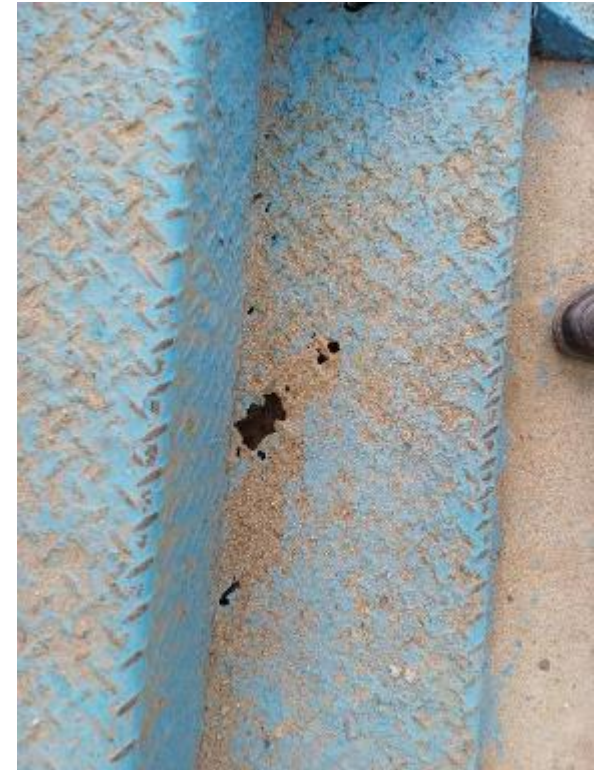
## **Corrosion in adjacent steel stair**

Corroded steel stair

Building Engineer is required to identify all corroded member, remove the corrosion and apply suitable anti-corrosive coating to the affected steel members.

| Item No. | Observation | Recommended Action Plan | Recommended Timeline |
|---|---|---|---|
| 11 | Corrosion in adjacent steel stair<br>Building-4 (Generator Building) | Building Engineer is required to identify all corroded member, remove the corrosion and apply suitable anti-corrosive coating to the affected steel members. | 6-weeks |

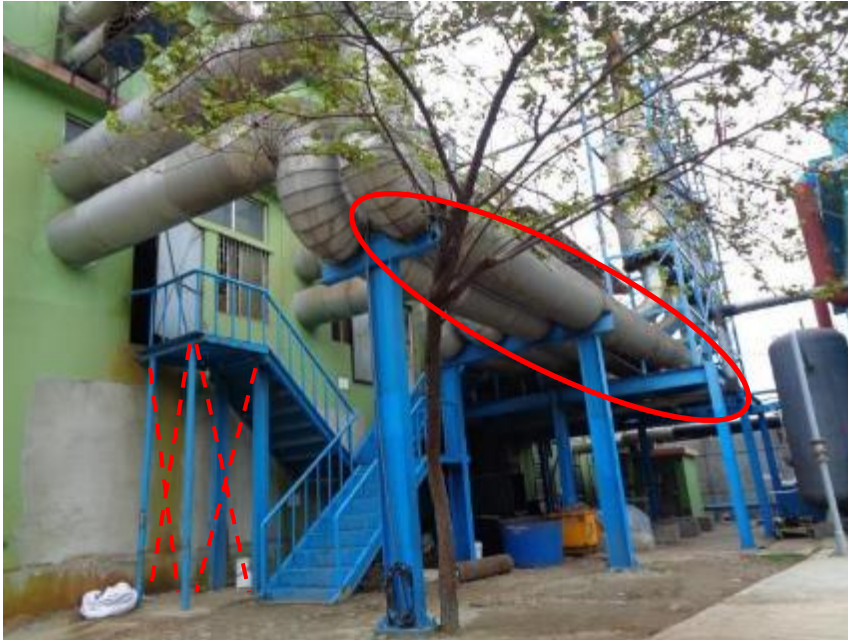
Lack of load transfer media along east-west dir.

Due to absence of load transfer media and improper connections the lateral stability of the steel structure is questionable. The building engineer is required to check the lateral stability and connection adequacy of the steel structures.

| Item No. | Observation | Recommended Action Plan | Recommended Timeline |
|---|---|---|---|
| 12 | Lack of lateral stability in adjacent steel stair and improper connection of steel platform<br>Building-4 (Generator Building) | Building Engineer is required to check the lateral stability and connection adequacy of the steel stair. | 6-weeks |
| 13 | Lack of lateral stability in adjacent steel stair and improper connection of steel platform<br>Building-4 (Generator Building) | Carry out suggested remedial works if required | 6-weeks |

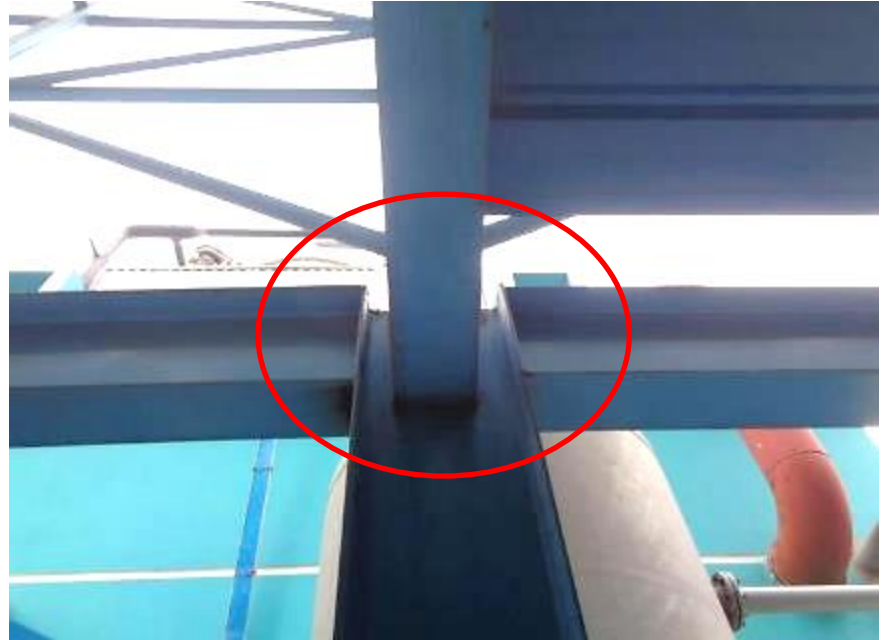
Discontinuity of top plate in beam-column joint

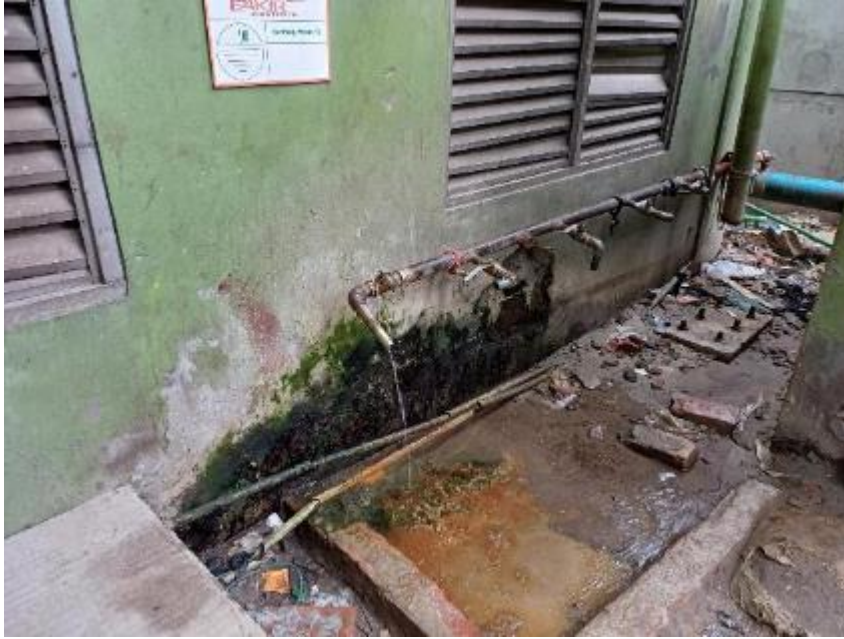
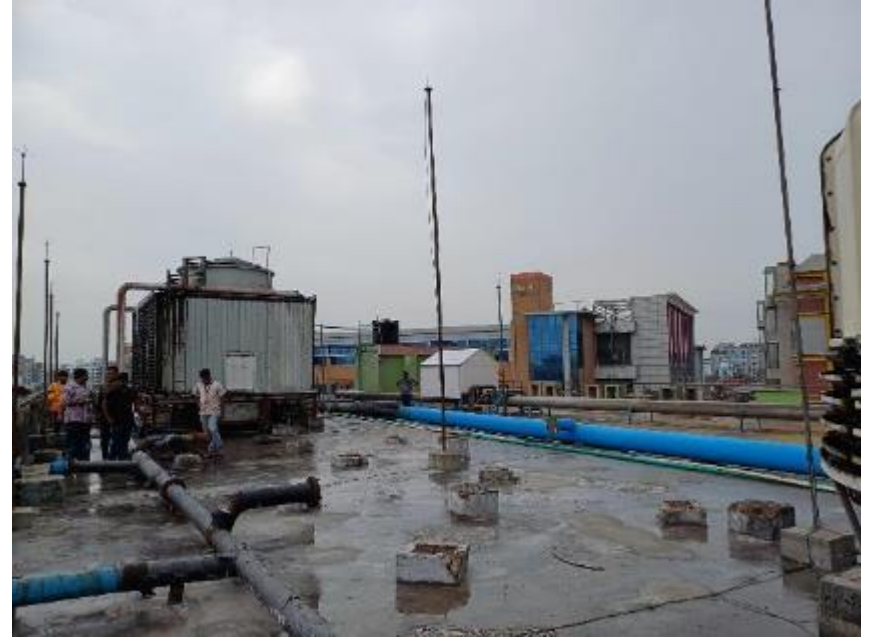
Dampness on wall and roof

Dampness observed on wall and roof slab. The roof is constructed with brick aggregate concrete (MCAC). The building engineer is required to take necessary steps to repair the damp areas and apply water proofing layer on the roof with proper slope.

| Item No. | Observation | Recommended Action Plan | Recommended Timeline |
|---|---|---|---|
| 14 | Dampness on wall and roof<br>Building-4 (Generator Building) | The building engineer is required to take necessary steps to repair the damp areas and apply water proofing layer on the roof with proper slope. | 6-weeks |

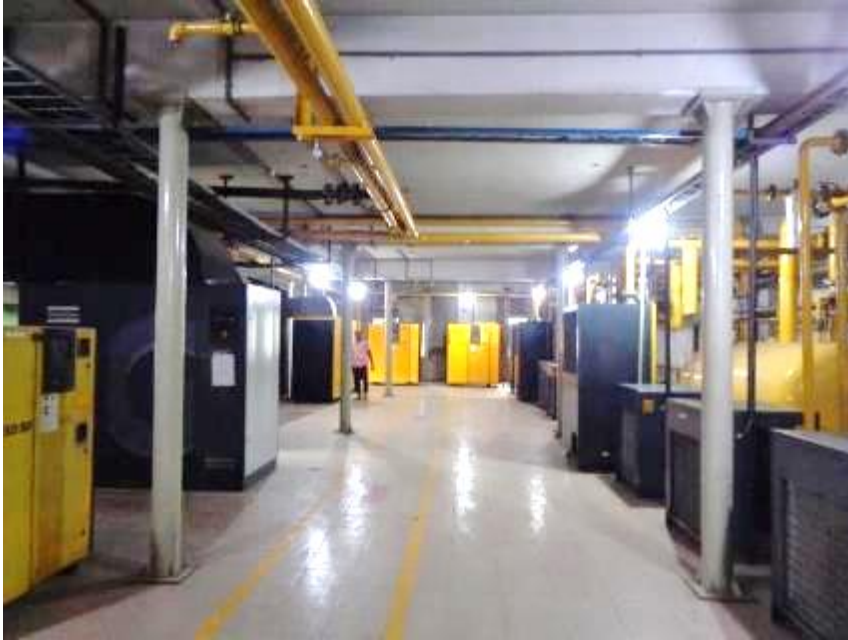
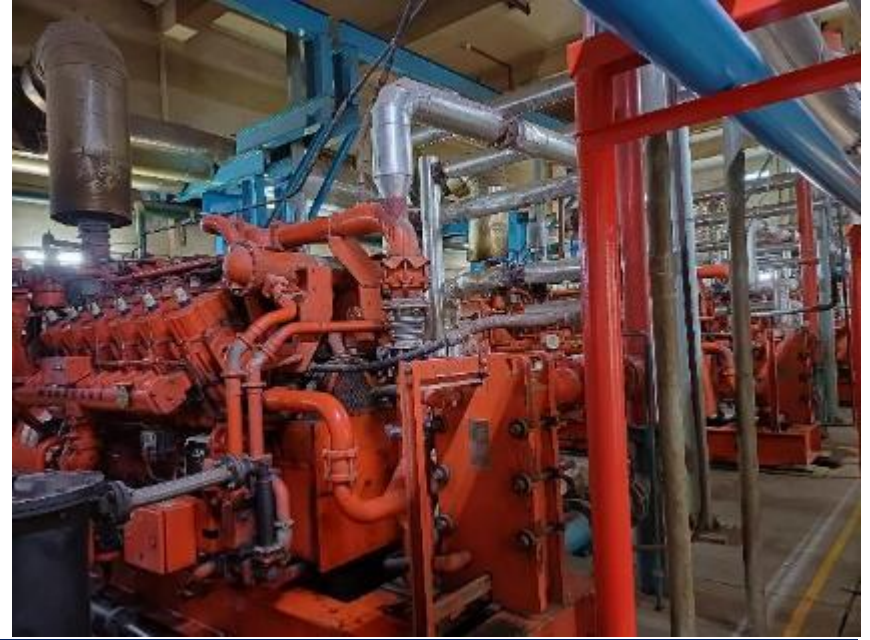
Heavy machineries: source of vibration

Vibration was felt at all floors due to heavy machinery operating on floor slab. Building engineer is required to identify the actual cause of vibration, check the long-term effect on the structure and suggest suitable action to reduce the vibration.

| Item No. | Observation | Recommended Action Plan | Recommended Timeline |
|---|---|---|---|
| 15 | Vibration in all floors<br>Building-4 (Generator Building) | Building engineer is required to identify the cause of vibration, check the long-term effect on the structure and suggest suitable action to reduce the vibration. | 6-weeks |

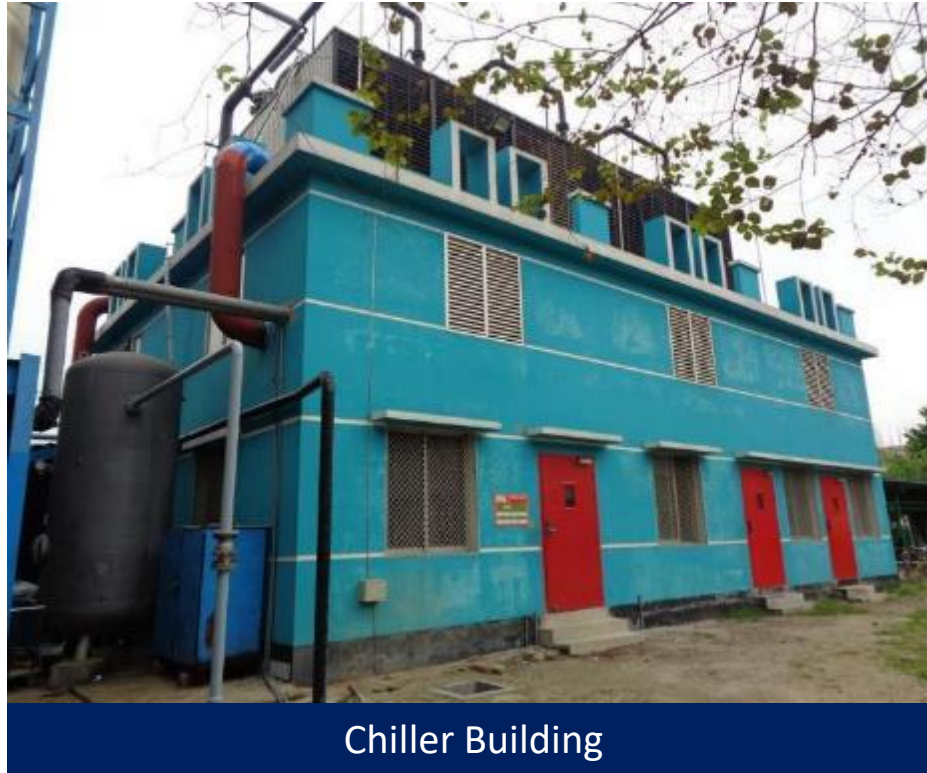
Chiller Building

## **Lack of design documents**

As per BNBC (part-6), every building or structures designed should have its design documents in accordance with section 1.9.1. During inspection, drawing and design report were not found on-site. The building engineer is required to prepare a set of design documents (including as-built drawings, floor load plan and design report based on in-situ material strength & software-based analysis) for the building following BNBC (part-6, section 1.9.1).

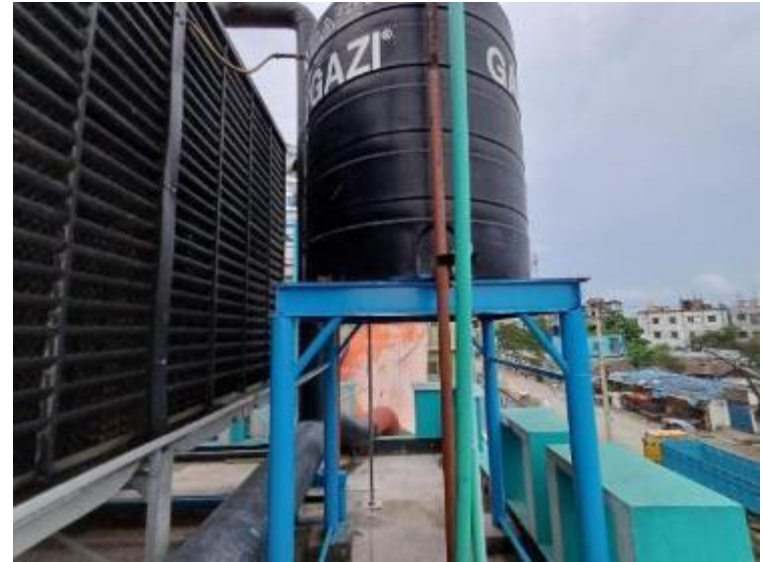
Plastic water tank on the roof

Plastic water tank was not shown in architectural drawing. Building engineer is required to revise the drawings as per site condition.

| Item No. | Observation | Recommended Action Plan | Recommended Timeline |
|---|---|---|---|
| 24 | Discrepancy in as-built drawings<br>Building-7: Chiller Building | Building engineer is required to revise the drawings as per site condition. | 6-weeks |

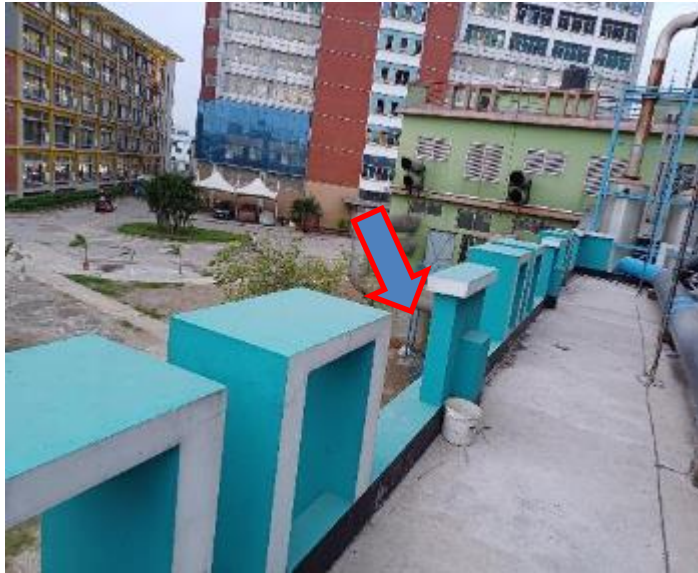
Discontinuous parapet on roof

Building engineer is required to add barrier for open area to prevent falling hazard for both roof and adjacent steel stair.

| Item No. | Observation | Recommended Action Plan | Recommended Timeline |
|---|---|---|---|
| 25 | Falling hazard at roof and adjacent steel stair<br>Building-7: Chiller Building | Building engineer is required to add barrier for open area to prevent falling hazard for both roof and adjacent steel stair. | 6-weeks |

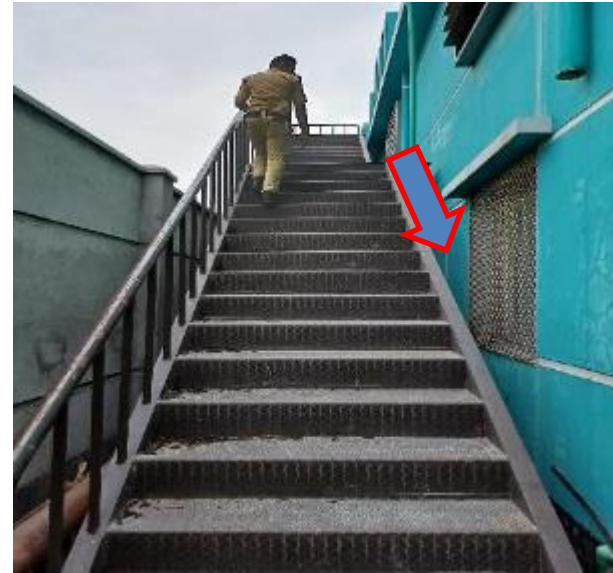
Lack of railing in stair

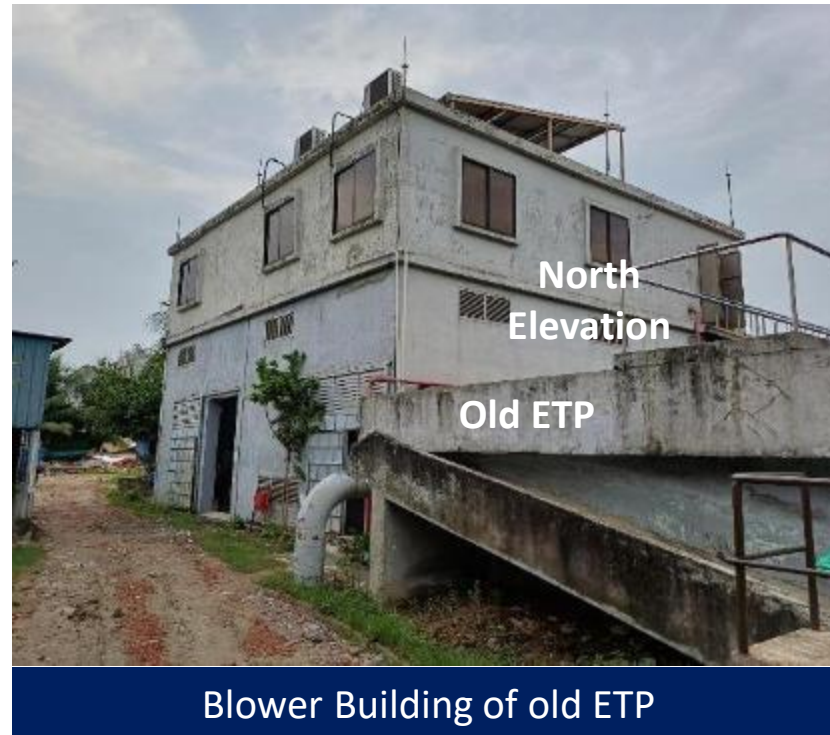
**Lack of design documents for blower building**

As per BNBC (part-6), every building or structures designed shall have its design documents in accordance with the provision of section 1.9.1. During inspection, proper design documents were not found on-site. The building engineer is required to prepare a set of design documents (including as-built drawings, floor load plan and design report based on in-situ material strength & software-based analysis) for the building following BNBC (part-6, section 1.9.1).

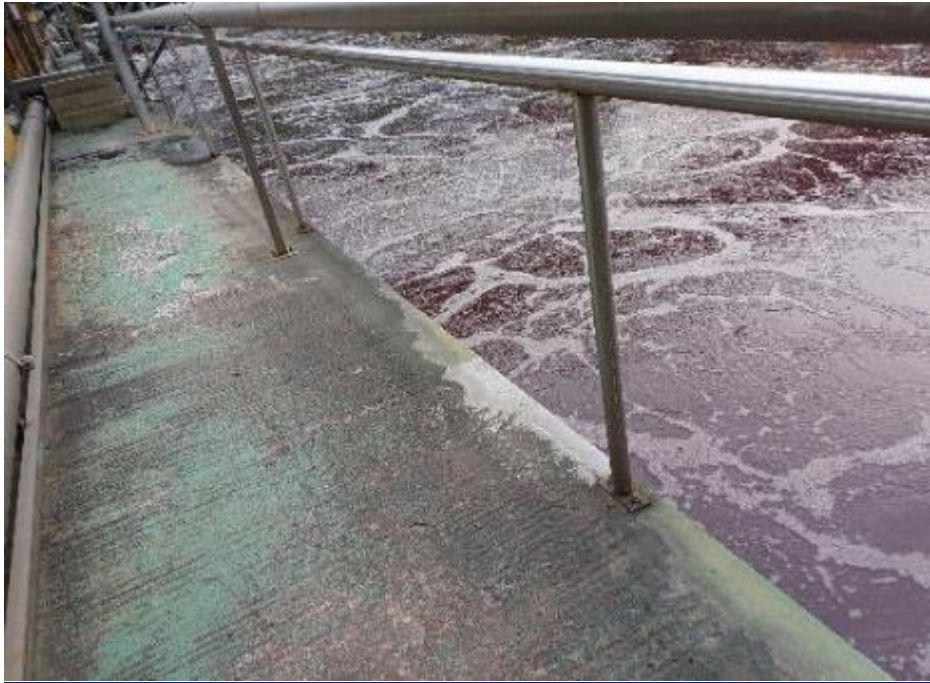
Huge gap between newel/balusters

Building engineer is required to provide additional newel post and balusters to the railing to prevent possible falling hazard.

| Item No. | Observation | Recommended Action Plan | Recommended Timeline |
|---|---|---|---|
| 28 | Falling hazard at Old ETP<br>Building-9: Old ETP Building | Building engineer is required to provide additional newel post and balusters to the railing to prevent possible falling hazard. | 6-weeks |

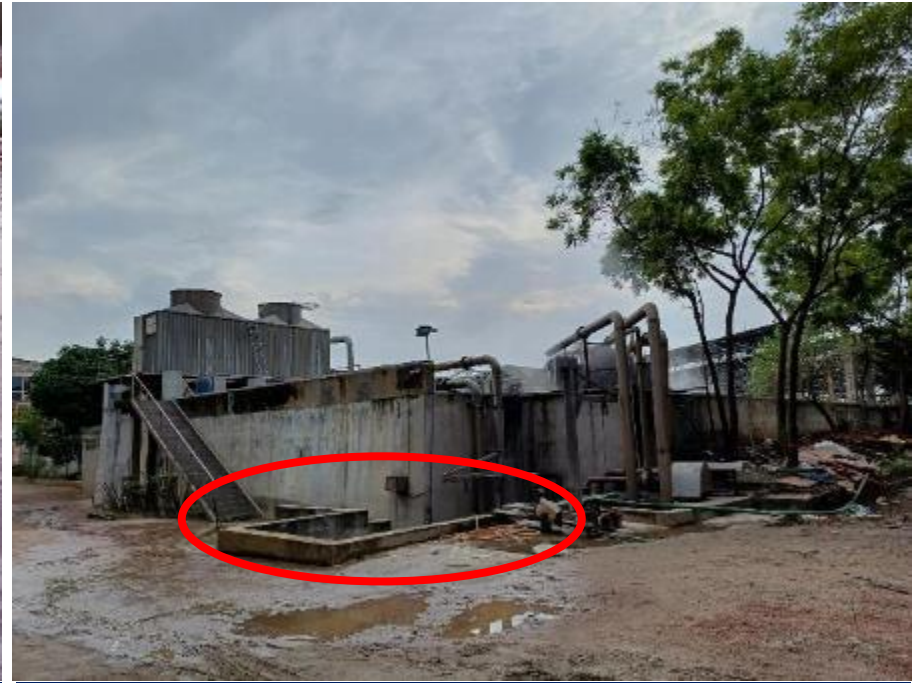
Lack of railing and falling hazard screening area

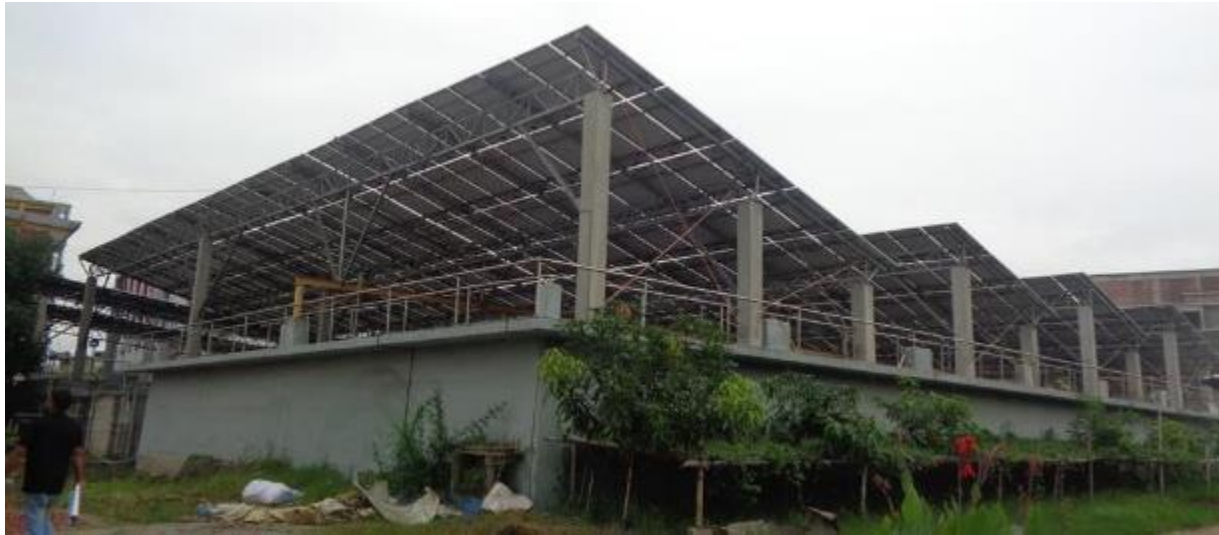
New ETP roof structure

**Lack of as-built drawings & design documents for  
the steel roof system**

As per BNBC (part-6), every building or structures designed shall have its design documents in accordance with the provision of section 1.9.1. During inspection, proper design documents were not found on-site. The building engineer is required to prepare a set of design documents (including as-built drawing and design report based on in-situ material strength & software-based analysis) for the roof structure following BNBC (part-6, section 1.9.1).

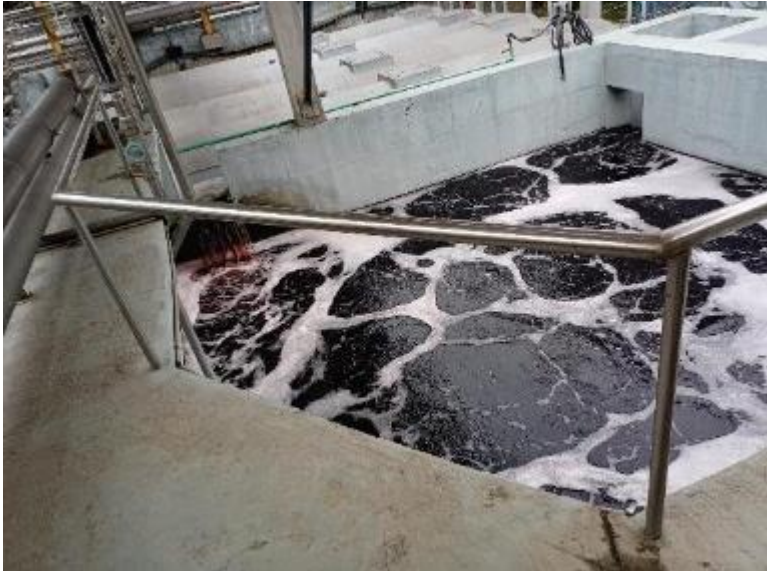
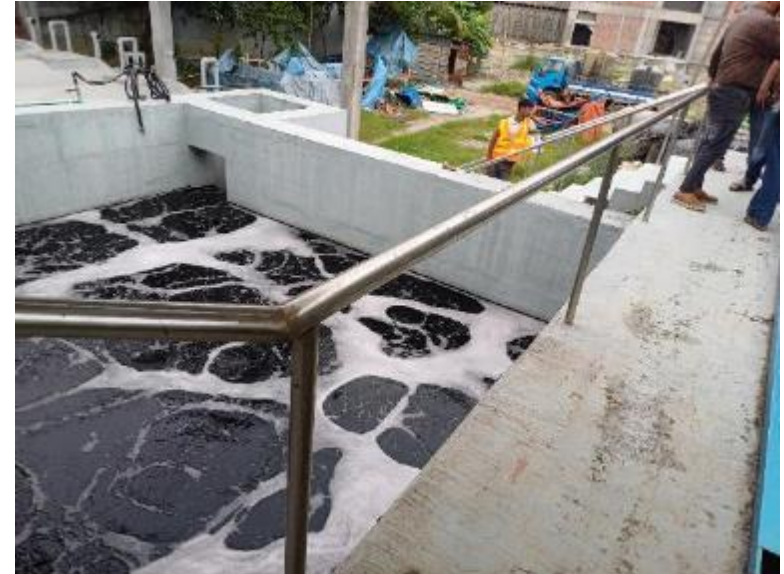
Huge gap between newel/balusters

Building engineer is required to provide additional newel post and balusters to the railing to prevent possible falling hazard.

| Item No. | Observation | Recommended Action Plan | Recommended Timeline |
|---|---|---|---|
| 31 | Inadequate railing at New ETP (Building-10: New ETP Building) | Building engineer is required to provide additional newel post and balusters to the railing to prevent possible falling hazard. | 6-months |

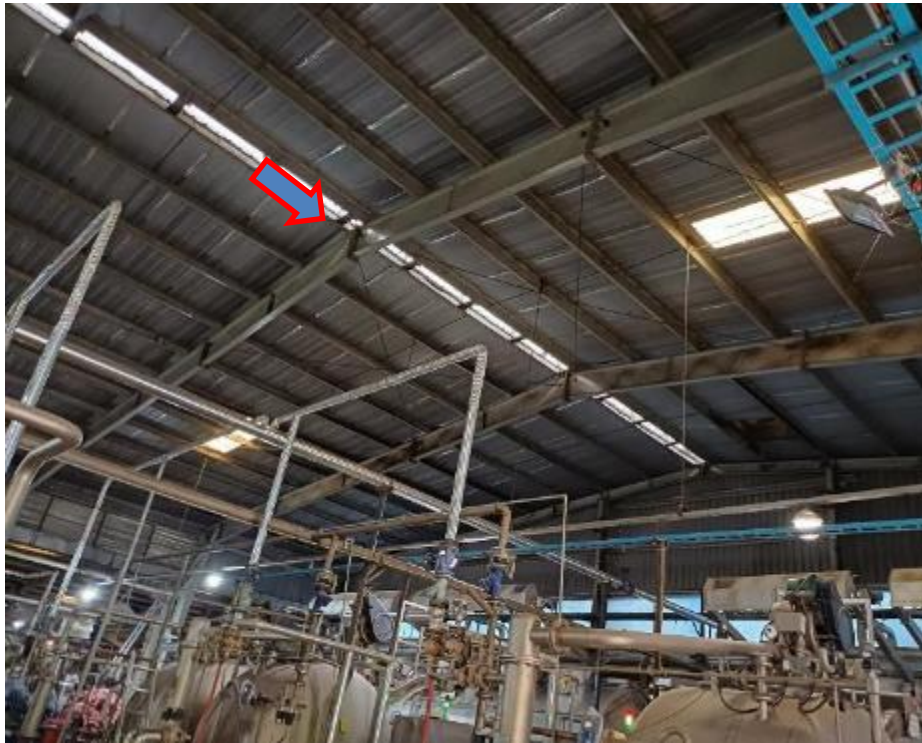
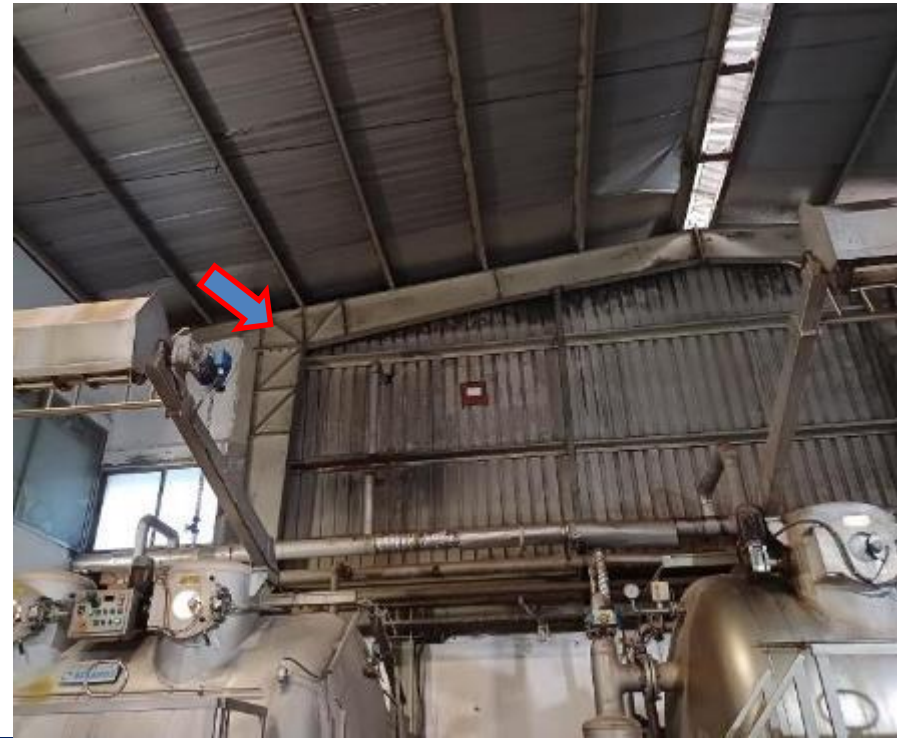
No vertical bracing/compression member provided

Only roof bracing is provided for the roof and load transfer media is not provided from frame to frame to transfer the lateral load. Also, no vertical bracing is provided for the shed. Hence, lateral stability system is structure is incomplete. The building engineer is required to check the lateral stability of the structure as part of EA and suggest proper remedial actions accordingly.

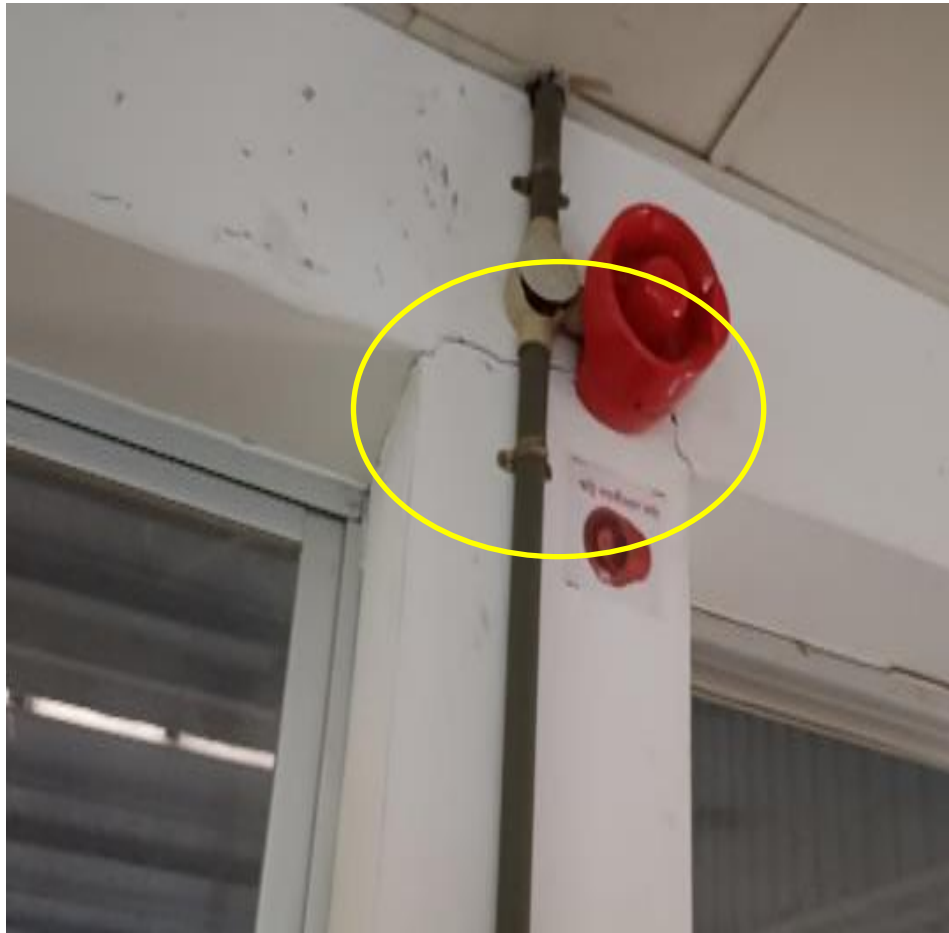
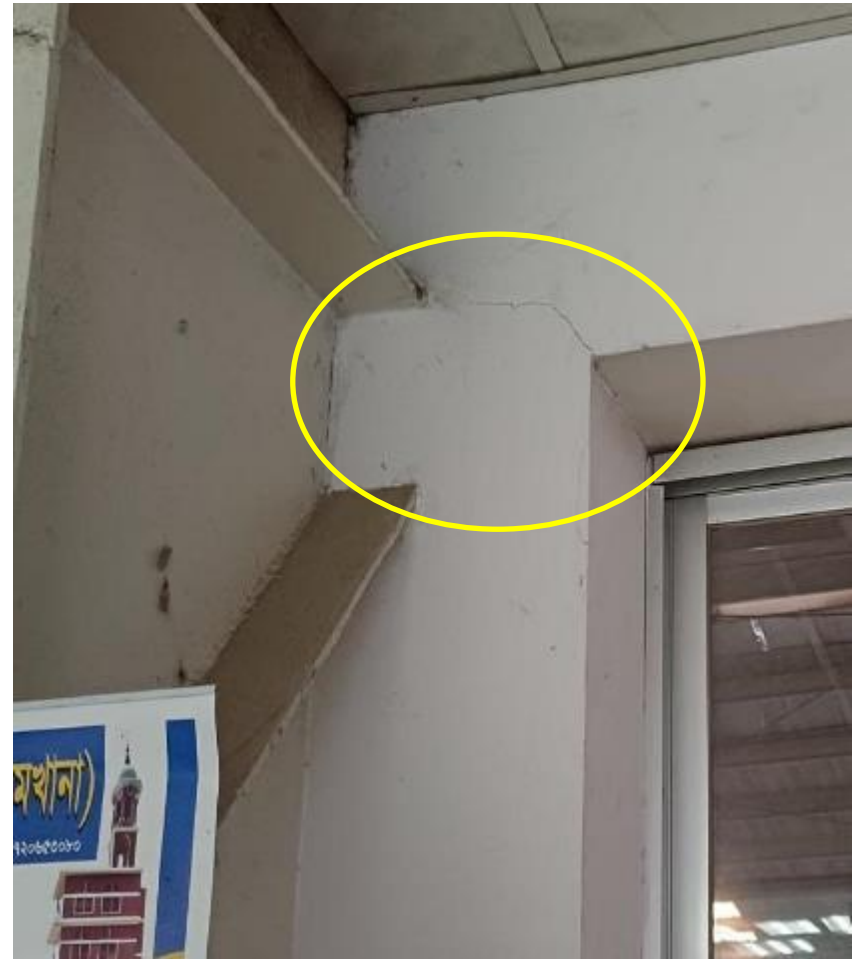
Crack on wall at several locations

During inspection, crack was observed on mezzanine floor walls and stair landing wall. The factory is required to identify the reason of the cracks and repair as per guidance by the building engineer.

| Item No. | Observation | Recommended Action Plan | Recommended Timeline |
|---|---|---|---|
| 34 | Cracks on wall at several locations.(Shed-8: Dyeing Color Lab) | The factory engineer is required to identify the reason of the cracks and suggest proper remedial works. | 6-weeks |
| 35 | Cracks on wall at several locations.(Shed-8: Dyeing Color Lab) | Carry out suggested remedial work if required. | 6-months |

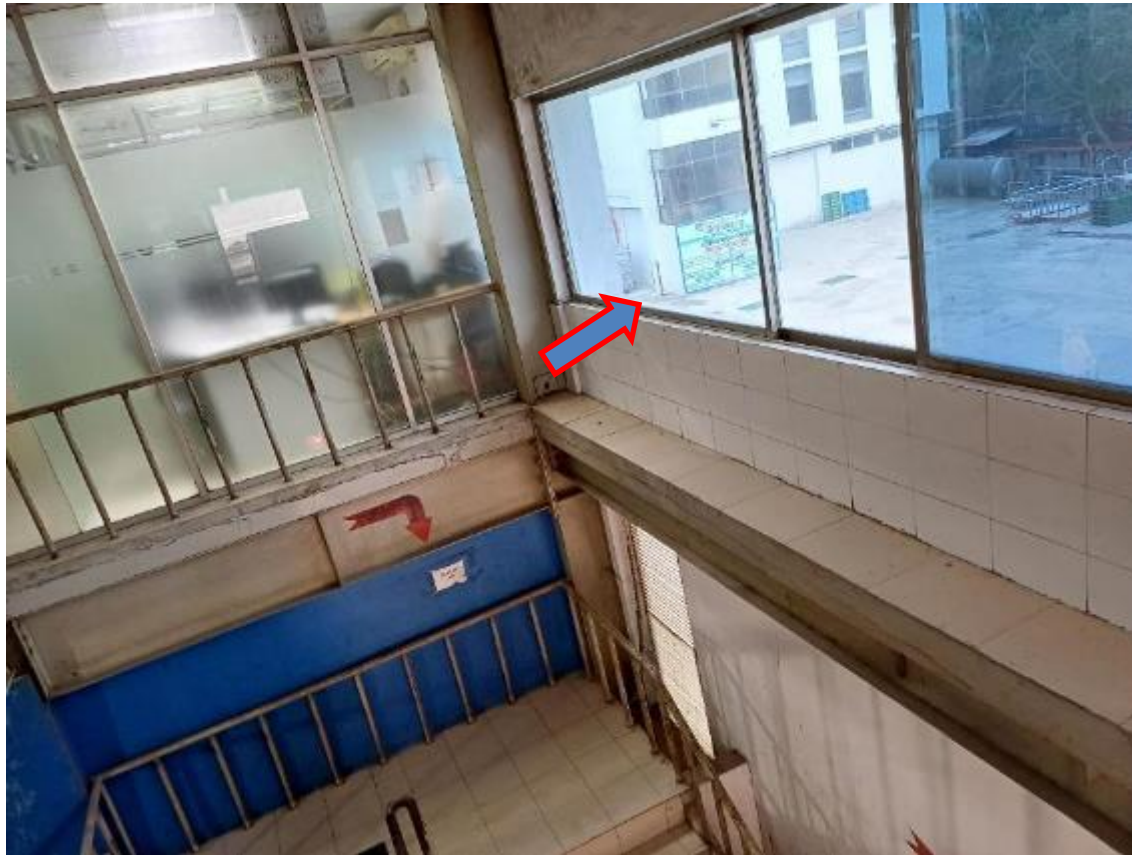
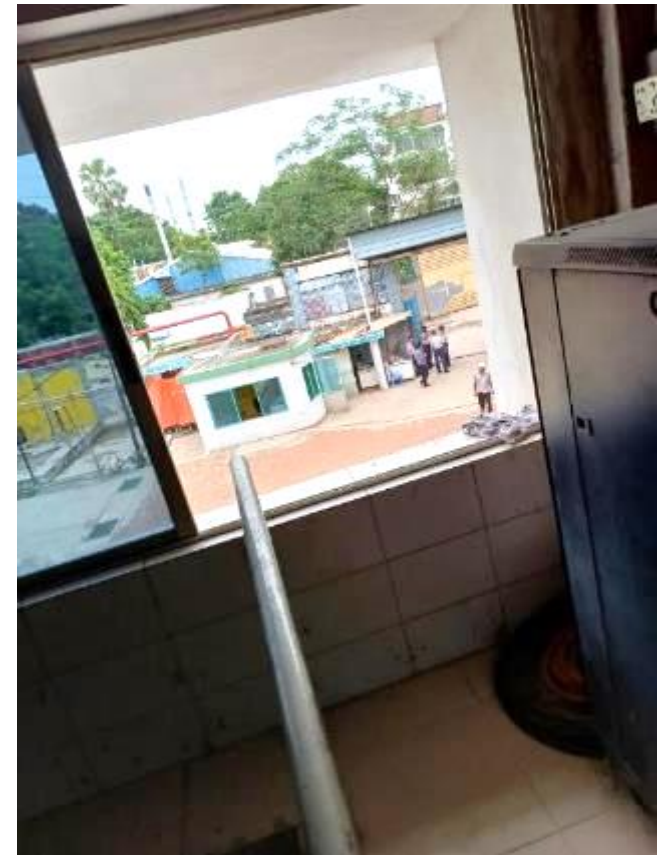
Falling hazard at mezzanine floor due to low height masonry wall

During inspection low height masonry wall found at the window area. The factory is required to provide adequate protection to avoid falling hazard.

| Item No. | Observation | Recommended Action Plan | Recommended Timeline |
|---|---|---|---|
| 36 | Falling hazard. (Shed-8: Dyeing Color Lab) | The factory is required to provide suitable fall protection system to avoid falling hazard. | 6-weeks |

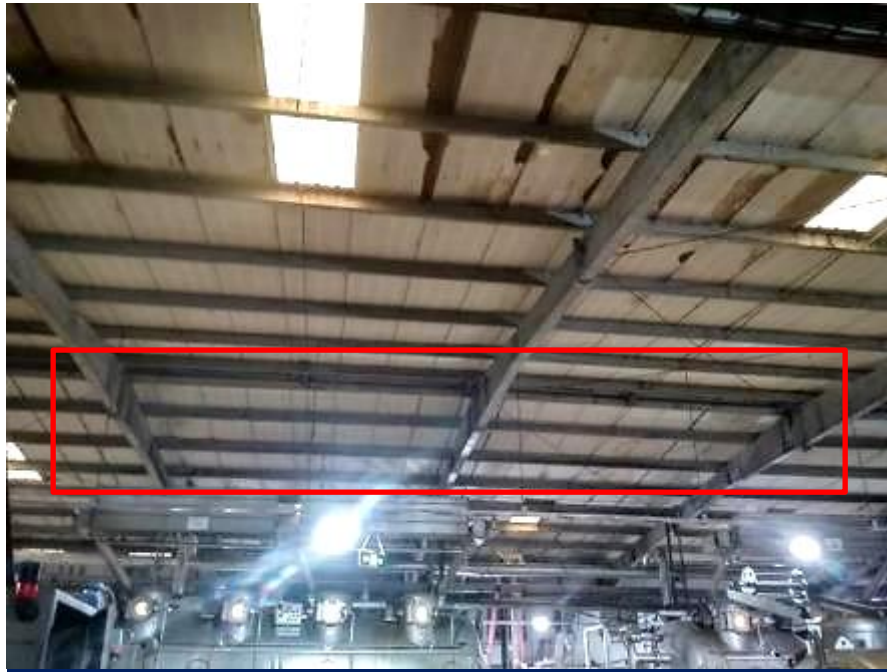
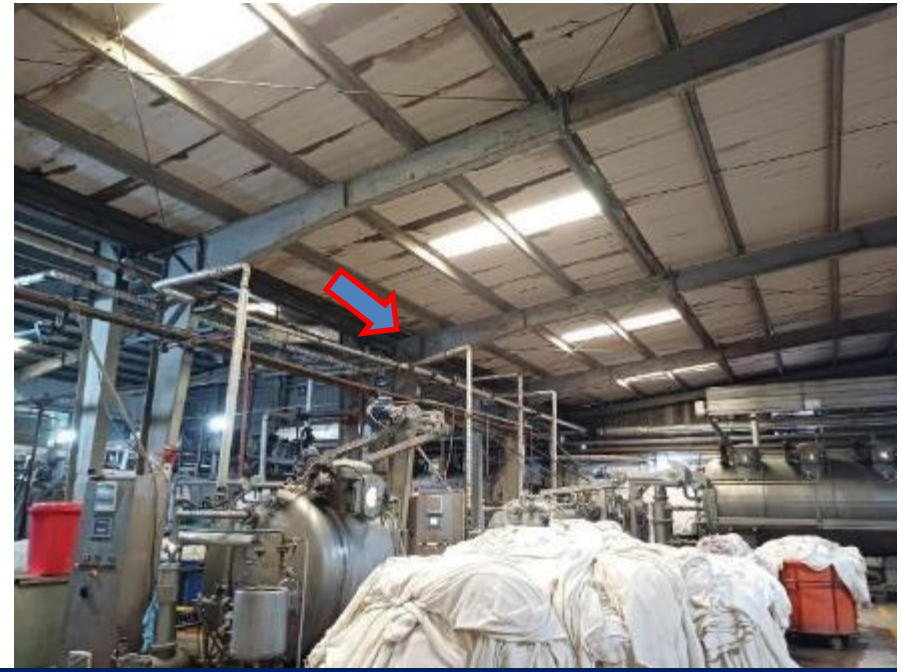
No vertical bracing/compression member provided

Only roof bracing is provided for the roof and load transfer media is not provided from frame to frame to transfer the lateral load. Also, no vertical bracing is provided for the shed. Hence, lateral stability system is structure is incomplete. The building engineer is required to check the lateral stability of the structure as part of EA and suggest proper remedial actions accordingly.

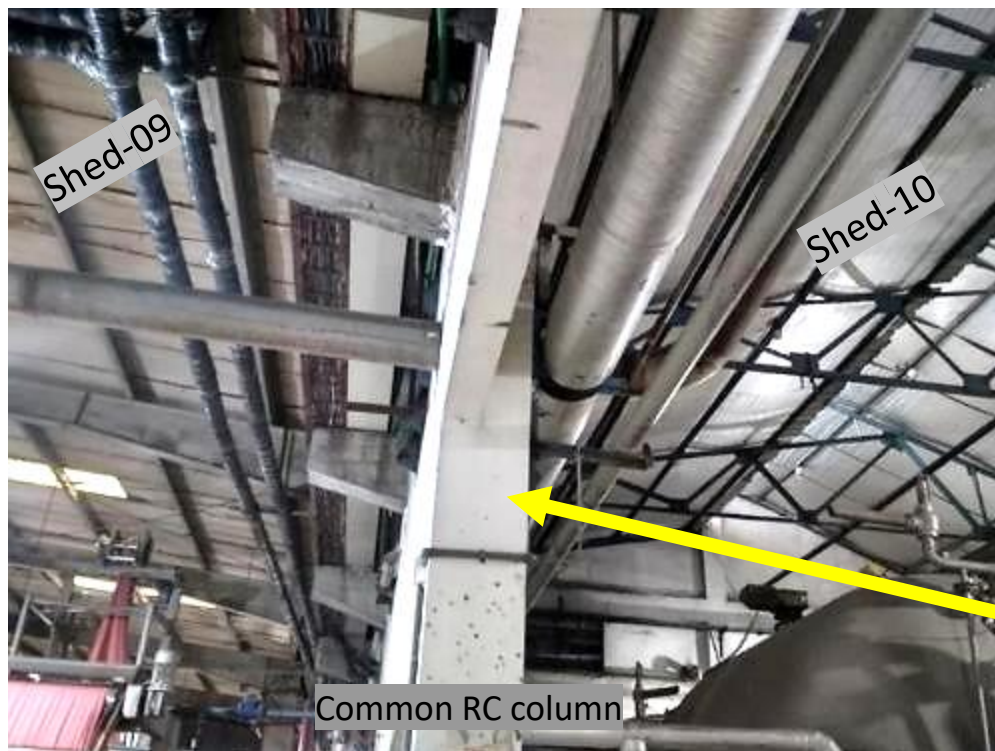
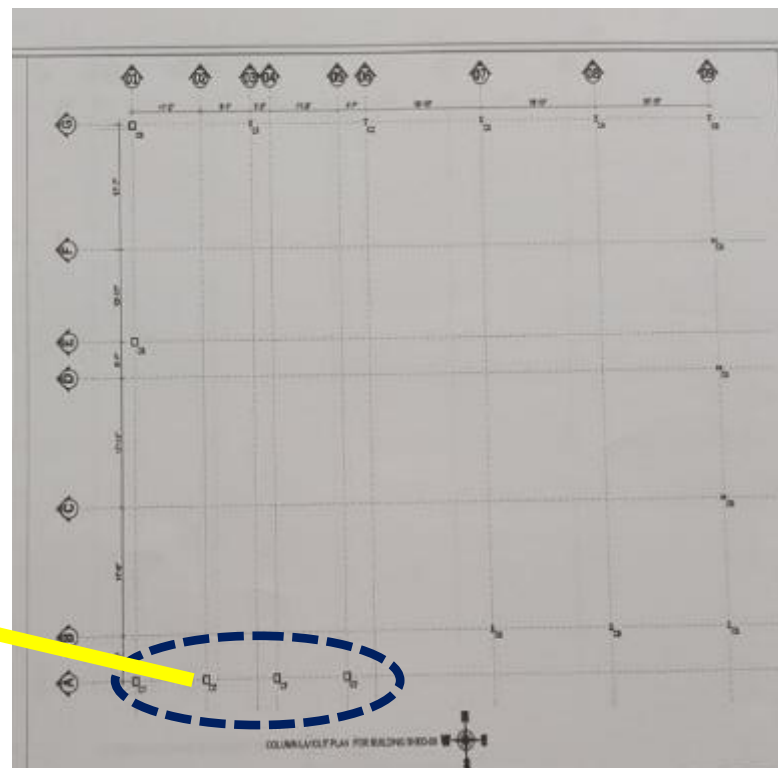
Connected portion of shed-9 with shed-10: The RC column is common for both sheds

Structural connection was observed between shed-9 and shed-10 which was not shown in drawing. Steel rafters of Shed-9 are resting on steel jack beam which is supported by a corbel of common RC column shared by both Shed-9 and Shed-10. Building engineer is required to either separate the structures or analyze the two structures as one.
