# Fakir Knitwears Ltd. (Extension)

Kayempur, Fatullah, Narayanganj

22 August 2023

# Observations

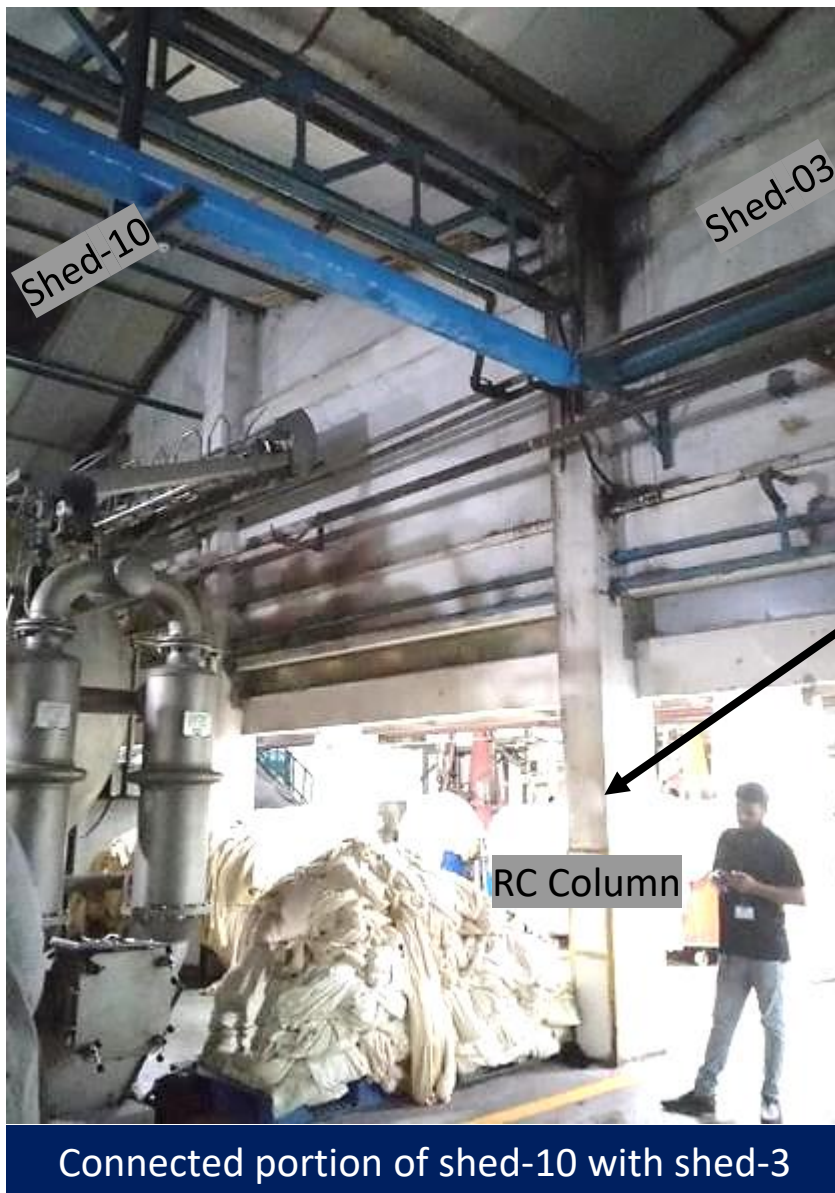
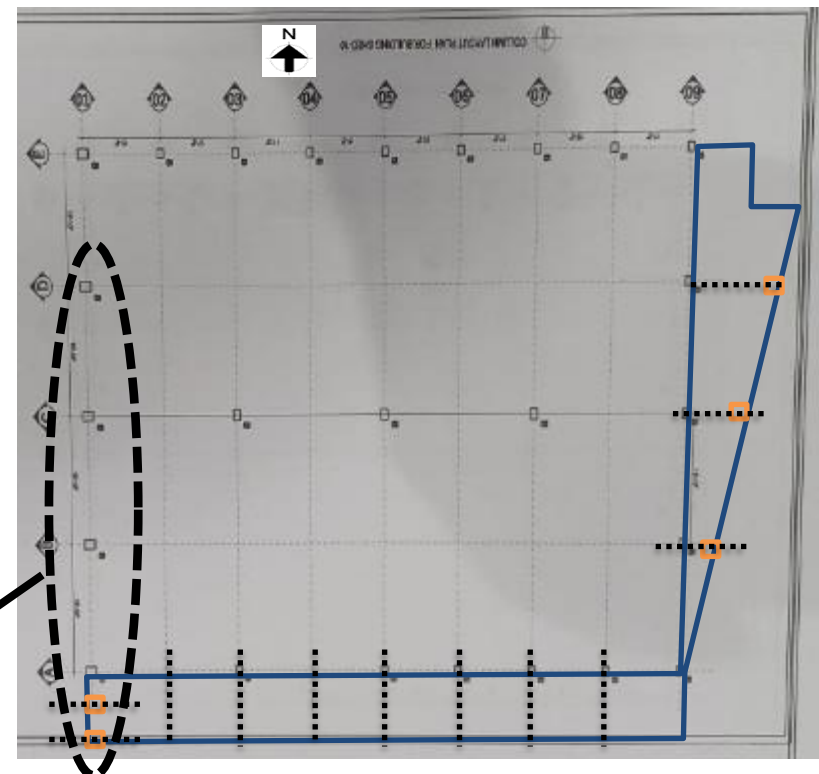
Floor layout of shed-10

## **Structural connection of Shed-10 with adjacent Shed-3 & Shed-9**

During inspection connection between shed-3 and shed-10 observed which was not shown in the drawing. Steel truss of Shed-10 connected with RC column of Shed-3. The building engineer is required to survey the structures and update the as-built drawing with structural connection details. Also, revise the design documents considering structural connection of the structures.

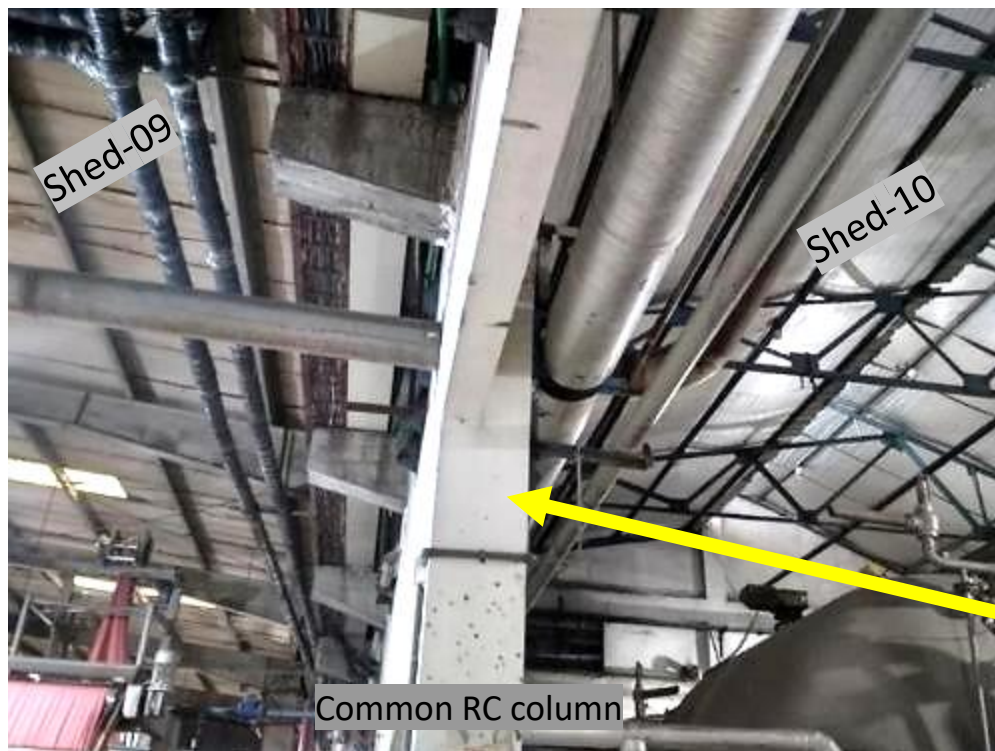
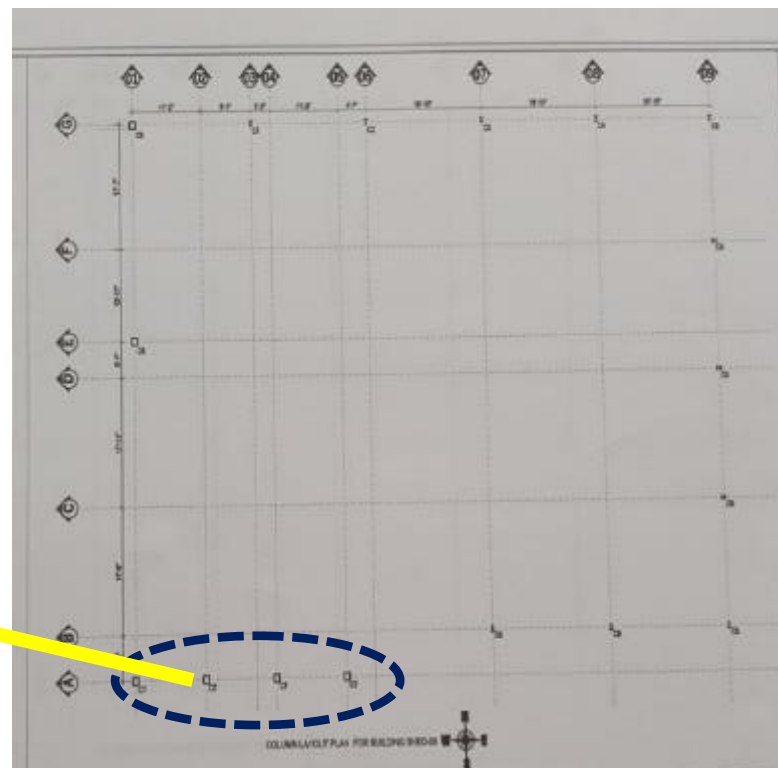
Connected portion of shed-9 with shed-10: The RC column is common for both sheds

During inspection connection between shed-9 and shed-10 observed which was not shown in the drawing. Steel rafter of Shed-9 rested steel jack beam which is supported by corbel of common RC column. The building engineer is required to survey the structures and update the as-built drawing with structural connection details. Also, revise the design documents considering structural connection of the structures.

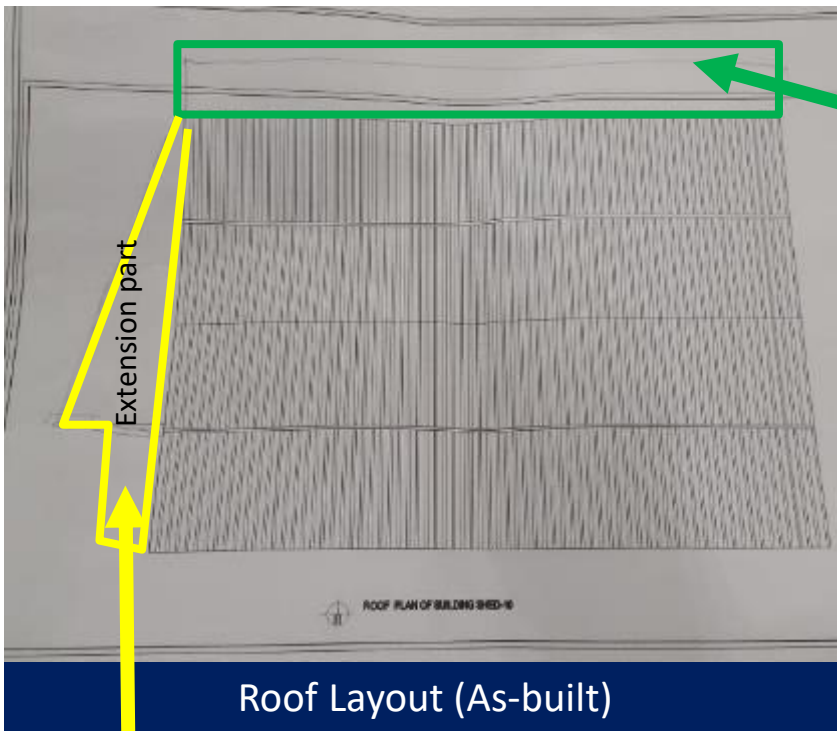
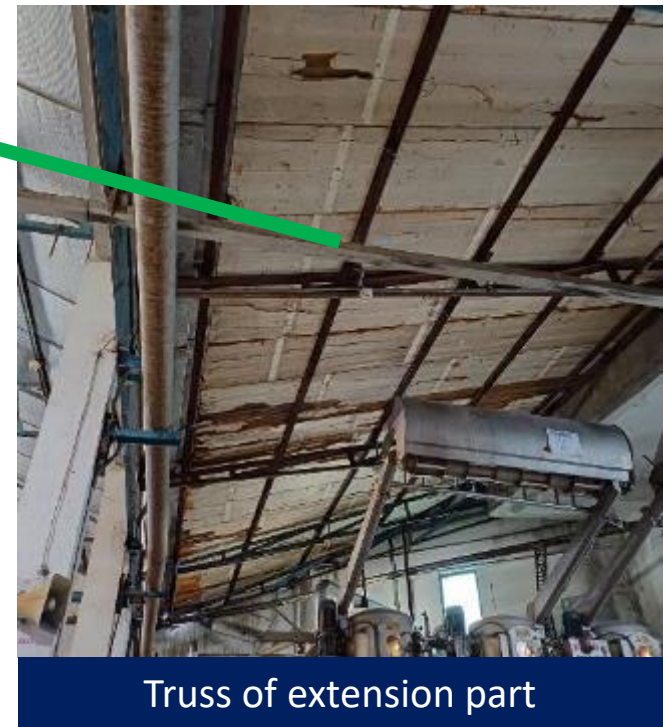
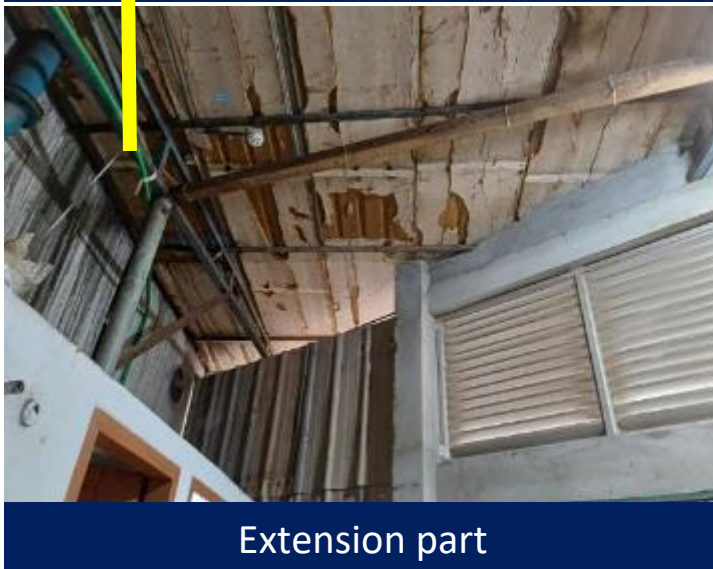
## **Discrepancies in as-built drawing**

Extension was observed for this structure which was not shown in as-built drawing. Building engineer is required to survey the structures thoroughly and update the as-built drawing and check the structural stability of whole structure considering the extension part.

| Item No. | Observation | Recommended Action Plan | Recommended Timeline |
|---|---|---|---|
| 47 | Discrepancies in as-built drawing.<br>(Shed-10: Old Dyeing Shed) | The building engineer is required to survey the structures thoroughly and update the as-built drawing as per actual site condition. | 6-weeks |

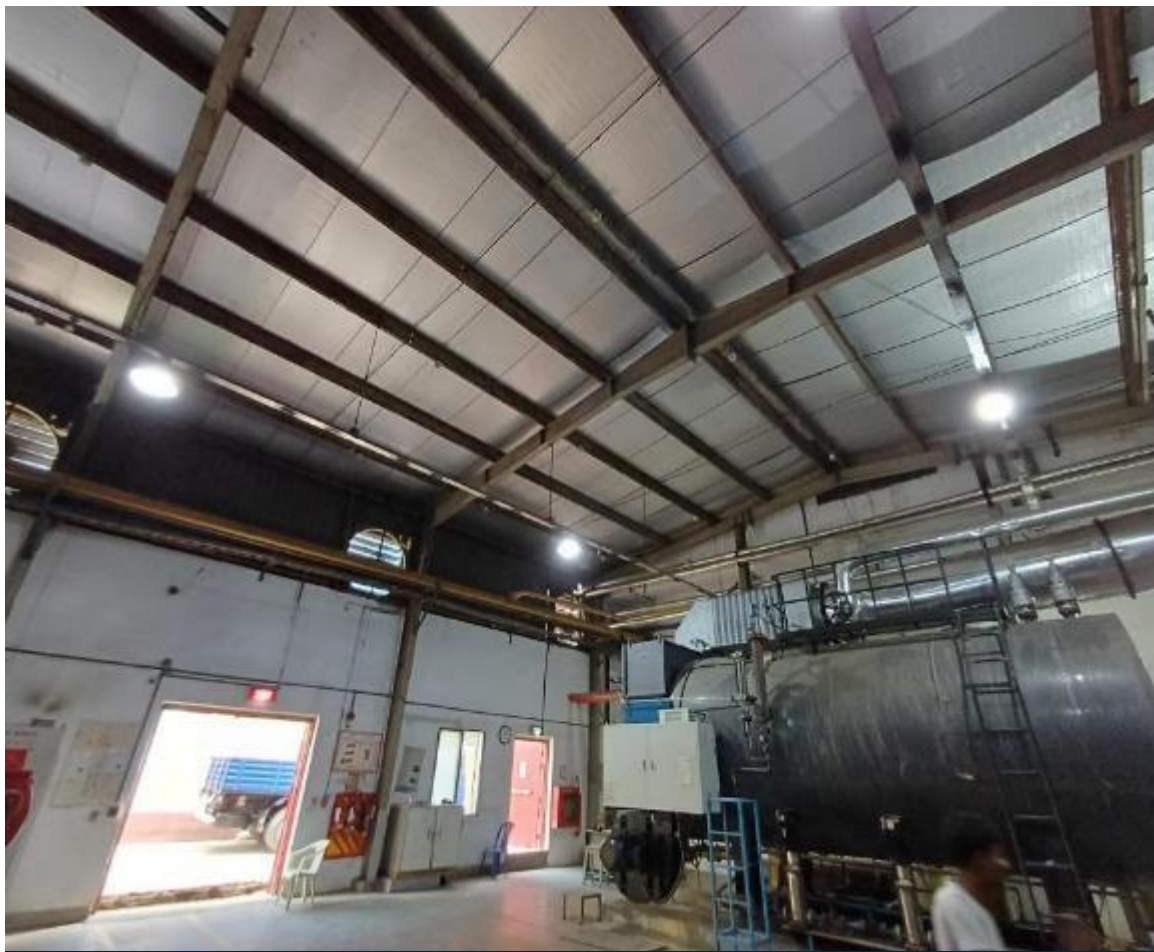
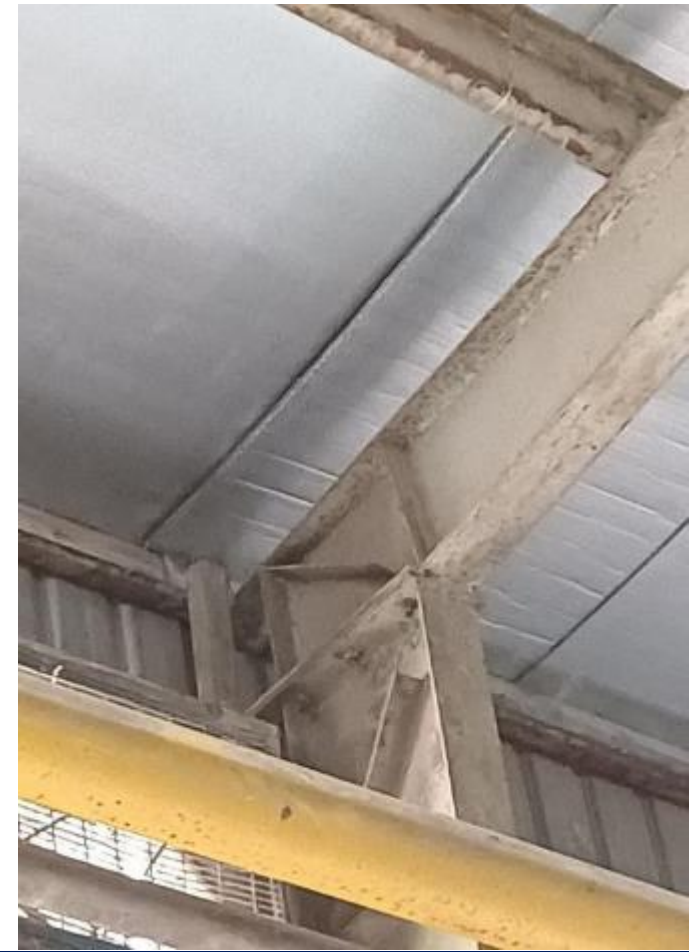
No bracing system/compression member is provided

No bracing/compression member is provided for the shed therefore the lateral stability system is absent for the structure. Building engineer is required to check the lateral stability of the shed as part of EA and suggest proper remedial work.

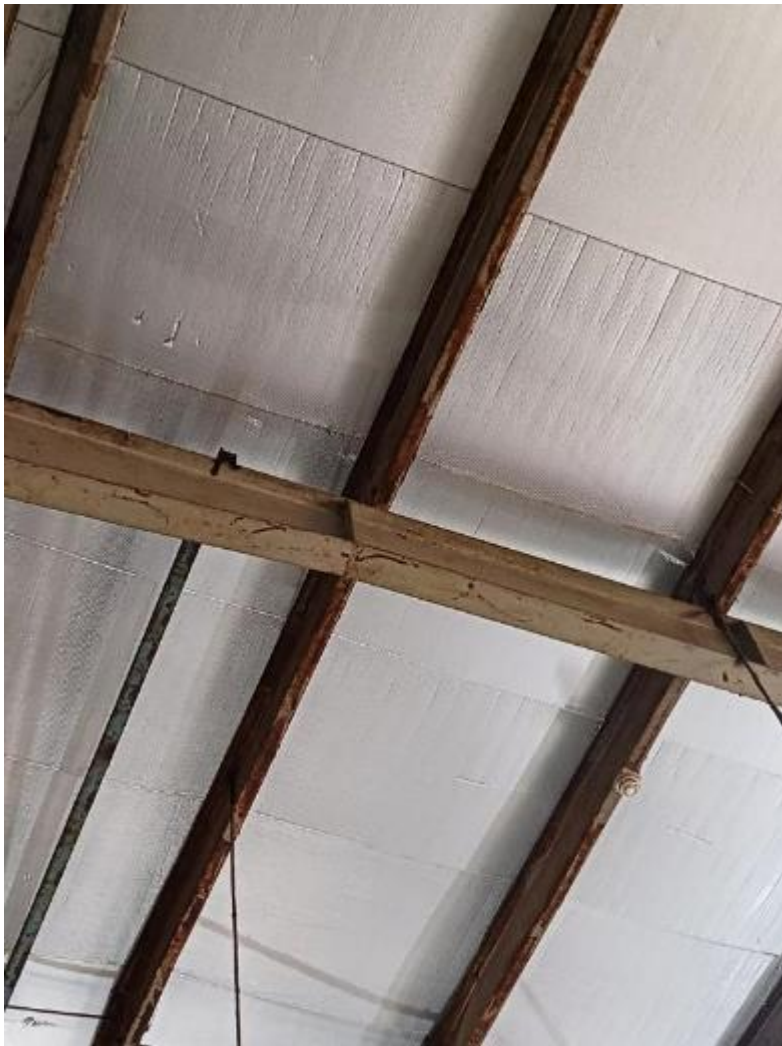
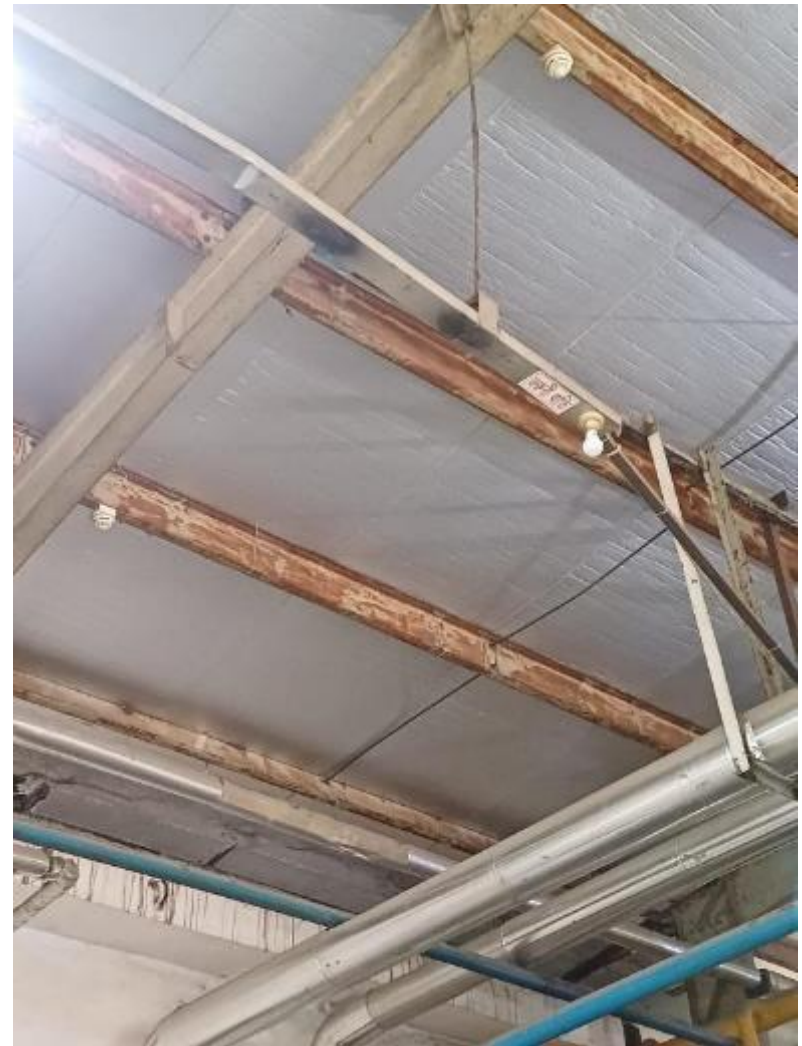
Several corroded steel members at the roof

The building engineer is required to identify all the corroded members and provide rust proof paint to prevent corrosion.

| Item No. | Observation | Recommended Action Plan | Recommended Timeline |
|---|---|---|---|
| 52 | Corrosion on steel member (Shed-11: Boiler Shed) | The building engineer is required to identify all the corrosive members and take proper remedial actions accordingly. | 6-weeks |

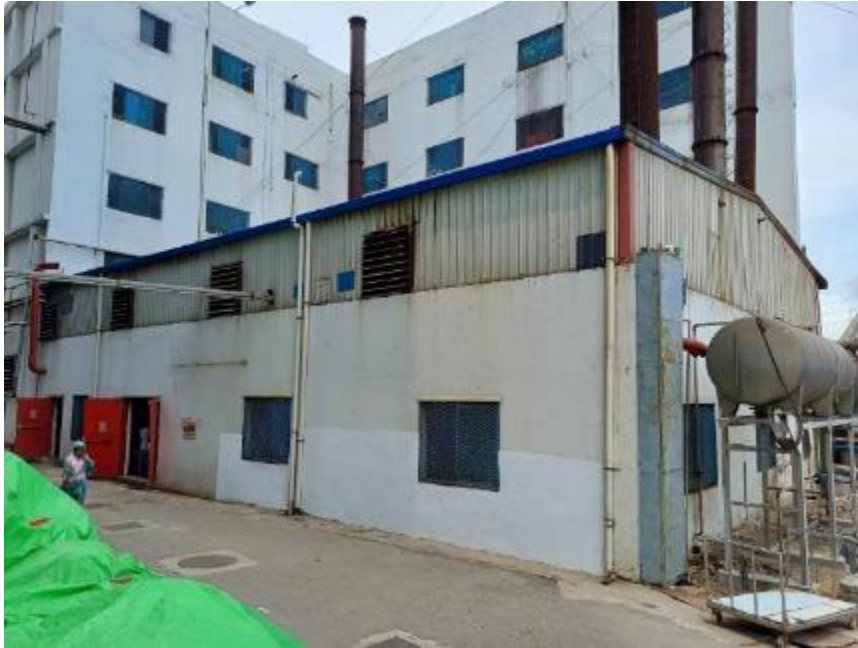
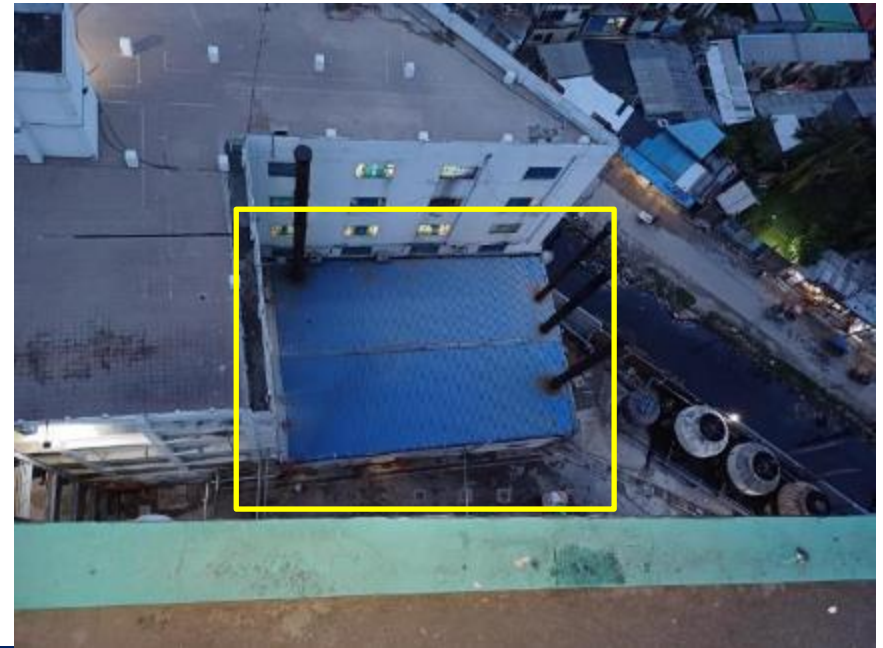
Shed-11 (Boiler Shed) has no building permit

Building permit drawing was not available for the mentioned structure.  
The factory is required to collect building permit from government approved local authority.

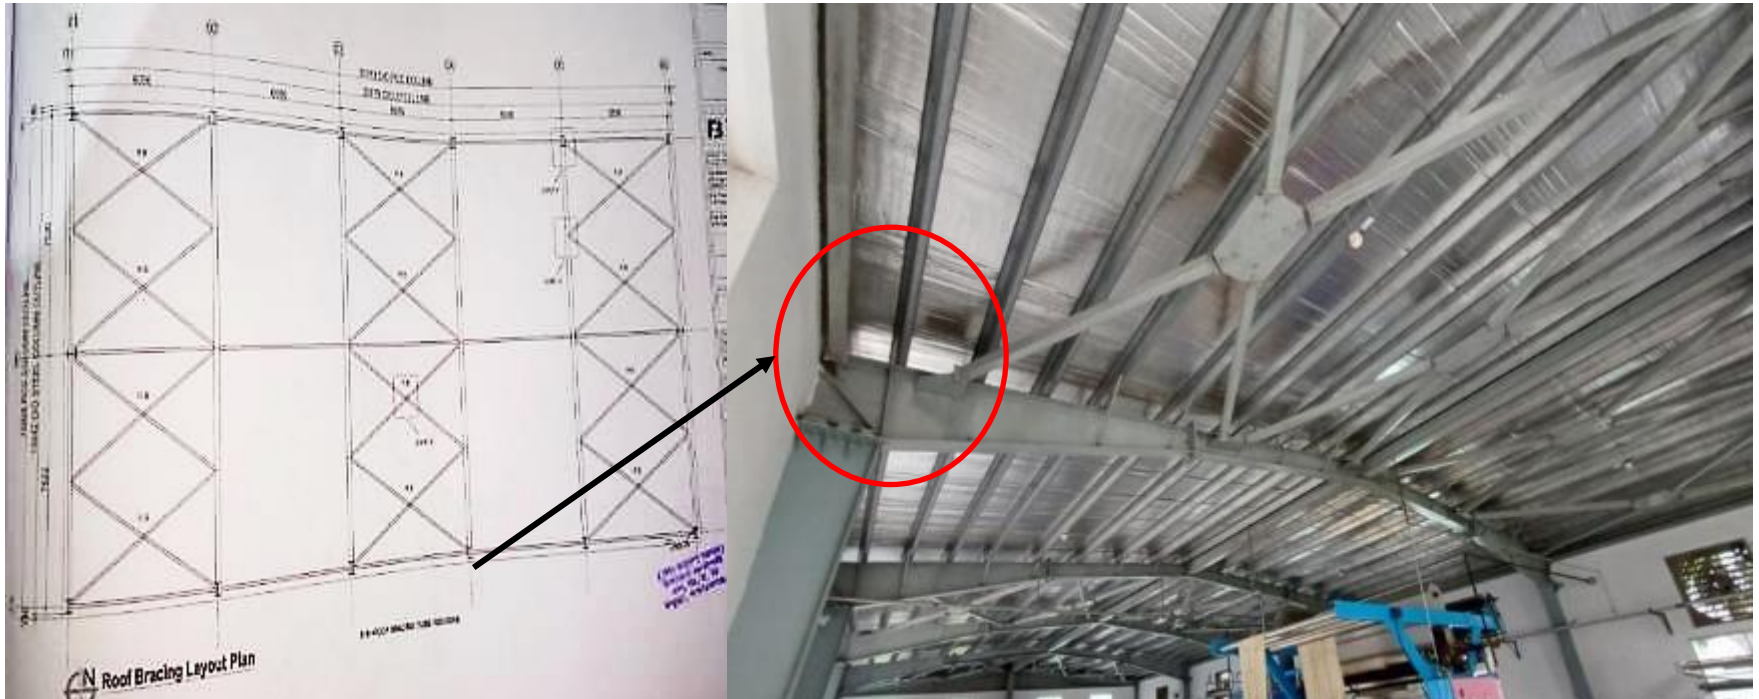
Bracings connected apart from column-rafter joint

As per drawing bracings are supposed to be connected in the column-rafter joint but bracings were connected apart from the column-rafter joint. The building engineer is required to check the bracing connections and update the as-built drawing accordingly. Also, revise the analysis as per onsite condition.

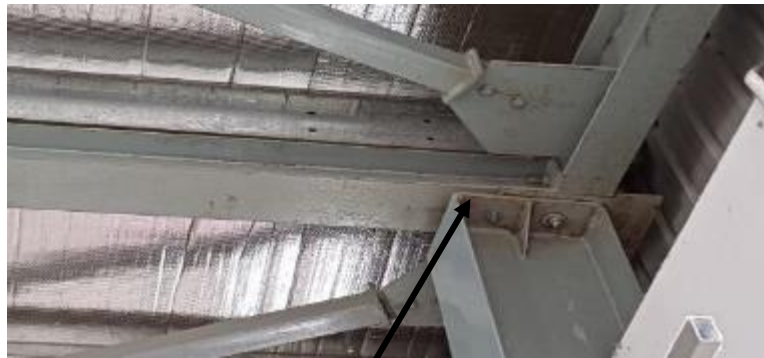
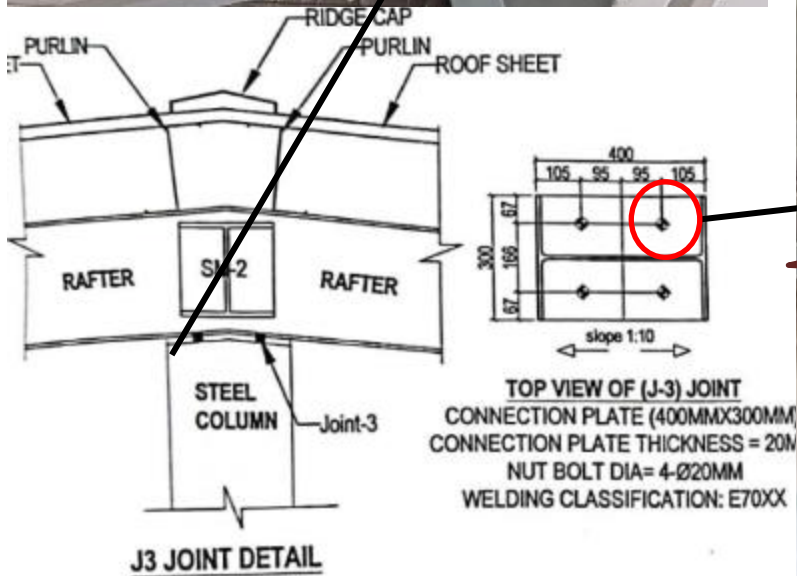
Connection plate and missing bolts

Bolt missing was observed for the steel column to rafter connection at ridge. Among 4, only one bolt was found. The building engineer is required to identify the locations and install missing bolts.

| Item No. | Observation | Recommended Action Plan | Recommended Timeline |
|---|---|---|---|
| 59 | Bolt missing in steel connection (Shed-12: Seinging Shed) | The building engineer is required to identify the locations and install missing bolt accordingly. | 6-weeks |

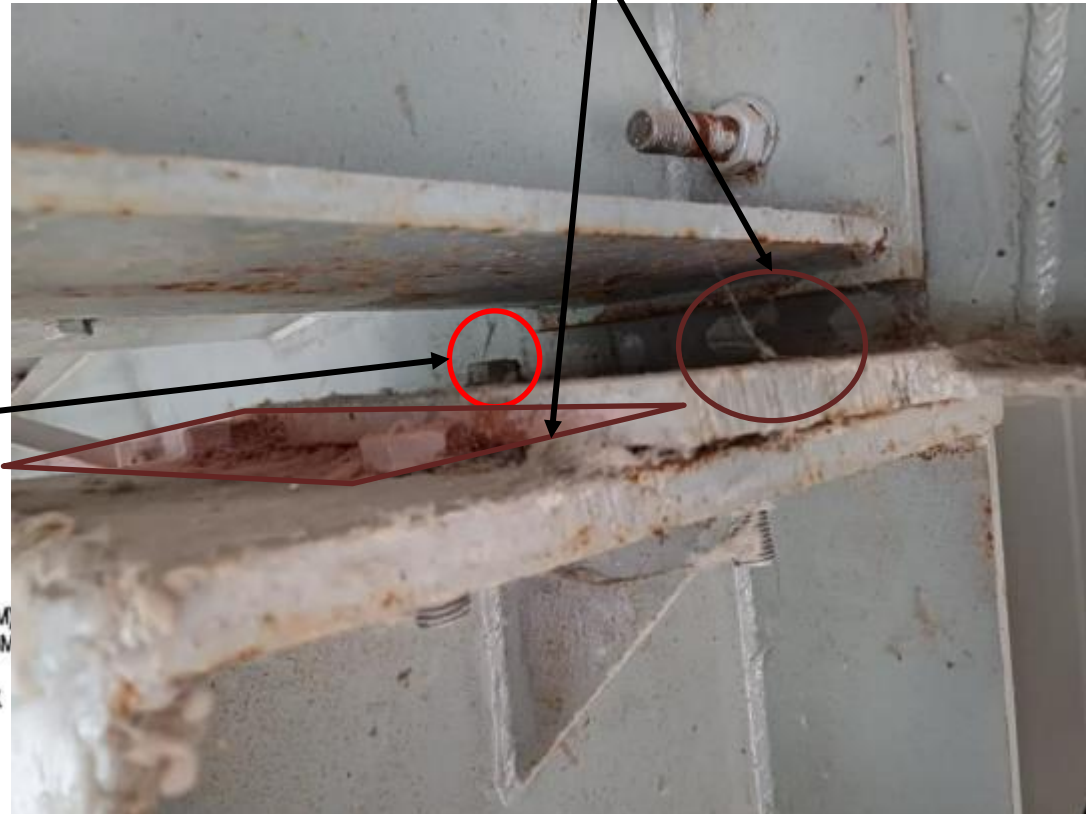
Bolt missing; only one connected bolt was found instead of four bolts

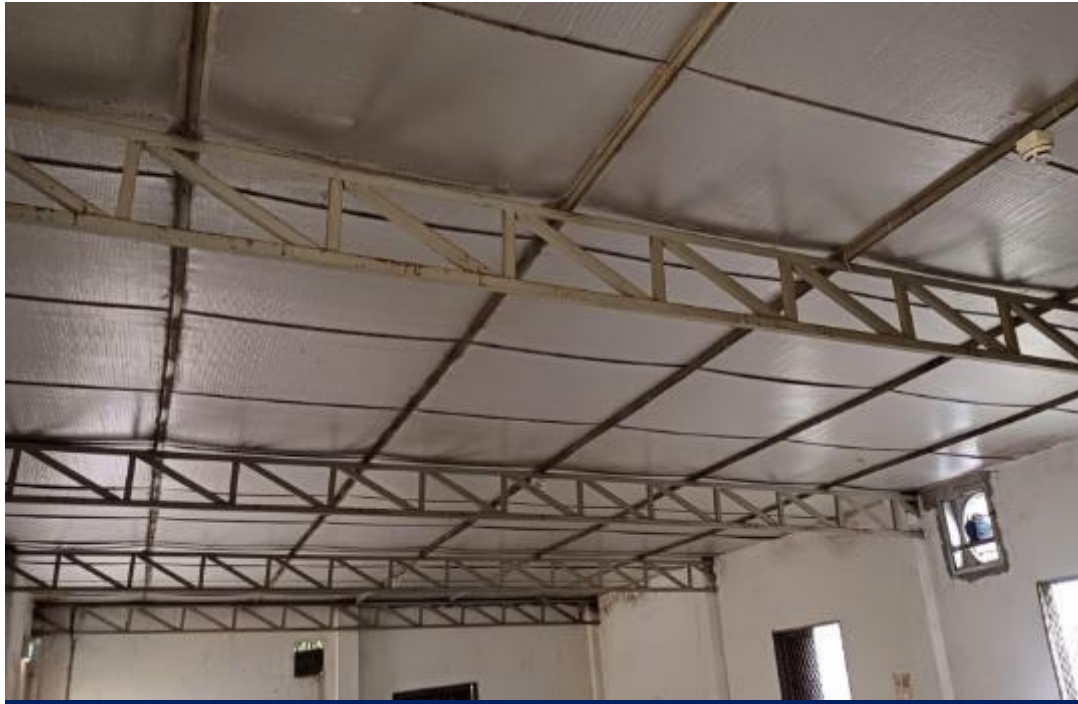
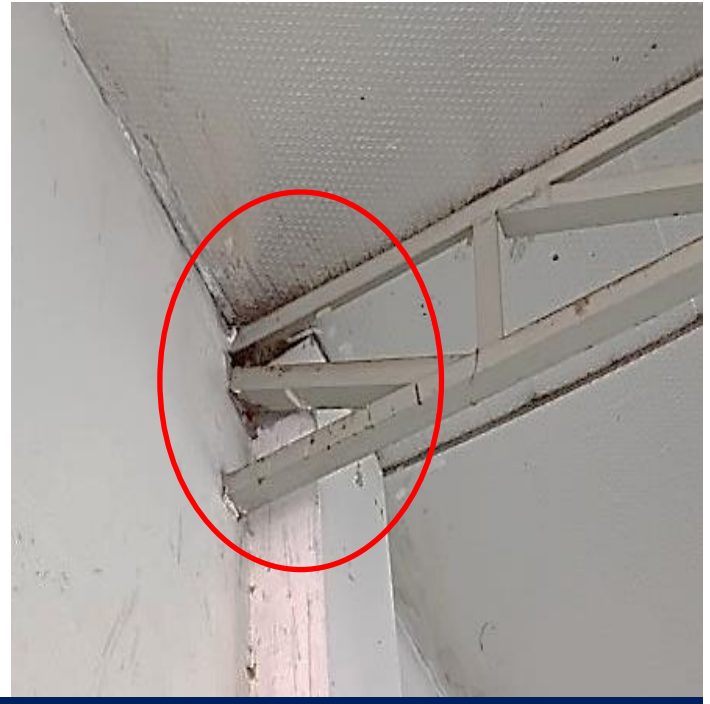
Roof truss connected to brick wall

Roof truss was found connected to brick wall which appeared to be inadequate. The building engineer is required to check the connection adequacy and suggest necessary remedial actions.

| Item No. | Observation | Recommended Action Plan | Recommended Timeline |
|---|---|---|---|
| 60 | Apparently inadequate connection. (Shed-13: Acid Store) | The building engineer is required to check the member & connection adequacy and suggest necessary remedial actions | 6-weeks |
| 61 | Apparently inadequate connection. (Shed-13: Acid Store) | Carry out suggested remedial works where required | 6-months |

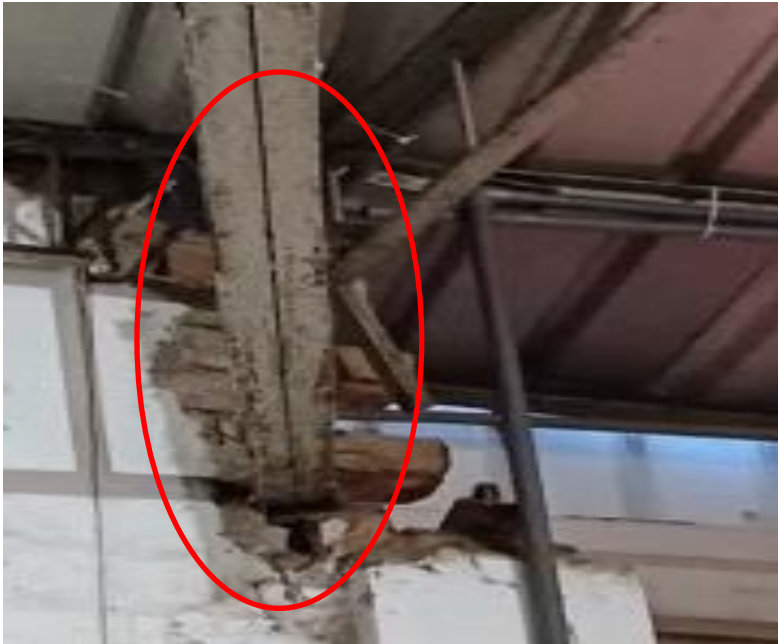
Truss is inserted to brick wall

Roof truss was found connected to brick wall which was appeared to be inadequate. Also, cut off truss member found in several locations. As part of Engineering Assessment (EA), the building engineer is required to check the connection system, prepare connection details, calculate the capacity of connections for lateral forces and suggest proper remedial actions accordingly.

| Item No. | Observation | Recommended Action Plan | Recommended Timeline |
|---|---|---|---|
| 64 | Apparently inadequate connection (Shed-14: Dyes Chemical Store) | As part of Engineering Assessment (EA), the building engineer is required to check the connection system, prepare connection details, calculate the capacity of connections for lateral forces and suggest proper remedial actions accordingly. | 6-weeks |
| 65 | Apparently inadequate connection (Shed-14: Dyes Chemical Store) | Carry out suggested remedial works as per EA. | 6-months |

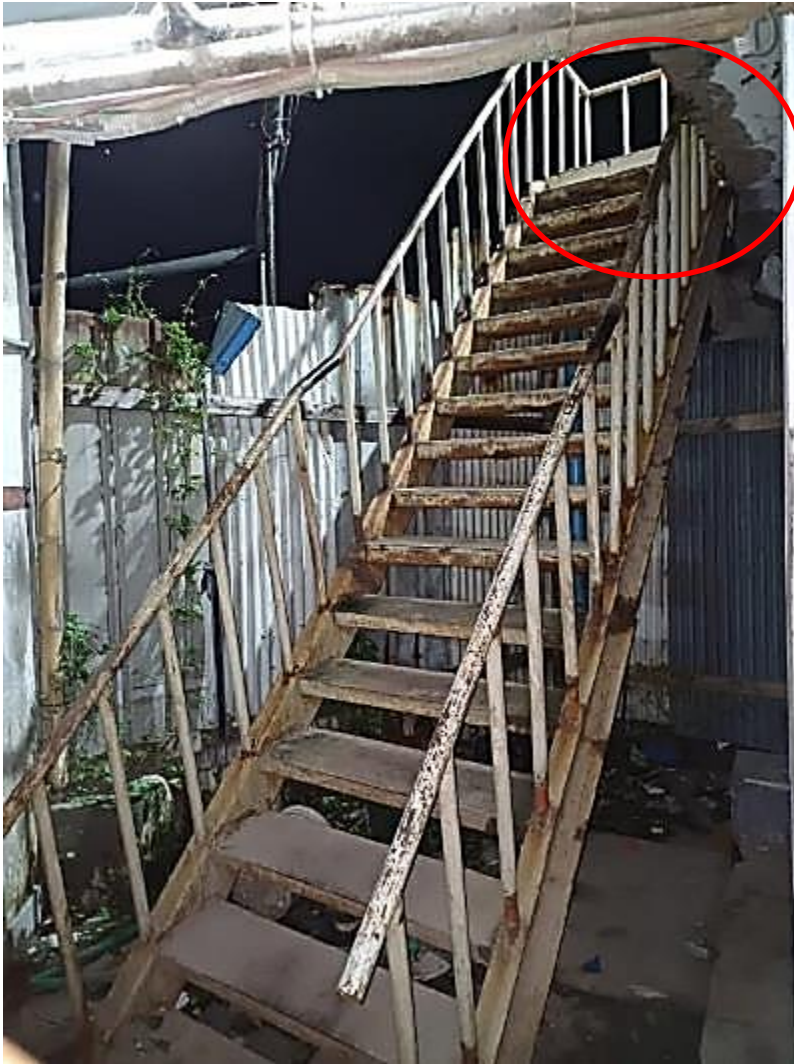
Connection of steel stair & RC slab was appeared to be inadequate.

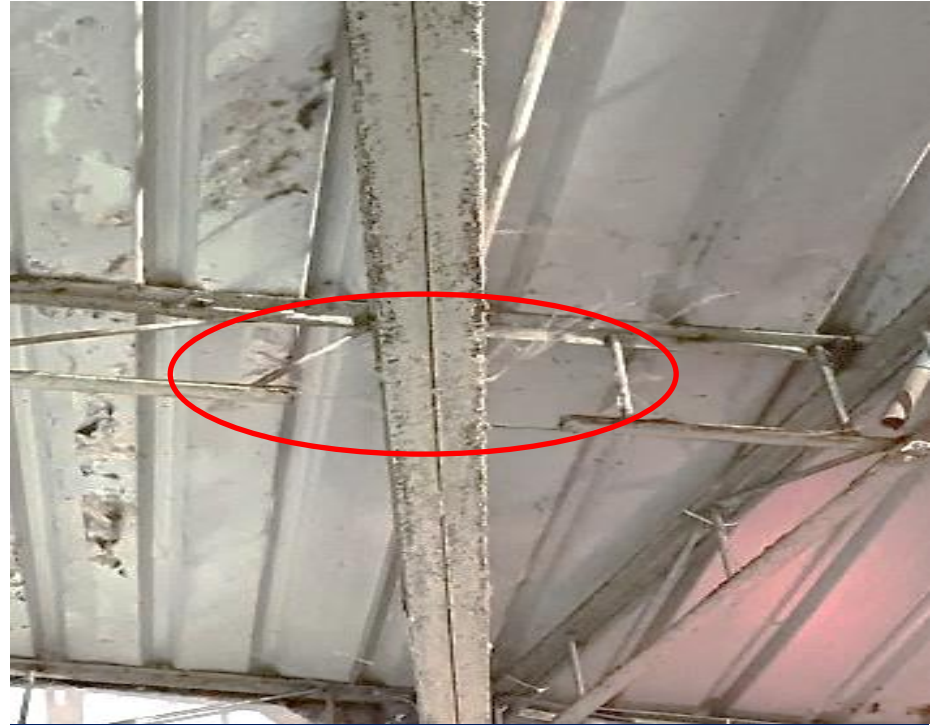
Cut off bottom truss member at several location

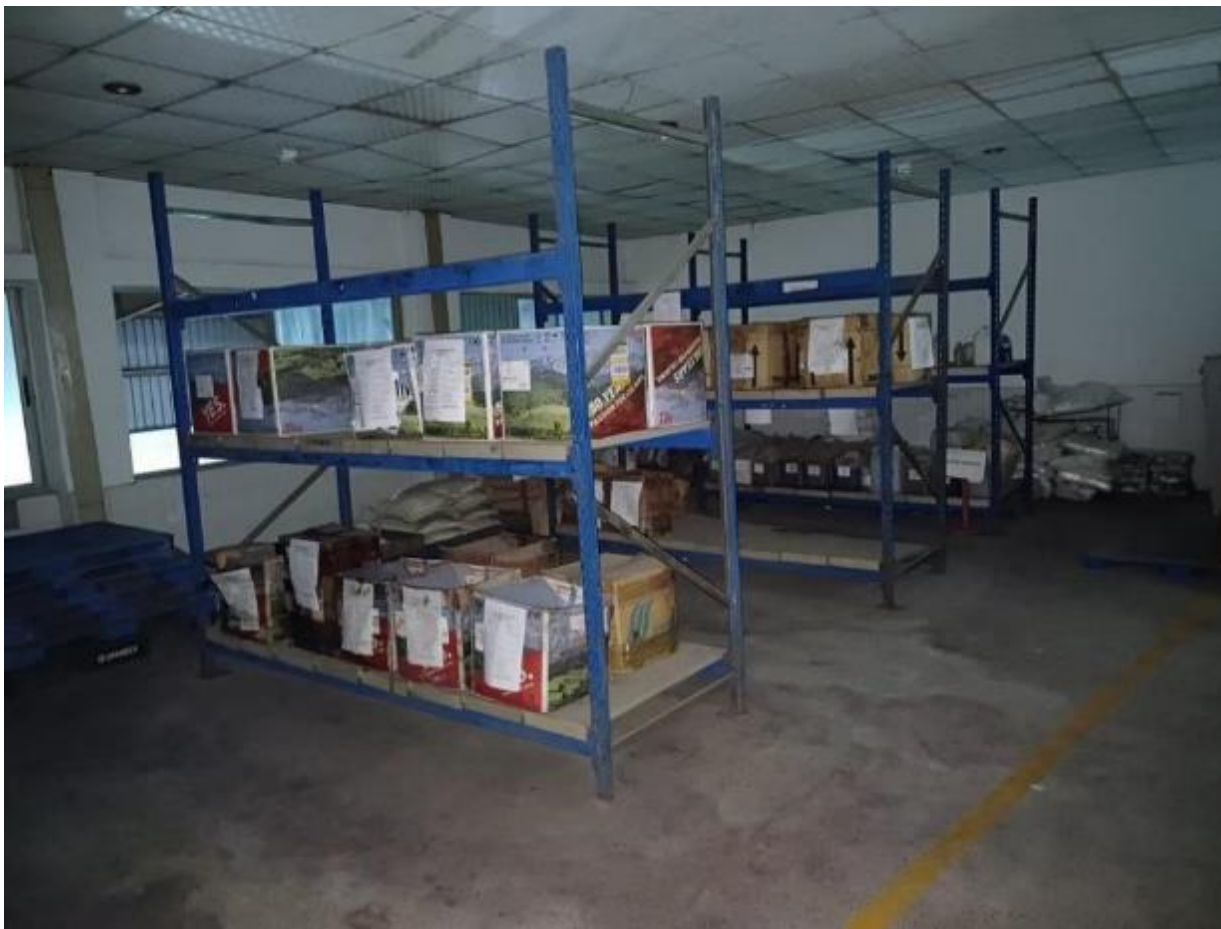
Storage rack found within the building without braced/anchored

All non-structural elements including storage racks in the building shall be adequately anchored or braced to resist earthquake forces.

| Item No. | Observation | Recommended Action Plan | Recommended Timeline |
|---|---|---|---|
| 68 | Non-structural elements found unbraced and not anchored (Shed-14: Dyes Chemical Store) | All non-structural elements including storage racks in the building shall be adequately anchored or braced to resist earthquake forces. | 6-months |

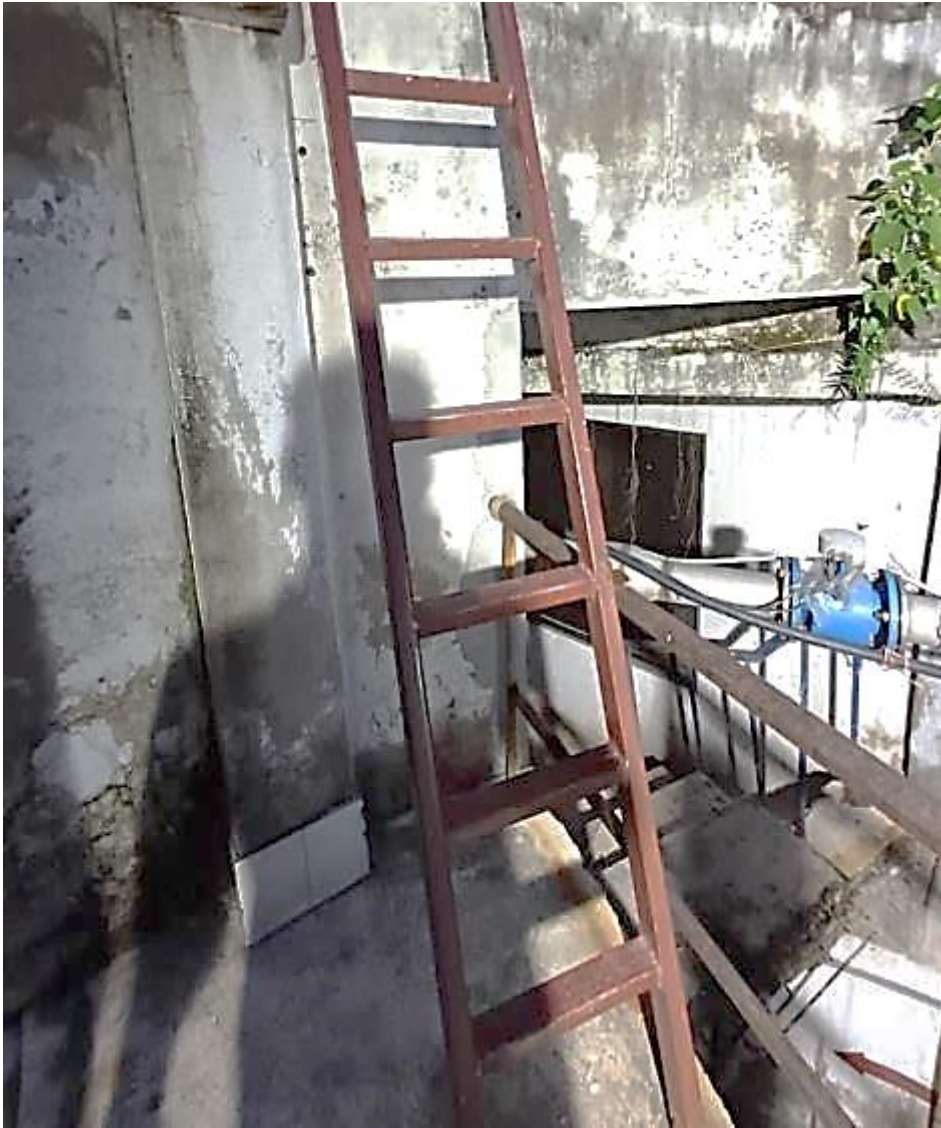
Dampness and vegetation were observed on the mezzanine level. Factory is required to repair the dampness.

Dampness and vegetation on exterior wall

| Item No. | Observation | Recommended Action Plan | Recommended Timeline |
|---|---|---|---|
| 69 | Dampness and vegetation on mezzanine level (Shed-14: Dyes Chemical Store) | Factory is required to clean the vegetation and repair the dampness. | 6-weeks |

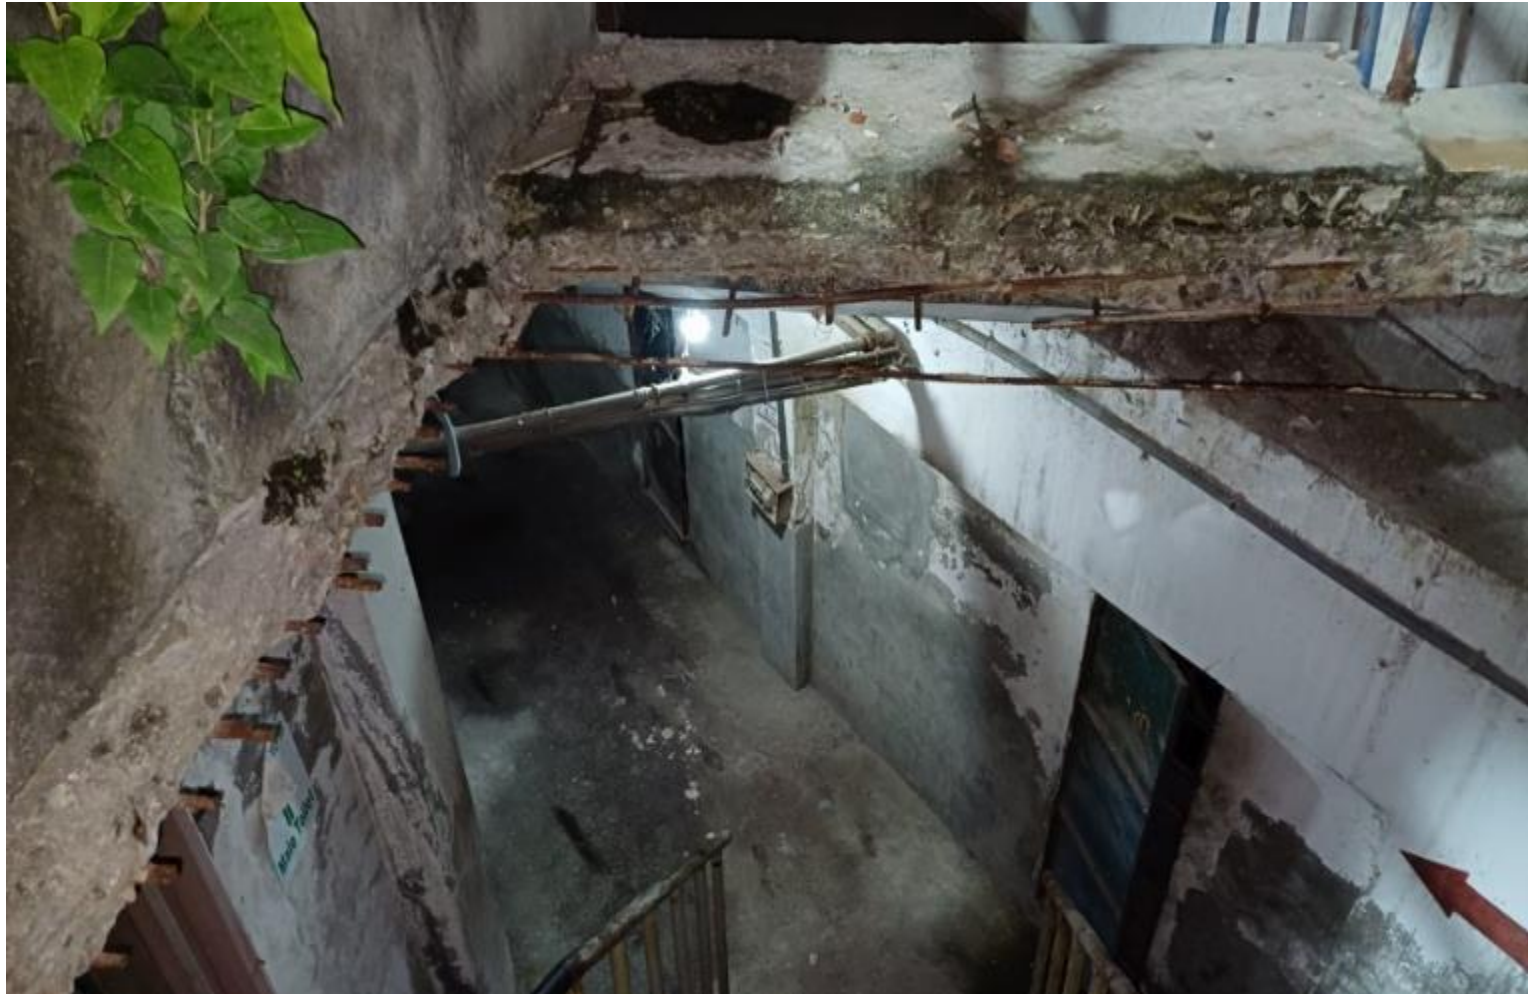
Exposed reinforcement left at mezzanine level

Exposed reinforcement is left which was prone to corrosion. Factory is required to provide rust proof paint on exposed reinforcement to protect from corrosion.

| Item No. | Observation | Recommended Action Plan | Recommended Timeline |
|---|---|---|---|
| 70 | Exposed reinforcement left at mezzanine level. (Shed-14: Dyes Chemical Store) | Factory is required to provide rust proof paint on exposed reinforcement to protect the rebar from corrosion | 6-months |

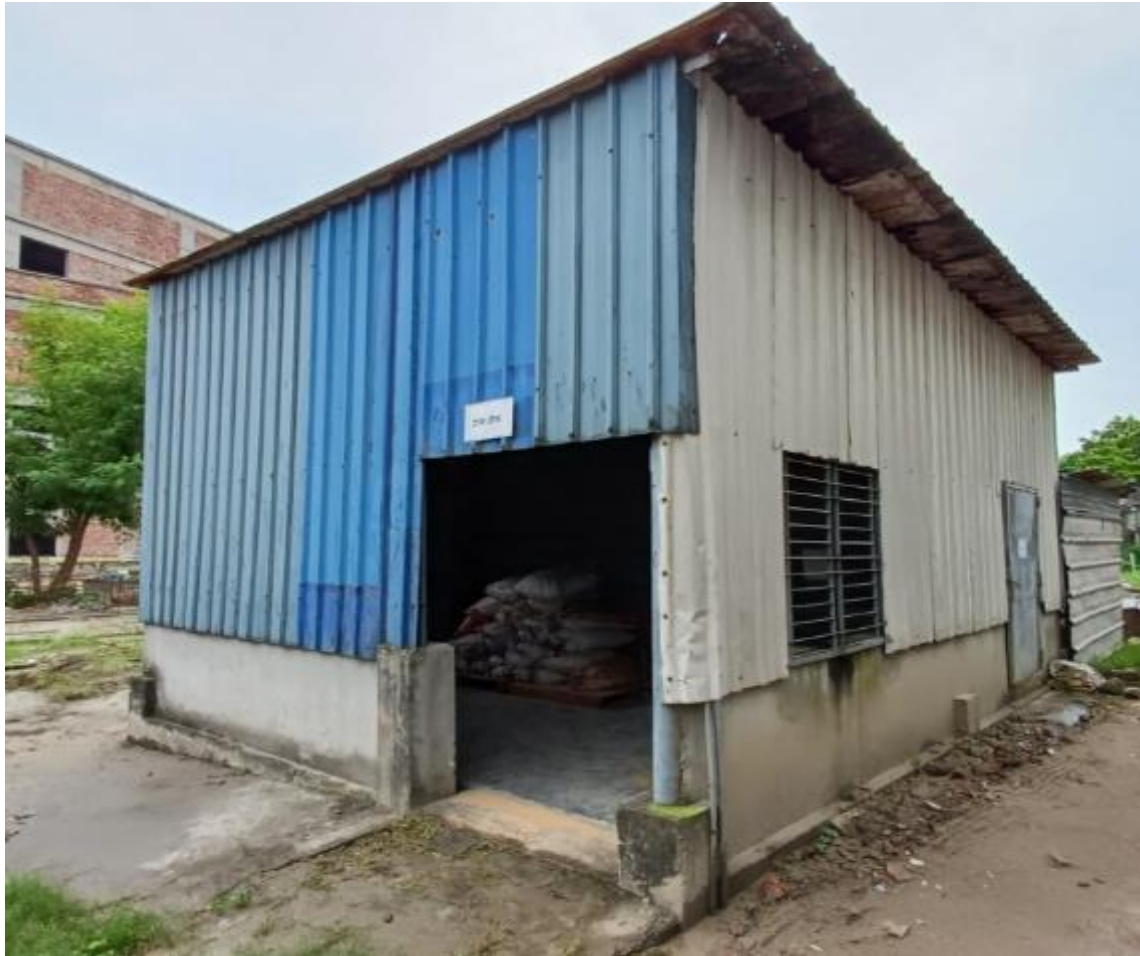
Shed-15

## **Lack of as-built drawing**

As-built drawing was not found on-site which is required to be prepared.

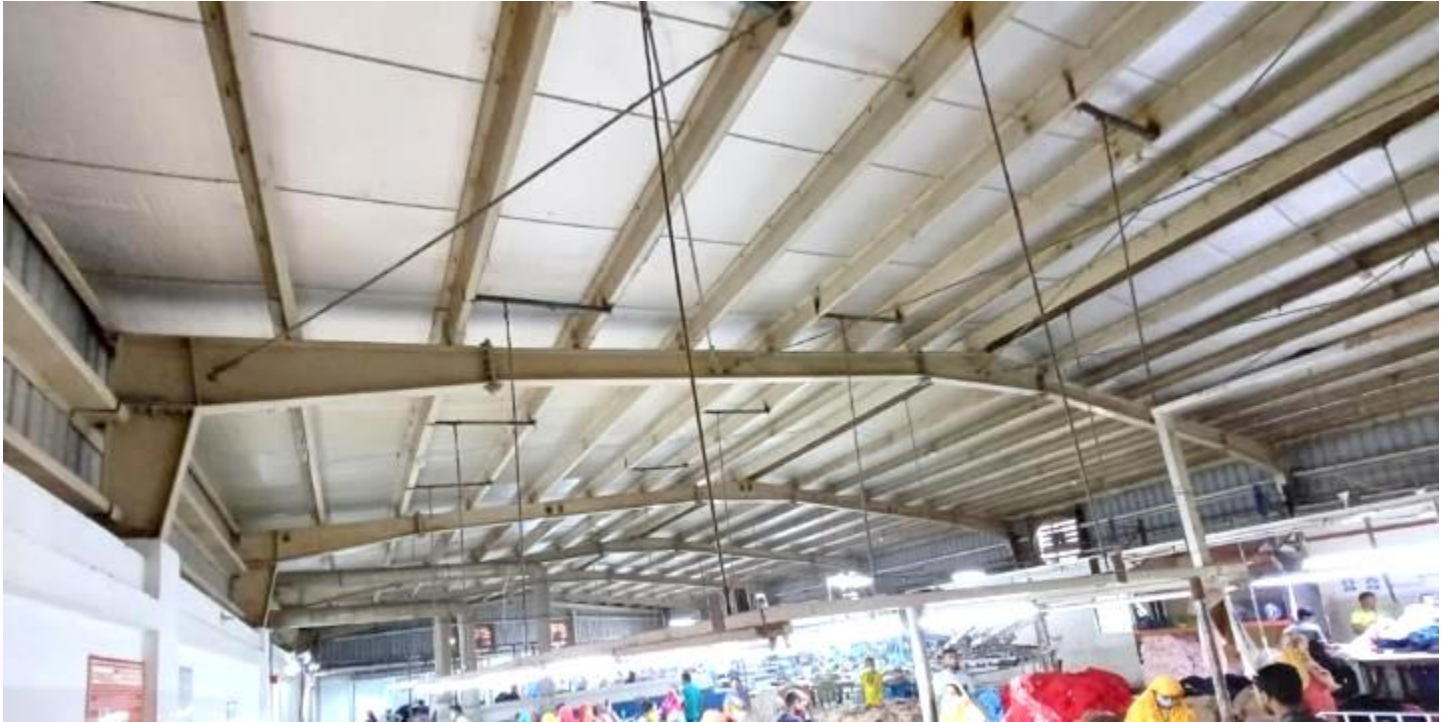
Absence of lateral load transfer media along transverse direction of rafter

Compression strut was not provided to transfer the lateral loads. The building engineer is required to carryout Engineering Assessment (EA) to check the lateral stability of the structure and suggest proper remedial actions accordingly.
