# Fakir Knitwears Ltd. (Extension)

Kayempur, Fatullah, Narayanganj

22 August 2023

# Observations

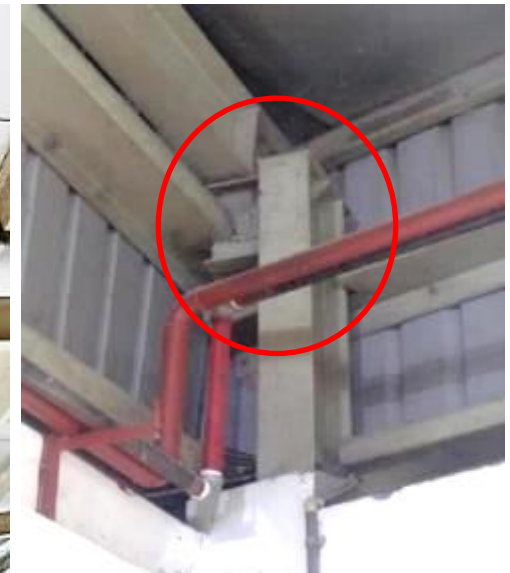
Offset of connection

The bracing is not connected to column-rafter joints. Besides, offset observed in connection. Also, large gap between connection plates were observed. The building engineer is required to fill the gap with appropriate method; check the connections system and incorporate the adequacy check in the design report.

| Item No. | Observation | Recommended Action Plan | Recommended Timeline |
|---|---|---|---|
| 74 | Improper connections<br>(Shed-16: Printing Shed) | The building engineer is required to fill the gap with appropriate method. | 6-weeks |

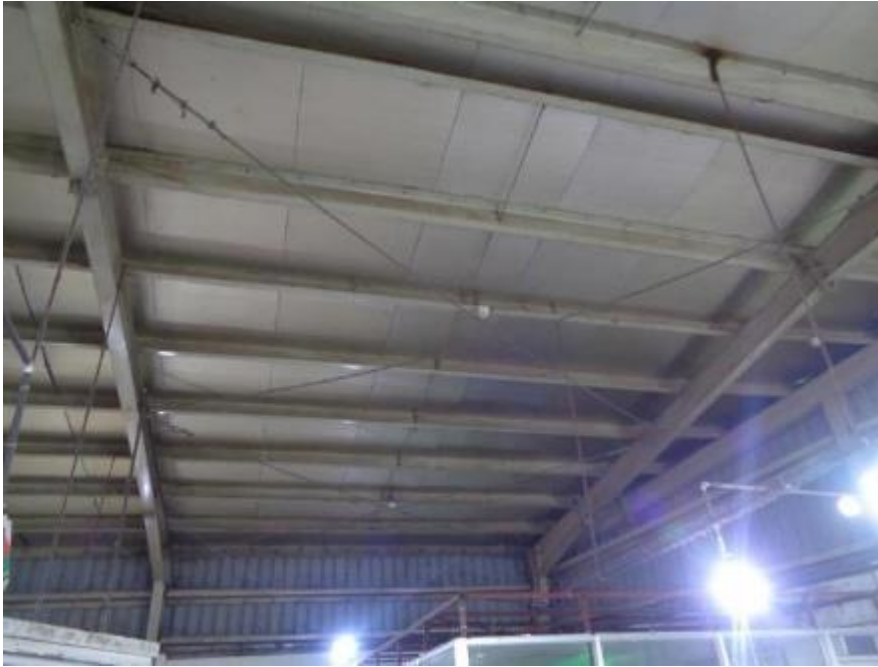
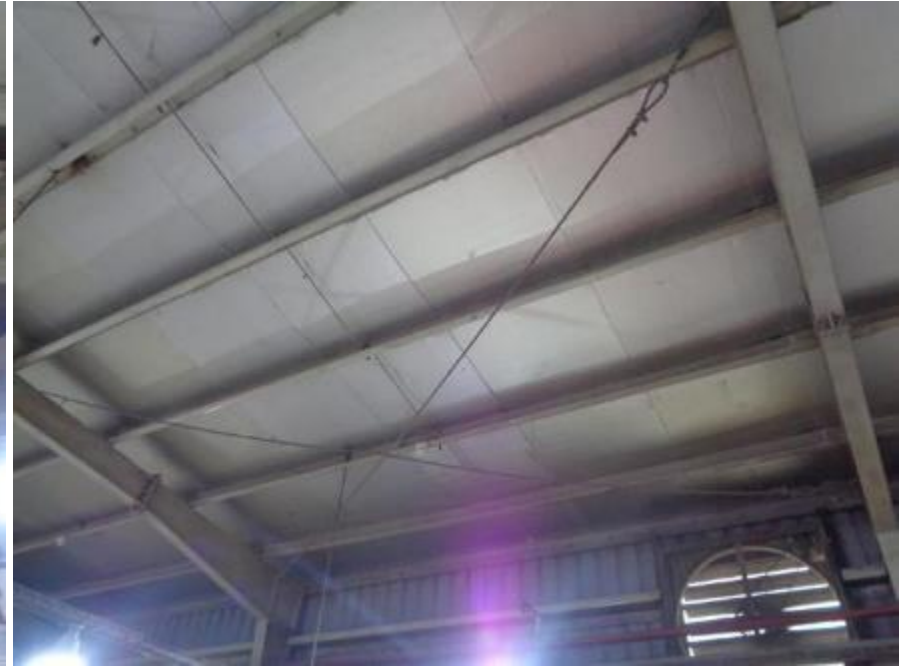
Loose cable bracing

Loose cable bracing was observed at several locations. The factory is required to identify the location and tighten the loose cable bracings.

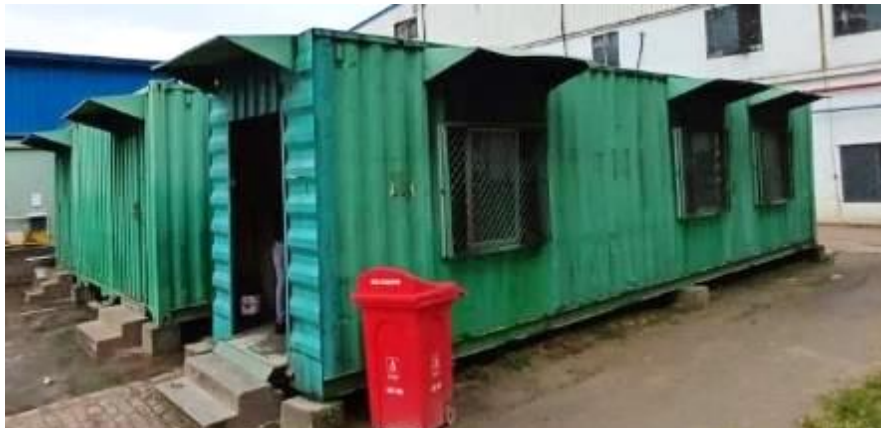
Lack ground anchorage and foundation system observed for ancillary 2, 3, 4, 5 & 6. The building engineer is required to check the stability of container sheds for uplift and lateral forces and suggest necessary alternatives accordingly.

Lack ground anchorage and foundation system for ancillary 2 & 3 (Canteen & Smoke Shed)

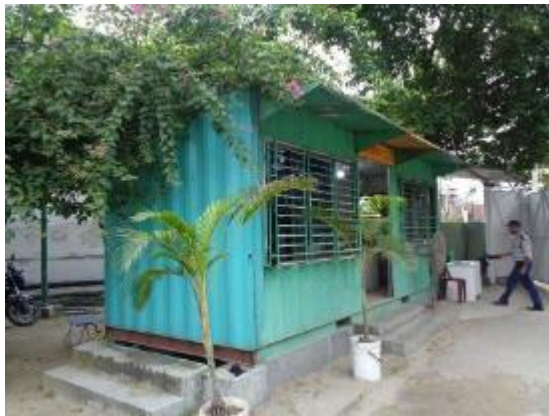
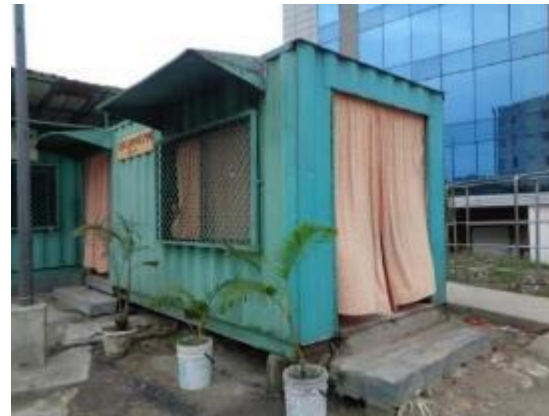
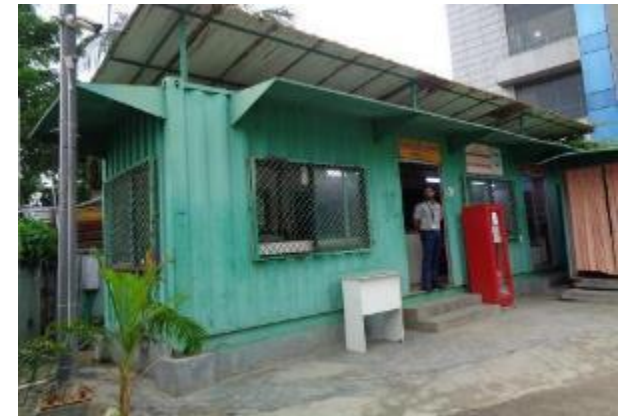
Lack ground anchorage and foundation system for ancillary 4, 5 & 6 (General Security Post, Female Security Post and Container Security Office at main gate)

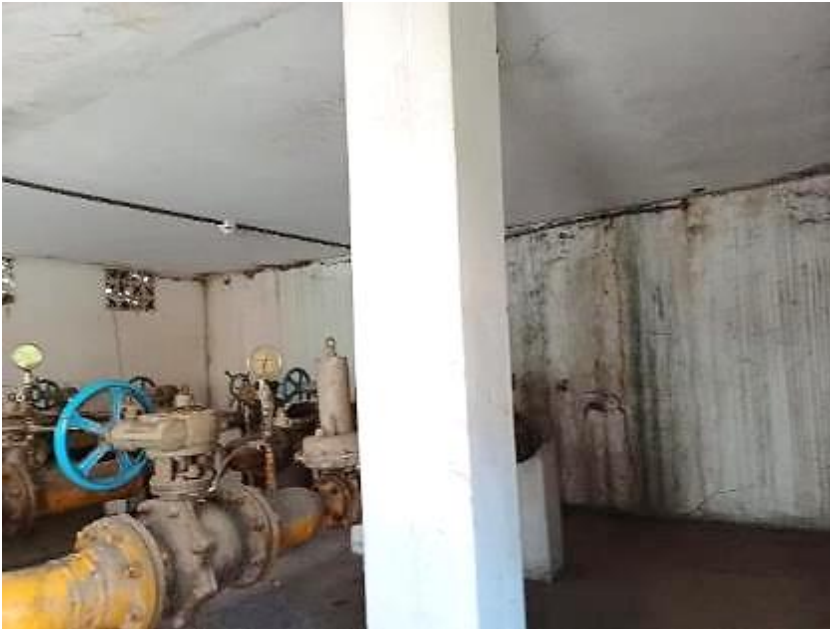
Dampness on wall and roof slab

The building engineer is required to identify the source of dampness on wall & roof slab; find the reason of crack on brick wall and carry out suitable repair works accordingly.

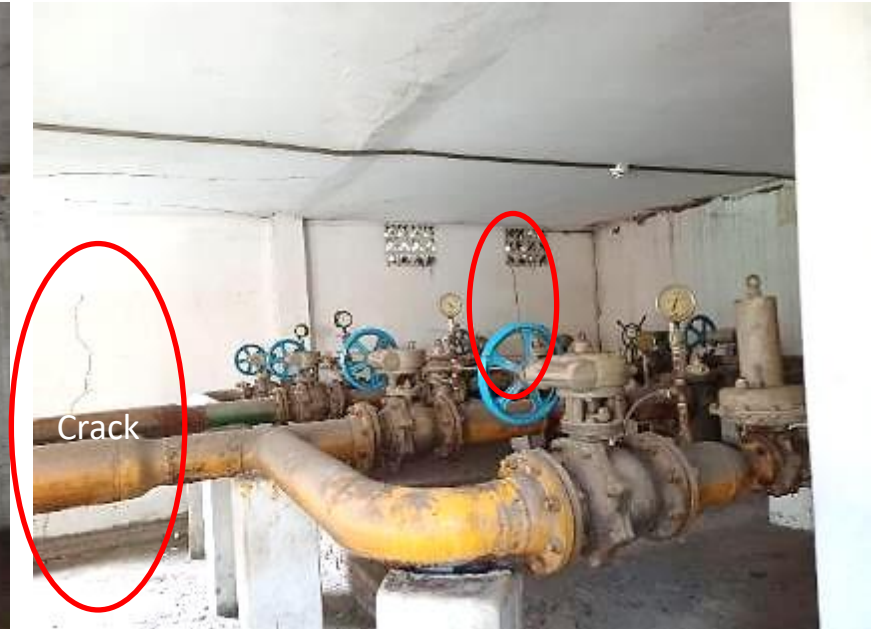
Crack on brick wall
