# Powertex Fashions Ltd (Extension)

Dr. Panjabali- Dr. Assaduzzaman Industrial Park, Kathora, National University, Gazipur

21 August 2023

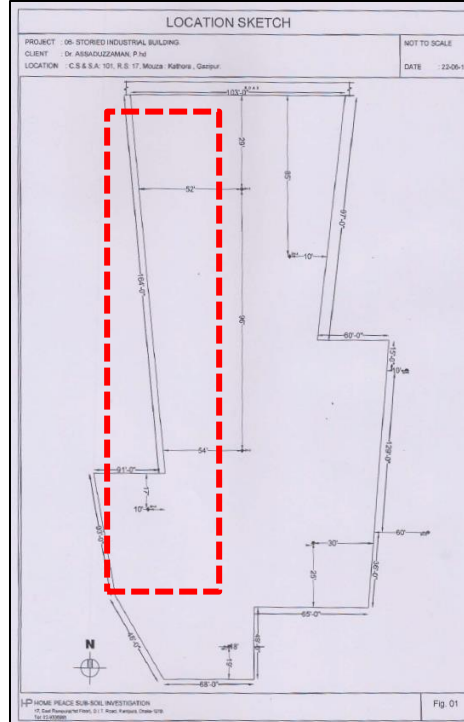
Bore hole layout and approximate Building-2 location (marked)

In EA report, the of footing capacity has been shown more than FoS-2.5 considering allowable bearing capacity 1.52 tsf (FoS-3) for BH-01. But the BH-01 is far away from the building-2 where the BH-03 & BH-07 are nearer to Building-2. Considering the allowable bearing capacity 0.849 tsf (FoS-3) for BH-03 & BH-07, the footing capacity was found marginally overstressed for few footings. Factory engineer is required to revise the EA considering actual bearing capacity of soil and suggest the factory for remedial works if required.

| Item No. | Observation | Recommended Action Plan | Recommended Timeline |
|---|---|---|---|
| 01 | Foundation found marginally overstressed (Building-02) | Building engineer is required to review the design load and adequacy of the foundations and suggest necessary remedial actions accordingly. | 6-weeks |

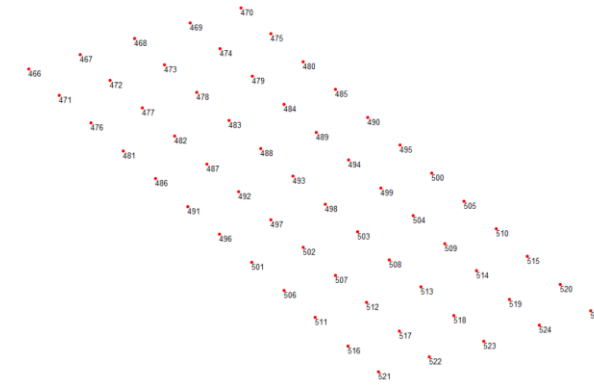
Allowable bearing capacity has been considered 1.52 tsf with FoS-3 at 5ft depth for BH-01.

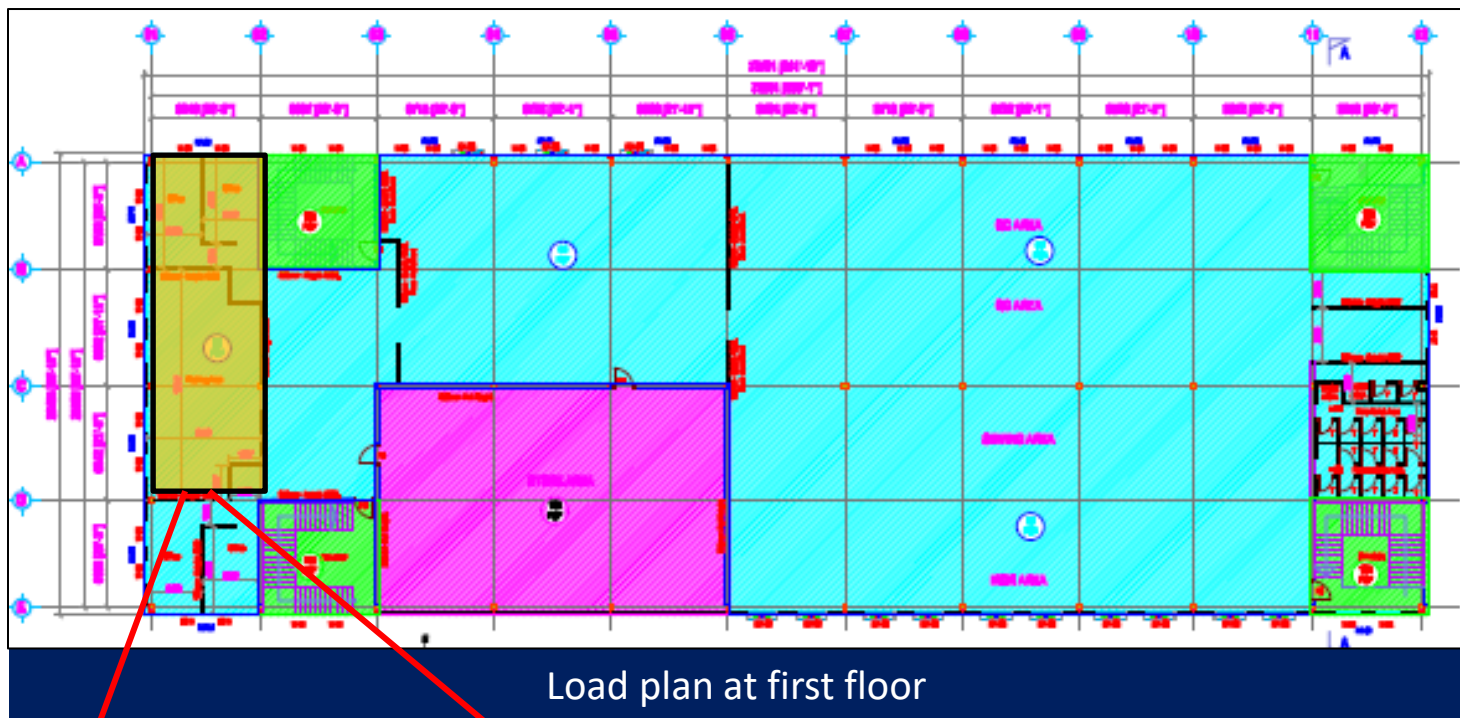
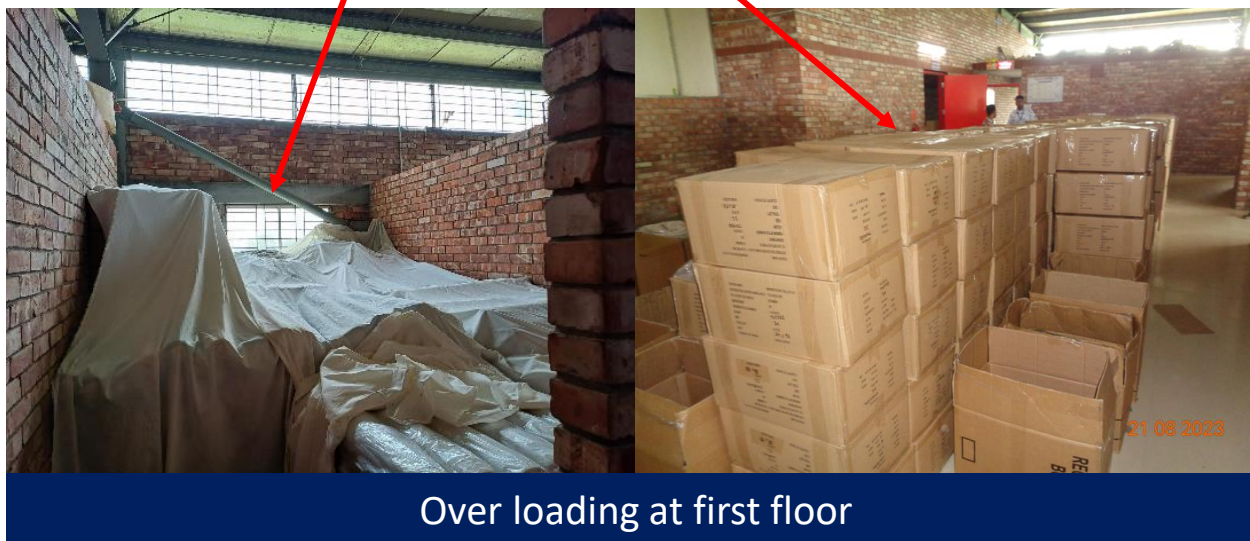
In the load plan 3kPa floor loading has been considered. During inspection, storage was found in the marked location. Building Engineer is required to implement the floor load management system.

| Item No. | Observation | Recommended Action Plan | Recommended Timeline |
|---|---|---|---|
| 03 | Floor loading mismatch with load plan (Building 02) | Building Engineer is required to update the load plan as per BNBC. | 6-weeks |
| 04 | Floor loading mismatch with load plan (Building 02) | Implement the floor loading plan. | 6-weeks |

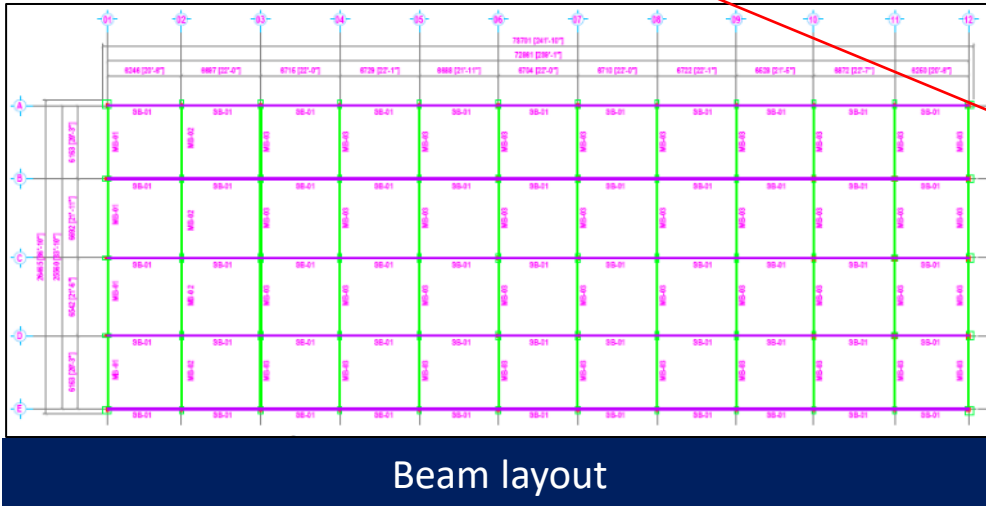
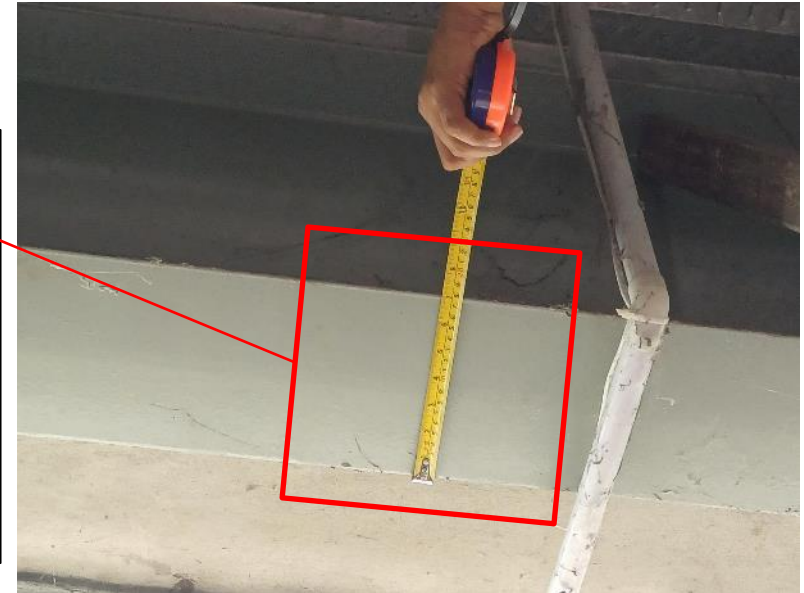
Flange width of MB-01 beam was found 175 mm instead of 200 mm

Mismatch found in steel beam size. Building Engineer is required to survey the structure and update the as-built drawings. Revise the assessment as per the updated as-built drawing.

| Item No. | Observation | Recommended Action Plan | Recommended Timeline |
|---|---|---|---|
| 05 | Discrepancy between as-built drawing & site condition (Building 02) | Building Engineer is required to survey the whole structure and prepare accurate as-built drawing. | 6-weeks |

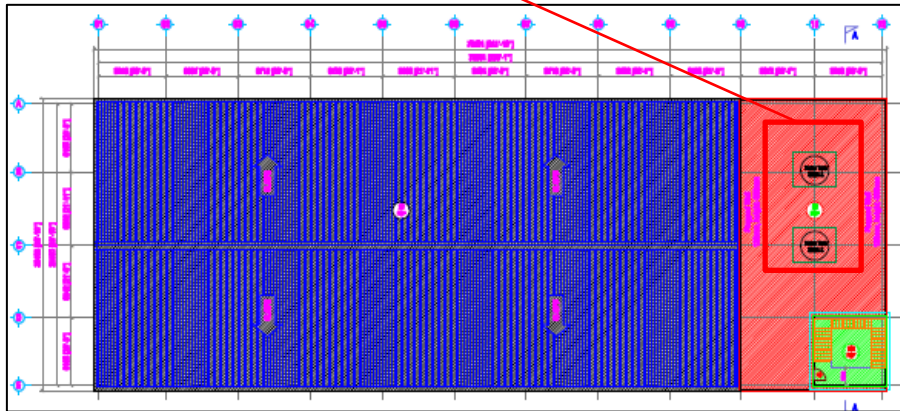
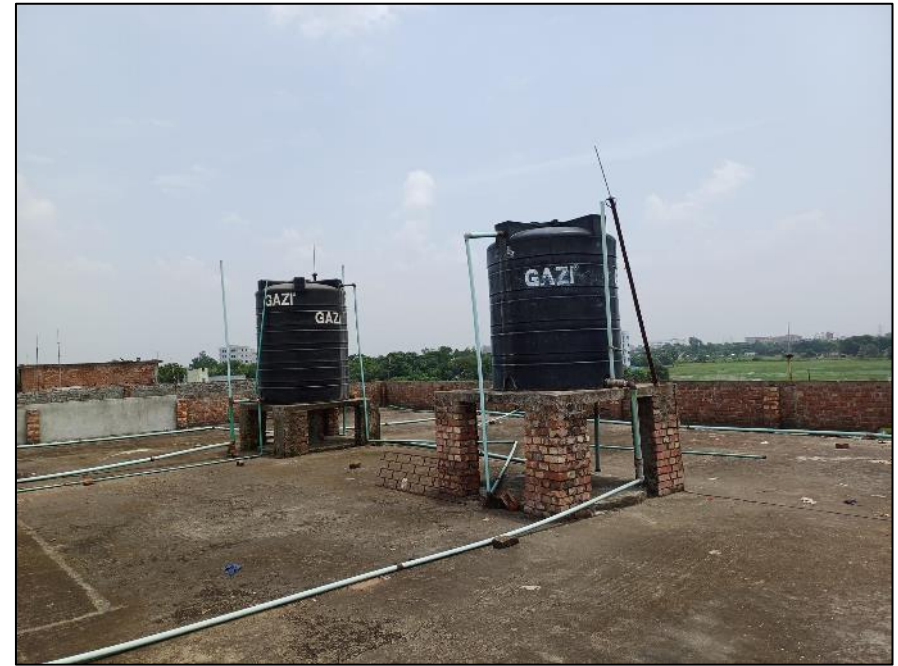
3000L & 5000L Water Tank

As built architectural drawings and roof live load layout plan is showing two 3000L PVC water tank. During inspection, one 5000L PVC water Tank and one 3000L PVC water tank was found. Building Engineer is required to revise the architectural drawings & check the capacity of structure according to existing water tank loading.

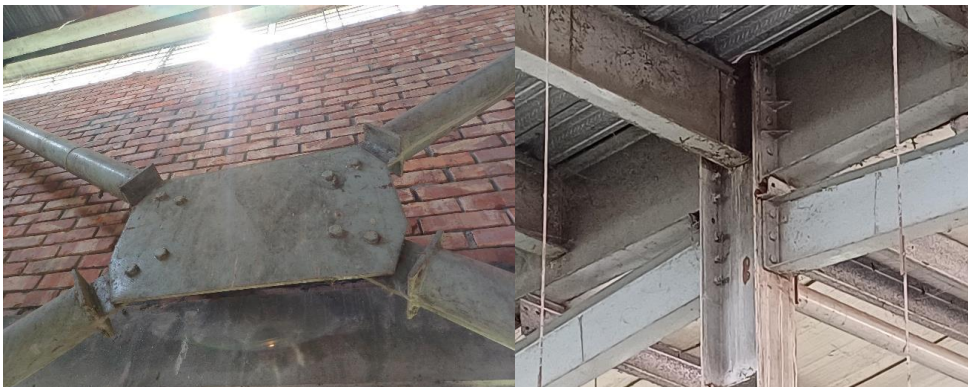
Bracing Connection and Column & Beam connection

Connection details was found missing in the drawings. Building Engineer is required to include connection details in as built drawings and provide all types of connection adequacy check in EA report.

| Item No. | Observation | Recommended Action Plan | Recommended Timeline |
|---|---|---|---|
| 07 | Discrepancy between as-built drawing & site condition (Building 02) | Building Engineer is required to include all the connection adequacy check in EA report. | 6-weeks |

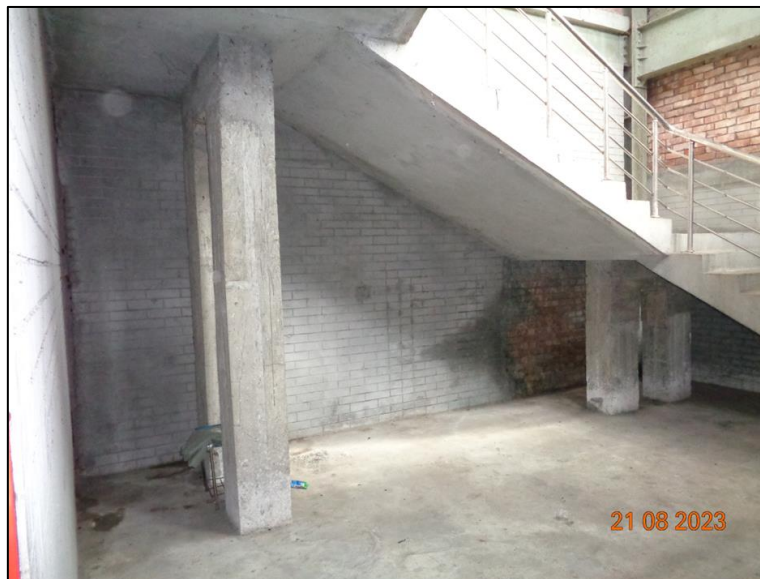
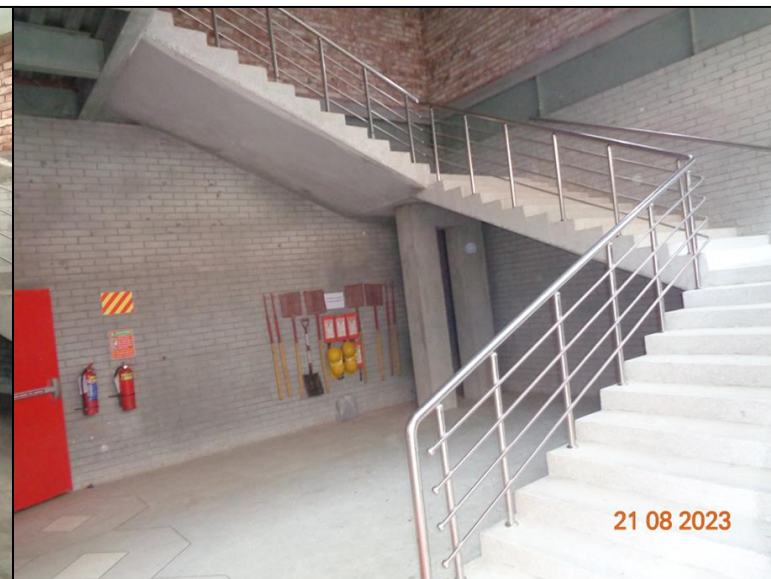
The details of the stairs were not available in as-built drawing. Building Engineer is required to survey the structure and update the as-built drawing. Also, Building Engineer is required to provide the adequacy check for the stairs.

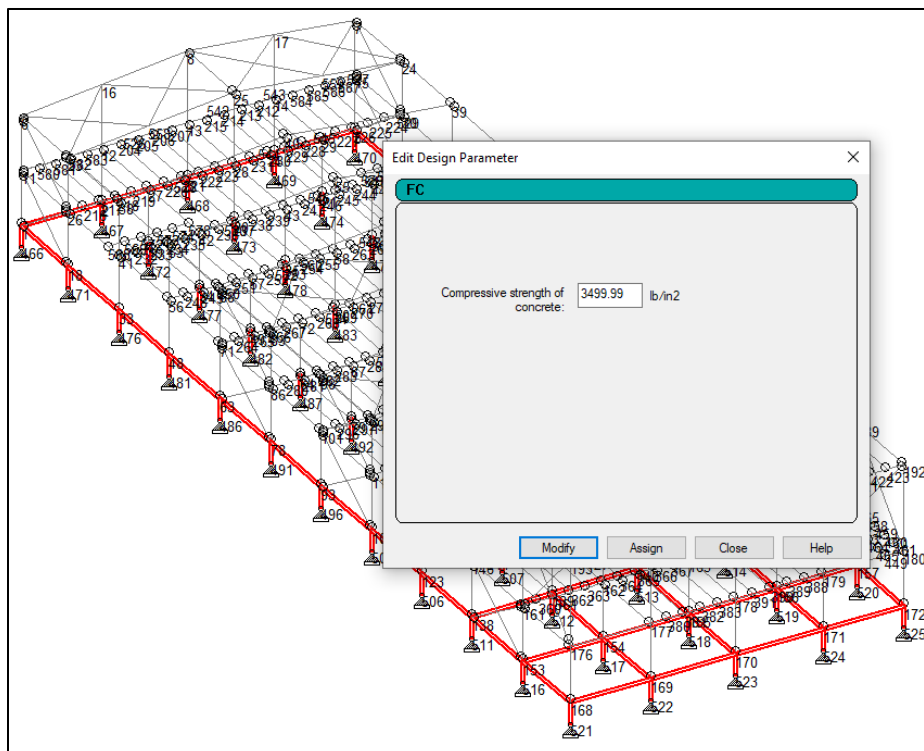
Concrete strength has been considered 3.5 ksi in FEA model and general note of the construction drawing

The concrete strength has been considered 3.5 ksi but no credible test report was available to support the concrete strength value. Factory engineer is required avail the proper documents to support the considered concrete strength or provide concrete core test report to check the in-situ concrete strength. Factory engineer is required to suggest the factory authority for the remedial works if required.

| Item No. | Observation | Recommended Action Plan | Recommended Timeline |
|---|---|---|---|
| 09 | Engineering assessment (EA) needs to revise (Building-02) | Provide creditable material test report or Verify in-situ concrete stresses by 100mm dia. cores from minimum of 4 columns. Revise the Engineering assessment (EA) and submit to RSC | 6-weeks |

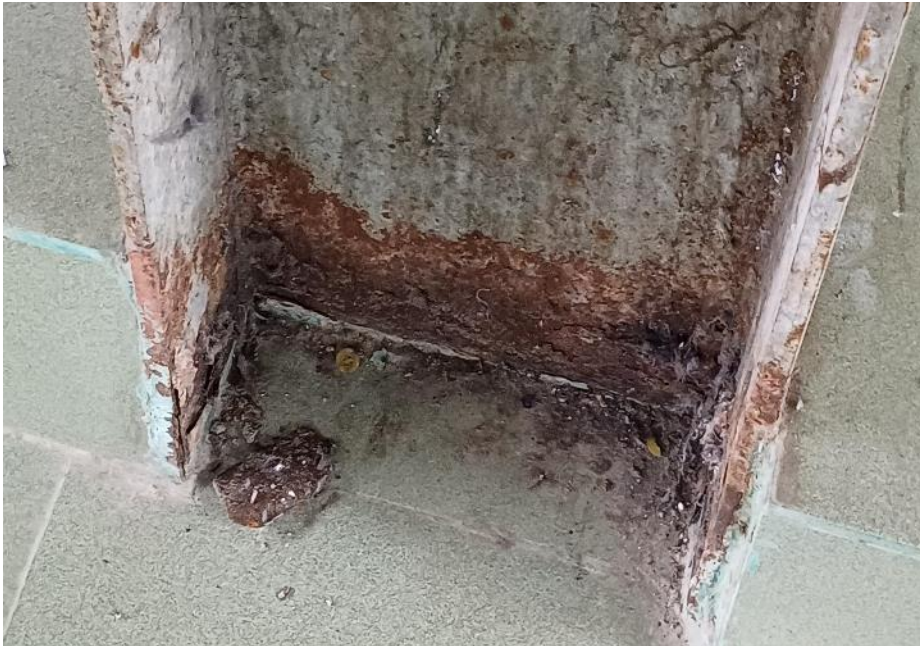
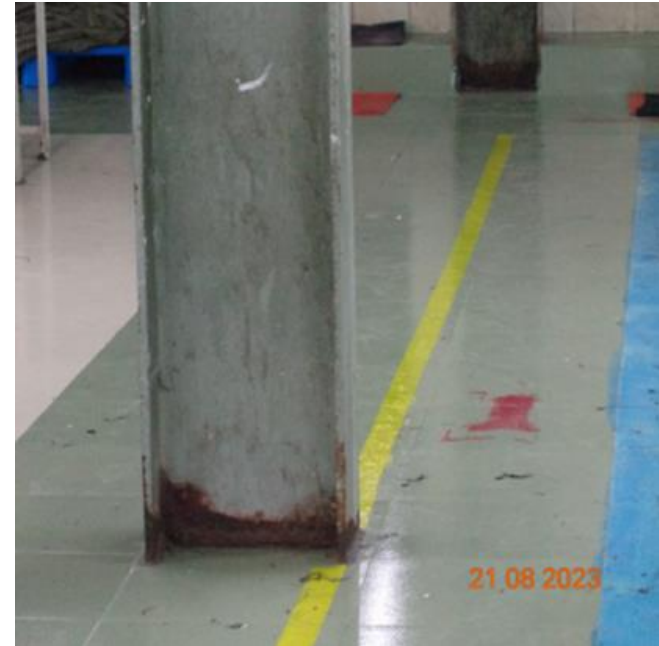
Corrosion in steel member

Corrosion in steel member is found during inspection. Factory is required to identify all corroded member, repair the corrosion and apply suitable anti-corrosive coating to prevent further corrosion in steel members.

| Item No. | Observation | Recommended Action Plan | Recommended Timeline |
|---|---|---|---|
| 12 | Corrosion in steel column (Building 02) | Building Engineer is required to repair the corrosion and take necessary measures to prevent further corrosion in steel members. | 6-weeks |

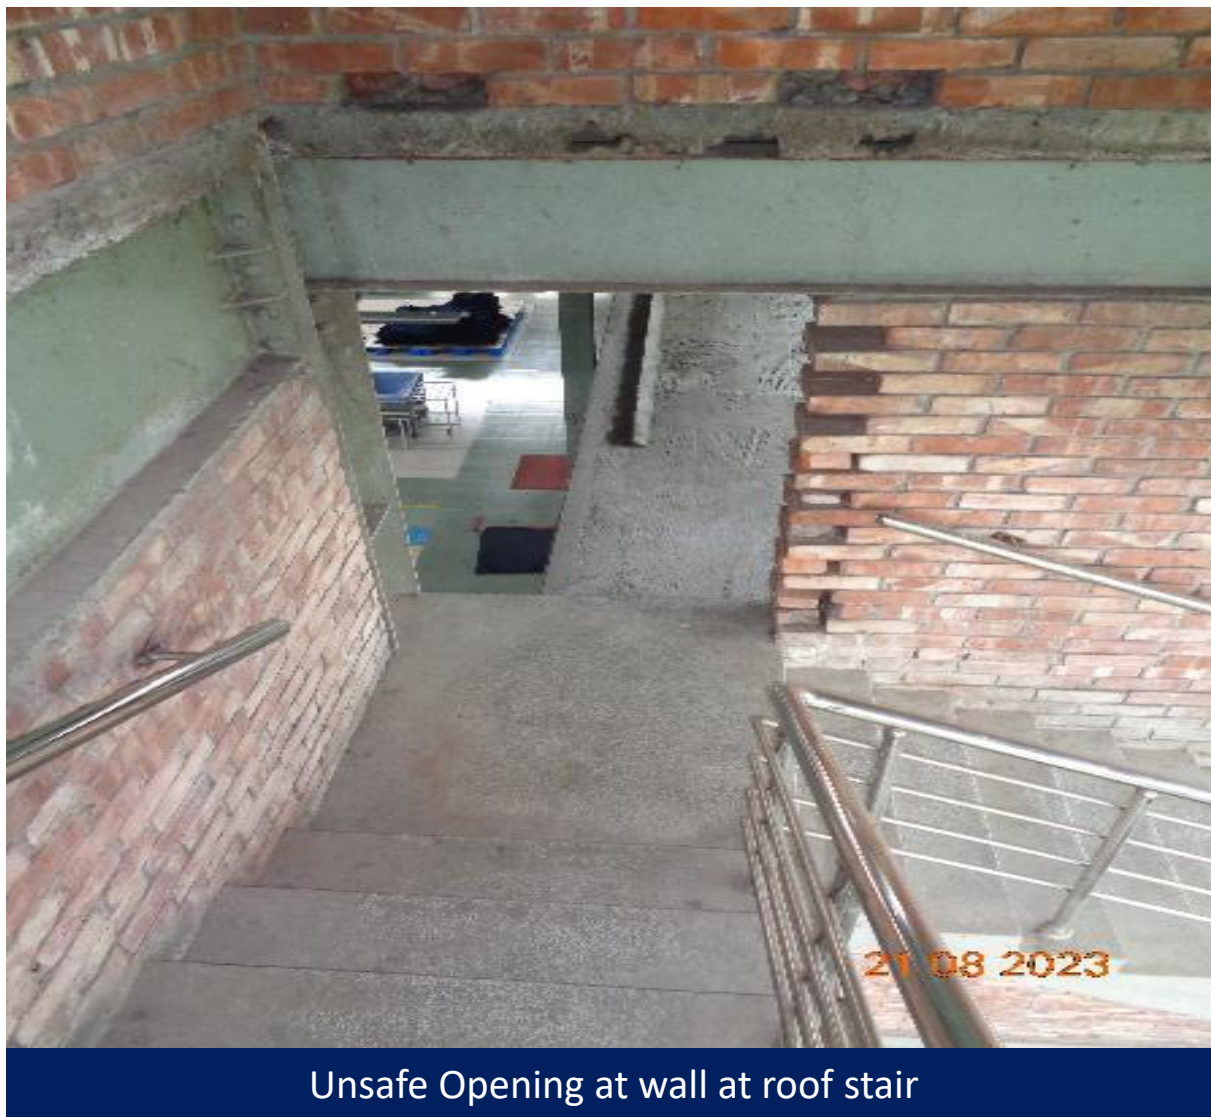
Unsafe Opening at wall at roof stair

During inspection, an unsafe opening of wall was observed at intermediate landing of roof stair. Building Engineer is required to take adequate measures for safe access to the stair.

| Item No. | Observation | Recommended Action Plan | Recommended Timeline |
|---|---|---|---|
| 13 | Falling hazard due to opening at wall (Building 02) | Building engineer is required to provide barrier to prevent falling hazard. | 6-weeks |

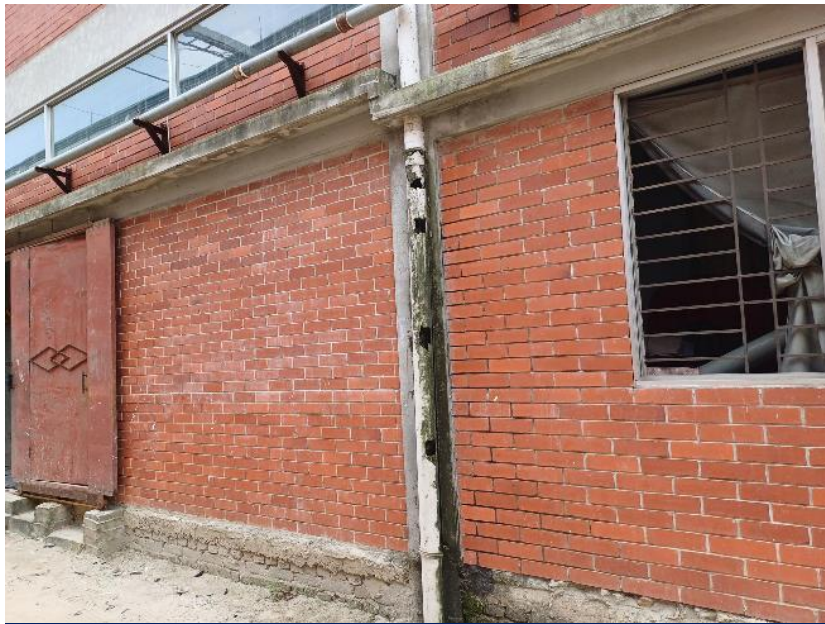
Dampness in column and grade beam due to broken PVC pipe

Building engineer is required to take adequate remedial measures to prevent column and beam from dampness and vegetation.

| Item No. | Observation | Recommended Action Plan | Recommended Timeline |
|---|---|---|---|
| 14 | Dampness & Water ponding (Building 02) | Building engineer is required to stop the source of moisture and suggest proper remedial measures to repair dampness in the column and grade beam. | 6-weeks |

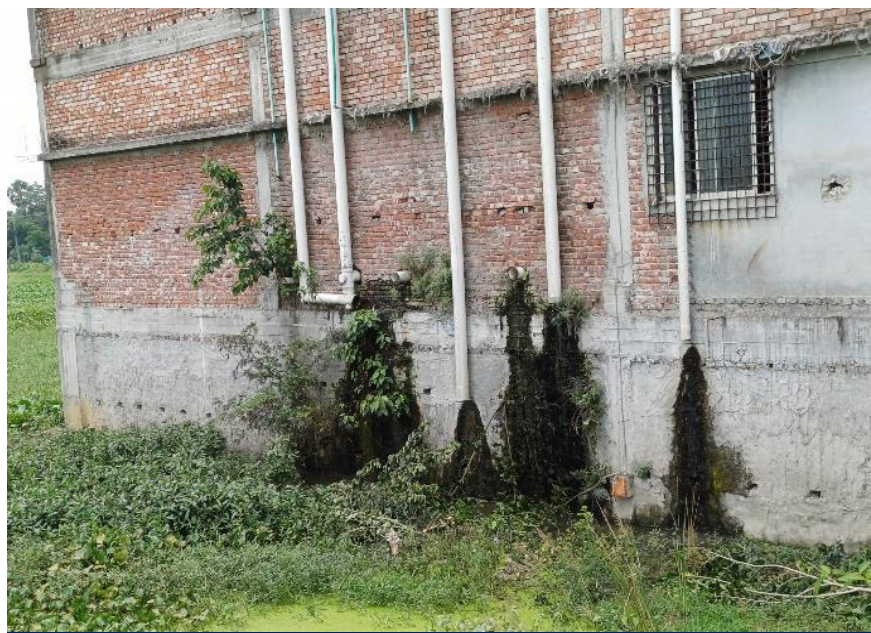
Vegetation on facade wall damp grade-beam due to exit of down pipe

| Item No. | Observation | Recommended Action Plan | Recommended Timeline |
|---|---|---|---|
| 15 | Dampness & Water ponding (Building 02) | Building engineer is required to take necessary measures to remove the vegetations from the facade wall. | 6-weeks |

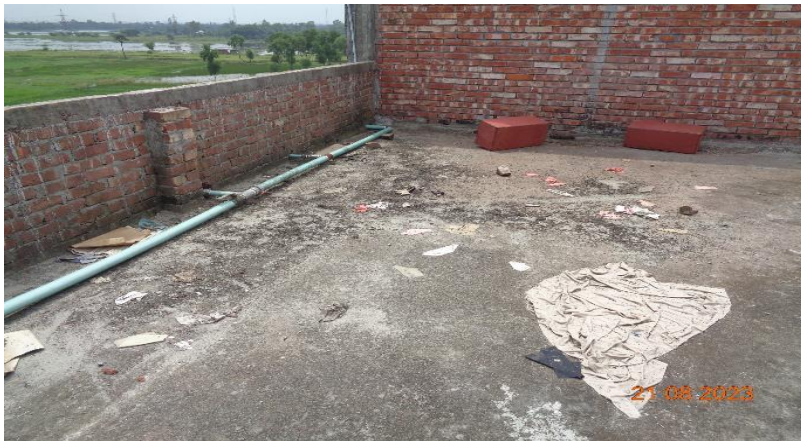
Water ponding signage at roof

Building engineer is required to provide adequate slope at roof to prevent water ponding and dampness.

| Item No. | Observation | Recommended Action Plan | Recommended Timeline |
|---|---|---|---|
| 16 | Dampness & Water ponding (Building 02) | Building engineer is required to provide adequate slope to prevent water ponding at roof. | 6-weeks |

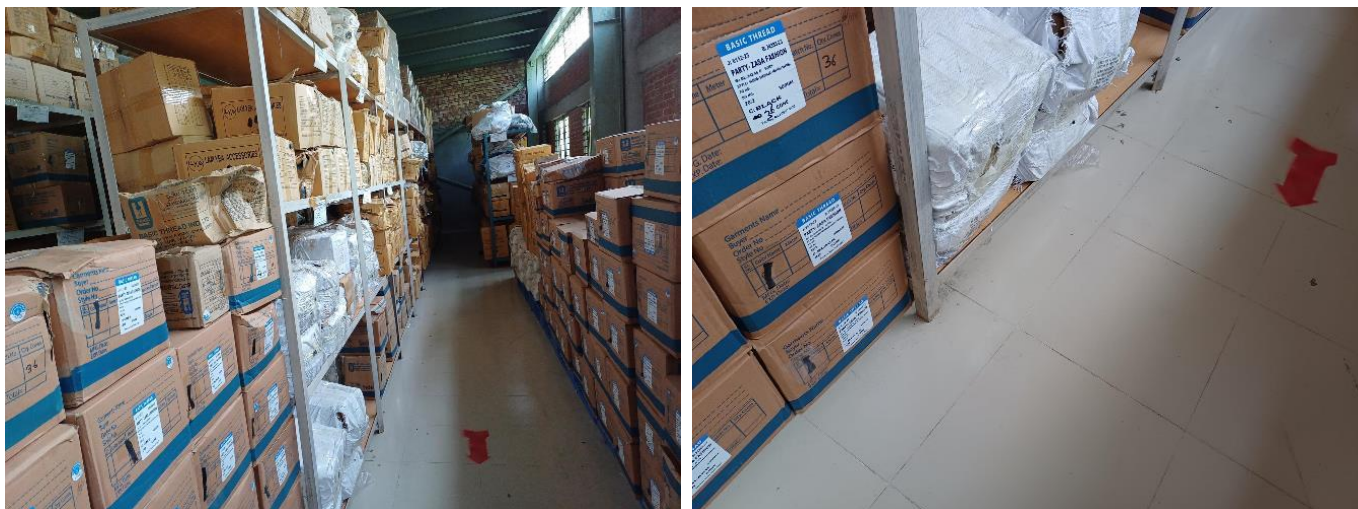
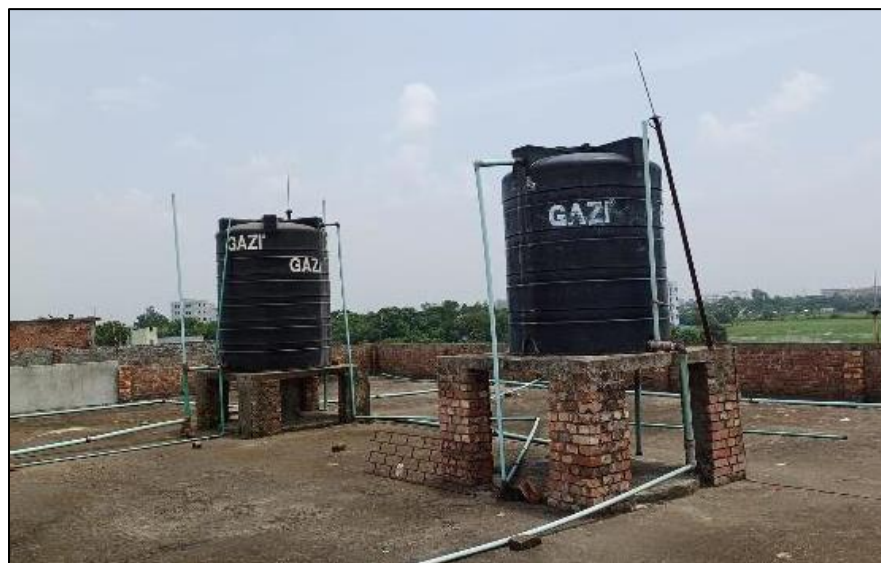
Steel racks without anchored/braced.

Building engineer is required to be provide adequate anchor/braced all non-structural elements to avoid falling hazard due to seismic events.

| Item No. | Observation | Recommended Action Plan | Recommended Timeline |
|---|---|---|---|
| 17 | Lack of anchorage of nonstructural elements (Building 02) | Building engineer is required to be provide adequate anchor/braced all non-structural elements to avoid falling hazard due to seismic event. | 6-weeks |

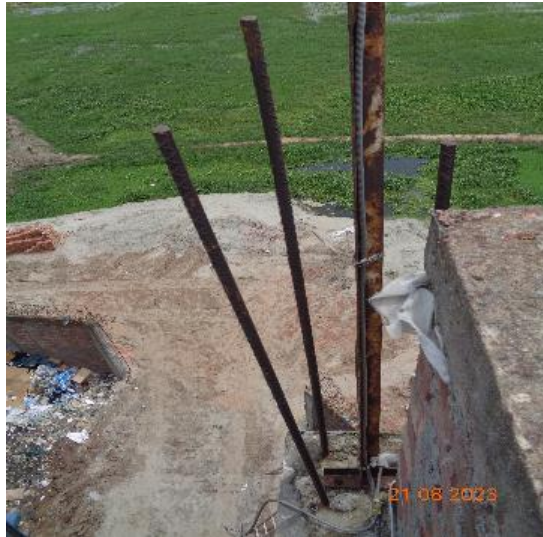
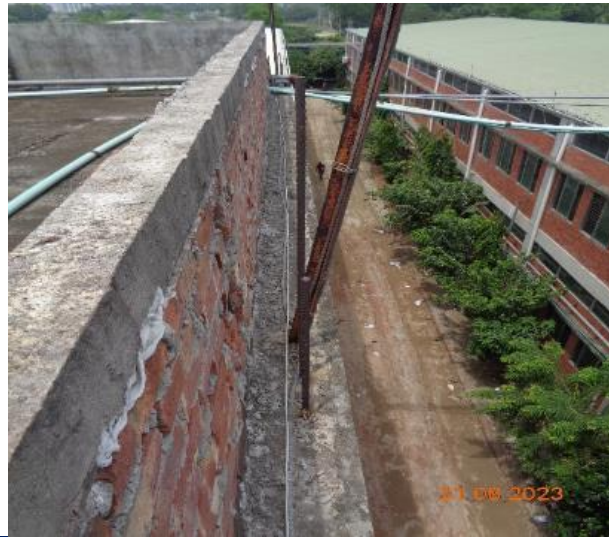
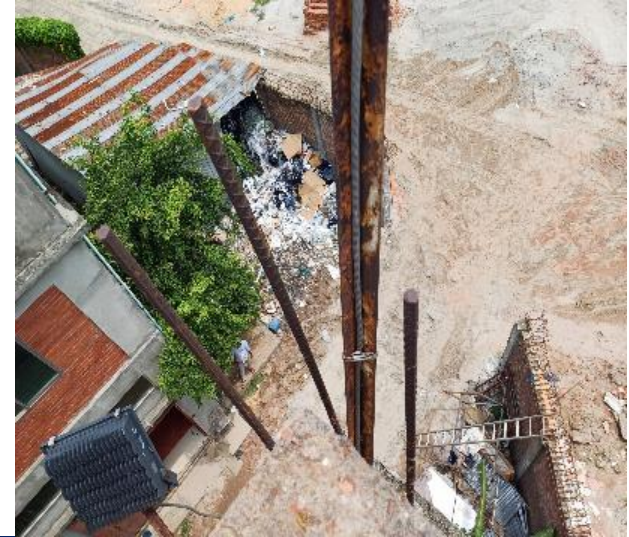
Exposed corroded rebar at roof

Building engineer is required to identify the exposed corroded rebar and take adequate measures to protect exposed rebar from corrosion.

| Item No. | Observation | Recommended Action Plan | Recommended Timeline |
|---|---|---|---|
| 18 | Exposed re-bar at roof (Building 02) | Building engineer is required to take necessary measures to repair the corrosion and measures to prevent further corrosion. | 6-weeks |

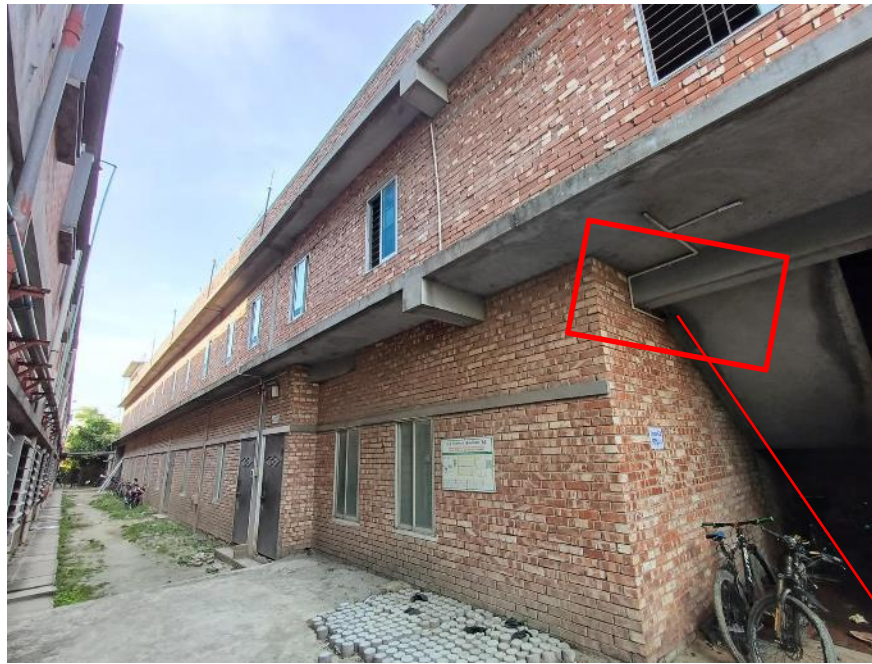
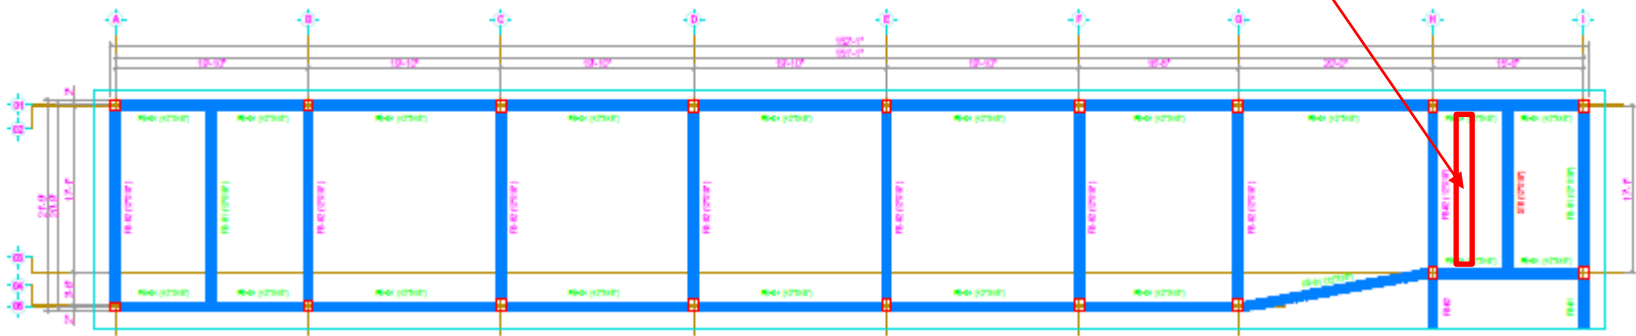
During inspection beam distance at stair was found 2 feet from grid H, which is mismatched with as built drawings. Building engineer is required to check the beam layout and update drawings as per site condition.

| Item No. | Observation | Recommended Action Plan | Recommended Timeline |
|---|---|---|---|
| 19 | Discrepancy between as-built drawing & site condition (Building 03) | Building Engineer is required to survey the whole structure and prepare accurate as-built drawing. | 6-weeks |

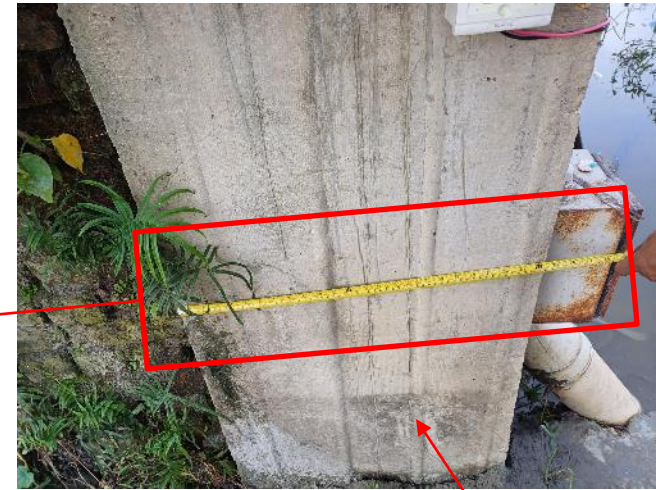
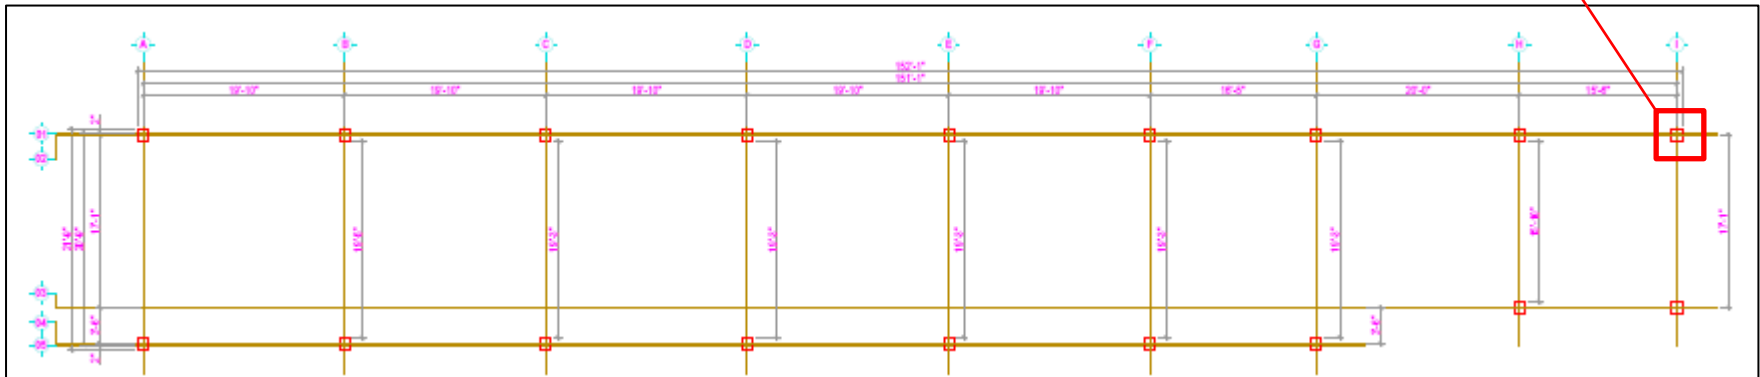
Column size mismatch with as built drawings in below ground level

During inspection column size found 24"x12" instead of 16"x24". Building engineer is required to check the column size and update drawings as per site condition.

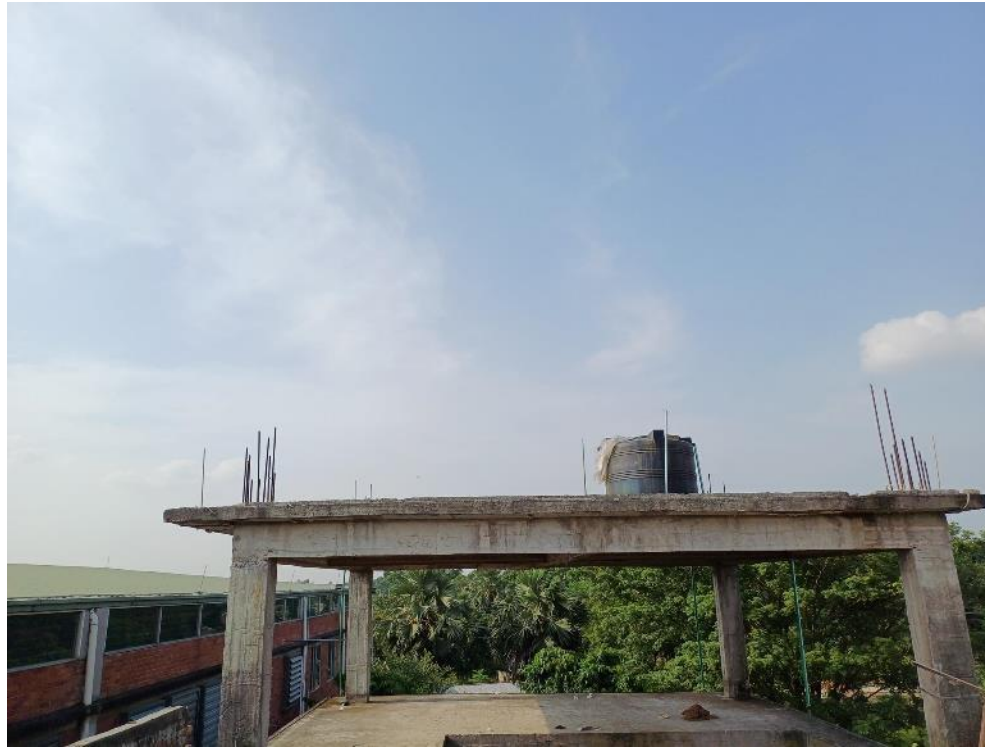
Undocumented water tank at roof of stair

Building engineer is required to update architectural drawings with water tank and check the capacity of structure for water tank loading.

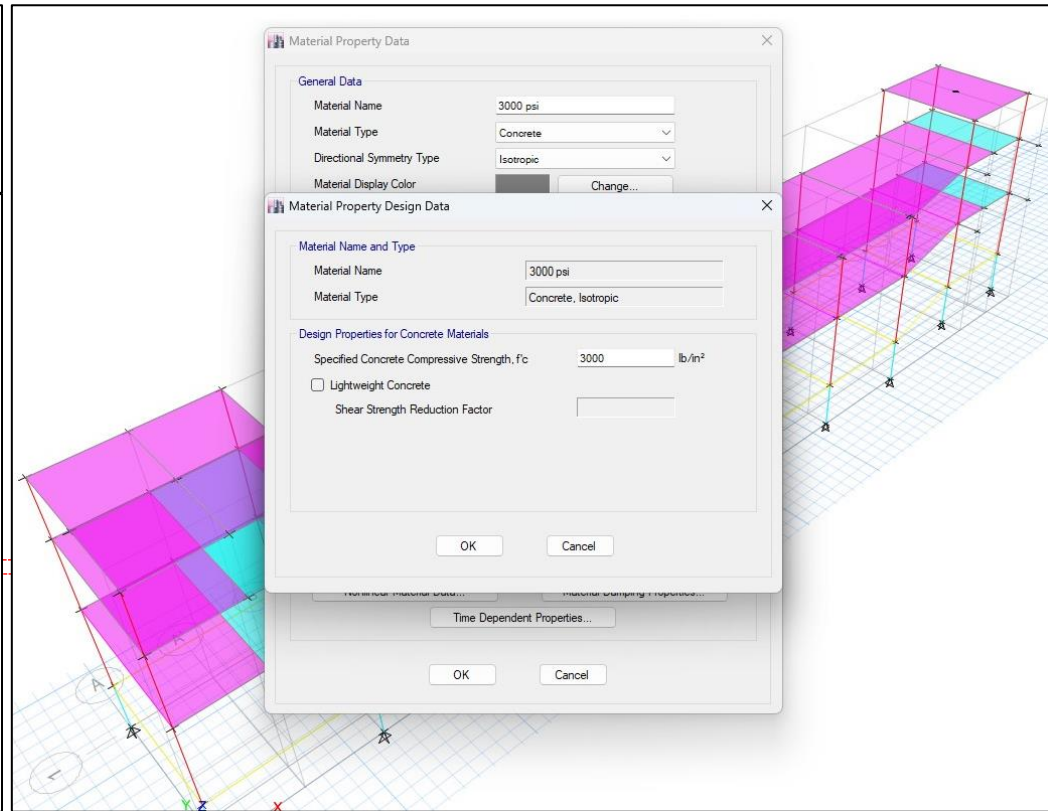
Concrete strength has been considered 3 ksi in FEA model and general note of the construction drawing and in engineering assessment report. Also, the  $f_y = 72.5$  ksi has been considered.

The concrete strength has been considered 3 ksi and  $f_y = 72.5$  ksi but no credible test report was available to support the strength value. Factory engineer is required avail the proper documents to support the considered concrete strength or provide concrete core test report to check the in-situ concrete strength. For the steel, factory is required to provide the tensile strength test report. Factory engineer is required to suggest the factory authority for the remedial works if required.

| Item No. | Observation | Recommended Action Plan | Recommended Timeline |
|---|---|---|---|
| 22 | Engineering assessment (EA) needs to revise (Building-03) | Provide creditable material test report or Verify in-situ concrete stresses by 100mm dia. cores from minimum of 4 columns. Revise the Engineering assessment (EA) and submit to RSC. | 6-weeks |

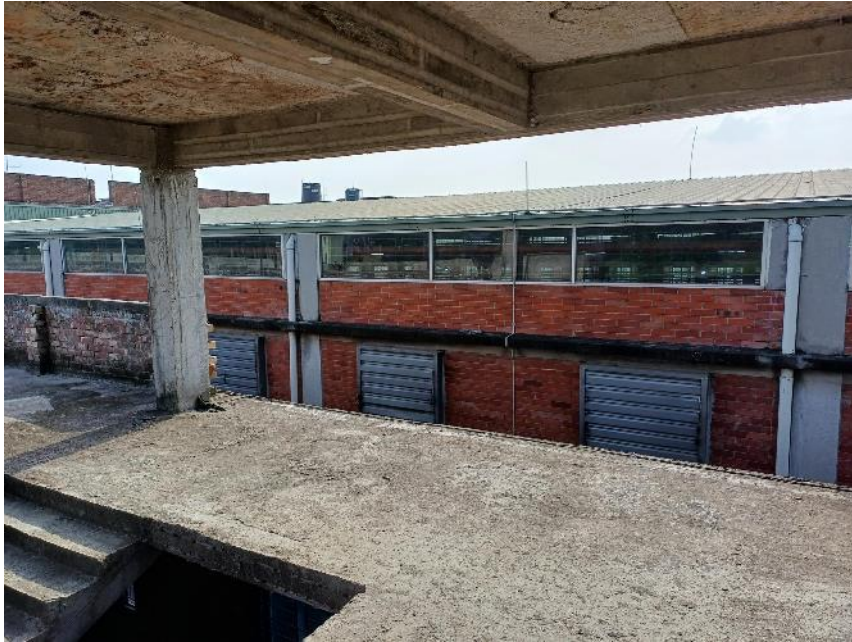
Falling hazard at roof

Falling hazard was found at roof and stair. Building engineer is required provide parapet at roof and railing in stair to mitigate the falling hazard.

| Item No. | Observation | Recommended Action Plan | Recommended Timeline |
|---|---|---|---|
| 25 | Falling hazard at roof and stair (Building 03) | Building engineer is required to provide parapet wall at roof and install railing in stair area to mitigate falling hazard. | 6-weeks |

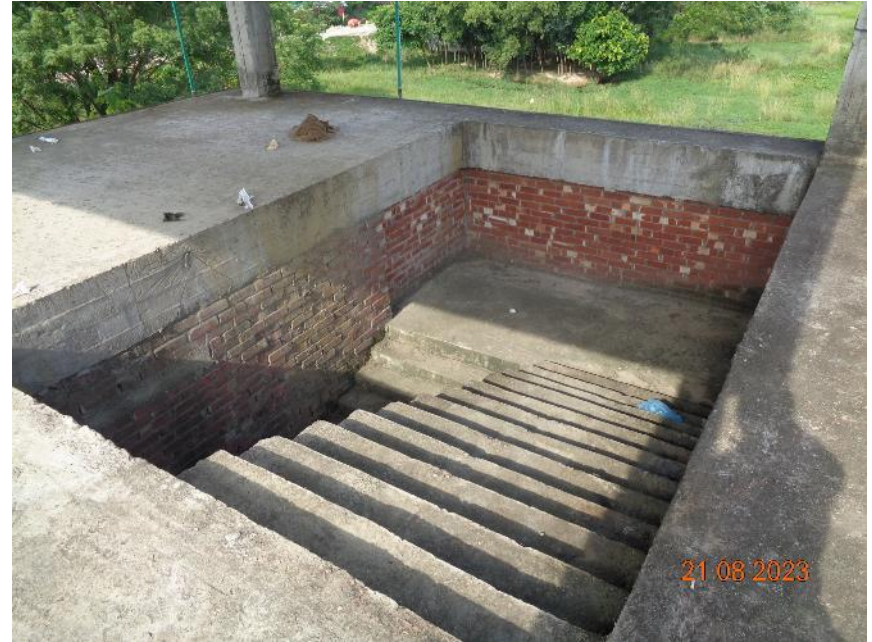
Falling hazard at stair

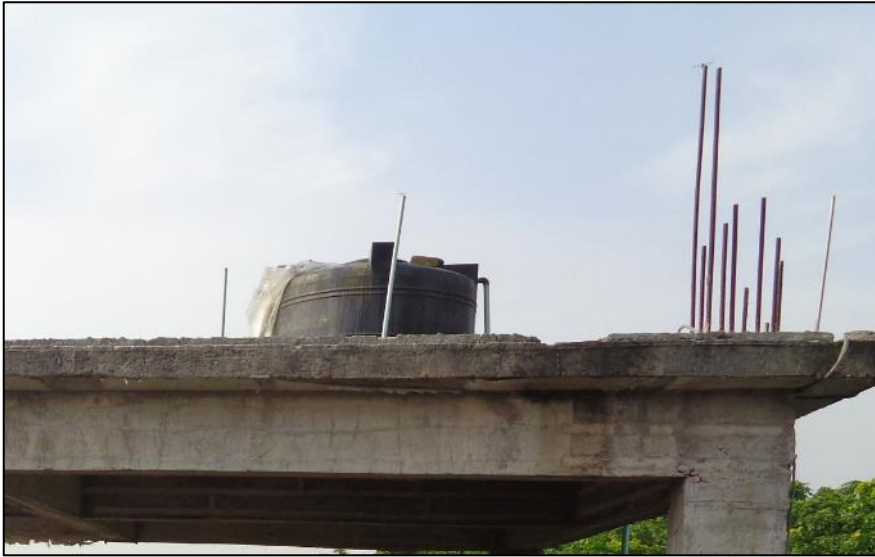
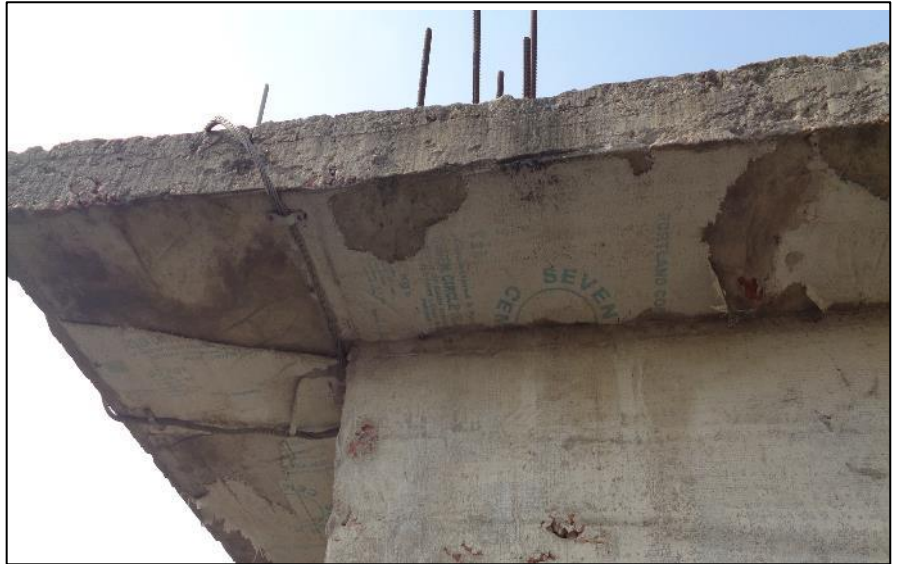
Exposed rebar at roof

Building engineer is required to identify the exposed corroded rebar and take adequate measures to protect exposed rebar from corrosion.

| Item No. | Observation | Recommended Action Plan | Recommended Timeline |
|---|---|---|---|
| 26 | Exposed rebar at roof (Building 03) | Building engineer is required to take necessary measures to repair the corrosion and measures to prevent further corrosion. | 6-weeks |

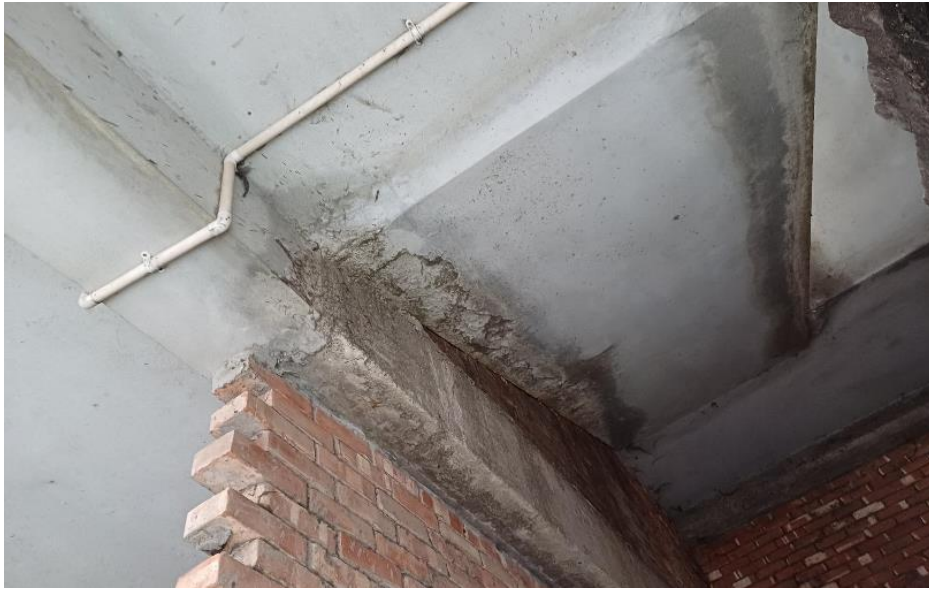
Dampness in stair area

Building engineer is required to identify dampness of source of the dampness and suggest proper remedial measures.

| Item No. | Observation | Recommended Action Plan | Recommended Timeline |
|---|---|---|---|
| 27 | Dampness in beam & wall (Building 03) | Building engineer is required to investigate the source of dampness and suggest proper remedial action to prevent dampness. | 6-weeks |

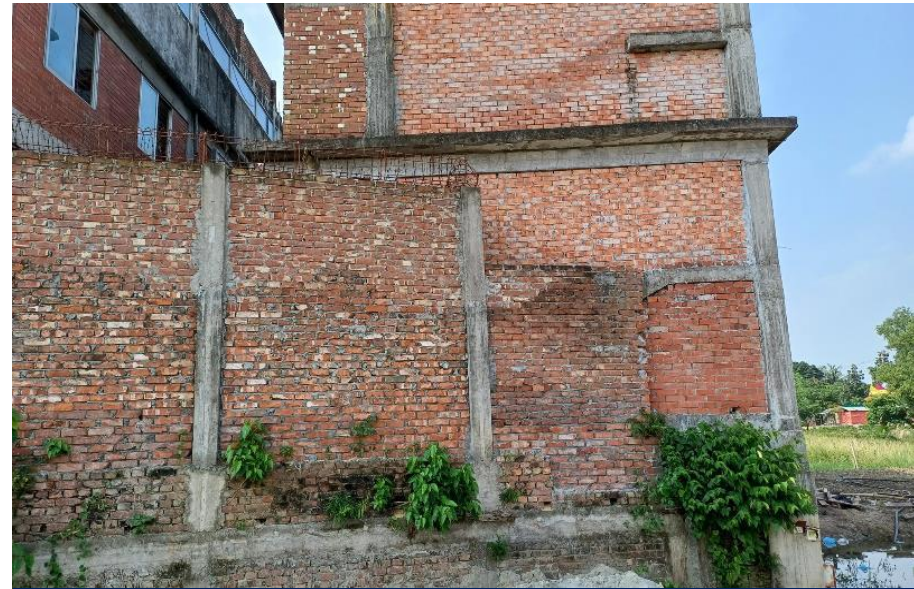
Vegetation grown on the facade wall

Building is required to take necessary measures to prevent vegetation from facade wall.

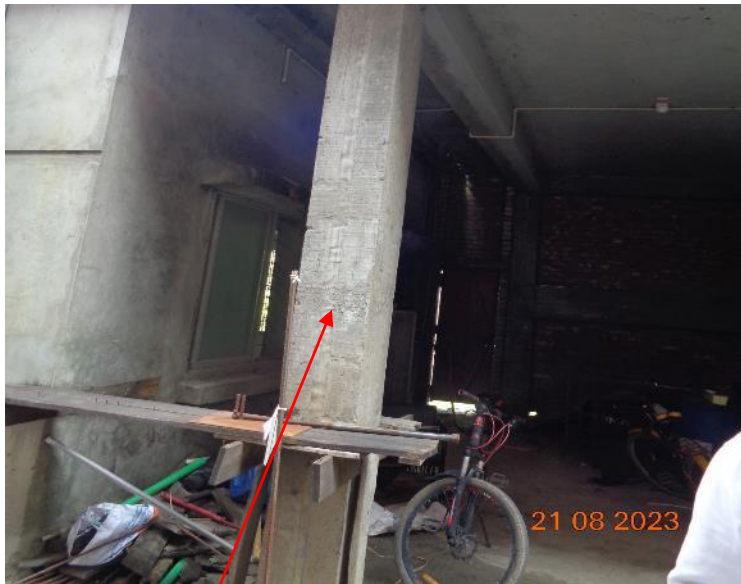
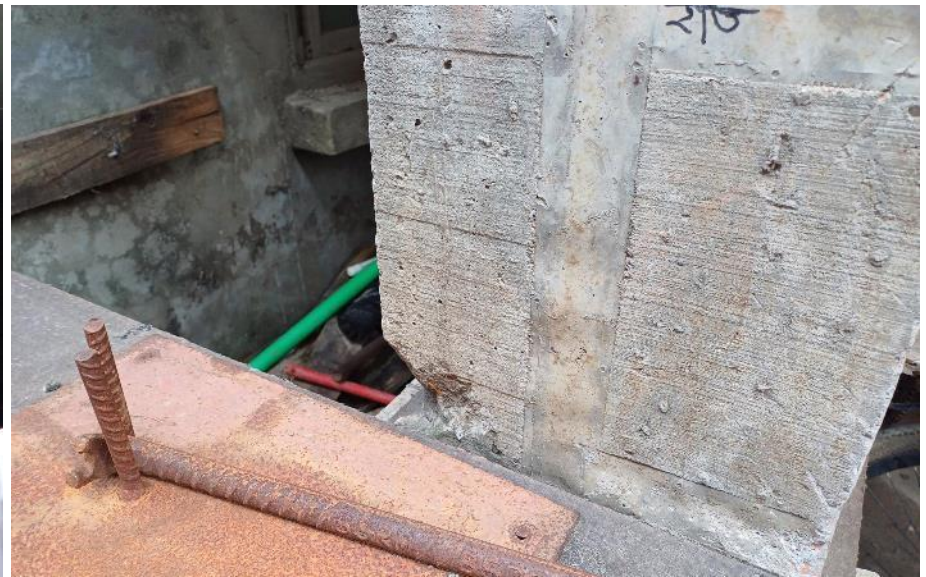
Damaged Column

Building engineer is required to rectify damaged column in ground floor with appropriate technique.

| Item No. | Observation | Recommended Action Plan | Recommended Timeline |
|---|---|---|---|
| 28 | Damaged column in ground floor (Building 03) | Building engineer is required to repair damaged column in ground floor with appropriate technique. | 6-weeks |
