# Powertex Fashions Ltd (Extension)

Dr. Panjabali- Dr. Assaduzzaman Industrial Park, Kathora, National University, Gazipur

21 August 2023

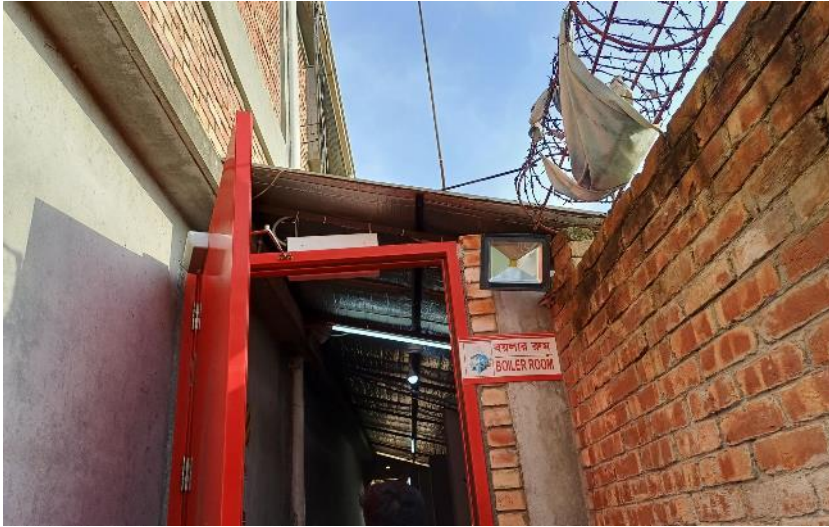
Non-Engineered structure

Building engineer is required to check the connection adequacy for the lightweight roof system and provide adequate documents for this structure.

| Item No. | Observation | Recommended Action Plan | Recommended Timeline |
|---|---|---|---|
| 29 | Connection adequacy of lightweight roof shed (Shed 03) | Building engineer is required to check the connection adequacy for the lightweight roof system and provide adequate documents for this structure | 6-weeks |

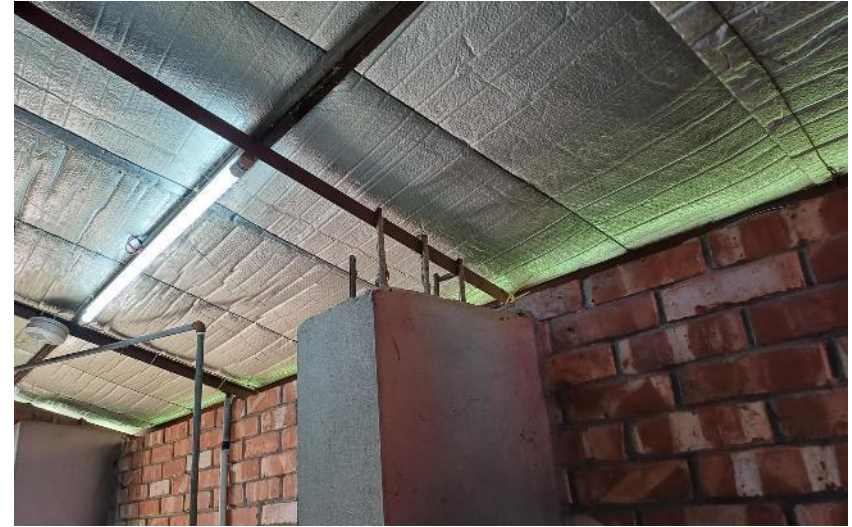
Lightweight roof shed
