# Norp Knit Industries Ltd.

## Unit- 02 (Extension)

R.I Park, 93, Islampur,Kodda, Nandun, Gazipur 1700  
(23.985522, 90.353672)  
17 September 2023

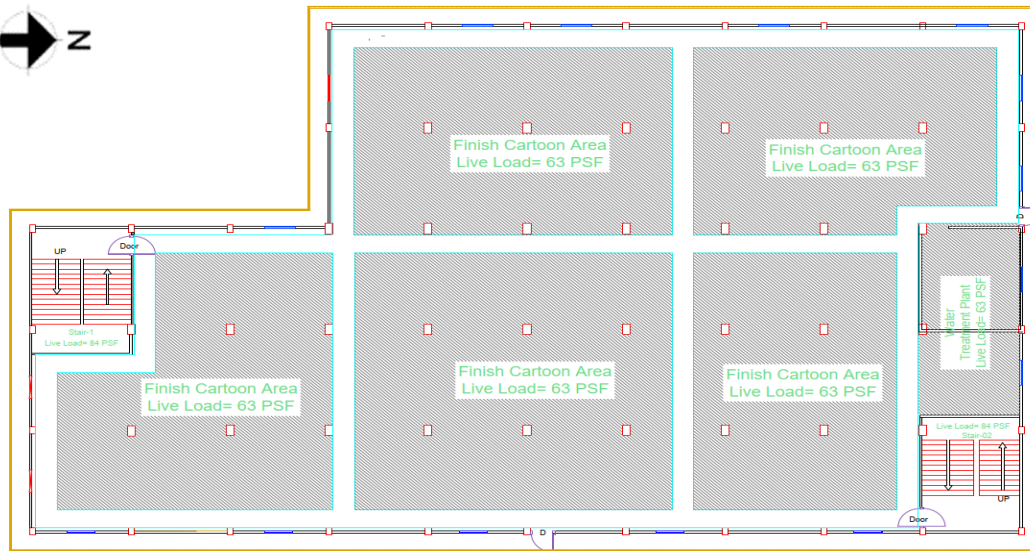
**3RD FLOOR LOAD PLAN**

**Load plan needs to revise**

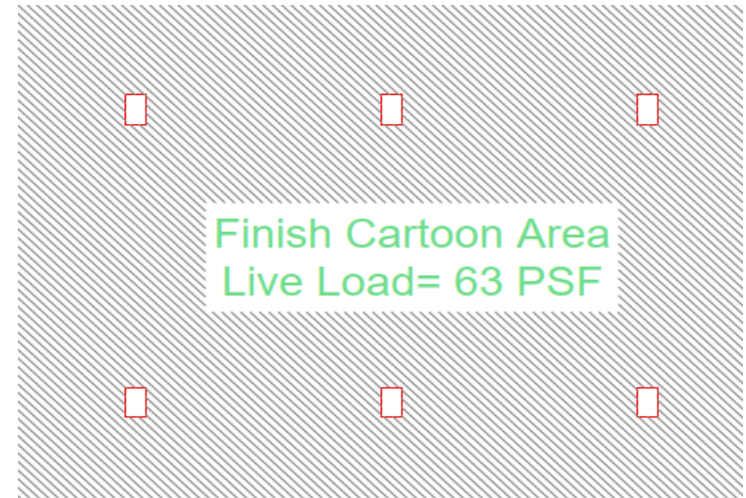
Live load plan- typical floor

Live load considered as 3 KPa for storage areas

Live load on typical floor is considered as 3 kPa in prepared load plan. As per BNBC- Part 6, live load for light storage areas is required to be considered minimum 6 kPa. However, the factory engineer is required to revise the load plan as per BNBC requirement and check the design accordingly.

| Item No. | Observation | Recommended Action Plan | Recommended Timeline |
|---|---|---|---|
| 03 | Load plan needs to be revised. (Dry Process Building) | Factory the factory engineer is required to revise the load plan as per BNBC requirement and check the design accordingly. | 6-weeks |

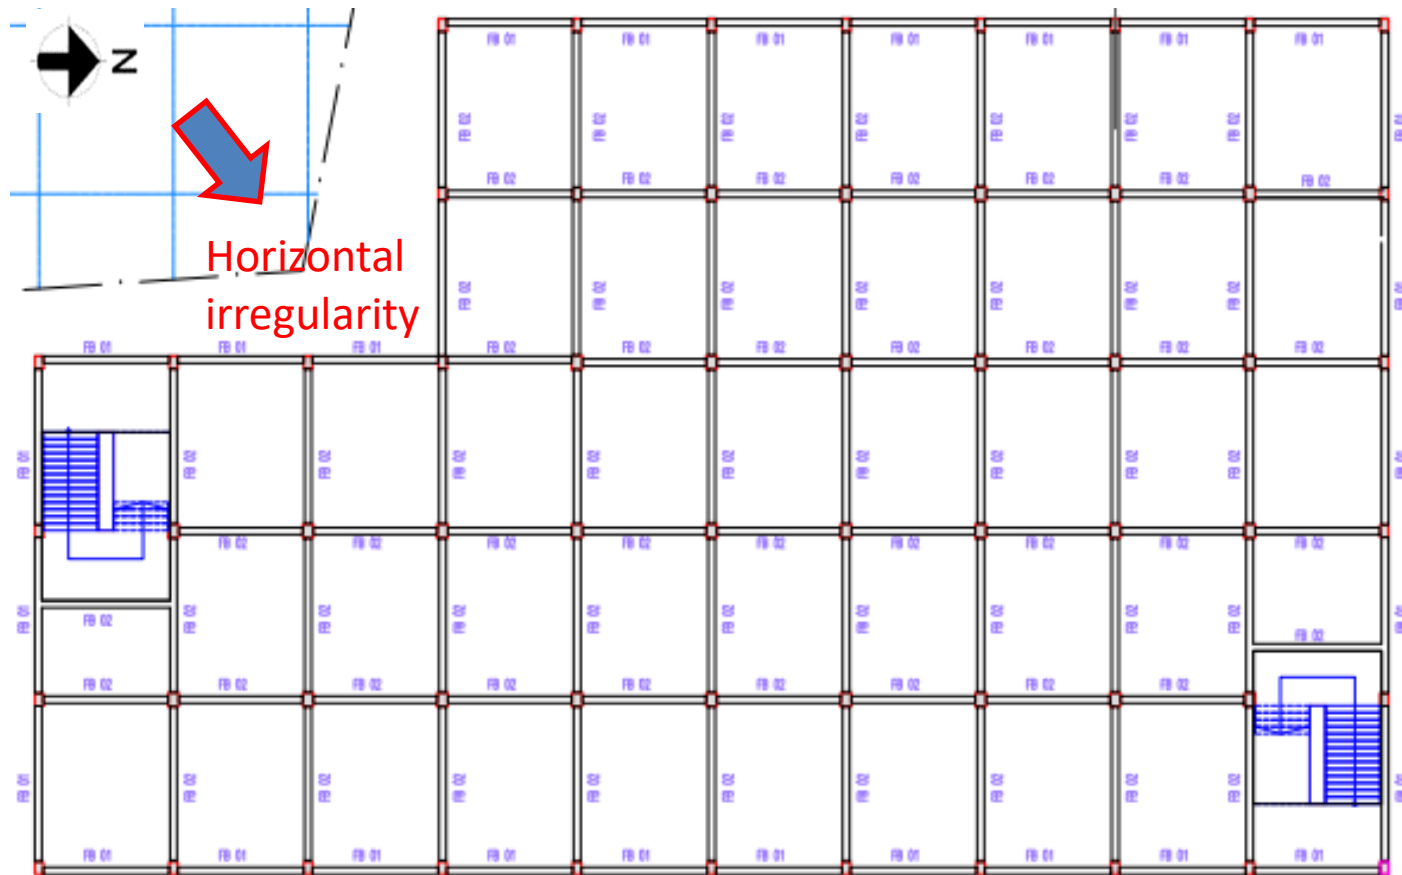
Typical Floor Beam layout

The structure is horizontally irregular at the marked location. Building engineer is required to revise the design report incorporating all irregularities including reentrant corner.

| Item No. | Observation | Recommended Action Plan | Recommended Timeline |
|---|---|---|---|
| 04 | Load plan needs to be revised. (Dry Process Building) | Building engineer is required to revise the design report incorporating all irregularities including reentrant corner. | 6-weeks |

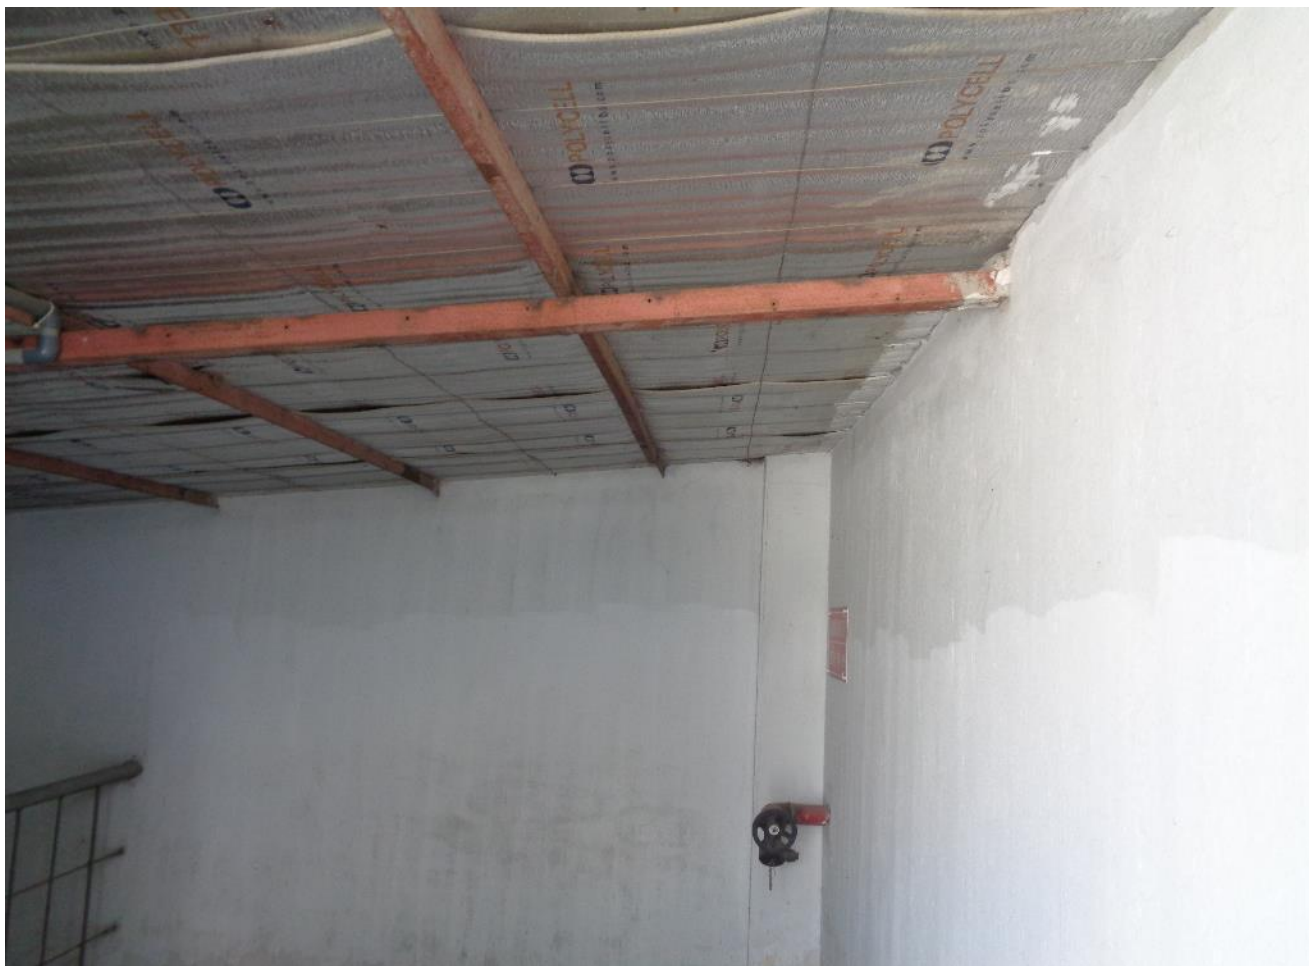
Steel members inserted to brick walls.

Rafter of stair roof was found inserted to brick wall which was appeared to be inadequate. Building engineer is required to check the connection adequacy for uplift forces.

| Item No. | Observation | Recommended Action Plan | Recommended Timeline |
|---|---|---|---|
| 07 | Apparently inadequate connection (Dry Process Building-Stair Roof Shed) | Building engineer is required to check the connection adequacy for uplift forces. | 6-weeks |
| 08 | Apparently inadequate connection (Dry Process Building-Stair Roof Shed) | Implement suggested remediation works. | 6-months |

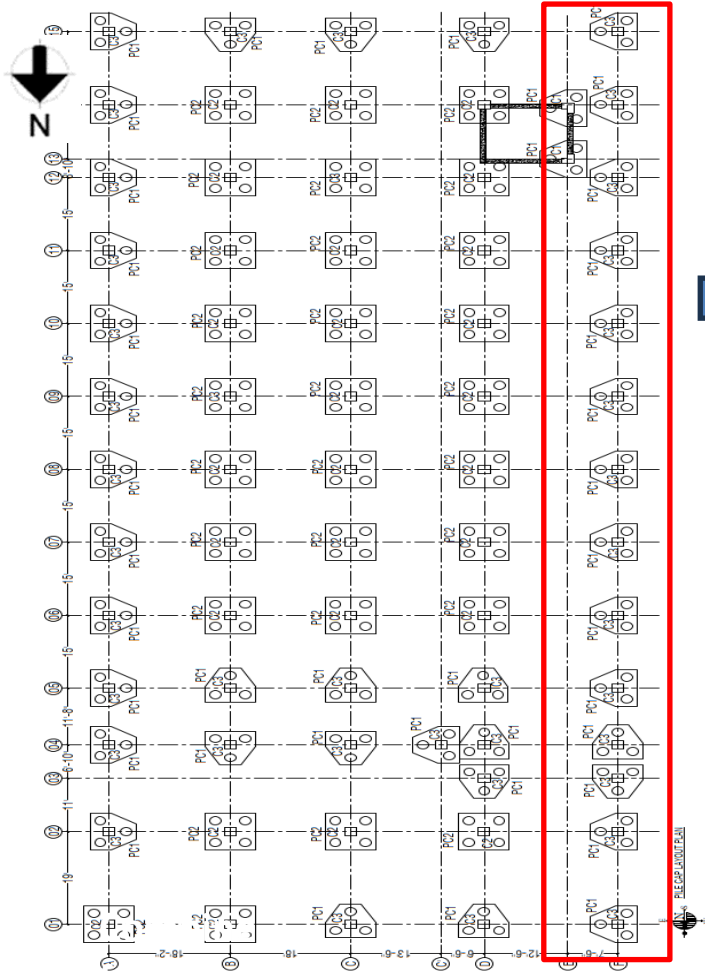
Pile layout of Six storied Store Building

Pile capacity has been checked as per provided soil test report of adjacent Dry Process Building. However, the bore hole-5 covers only the red marked piles of Six storied Store Building. Building engineer is required to check the pile capacity as per in-situ soil bearing capacity.

| Item No. | Observation | Recommended Action Plan | Recommended Timeline |
|---|---|---|---|
| 09 | Design report needs to be updated. (Six Storied Store Building) | Building engineer is required to check the pile capacity as per in-situ soil bearing capacity. | 6-weeks |

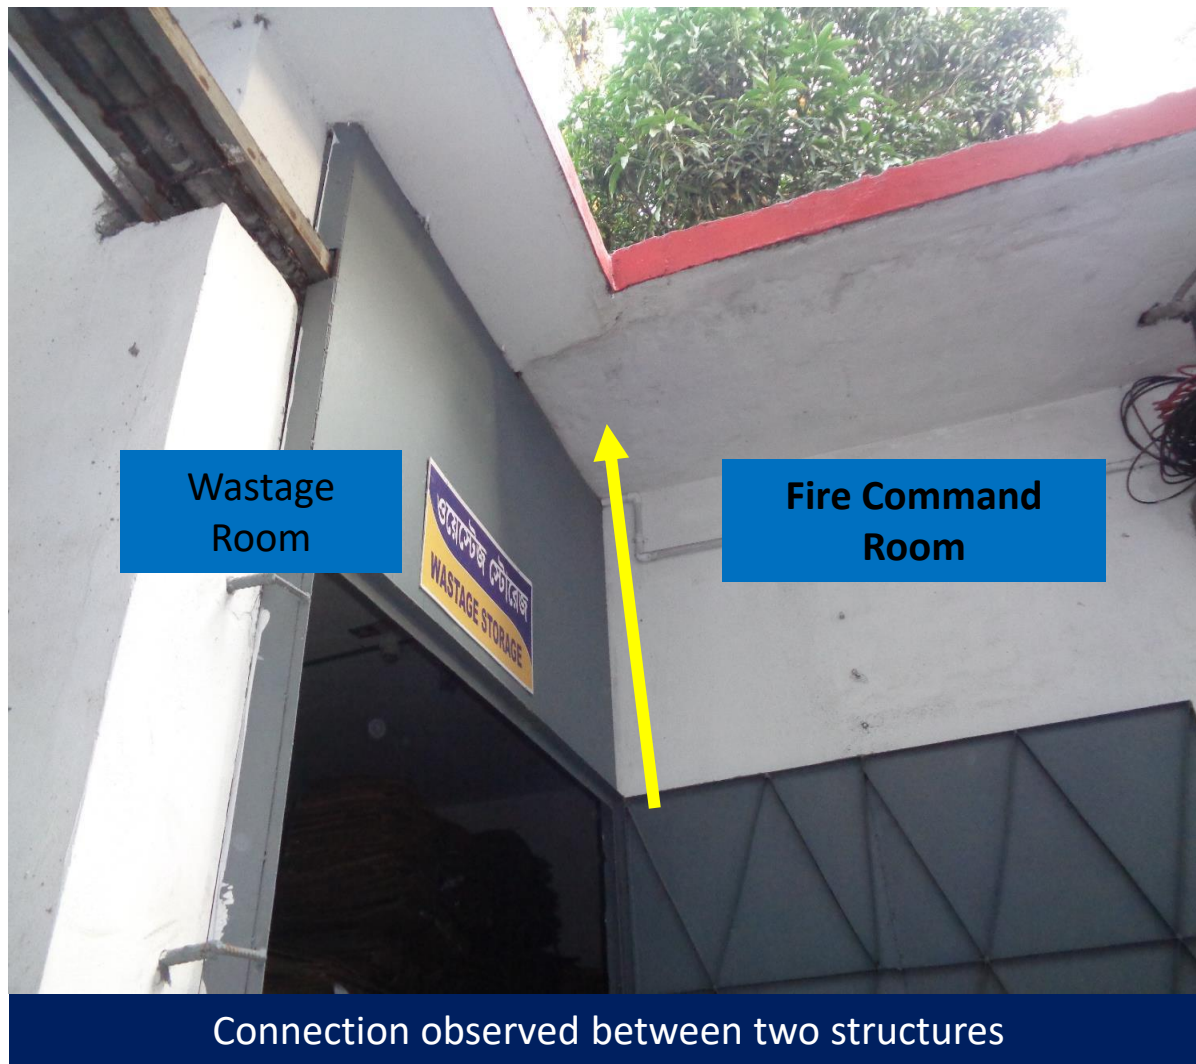
## **Connection found between two structures**

Connection observed between two structures. Building engineer is required to investigate the connection and update as-built drawing accordingly.

| Item No. | Observation | Recommended Action Plan | Recommended Timeline |
|---|---|---|---|
| 16 | Connection found between two structures (Wastage Room and Fire Command Room) | Building engineer is required to update the as-built drawing. | 6-weeks |

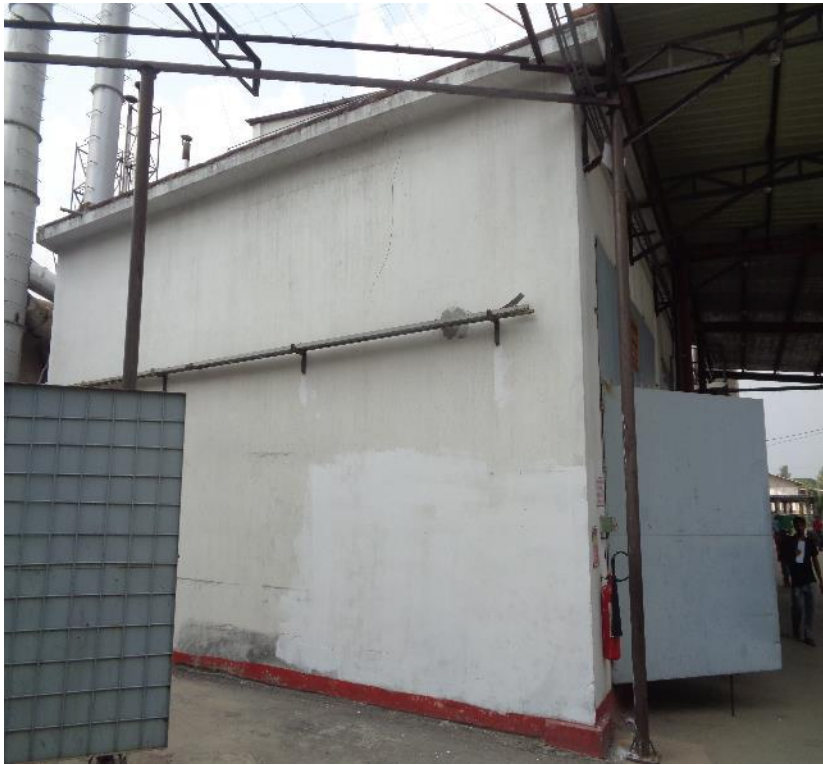
Boiler Room

As-built structural drawing was not available for any of the structures. Building engineer is required to produce As-built structural drawing for all of these structures.

| Item No. | Observation | Recommended Action Plan | Recommended Timeline |
|---|---|---|---|
| 17 | Lack of structural drawing (Boiler Room, Wastage Room, Fire Command Room) | Building engineer is required to produce as-built structural drawing. | 6-weeks |
