# Green Life Knit Composite Ltd. (Extension)

Tongabari, Ashulia, Savar, Dhaka-1341  
(23.903056N,90.320529E)  
10 September 2023

# Observations

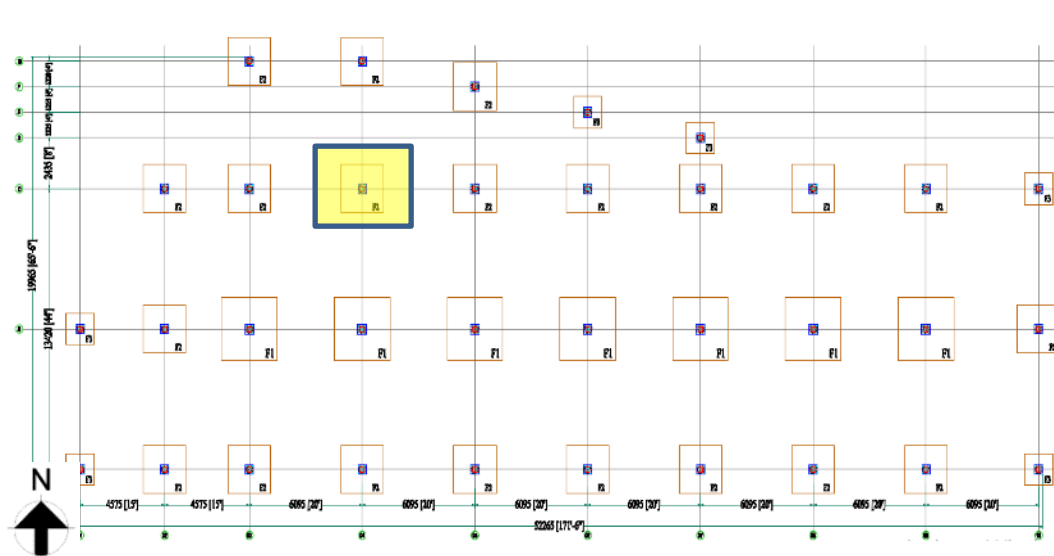
Foundation Layout plan

**Stress in foundation exceeds normal design limit**

Cursory calculation indicates that foundation is stressed above normal design limits for punching at the marked locations considering 3 kPa live load on typical floor, 6 kPa on storage areas, 1.5 kPa on roof and minimum concrete strength based on aggregate type. Building engineer to review design, loads and foundation stresses for the marked location above.

| Item No. | Observation | Recommended Action Plan | Recommended Timeline |
|---|---|---|---|
| 01 | Stress in foundation exceeds normal design limit. (Wash Building) | Building engineer to review design, loads and foundation stresses for the marked location above. | 6-weeks |
| 02 | Stress in foundation exceeds normal design limit. (Wash Building) | Produce and actively manage load plan for all floors based on column and foundation capacity. | 6-weeks |

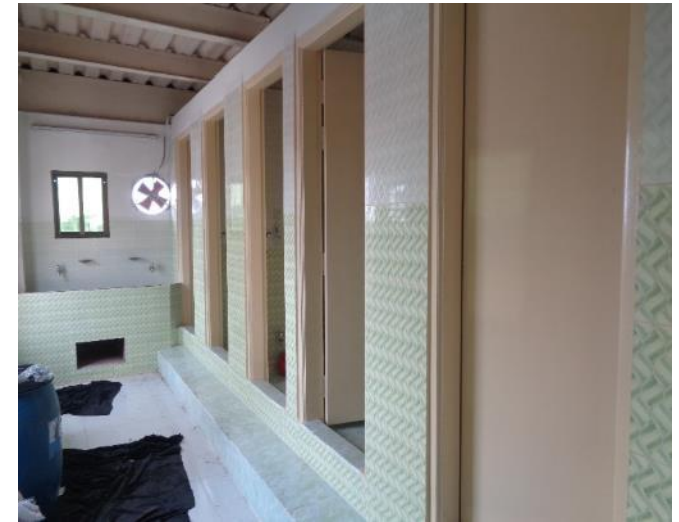
Source of loading: Toilet build up and partition wall on 2<sup>nd</sup> floor

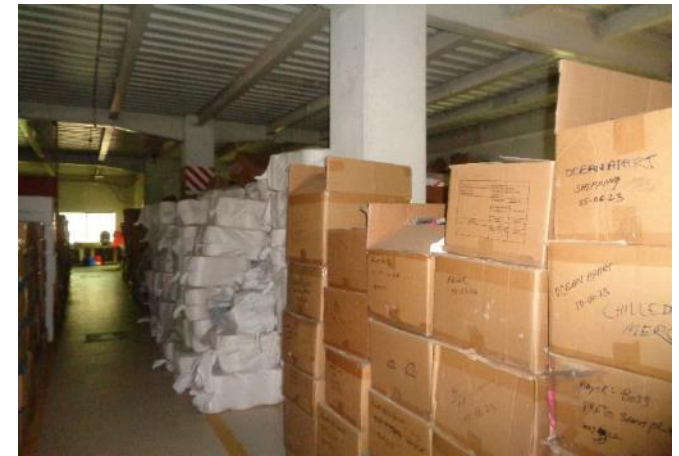
Source of loading: Storage on 1<sup>st</sup> floor

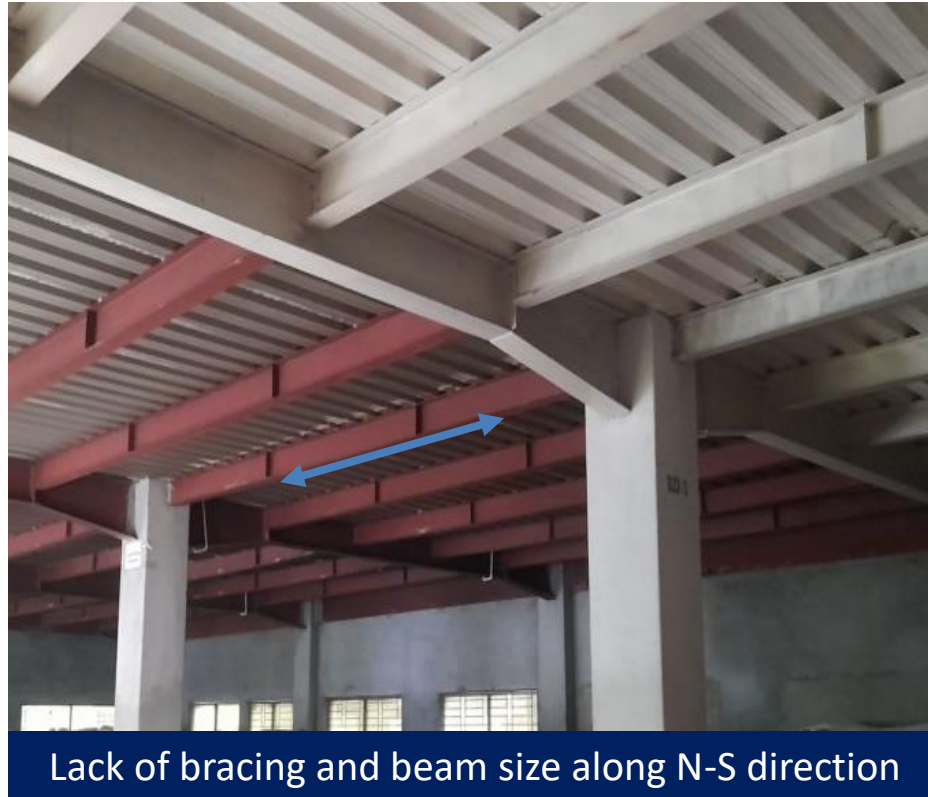
Lack of bracing and beam size along N-S direction

There is no bracing along N-S direction and the depth of secondary framing beam size is very low which indicates lack of lateral stability of the building along this direction. The building engineer is required to check the stability system and suggest necessary alternatives accordingly.

| Item No. | Observation | Recommended Action Plan | Recommended Timeline |
|---|---|---|---|
| 05 | Inadequate lateral stability system along N-S direction. (Wash Building) | The building engineer is required to check the stability system and suggest necessary alternatives accordingly. | 6-weeks |
| 06 | Inadequate lateral stability system along N-S direction. (Wash Building) | Carry out connection adequacy check and suggest necessary remedial action. | 6-weeks |

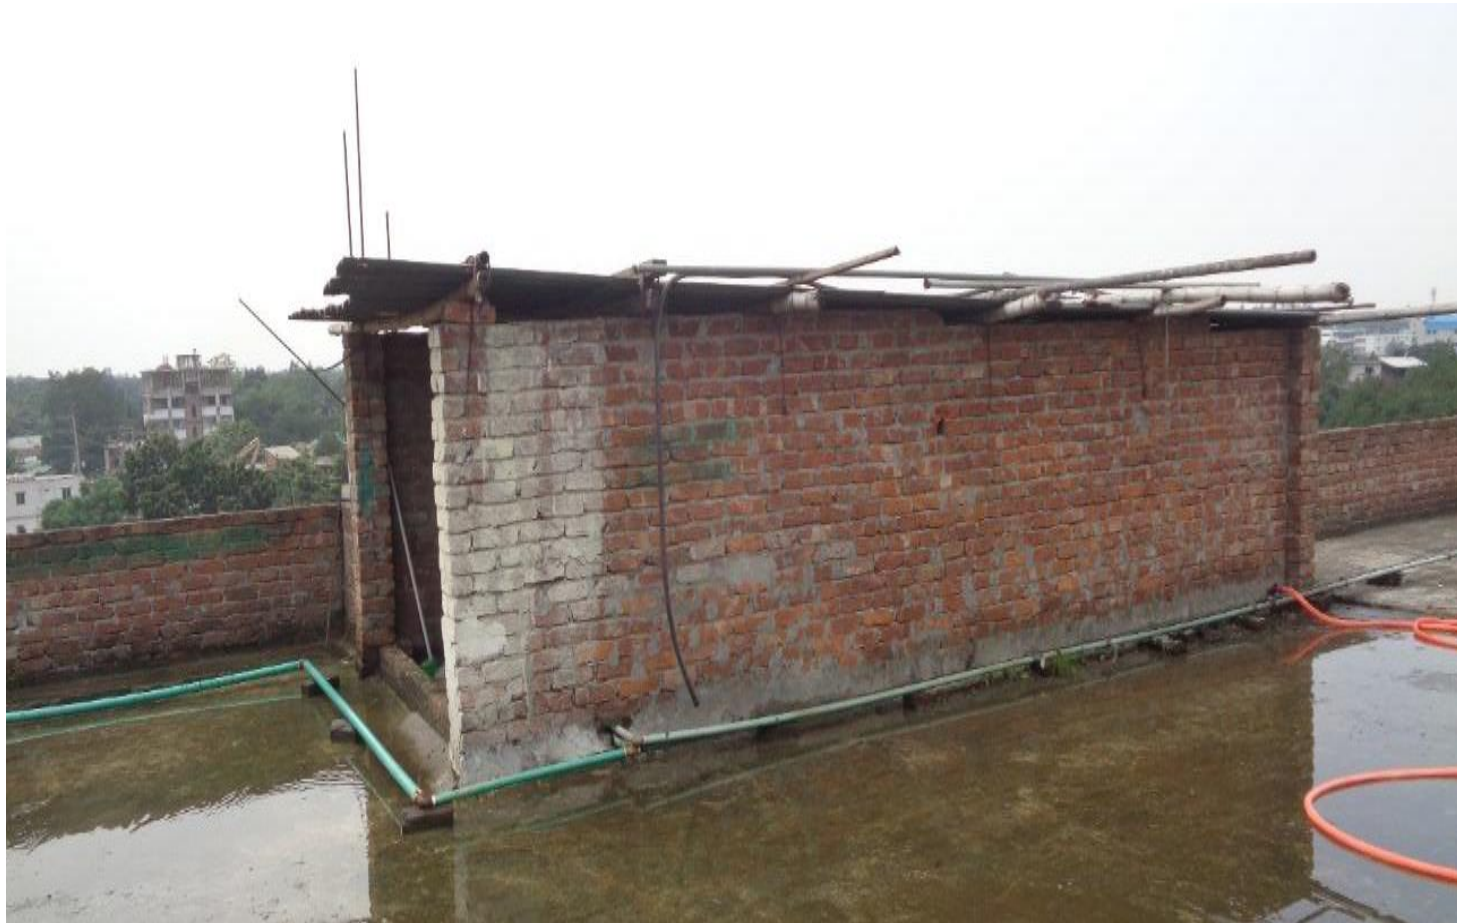
Non-engineered bamboo shed over staircase

Non-engineered bamboo shed observed over staircase. The factory is required to replace the shed with any well design structure.

| Item No. | Observation | Recommended Action Plan | Recommended Timeline |
|---|---|---|---|
| 08 | Non-engineered bamboo shed over staircase. (Wash Building) | Factory is required to replace the shed with any well design structure | 6-months |

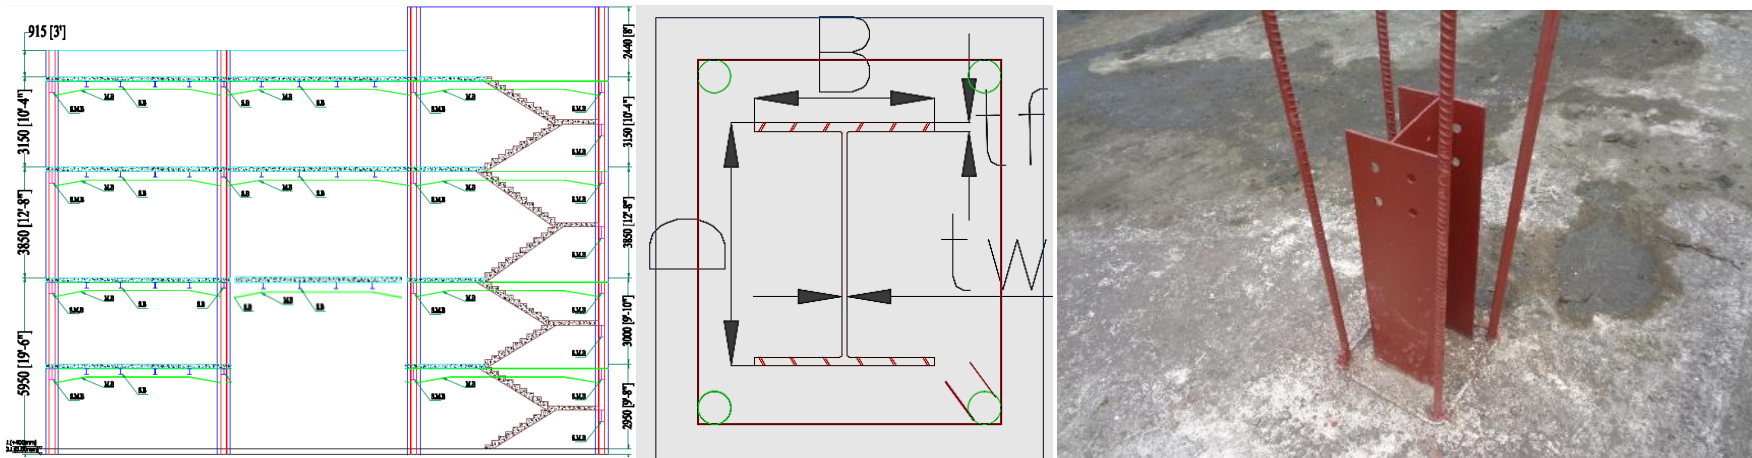
Column size, rebar diameter, steel to RC connection, Steel column to beam connection details are missing in the drawing

Building engineer is required to survey the structure, verify the connections between RC and steel member and prepare accurate the as-built drawings.

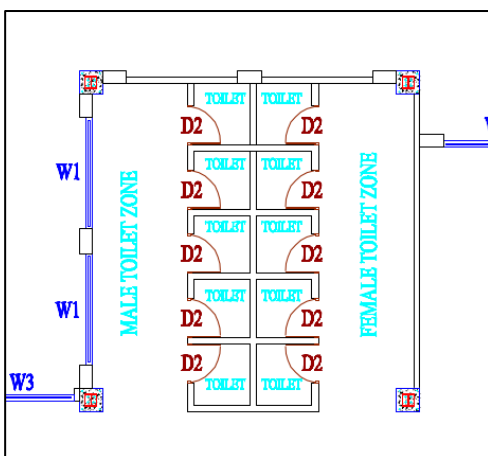
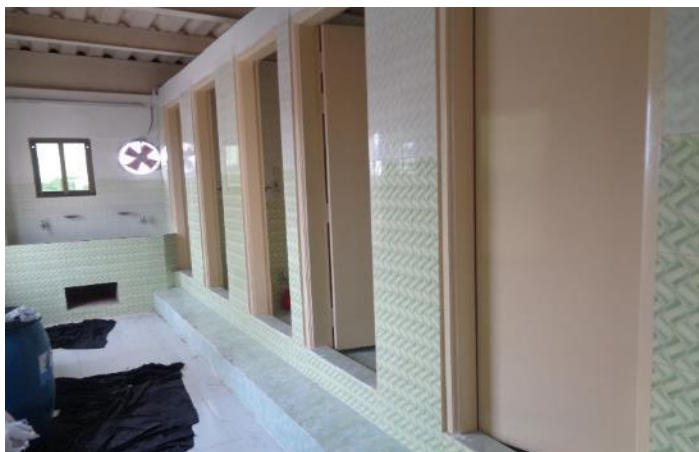
350 mm floor build up at toilet zone not shown in the drawing

Composite column was found on-site. Steel column to beam connection details as well as rebar detailing is not provided in drawing.

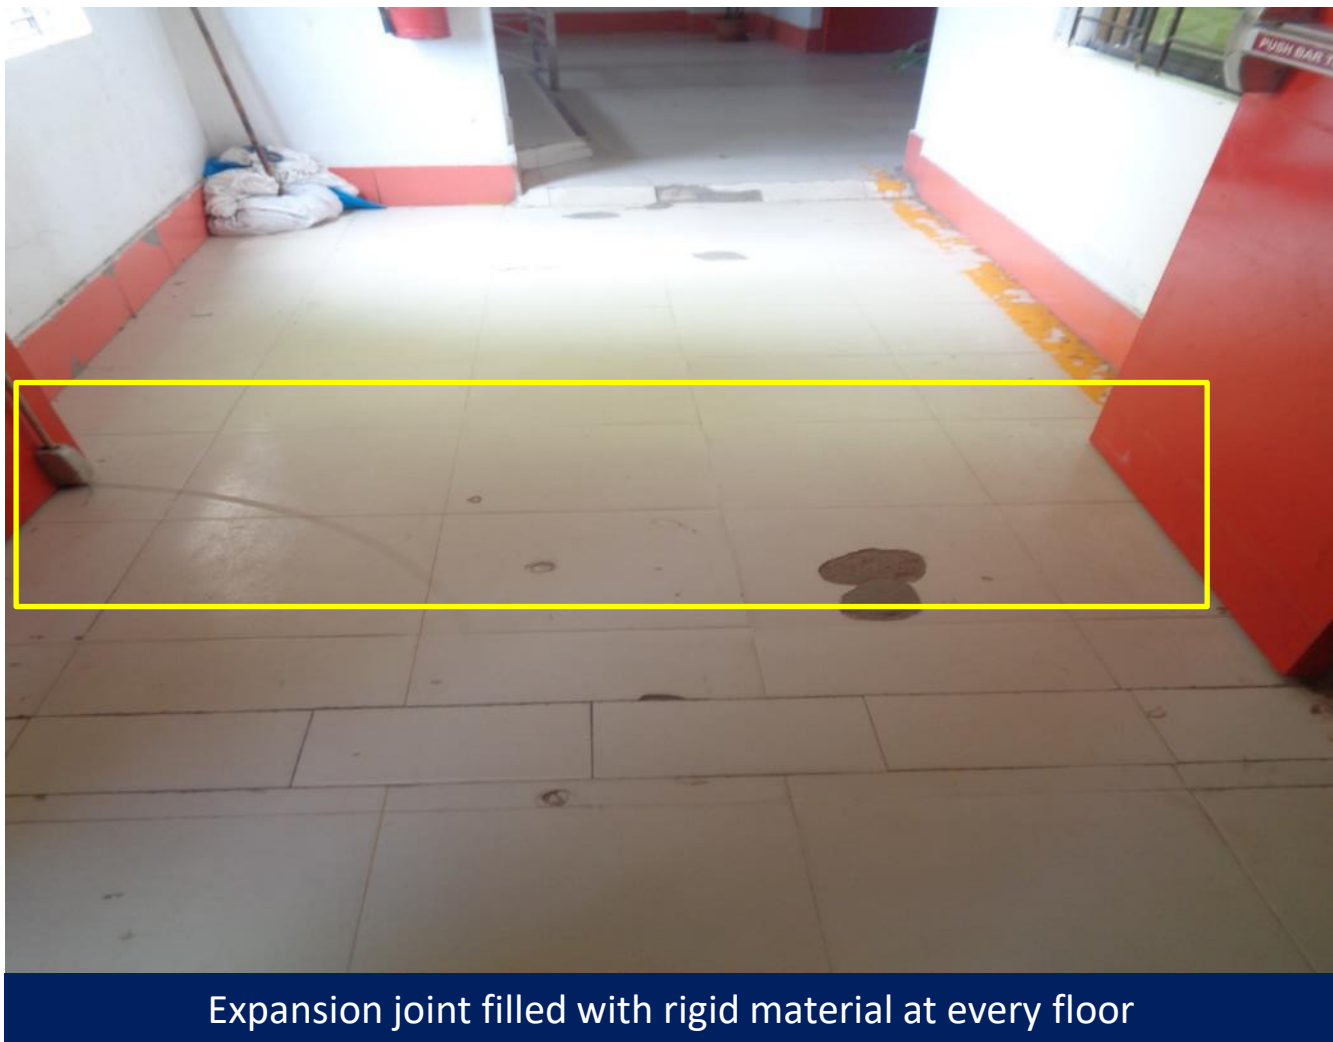
Expansion joint filled with rigid material at every floor

Expansion joint with adjacent building was found filled with rigid material which may result in development of crack and falling hazard during lateral movement of the buildings. Factory is required to fill the gap with fireproof & flexible material suggested by the building engineer.

| Item No. | Observation | Recommended Action Plan | Recommended Timeline |
|---|---|---|---|
| 10 | Expansion joint filled with rigid material. (Wash Building) | Factory is required to fill the gap with any flexible material suggested by the structural/fire engineer. | 6-months |

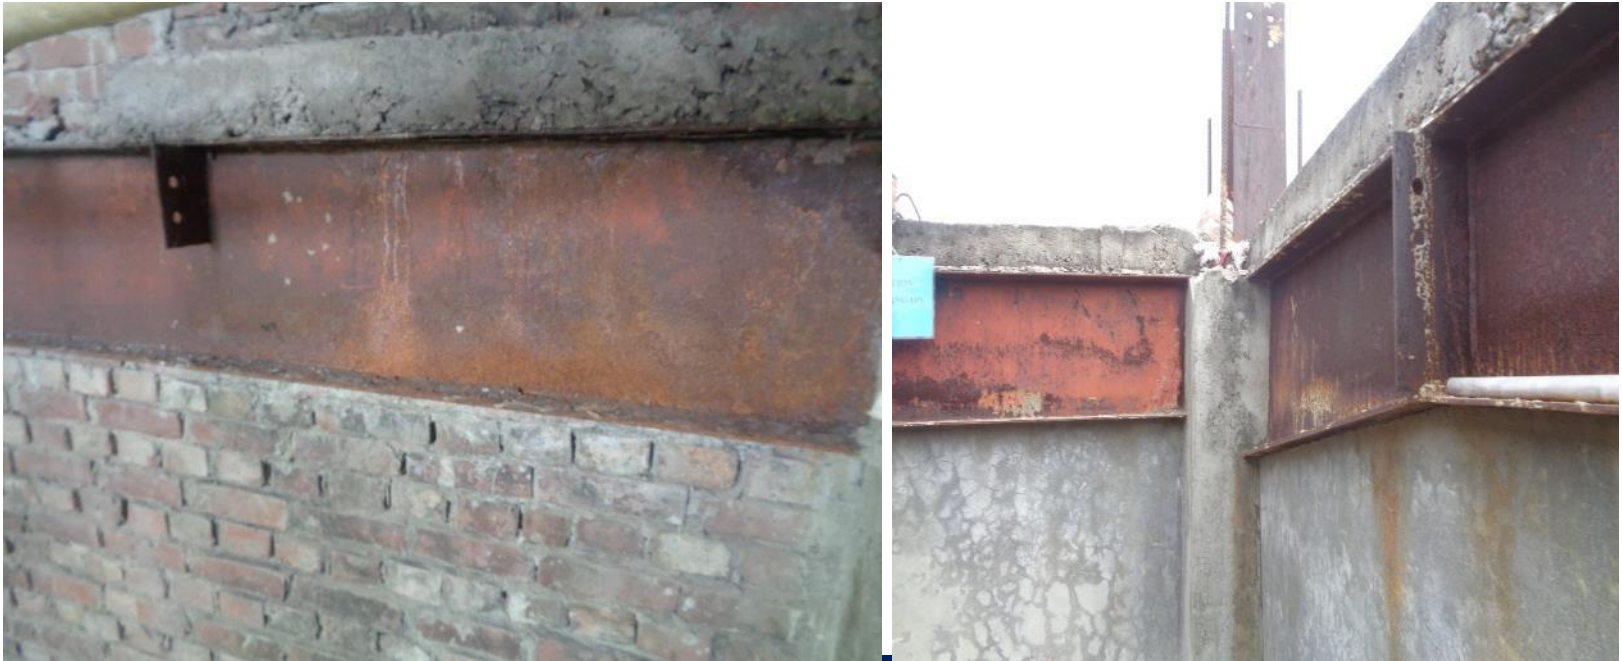
Corrosion on steel beam at staircase

Severe corrosion was found in the steel members. Factory is required to remove the corrosion and apply rust proof coating on the corroded surface.

| Item No. | Observation | Recommended Action Plan | Recommended Timeline |
|---|---|---|---|
| 11 | Severe corrosion on steel members. (Wash Building) | Factory is required to remove the corrosion and apply rust proofing on the corroded areas to protect the steel members from corrosion. | 6-weeks |

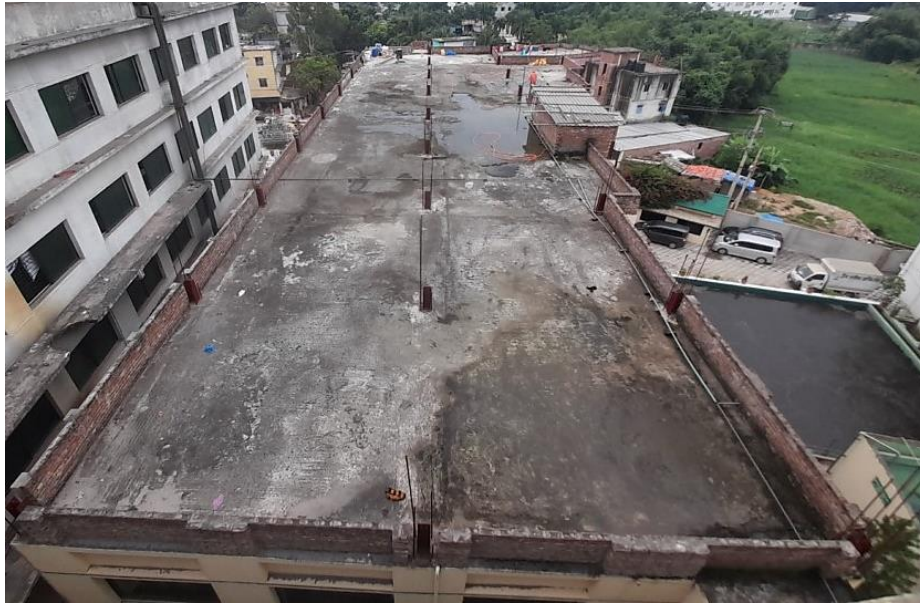
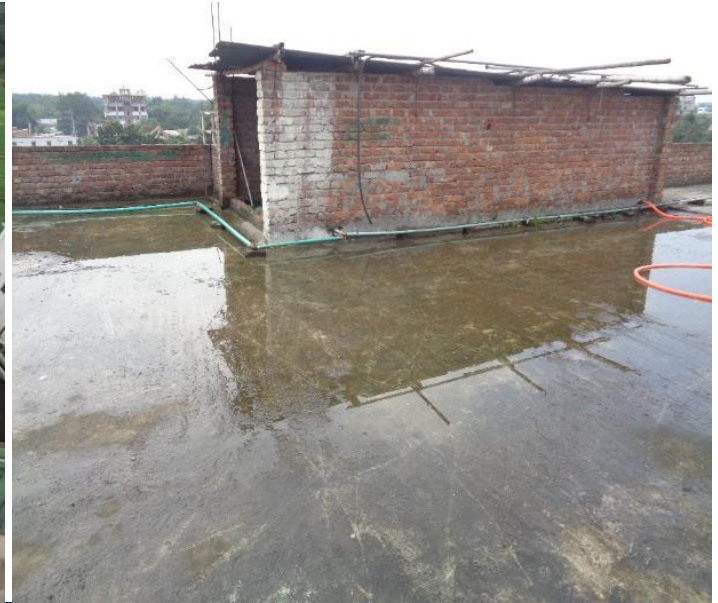
Water ponding on roof slab due to poor drainage system

Water ponding observed on roof slab due to poor drainage system. Aggregate of roof slab was found as brick chips. Factory is required to improve drainage system with adequate water outlets and apply water proofing layer with adequate slope on roof.

| Item No. | Observation | Recommended Action Plan | Recommended Timeline |
|---|---|---|---|
| 12 | Water ponding on roof. (Wash Building) | Factory is required to improve drainage system with adequate water outlets and apply water proofing layer with adequate slope on roof. | 6-months |

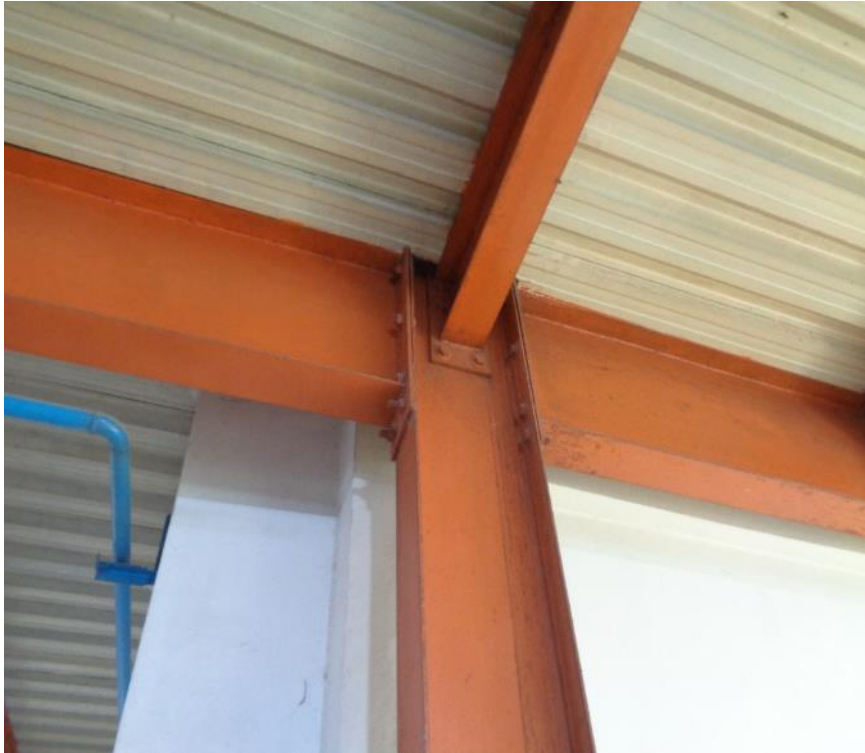
Moment frame in E-W direction

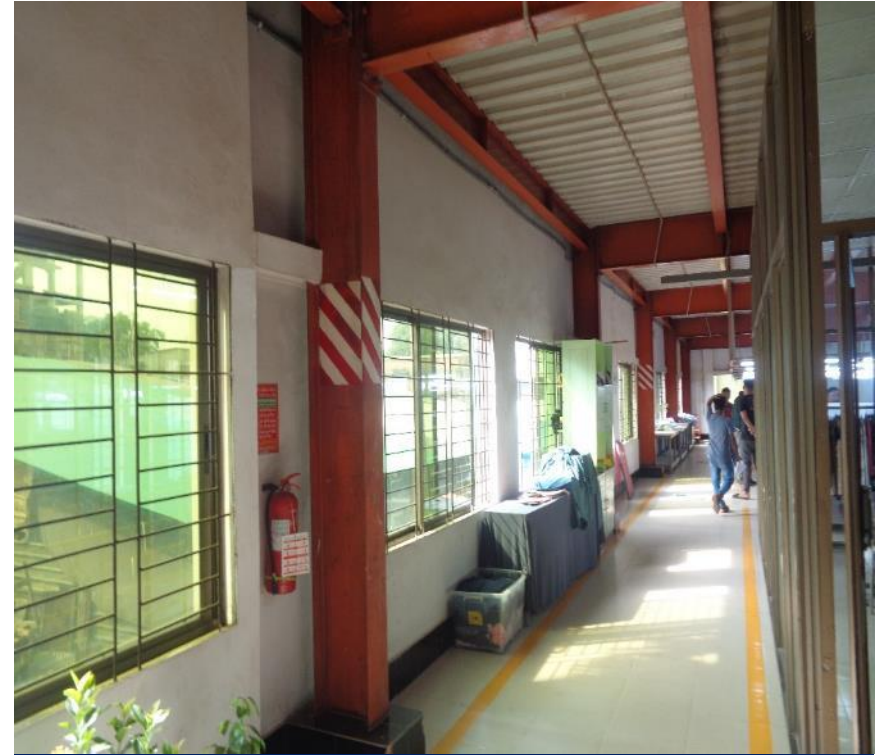
No bracing or any lateral load resisting system along N-S direction

Neither moment resisting connection is not provided in N-S direction nor bracing or other lateral load resisting system is provided which indicates lack of stability along this direction. Building engineer is required to check the lateral stability of the structure and suggest proper remedial action.

| Item No. | Observation | Recommended Action Plan | Recommended Timeline |
|---|---|---|---|
| 13 | Lack of lateral stability. (Printing & Embroidery Building) | Building engineer is required to check the lateral stability of the structure and suggest proper remedial action. | 6-weeks |

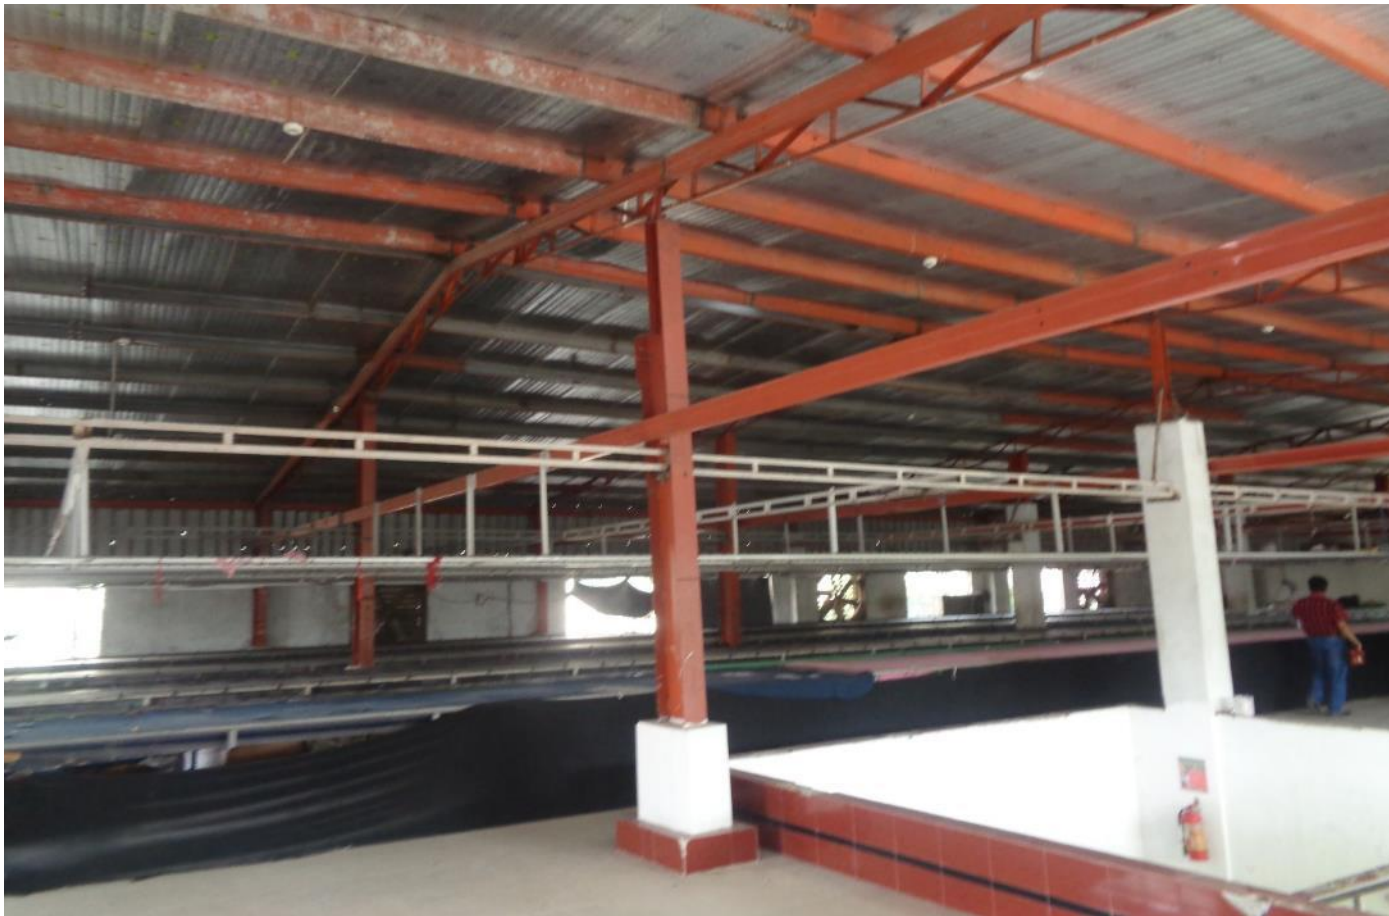
No load transfer media and load resisting system is provided in the truss roof

No compression member is provided from frame to frame along N-S direction to transfer the lateral load and no bracing is provided for the structure. Building engineer is required to check the lateral stability of the structure and suggest proper remedial action.

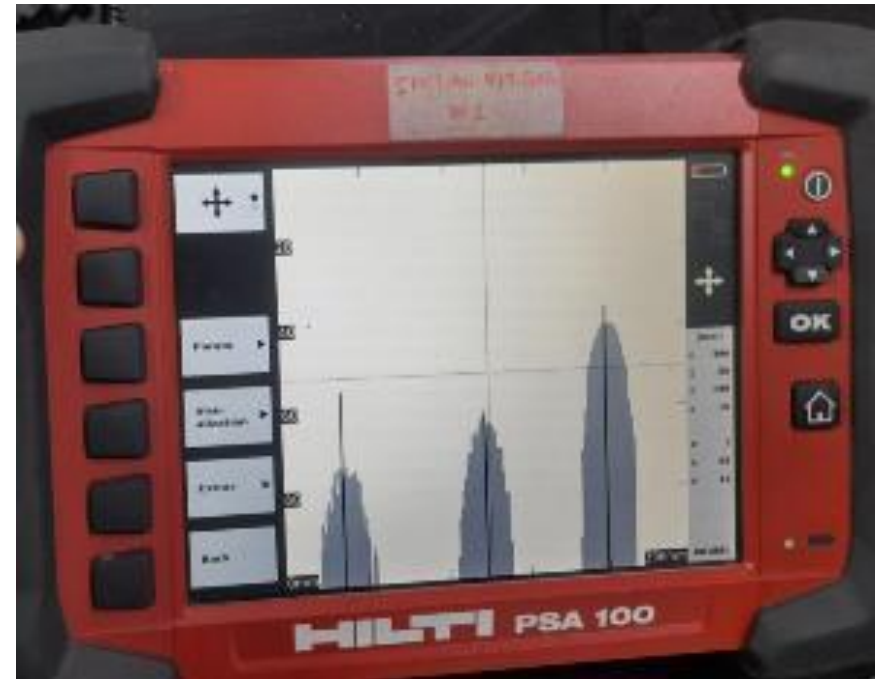
8 rebars (3 on each side) found on-site

8 rebars (3 on each side) found on-site instead of 10 rebars. Building engineer is required to check the column rebar and update the as-built structural drawing accordingly.

| Item No. | Observation | Recommended Action Plan | Recommended Timeline |
|---|---|---|---|
| 15 | Missing information and discrepancy in the provided drawing.<br>(Printing & Embroidery Building) | Building engineer is required to check the columns layout & sizes, rebar quantity and update the as-built structural drawing with necessary connection details. | 6-weeks |

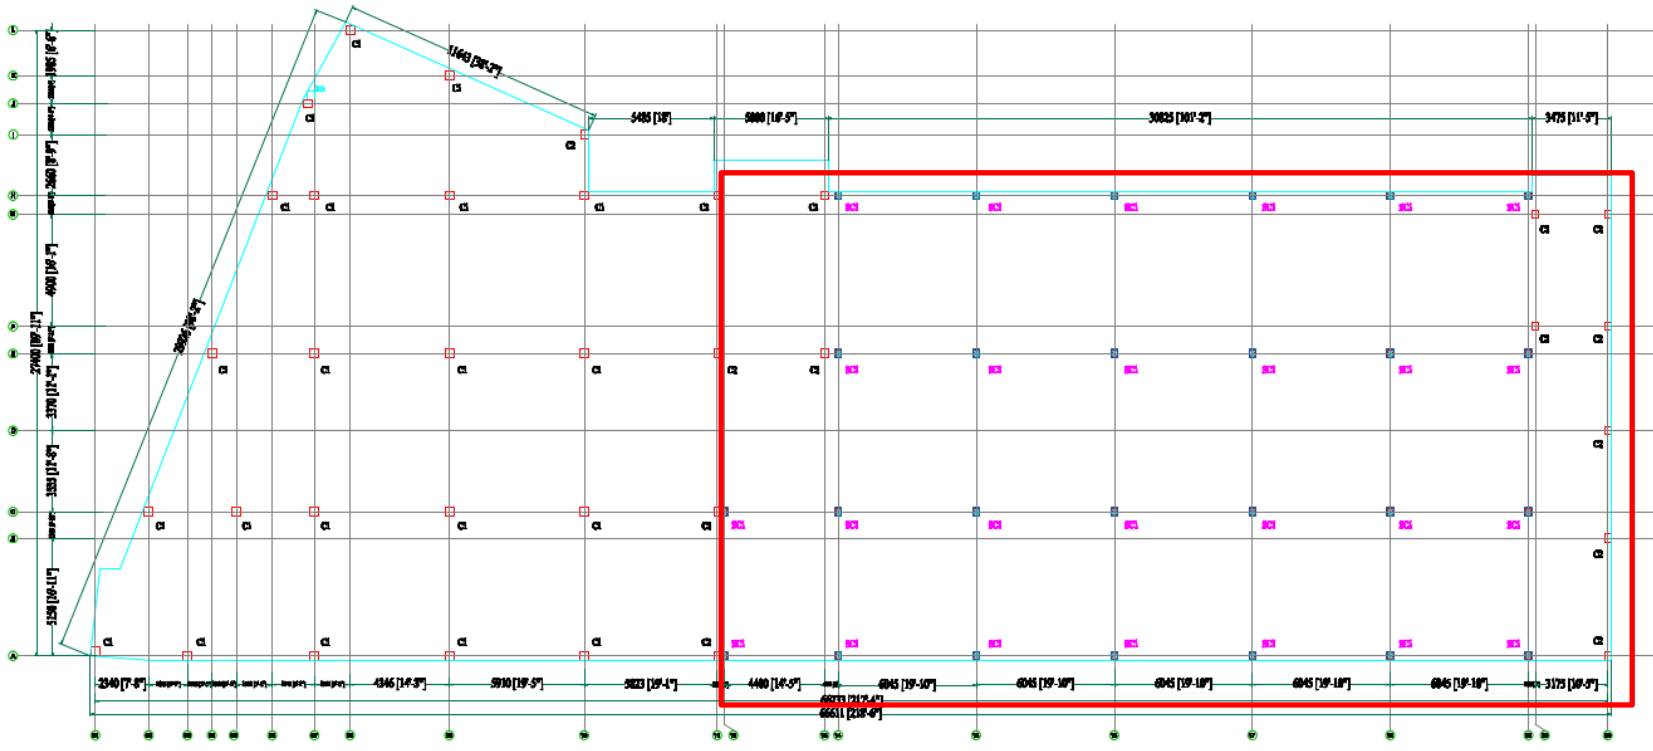
Pedestal column/baseplate layout is not shown for steel column

Pedestal column/baseplate layout is not shown for steel column in column layout. Also, connection detail is not provided in drawing. Building engineer is required to check the pedestal column, rebar quantity and its connection and update the as-built structural drawing accordingly.

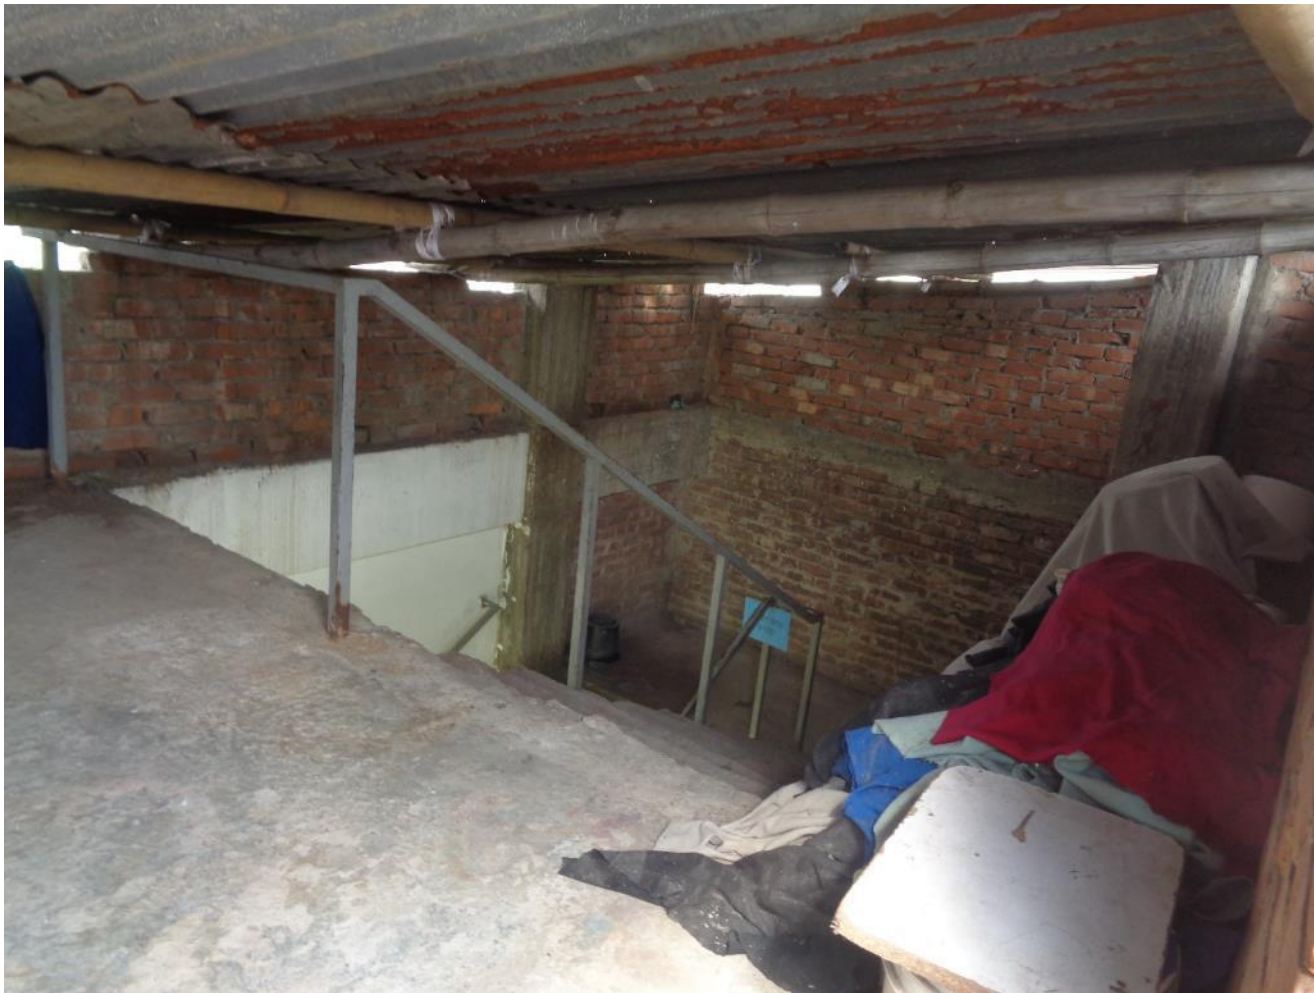
Bamboo shed over staircase

Non-engineered bamboo shed observed over staircase. The factory is required to replace the shed with any well design structure.

| Item No. | Observation | Recommended Action Plan | Recommended Timeline |
|---|---|---|---|
| 16 | Non-engineered bamboo shed over staircase. (Printing & Embroidery Building) | Factory is required to replace the shed with any well design structure. | 6-months |

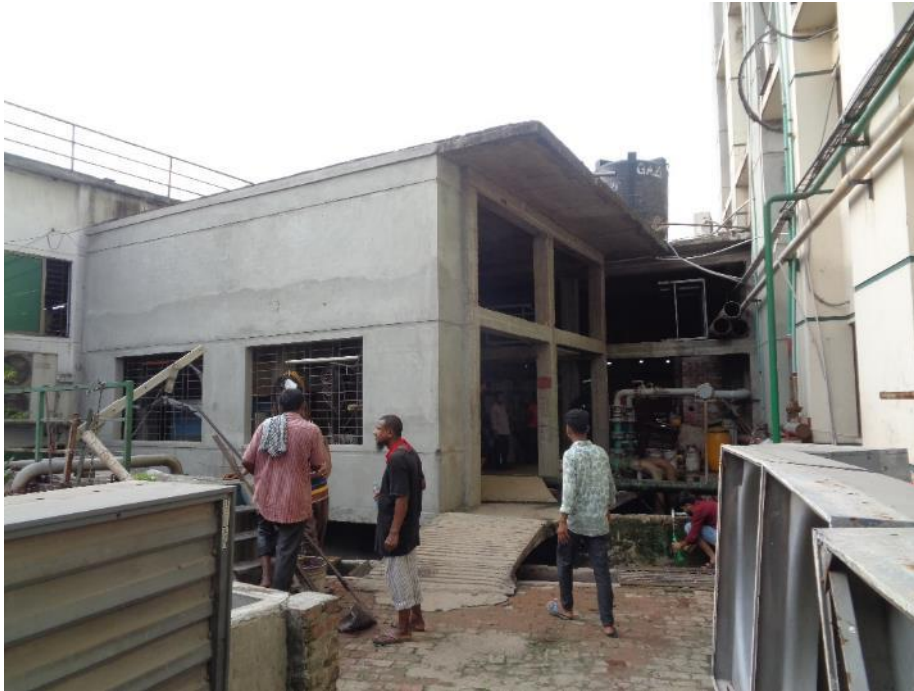
Fire Pump House

As per BNBC, every building or structure designed shall have its design documents prepared in accordance with the provision of Section 1.9.1. The design document shall include a design report, and a set of structural drawings, which shall be prepared in compliance with section 1.9.1.1 and section 1.9.1.2 as per BNBC. At the time of inspection, design report and as-built drawing were not available which are required to be prepared in compliance with section 1.9.1.1 and 1.9.1.2 (BNBC).

| Item No. | Observation | Recommended Action Plan | Recommended Timeline |
|---|---|---|---|
| 17 | Absence of design documents.<br>(Fire Pump House) | Building engineer is required to prepare the design report and as-built drawings in compliance with section 1.9.1 of BNBC (part-6). | 6-months |

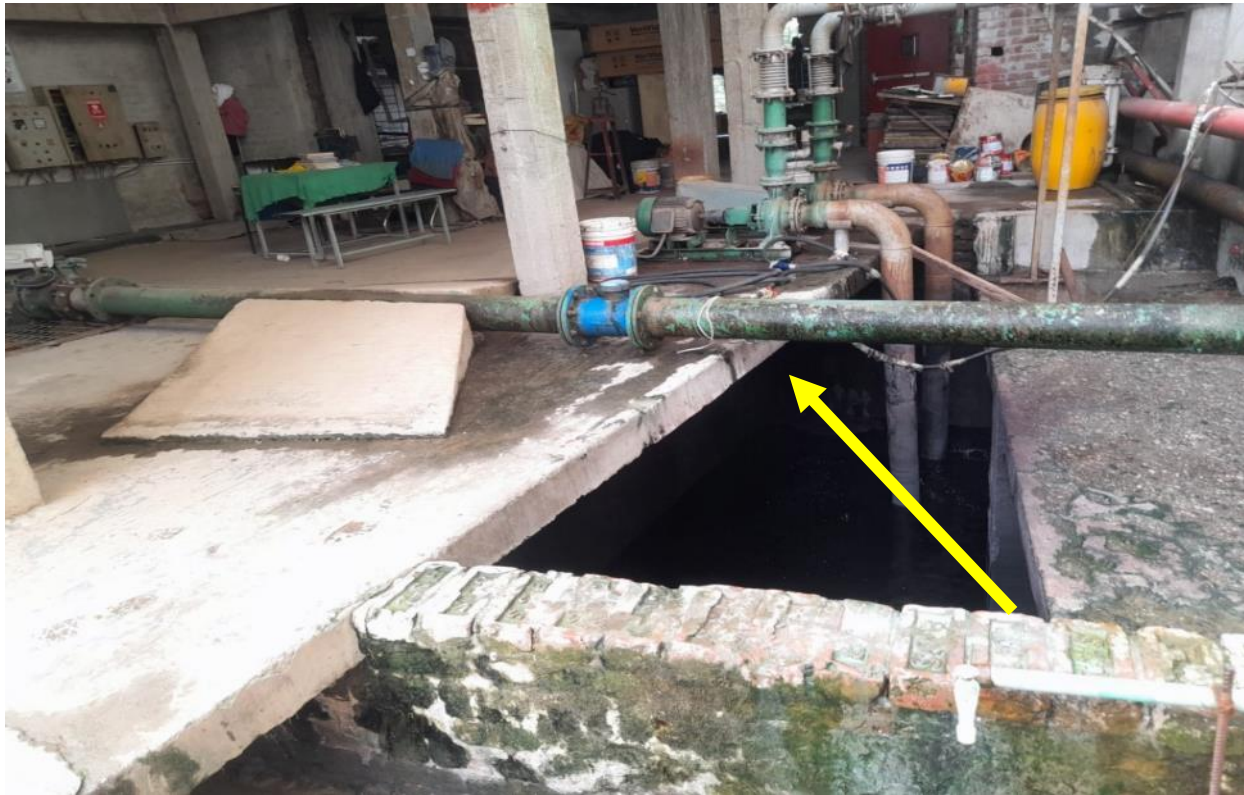
No edge protection provided on underground water tank top slab

No edge protection was provided underground water tank top slab tank which may create falling hazard. Factory is required to provide edge protection to avoid falling hazard.

| Item No. | Observation | Recommended Action Plan | Recommended Timeline |
|---|---|---|---|
| 19 | Falling hazard. (Fire Pump House) | Factory is required to provide edge protection to prevent falling hazard. | 6-weeks |

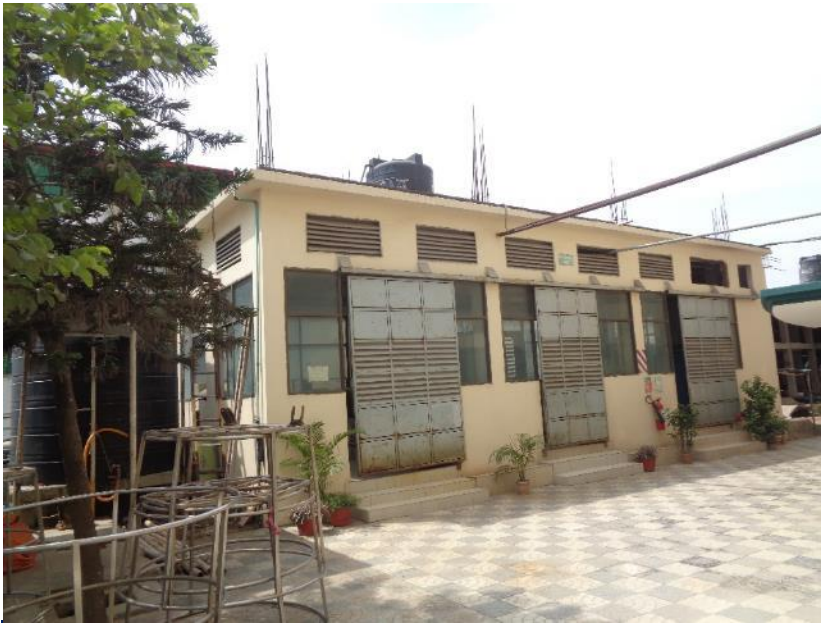
As-built drawing of ETP Control Room and Transformer Room was not available onsite.  
Building engineer is required to produce as-built drawing for both structures.

| Item No. | Observation | Recommended Action Plan | Recommended Timeline |
|---|---|---|---|
| 20 | Absence of as built drawing.<br>(ETP Control Room & Transformer Room) | Building engineer is required to produce as-built drawing of both structures. | 6-weeks |
