# Ananta Huaxiang Ltd. (Extension)

222-223, H1, H2, H3, H4, Aepz, Narayanganj.  
(23.677063, 90.523734)  
13 September 2023

# Building Information

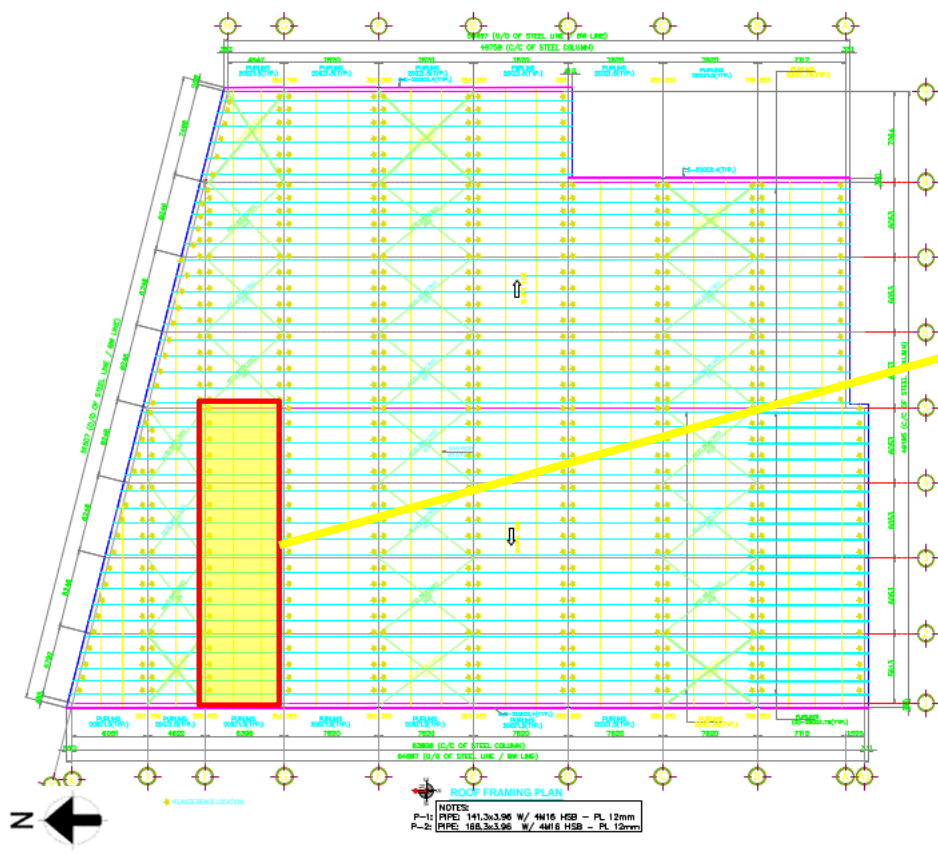
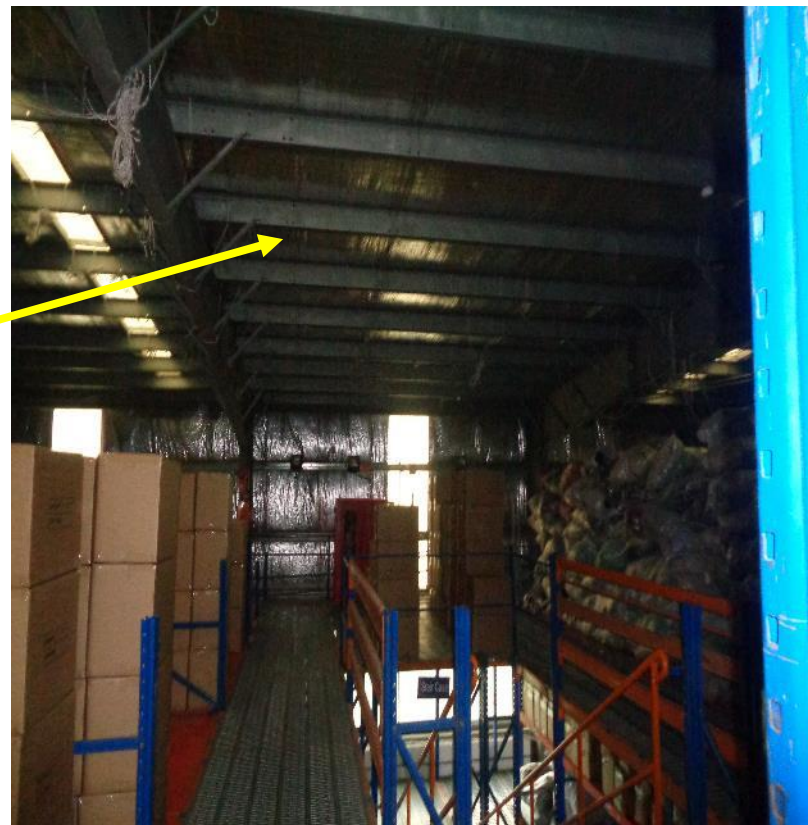
Roof bracing is not continuous at the marked location

Roof bracing is not continued at the highlighted area. Irregular roof bracing system observed for the lateral load path. Building engineer is required to check the lateral stability system for the shed.

| Item No. | Observation | Recommended Action Plan | Recommended Timeline |
|---|---|---|---|
| 01 | Irregular roof bracing system and slender columns. (H-1 Shed) | Building engineer is required to check the lateral stability system for the shed. | 6-weeks |
| 03 | Irregular roof bracing system and slender columns. (H-1 Shed) | Carry out the remedial works if required. | 6-months |

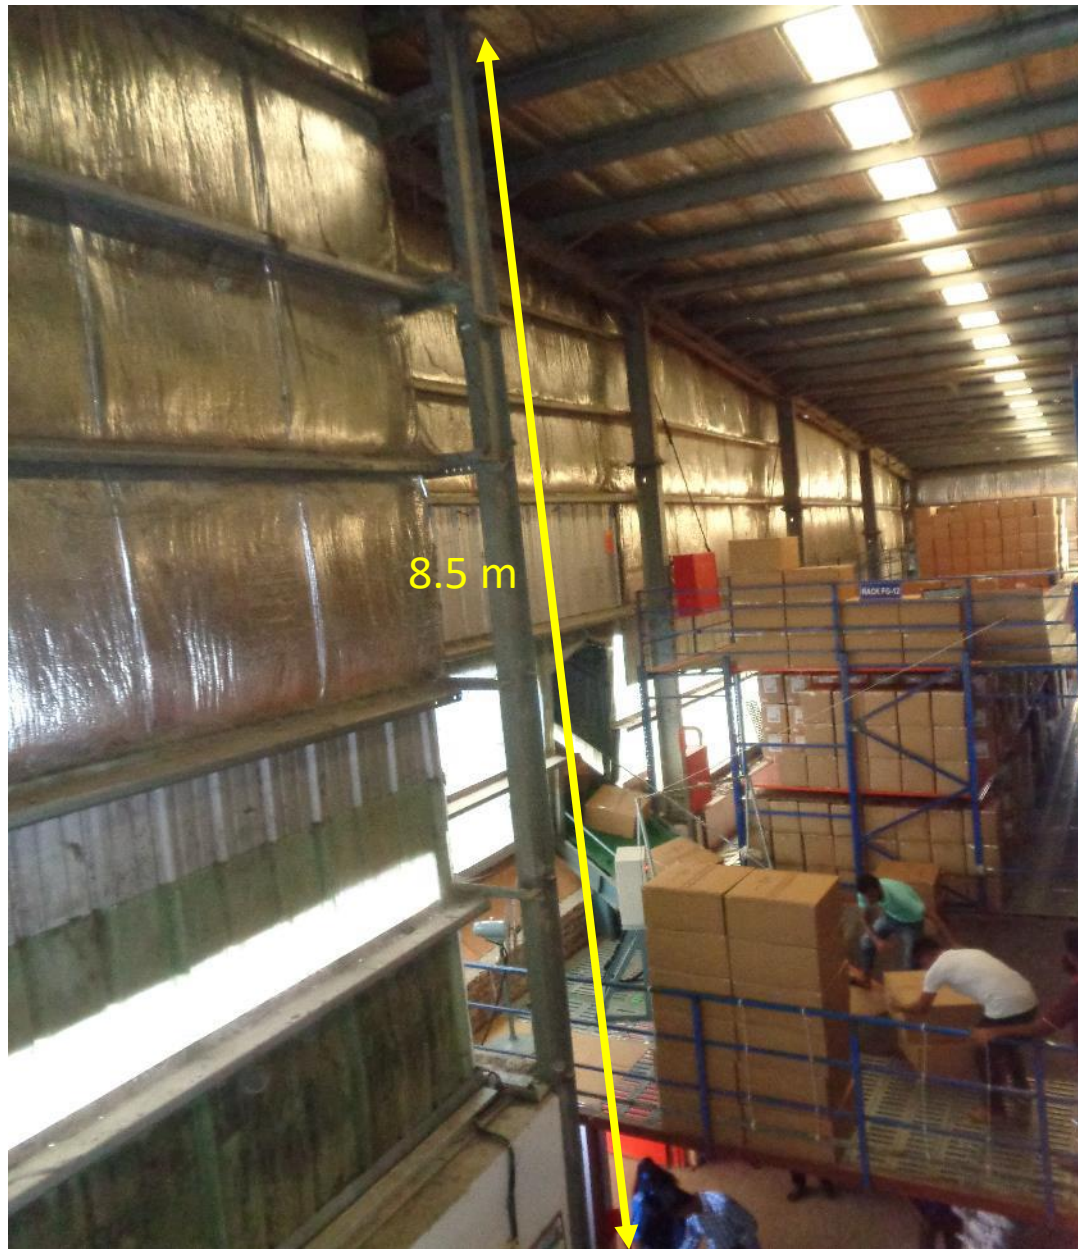
The column size is F-125mmX6mm Web-262mmX4mm and the unsupported column is 8.5 m which indicates slenderness in highlighted columns due to long unsupported length. Building engineer is required to review the design of the column considering the slenderness effect.

Steel column with long unsupported length

| Item No. | Observation | Recommended Action Plan | Recommended Timeline |
|---|---|---|---|
| 02 | Irregular roof bracing system and slender columns. (H-1 Shed) | Building engineer is required to carryout adequacy check of the columns considering slenderness effect and update the design report accordingly. | 6-weeks |

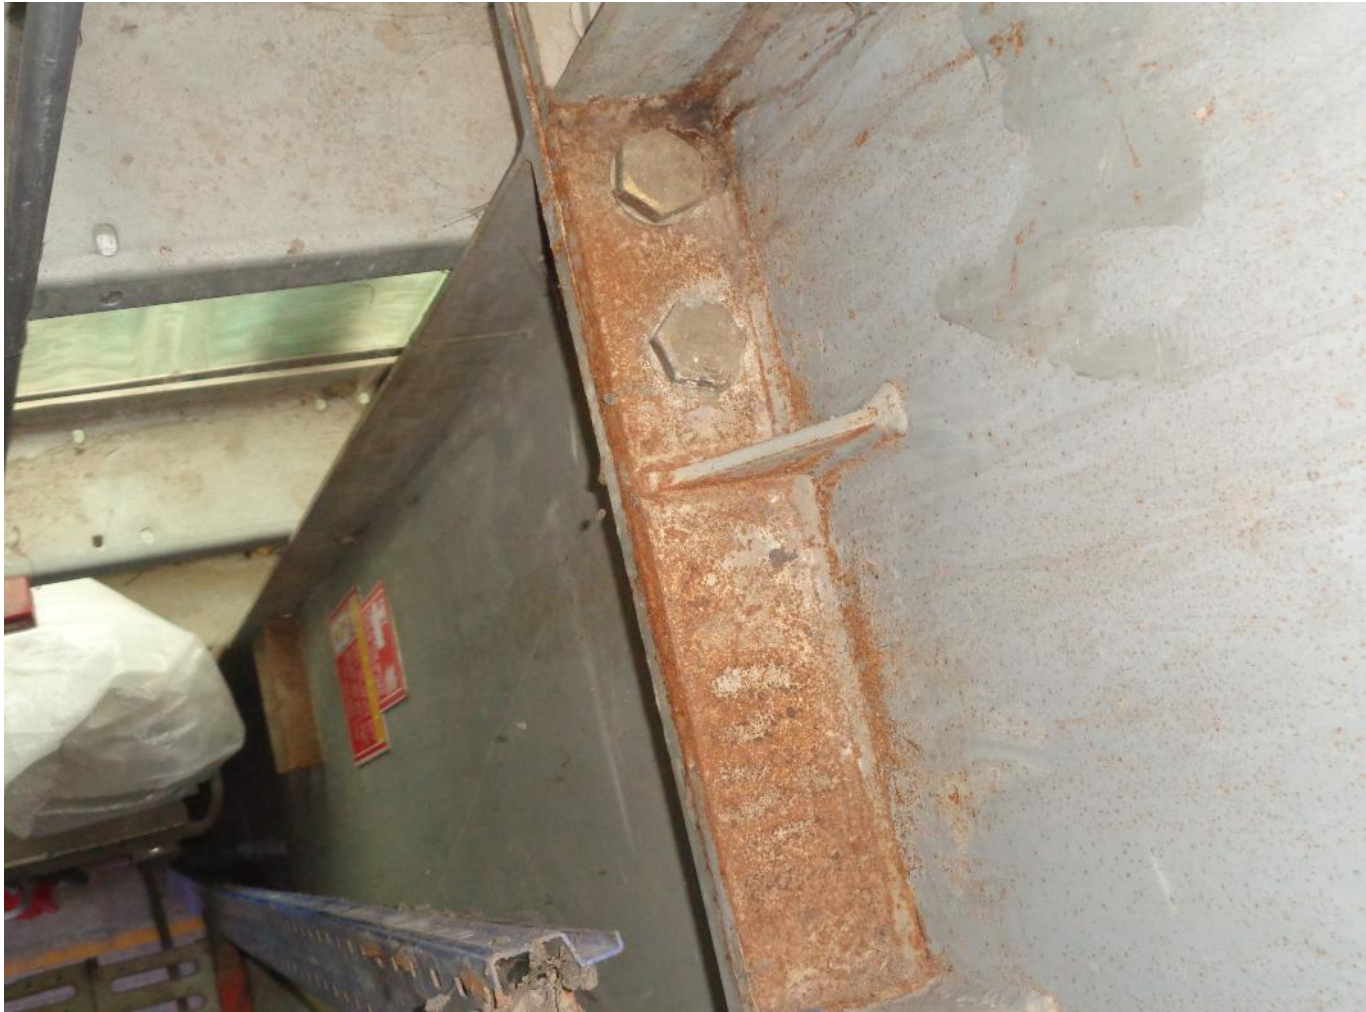
Corrosion on steel column

Corrosion was found in the steel members. Building engineer is required to apply rust proofing on the corroded areas to protect the steel members from corrosion.

| Item No. | Observation | Recommended Action Plan | Recommended Timeline |
|---|---|---|---|
| 04 | Corrosion on steel members . (H-1 Shed) | Factory is required to apply rust proofing on the corroded areas to protect the steel members from corrosion. | 6-weeks |

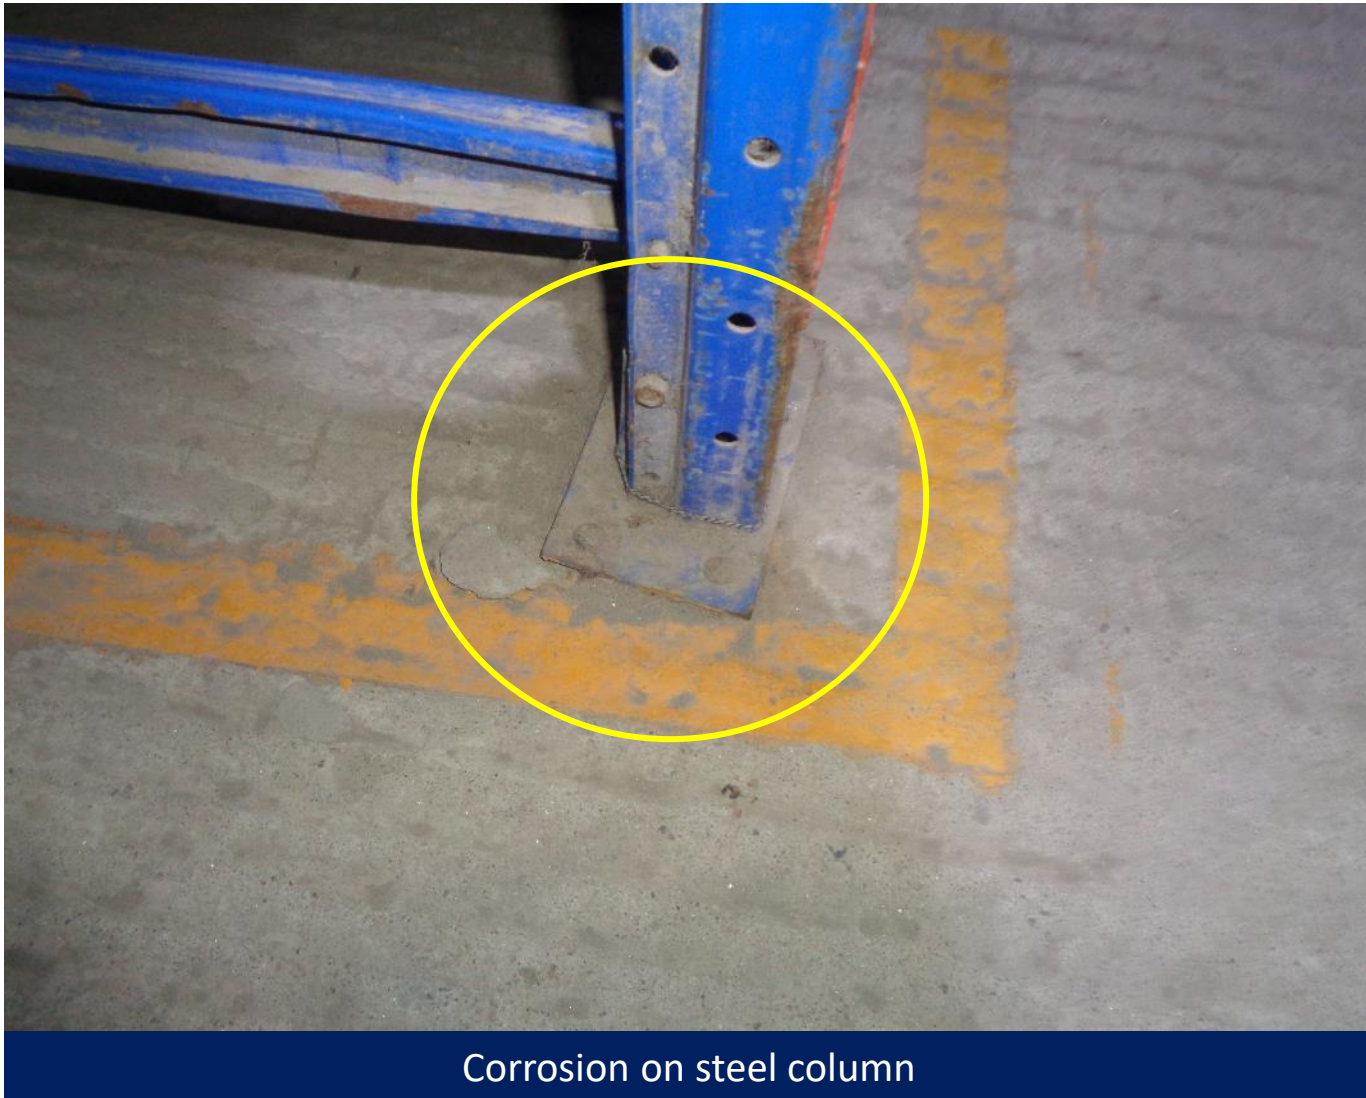
**Steel rack found not anchored at base**

Corrosion on steel column

Corrosion was found in the steel members. Factory is required to apply rust proofing on the corroded areas to protect the steel members from corrosion.

| Item No. | Observation | Recommended Action Plan | Recommended Timeline |
|---|---|---|---|
| 05 | Steel rack found not anchored at base. (H-1 Shed) | Factory is required to brace/anchor all non-structural elements. | 6-weeks |

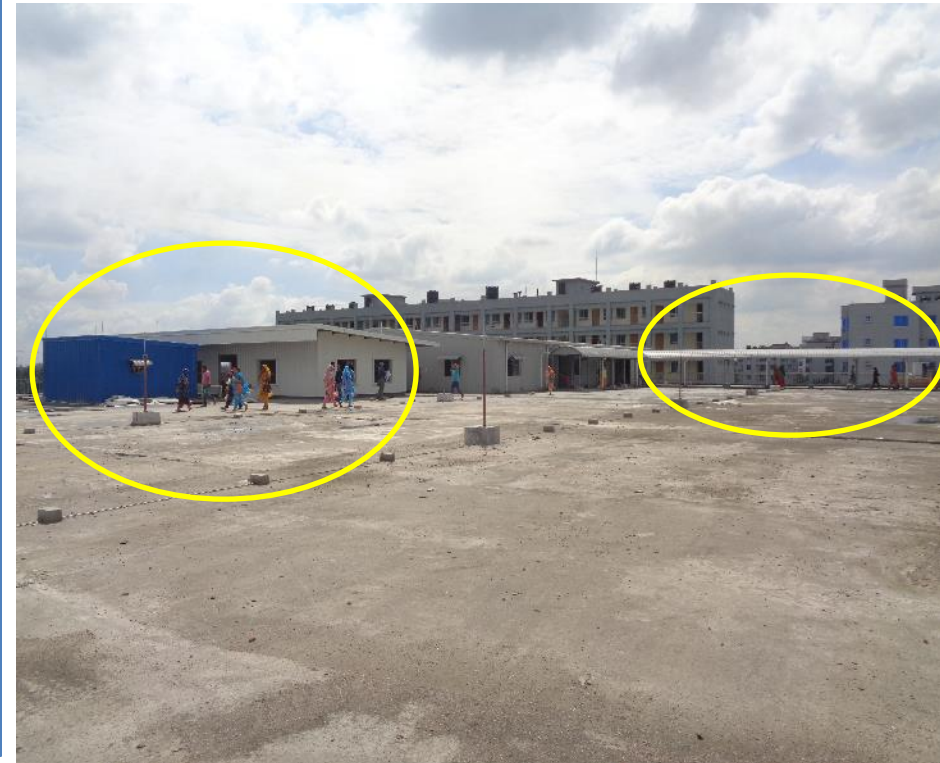
Prayer room, RO room and walkway not considered in analysis model

Prayer room, RO room and walkway at roof level

Load of Prayer room, RO room and walkway not considered in analysis model. Building engineer is required to update the analysis model as per onsite condition and update the design report accordingly.

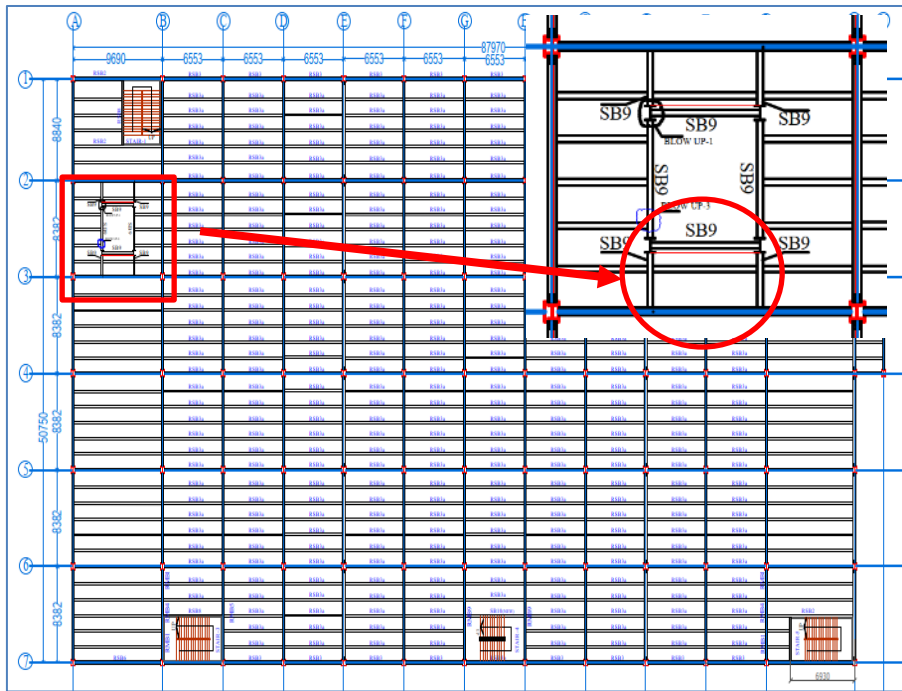
Highlighted beam was shown in drawing

Highlighted beam was shown in drawing but not found on site. Building engineer is required to update the as-built drawing, analysis model as per onsite condition and update the design report accordingly.

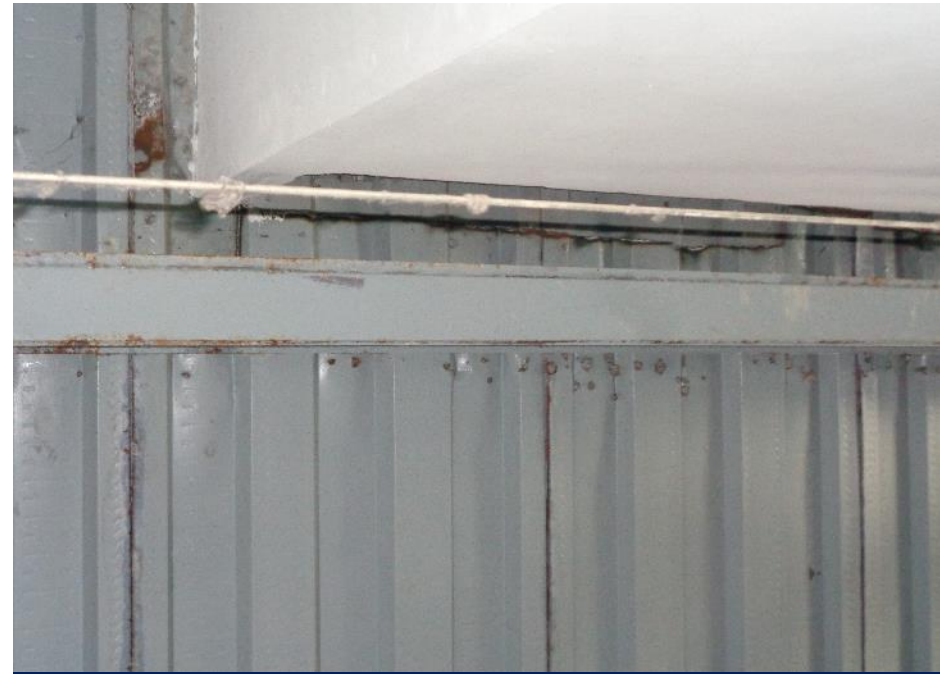
Highlighted beam was not found on site

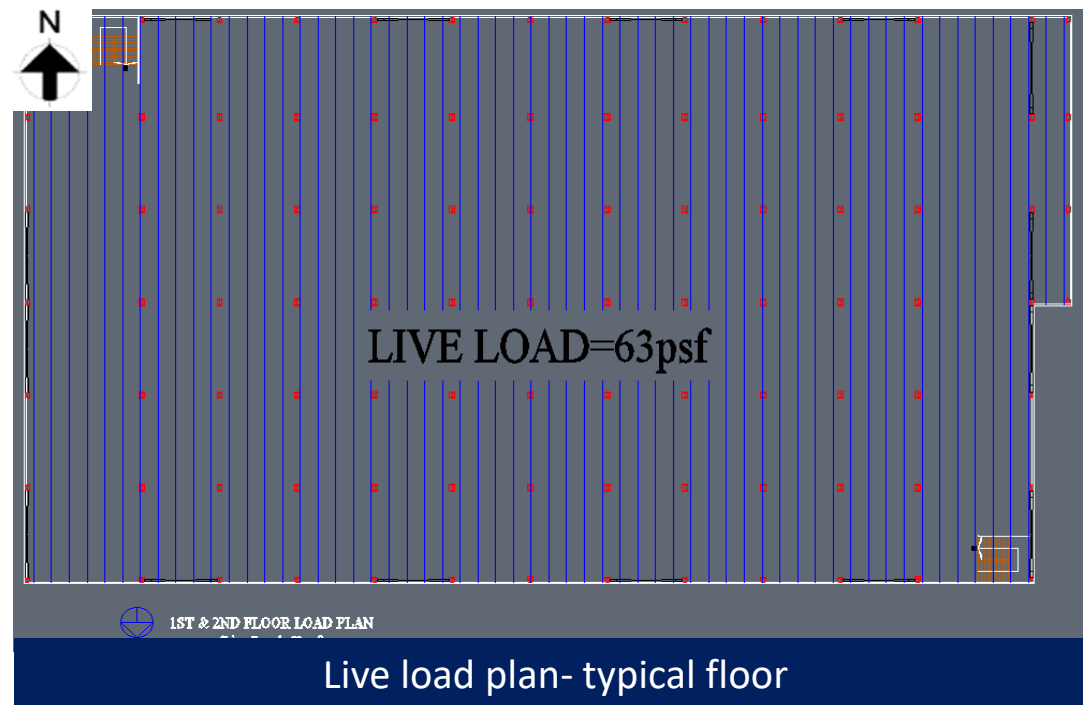
Live load on typical floor is considered as 3 kPa in prepared load plan. As per BNBC- Part 6, live load for light storage areas is required to be considered minimum 6 kPa. However, the Building engineer is required to revise the load plan as per BNBC requirement and check the design accordingly.

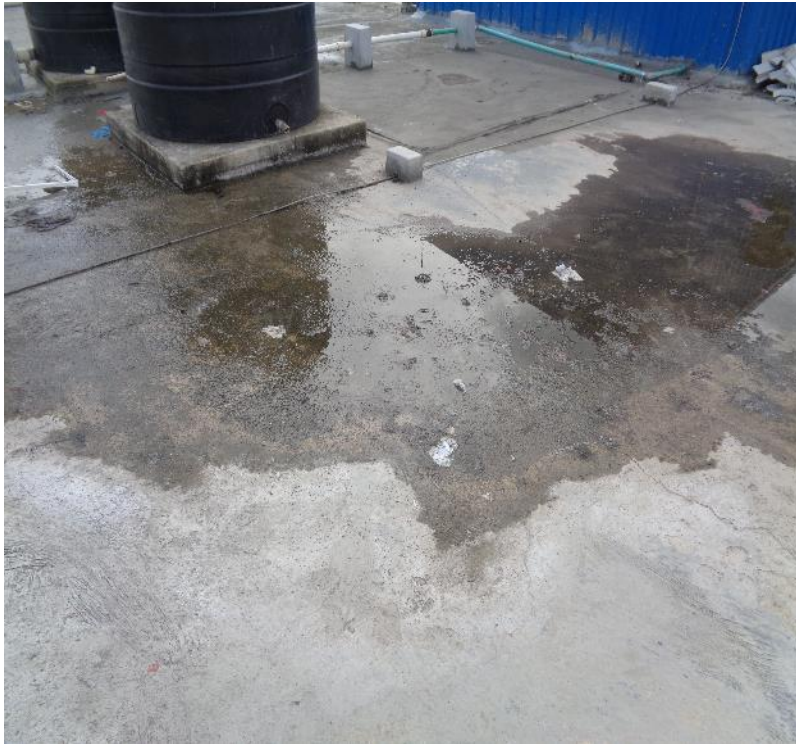
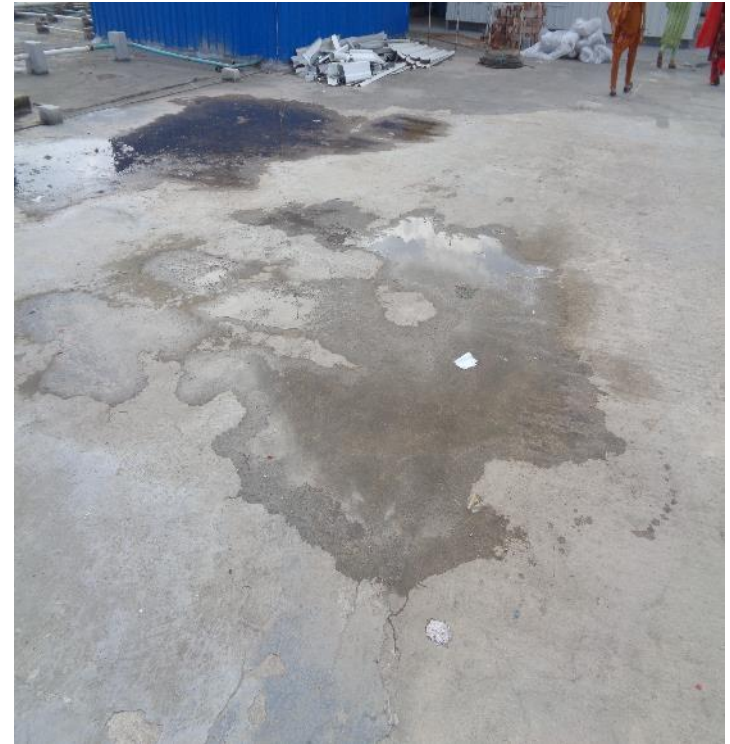
Water ponding on roof slab due to poor drainage system

Stagnant water was found on the roof slab. Building engineer is required to improve the drainage system to drain out the stagnant water.

| Item No. | Observation | Recommended Action Plan | Recommended Timeline |
|---|---|---|---|
| 08 | Stagnant water on roof slab.<br>(Building-C) | Factory is required to improve drainage system and apply water proofing on roof slab. | 6-weeks |

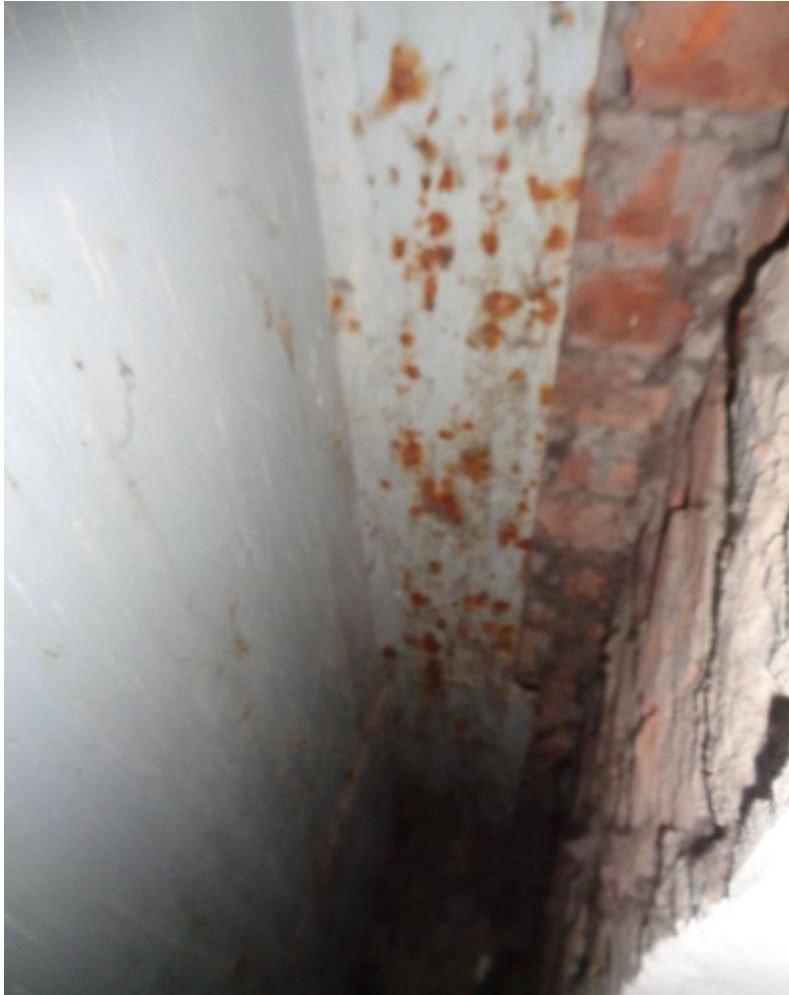
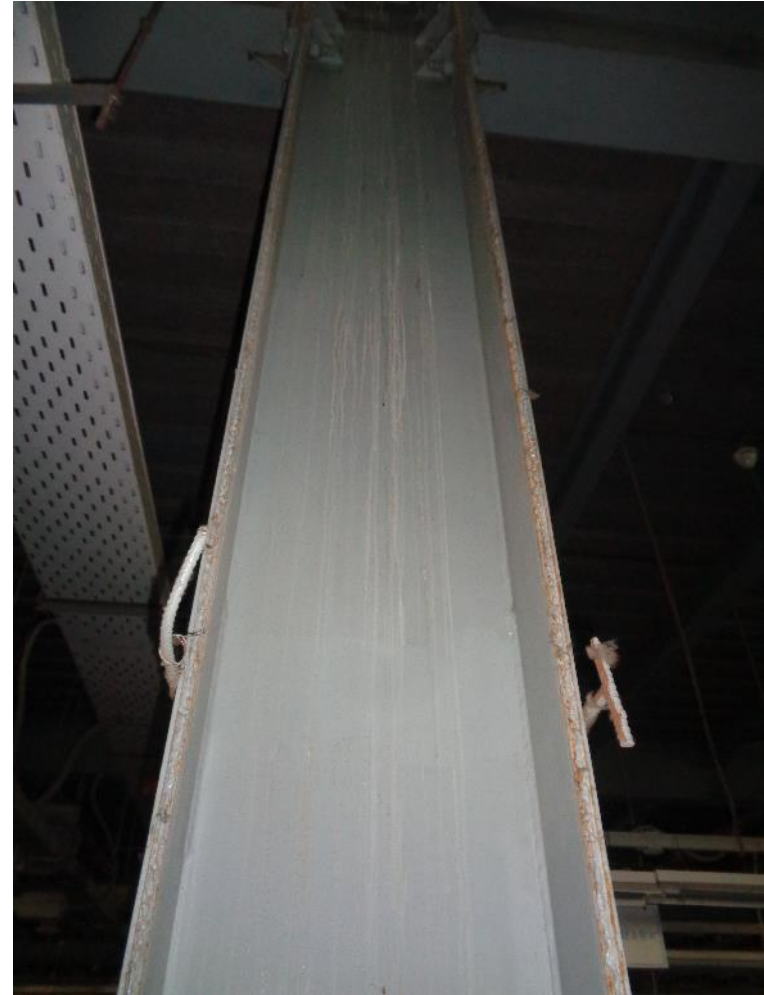
Corrosion in steel column

Corrosion was found in the steel members. Building engineer is required to apply rust proofing on the corroded areas to protect the steel members from corrosion.

| Item No. | Observation | Recommended Action Plan | Recommended Timeline |
|---|---|---|---|
| 09 | Corrosion on steel members.<br>(Building-C) | Factory is required to apply rust proofing on the corroded areas to protect the steel members from corrosion. | 6-weeks |

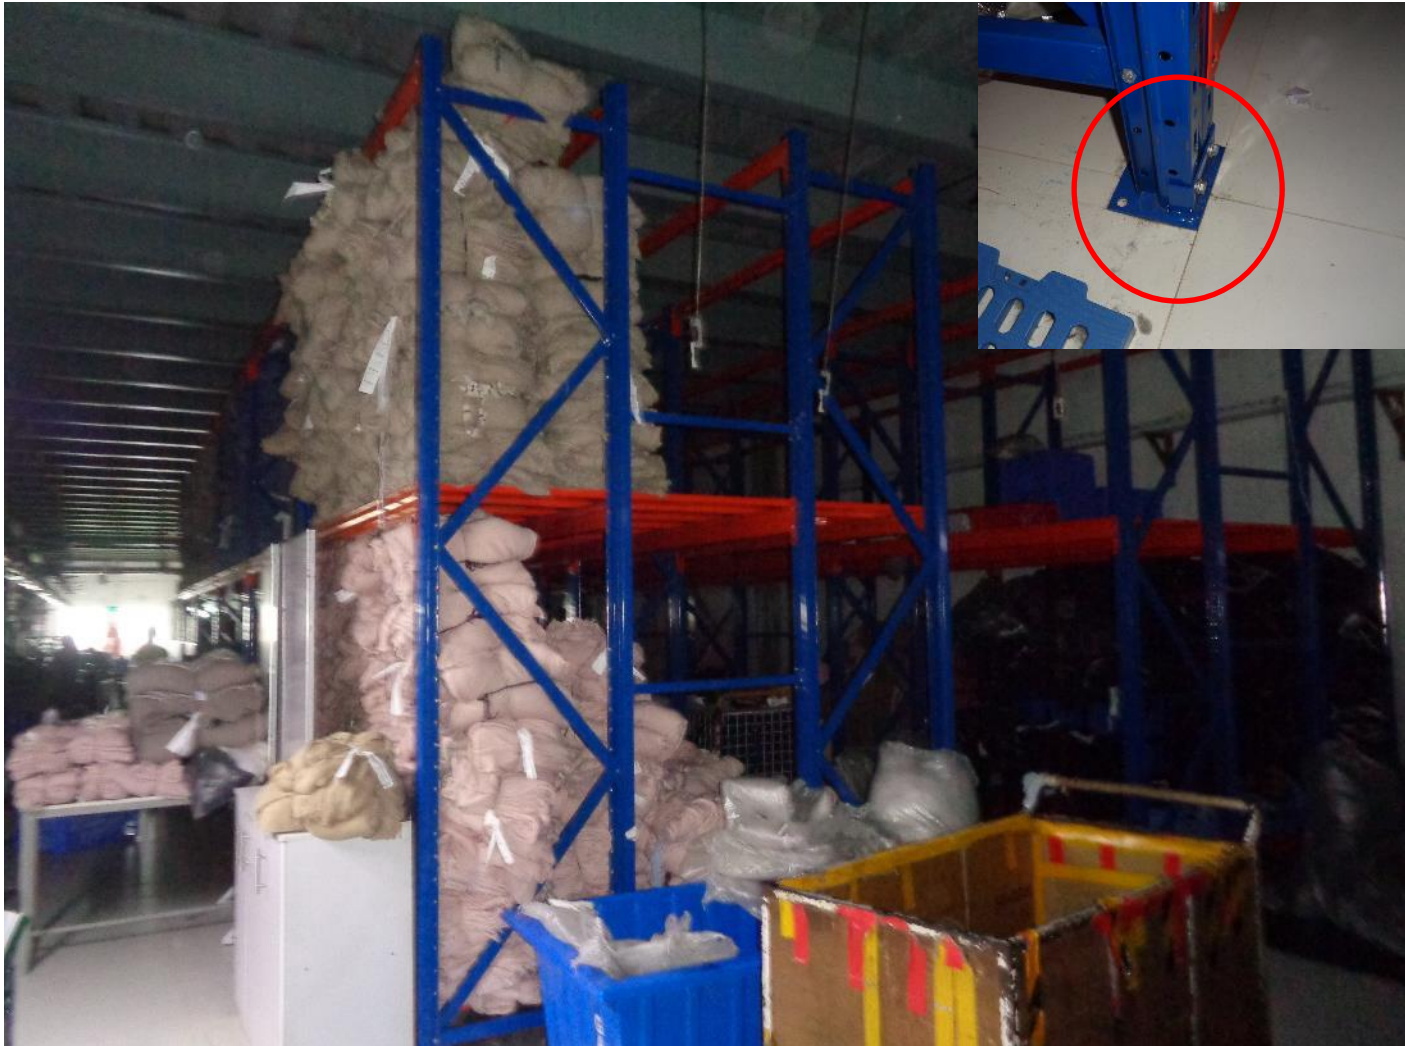
Storage rack found within the building without braced/anchored

Building engineer is required to brace/anchor all non-structural elements.

| Item No. | Observation | Recommended Action Plan | Recommended Timeline |
|---|---|---|---|
| 10 | Non-structural elements found unbraced/not anchored.<br>(Building-C) | Factory is required to brace/anchor all non-structural elements. | 6-weeks |

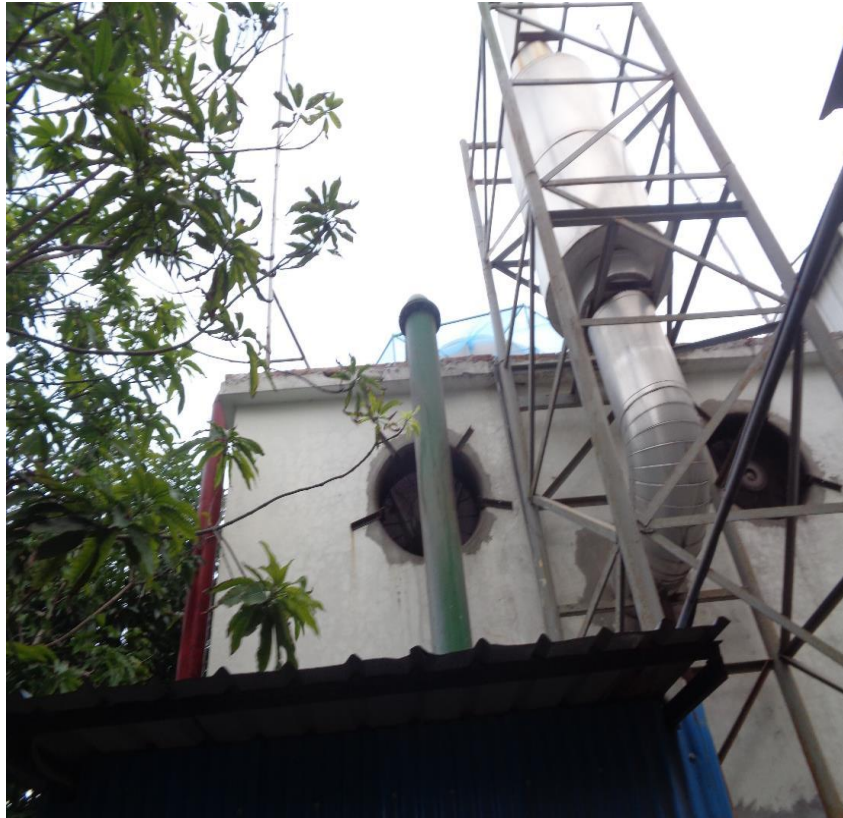
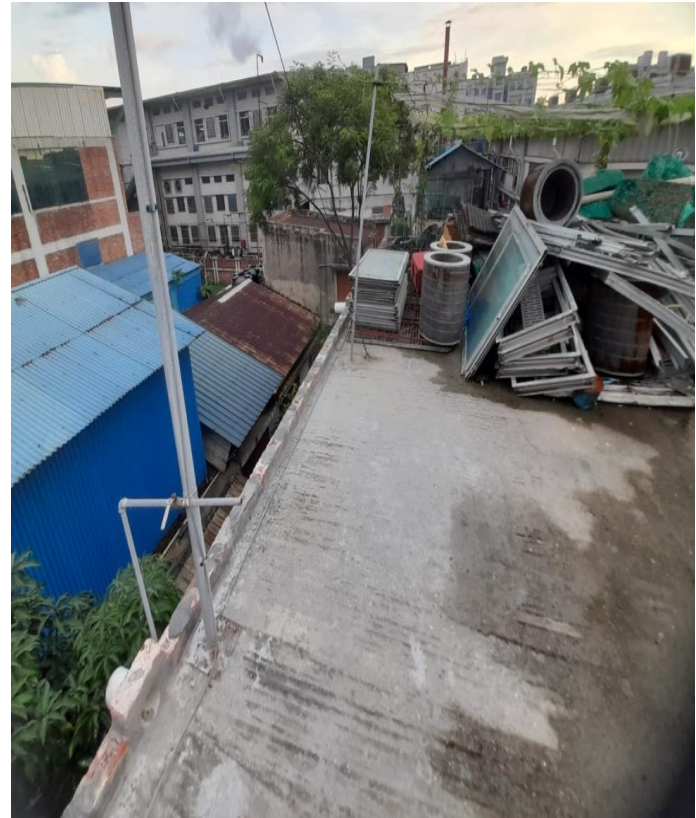
No parapet wall found at roof level

Building engineer is required to provide edge protection to prevent falling hazards.

| Item No. | Observation | Recommended Action Plan | Recommended Timeline |
|---|---|---|---|
| 13 | Falling hazard at roof level.<br>(Gas Generator Building) | Factory is required to provide edge protection to prevent falling hazard. | 6-weeks |
