# International Classic Composite Ltd. (9353)

Naojur, Kodda, Joydebpur, Gazipur, Bangladesh

08.MARCH.2014

## Site Observations

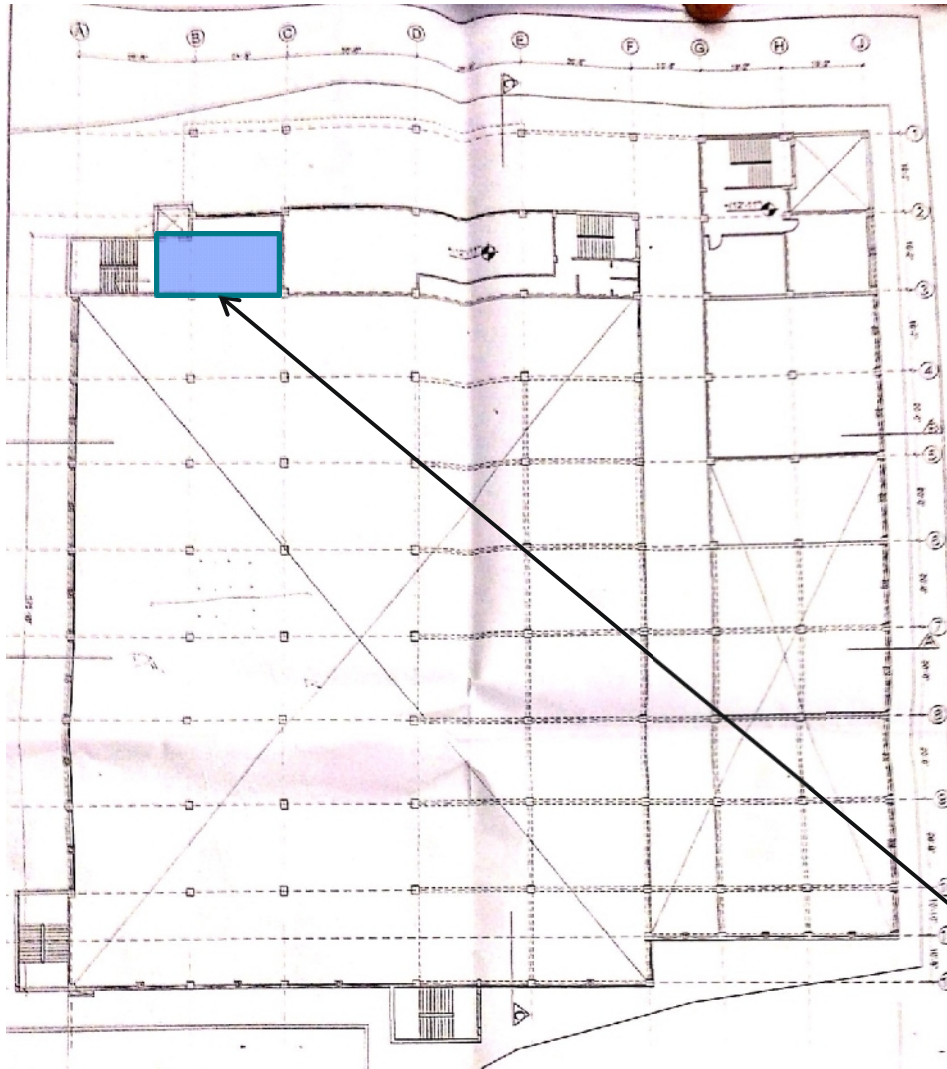
Mezzanine Floor Plan

Connecting bridge on mezzanine floor does not match construction documentation, therefore, capacity check is required for supporting beam

- Factory Engineer to review design, loads, for this and connecting bridge on mezzanine floor and additional steel staircase and confirm suitability for such applied loads

- Verify in situ concrete stresses either by cores or existing cylinder strength data for affected beams and columns.
- Detail engineering assessment to be completed.
- Produce and actively manage loading plan for all floor plates giving consideration to floor capacity and column capacity

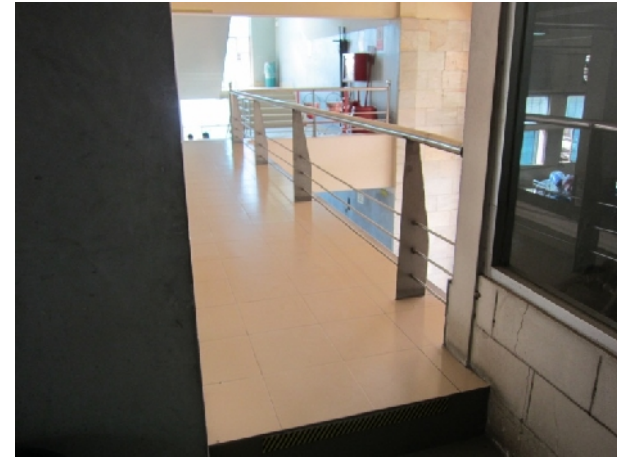
Bridge connecting with stair landing on mezzanine floor does not match the existing floor plan. Capacity check is required for supporting beam.

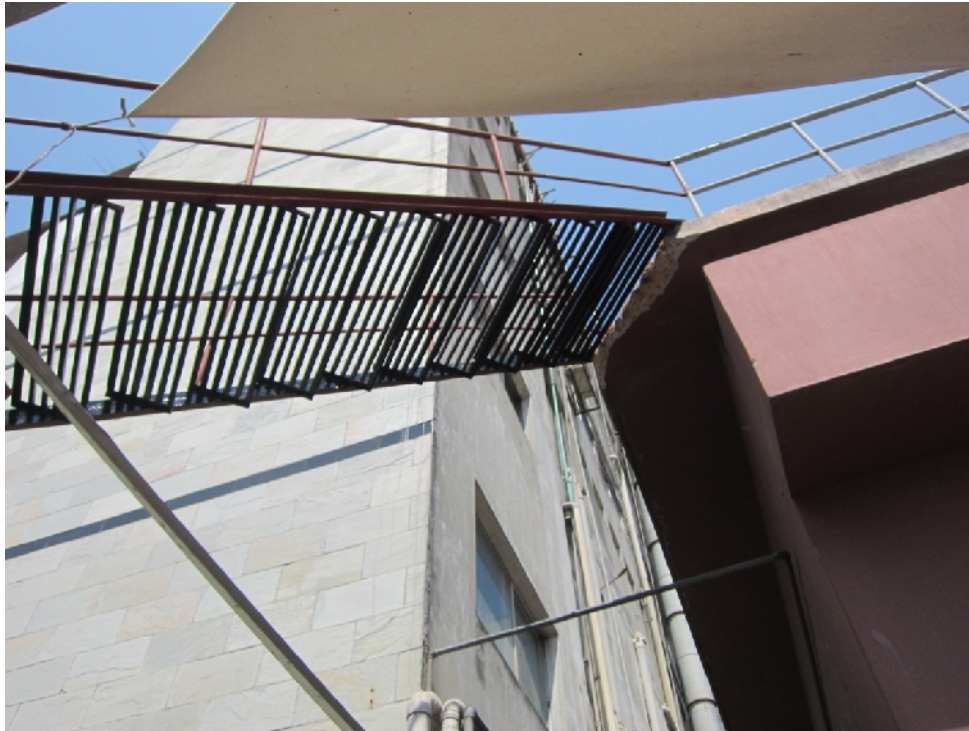
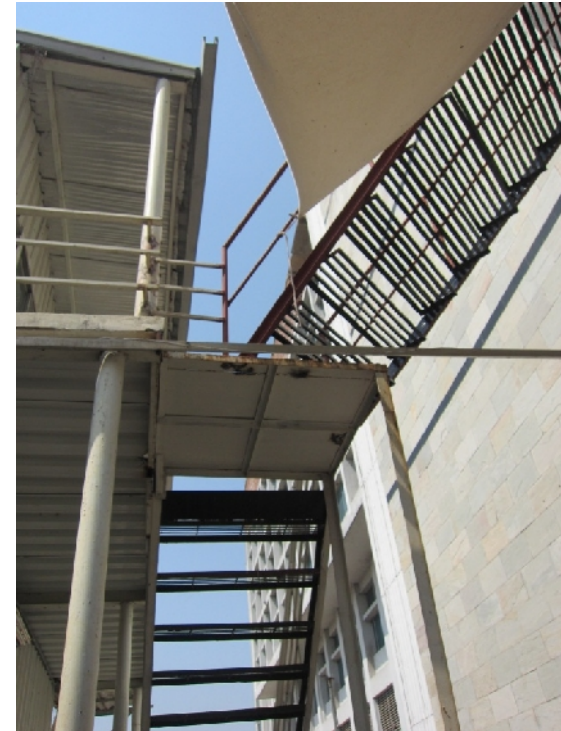
Additional Steel staircase connected with one storey building and waste water treatment plant.

Capacity check for structural element to support this additional load, especially at support connections.

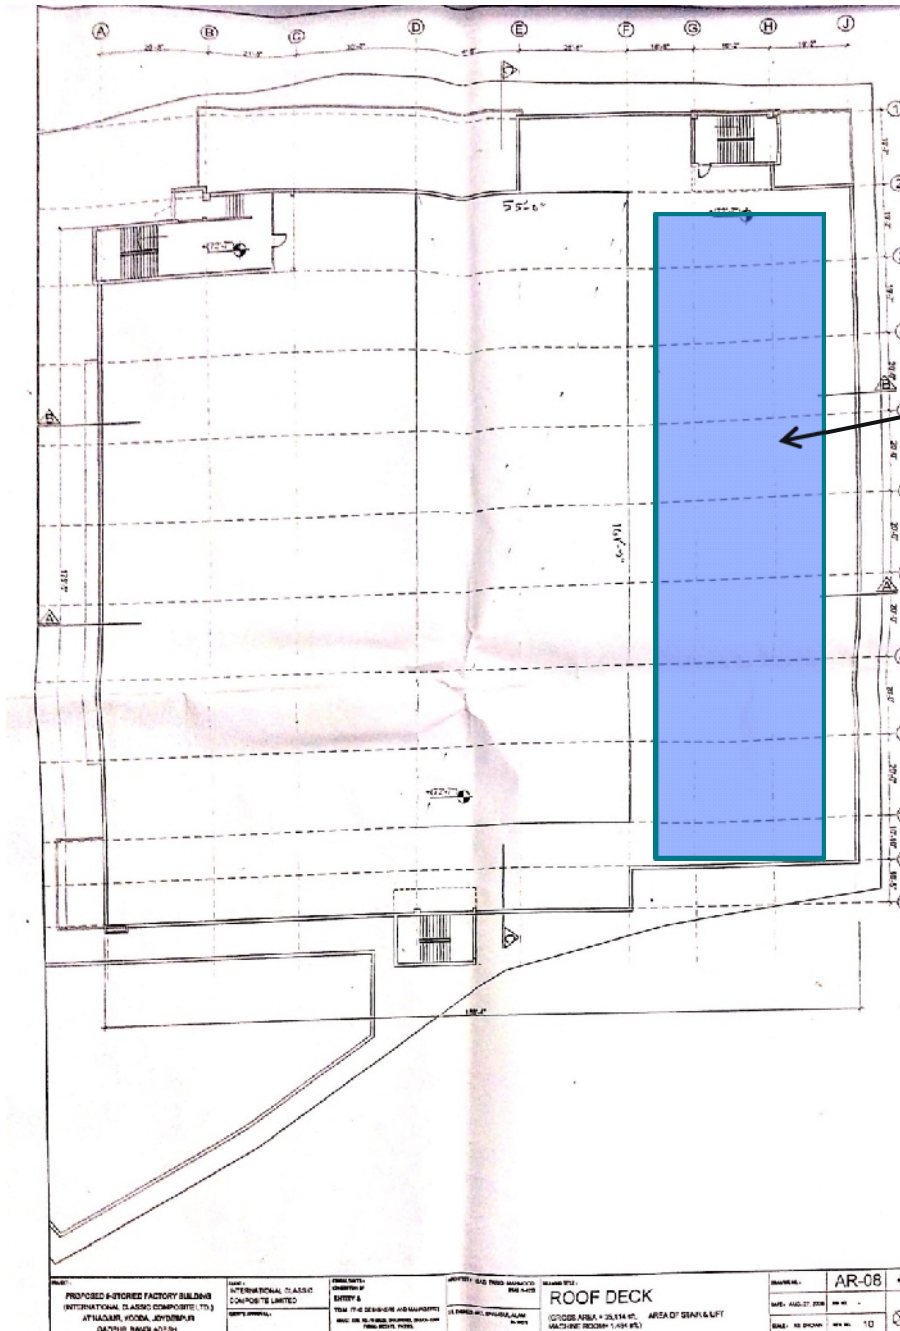
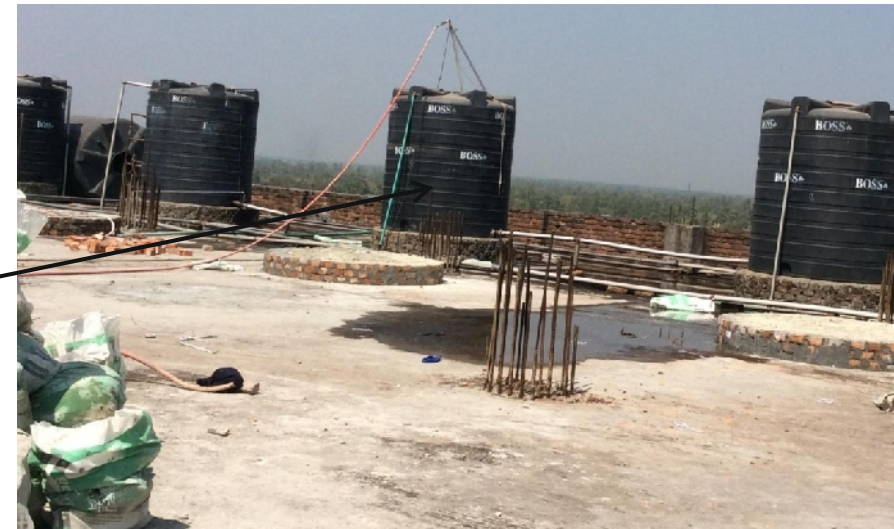
Uncontrolled heavy water storage loading on roof deck.

- Adopt some sort of signage/staff guidance to ensure that the maximum weight of storage is not exceeded .

- Maintain standards of quality control to ensure that storage procedures are correctly followed so that overloading problems do not arise in the future.

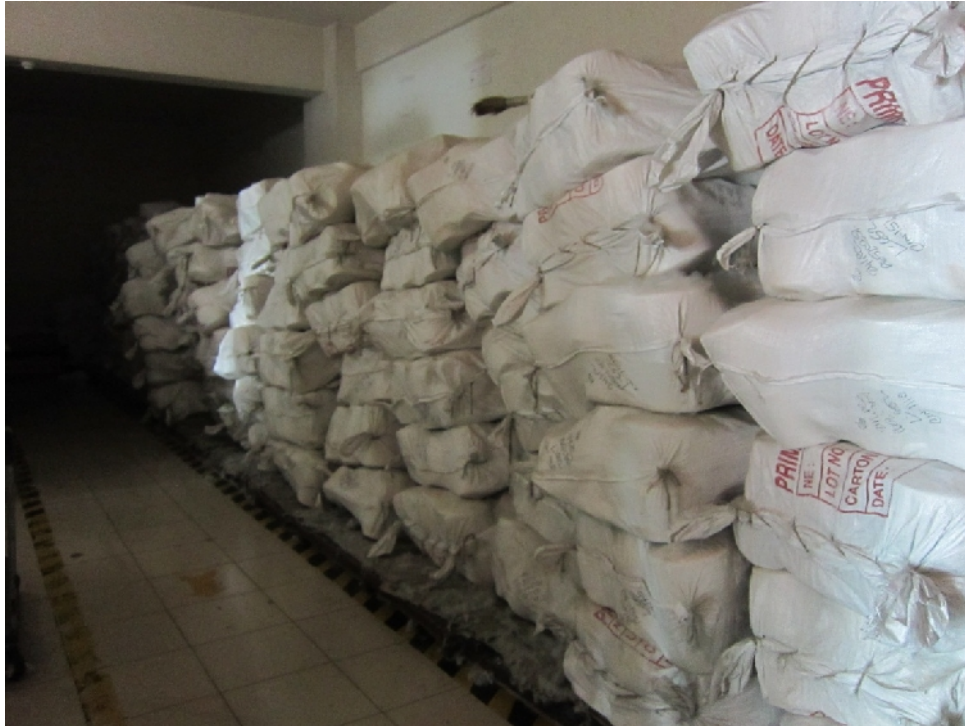
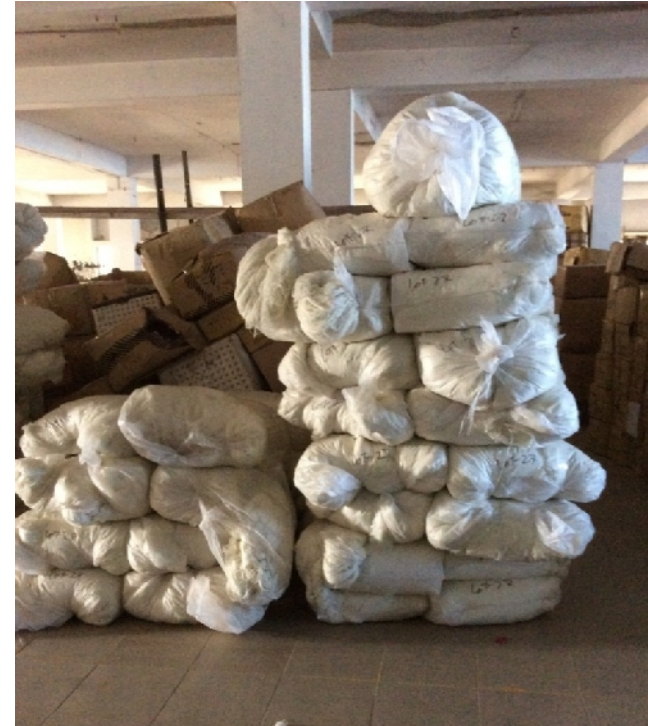
Uncontrolled heavy storage on 2<sup>nd</sup>  
& 3<sup>rd</sup> floors.

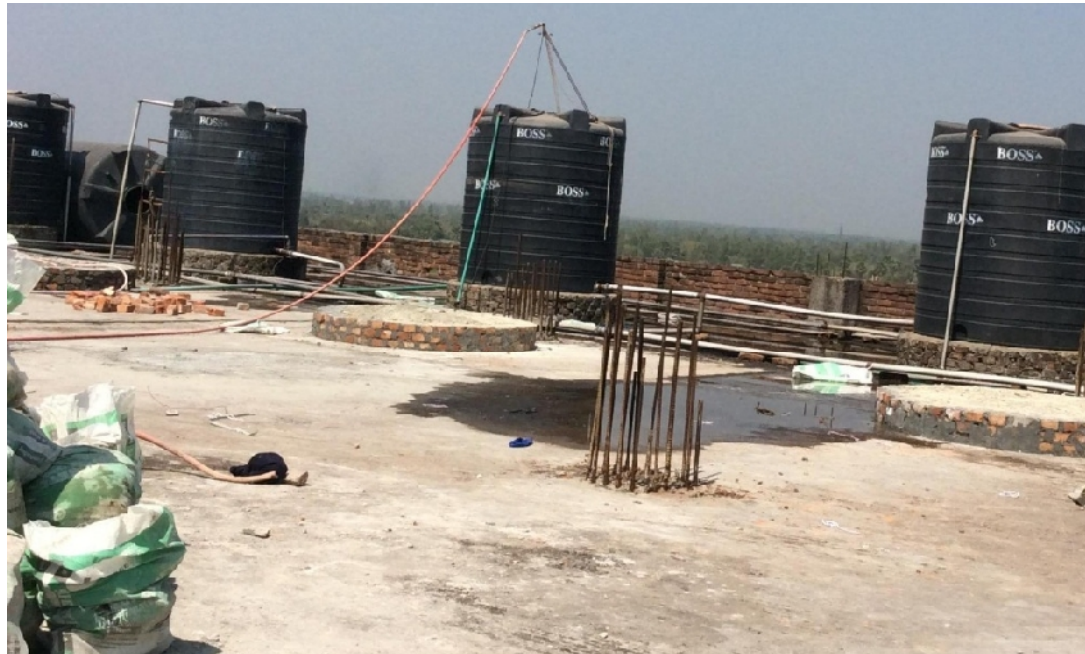
Waterproofing material to be applied including rust-proof paint for the exposed reinforcement

An appropriate layer of waterproofing needs to be applied including rust-proof paint for the exposed reinforcement.

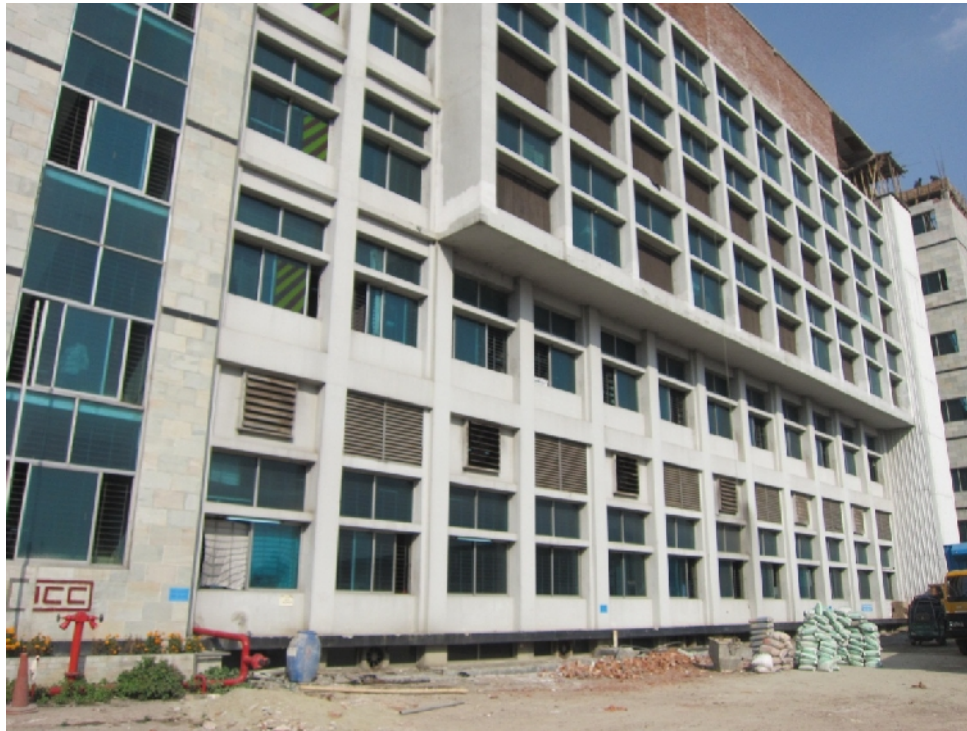
Concerns on the stability system for lateral loading and seismic loading. Façade brickwork with little capacity; lack of moment capacity in connection between columns and beams.

Further detail engineering assessment is required whether such system can resist the lateral load from wind & earthquake

- Detail engineering assessment to be carried out in particular stability and foundation aspects to be investigated in detail.

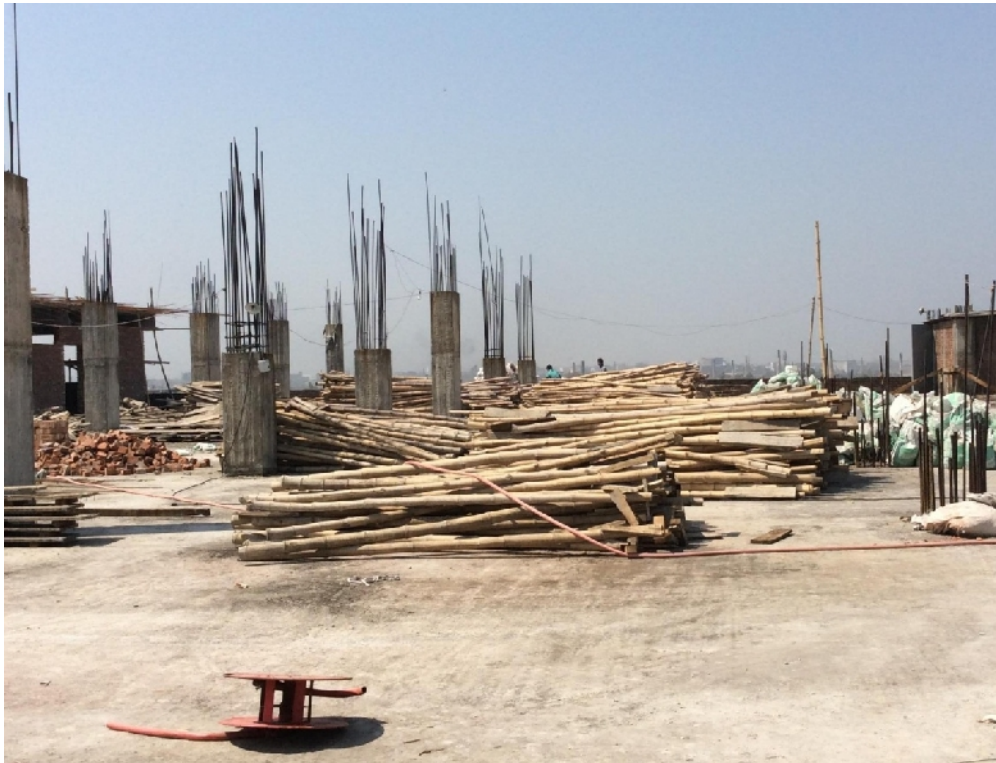
There is no evidence of water ingress at the roof level, however, it should be considered as an on-going action to apply waterproofing measures during construction, while the 6th floor acts as a roof level.

- The existing roof level does not have any waterproofing. This is not a long-term problem as another level is under construction above, however it should be considered as an on-going action to apply temporary waterproofing measures during construction, while the 6th floor acts as a roof level.

- Ensure that an appropriate layer of waterproofing is included in the build-up of the final roof level, once construction is complete.
