# Mondol Knitwears Ltd (shed)

Rashid Tower, Tongabari, Ashulia, Savar, Dhaka

27 September 2023

1. Single Storied Prefabricated steel shed.

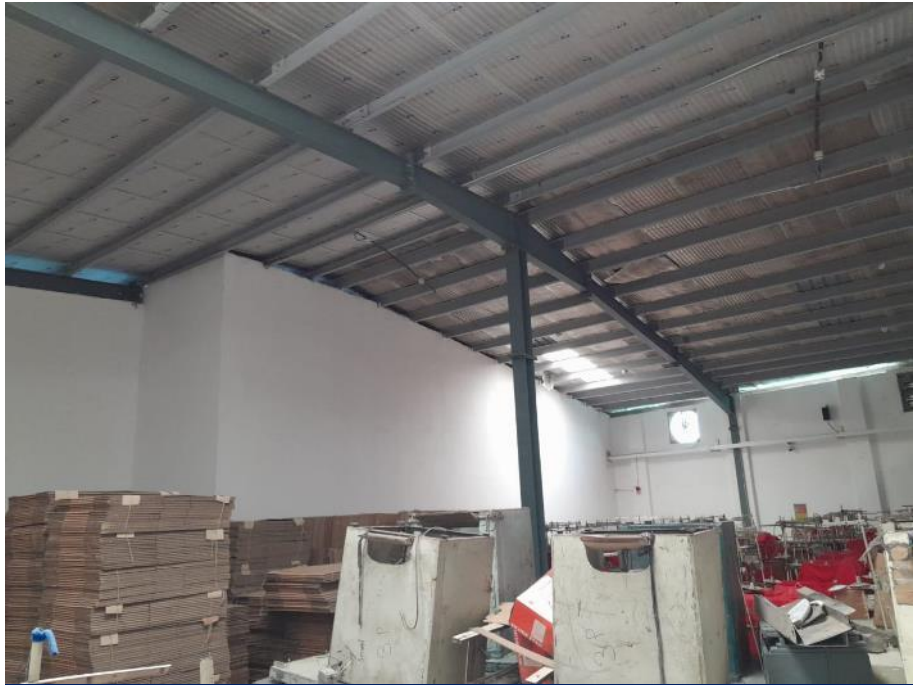
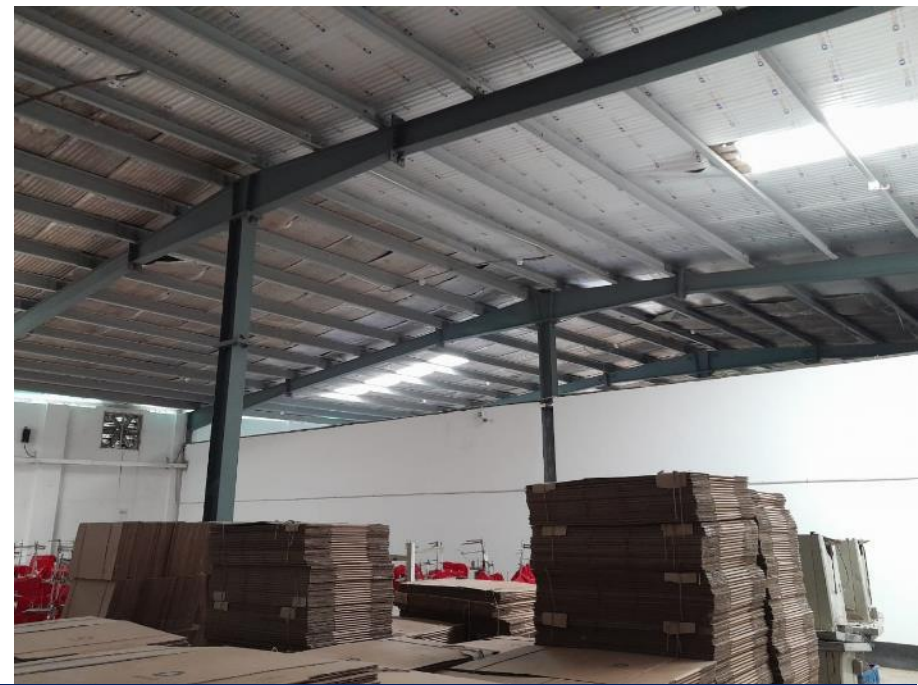
**Lack of lateral stability system in long direction**

No bracing or strut member observed along long direction

No bracing or strut member was observed in the long direction of the shed. Building engineer to carry out Engineering Assessment (EA) to check the lateral stability of the structure.

| Item No. | Observation | Recommended Action Plan | Recommended Timeline |
|---|---|---|---|
| 01 | Lack of lateral stability system in long direction. | Building engineer to carry out Engineering Assessment (EA) to check the lateral stability of the structure | 6-weeks |
| 02 | Lack of lateral stability system in long direction. | Carry out suggested remedial works where required. | 6-months |

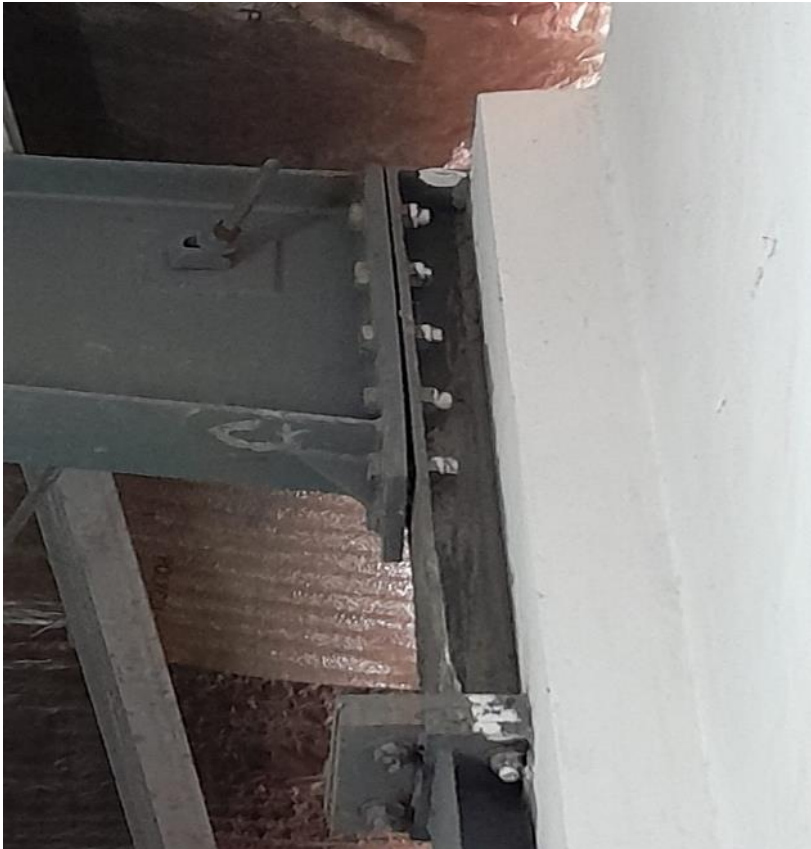
Connection gap in steel column-rafter joint

Significant gap in the connection of the rafter to the column and base plate to the concrete pedestal was found. Building engineer is required to survey the whole structure & and identify the locations of the connection gaps and suggest proper remediation.

| Item No. | Observation | Recommended Action Plan | Recommended Timeline |
|---|---|---|---|
| 03 | Significant gap in connection. | Building engineer is required to identify the locations of the connection gaps and repair the gap with suitable method. | 6-weeks |

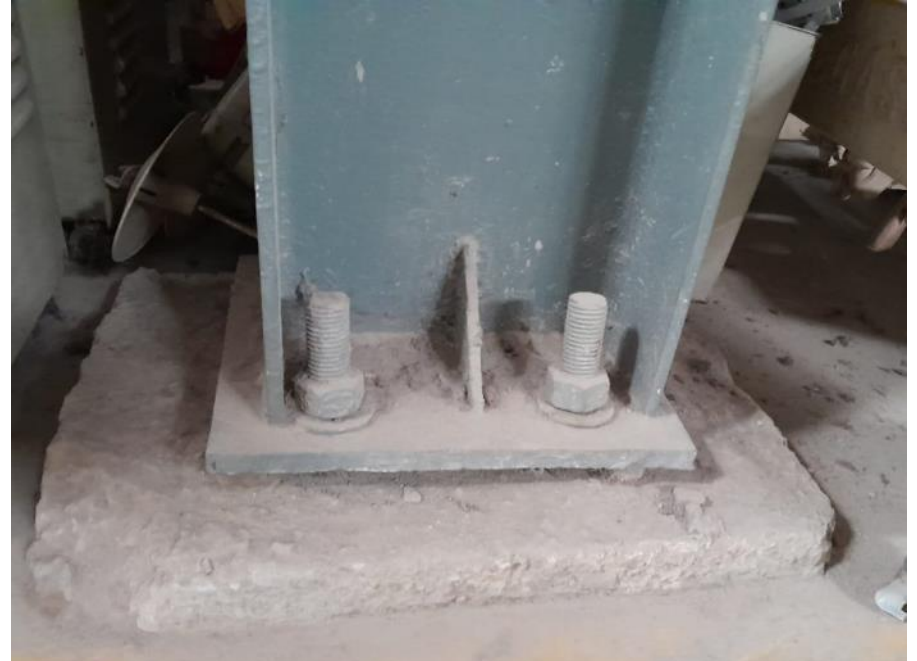
Connection gap in baseplate joint

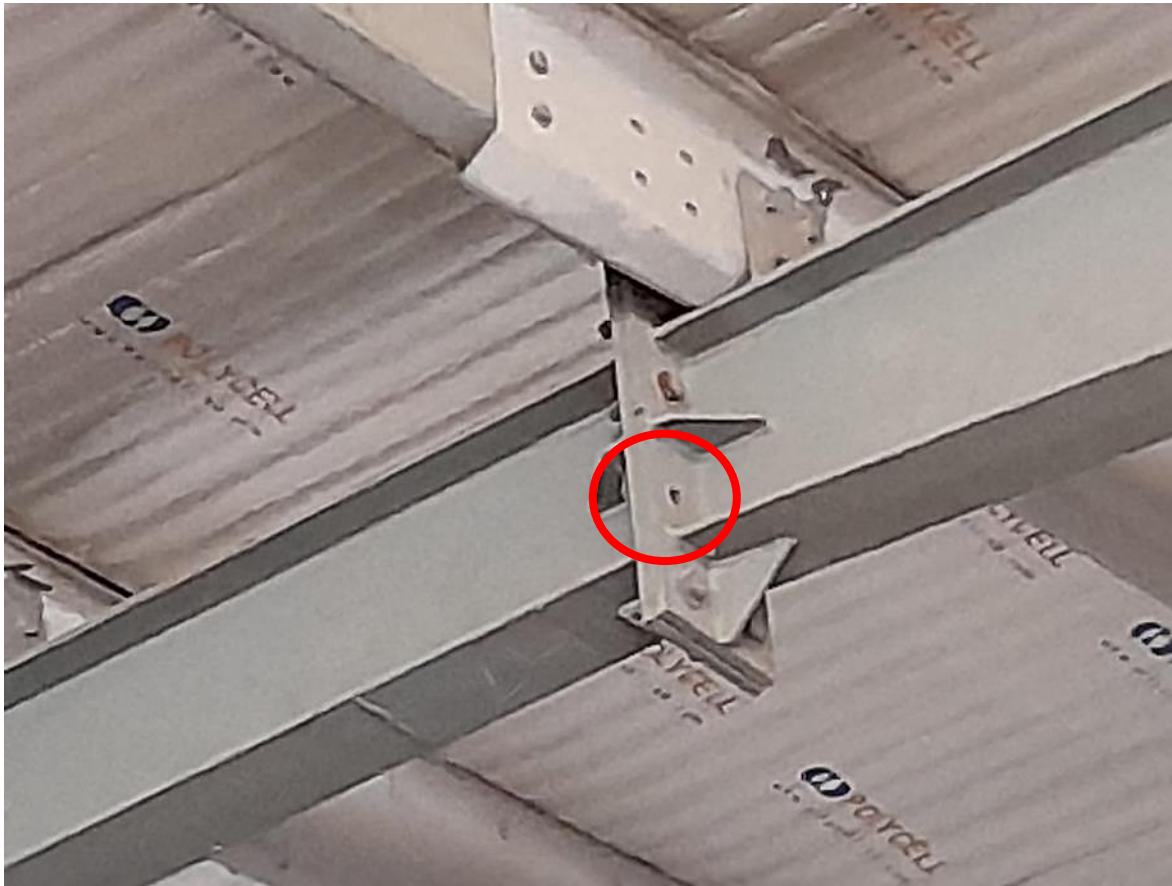
Bolt missing

Bolt missing in several connection joints. Building engineer is required to identify all the locations and install missing bolts accordingly.

| Item No. | Observation | Recommended Action Plan | Recommended Timeline |
|---|---|---|---|
| 04 | Bolt missing in steel connection. | Building engineer is required to identify all the locations and install missing bolts as per specification. | 6-weeks |

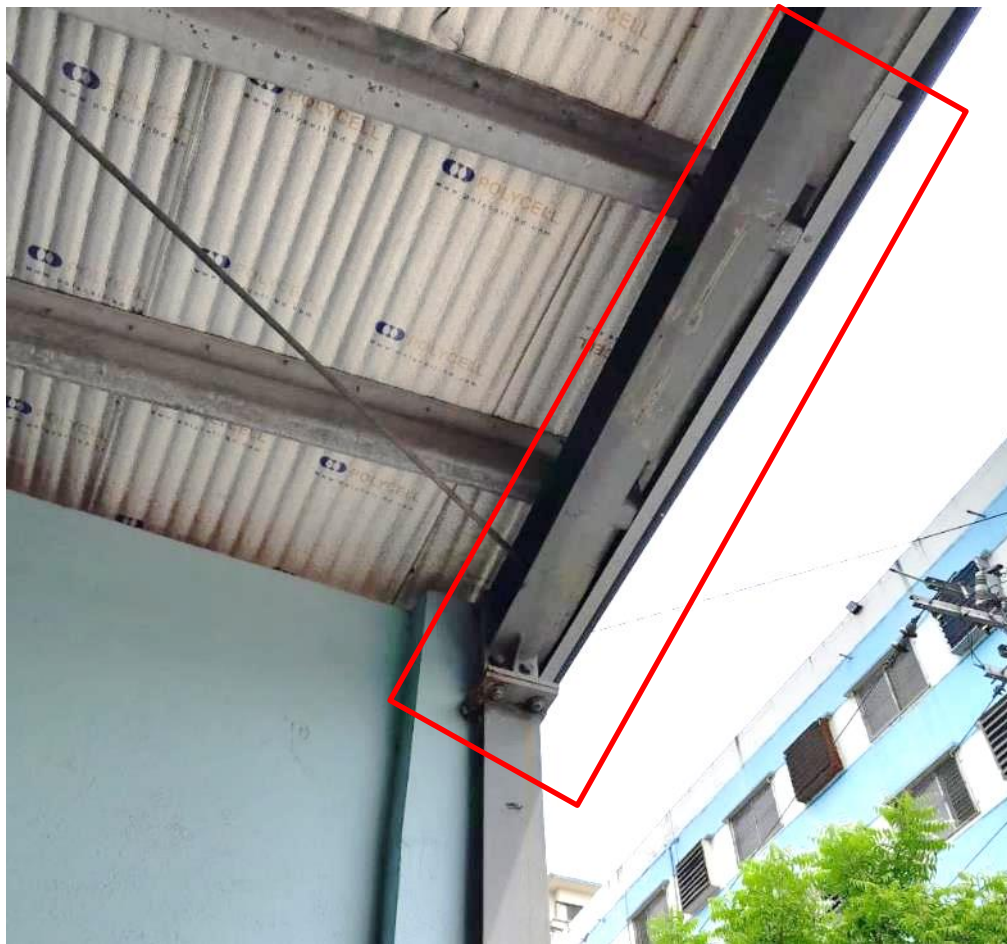
Corrosion in steel members

Severe corrosion was observed on steel members. Building engineer is required to remove the corrosion and provide rust-proof paint on all steel members to protect from corrosion.

| Item No. | Observation | Recommended Action Plan | Recommended Timeline |
|---|---|---|---|
| 05 | Corrosion on steel members. | Building engineer is required to remove the corrosion and apply the anti-rust coating to the steel members. | 6-months |

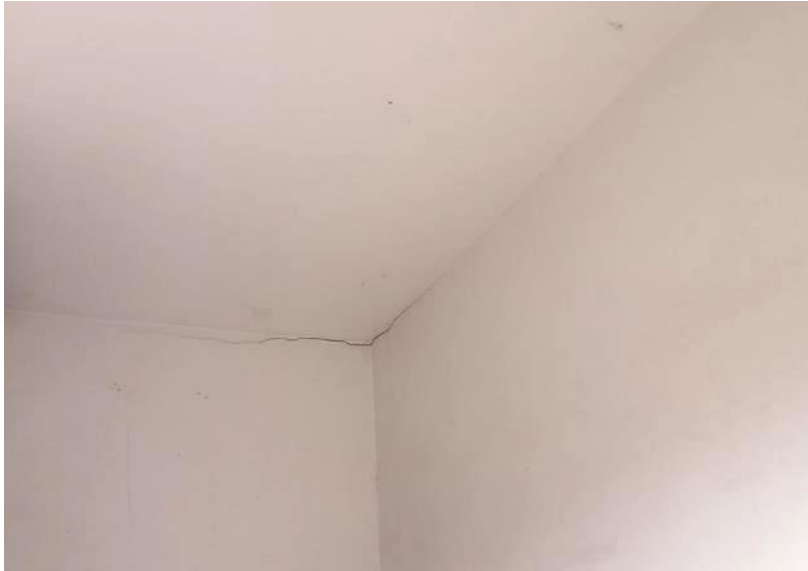
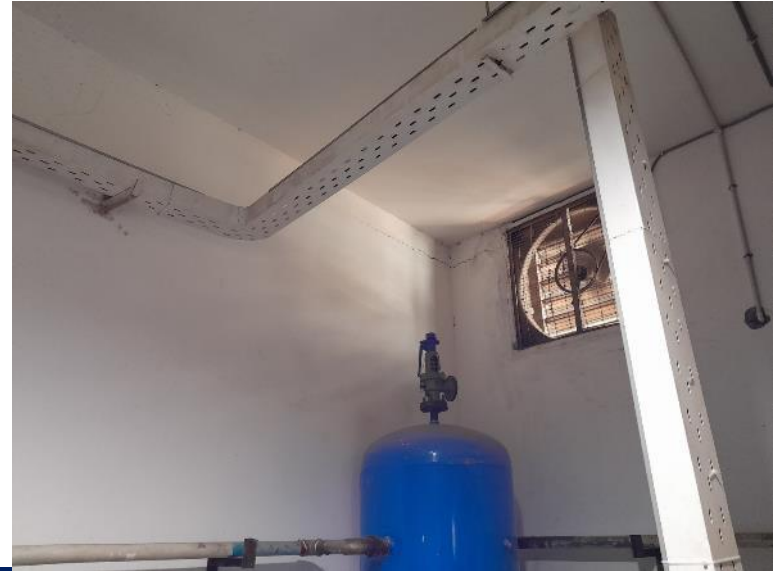
**Crack between load-bearing brick wall of boiler,  
compressor, RMS room**

Crack between the load-bearing brick wall and RC slab

Building engineer is required to investigate the cause of the crack and suggest any remediation required.

| Item No. | Observation | Recommended Action Plan | Recommended Timeline |
|---|---|---|---|
| 06 | Crack in load-bearing brick wall of boiler, compressor, RMS room. | Building engineer is required to investigate the cause of wall cracks and suggest any remediation required. | 6-weeks |
| 07 | Crack in load-bearing brick wall of boiler, compressor, RMS room. | Carry out suggested remedial works. | 6-months |

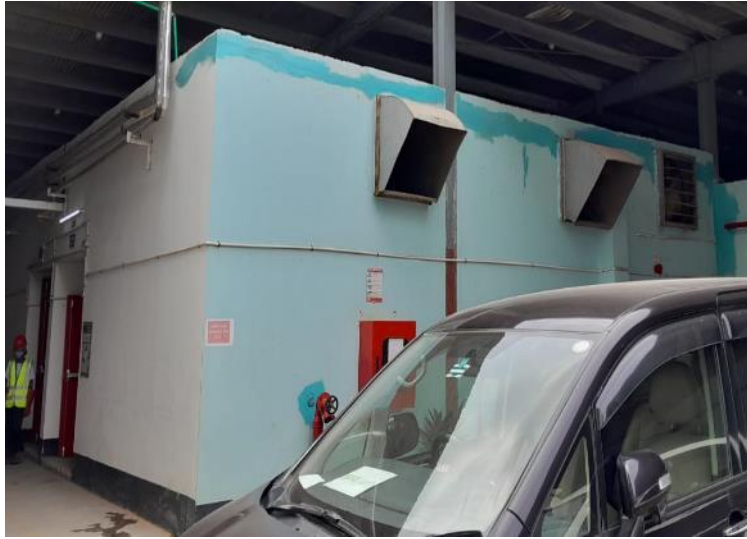
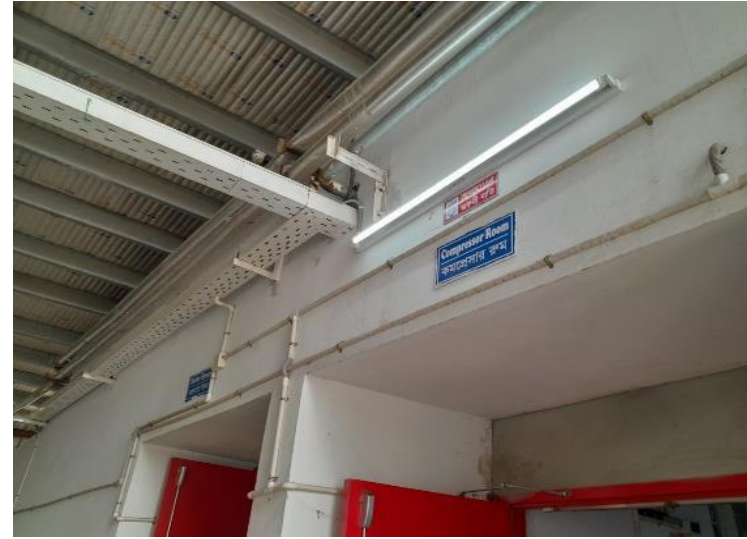
## **Lack of foundation details**

The structural system of the boiler, compressor and RMS room is an RC slab-supported 250 mm brick wall. The structure is constructed inside the shed. No foundation system is shown in the drawing. Building engineer is required to prepare foundation details and carry out foundation adequacy check for the load bearing walls.

| Item No. | Observation | Recommended Action Plan | Recommended Timeline |
|---|---|---|---|
| 08 | Lack of foundation details. | Building engineer is required to prepare foundation details and carry out foundation adequacy check for the load bearing walls. | 6-weeks |
| 09 | Lack of foundation details. | Carry out suggested remedial works. | 6-months |
