# Montex Fabrics Ltd. (Extension)

04 October 2023

# Executive Summary

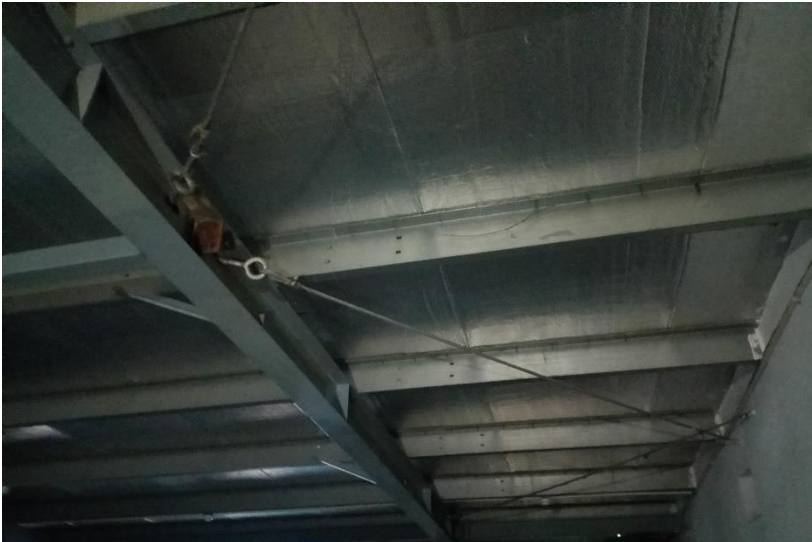
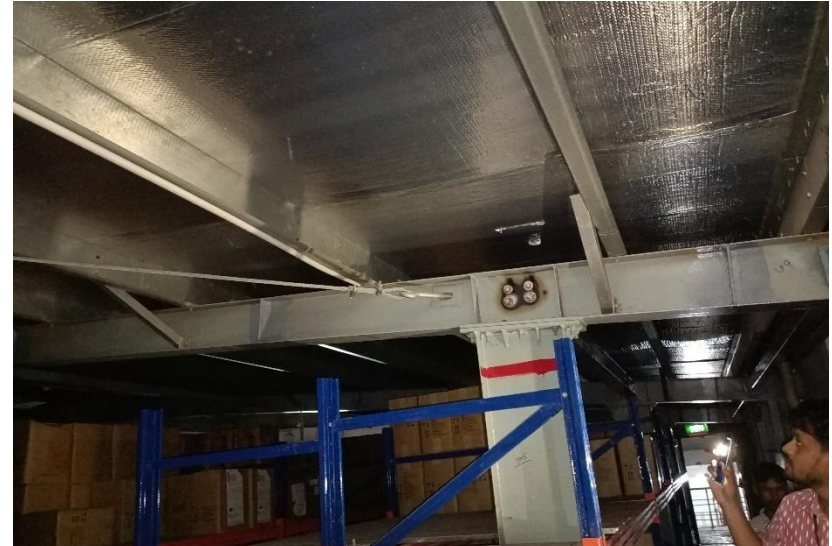
Missing compression strut member

Compression strut was found missing in several locations. So lateral stability in the long direction is incomplete. The building engineer is required to check the stability system of the existing structure and suggest remedial measures where necessary.

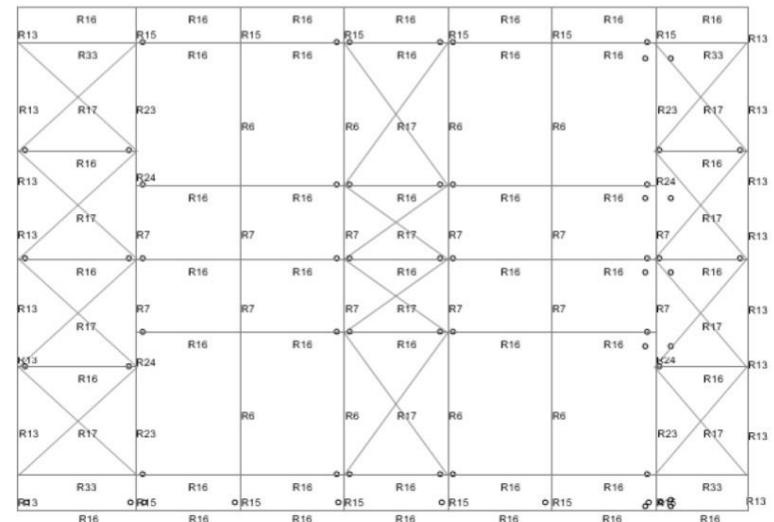
Figure 3.5: Roof Layout (Structural Steel)

Bracing and strut layout in design report

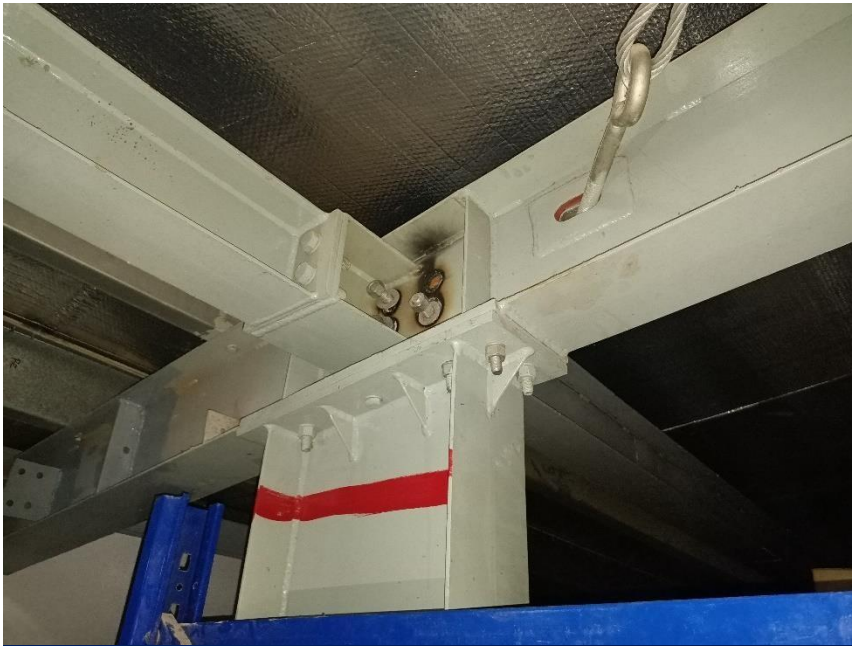
Loose nut and Bolt missing observed in joint at several locations. Building engineer is required to tighten the loose nut and install the missing bolt where necessary.

Loose nut

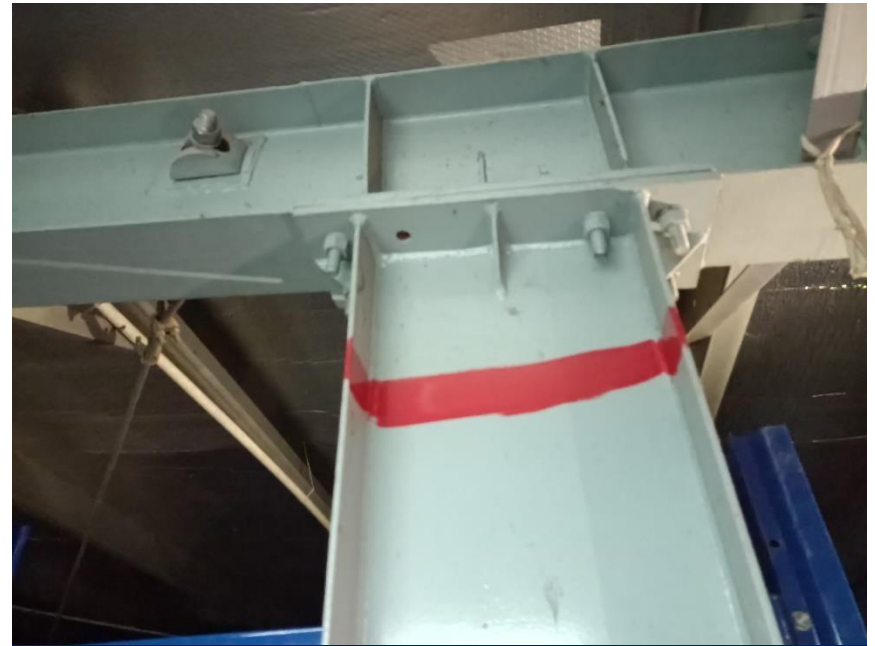
Bolt missing

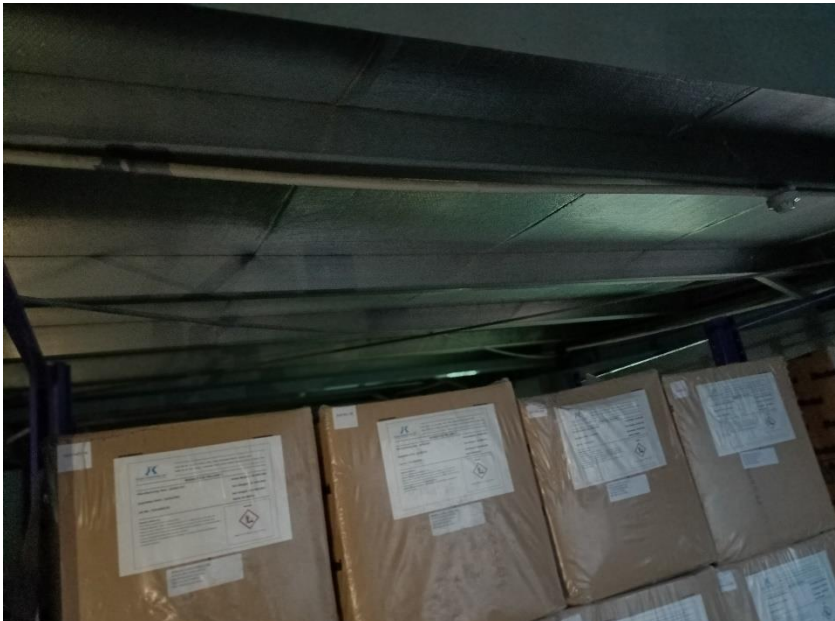
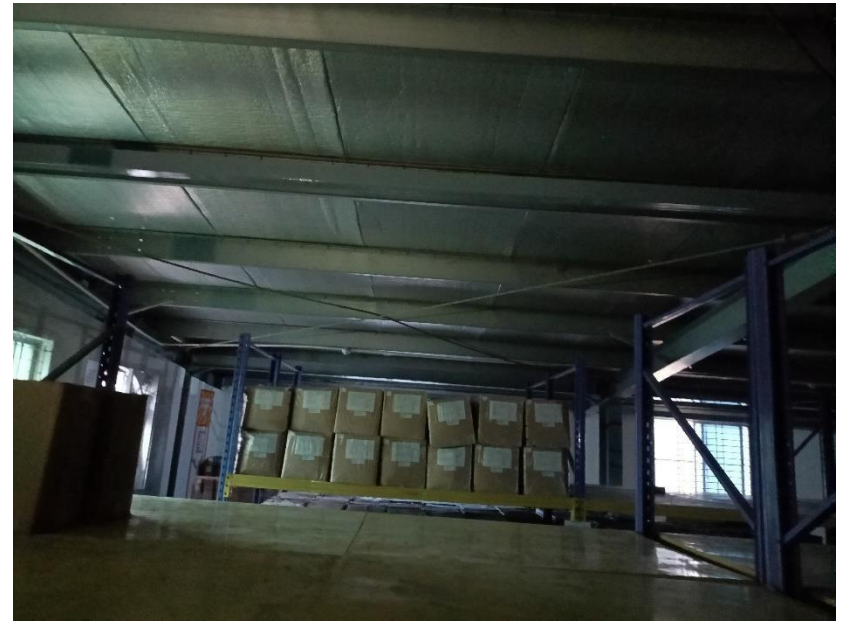
Roof cable bracings were found loose at several locations. Building engineer is required to tighten the loose bracing where necessary.

Loose cable bracing

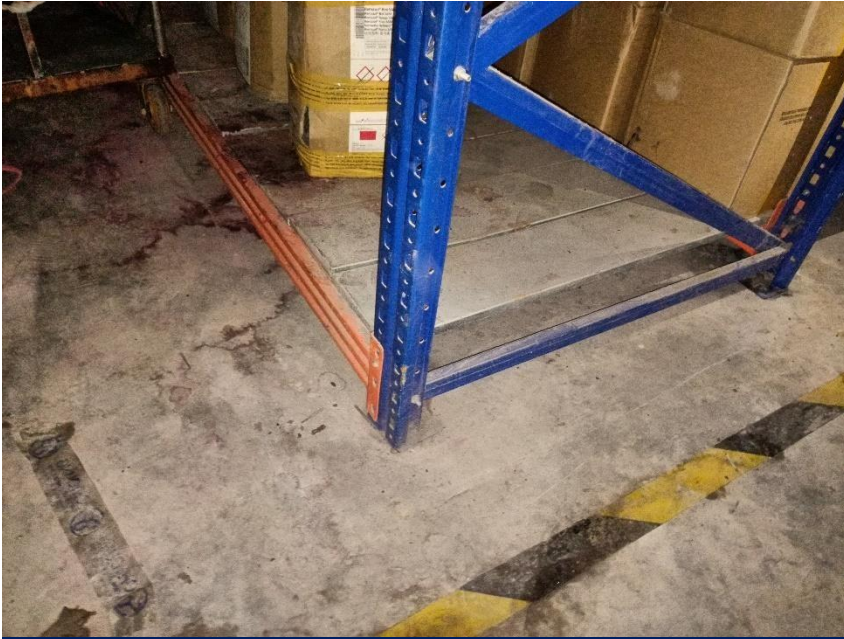
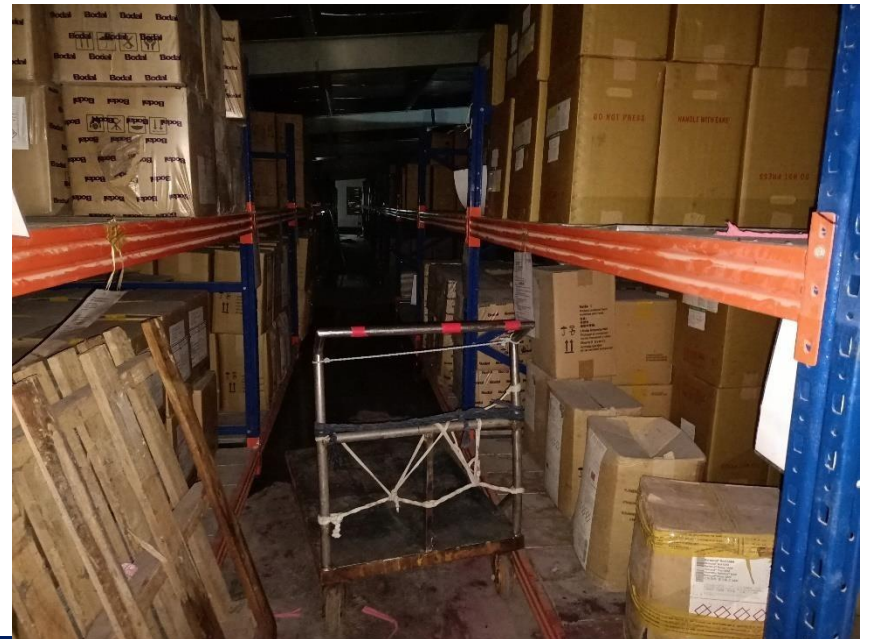
Non-anchored storage rack at first floors

Racks on the first floors are not anchored or braced to resist lateral (earthquake) forces. Building engineer is required to anchor/brace all non-structural elements adequately to resist earthquake forces.

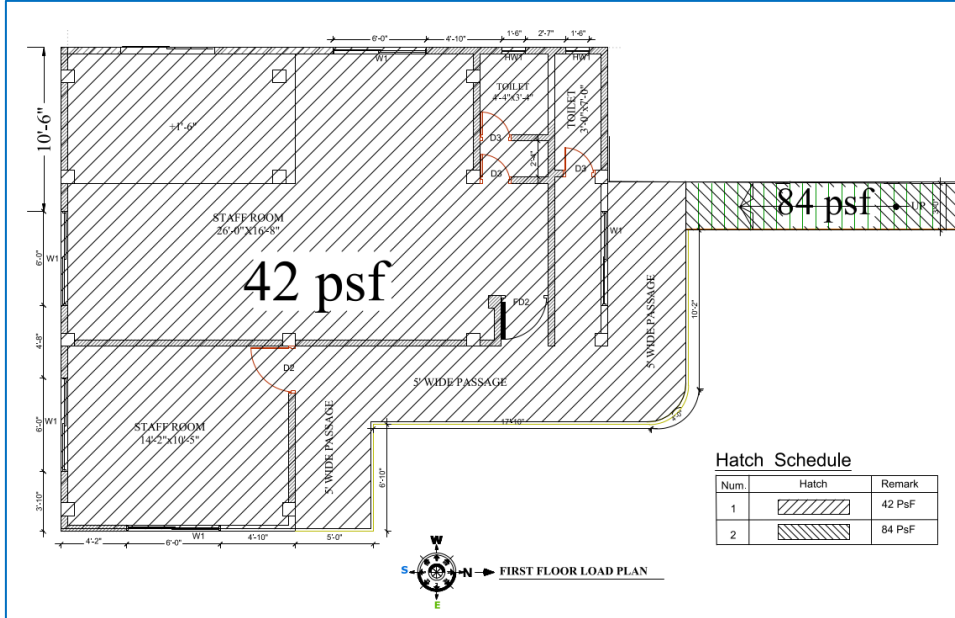
Load plan with 42 psf (2N/m<sup>2</sup>) for first floor

The cursory calculation indicates that internal footing stress exceeds the normal design limit considering a floor live load of 2 kPa, and soil bearing capacity of 2 ksf (FS 2.5). The building engineer is required to review the design, loads, and footing stresses.

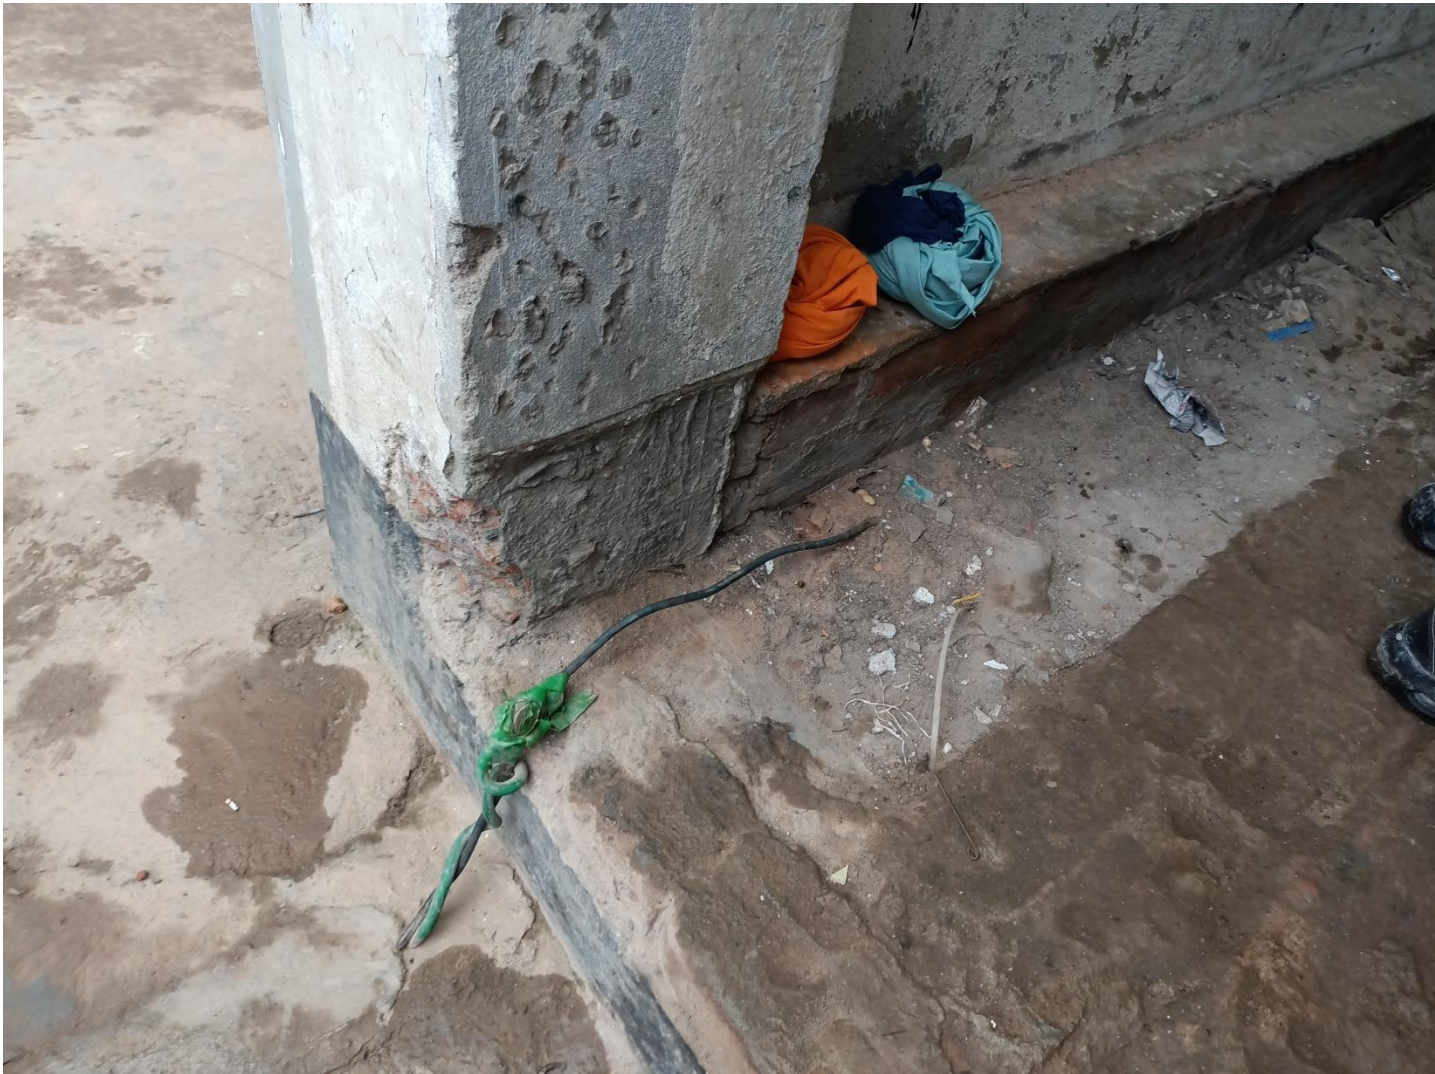
Bricks chips in column
