Carlos Leather Fashion Ltd. (Extension)

Teknogpara, Joydebpur, Gazipur
(24.003962, 90.386709)
3 October 2023

Building Information

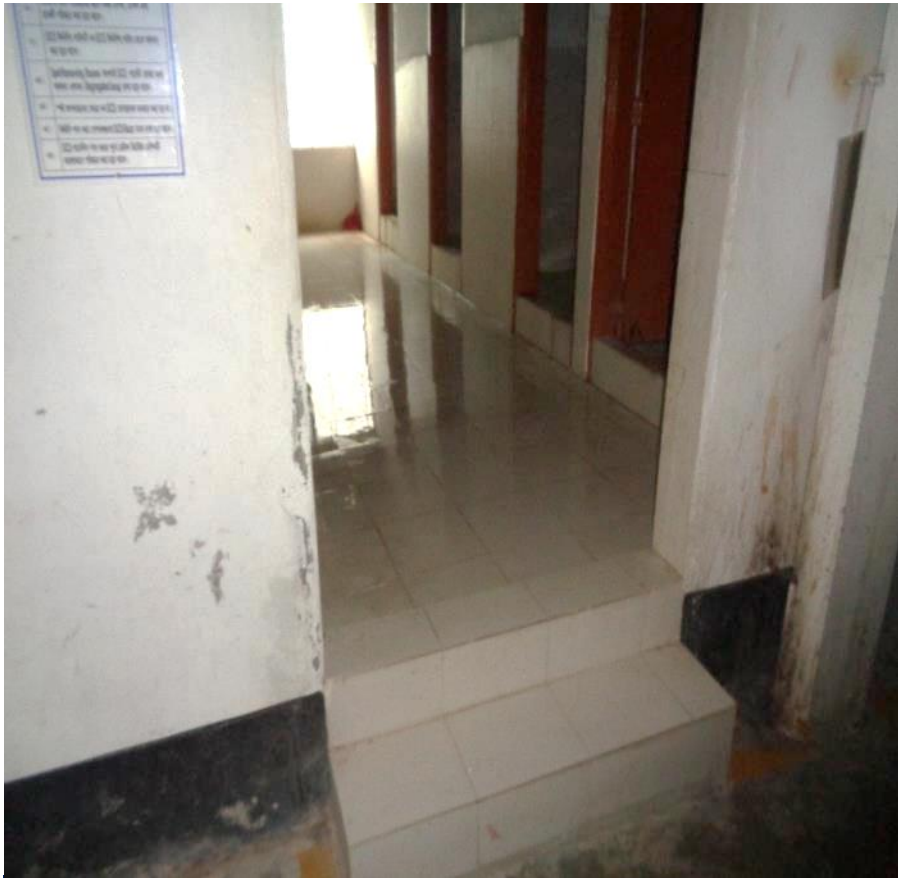
300 mm Build up found at toilet area

300 mm Build up was found at toilet area. Building engineer is required to update the as-built drawing.

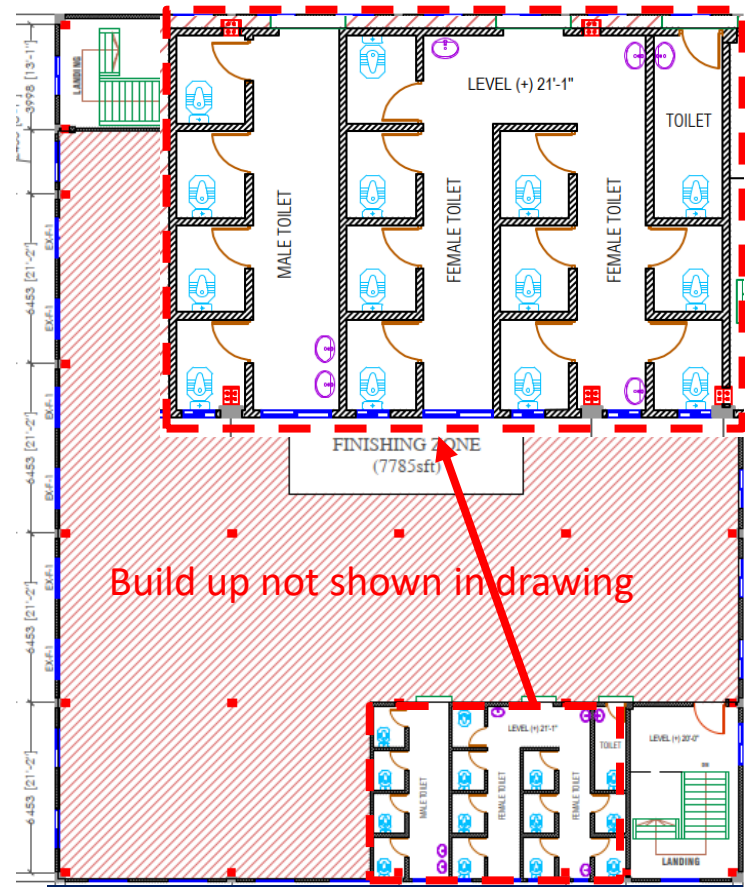
Second floor plan

Build up not shown in drawing

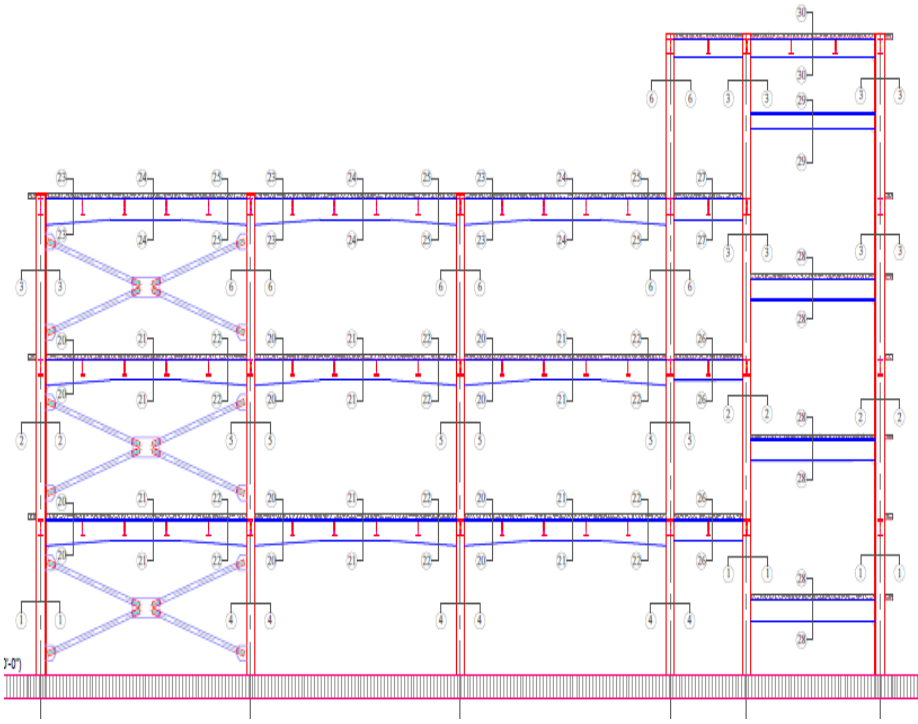
Typical sectional details

No connection detail was included in as-built structural drawing. Building engineer is required to update as-built drawing incorporating connection details for all types of connections.

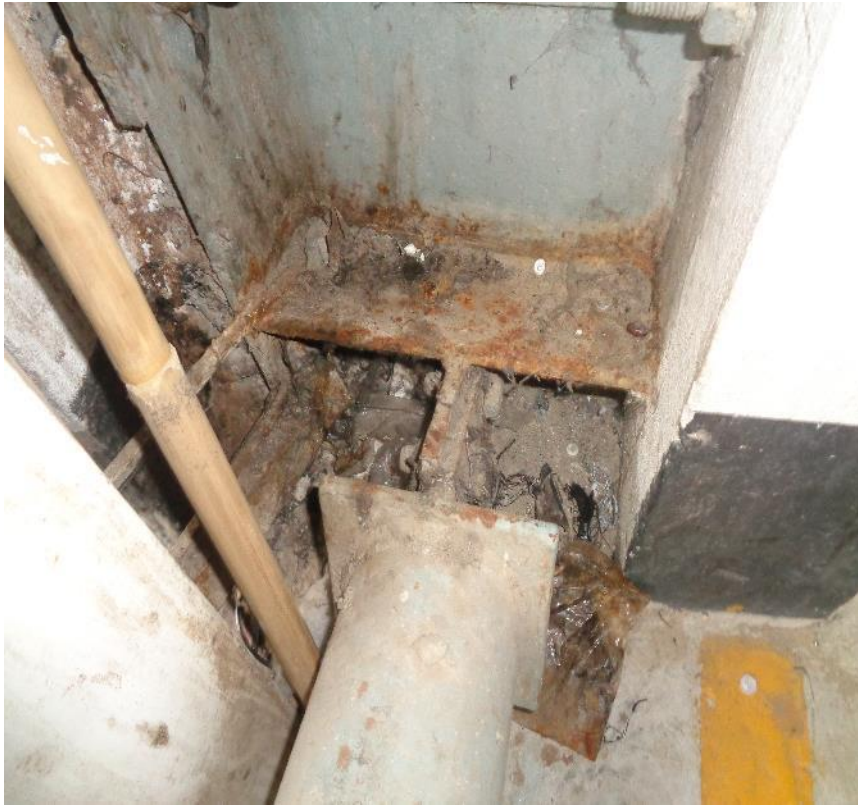
Corrosion on steel members

Corrosion was observed on exposed rebar and steel members at several locations. Building engineer is required to provide rust-proof paint on all steel members to protect from corrosion.

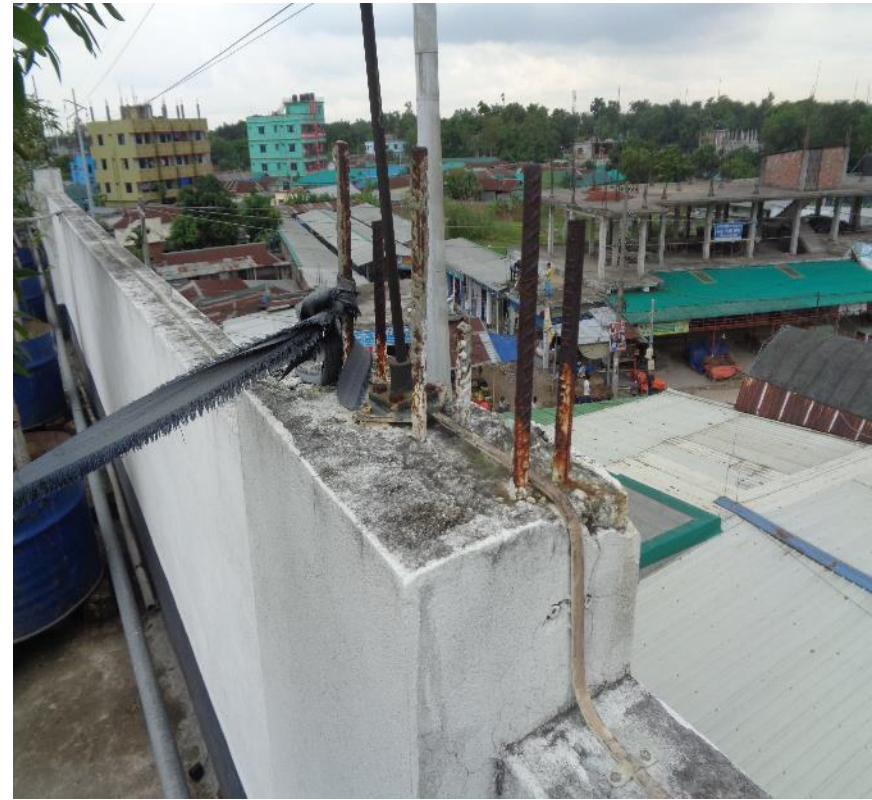
Corrosion on exposed rebar

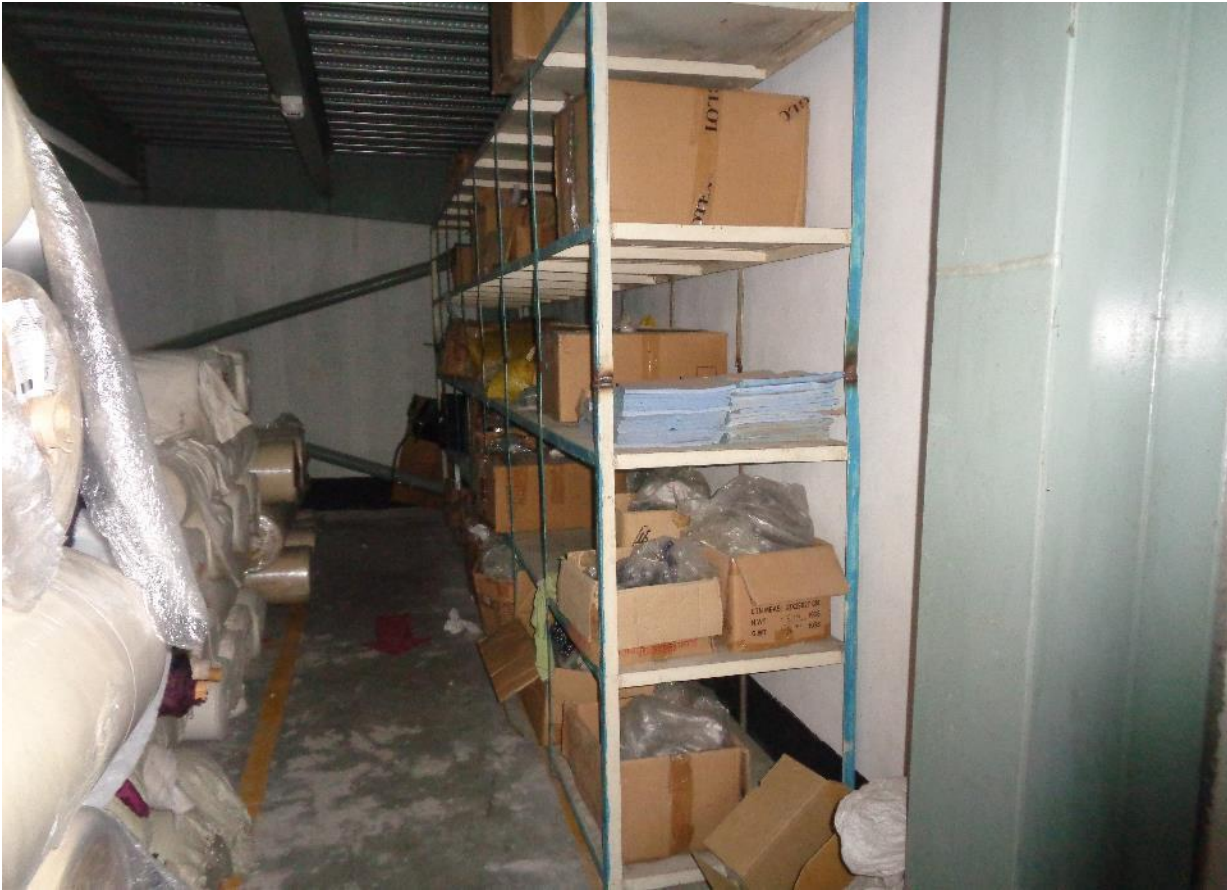
Storage rack found within the building without braced/anchored

Building engineer is required to brace/anchor all non-structural elements.

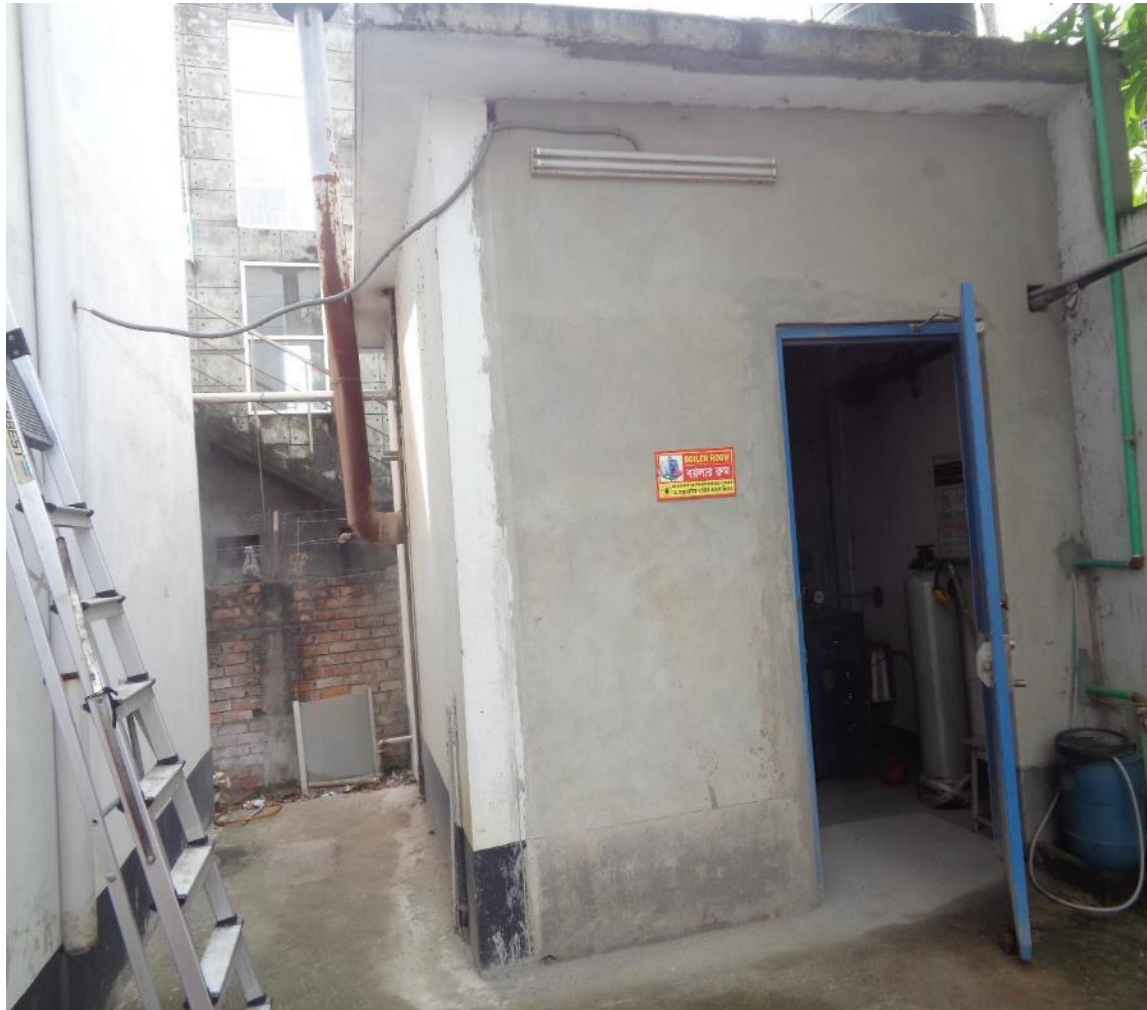
As-built drawing not available for Boiler Building

As-built drawing was not available for Boiler Building. The building engineer is required to produce as-built drawing for this structure.
