# Impress Printing & Embroidery

5 October 2023

# Observations

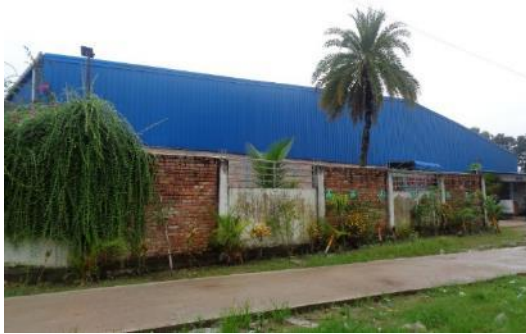
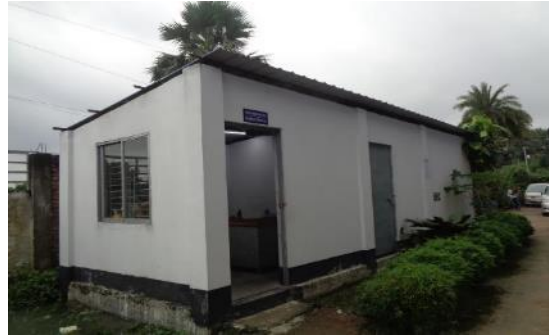
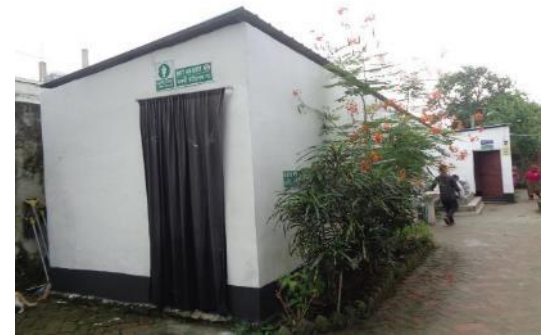
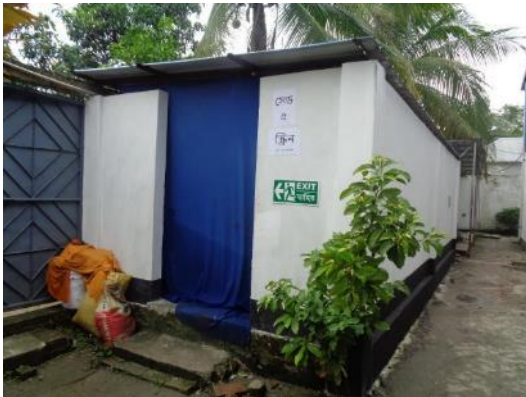
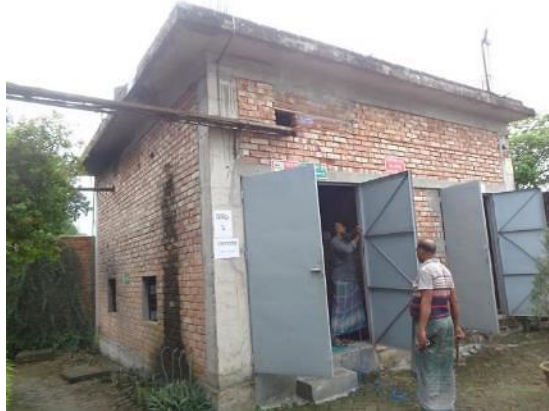
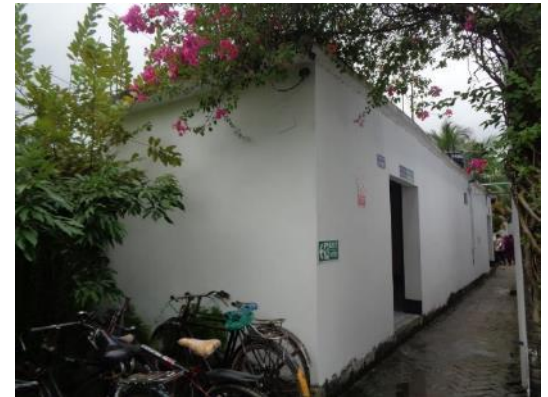
**Lack of building permit**

There were no building permit drawings for any structure. The factory is required to collect building permit from government approved local authority.

| Item No. | Observation | Recommended Action Plan | Recommended Timeline |
|---|---|---|---|
| 01 | Lack of building permit from local authority (All Buildings) | Factory is required to collect building permit from government approved local authority. | 6-months |

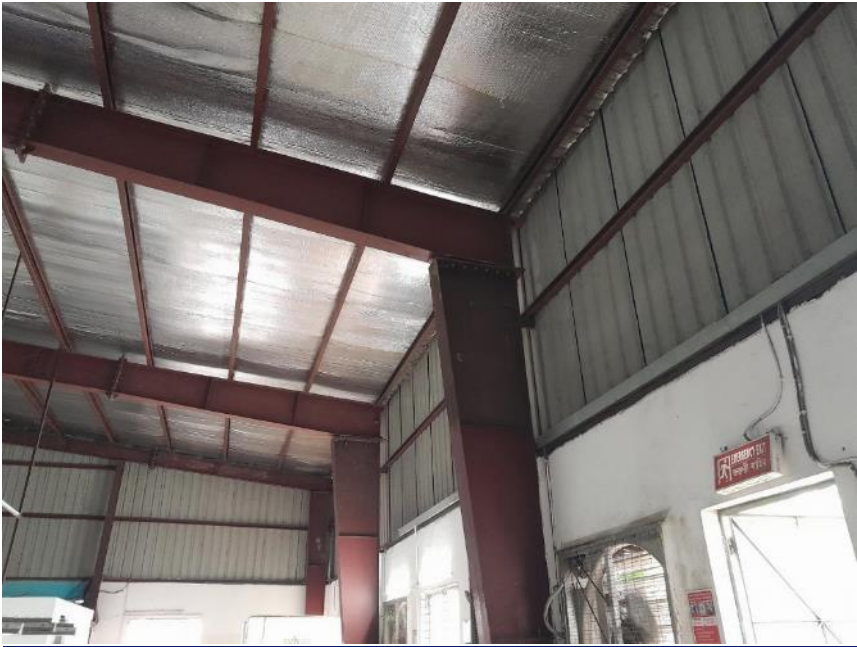
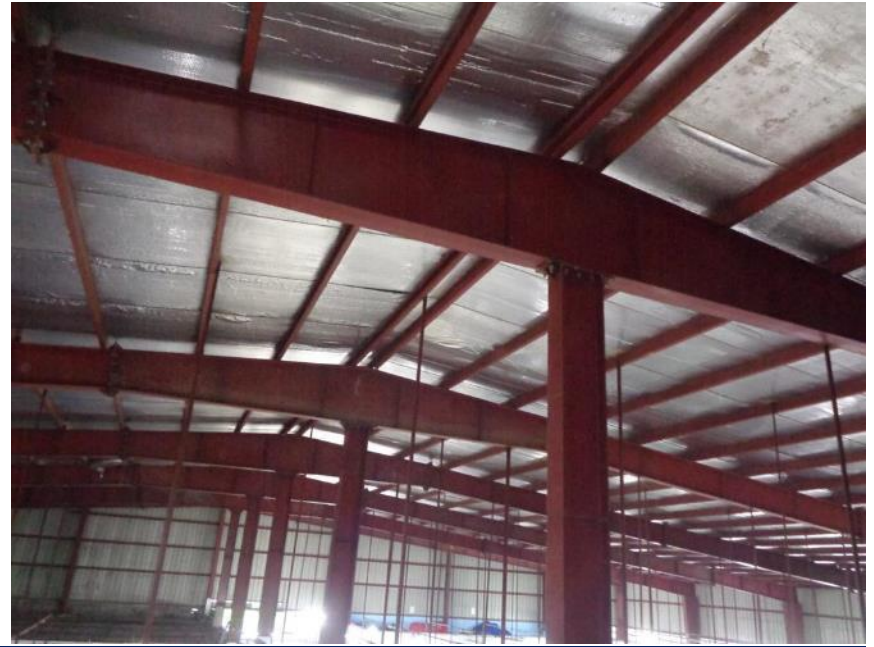
Absence of load transfer media (compression strut) along transverse direction of rafter and absence of bracing both at sidewall & roof

Lack of lateral stability system (bracing & compression strut) was observed in the structure. The building engineer is required carryout Engineering Assessment (EA) to check the lateral stability of the structure and suggest proper remedial actions accordingly. Submit the EA documents to the RSC for review.

| Item No. | Observation | Recommended Action Plan | Recommended Timeline |
|---|---|---|---|
| 02 | Lack of lateral stability. Shed-1 (Production Shed) | The building engineer is required to carryout Engineering Assessment (EA) to check the lateral stability of the structure and suggest proper remedial actions accordingly. Submit the EA documents to the RSC for review. | 6-weeks |
| 03 | Lack of lateral stability. Shed-1 (Production Shed) | Carry out suggested remedial work. | 6-months |

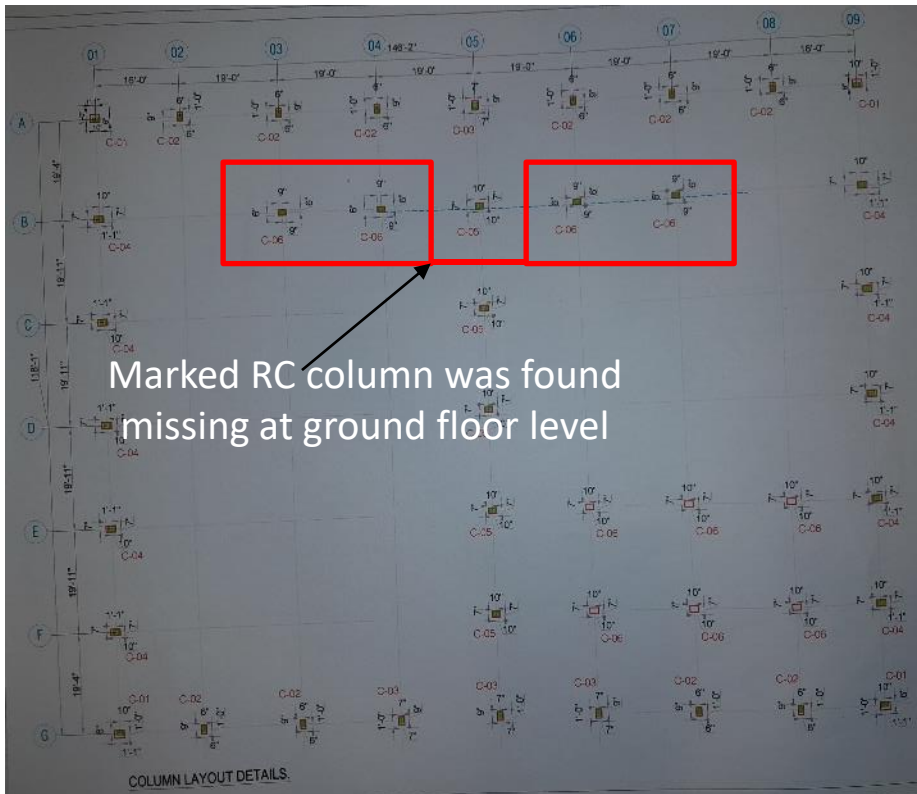
RC Column layout

During inspection, mismatch was found between onsite condition and as-built drawing. Marked RC column was found missing at ground floor, some steel column size was found oversized and undersized, and mismatch was found in steel beam size at mezzanine floor. The building engineer is required to survey the full structure and produce accurate as-built drawings.

| Item No. | Observation | Recommended Action Plan | Recommended Timeline |
|---|---|---|---|
| 04 | Mismatches between construction drawing and as-built condition. Shed-1 (Production Shed) | The building engineer is required to survey the structure and produce accurate as-built drawings. | 6-weeks |

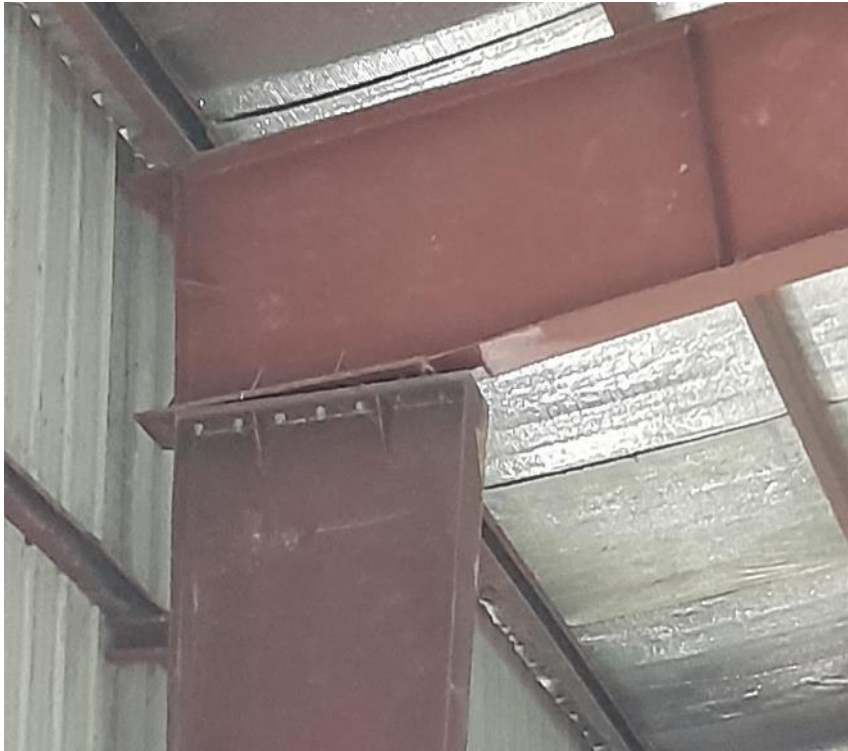
Gap between rafter and steel column joint

Considerable gap between rafter and steel column joint and also under the steel baseplate was observed. The factory is required to take necessary action to fill the gap in connection as per the suggestion of building engineer.

| Item No. | Observation | Recommended Action Plan | Recommended Timeline |
|---|---|---|---|
| 05 | Connection gap in baseplate and column-rafter joint plate. Shed-1 (Production Shed) | The factory is required to take necessary action to fill the gap in connection as per the suggestion of building engineer. | 6-weeks |
| 06 | Connection gap in baseplate and column-rafter joint plate. Shed-1 (Production Shed) | Carry out suggested remedial work. | 6-months |

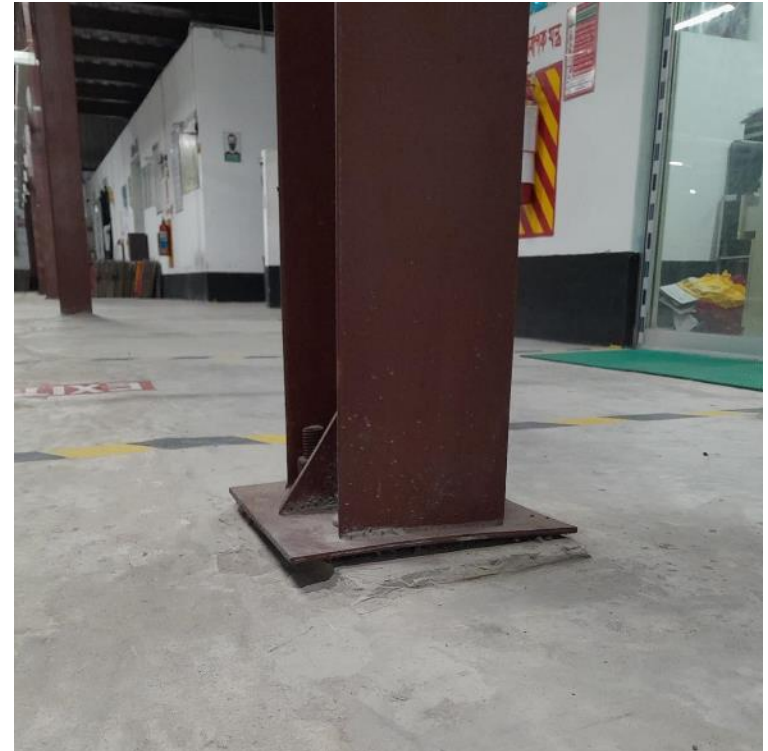
Gap between baseplate & pedestal joint

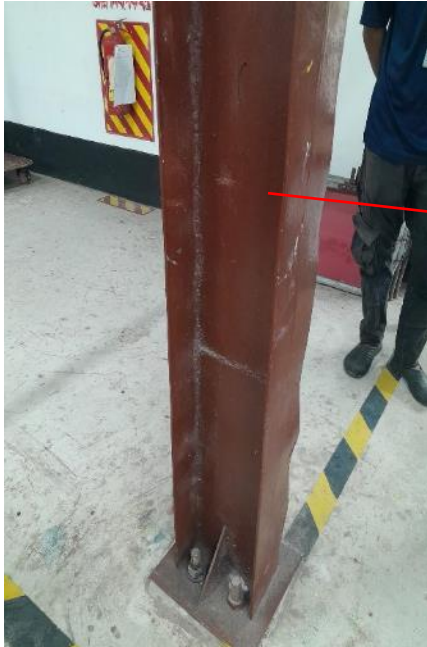
Distorted steel column

Steel column of mezzanine floor at south-east corner is distorted. The connection between that column and steel beam also seems inadequate. The building engineer is required to investigate the reason of such distortion and take necessary action for remedial procedure.

| Item No. | Observation | Recommended Action Plan | Recommended Timeline |
|---|---|---|---|
| 07 | Distorted steel column of mezzanine. Shed-1 (Production Shed) | Factory is required to investigate the reason of column distortion and take necessary action for remediation as per the suggestion of building engineer. | 6-weeks |
| 08 | Distorted steel column of mezzanine. Shed-1 (Production Shed) | Carry out suggested remedial work. | 6-months |

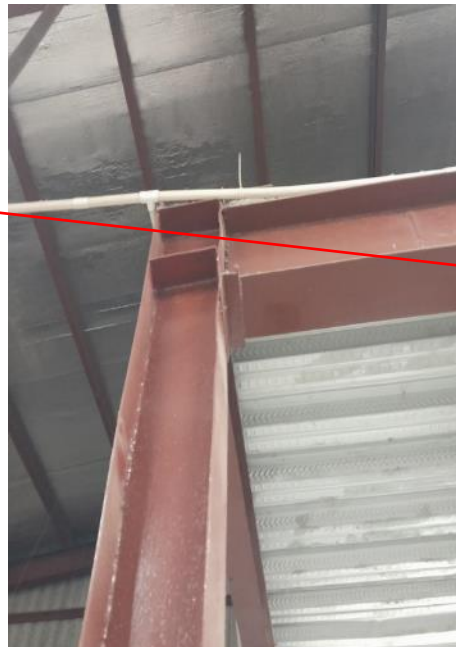
Distorted steel beam-column joint

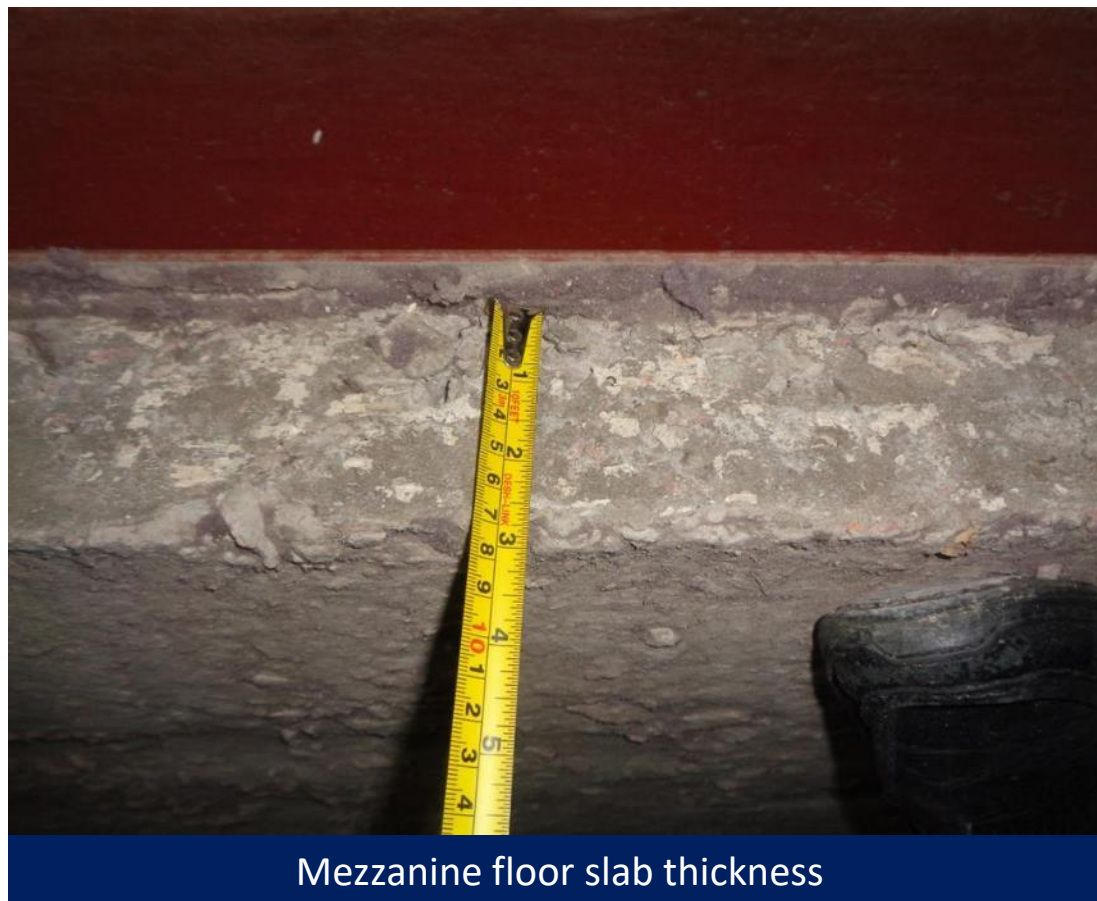
Mezzanine floor slab thickness

Slab thickness of mezzanine floor is found 75 mm. This thickness seems to be inadequate. Also, there is considerable vibration on the floor. The building engineer is required carryout Engineering Assessment (EA) to check the adequacy of the slab in terms of stress & serviceability issues and suggest proper remedial actions accordingly. Submit the EA documents to the RSC for review.

| Item No. | Observation | Recommended Action Plan | Recommended Timeline |
|---|---|---|---|
| 09 | Inadequate slab thickness and vibration in mezzanine floor. Shed-1 (Production Shed) | The building engineer is required carryout Engineering Assessment (EA) to check the adequacy of the slab in terms of stress & serviceability issues and suggest proper remedial actions accordingly. Submit the EA documents to the RSC for review. | 6-weeks |
| 10 | Inadequate slab thickness and vibration in mezzanine floor. Shed-1 (Production Shed) | Carry out suggested remedial work. | 6-months |

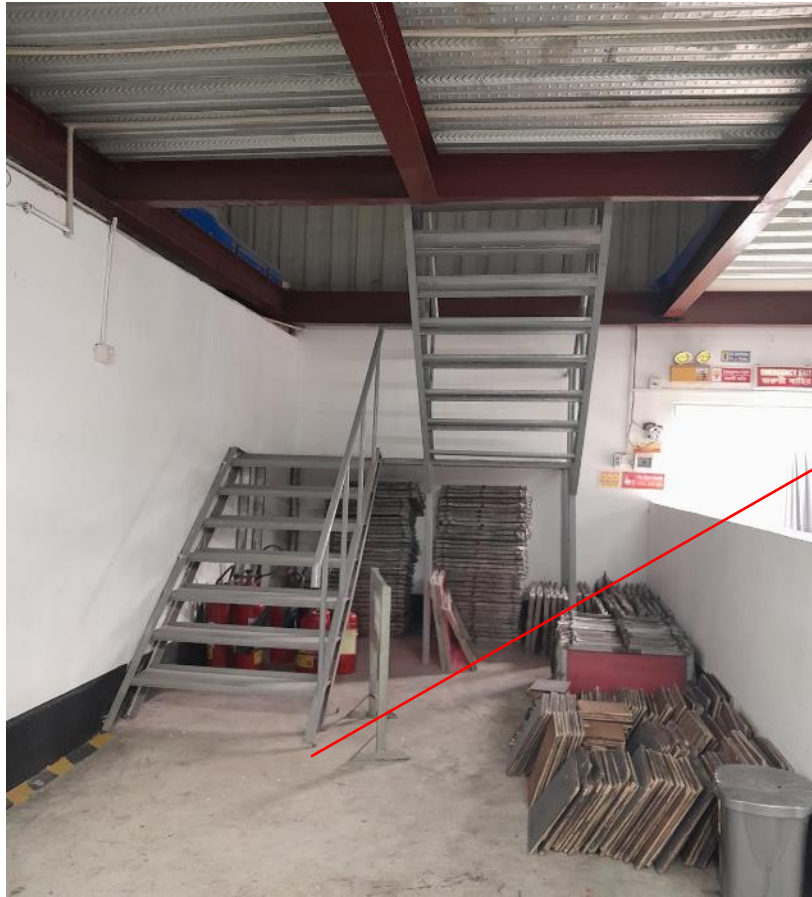
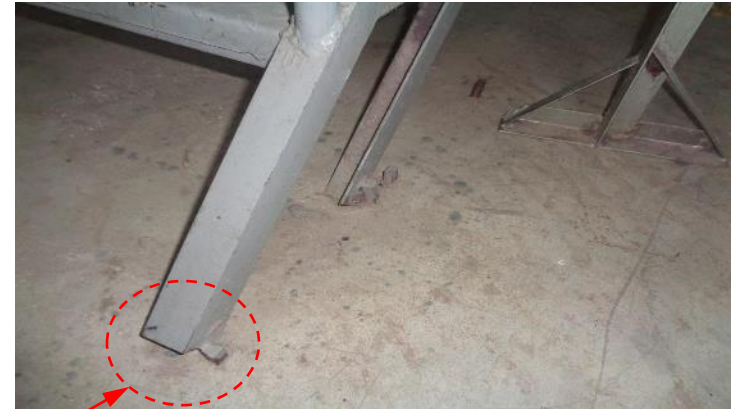
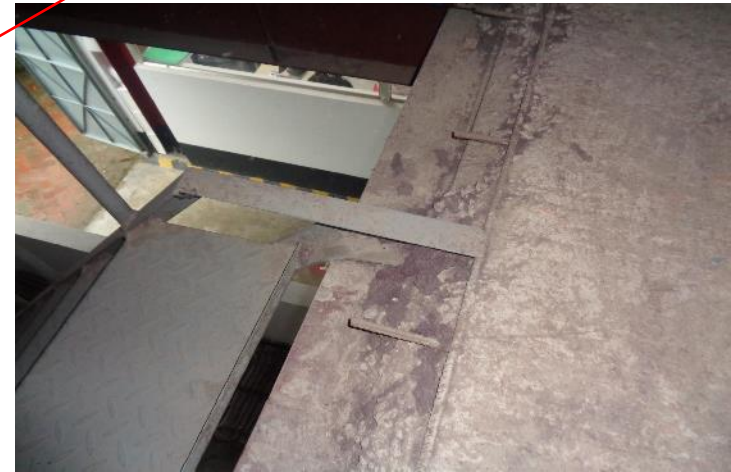
Steel stair and connections

The building engineer is required carryout Engineering Assessment (EA) to check the lateral stability of the steel stair, check adequacy of steel members & connections and suggest proper remedial actions accordingly. Submit the EA documents to the RSC for review.

| Item No. | Observation | Recommended Action Plan | Recommended Timeline |
|---|---|---|---|
| 11 | Apparently non-engineered steel stair. Shed-1 (Production Shed) | As part of EA, the building engineer is required to check the lateral stability of the steel stair, check adequacy of steel members & connections and suggest proper remedial actions accordingly. | 6-weeks |
| 12 | Apparently non-engineered steel stair. Shed-1 (Production Shed) | Carry out remedial works if required. | 6-months |

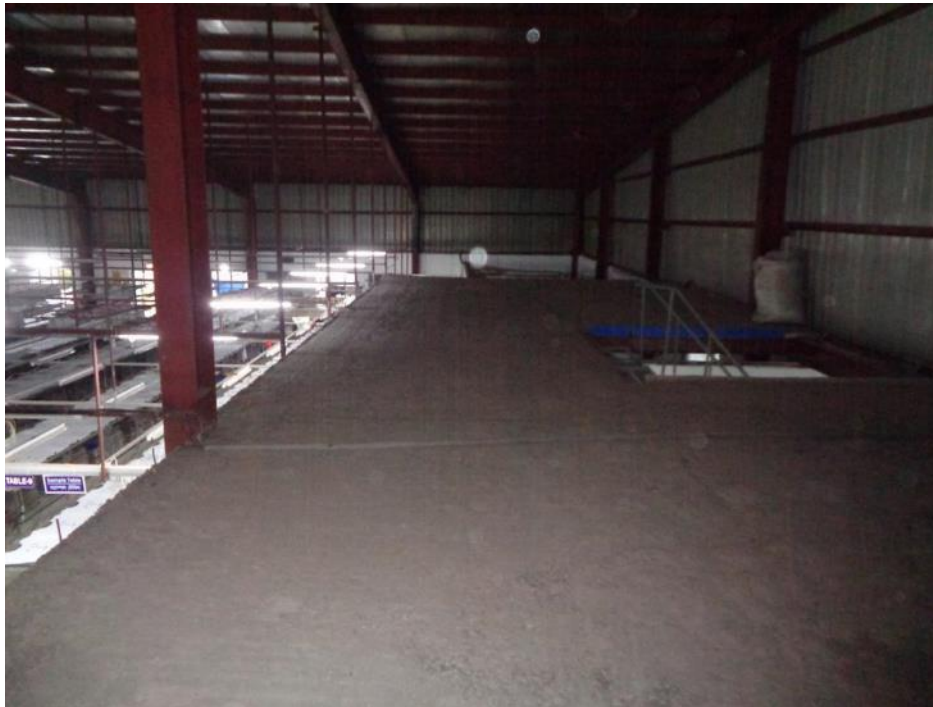
No barrier at mezzanine floor

The factory is required to provide adequate barrier to avoid possible falling hazards.

| Item No. | Observation | Recommended Action Plan | Recommended Timeline |
|---|---|---|---|
| 13 | Falling hazard at mezzanine floor. Shed-1 (Production Shed) | The factory is required to provide adequate barrier to avoid possible falling hazards. | 6-weeks |

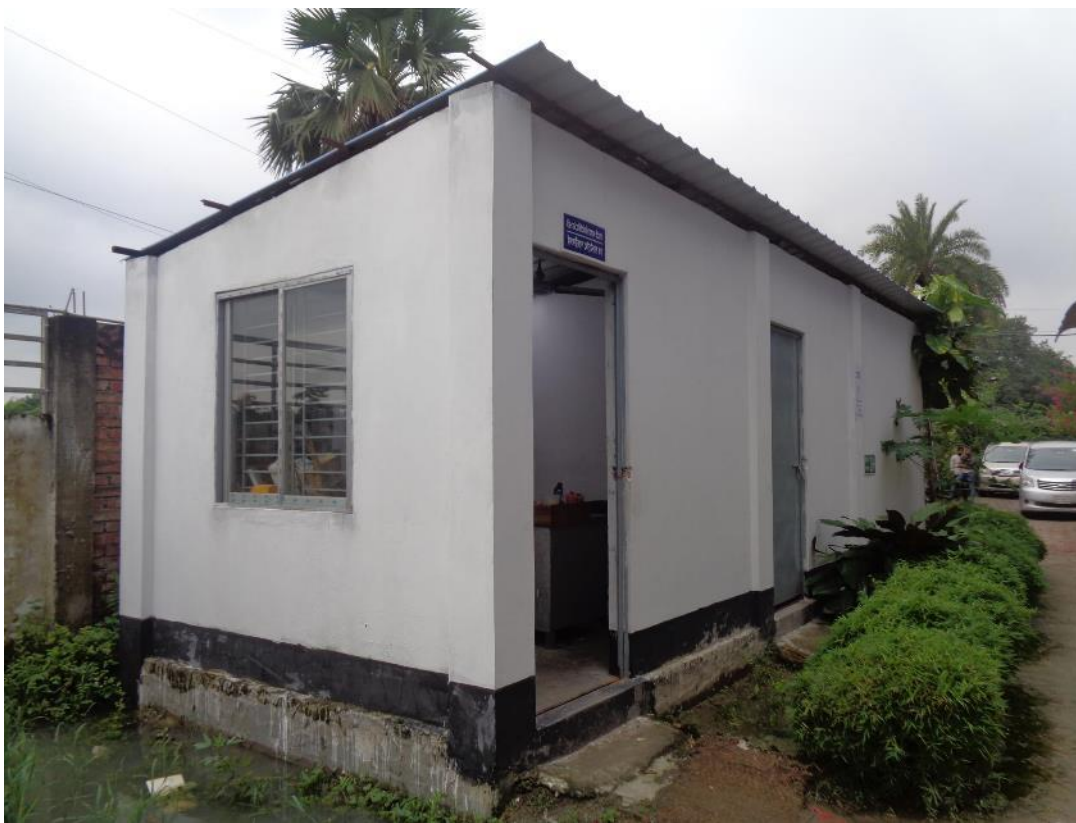
During inspection, as built drawing was not found. Building engineer is required to prepare as-built drawings.

| Item No. | Observation | Recommended Action Plan | Recommended Timeline |
|---|---|---|---|
| 14 | Lack of as-built drawings. Shed-2 (Maintenance) | The building engineer is required to prepare as built drawings. Submit the documents to the RSC for review. | 6-weeks |

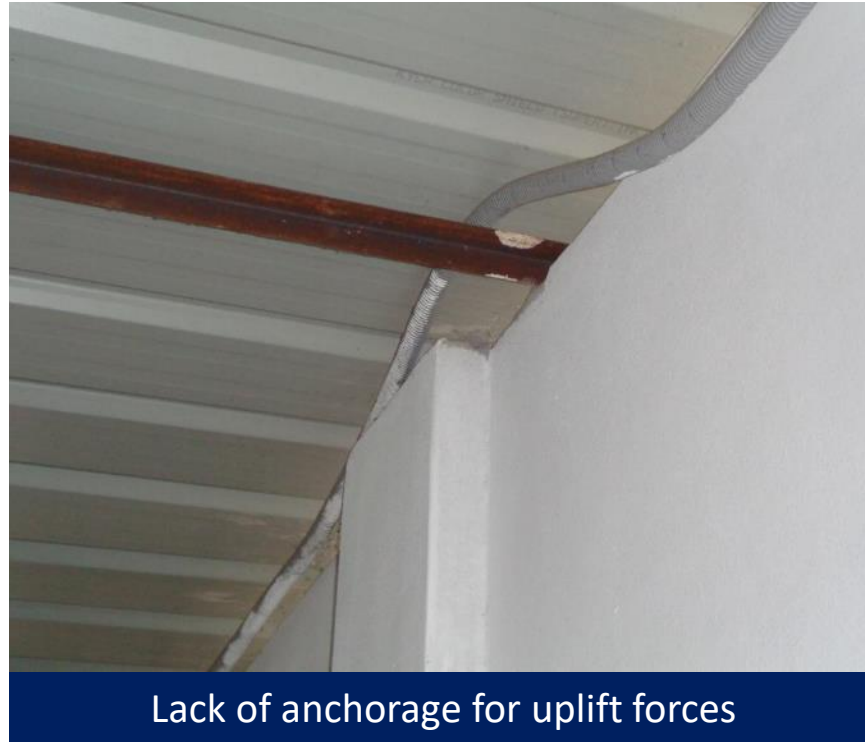
Lack of anchorage for uplift forces

Building engineer is required to check the connection between the steel rafter and brick wall for uplift forces. Take necessary remedial actions as per the suggestion of building engineer.

| Item No. | Observation | Recommended Action Plan | Recommended Timeline |
|---|---|---|---|
| 15 | Lack of anchorage for uplift forces. Shed-2 (Maintenance) | Provide necessary anchorage between roof & walls. | 6-months |

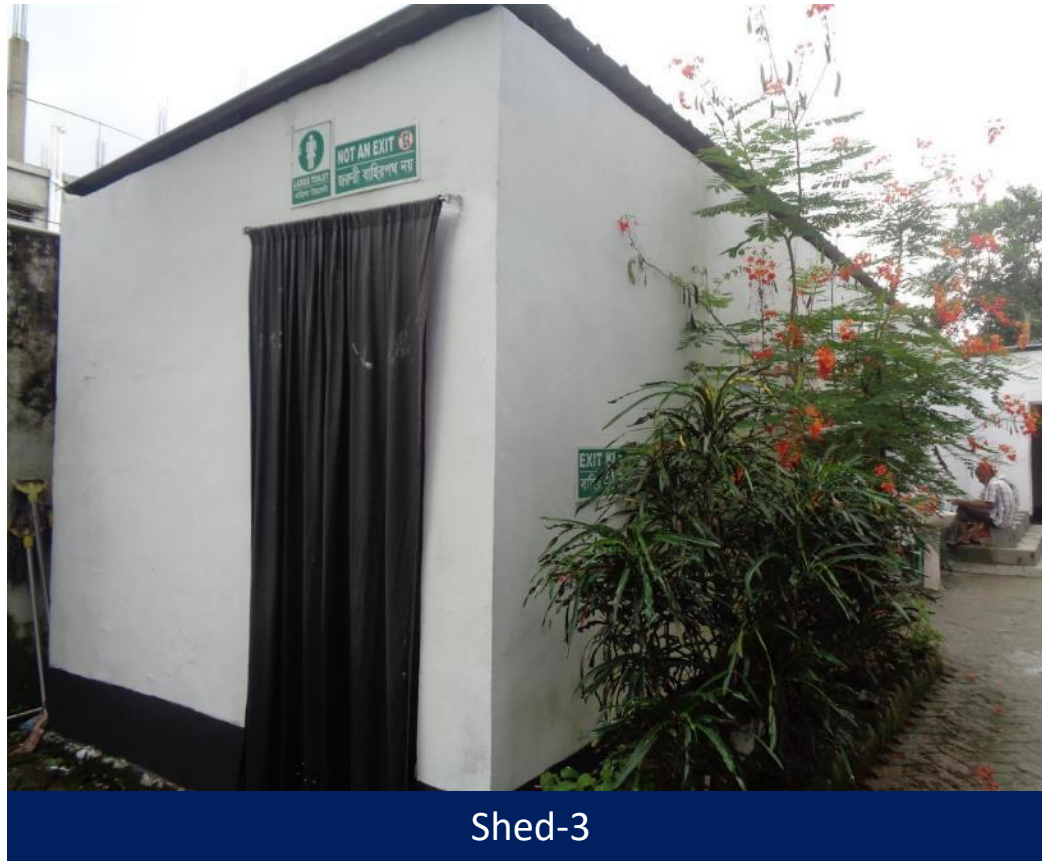
During inspection, as built drawing was not found. Building engineer is required to prepare as-built drawings of the structure.

| Item No. | Observation | Recommended Action Plan | Recommended Timeline |
|---|---|---|---|
| 16 | Lack of as-built drawings. Shed-3 (Canteen) | The building engineer is required to prepare as-built drawings. | 6-weeks |

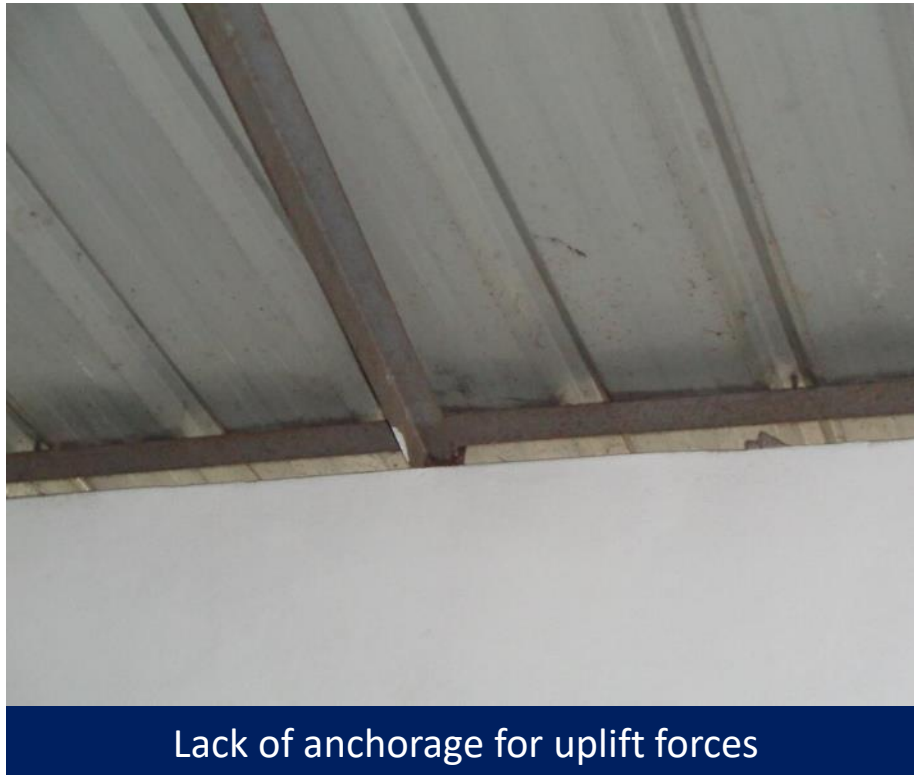
Lack of anchorage for uplift forces

Building engineer is required to check the connection between the steel rafter and brick wall for uplift forces. Take necessary remedial actions as per the suggestion of building engineer.

| Item No. | Observation | Recommended Action Plan | Recommended Timeline |
|---|---|---|---|
| 17 | Lack of anchorage for uplift forces. Shed-3 (Canteen) | Provide necessary anchorage between roof & walls. | 6-months |

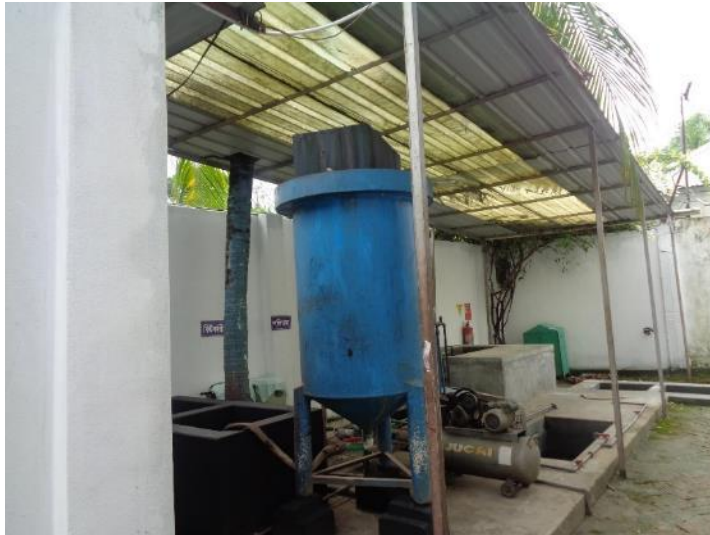
During inspection, as built drawing was not found. Building engineer is required to prepare as-built drawings with connection details.

| Item No. | Observation | Recommended Action Plan | Recommended Timeline |
|---|---|---|---|
| 18 | Lack of as-built drawings & connection details. Shed-4 (ETP) | The building engineer is required to prepare as built drawings with connection details. | 6-weeks |

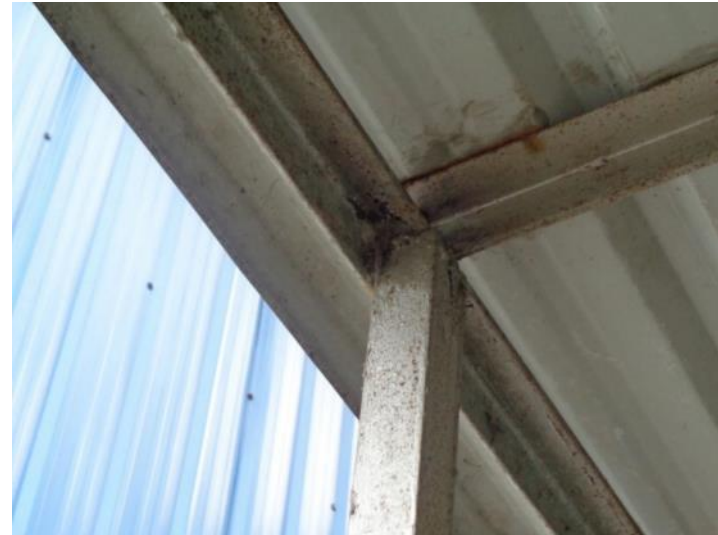
rafter and steel column connection

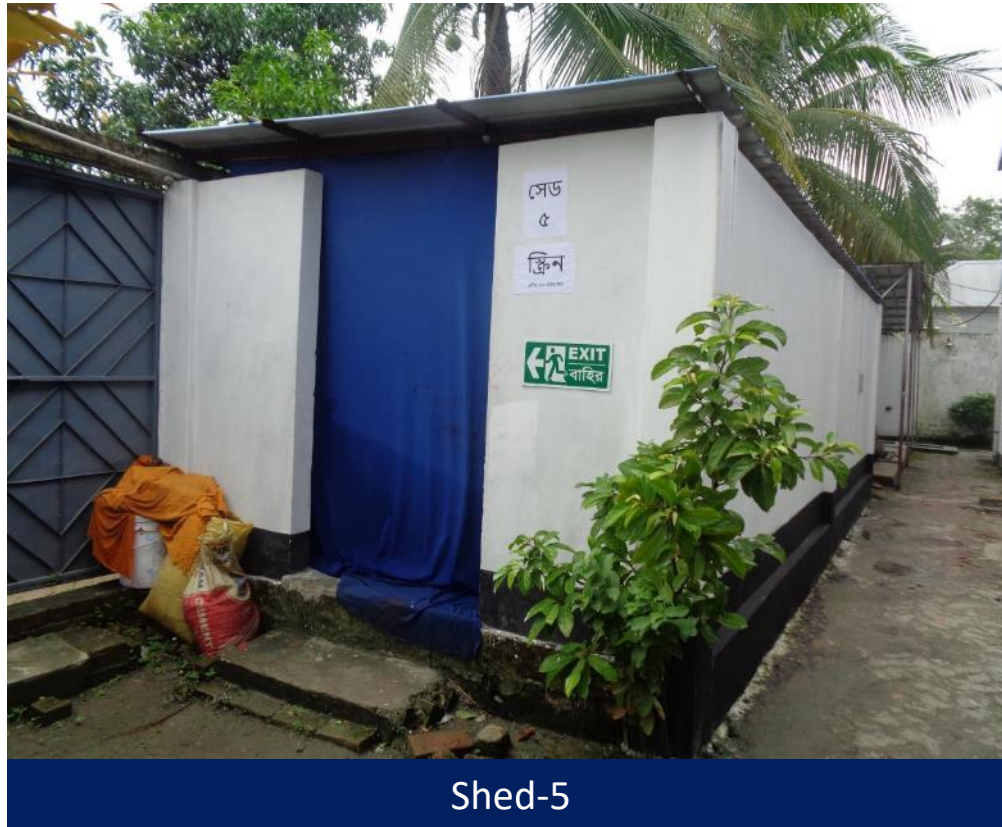
During inspection, as built drawing was not found. Building engineer is required to prepare as built drawings of the structure.

| Item No. | Observation | Recommended Action Plan | Recommended Timeline |
|---|---|---|---|
| 19 | Lack of as-built drawings. Shed-5 (Screen Shed) | The building engineer is required to prepare as built drawings. | 6-weeks |

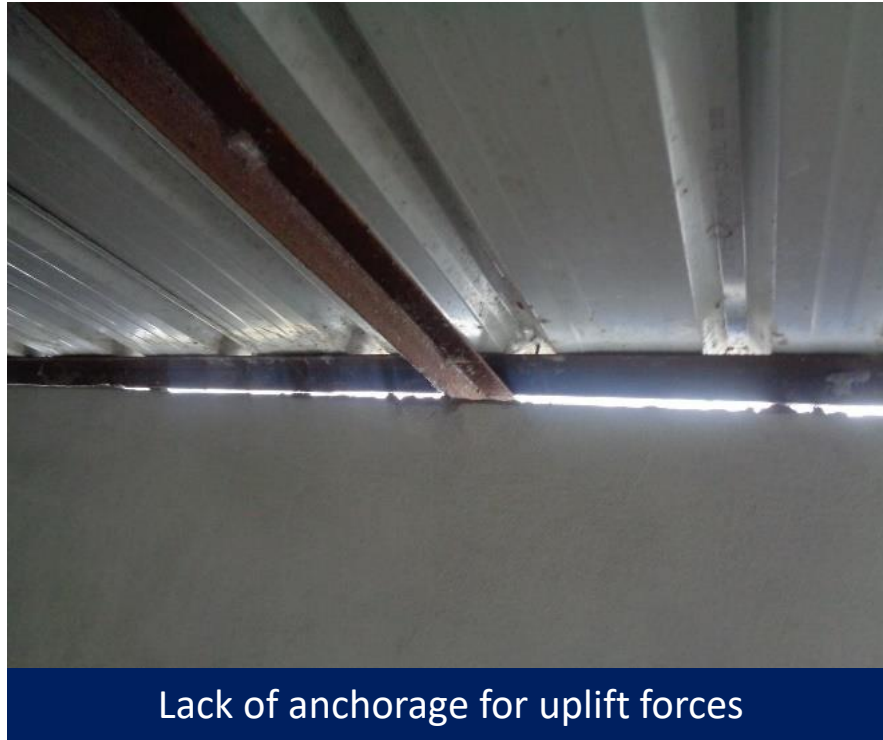
Lack of anchorage for uplift forces

Building engineer is required to check the connection between the steel rafter and brick wall for uplift forces. Take necessary remedial actions as per the suggestion of building engineer.

| Item No. | Observation | Recommended Action Plan | Recommended Timeline |
|---|---|---|---|
| 20 | Lack of anchorage for uplift forces. Shed-5 (Screen Shed) | Provide necessary anchorage between roof & walls. | 6-months |

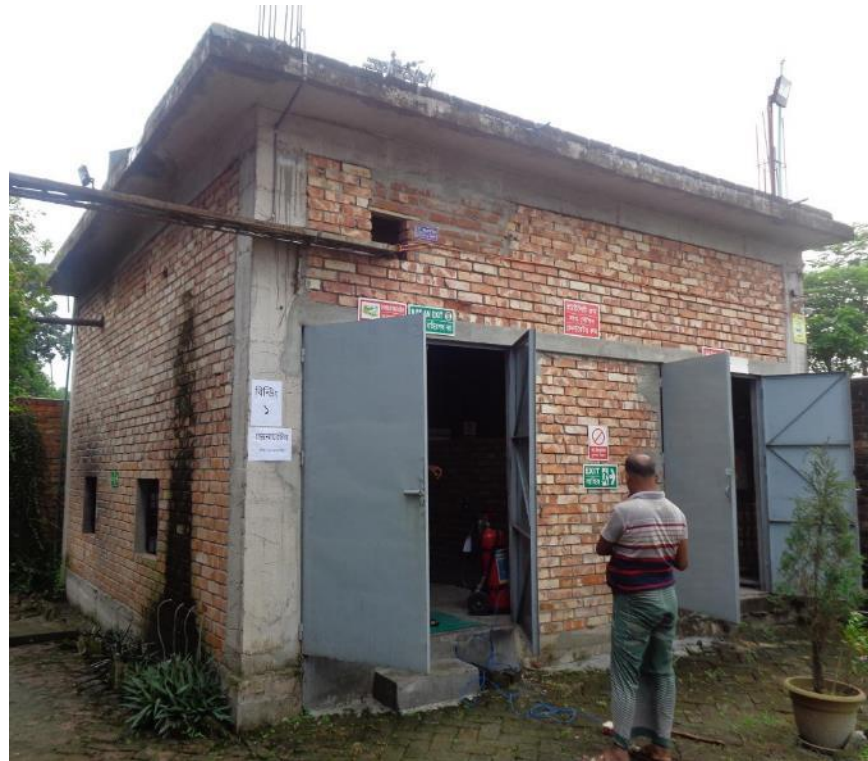
As-built drawing was not found on-site. Building engineer is required to survey the structure and prepare as built drawings with foundation details.

| Item No. | Observation | Recommended Action Plan | Recommended Timeline |
|---|---|---|---|
| 21 | Lack of as-built drawings. Building-1 (Utility) | Building engineer is required to survey the structure and prepare as built drawings with foundation details. | 6-weeks |

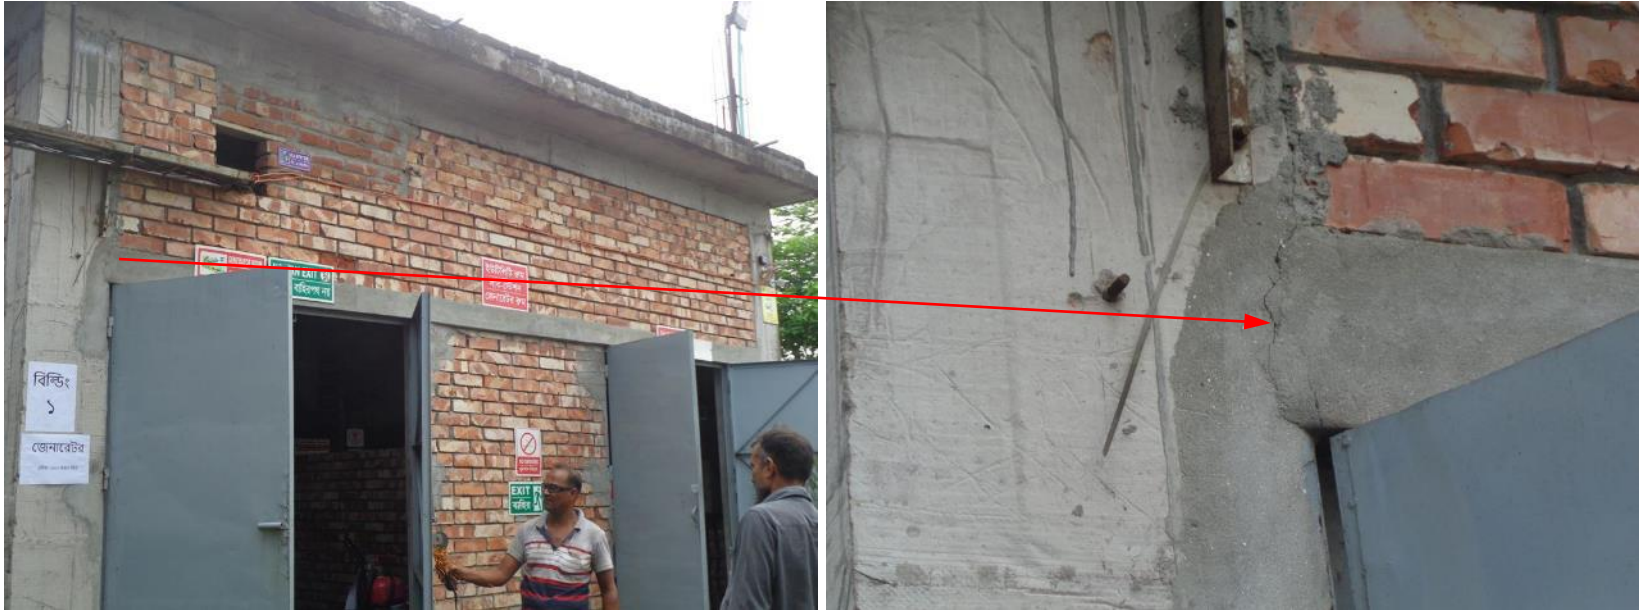
Hairline crack at the lintel-column joint over the door

The factory is required to take necessary remedial actions as per the suggestion of building engineer.

| Item No. | Observation | Recommended Action Plan | Recommended Timeline |
|---|---|---|---|
| 22 | Improper connection between lintel & column. Building-1 (Utility) | The factory is required to take necessary remedial actions as per the suggestion of building engineer. | 6-months |

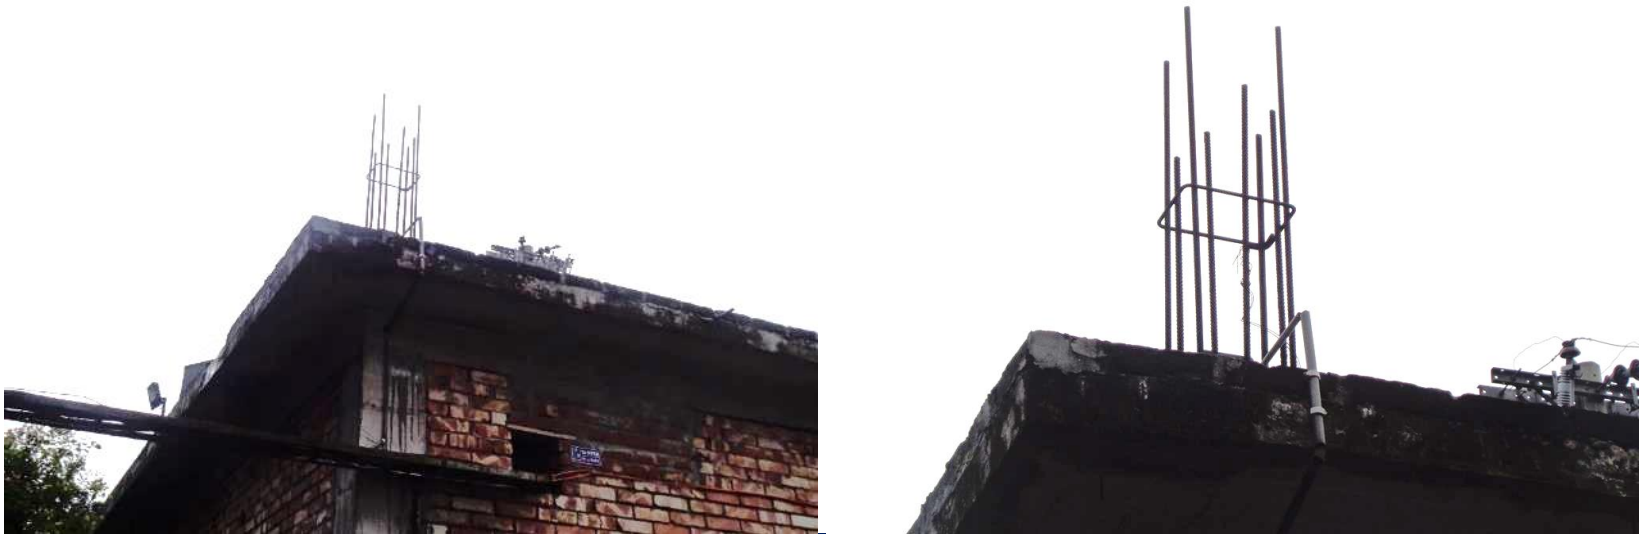
Exposed rebar on roof

Exposed rebar observed on roof which is prone to corrosion. The factory is required to provide anti-corrosive coating on the exposed rebar.

| Item No. | Observation | Recommended Action Plan | Recommended Timeline |
|---|---|---|---|
| 23 | Exposed rebar at roof. Building-1 (Utility) | The factory is required to provide anti-corrosive coating on the exposed rebar. | 6-months |

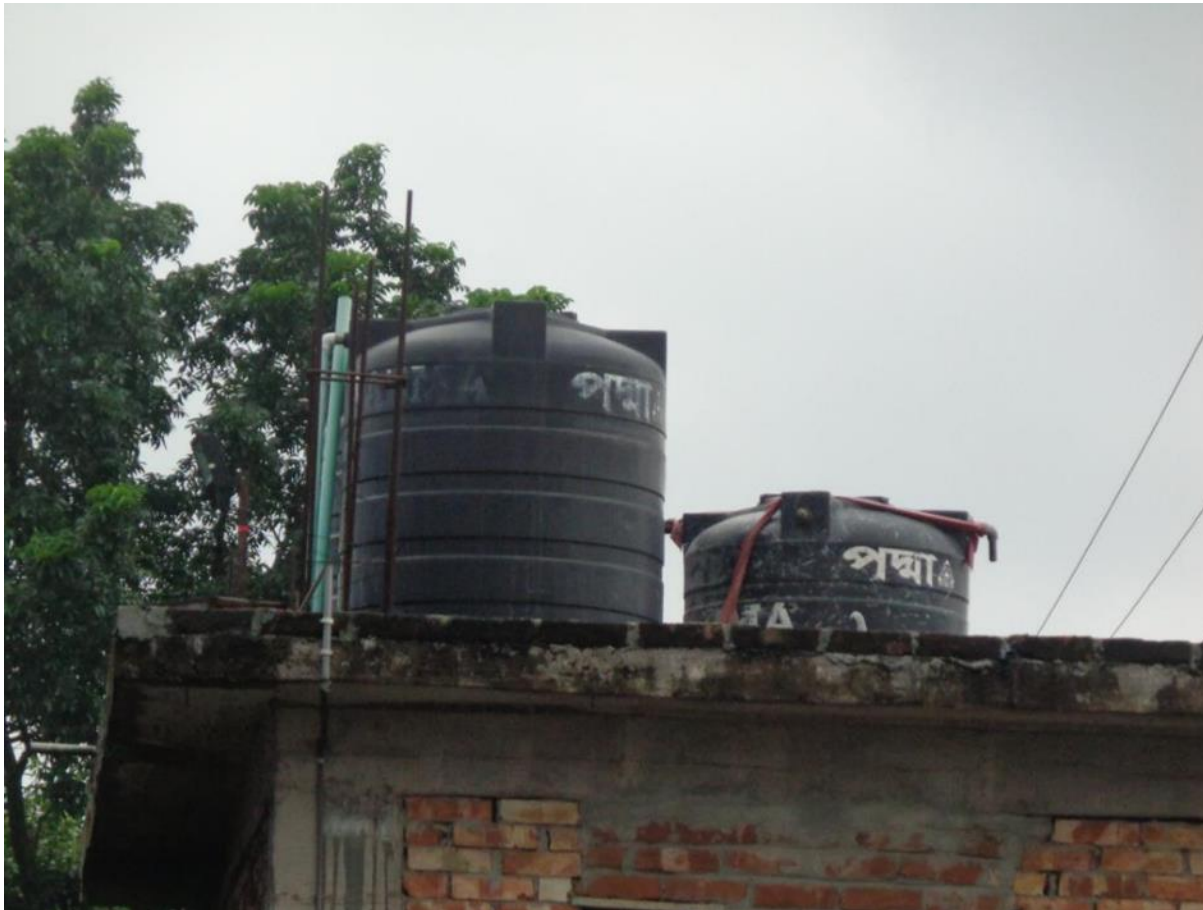
Water tank on the roof has no lateral brace

The factory is required to provide lateral bracing for water tanks to resist seismic forces.

| Item No. | Observation | Recommended Action Plan | Recommended Timeline |
|---|---|---|---|
| 24 | Lack of anchorage of non-structural elements. Building-1 (Utility) | The factory is required to provide lateral bracing for water tanks to resist seismic forces. | 6-months |

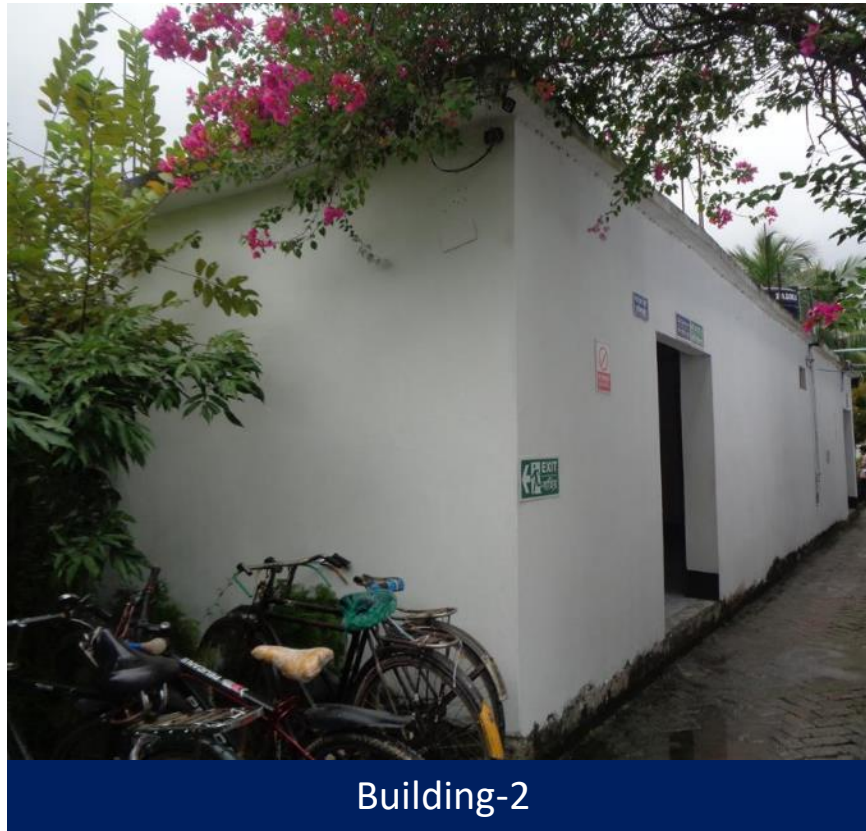
As per BNBC, every building or structure designed shall have its design documents prepared in accordance with the provision of Section 1.9.1, part-6 of BNBC. The design document shall include a design report, and a set of structural drawings, which shall be prepared in compliance with section 1.9.1.1 and section 1.9.1.2 as per BNBC. During inspection design report was not found which is required to be prepared in compliance with section 1.9.1.1 (part-6, BNBC).

| Item No. | Observation | Recommended Action Plan | Recommended Timeline |
|---|---|---|---|
| 25 | Lack of design document. Building-2 (Medical) | The building engineer is required to prepare design documents in compliance with section 1.9.1.1 (part-6, BNBC). | 6-weeks |
| 26 | Lack of design document. Building-2 (Medical) | Carry out remedial works if required. | 6-months |

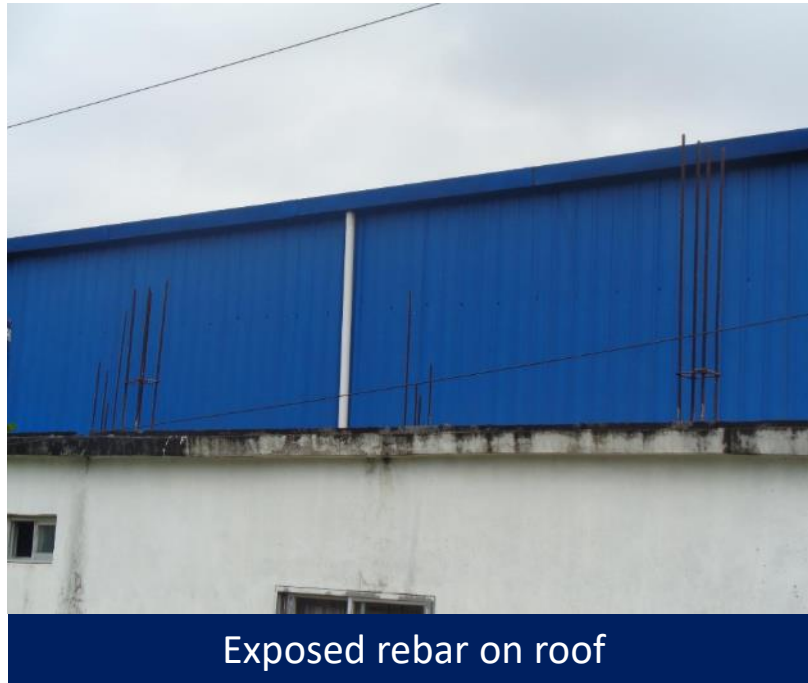
Exposed rebar observed on roof which is prone to corrosion. The factory is required to provide anti-corrosive coating on the exposed rebar.

| Item No. | Observation | Recommended Action Plan | Recommended Timeline |
|---|---|---|---|
| 27 | Exposed rebar at roof. Building-2 (Medical) | The factory is required to provide anti-corrosive coating on the exposed rebar. | 6-months |

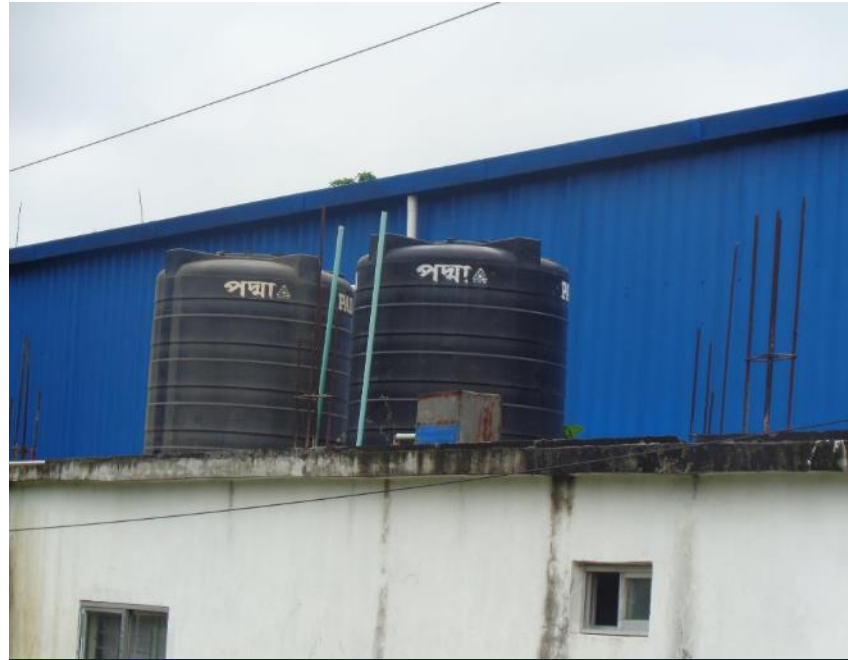
Water tank on the roof has no lateral brace

The factory is required to provide lateral bracing for water tanks to resist seismic forces.

| Item No. | Observation | Recommended Action Plan | Recommended Timeline |
|---|---|---|---|
| 28 | Lack of anchorage of non-structural elements. Building-2 (Medical) | The factory is required to provide lateral bracing for water tanks to resist seismic forces. | 6-months |
