Asrotex (Extension)

Dharmaganj, Enayetnagar, Fatullah, Narayanganj, Bangladesh

08th October 2023

01. Building-2: The structure is a seven (G+6) storied reinforced concrete (RC) building with a semi-basement.

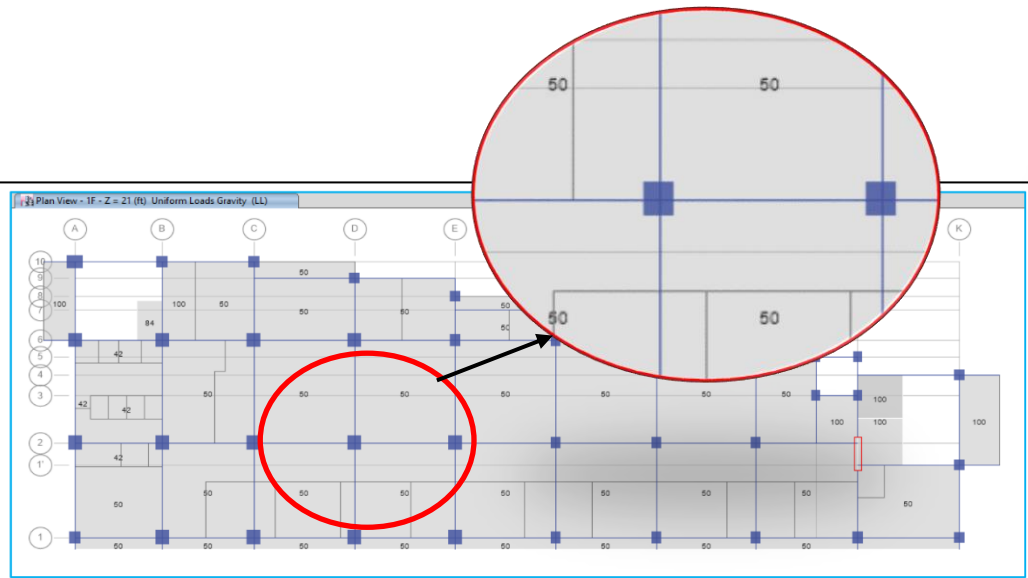
Figure 3.7-14: Live load on 1st Floor (unit=lb/sft)

Software based analysis: 50psf (2.5 kPa) live load

In design and analysis, first floor live load was considered as 50psf. Hence, in the posted load plan 125psf has been considered beyond the design & analysis. Building engineer is required to check the floor load plan, update as per NBC requirement and revise the design documents accordingly.

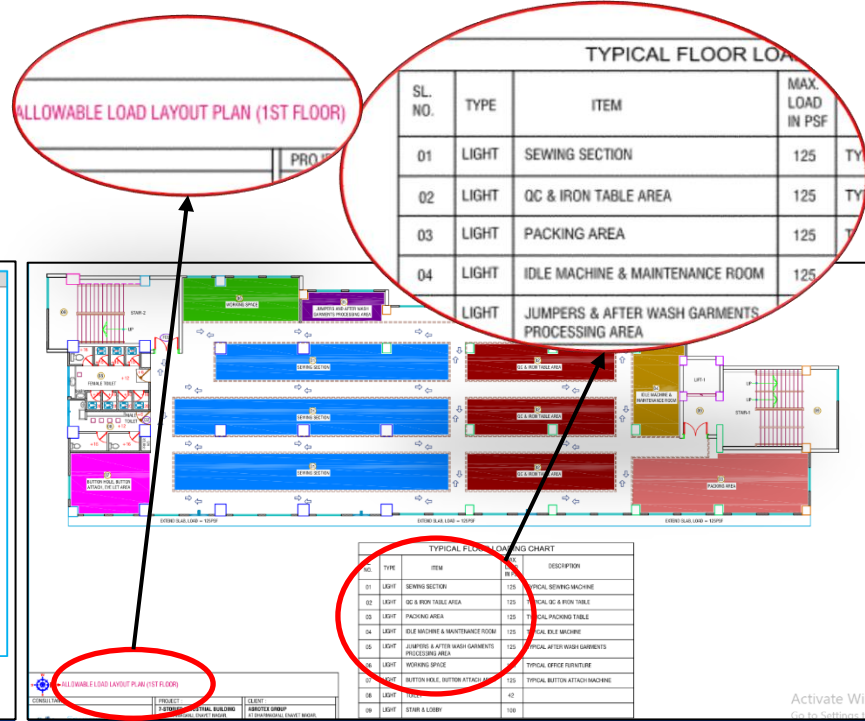
Load plan: 125psf (6 kPa) live load on 1st

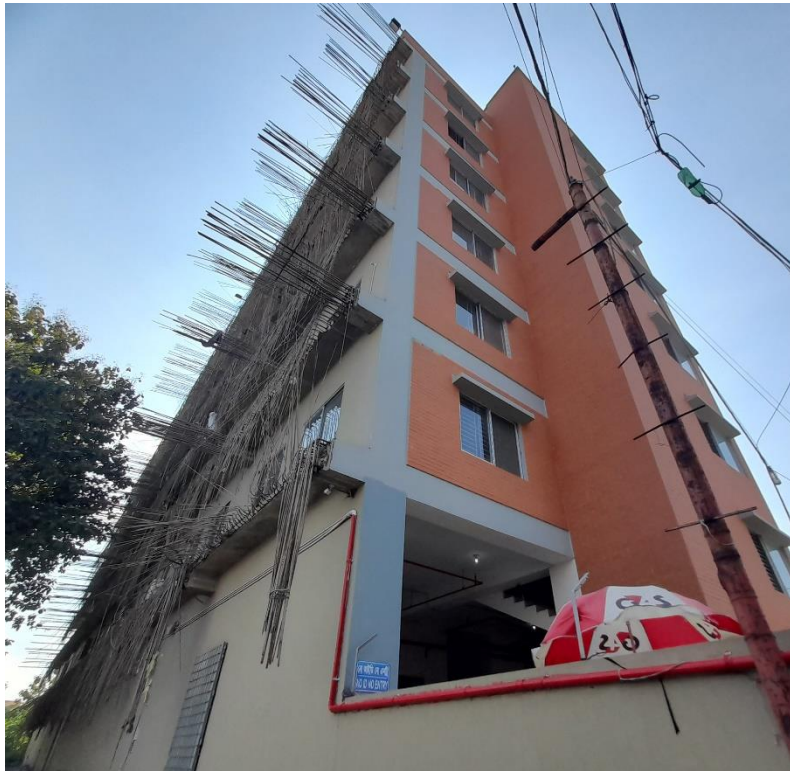
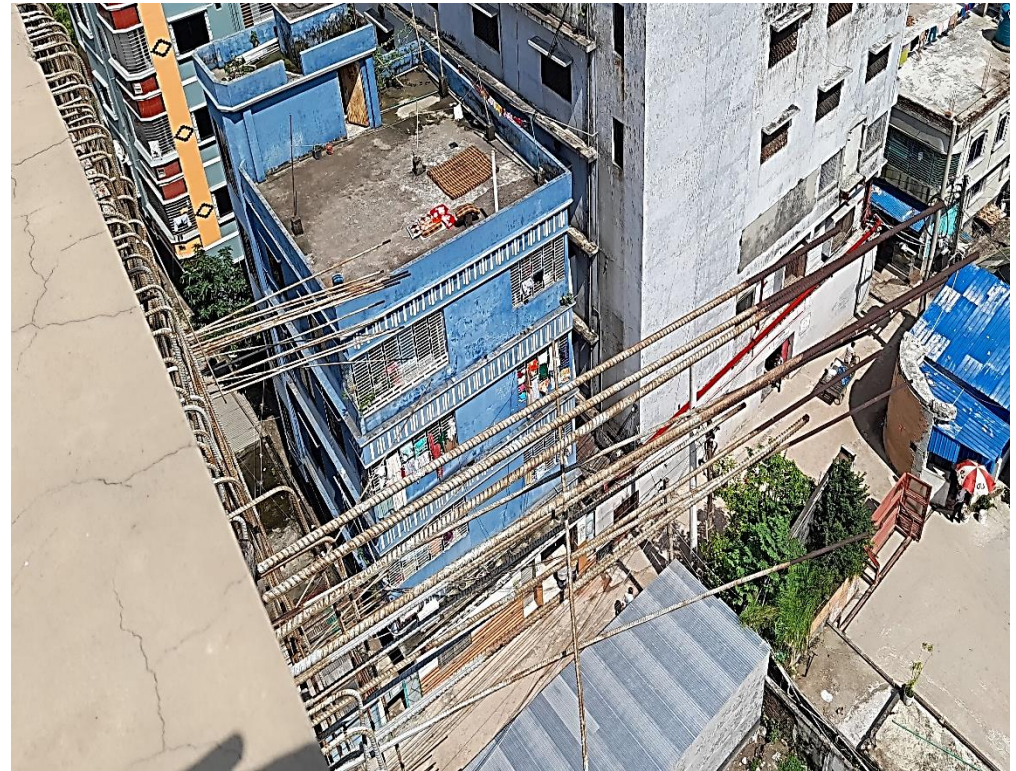
Exposed reinforcement left at each level

Exposed reinforcements had been left at each floor level staircase which were prone to corrosion. Factory is required to provide rust proof paint on exposed reinforcement to protect from corrosion.

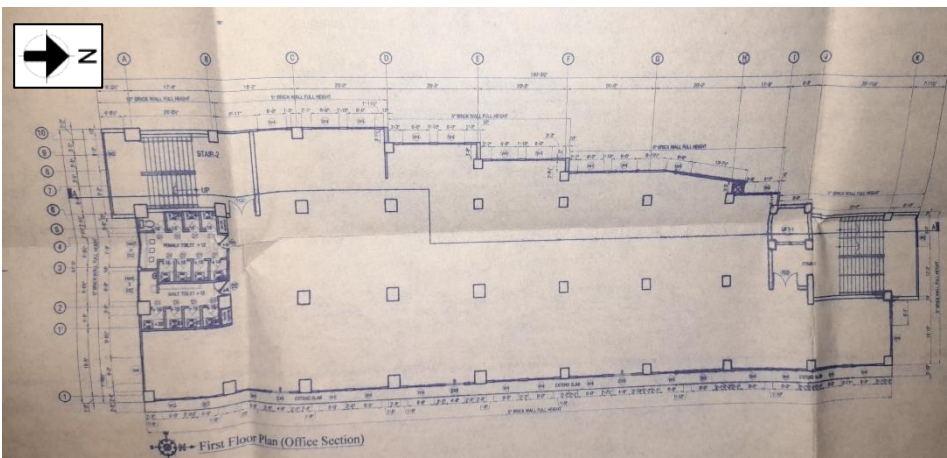
Floor outline in the permit drawing

The building is currently existed as per the permit drawing. However, the factory has a plan to conduct horizontal expansion in future. Projected reinforcement left at east side which indicates possible future horizontal expansion.

The factory is required to collect building permit drawing considering expansion part and prepare a Detailed Engineering Assessment (DEA) report prior conducting any horizontal expansion.

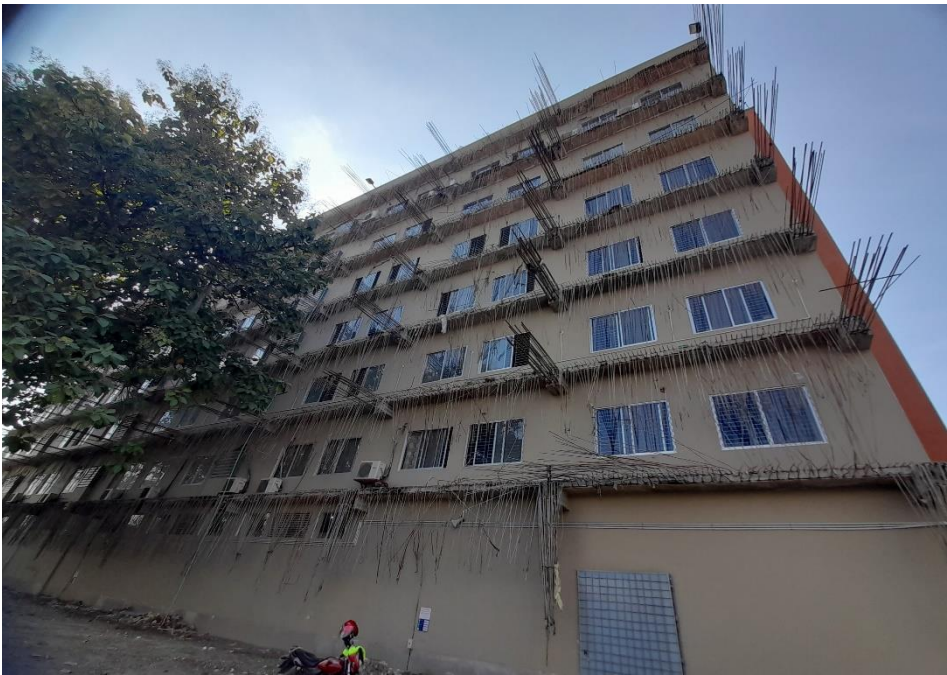
Projected reinforcement left at east side which indicates possible future horizontal expansion

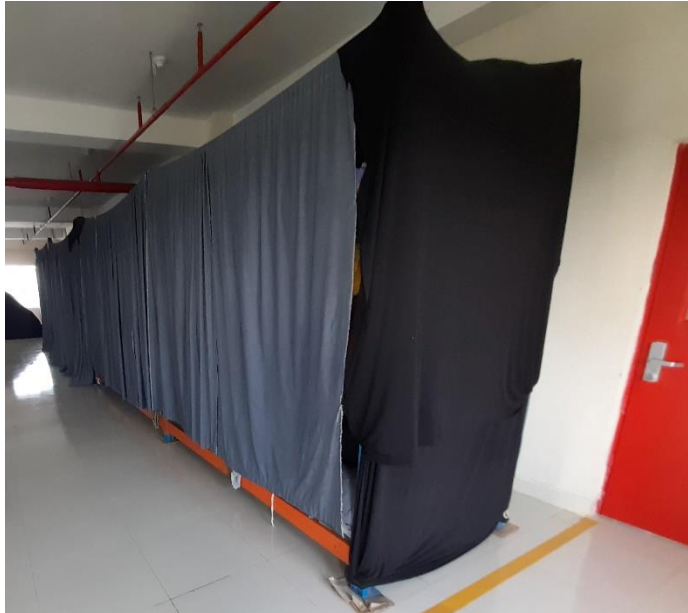
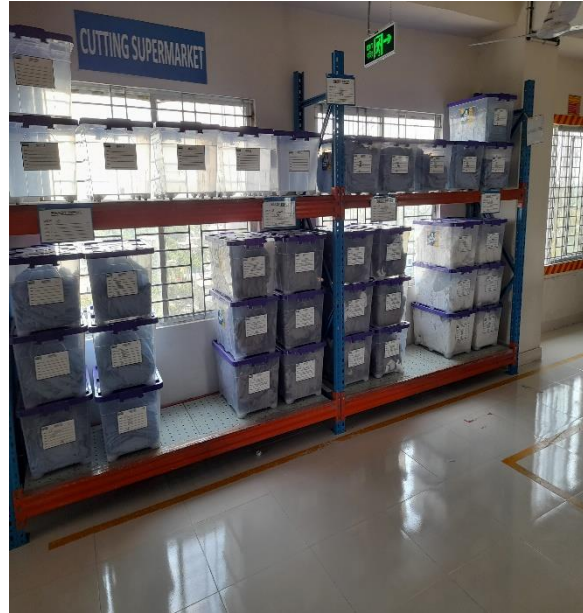
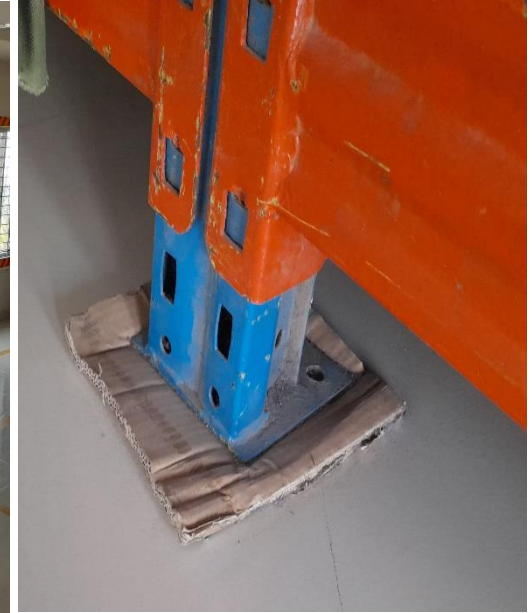
Storage rack found within the building without braced/anchored

Non-structural elements suspended from, attached to, or resting atop the structure shall be adequately anchored and braced to resist earthquake forces. Factory is required to brace/anchor all non-structural elements.

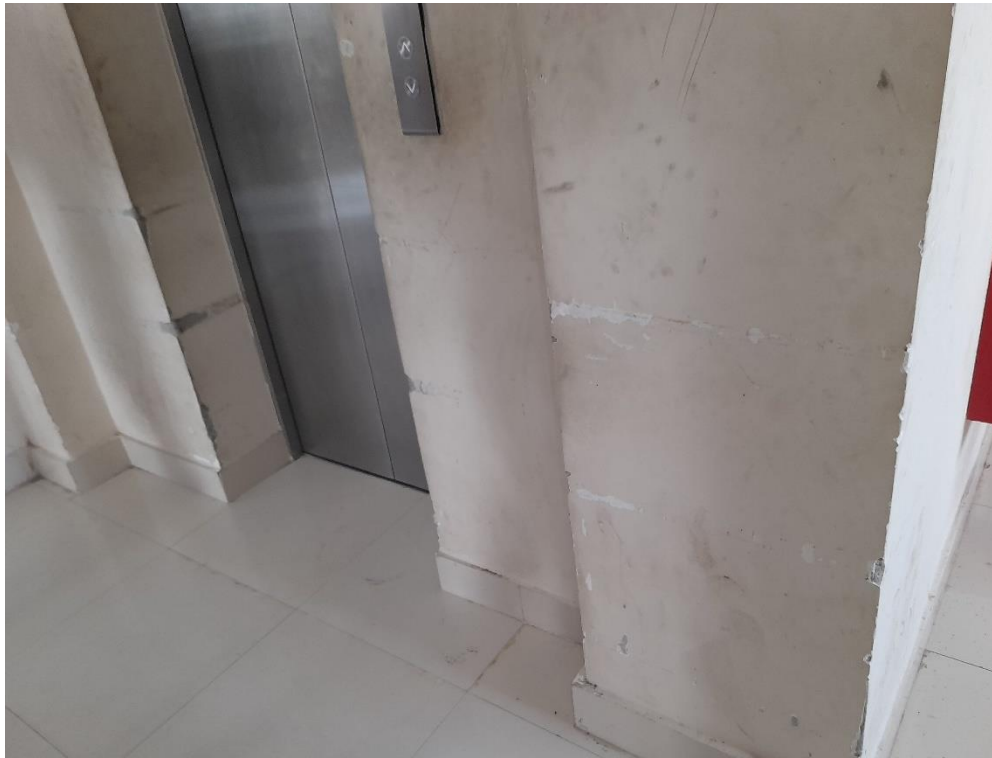
Affected columns at lift zone

Columns and walls are susceptible to impact loading from trolley. Signs of damages were observed at several floor. Factory is required to provide necessary protection on the affected and suspected locations.

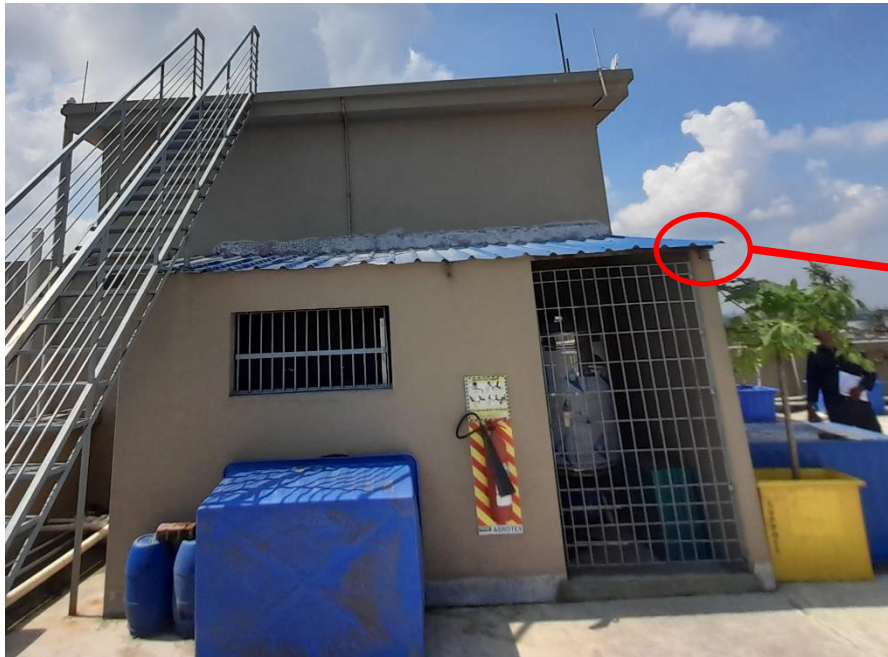
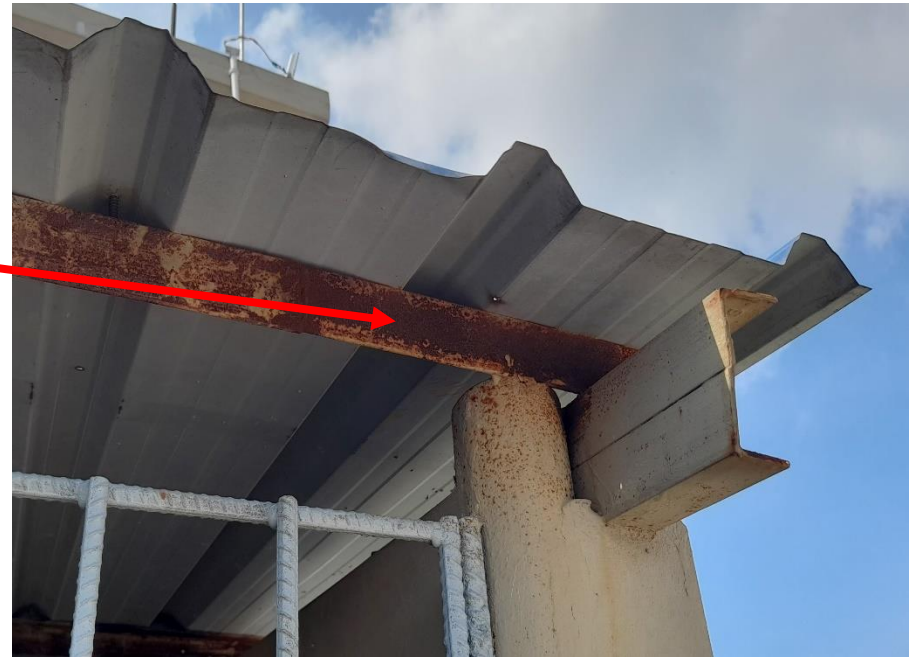
Corrosion on steel member

Corrosion was observed on steel members on roof shed. Factory is required to provide rust proof paint on steel members.
