# Olympic Fashion Ltd

B.K.Bari, Mirzapur Bazar, Gazipur Sadar, Gazipur, Bangladesh  
(24.105266, 90.402996)  
15<sup>th</sup> October 2023

# Building Information

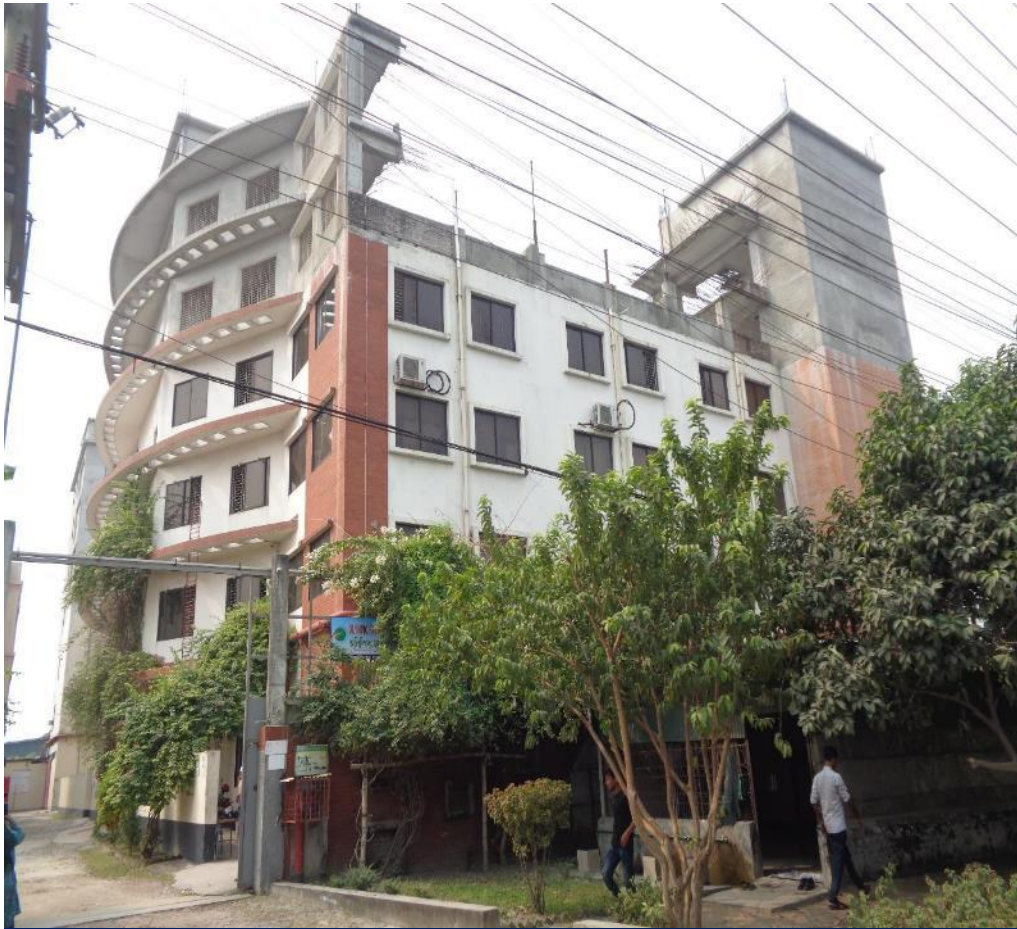
Main Building

As per BNBC, every building or structure designed shall have its design documents prepared in accordance with the provision of Section 1.9.1. The design document shall include a design report, and a set of structural drawings, which shall be prepared in compliance with section 1.9.1.1 and section 1.9.1.2 as per BNBC.

At the time of inspection, design report was not available which is required to be prepared in compliance with section 1.9.1.1 (part-6, BNBC).

| Item No. | Observation | Recommended Action Plan | Recommended Timeline |
|---|---|---|---|
| 01 | Absence of design documents (Main Building) | Building is required to prepare a set of design report in compliance with section 1.9.1.1 (part-6, BNBC). | 6-weeks |

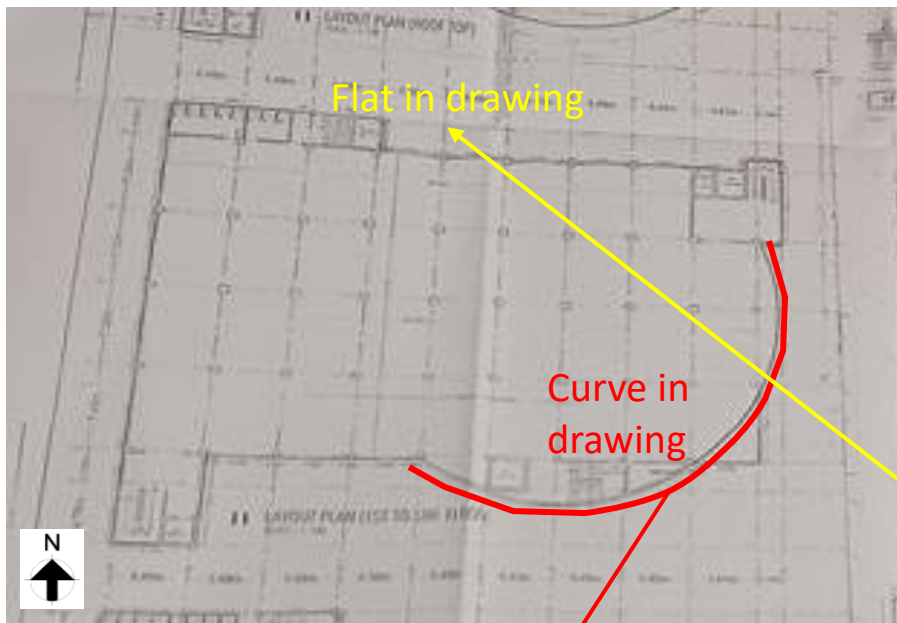
Typical floor plan in permit drawing from local authority

Onsite condition of the structure was found significantly different from permit drawing. East side of the structure was found straight but shown as round in the permit drawing.

Factory is required to collect the updated permit drawing from local authority.

| Item No. | Observation | Recommended Action Plan | Recommended Timeline |
|---|---|---|---|
| 03 | As-built condition differs from permit drawing (Main Building) | Factory is required to collect the updated permit drawing from local authority. | 6-months |

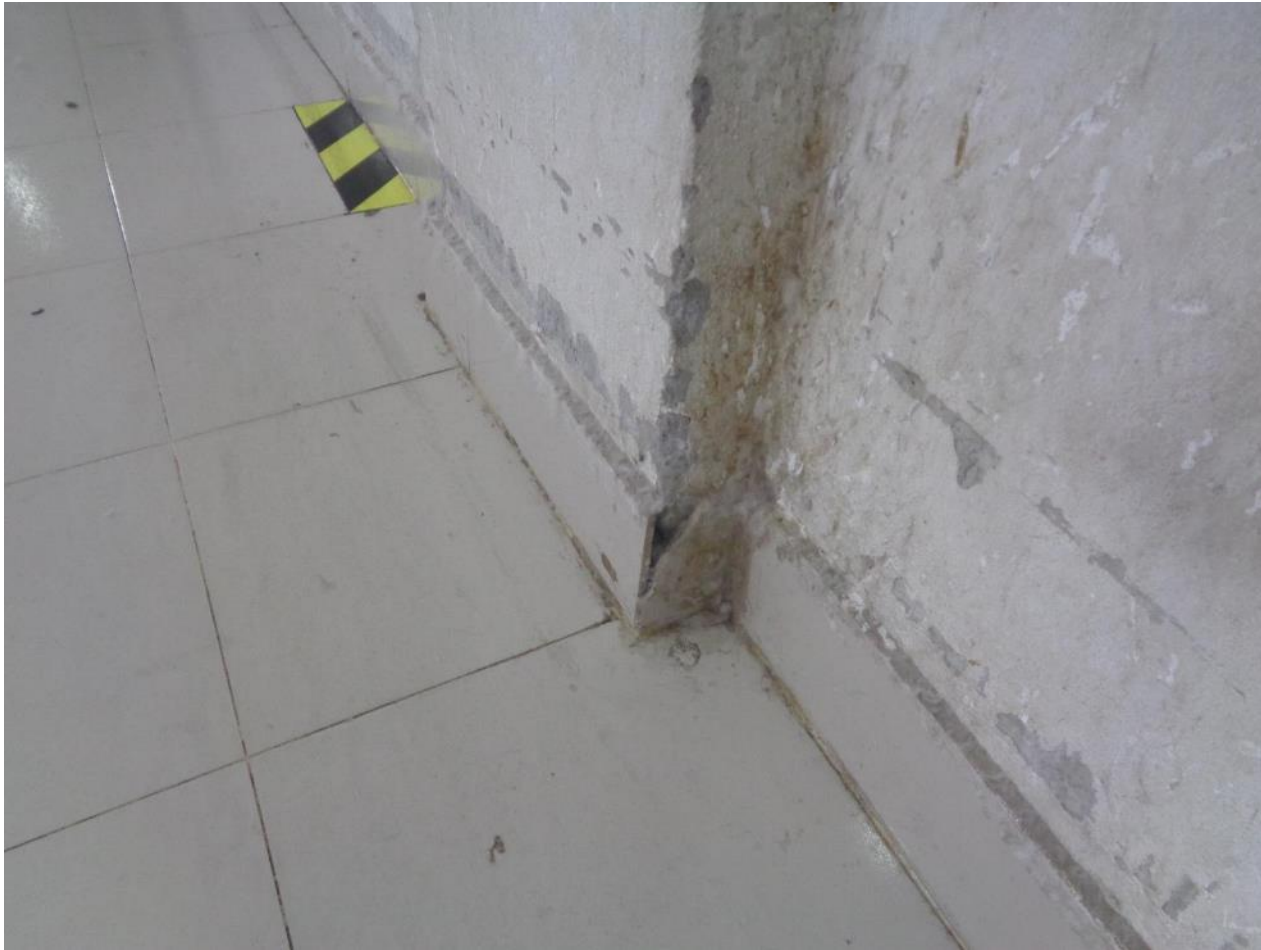
Plaster was damaged on column at several locations

Due to trolley impact some damage in columns plaster were observed.  
The factory is required to provide necessary column protection/guard.

| Item No. | Observation | Recommended Action Plan | Recommended Timeline |
|---|---|---|---|
| 04 | Trolley impact on column (Main Building) | Factory is required to provide protection for trolley impact. | 6-weeks |

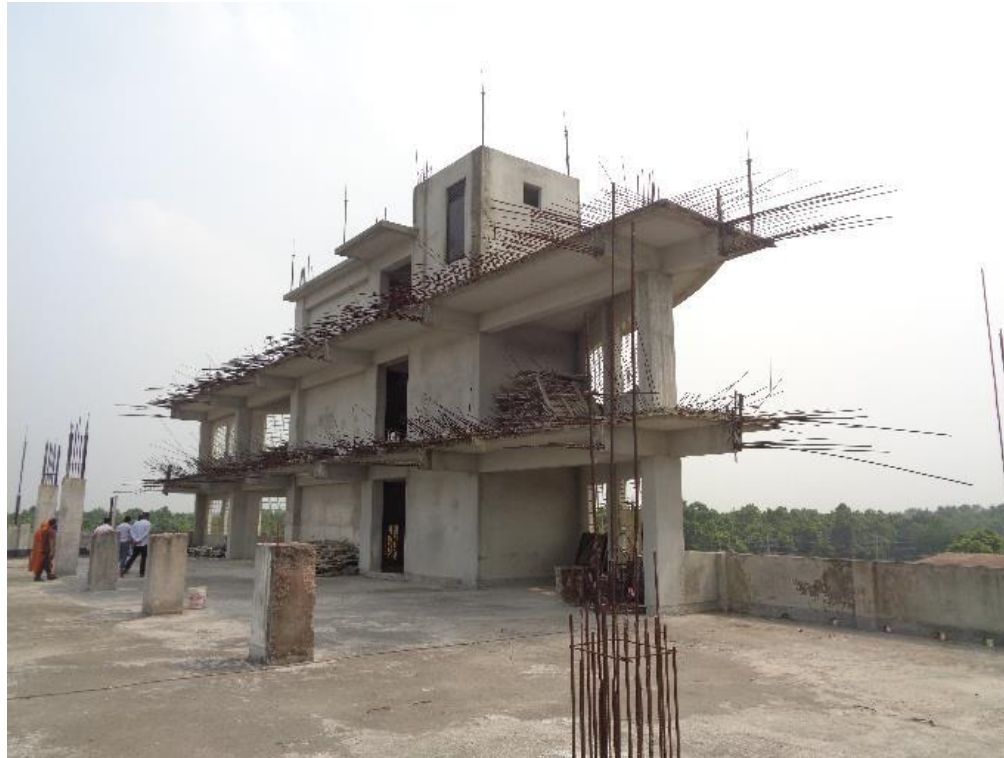
Exposed reinforcement left at roof (Main Building)

Factory is required to provide rust proof paint on exposed reinforcement to protect from corrosion.

| Item No. | Observation | Recommended Action Plan | Recommended Timeline |
|---|---|---|---|
| 05 | Corrosion on exposed rebar (Main Building) | Factory is required to provide rust proof paint on exposed rebar to prevent corrosion. | 6-months |

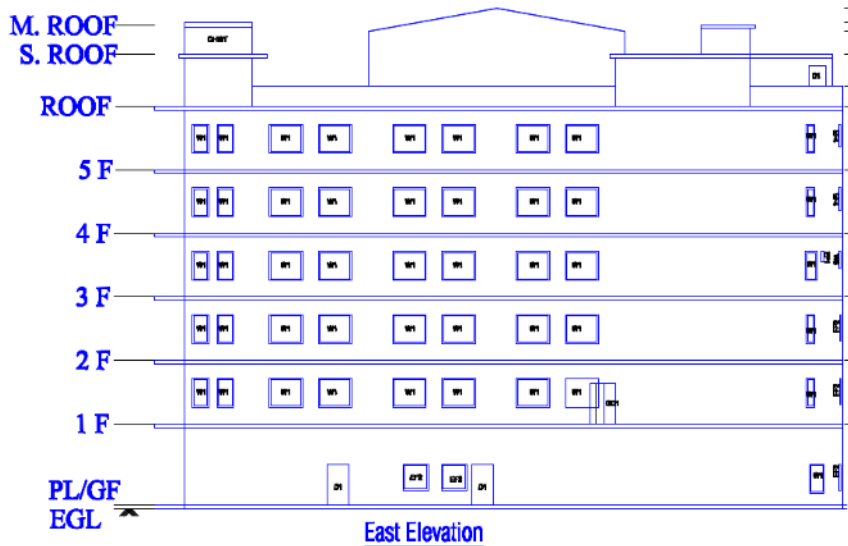
Building is designed as 6 storied

The building is currently existed as four storied, but the all the star cases are constructed up to six storied. The building has permit drawing for 6 storied and factory is intended to conduct vertical extension in future.

However, the building engineer is required to prepare a Detail Engineering Assessment (DEA) report and submit to RSC for review prior commencement of any extension work.

| Item No. | Observation | Recommended Action Plan | Recommended Timeline |
|---|---|---|---|
| 06 | Possible vertical extension (Main Building) | Building engineer is required to prepare a Detail Engineering Assessment (DEA) report and submit to RSC for review prior commencement of any extension work. | 6-months |

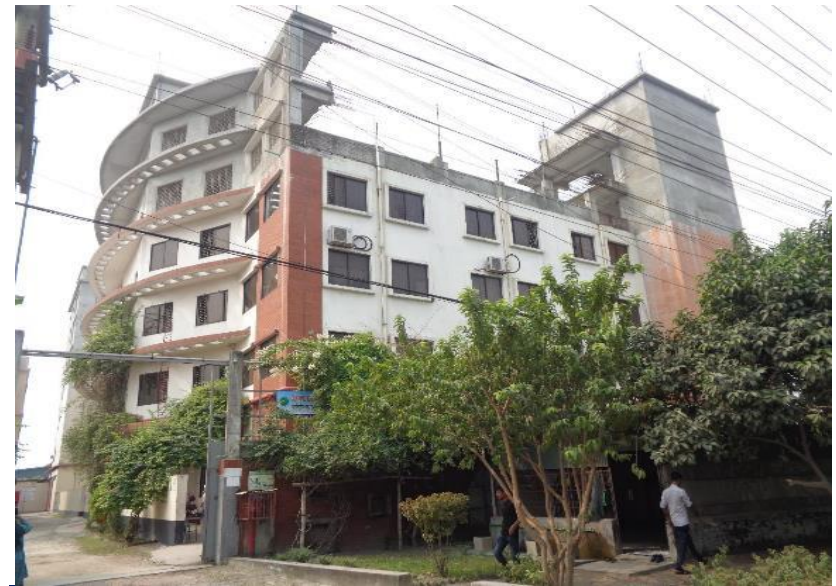
Building is currently 4 storied

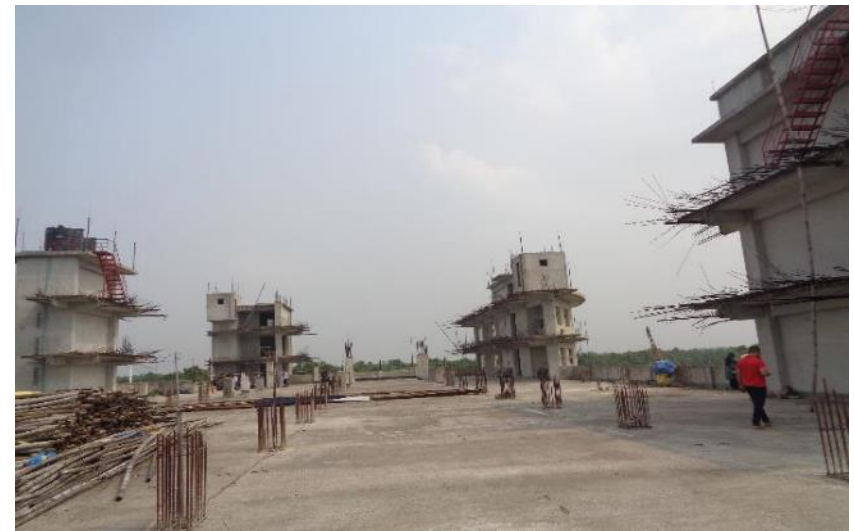
Projected rebar observed at roof level

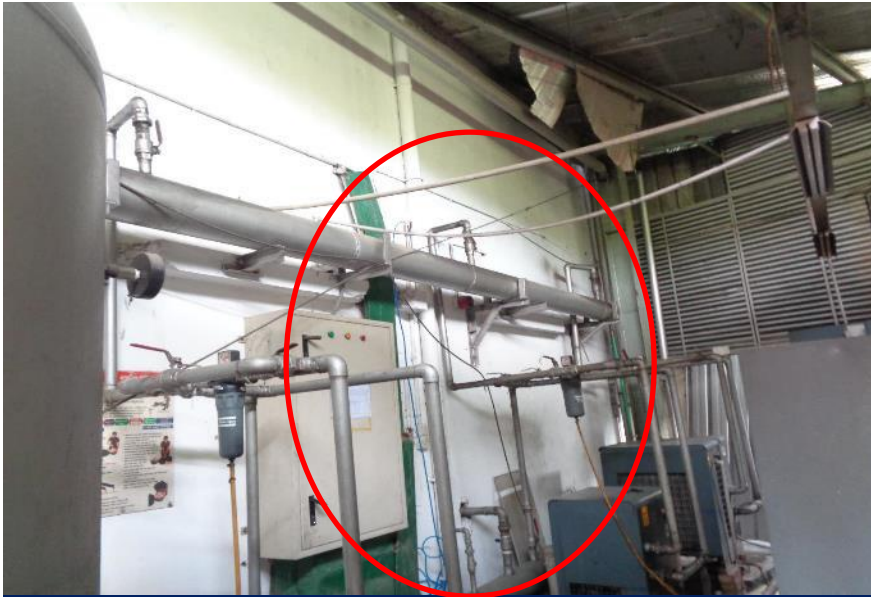
Torn cable bracing (Compressor Shed)

The factory is required to fix the torn bracing and tighten the loose bracings for transferring the lateral loads properly.

| Item No. | Observation | Recommended Action Plan | Recommended Timeline |
|---|---|---|---|
| 08 | Loose and torn cable bracing (Compressor Shed) | The factory is required to fix the torn bracing and tighten the loose bracings for transferring the lateral loads properly. | 6-weeks |

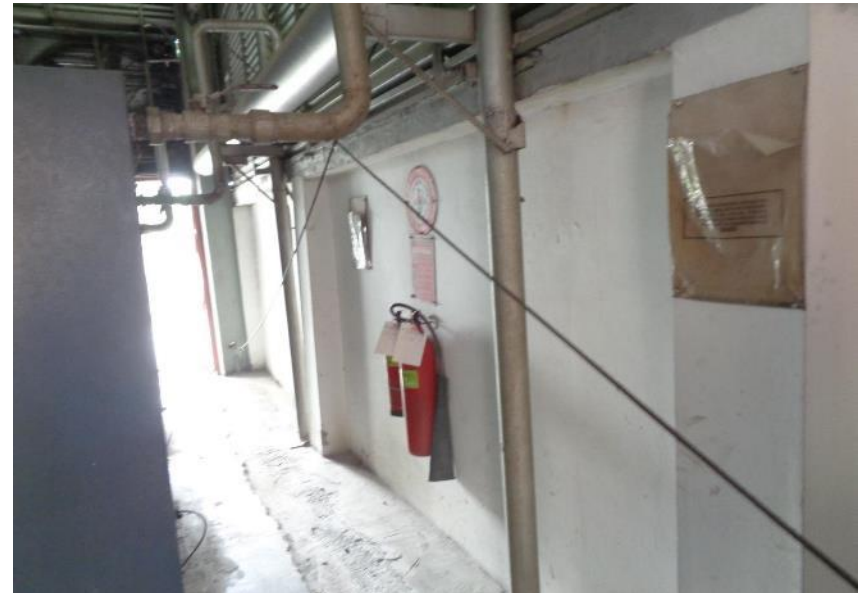
Loose cable bracing (Compressor Shed)

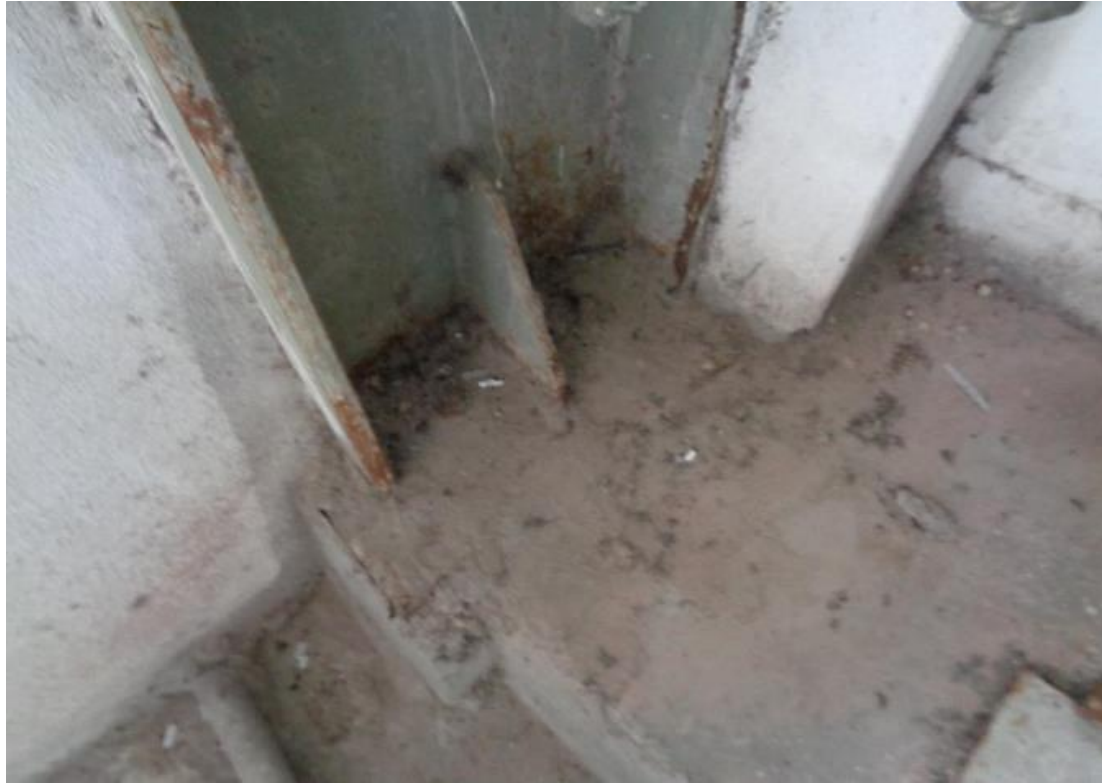
Corrosion on steel column (Compressor Shed)

Factory is required to remove the rust and provide rust proof paint on steel members to protect from corrosion.

| Item No. | Observation | Recommended Action Plan | Recommended Timeline |
|---|---|---|---|
| 09 | Corrosion on steel members (Compressor Shed) | Factory is required to provide rust proof paint on steel members to prevent corrosion. | 6-months |

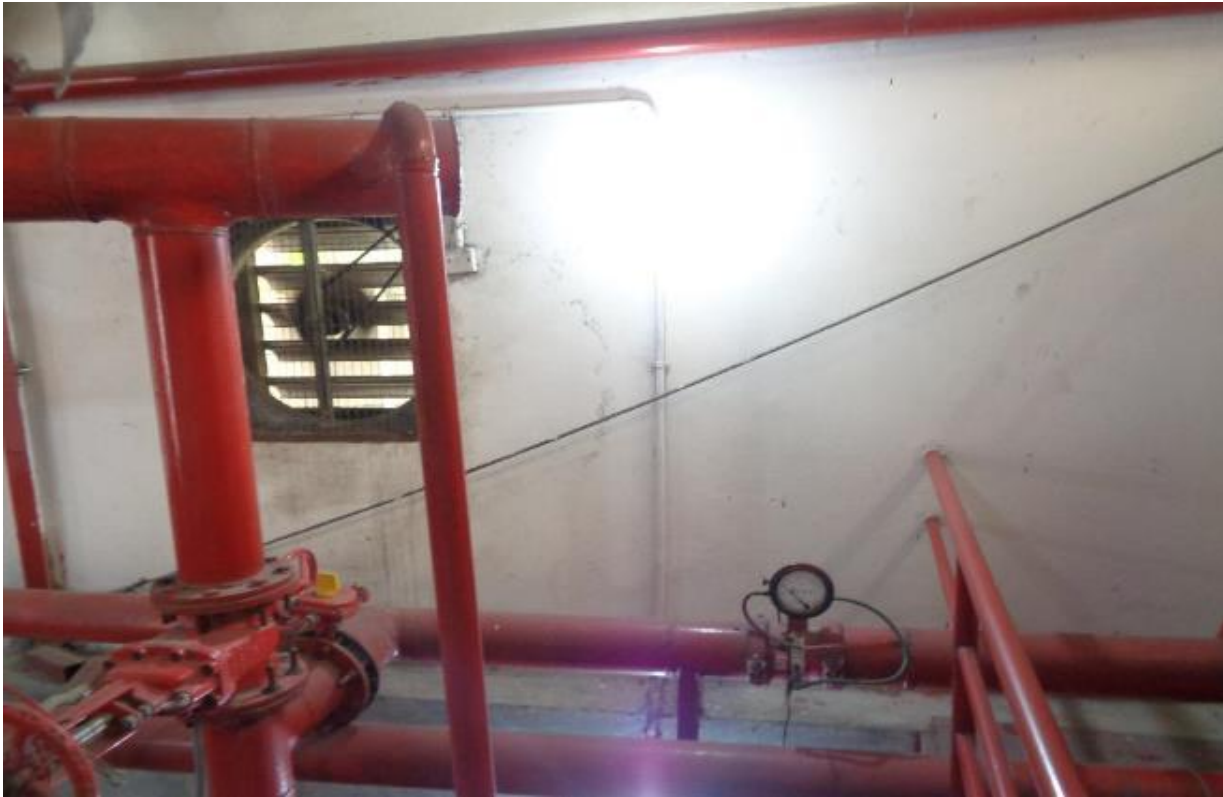
Loose cable bracing (Fire Pump Shed)

Some wall cable bracings were found loose in Fire Pump Shed. The factory is required to tighten the loose bracings for transferring the lateral loads properly.

| Item No. | Observation | Recommended Action Plan | Recommended Timeline |
|---|---|---|---|
| 10 | Loose cable bracing (Fire Pump Shed) | The factory is required to tighten the loose bracings for transferring the lateral loads properly. | 6-weeks |
