# Cotton Field (BD) Ltd. (Extension)

Plot- 42/3, Rajnagar, Sataish Road, Tongi, Gazipur.

1<sup>st</sup> October 2023

# Observations

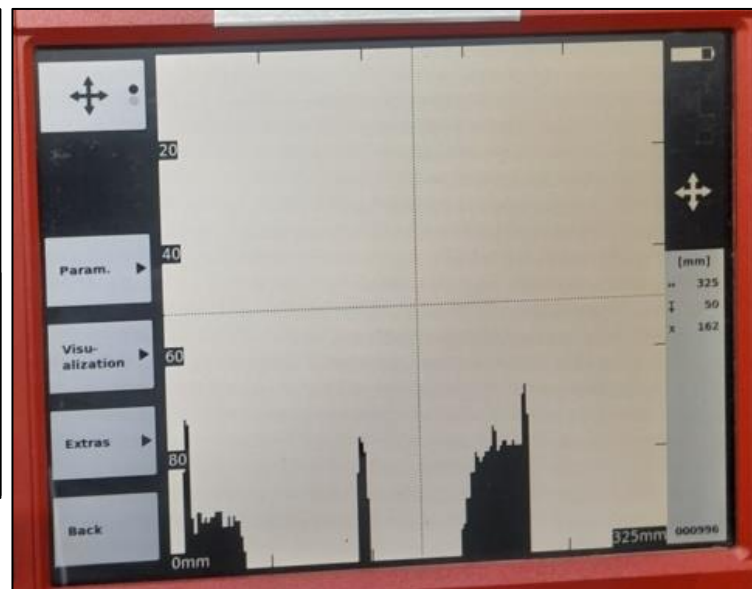
Column Schedule. 4 re-bar has been shown in a face

The re-bar number was found mismatched for the C1A column. In as-built drawing, total re-bar of the C1A column has been shown 8-nos. But total re-bar was revealed 6-nos for the column by ferro-scanning. Also 8-nos of the re-bar has been assigned in FEA model.

The Building engineer is required to survey the whole structure and update as built structural drawing as per onsite condition and revise the design report in compliance with BNBC.

| Item No. | Observation | Recommended Action Plan | Recommended Timeline |
|---|---|---|---|
| 01 | Mismatch in structural drawings. (Building-3) | Building engineer is required to produce full set of as-built drawing reflecting the as constructed condition in compliance with BNBC. | 6-weeks |
| 02 | Mismatch in structural drawings. (Building-3) | Building engineer to revise the Desing Report including a design report, and a set of structural drawings in compliance with section 1.9.1.1 and section 1.9.1.2 as per BNBC. | 6-weeks |

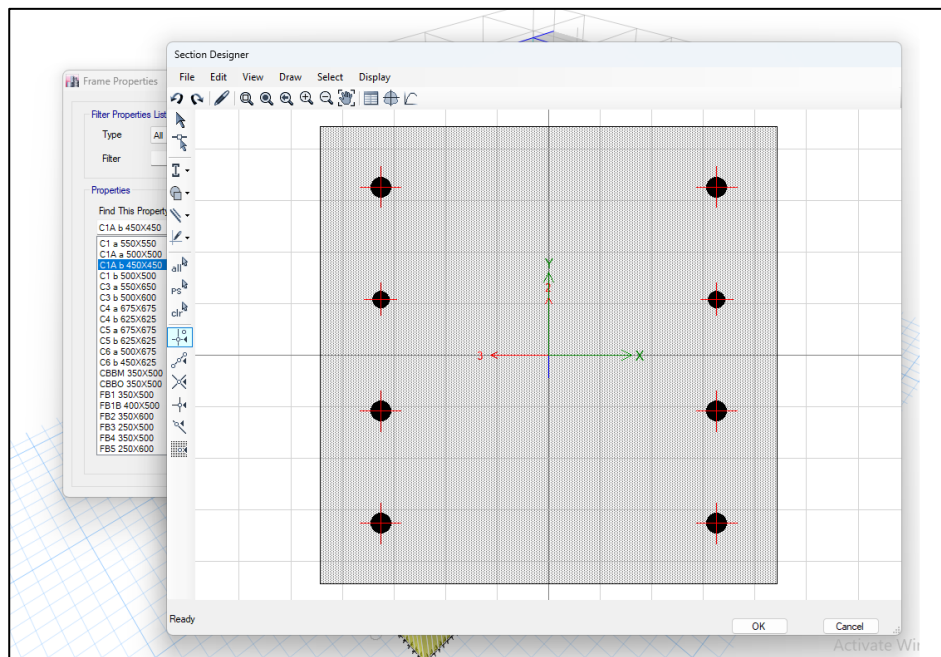
3-nos of re-bar was found by ferro-scanning instead of 4-nos of re-bar in a face.

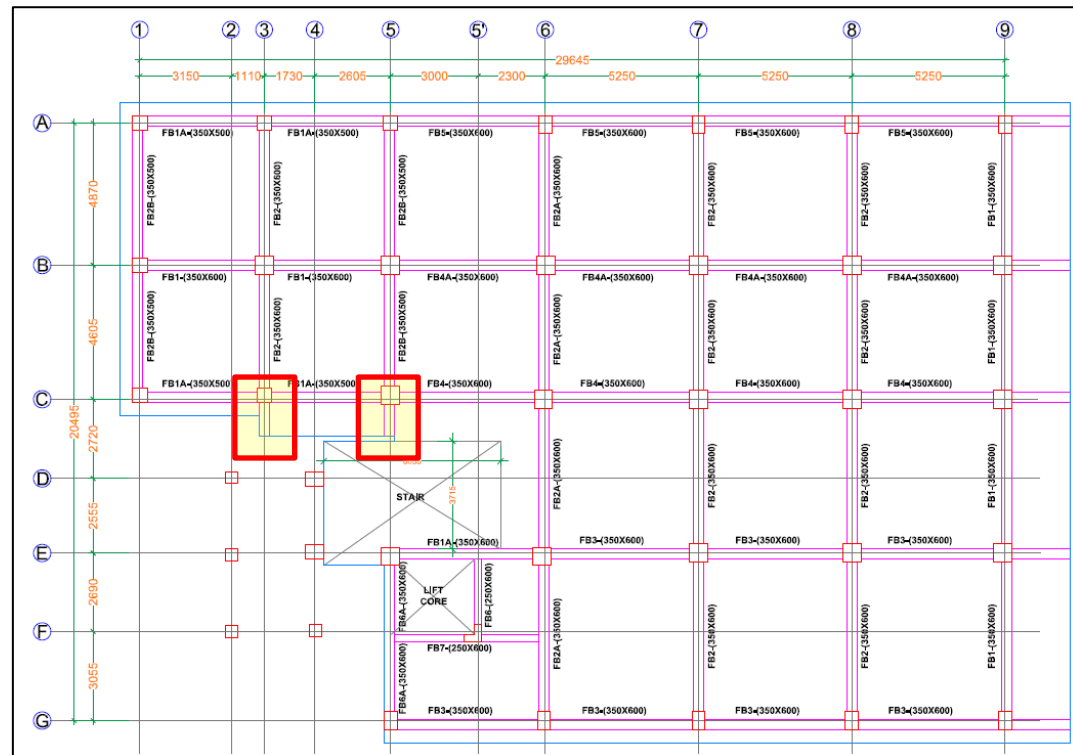
Cantilever slab. Contriver beam was not found at that position.

The marked location of beam layout plan, the cantilever beam was not found at site condition. The slab is cantilever.

The Building engineer is required to survey the whole structure and update as built structural drawing as per existing condition and revise the design report in compliance with BNBC.

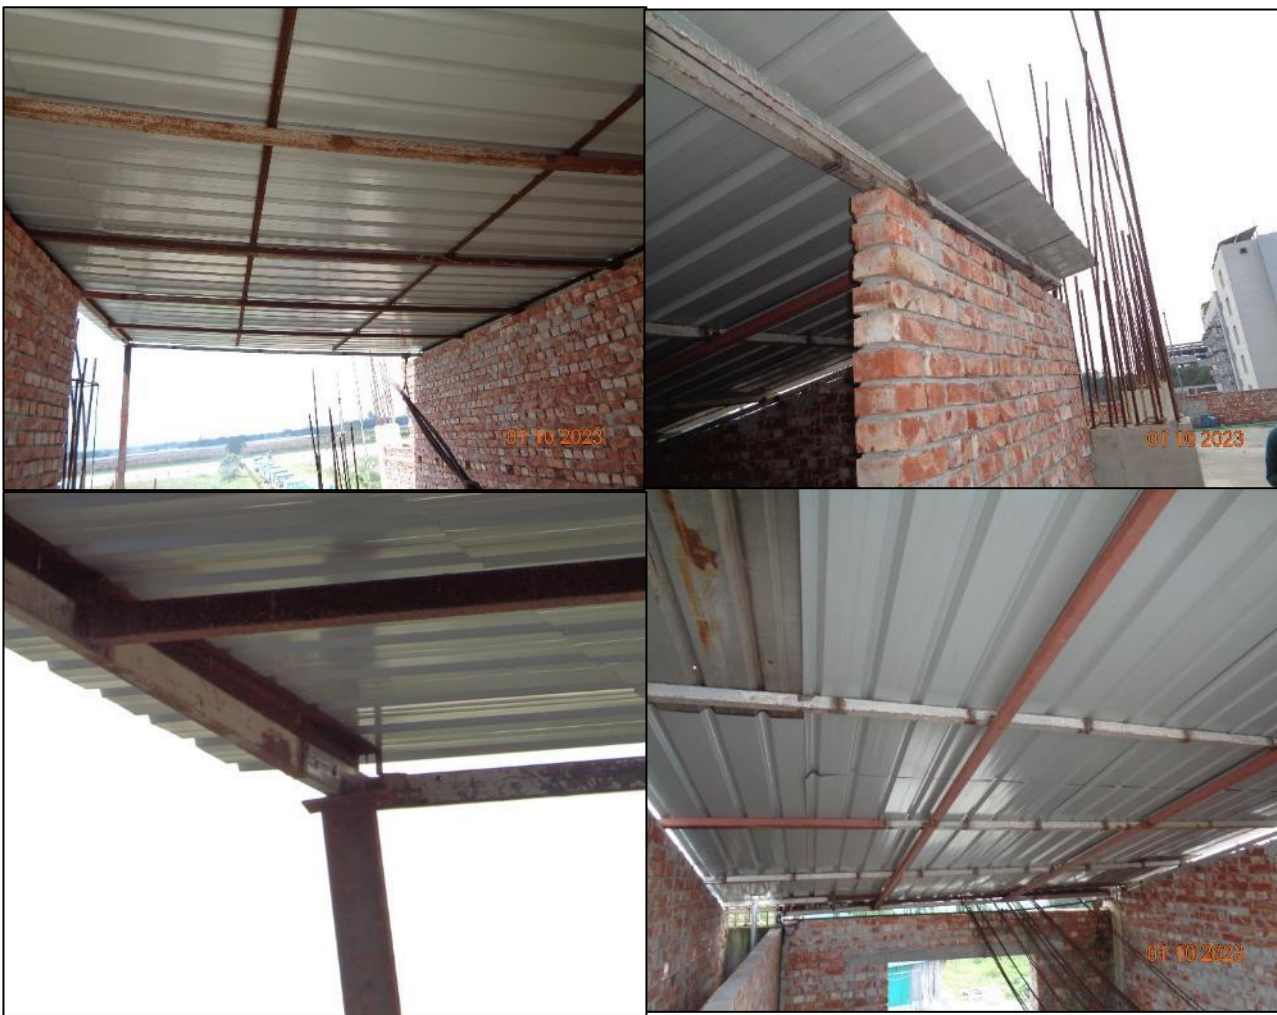
The stair roof is light-weight steel shed made of C channel & angle section is supported by brick wall. Inadequate structural member, poor connection details observed. Apparently non-engineered shed.

Building engineer is required to prepare as-built drawing and perform the adequacy check for the light-weight steel roof shed.

| Item No. | Observation | Recommended Action Plan | Recommended Timeline |
|---|---|---|---|
| 04 | Light-weigh steel roof shed (Building-3) | Building engineer is required to prepare as-built drawing for the stair roof shed. | 6-weeks |
| 05 | Light-weigh steel roof shed (Building-3) | Building Engineer is required to check the connection adequacy for the stair roof shed. | 6-weeks |
| 06 | Light-weigh steel roof shed (Building-3) | Implement remediation works deemed necessary from connection adequacy report. | 6-months |

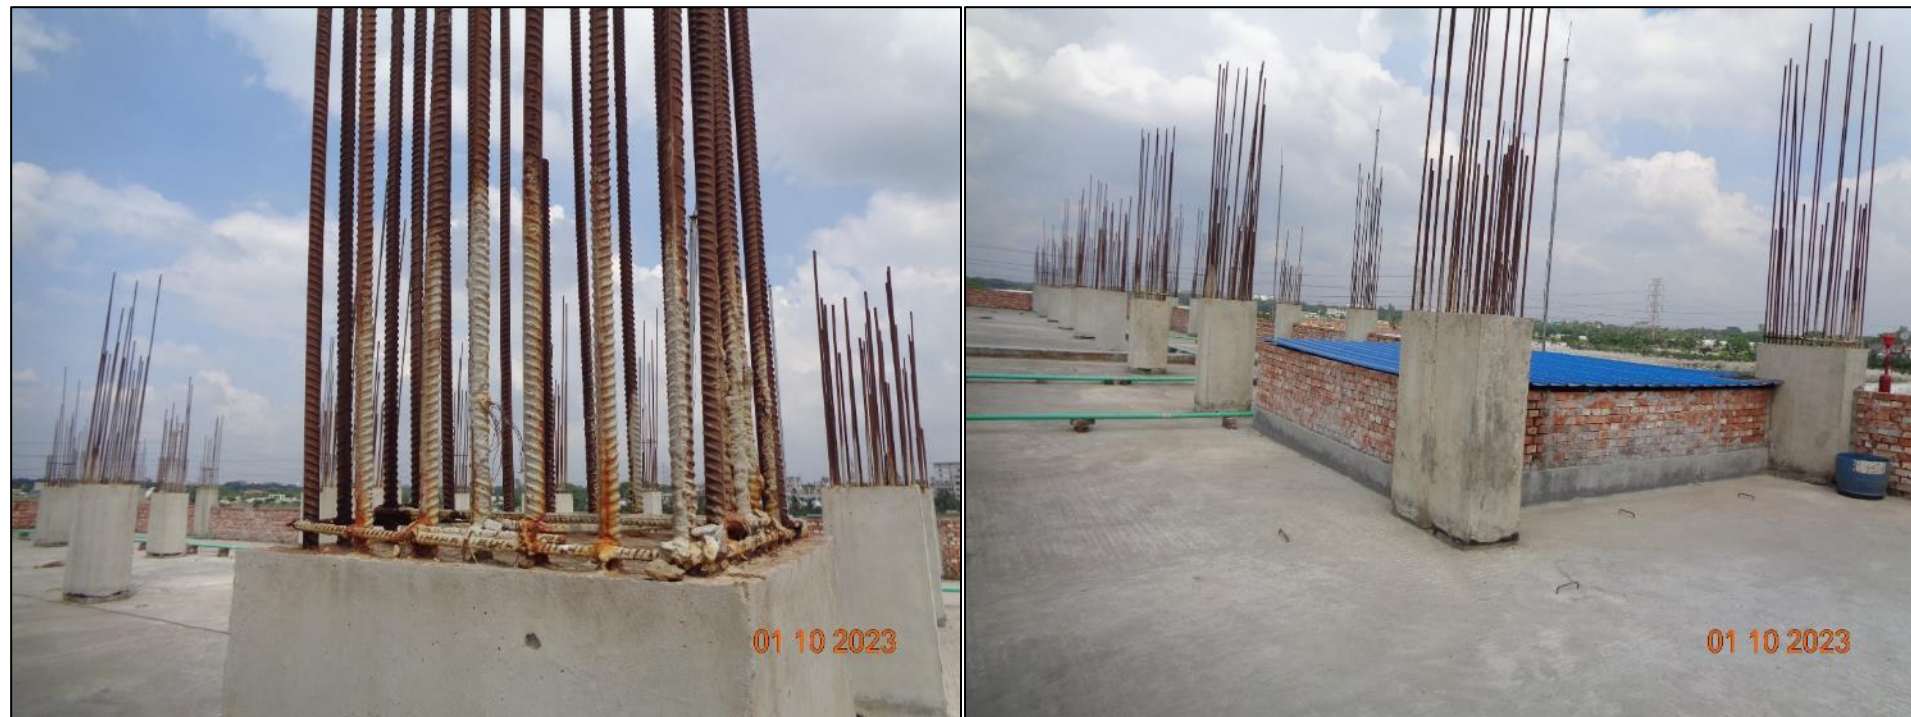
Exposed rebar of Column

Exposed reinforcement was found on rooftop columns. Building engineer is required to take necessary measures to prevent corrosion in exposed rebar.

| Item No. | Observation | Recommended Action Plan | Recommended Timeline |
|---|---|---|---|
| 07 | Exposed re-bar at roof (Building-3) | All exposed reinforcement is to be protected from corrosion which may cause degradation of the concrete. | 6-weeks |

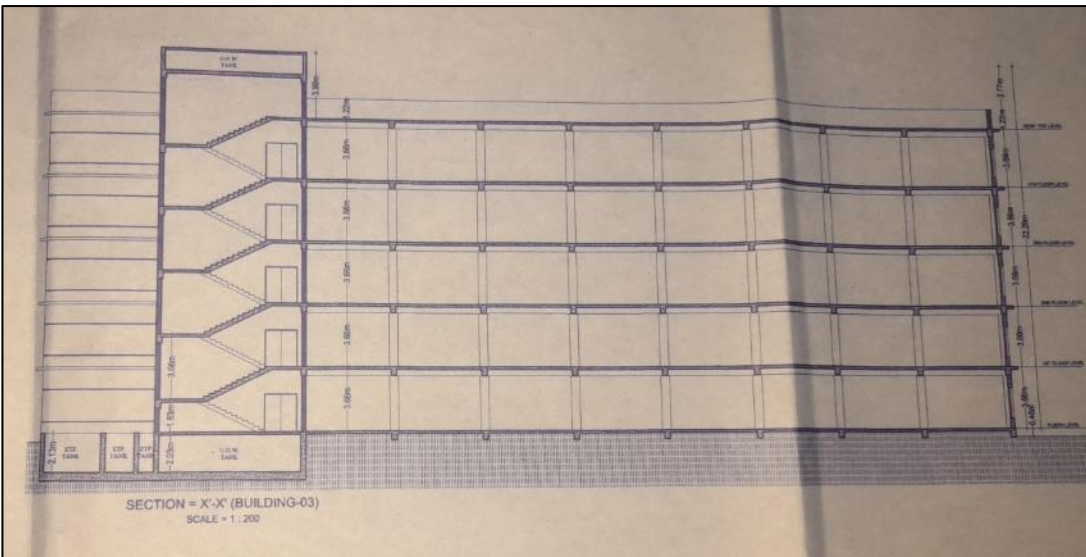
Permit drawing for 5 storied from Gazipur City Corporation

The building permission layout is for 5 storied structure. Also, the design report of the structure was prepared for 5 storied structure. Till the date of this inspection, Building was constructed up-to two storied and exposed rebar was found on roof. So, there is a possibility of future vertical extension. Building engineer is required to follow the construction safety measures during commencement of further extension work.

| Item No. | Observation | Recommended Action Plan | Recommended Timeline |
|---|---|---|---|
| 08 | Future Vertical Extension (Building-3) | Prior to vertical extension, factory engineer is required to produce follow the construction safety measures as per BNBC. | 6-weeks |

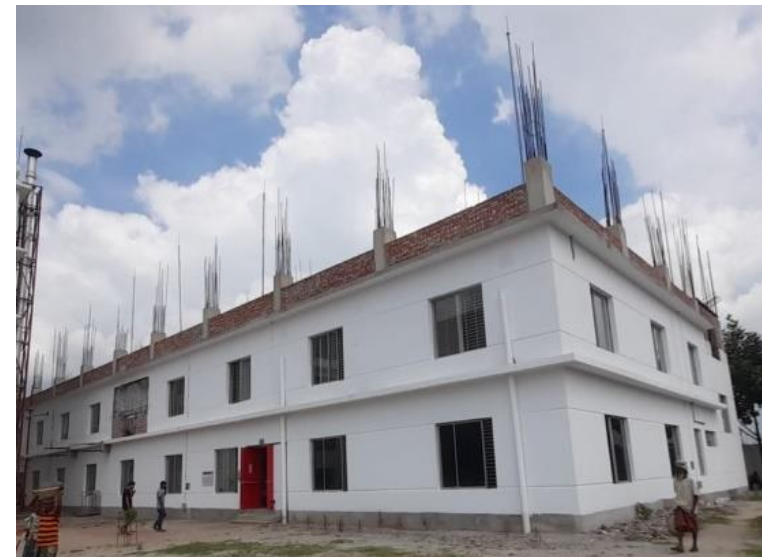
Building constructed up-to two storied.  
Extended column re-bar at roof/2<sup>nd</sup> floor

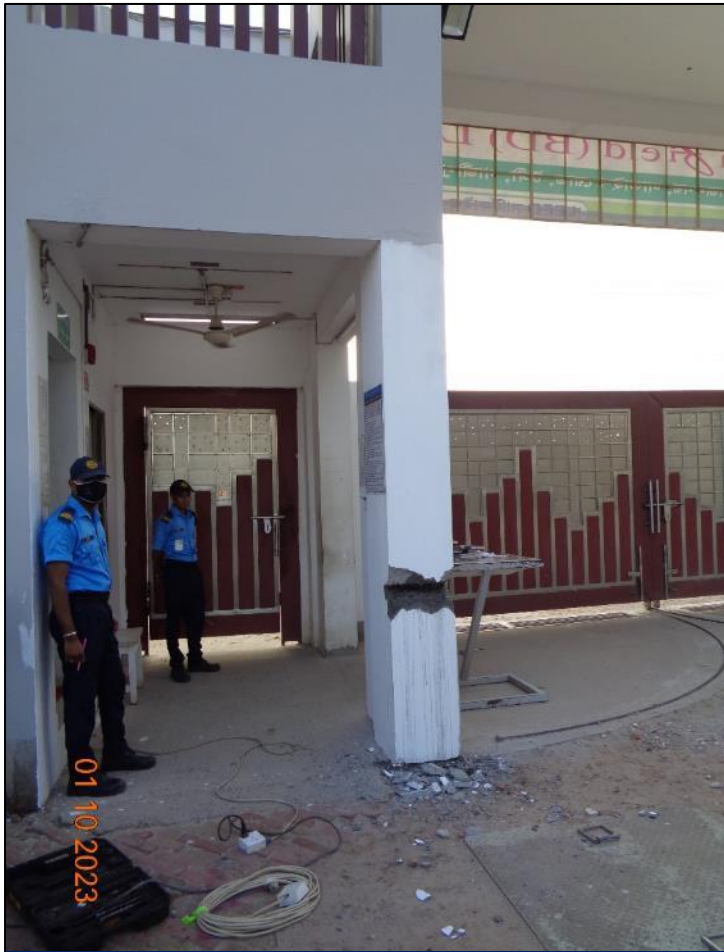
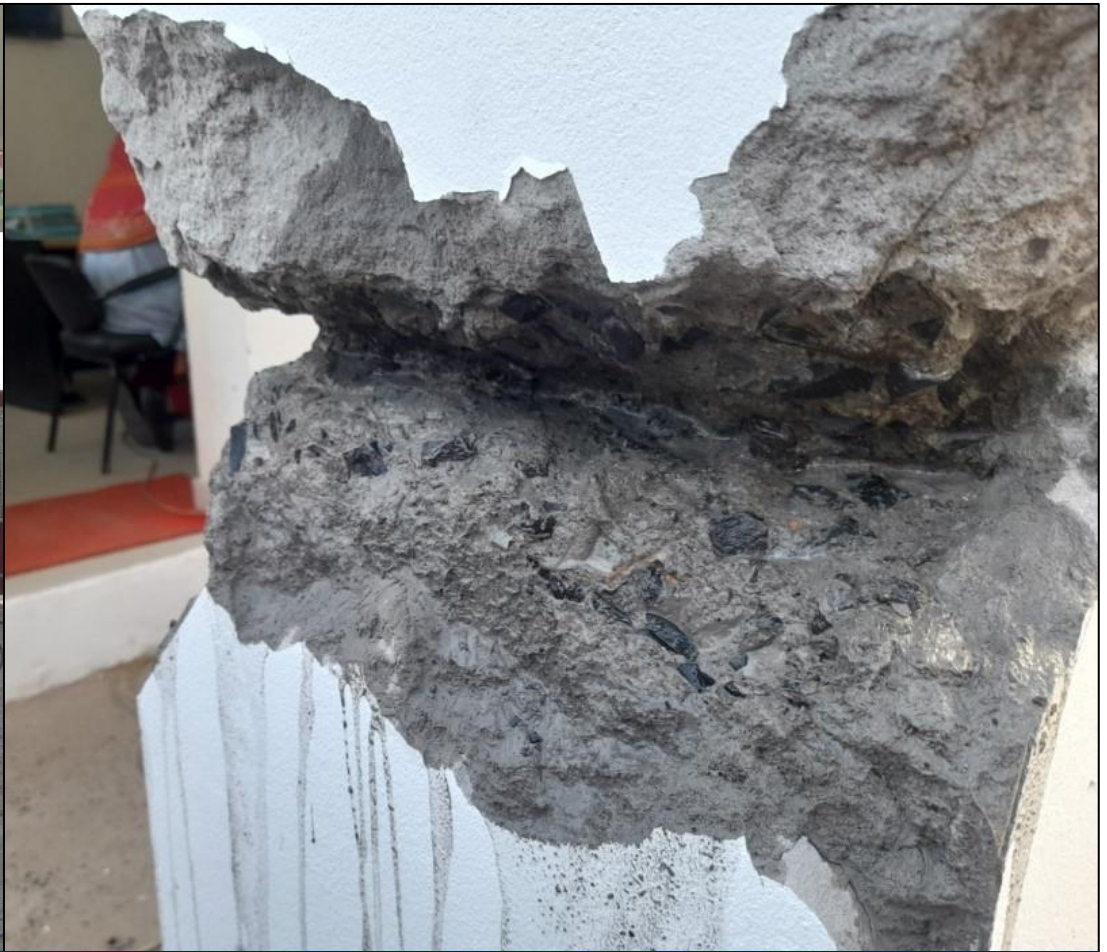
Strip cutting has been performed to confirm the re-bar number

The C2 column, strip has been cut to verify the re-bar number in the short face of column. No probing has been provided. Factory engineer is required to fill up the gap immediately with non-shrinkage grout.

| Item No. | Observation | Recommended Action Plan | Recommended Timeline |
|---|---|---|---|
| 09 | Column strip cut location to be filled up (Building-7) | Factory is required to fill up the gap immediately with non-shrinkage grout. | 6-weeks |

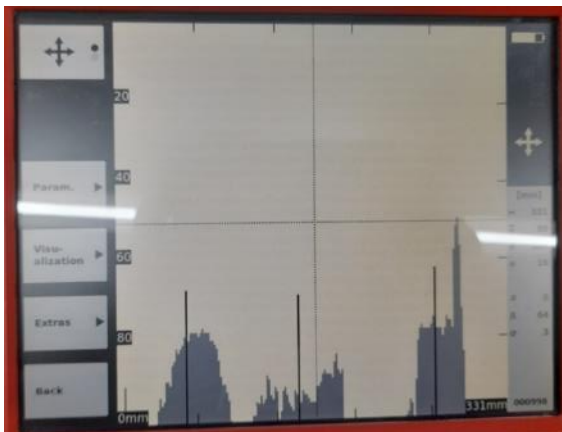
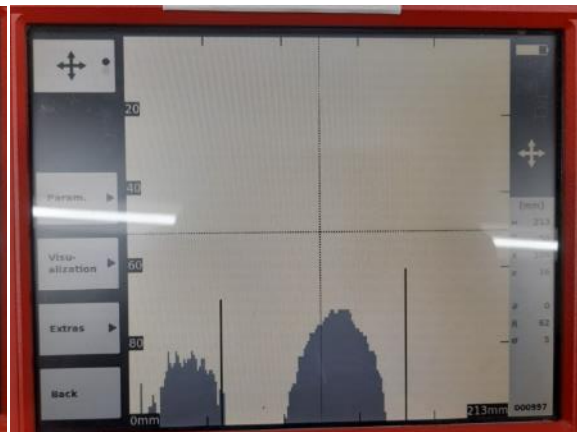
Total 6 re-bar was found by ferro-scanning instead of 8 re-bar in C2 column.

The re-bar number was found mismatched for the C2 column. In as-built drawing, total re-bar of the C2 column has been shown 8-nos. But total re-bar was revealed 6-nos for the column by ferro-scanning & strip cutting. The Building engineer is required to survey the whole structure and update as built structural drawing as per existing condition and revise the design report in compliance with BNBC.

| Item No. | Observation | Recommended Action Plan | Recommended Timeline |
|---|---|---|---|
| 10 | Mismatch in structural drawings (Building-7) | Building engineer is required to produce full set of as-built drawing reflecting the as constructed condition in compliance with BNBC. | 6-weeks |
| 11 | Mismatch in structural drawings (Building-7) | Building engineer to revise the Desing Report including a design report, and a set of structural drawings in compliance with section 1.9.1.1 and section 1.9.1.2 as per BNBC. | 6-weeks |

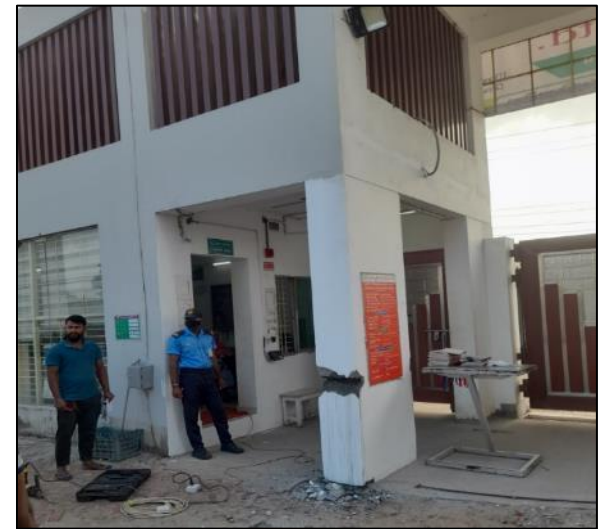
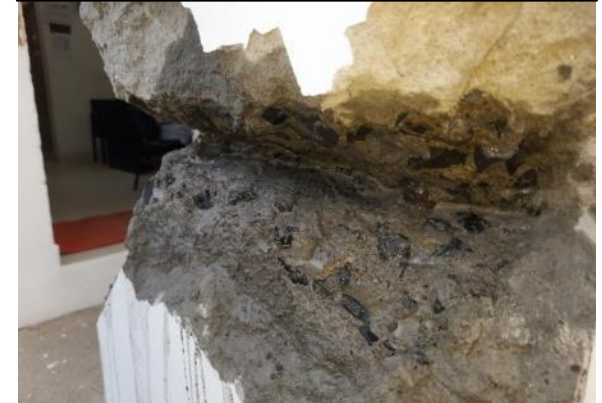
Column Schedule. 8 re-bar was shown with 3 rebar each face

2-Nos column re-bar was found in short face
