# Network Clothing Ltd. Network Apparel Ltd.

228/3, Shahid Rawshan Sarak, Chandana, Gazipur-1702  
(23.977707 N, 90.389448 E)

# Observations

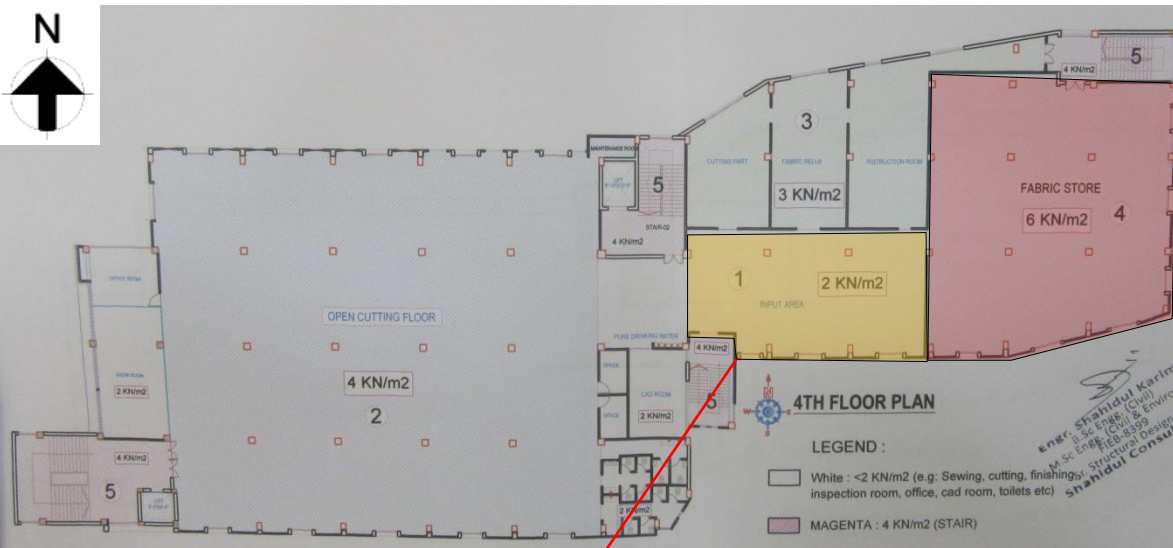
# Overloaded storage areas

Load was observed almost double from the load plan

| Item No. | Observation | Recommended Action Plan | Recommended Timeline |
|---|---|---|---|
| 1 | Overloaded storage areas | The quantity of the stored materials (piles of cloth and packages) must be reduced to the level presented by the original designer in the Loads Plans | 6-weeks |
| 2 | Overloaded storage areas | Reduce loading to the recommendations of the loading plan | 6-months |

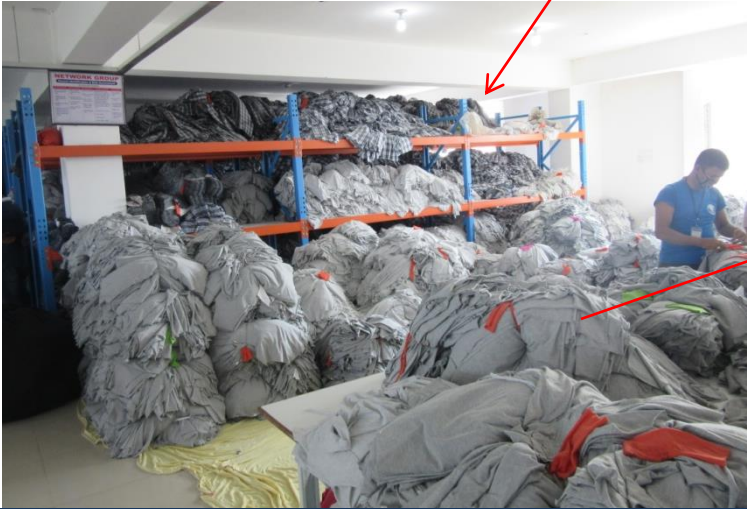
Each bundle was measured to be 6.45 kg

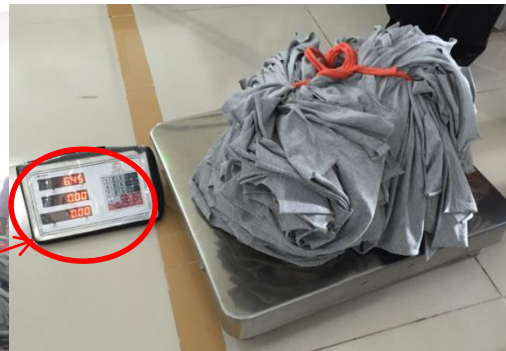
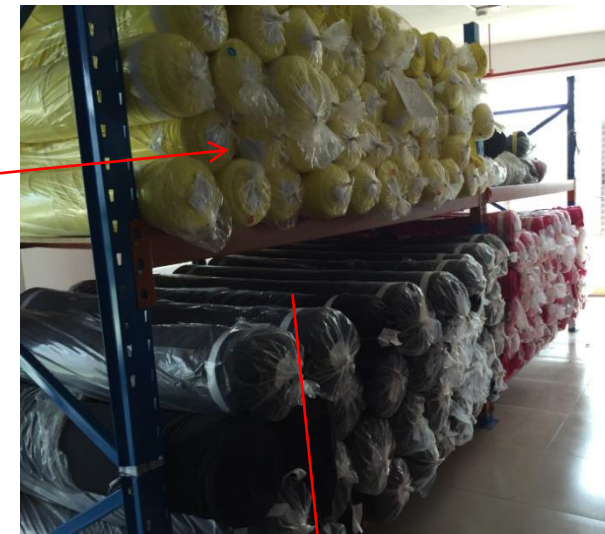
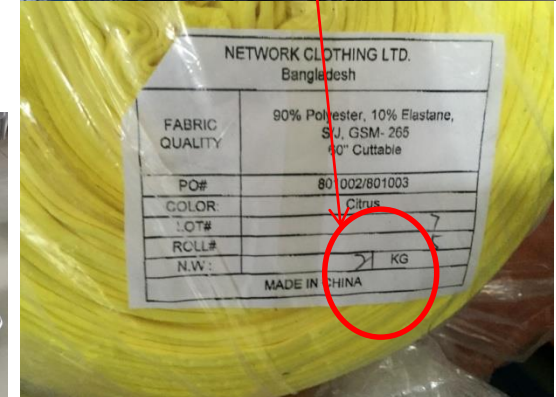
Each roll was measured to be 21 kg

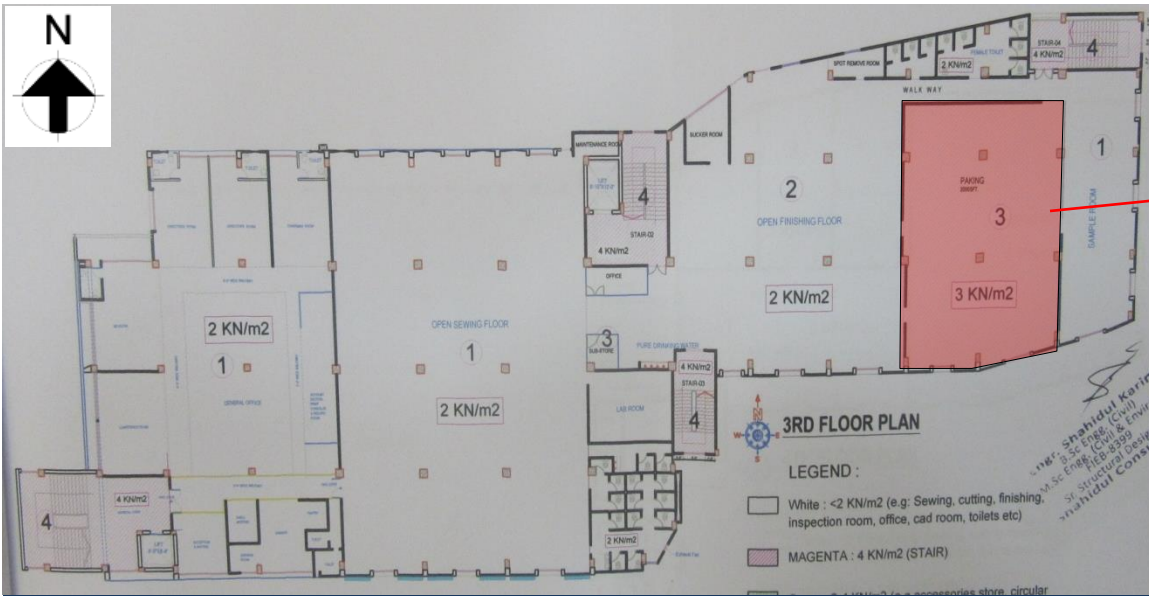
Load was observed to be almost double that indicated on the load plan

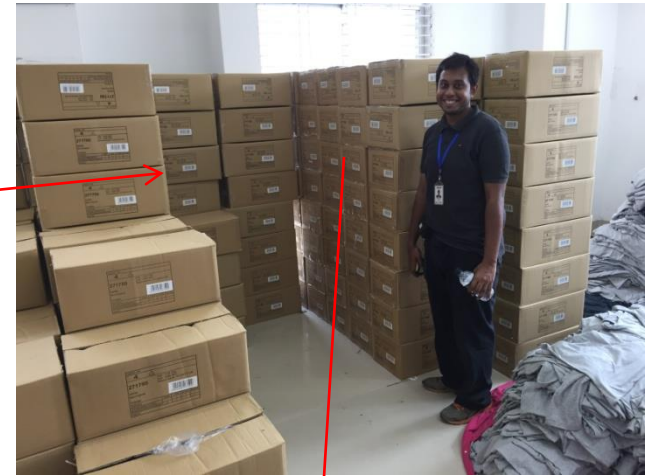
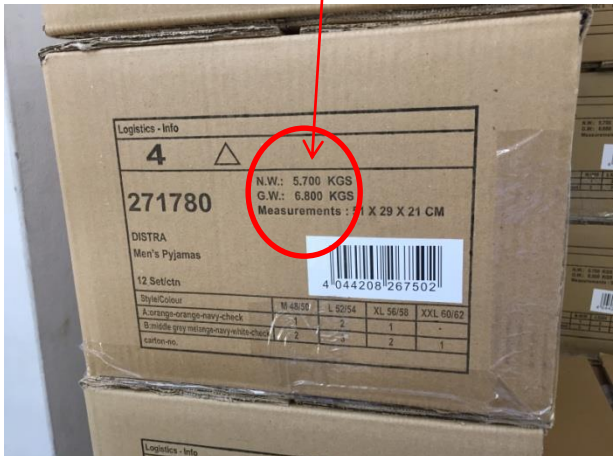
Each box was indicated to be 6.8 kg

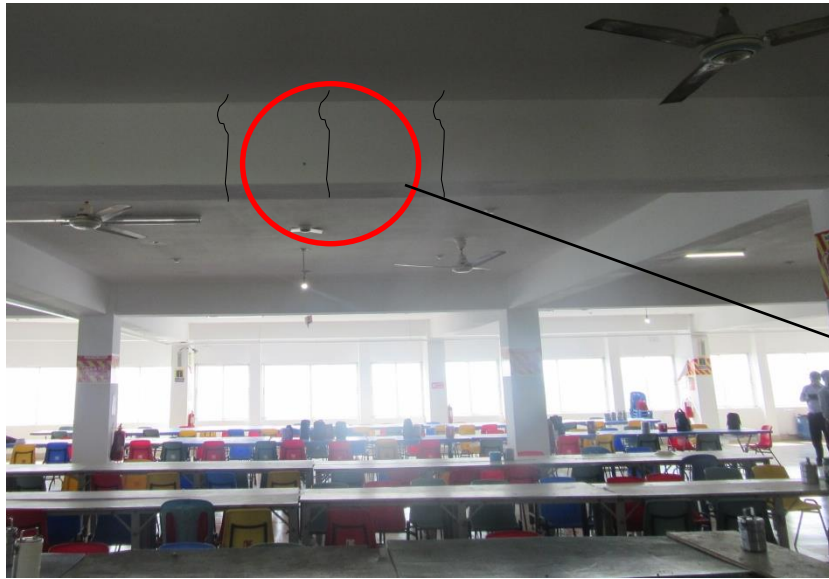
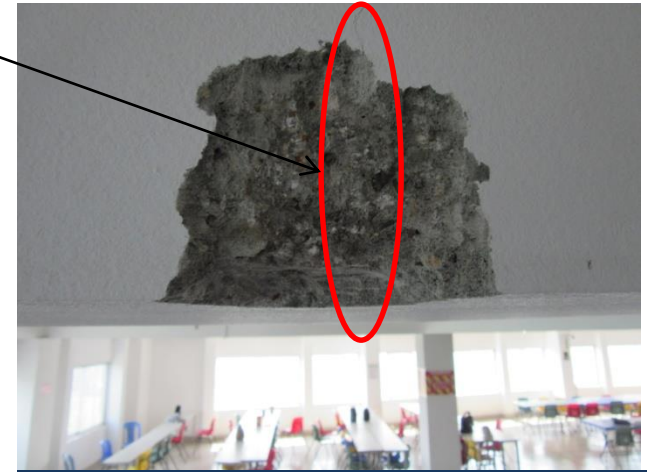
# **Cracks in the beams and slabs at upper levels**

One of them was exposed during survey and found it was on concrete

| Item No. | Observation | Recommended Action Plan | Recommended Timeline |
|---|---|---|---|
| 3 | Cracks in the beams and slabs at upper levels | Building Engineer to investigate all cracks and check the static calculations for thermal effects at the upper levels | 6-weeks |
| 4 | Cracks in the beams and slabs at upper levels | Repair cracking following the above investigation | 6-months |

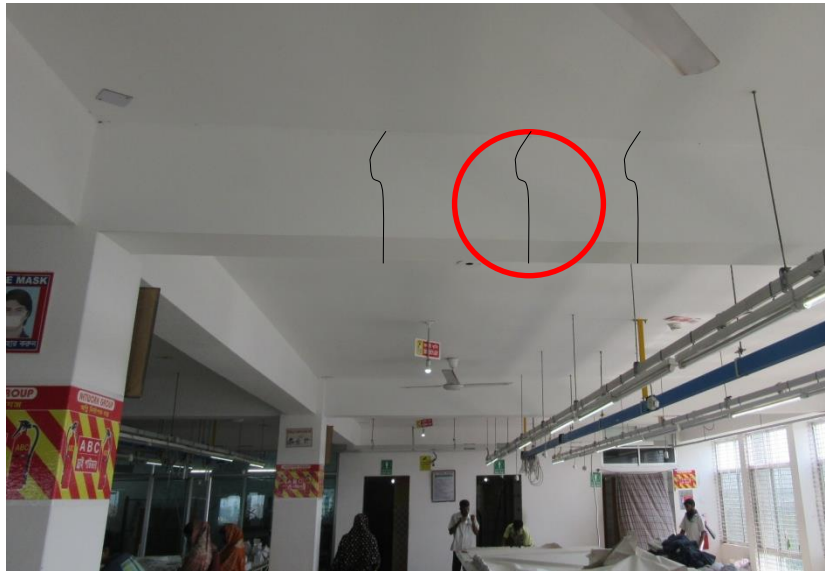
At 3<sup>rd</sup> to 5<sup>th</sup> floor many cracks were visible on beams and slabs

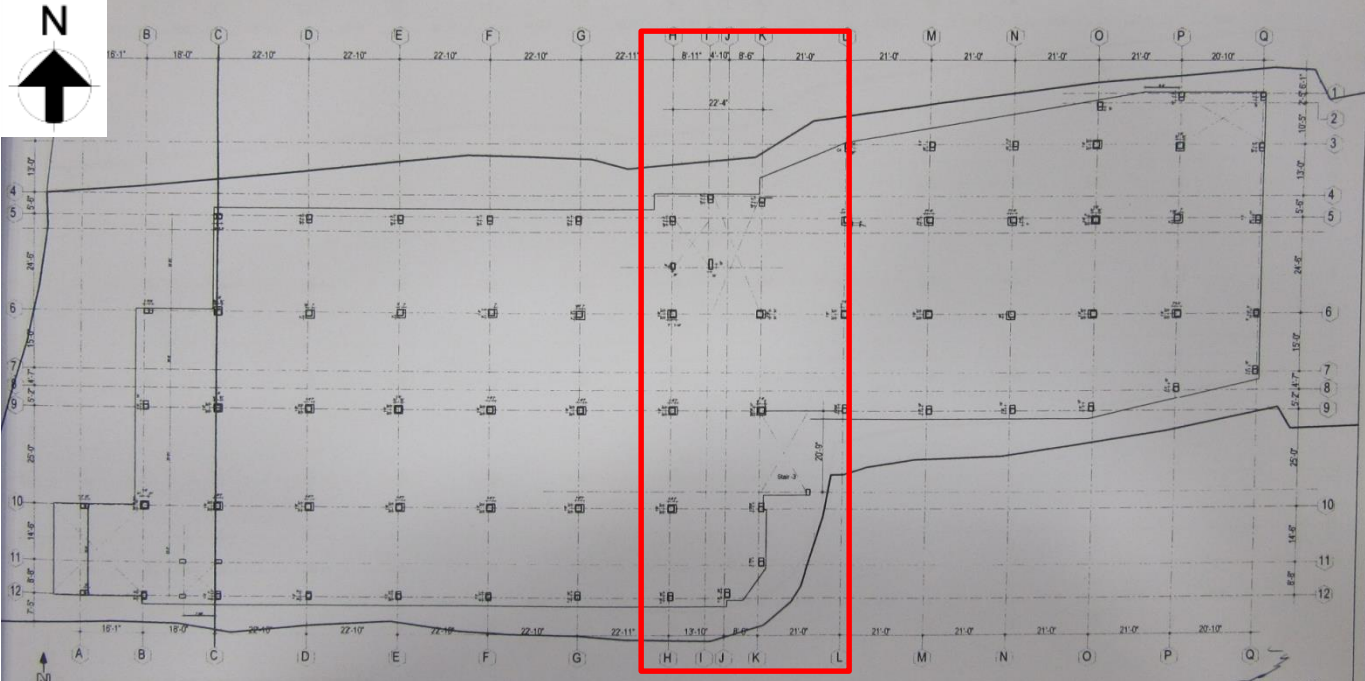
# Lack of movement joint

No movement joint for almost 100M long building

| Item No. | Observation | Recommended Action Plan | Recommended Timeline |
|---|---|---|---|
| 5 | Lack of movement joint | Building Engineer to check the static calculations for thermal and shrinkage effect of the 100m long structure system. | 6-weeks |
