Ishayat Apparels Ltd

Sharmin Group, Narashingapur, Ashulia, Savar, Dhaka – 1341
(23.9319341, 90.306416)
18 October 2023

Building Information

Observations

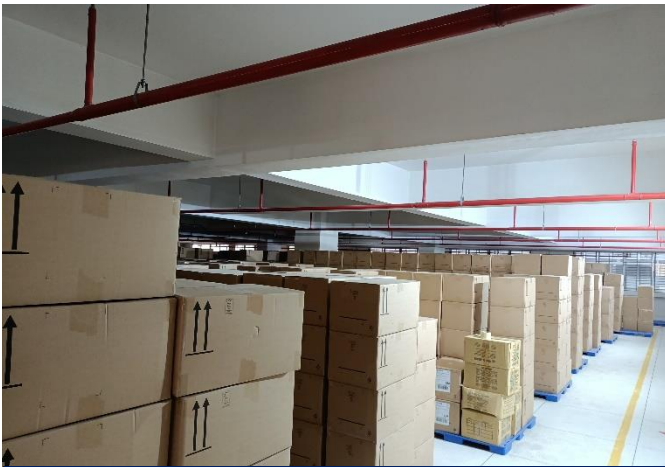
Storage on 1st floor

Currently, the first floor of the building is being used for a finished goods store. As per BNBC, the minimum floor live load for light storage is 6 kN/m² (125 psf). But the first floor is being designed for 4 kN/m² live loads.

The building engineer is required to revise the floor live load plan following the BNBC storage live load requirement and revise the design documents based on in-situ material strength.

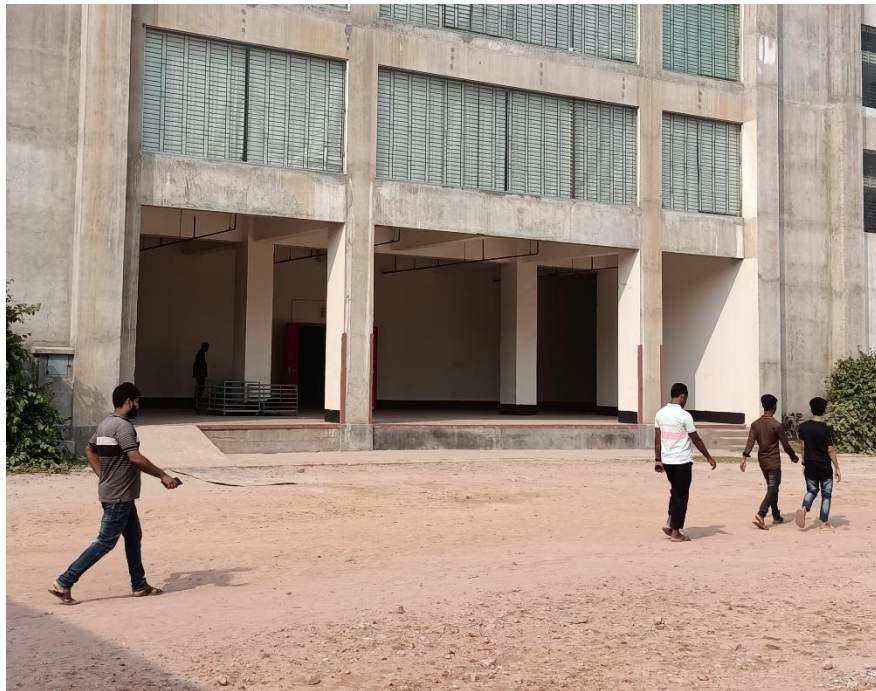
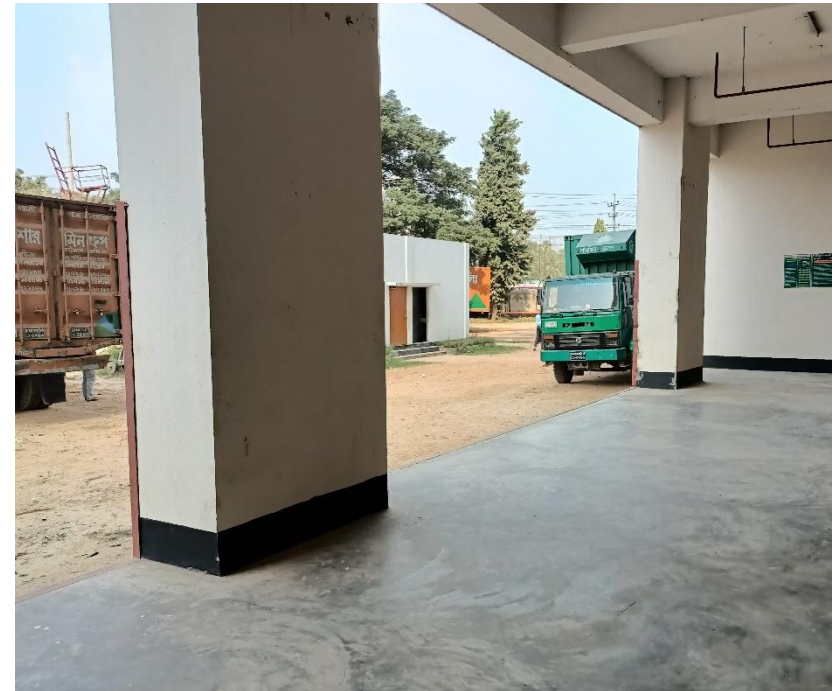
Column adjacent of driveway of loading unloading area is susceptible to vehicle impact. The factory has provided light barrier touching the column surface. The building engineer is required to provide sufficient barrier just outside of exposed column to prevent the vehicle impact.

Column adjacent of driveway of loading unloading

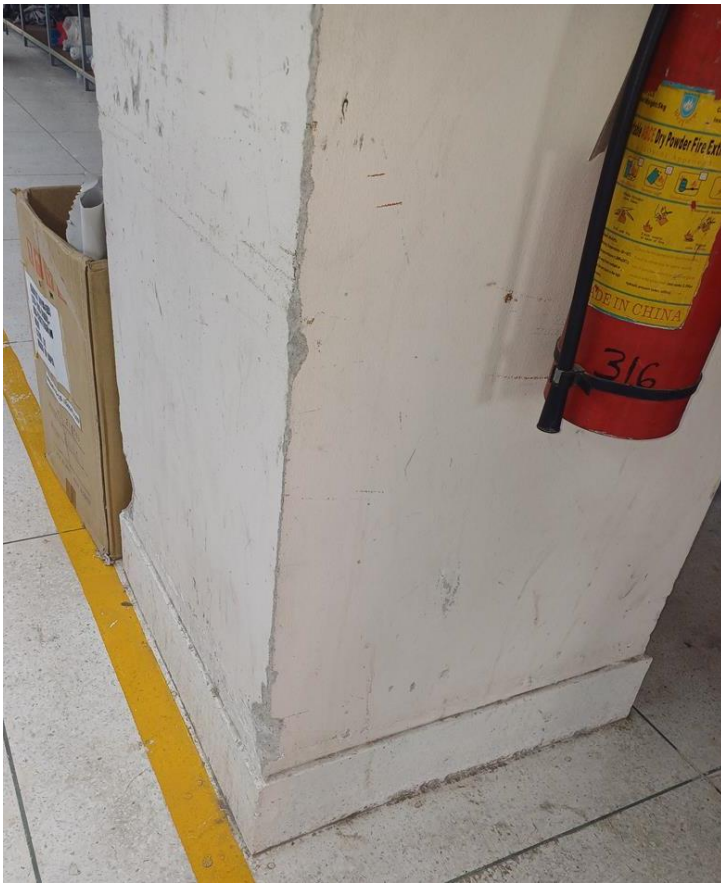
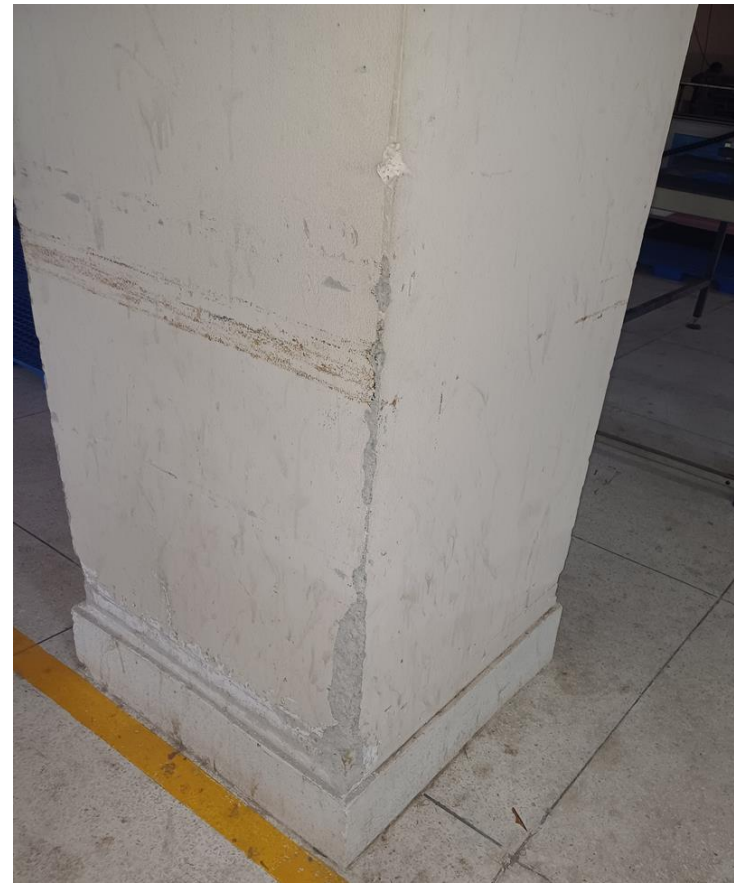
Susceptible column on 4th floor

Column on the 4th floor is susceptible to trolley impact. The building engineer is required to provide a separate barrier around the column to avoid possible trolley impact.

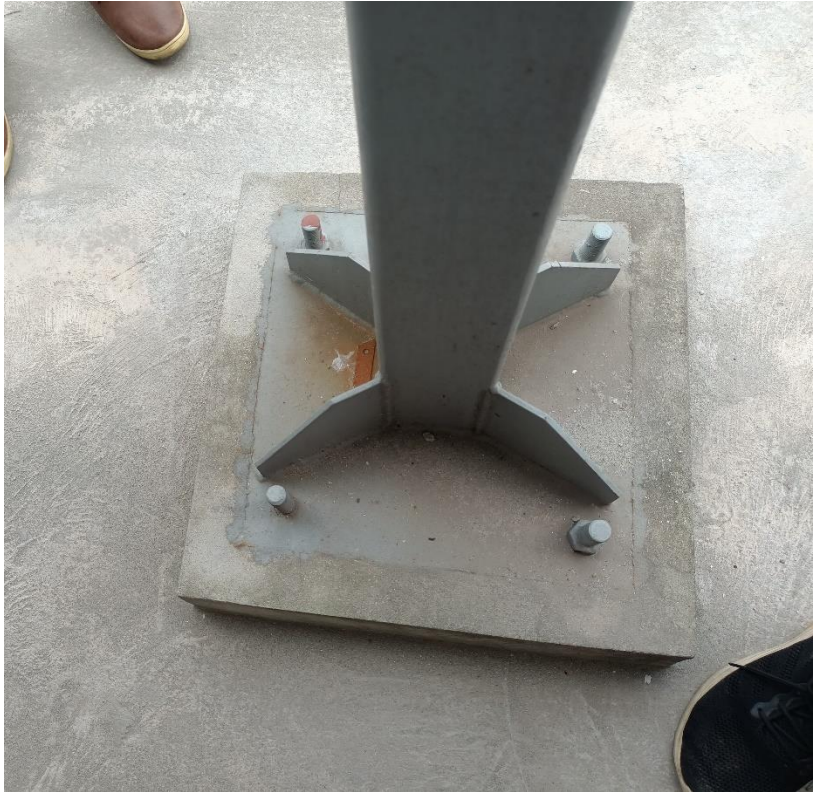
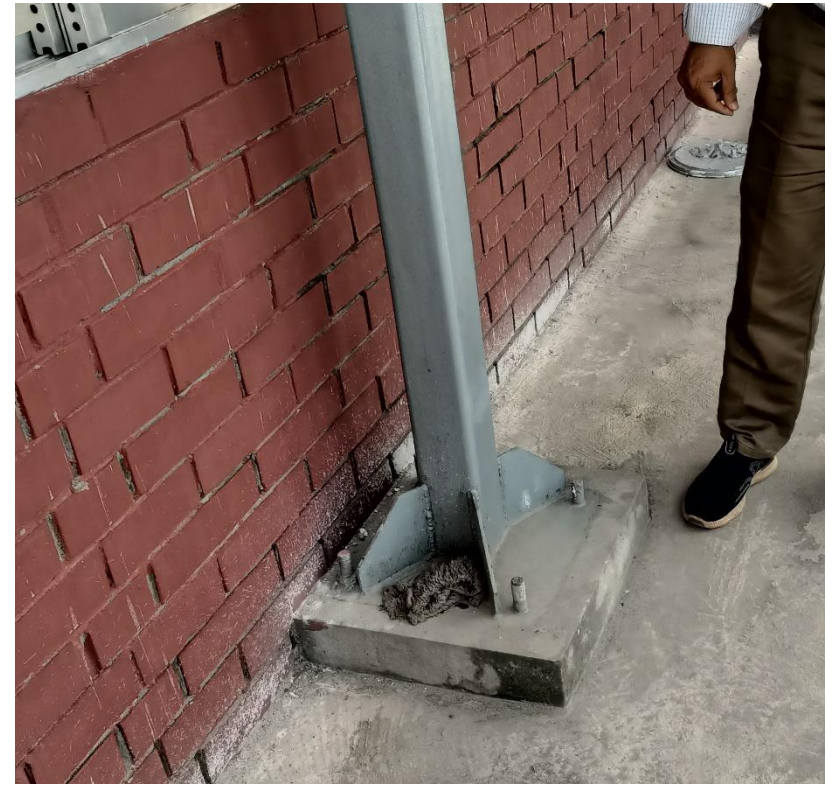
Nut missing in several bolts on base plat. Building engineer is required to install the missing nuts where necessary.

Nut missing in several bolts

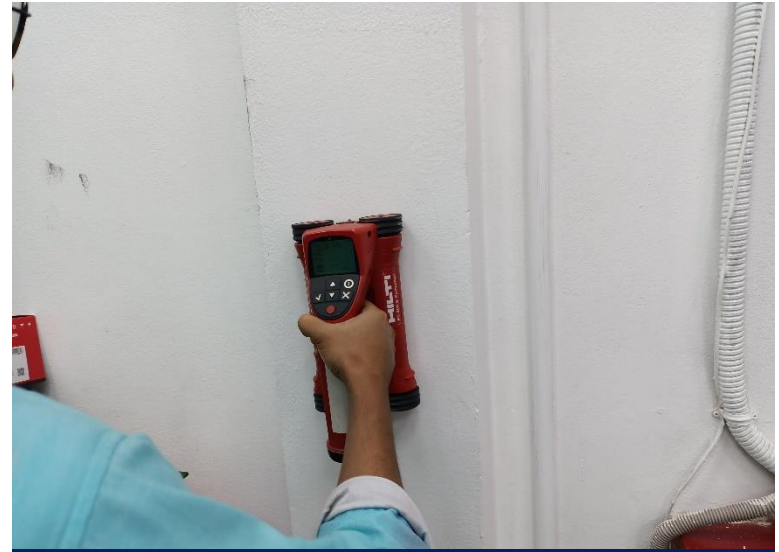
CCTV Control Room

Brick columns were found instead of RC column for the mentioned structures. The building engineer is required to survey the whole structure and prepare a full set of as-built drawings in compliance in compliance with section 1.9.1.2, part 6 of BNBC.

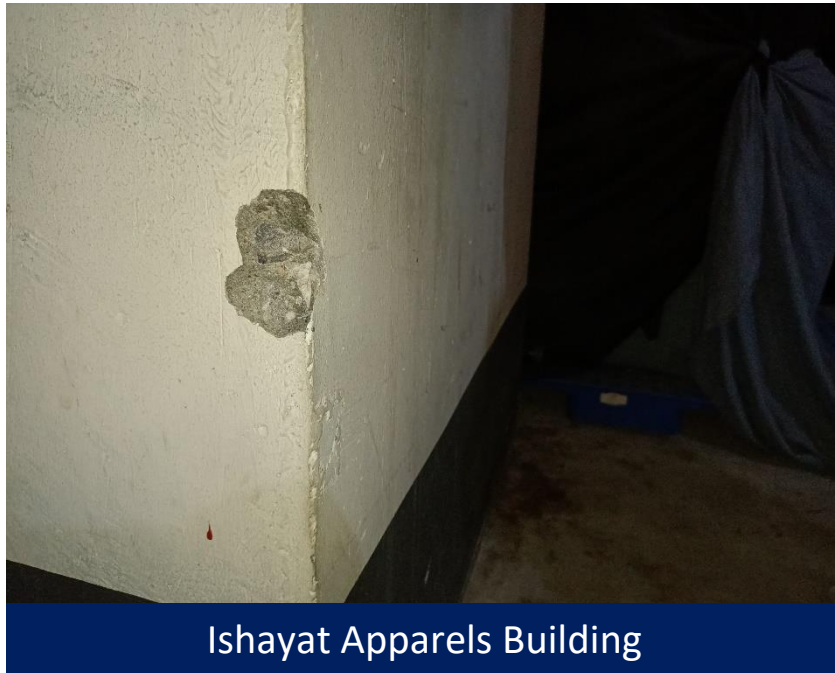
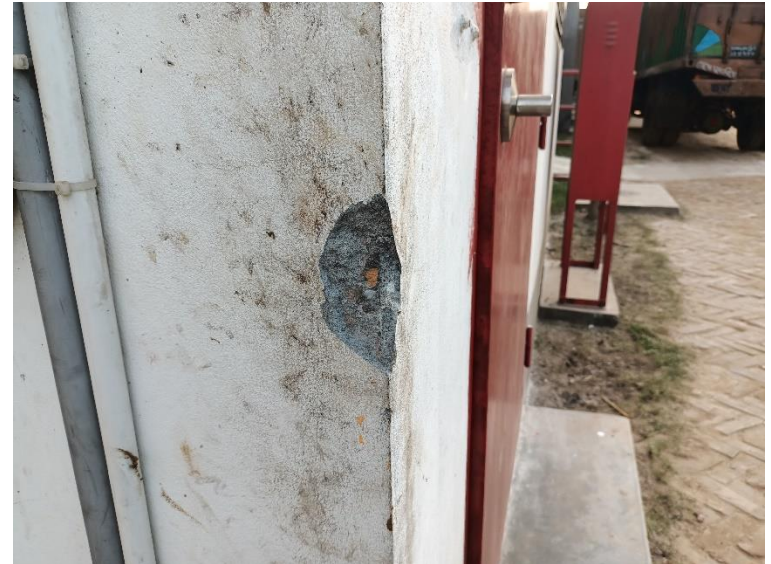
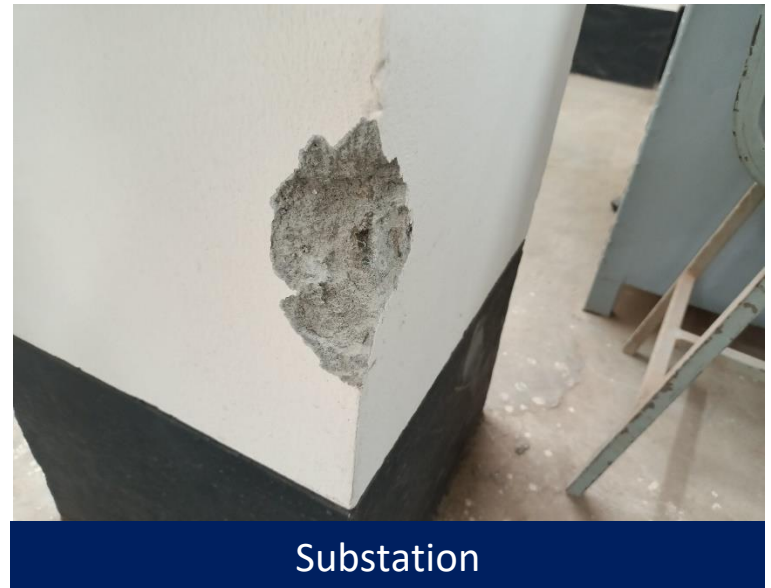
Stone chips found the in tested column
