Shirt & Jacket Zone Ltd.

Gobindopur,Uzampur,Moinartake,Uttarkhan,Uttara,Dhaka-1230
(23.883003N, 90.451259E)
19 September 2023

Observation

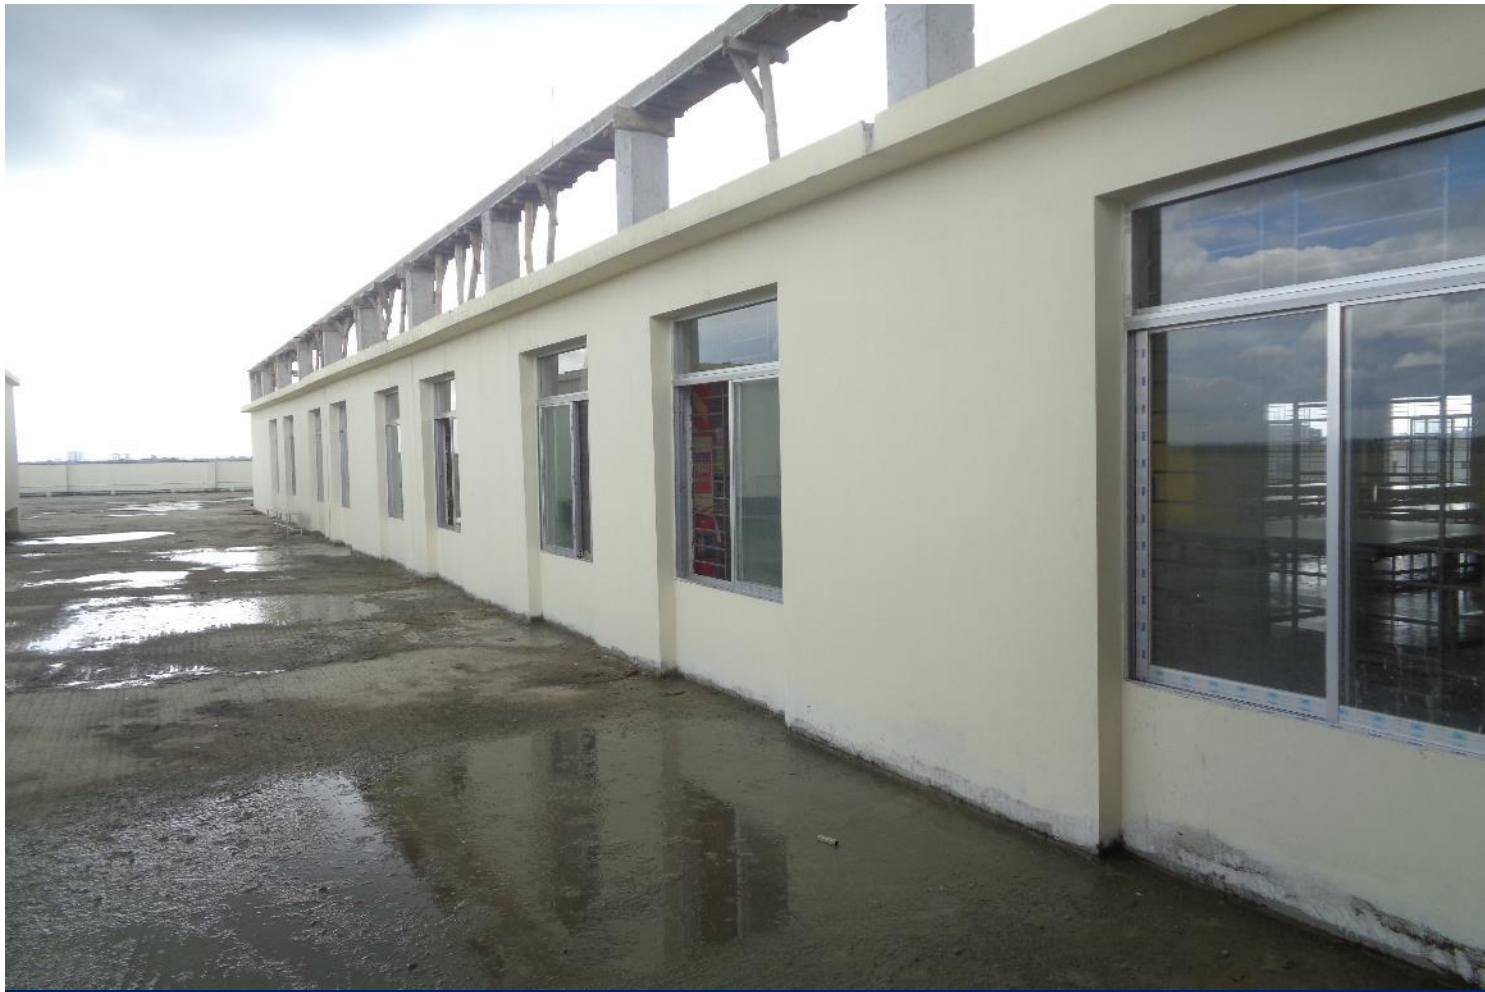
Water ponding on roof slab

Water ponding observed on roof slab

Water ponding observed on roof slab due to poor drainage system. Factory is required to improve drainage system to drain out all stagnant water.

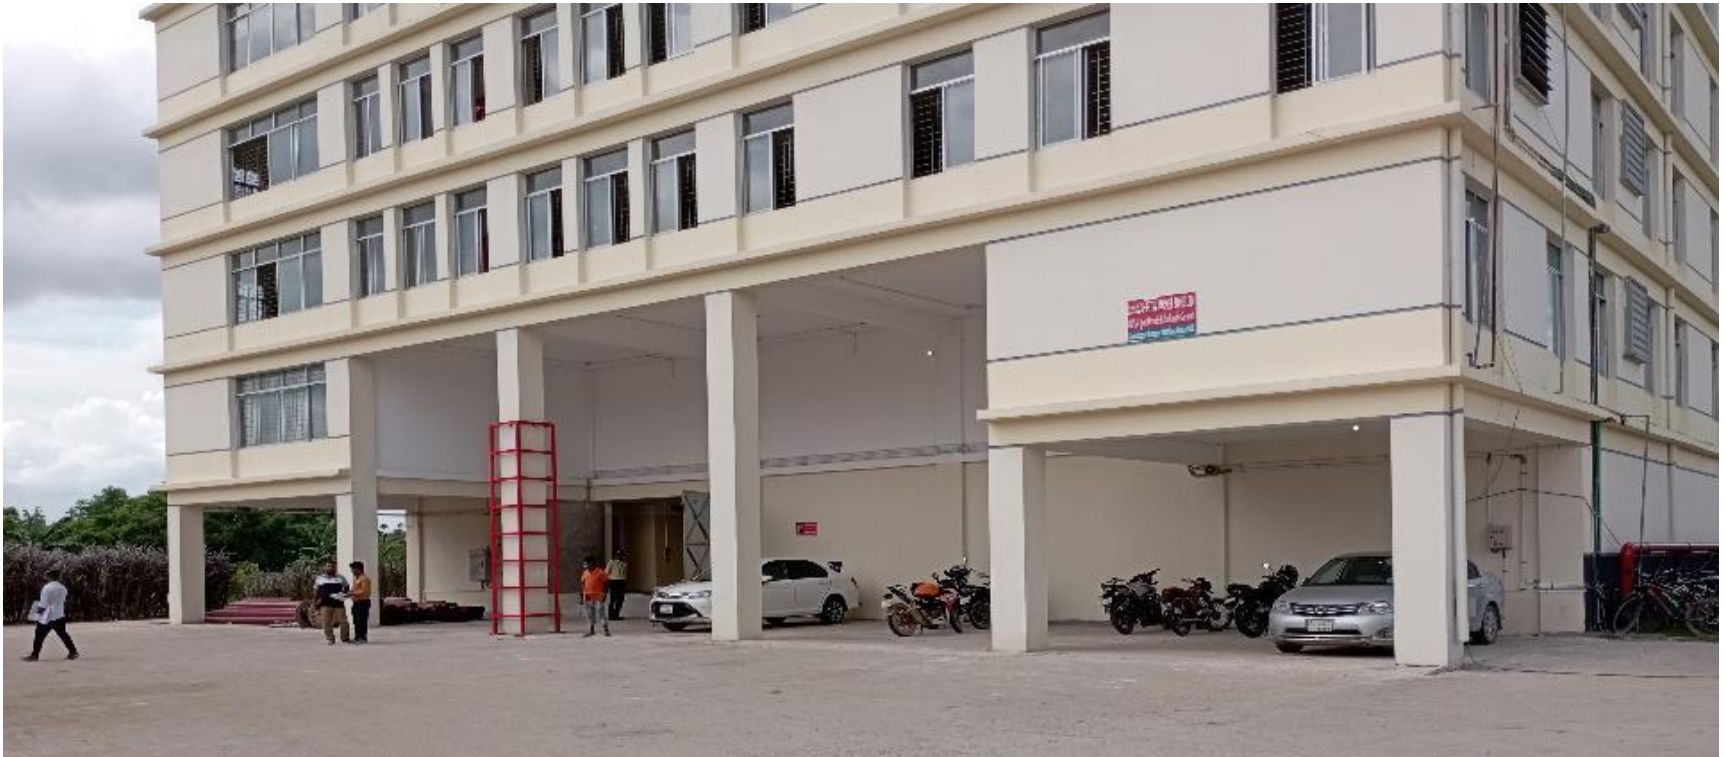
Possible vehicle impact for column

Barrier is not provided for all exposed columns at ground floor parking & loading-unloading zone

Columns at ground floor are prone to possible vehicle impact. Factory is required to provide barrier for all exposed column at ground floor to prevent from possible vehicle impact.

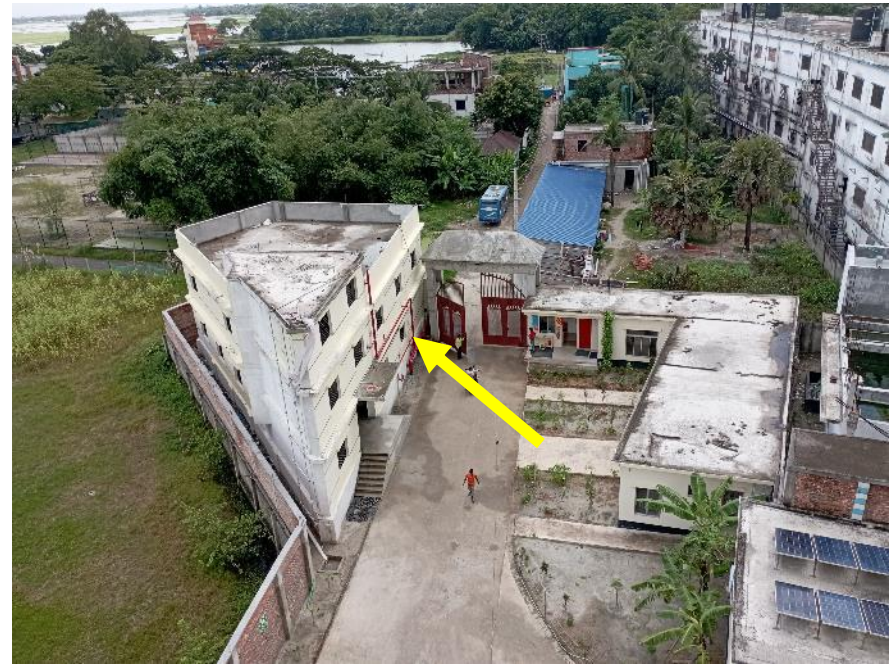
Design report needs to be updated

All serviceability check not provided in report

The structure is horizontally irregular

The structure is horizontally irregular and no torsional irregularity/drift check provided in report. Building engineer is required to update the design report as per 1.9.1.1 (BNBC) including all serviceability checks.

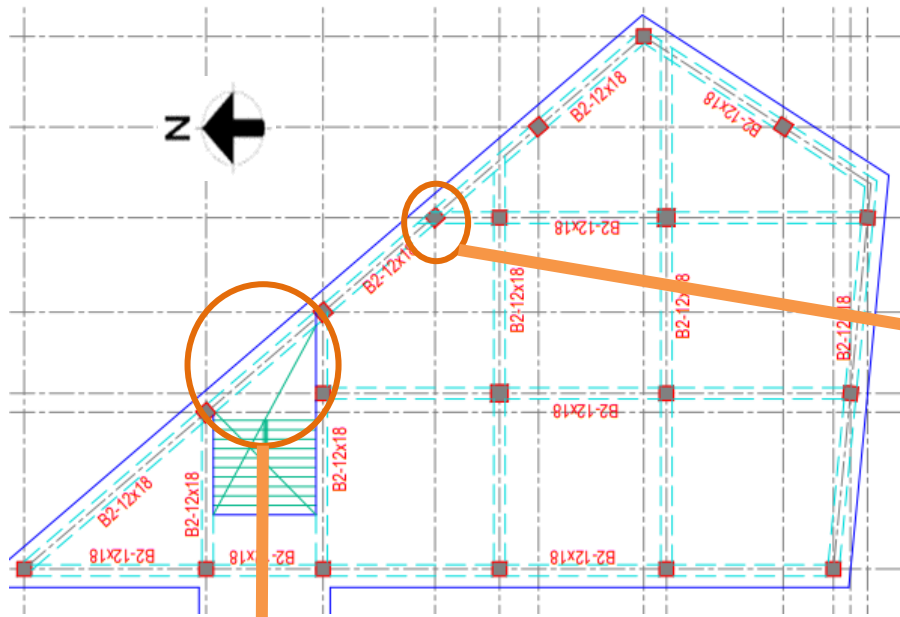
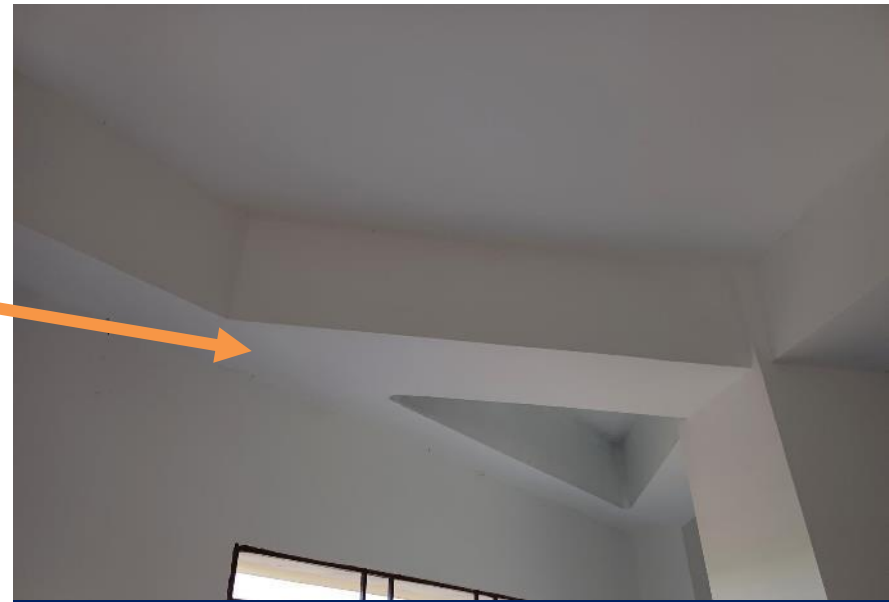
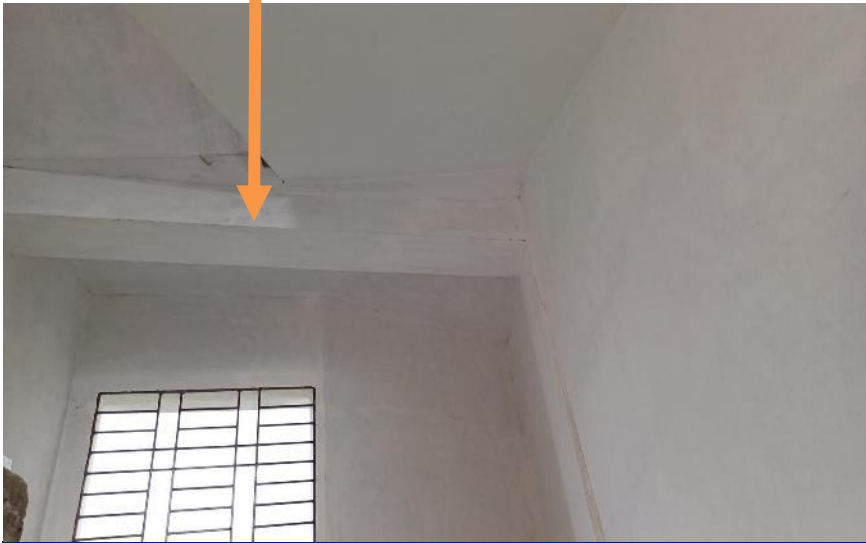
Discrepancies in As-built drawing

As-built floor beam layout

Beam layout does not match with drawing

No diagonal but straight beam at stair

As built beam layout does not match with on site condition at floor level & stair portion. Building engineer is required to update the as built structural drawing as well as FEM model and design report as per 1.9.1.1 (BNBC).

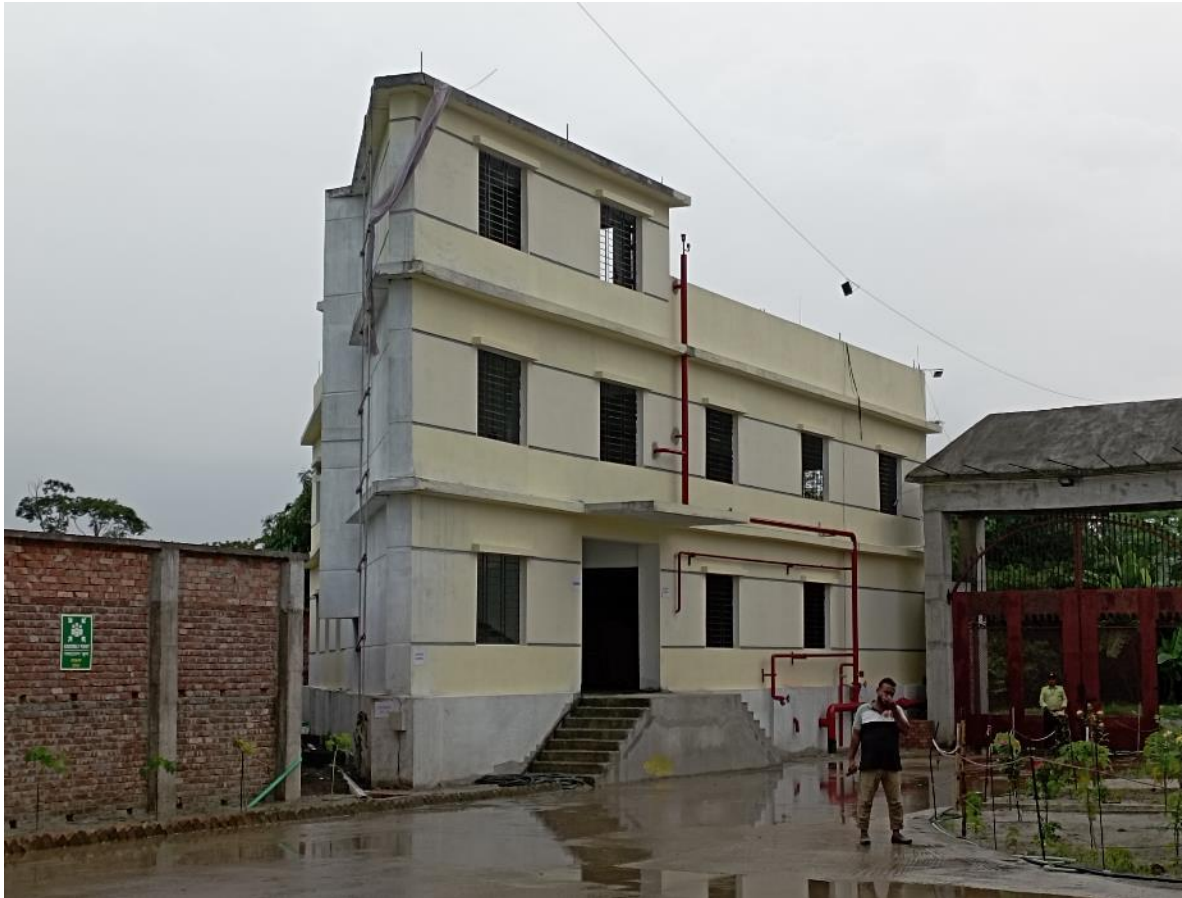
Lack of floor load plan

Load plan was not provided for this structure

This is a multistoried building, but floor load plan was not provided for this structure. Building engineer is required to produce floor live load plan for this structure.

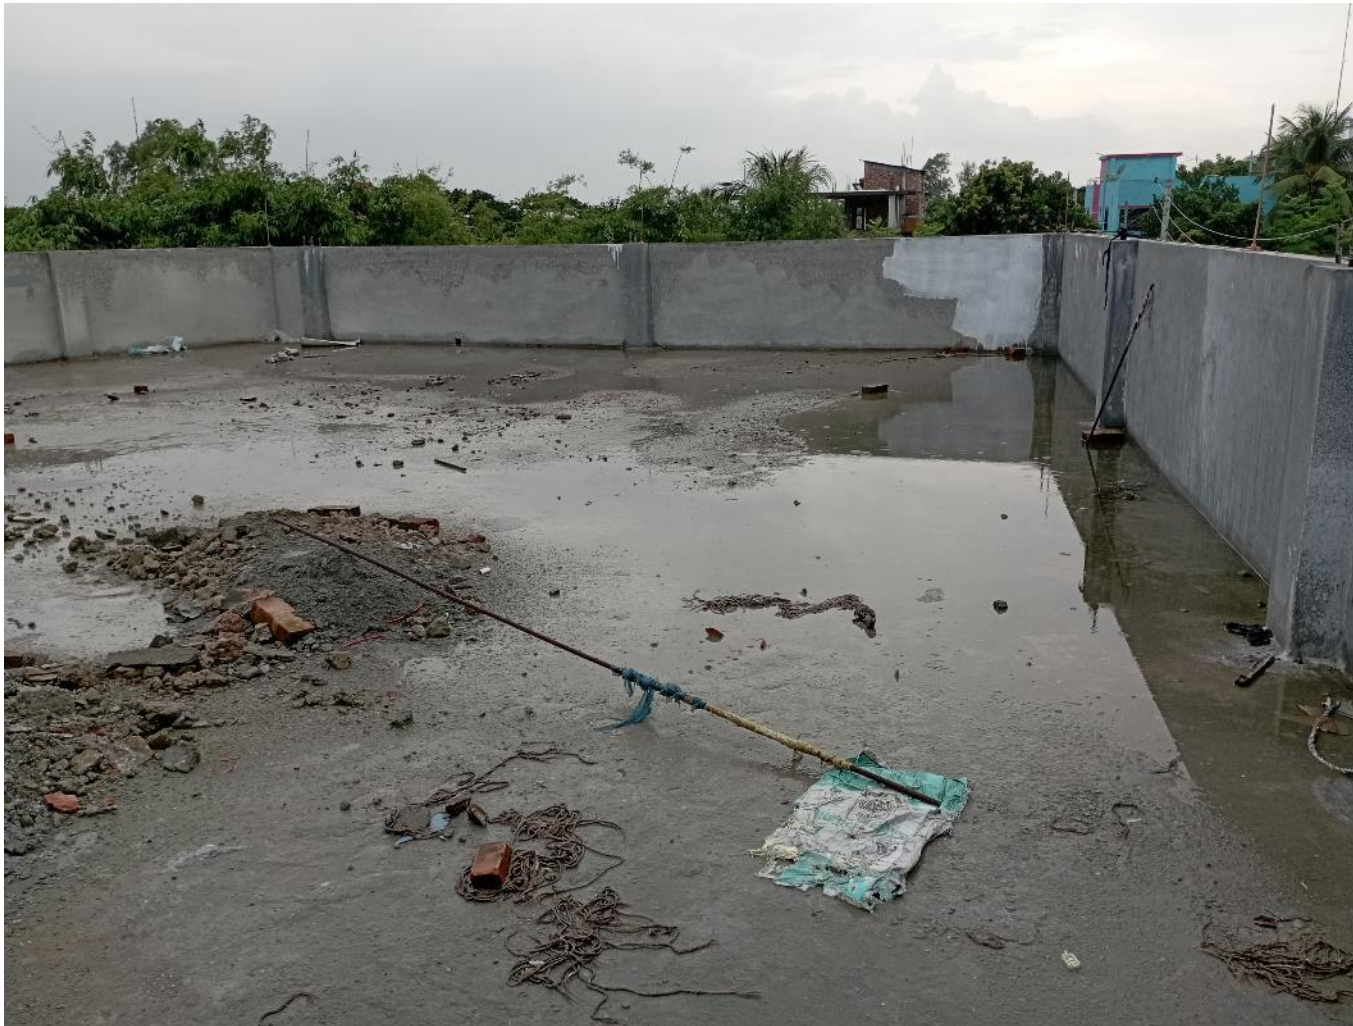
Water ponding on roof slab

Water ponding observed on roof slab

Water ponding observed on roof slab due to poor drainage system. Factory is required to improve drainage system with proper slope and adequate water outlets to drain out all stagnant water.

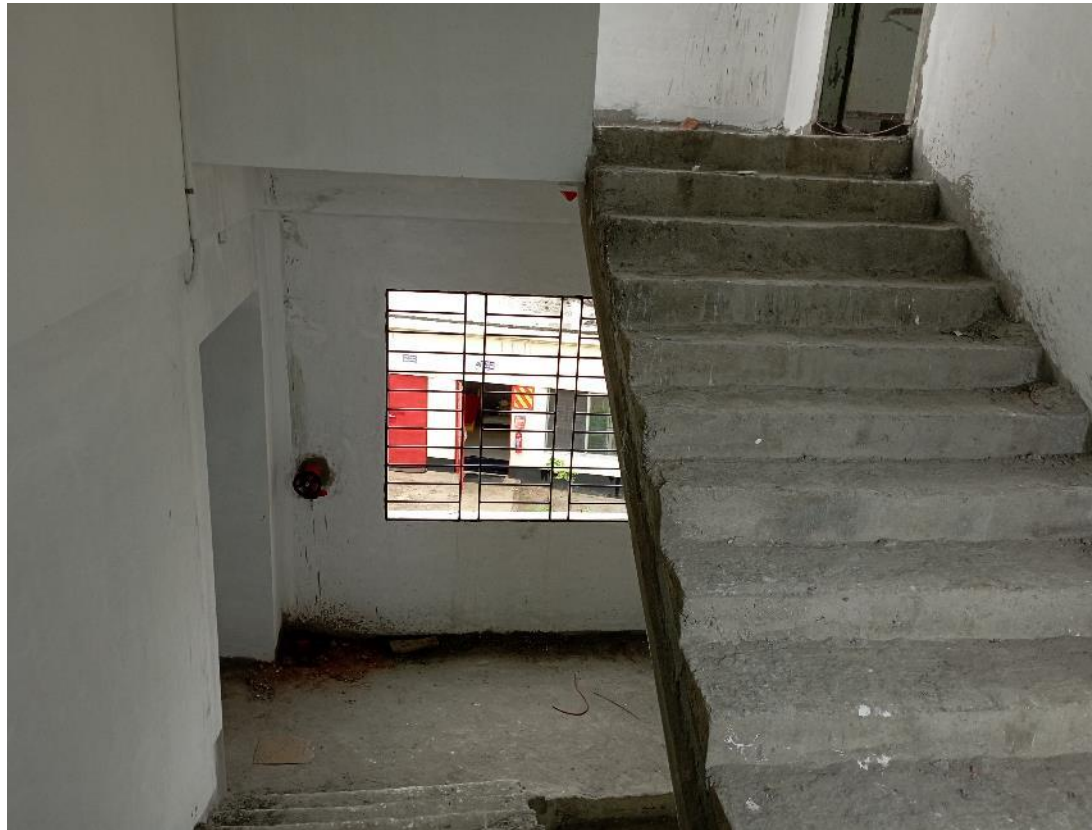
Falling Hazard at roof level and stair area

Railing was missing at staircase

Railing was missing at staircase. Factory is required to provide railing at staircase to avoid possible falling hazard.

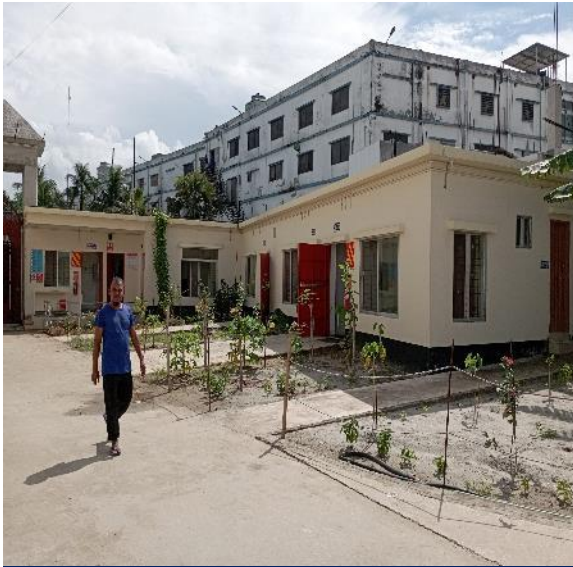
Medical, Daycare & Security
Room

As-built drawing was not available for these structure. Building engineer is required to produce as-built drawings for the structures.
