# Best Wool Sweaters Ltd. (New Building)

Jarun, Konabari, Gazipur  
(24.000421N, 90.323217E)  
26 September 2023

**Production Building-2:** This structure is a seven-storied (B+G+6) reinforced concrete (RC) building with a basement.

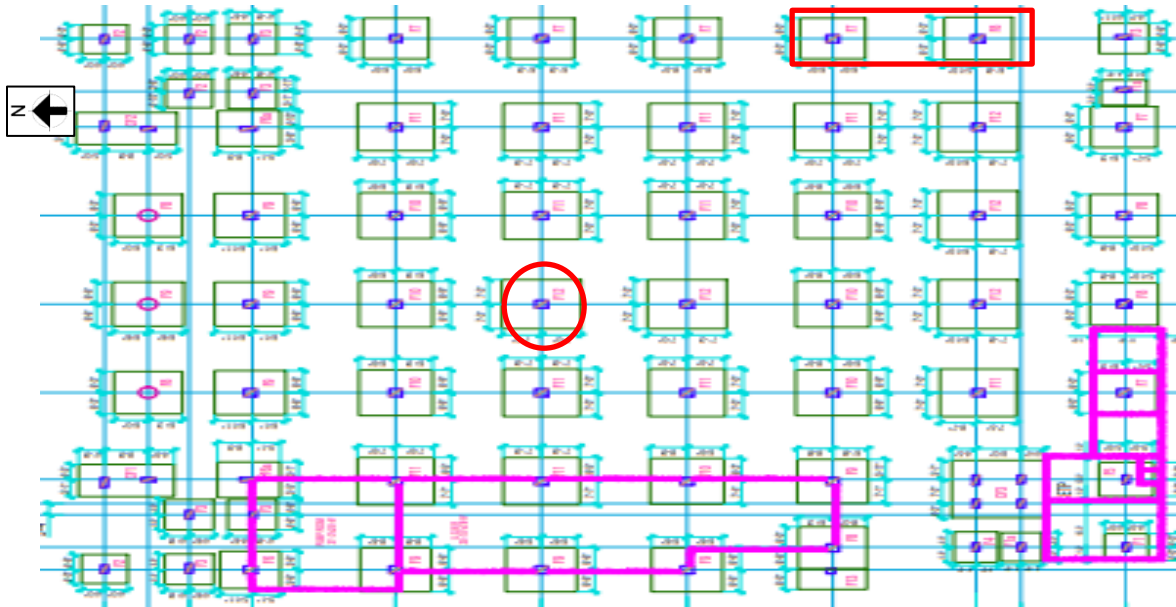
Column layout plan

**Stress in foundation exceed normal design limit**

Cursory calculation indicates that the marked footing are overstressed based on live load (4kPa for typical floor, 6 kPa for storage area, 2 kPa for toilet, & 5 kPa for stair), dead load (including observed toilet built-up and wall load) and 156 kPa for foundation capacity. The source of loadings are storage floor and toilet built-up. Building engineer is required to carry out Detail Engineering Assessment (DEA) to review the design, loads and foundation stress based on material strength, and minimum floor live loads.

Lowest Foundation Capacity (156 kPa)

| Item No. | Observation | Recommended Action Plan | Recommended Timeline |
|---|---|---|---|
| 01 | Stress in foundation exceed normal design limit (Production Building-2). | The building engineer is required to review the design, loads and foundation stress. | 6-weeks |
| 02 | Stress in foundation exceed normal design limit (Production Building-2). | Carry out remedial works if required. | 6-month |

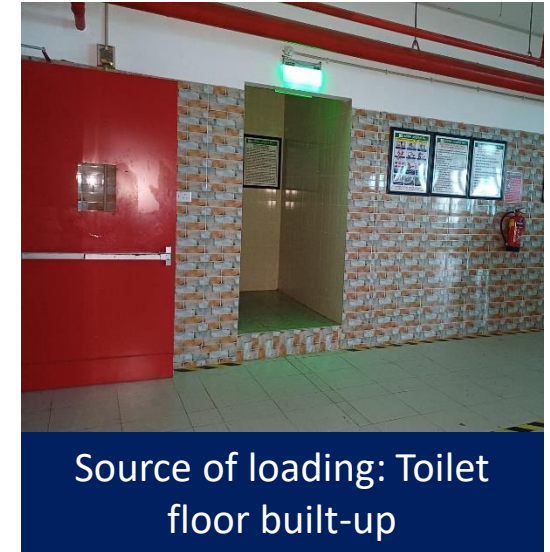
Source of loading: Toilet floor built-up

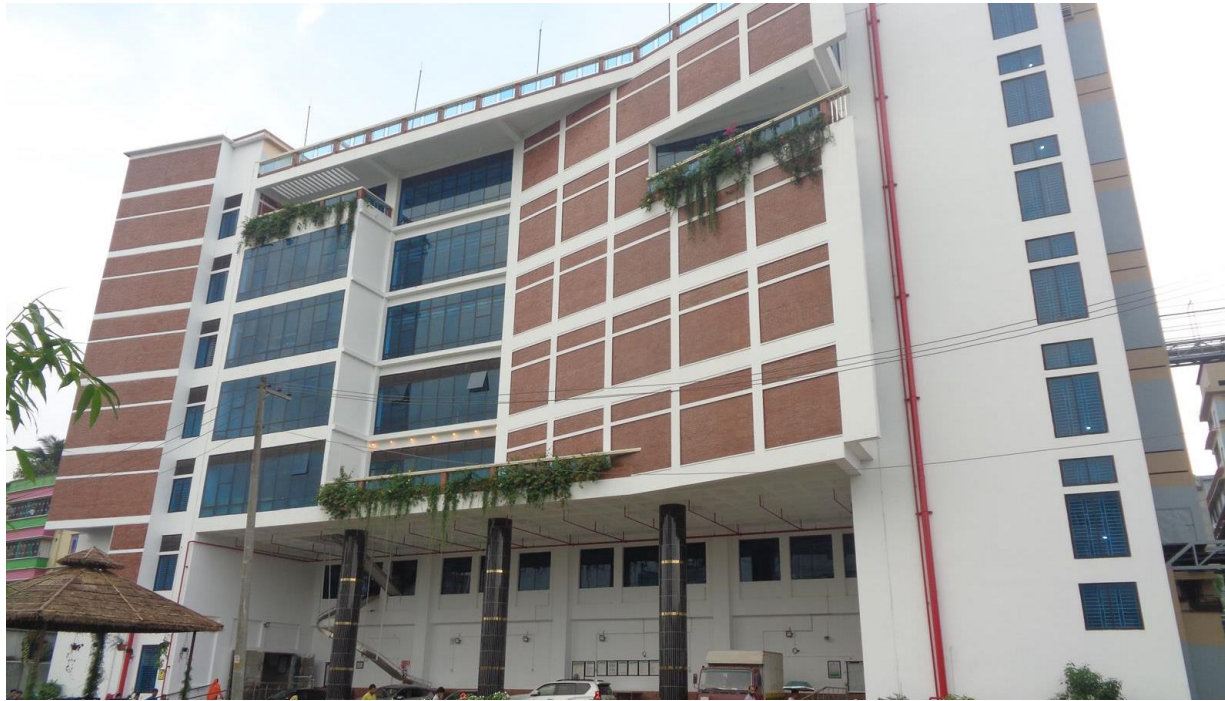
Production building-2

## **Lack of design document**

As per BNBC (part-6), every building or structures designed shall have its design documents in accordance with the provision of section 1.9.1. During inspection, no design report and load plan were found on-site. Building engineer is required to prepare a set of design documents (including load plan as per BNBC and design report based on material strength & software-based analysis) for the structure following BNBC (part-6, section 1.9.1).

| Item No. | Observation | Recommended Action Plan | Recommended Timeline |
|---|---|---|---|
| 03 | Lack of design document (Production Building-2). | Building engineer is required to prepare a set of design documents (including load plan as per BNBC and design report based on material strength & software-based analysis) for the structure following BNBC (part-6, section 1.9.1) | 6-weeks |

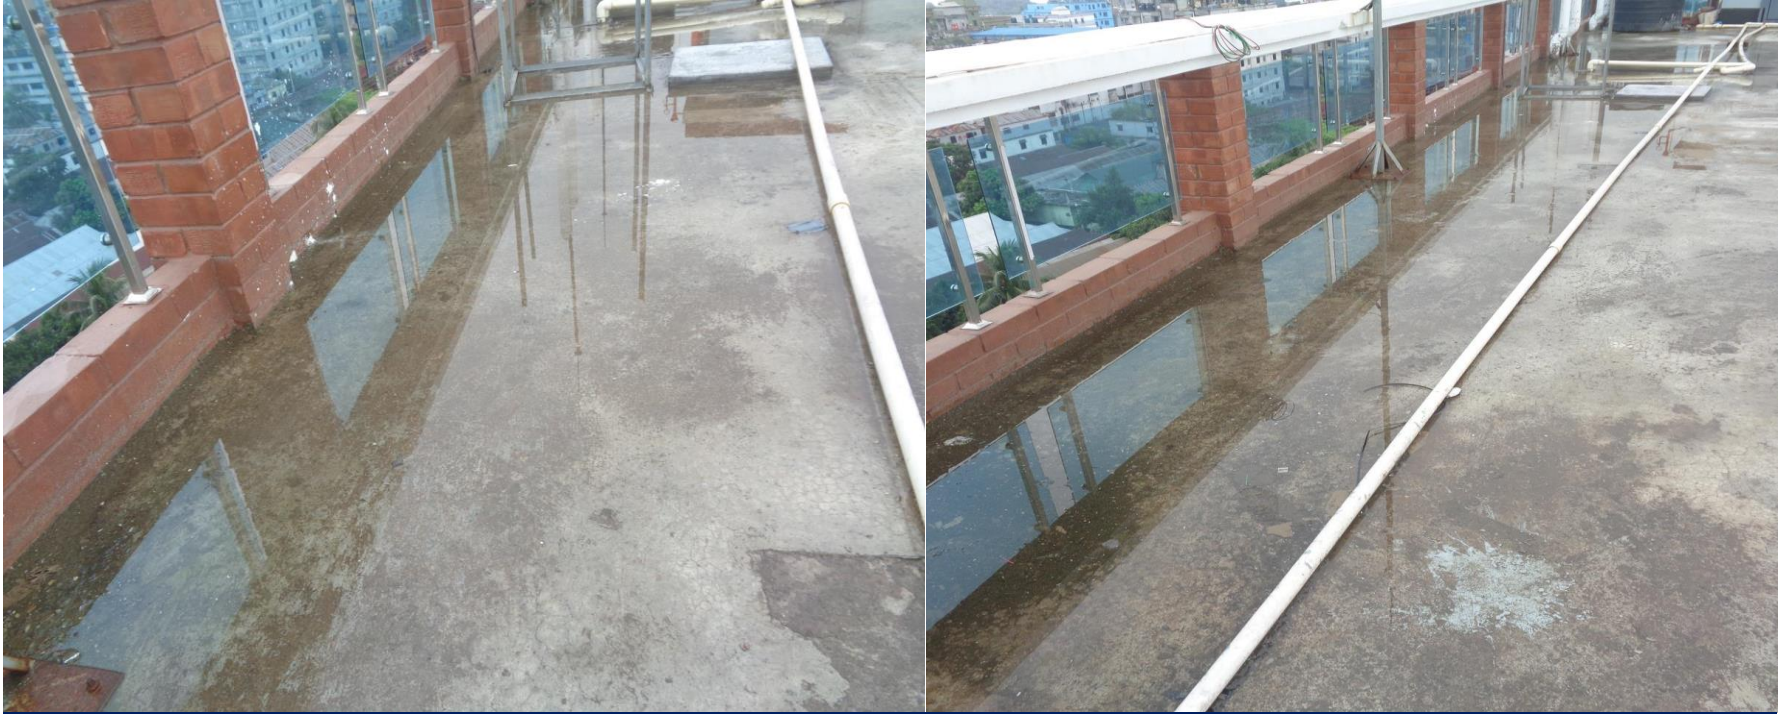
Water ponding on roof

During inspection, water ponding was observed on the roof of production building-2. Building engineer is required to improve the drainage system maintaining proper slope.

| Item No. | Observation | Recommended Action Plan | Recommended Timeline |
|---|---|---|---|
| 05 | Water ponding on roof (Production Building-2). | Building engineer is required to improve the drainage system maintaining proper slope. | 6-weeks |

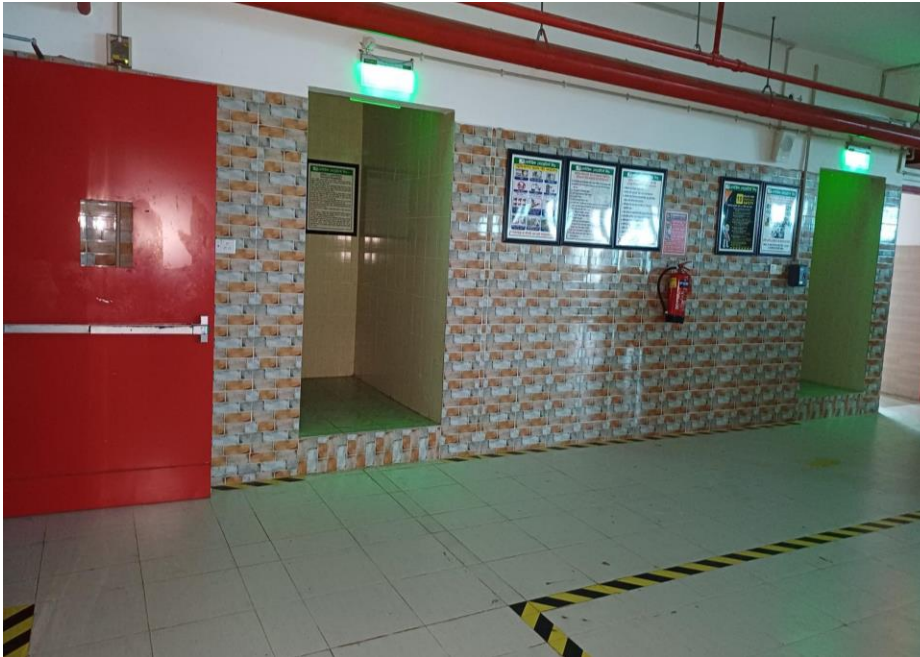
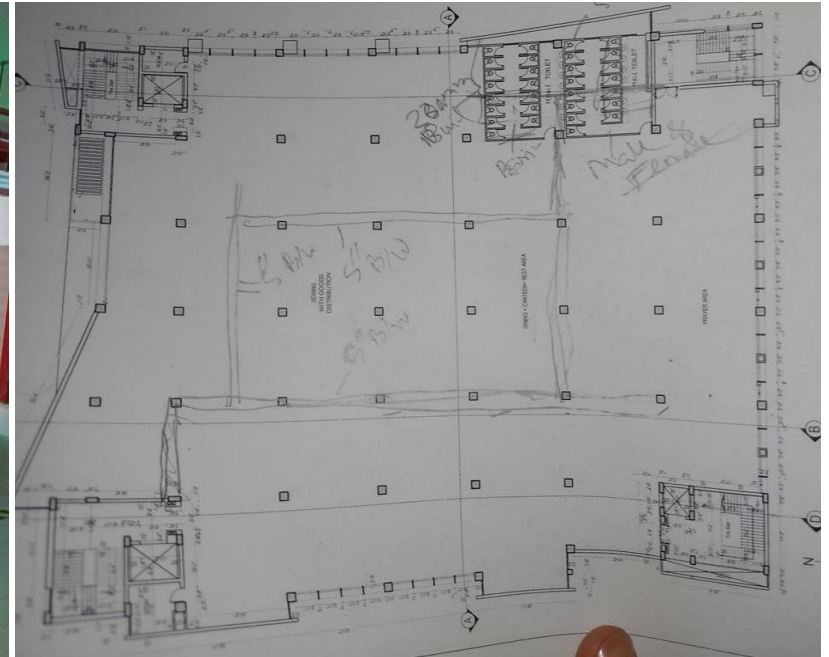
## **Discrepancy in as built drawing**

| Item No. | Observation | Recommended Action Plan | Recommended Timeline |
|---|---|---|---|
| 06 | Discrepancy in as built drawing (Production Building-2). | Building engineer is required to update the as-built drawing as per site condition and consider the load from wall and floor built-up in design and design report. | 6-weeks |

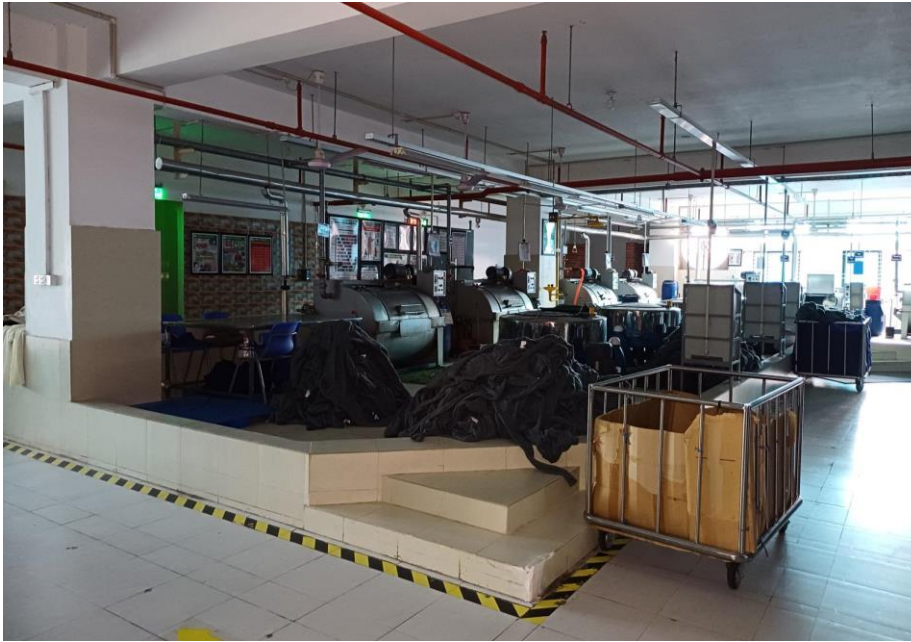
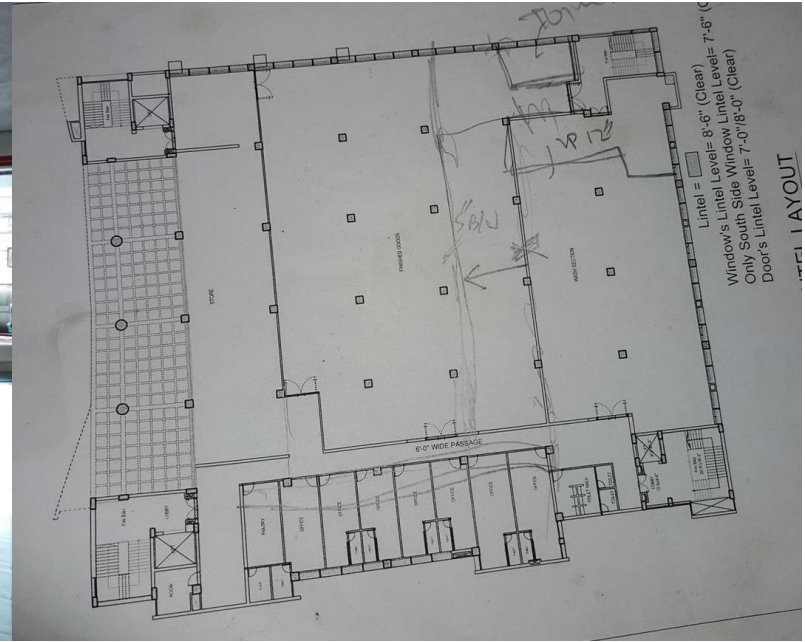
## Mismatch in wall and toilet layout in 6<sup>th</sup> floor

Mismatch in wall layout and floor built-up

During inspection, mismatch was observed regarding brick wall layout, toilet layout and floor built up layout. Building engineer is required to update the as-built drawing as per site condition and consider the load from wall and floor built-up in design and design report.

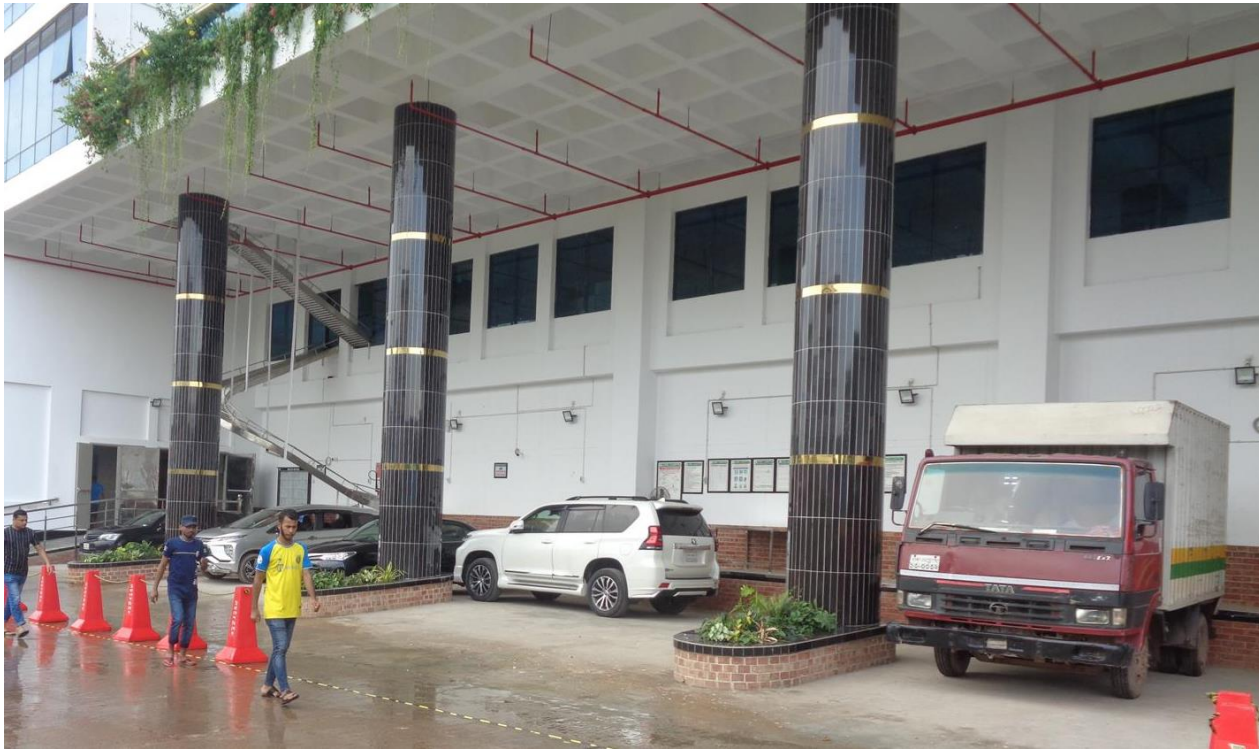
Column unprotected from possible vehicle impact.

During inspection, columns were found unprotected for possible vehicle impact. Building engineer is required to provide appropriate protection to column for vehicle impact.

| Item No. | Observation | Recommended Action Plan | Recommended Timeline |
|---|---|---|---|
| 07 | Possible vehicle impact (Production Building-2). | Building engineer is required to provide appropriate protection to column for vehicle impact. | 6-weeks |

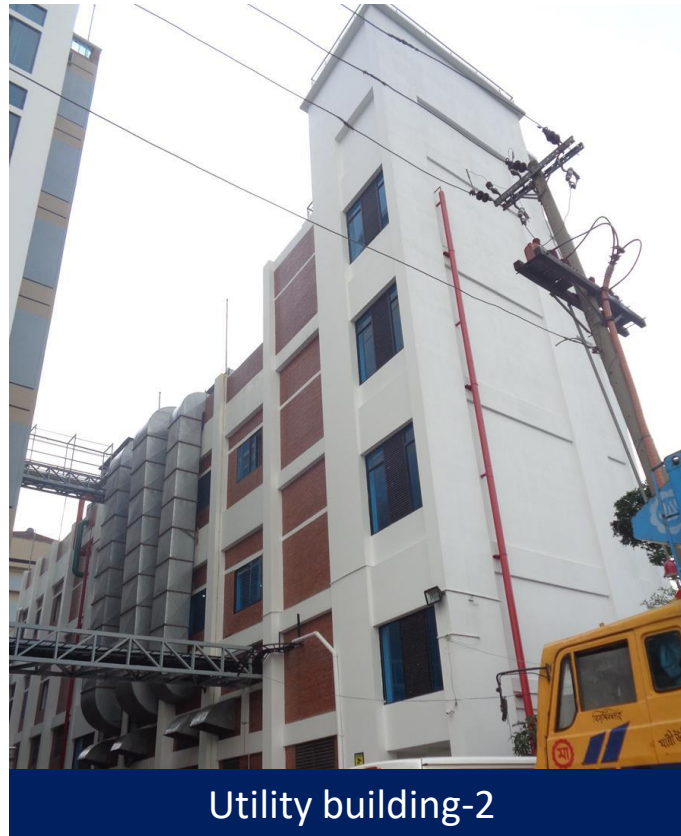
Utility building-2

**Lack of design document**

As per BNBC (part-6), every building or structures designed shall have its design documents in accordance with the provision of section 1.9.1. During inspection, no design report and load plan were found on-site. Building engineer is required to prepare a set of design documents (including load plan as per BNBC and design report based on material strength & software-based analysis) for the structure following BNBC (part-6, section 1.9.1).

| Item No. | Observation | Recommended Action Plan | Recommended Timeline |
|---|---|---|---|
| 08 | Lack of design document (Utility Building-2). | Building engineer is required to prepare a set of design documents (including load plan as per BNBC and design report based on material strength & software-based analysis) for the structure following BNBC (part-6, section 1.9.1). | 6-weeks |

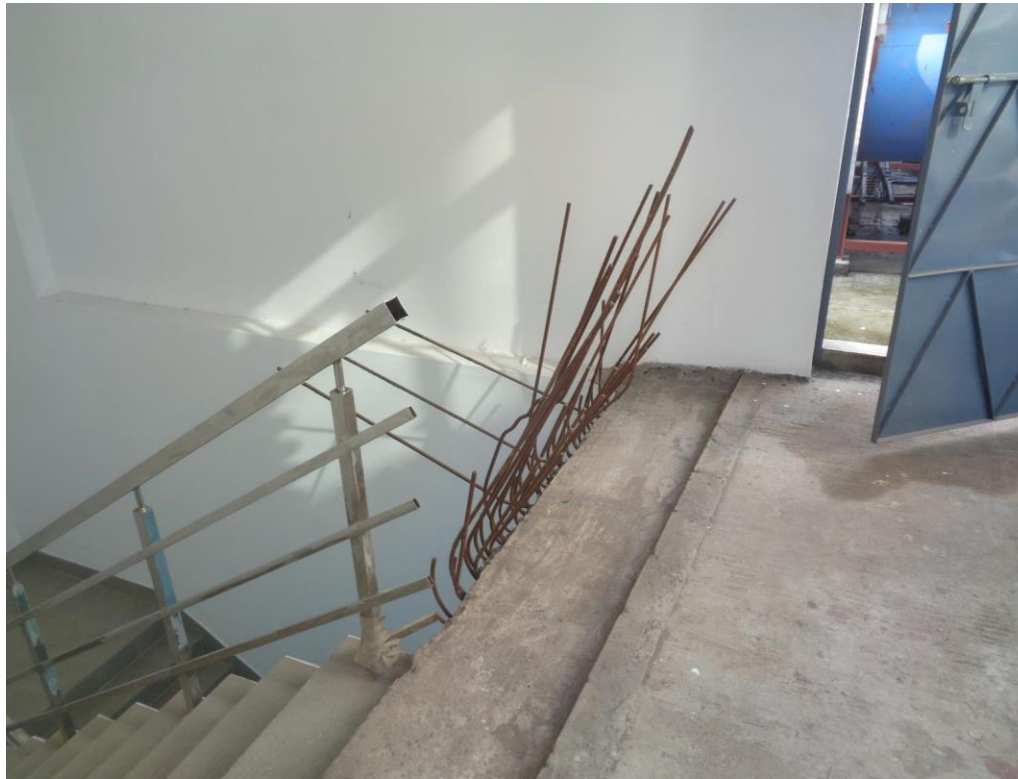
Exposed rebar and falling hazard in stair

During inspection, exposed rebar and falling hazard was observed in stair. Building engineer is required to provide anti-corrosive paint on exposed rebar and barrier to stair edge.

| Item No. | Observation | Recommended Action Plan | Recommended Timeline |
|---|---|---|---|
| 10 | Exposed rebar and falling hazard (Utility Building-2). | Building engineer is required to provide anti-corrosive paint on exposed rebar and barrier to stair edge. | 6-weeks |

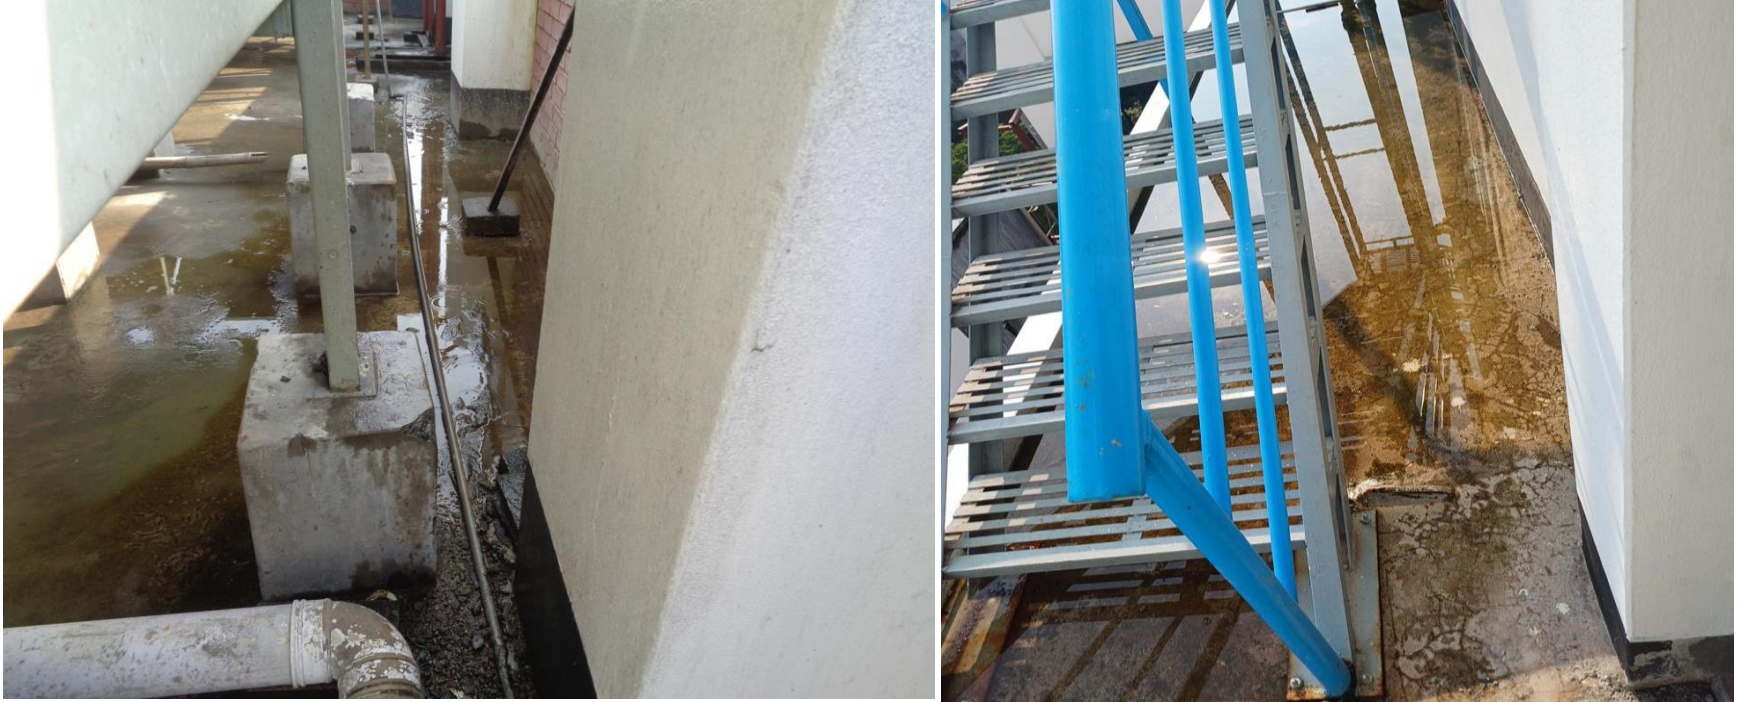
Water ponding on roof

During inspection, water ponding was observed on the roof of utility building-2. Building engineer is required to improve the drainage system on roof maintaining proper slope.

| Item No. | Observation | Recommended Action Plan | Recommended Timeline |
|---|---|---|---|
| 11 | Water ponding on roof (Utility Building-2). | Building engineer is required to improve the drainage system on roof maintaining proper slope. | 6-weeks |

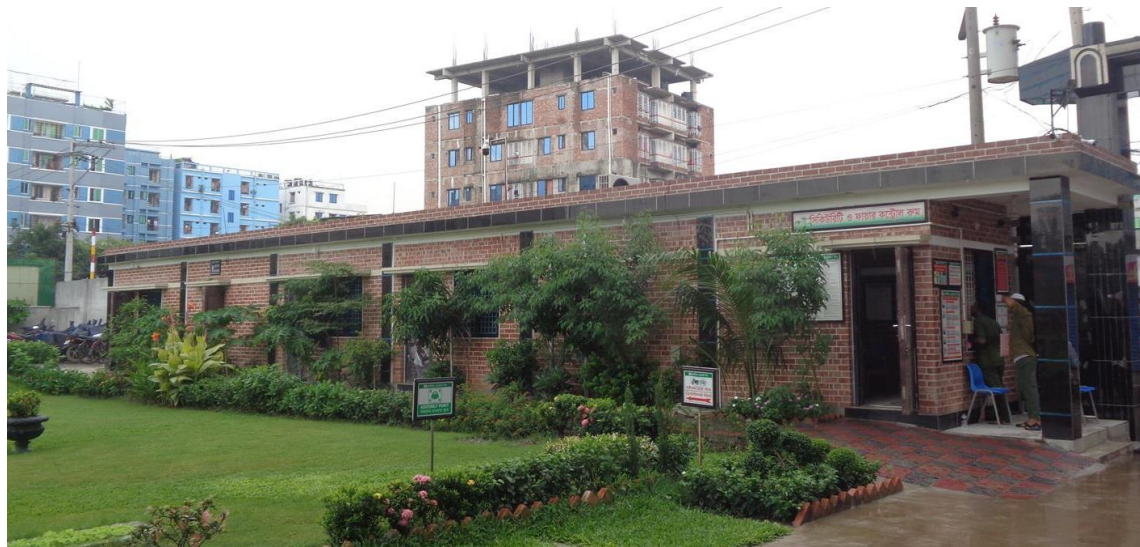
Security building-2

**Lack of as built drawing**

As-built drawing was not available for security building-2. Building engineer is required to produce as-built drawing for the structure.

| Item No. | Observation | Recommended Action Plan | Recommended Timeline |
|---|---|---|---|
| 12 | Lack of as-built drawings (Security Building-2). | Building engineer is required to produce as-built drawing for the structure. | 6-weeks |
