# Vision Garments Ltd (New Building)

B-47, Purbo Rajashan, Savar, Dhaka.

25-Sep-2023

# Executive Summary

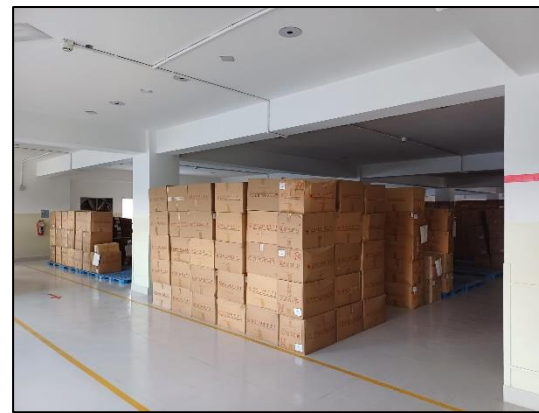
Live load Table- BNBC 2006

**Storage live load limit not comply BNBC requirement**

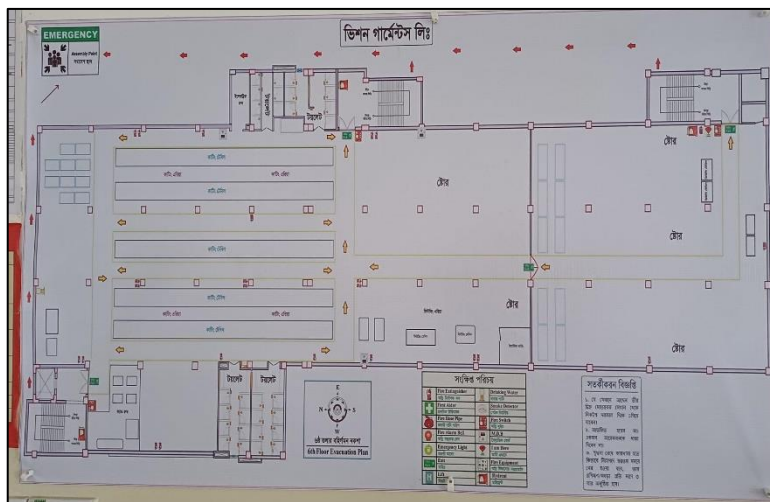
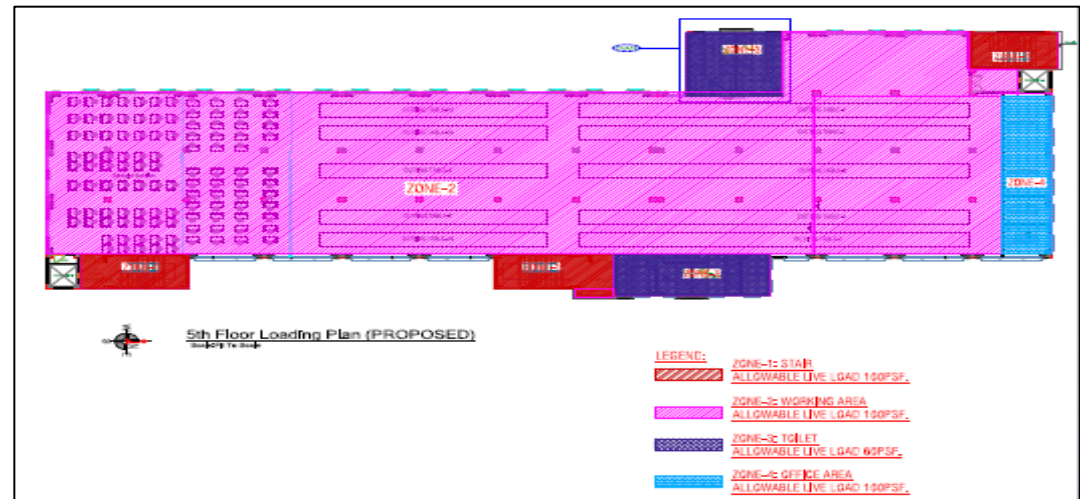
Storage area in 5<sup>th</sup> Floor

Prepared load plan for 5<sup>th</sup> floors. Floor loading has been considered 5kPa (100 psf) instead of 6kPa (125 psf) for storage areas.

As per BNBC, 6 kPa is required to consider as floor loading for the light storage facilities. During inspection, load plan was found posted considering (100 psf) 5kPa at 5<sup>th</sup> floor storage area. Also, 5 kPa live load considered in the software-based structural analysis. However, update the storage live load limit as per BNBC requirement, revise the structural analysis & design accordingly.

| Item No. | Observation | Recommended Action Plan | Recommended Timeline |
|---|---|---|---|
| 01 | Storage live load limit not comply BNBC requirement (New building-1) | Revise storage live load limit as per BNBC requirement, update floor load plan and incorporate the changes in the structural analysis and design report. Design report shall be revised based on in situ concrete strength. | 6-weeks |
| 02 | Storage live load limit not comply BNBC requirement (New building-1) | Carry out suggested remedial works if required and provide implementation of load plan. | 6-months |

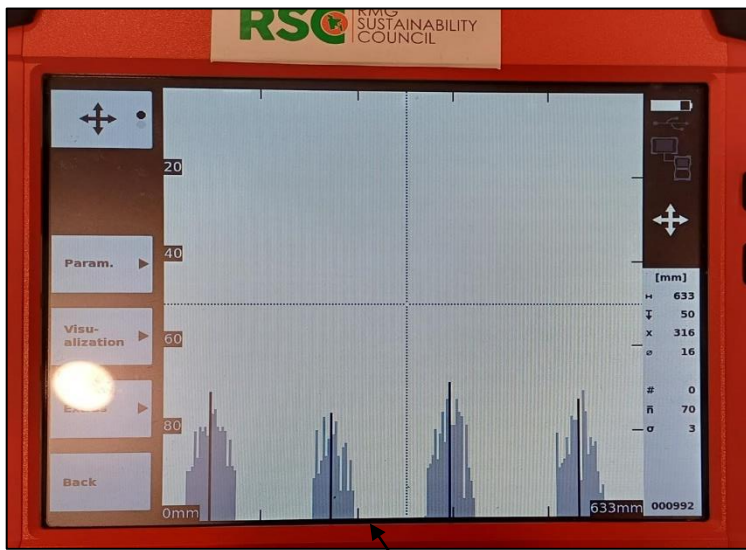
4 no's rebar each side at column C5

Building engineer is required to survey the whole structure, update the as-built drawings and perform Engineering Assessment (EA)

| Item No. | Observation | Recommended Action Plan | Recommended Timeline |
|---|---|---|---|
| 03 | Mismatch in as-built drawings (New Building-1) | Building engineer is required to survey the whole structure, update the as-built drawings. | 6-weeks |

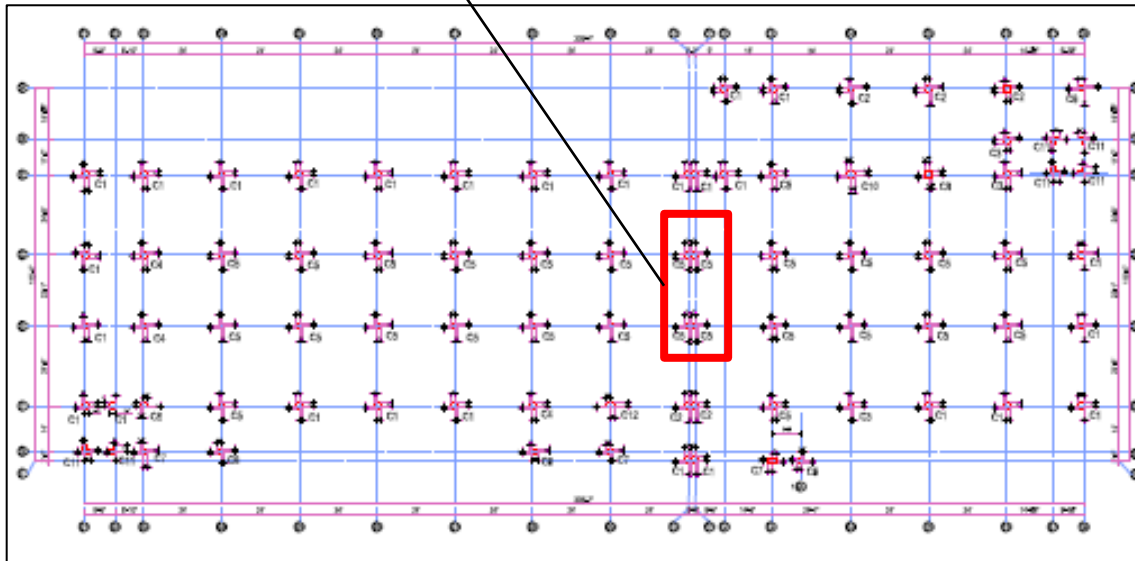
Column layout plan

Column schedule: Column rebar 5 no's each side

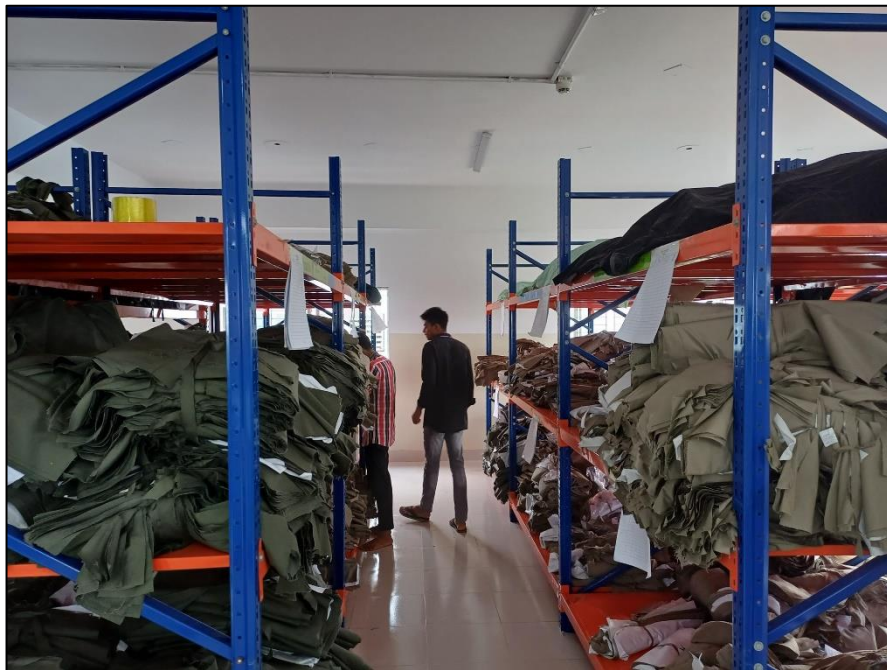
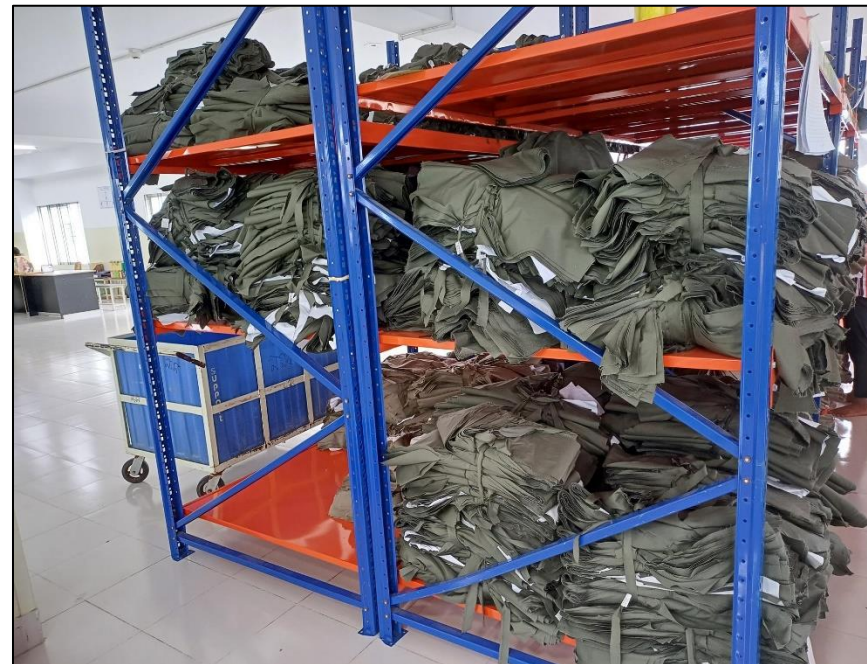
Storage rack without anchorage

Racks on different floors are not adequately anchored or braced to resist lateral (earthquake) forces. Building Engineer is required to adequately anchor and brace all non-structural elements to resist earthquake forces to comply with the BNBC.

| Item No. | Observation | Recommended Action Plan | Recommended Timeline |
|---|---|---|---|
| 04 | Lack of anchorage/bracing for non-structural elements(New Building-1) | Building Engineer is required to adequately anchor and brace all non-structural elements to resist earthquake forces to comply with the BNBC | 6-months |

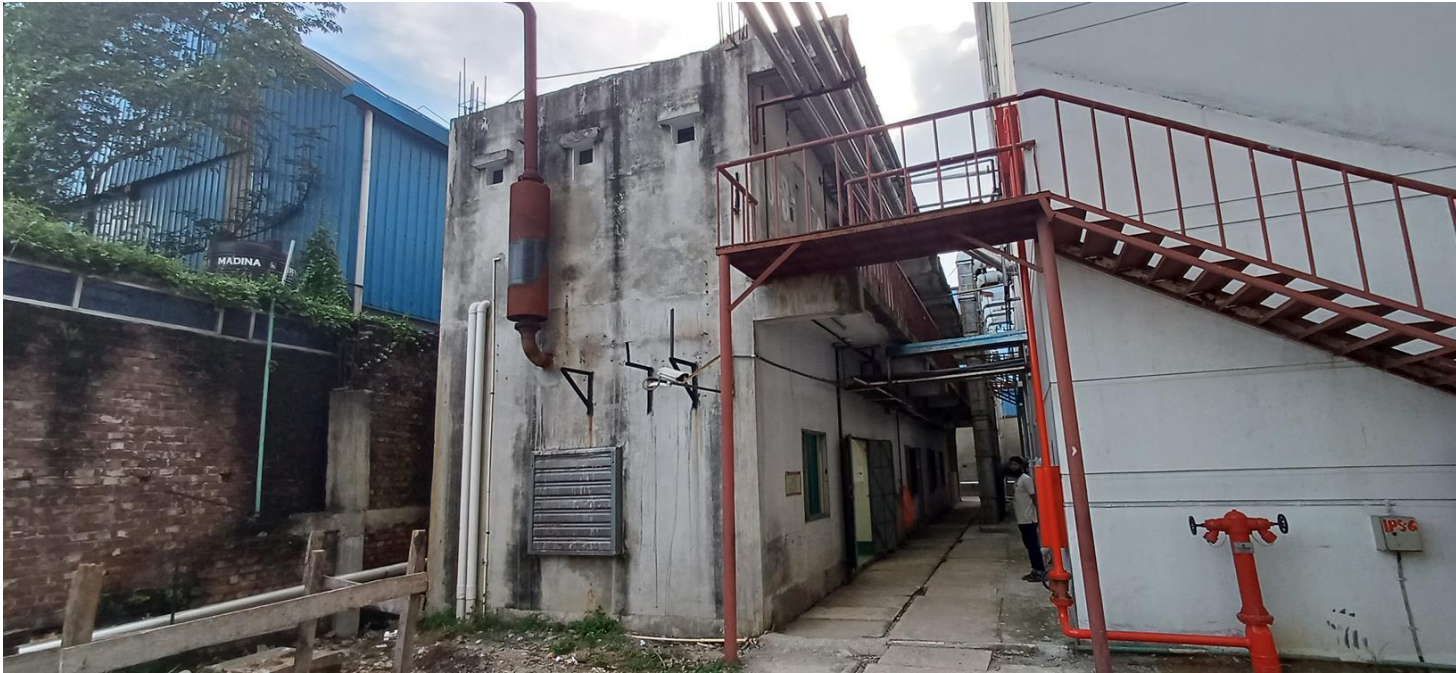
Utility Building

As per BNBC (part-6), every building or structure designed shall have its design documents prepared in accordance with the provision of Section 1.9.1. The design document shall include a design report, and a set of structural drawings, which shall be prepared in compliance with section 1.9.1.1 & section 1.9.1.2 of BNBC (part-6).

At the time of inspection, no design report was available. Building engineer is required to prepare a set of design documents in compliance with BNBC.

| Item No. | Observation | Recommended Action Plan | Recommended Timeline |
|---|---|---|---|
| 05 | Lack of design report (Utility Building) | Building engineer is required to prepare a set of design documents in compliance with BNBC. | 6-weeks |

| Item No. | Observation | Recommended Action Plan | Recommended Timeline |
|---|---|---|---|
| 06 | Lack of design report (Utility Building) | Carry out suggested remedial works if required. | 6-months |

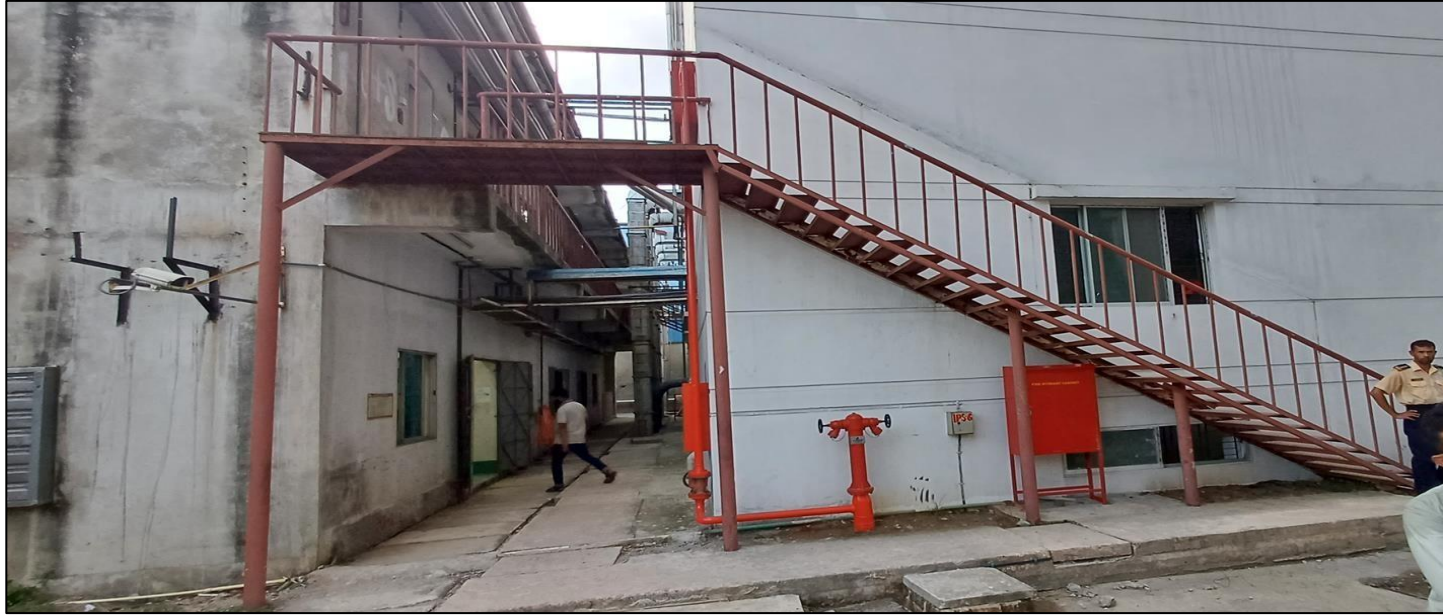
No vertical bracing provide for the stair

The steel stair was appeared to be unstable due to lack of vertical bracing. The building engineer is required to check the lateral stability of the steel stair, perform Engineering assessment (EA ) and suggest remediation if required.

| Item No. | Observation | Recommended Action Plan | Recommended Timeline |
|---|---|---|---|
| 07 | Lack of lateral stability of adjacent steel stair (Utility Building) | building engineer is required to check the lateral stability of the steel stair as part of Engineering assessment (EA). | 6-weeks |
| 08 | Lack of lateral stability of adjacent steel stair (Utility Building) | Carry out suggested remedial works if required. | 6-months |

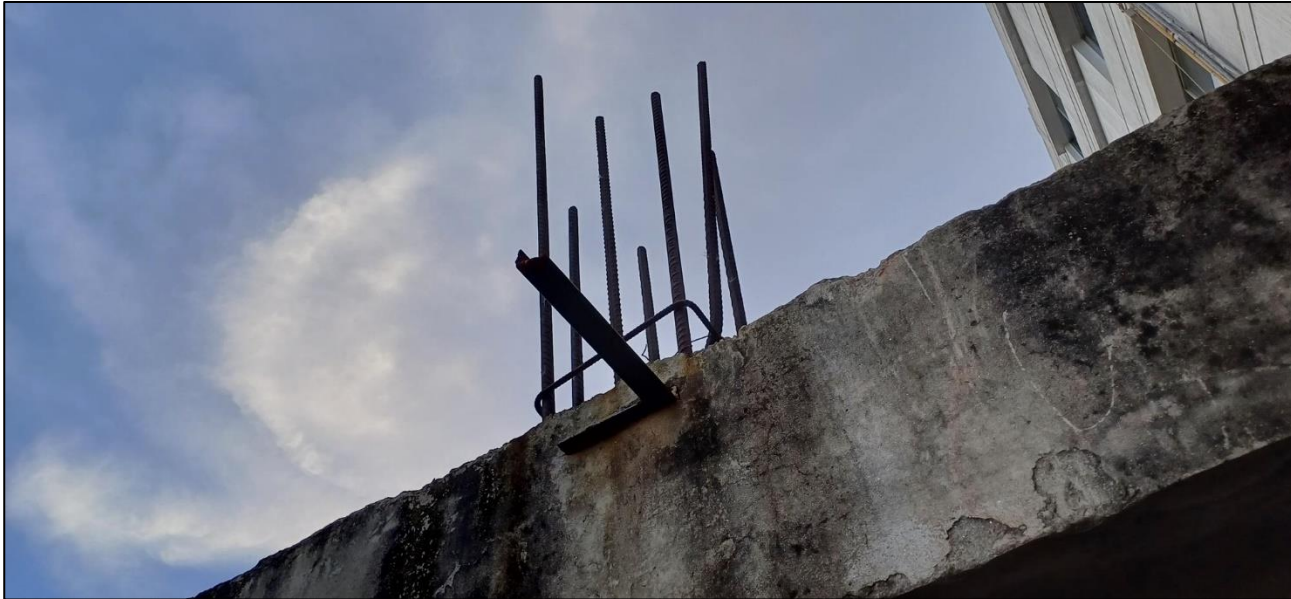
Exposed rebar of Column

Exposed reinforcement was found on rooftop columns. Building engineer is required to take necessary measures to prevent corrosion in exposed rebar.

| Item No. | Observation | Recommended Action Plan | Recommended Timeline |
|---|---|---|---|
| 09 | Exposed re-bar at roof (Utility Building) | Building engineer is required to take necessary measures to prevent corrosion in exposed rebar. | 6-weeks |

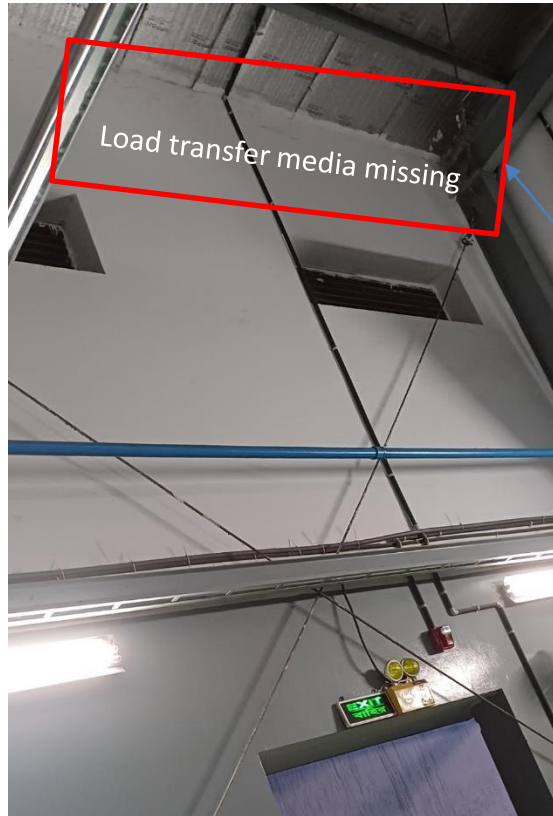
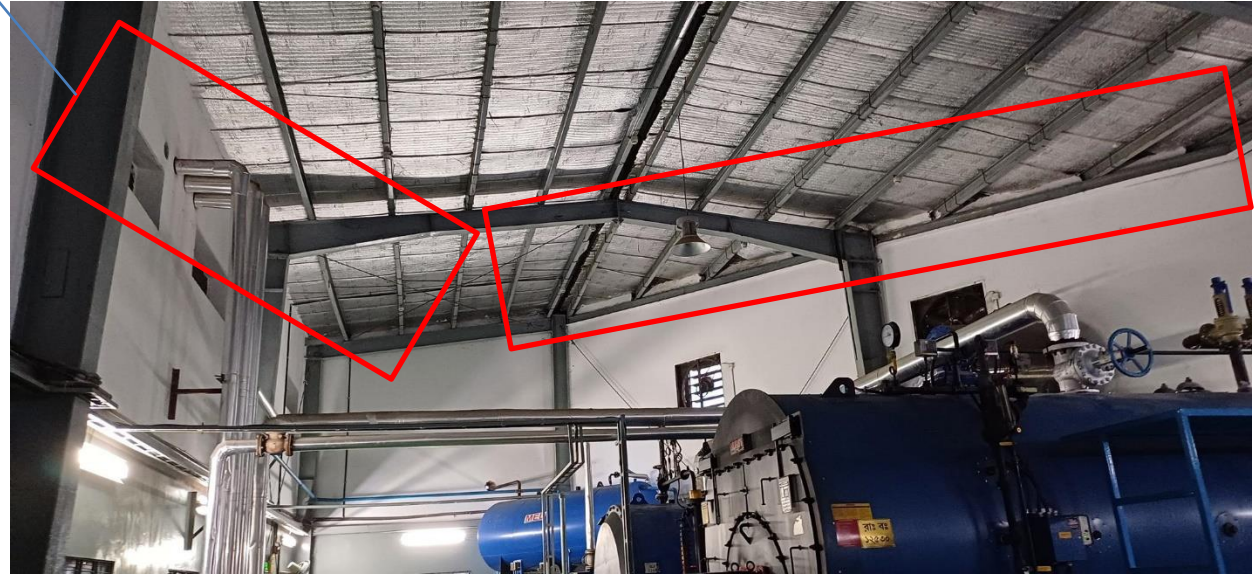
Horizontal compression members are not provided along long direction

load transfer media is not provided from frame to frame to transfer the lateral load at top at all sides. Hence, lateral stability system of structure is incomplete. The building engineer is required to check the lateral stability of the structure as part of EA and suggest proper remedial actions accordingly.

| Item No. | Observation | Recommended Action Plan | Recommended Timeline |
|---|---|---|---|
| 10 | Lack of lateral stability (Boiler Shed) | Building engineer is required to prepare a set of design documents in compliance with BNBC. | 6-weeks |
| 11 | Lack of lateral stability (Boiler Shed) | Carry out suggested remedial works if required. | 6-months |

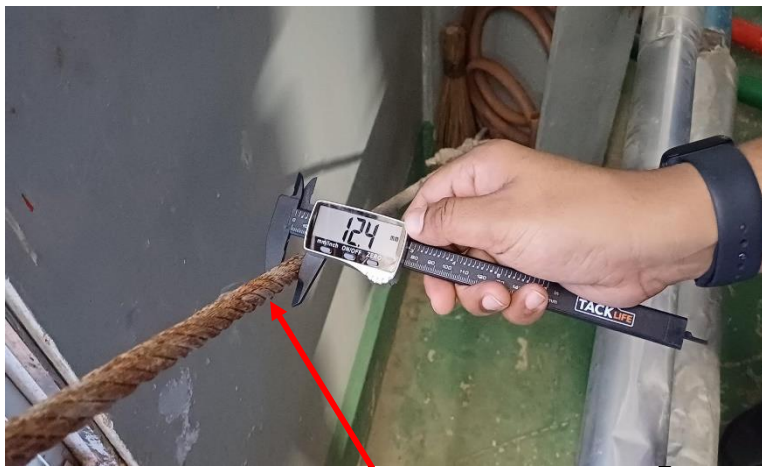
Wall bracing size 12.4 mm

Building engineer is required to survey the whole structure and update the as-built drawings as per site condition.

| Item No. | Observation | Recommended Action Plan | Recommended Timeline |
|---|---|---|---|
| 12 | Mismatch in as-built drawings (Boiler Shed) | Building engineer is required to survey the whole structure and update the as-built drawings. | 6-weeks |
