# MEEK KNIT LIMITED

Vogra , National University , Joydebpur,Gazipur  
(23.58530N ,90.22504E)

28<sup>th</sup> October 2015

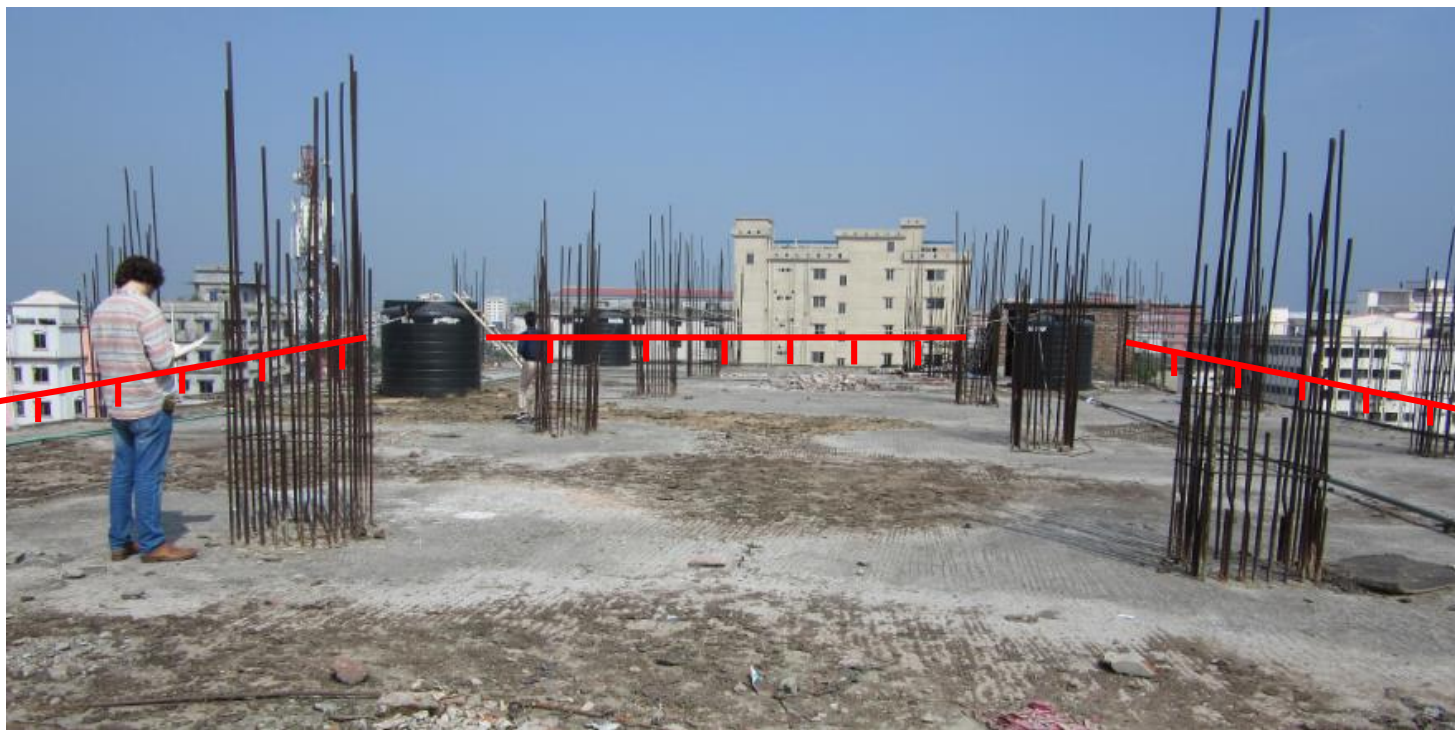
**No roof parapets or fall restrains (non-structural observation)**

No edge protection on the roof

Item No.	Observation	Recommended Action Plan	Recommended Timeline
1	No roof parapets or fall restraints (non structural)	Roof edge to be made safe	6-weeks
2	Uncontrolled conditions on the roof slab	Remove construction materials from the roof	6-weeks
3	Uncontrolled conditions on the roof slab	Protect roof slab surface and against weather conditions	6-weeks
4	Uncontrolled conditions on the roof slab	Cover the lift shafts	6-weeks

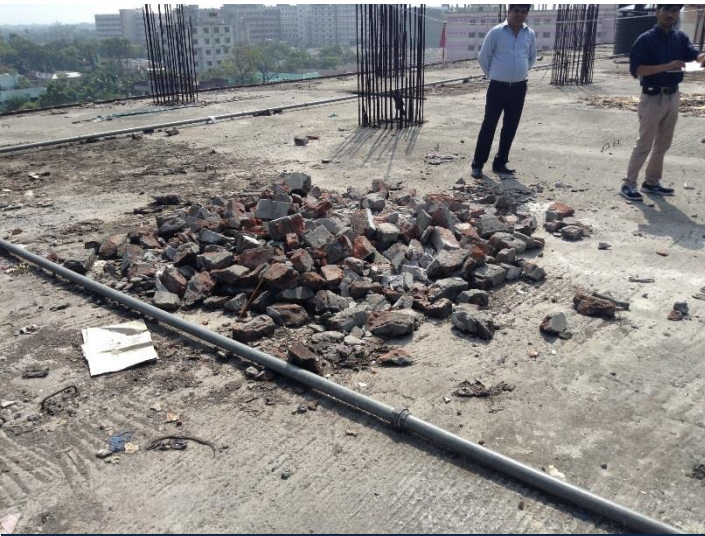
# Uncontrolled roof slab conditions

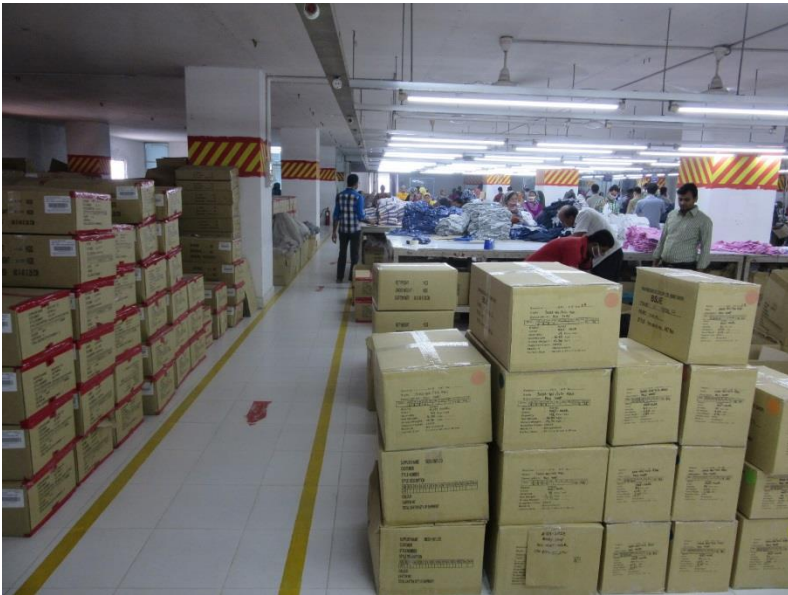
2nd Floor

# Uncontrolled storage areas

Item No.	Observation	Recommended Action Plan	Recommended Timeline
5	Uncontrolled storage areas	The quantity of the stored materials must be reduced to the level specified by the original designer	6-weeks
6	Uncontrolled storage areas	Building Engineer to provide Load Plans for each level	6-weeks
7	Uncontrolled storage areas	Reduce loading to the recommendations of the loading plans	6-months
8	Façade breakouts	Repair the cracks	6-months

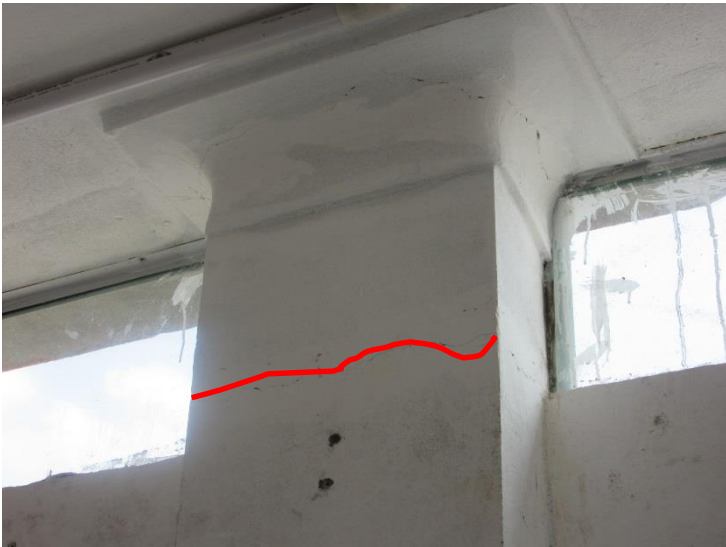
# Facade breakouts

West Facade pillar

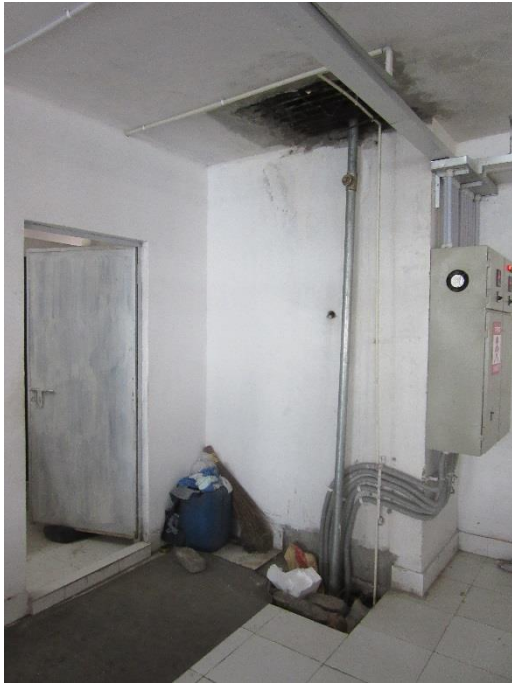
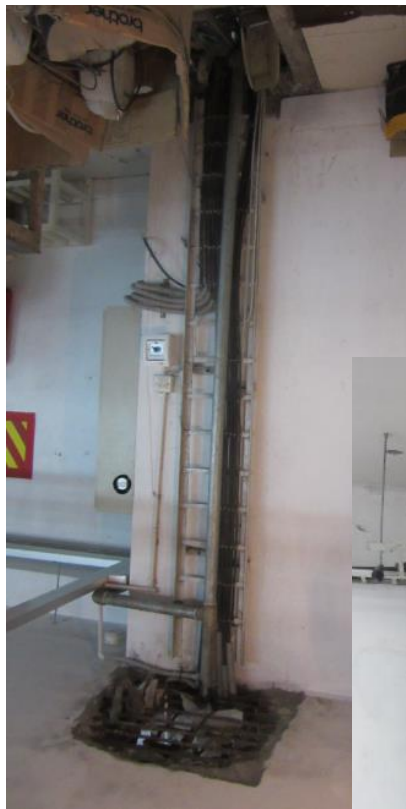
3rd Floor

# Non-engineered riser

<b>Item No.</b>	<b>Observation</b>	<b>Recommended Action Plan</b>	<b>Recommended Timeline</b>
9	Non-engineered riser	The slab openings should be filled-out with concrete material	<b>6-weeks</b>
10	Wet surface on the toilet wall	Building Engineer to check the cause of the water leak and it should be repaired	<b>6-months</b>
11	Defective beam	Repair the beam	<b>6-months</b>
12	Non-engineered pedestrian bridge	Building Engineer to check the support detail of the pedestrian bridge on the 1st level structure of the Main Building	<b>6-weeks</b>
13	Non-engineered pedestrian bridge	Carry out any remedial works from the design Engineers study	<b>6-months</b>

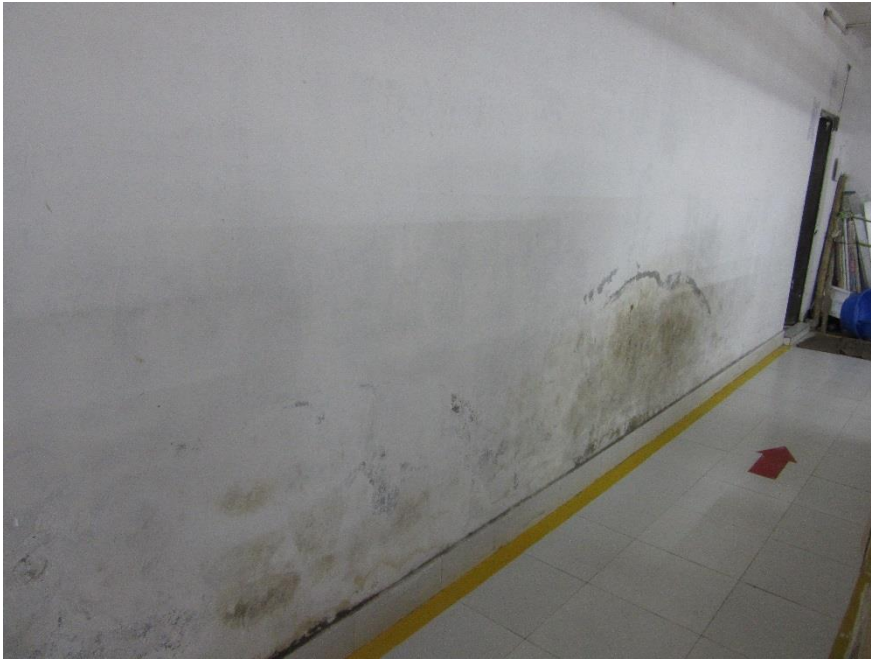
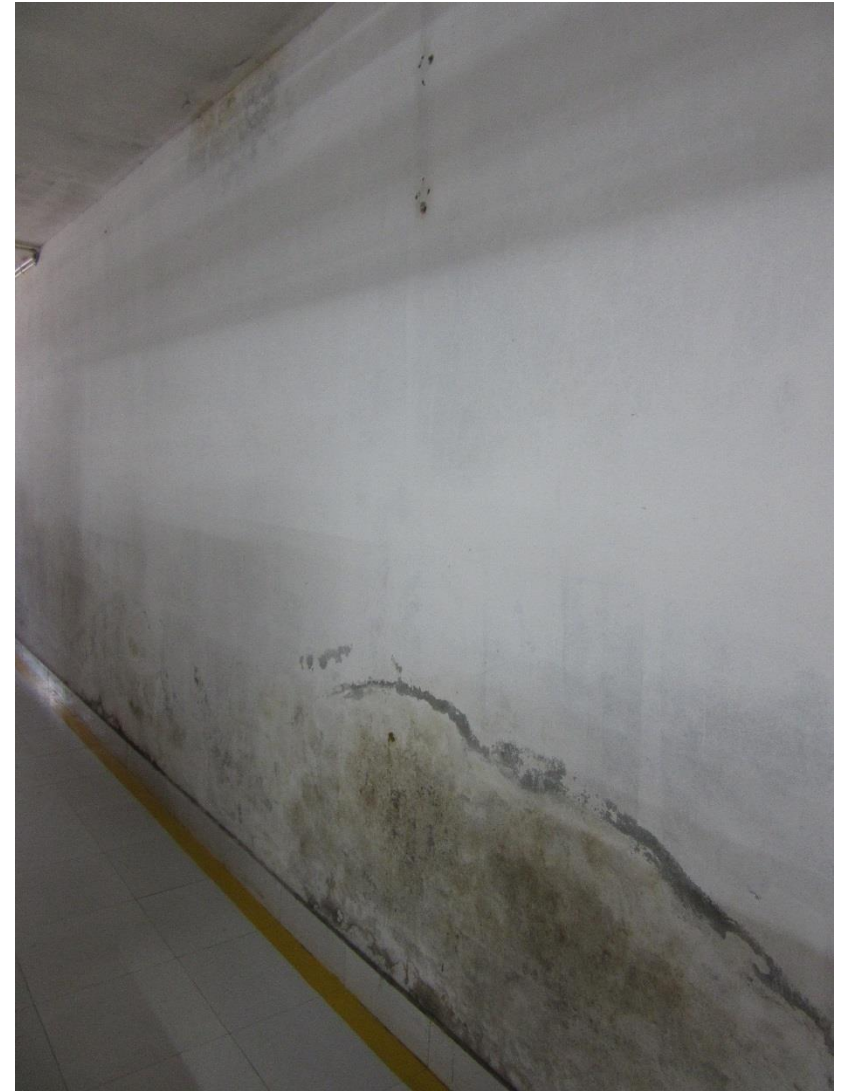
1st Floor Toilet wall, On production side

# Wet surface on the toilet wall

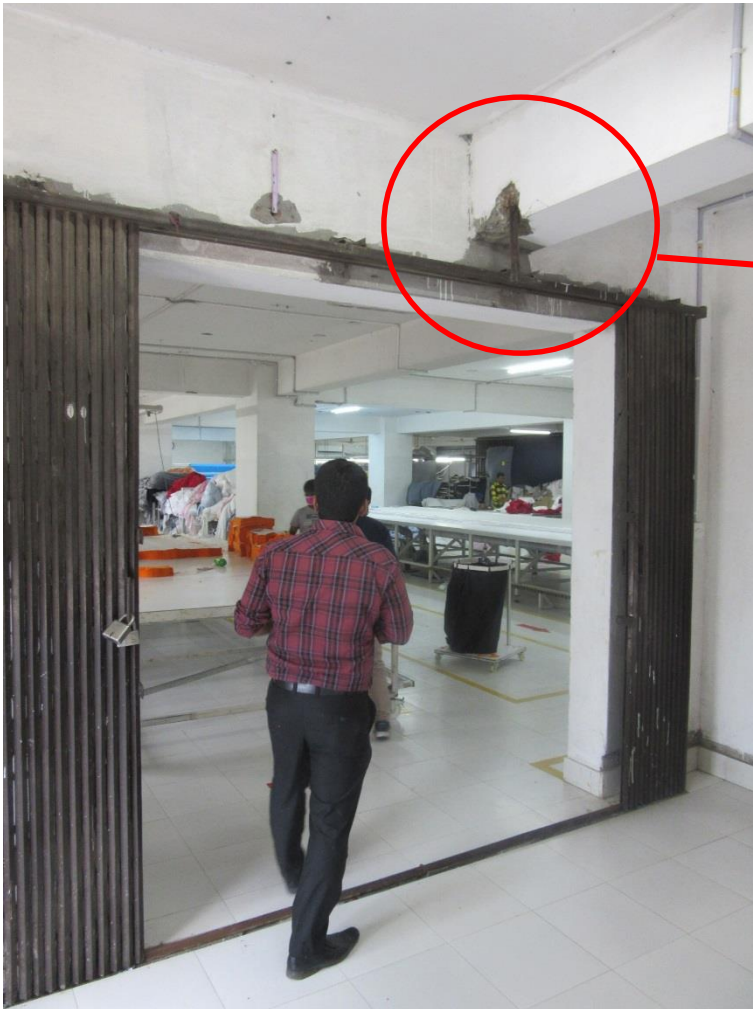
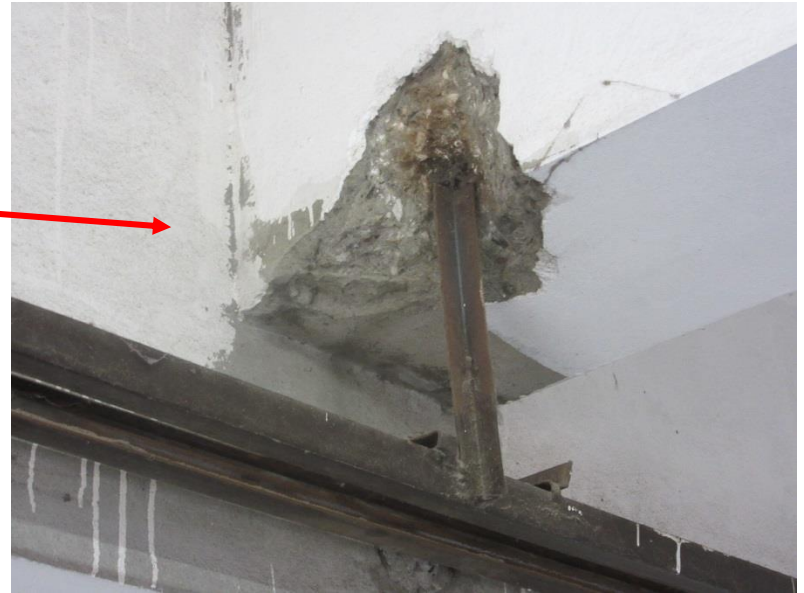
1st Floor. Staircase

# Defective beam

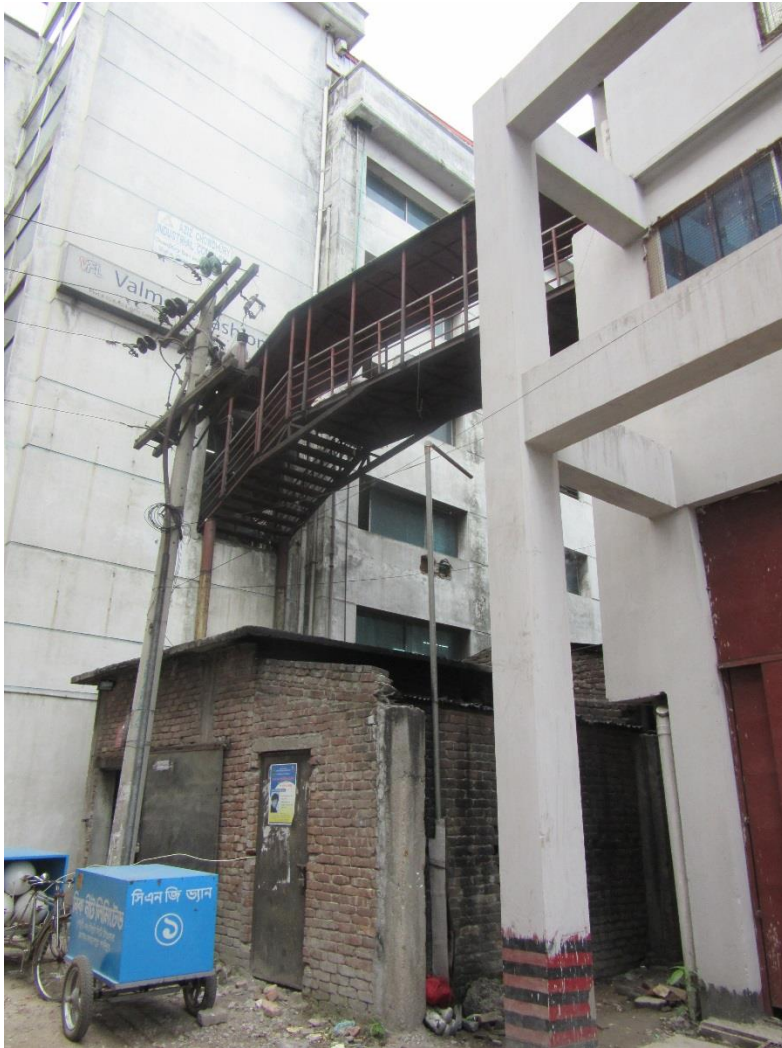
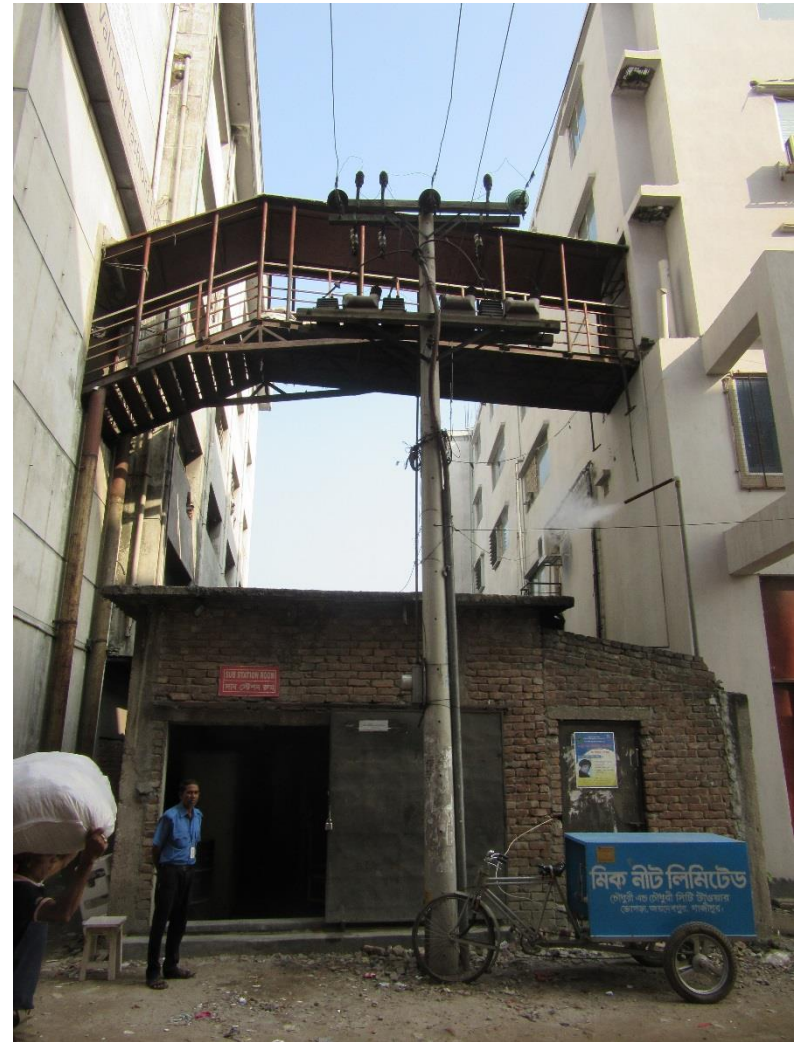
# Non-engineered pedestrian bridge

Pedestrian link between 2 buildings – No structural documentation
