# Aman Fashions & Designs Ltd. (Extension)

Nalam, Mirzanagar, Asulia, Savar, Dhaka.

2 November 2023

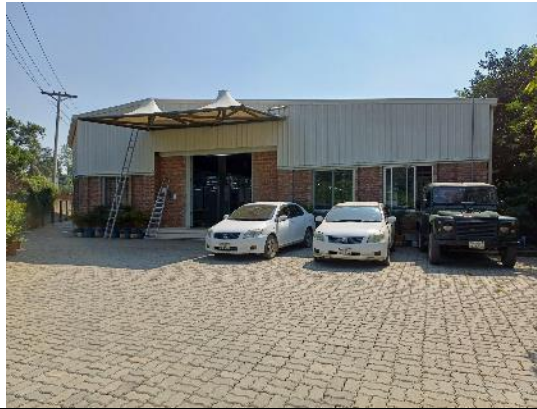
#### Observation-1: Lack of design report.

**Description:** As per BNBC, every building or structure designed shall have its design documents prepared in accordance with the provision of Section 1.9.1. The design documents shall include as built drawings and a design report which shall be prepared in compliance with section 1.9.1, part-6 of BNBC.

During inspection, the design report was not available on site. The building engineer is required to prepare a design report based on in-situ material strength & software-based analysis and submit it to RSC for review.

| Serial No. | Observation | Action Plan | Timeline |
|---|---|---|---|
| 1 | Lack of design report. (Socks & Tights Shed) | The building engineer is required to prepare a design report based on in-situ material strength & software-based analysis and submit the documents to RSC for review. | within 6 weeks |
| 2 | Lack of design report. (Socks & Tights Shed) | Carry out suggested remedial works if required. | within 6 months |

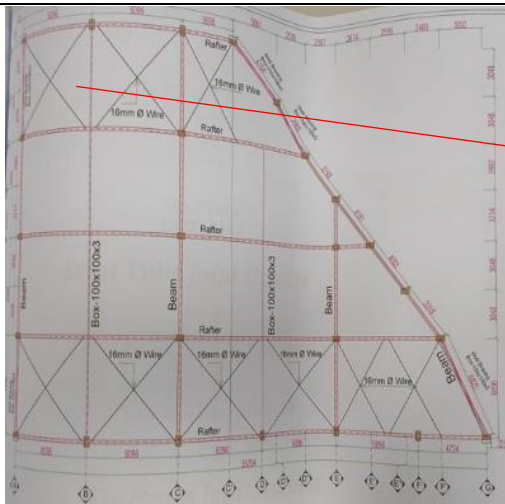
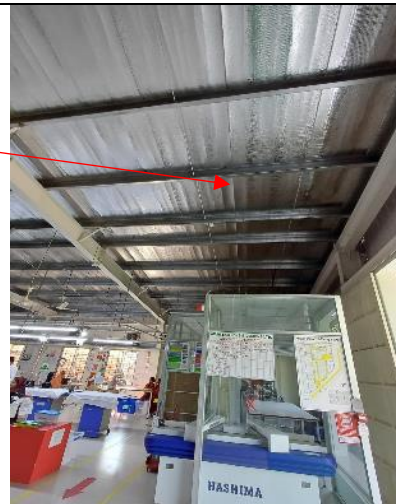
#### Observation-2: Discrepancies in as built drawings.

**Description:** During inspection, mismatches were found between onsite condition and as-built drawing. Horizontal bracing missing is as built condition. The building engineer is required to survey the full structure and produce accurate as-built drawings.

| Serial No. | Observation | Action Plan | Timeline |
|---|---|---|---|
| 3 | Discrepancies in as built drawings. (Socks & Tights Shed) | The building engineer is required to survey the full structure and produce accurate as-built drawings. | within 6 weeks |

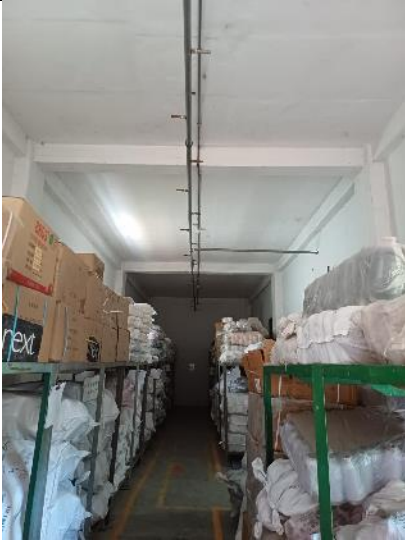
| <b>Observation-3:</b> Lack of design report. | |
| <p><b>Description:</b> As per BNBC, every building or structure designed shall have its design documents prepared in accordance with the provision of Section 1.9.1. During inspection, the design report and as built structural drawing was not available on site.</p> <p>The building engineer is required to prepare a set of design documents including as built drawings, live load plan at roof and a design report based on in-situ material strength and software-based analysis which shall be prepared in compliance with section 1.9.1, part-6 of BNBC.</p> | |

| Serial No. | Observation | Action Plan | Timeline |
|---|---|---|---|
| 4 | Lack of Design Report. (Store Building) | The building engineer is required to prepare a set of design documents including as built drawings and a design report. | within 6 weeks |
| 5 | Lack of Design Report. (Store Building) | Carry out remedial works if required. | within 6 months |

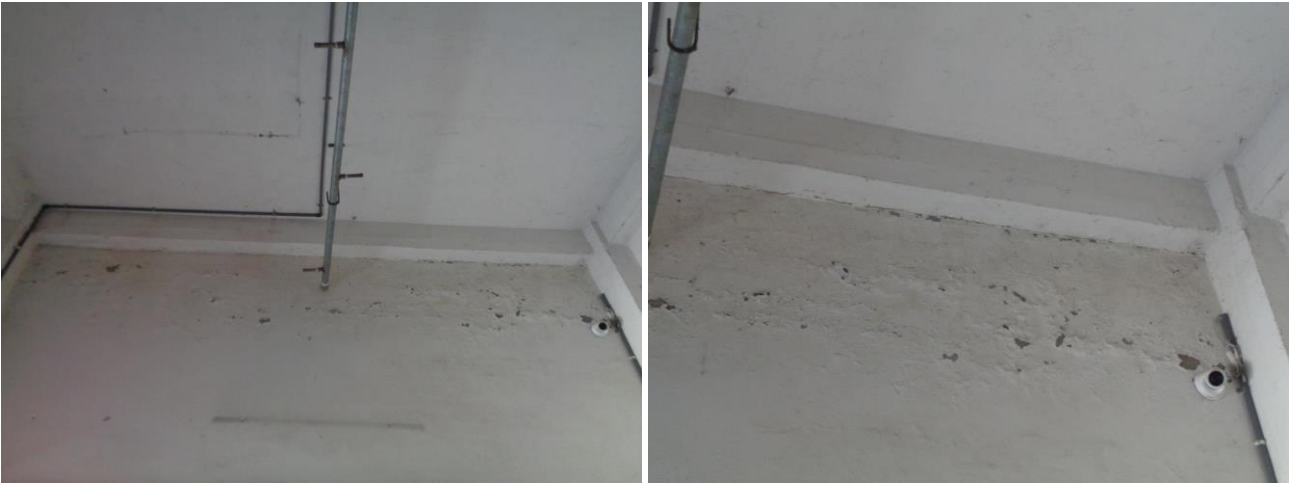
| <b>Observation-4:</b> Dampness of brick wall. | |
| <p><b>Description:</b> Dampness found on brick wall of store building. The factory is required to identify the source of dampness, take remedial measure to repair the wall accordingly.</p> | |

| Serial No. | Observation | Action Plan | Timeline |
|---|---|---|---|
| 6 | Dampness of brick wall. (Store Building) | Factory is required to identify the source of dampness, take remedial measure to repair the damped area accordingly. | within 6 months |

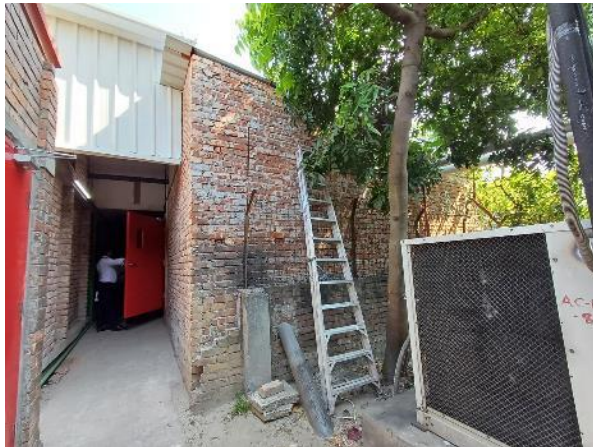
**Observation-5:** Lack of as built drawing.

**Description:** As built drawing of substation shed not available on site at the time of inspection. The building engineer required to prepare as built drawing of the substation shed.

| Serial No. | Observation | Action Plan | Timeline |
|---|---|---|---|
| 7 | Lack of as-built drawing. (Substation Shed) | The building engineer required to prepare accurate as built drawing of the substation shed. | within 6 weeks |

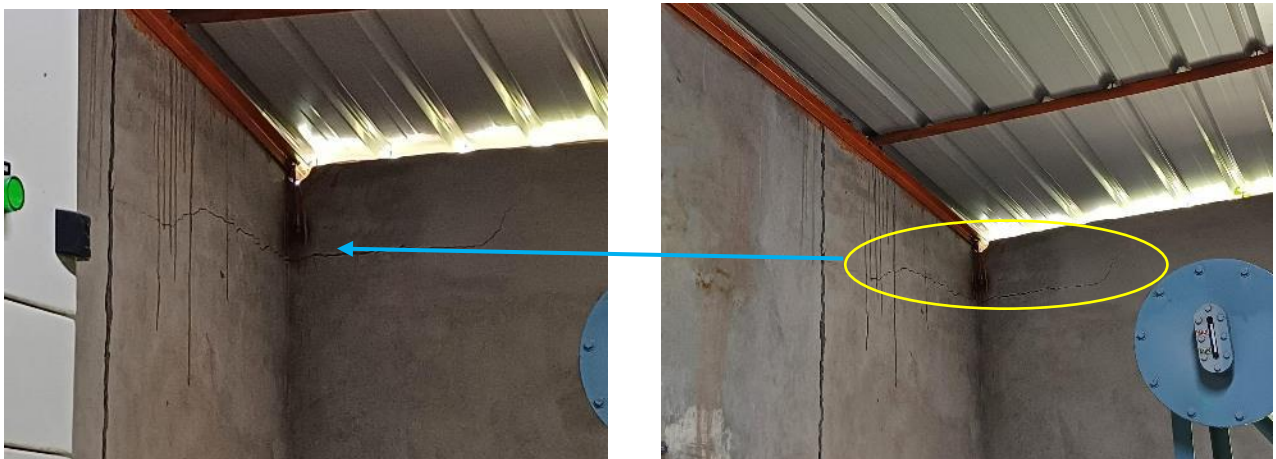
**Observation-6:** Crack on brick wall.

**Description:** Crack found on brick wall of substation shed. Factory is required to identify the reason of crack, take necessary remedial measure to repair the wall accordingly.

| Serial No. | Observation | Action Plan | Timeline |
|---|---|---|---|
| 8 | Crack of brick wall. (Substation Shed) | Factory is required to identify the reason of crack, take necessary remedial measure to repair the wall accordingly. | within 6 weeks |

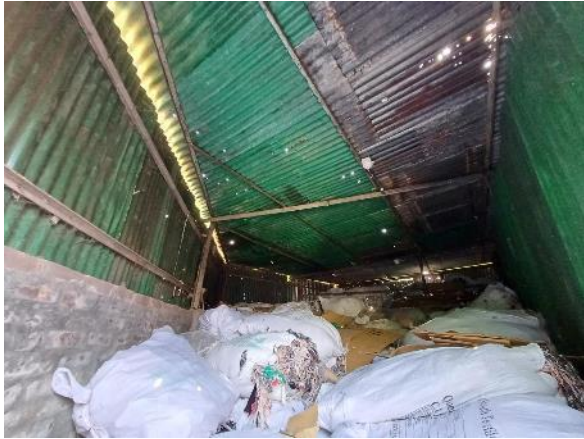
| <b>Observation-7:</b> Non-engineered structure. |
| <p><b>Description:</b> Lack of lateral stability system (strut and bracing), apparent inadequate members and non-engineered connection was observed. The building engineer is required to check the member, connection &amp; stability system of the structure and suggest proper alternatives accordingly.</p> |

| Serial No. | Observation | Action Plan | Timeline |
|---|---|---|---|
| 9 | Non-engineered structure. (Wastage Shed) | The building engineer is required to check the member, connection & stability system of the structure and suggest proper alternatives accordingly. | within 6 weeks |
| 10 | Non-engineered structure. (Wastage Shed) | Carry out suggested remedial works. | within 6 months |
