# Fakir Fashion Ltd.(Extension)

Dohargaon, Baliapara, Rupgonj.

21<sup>st</sup> June 2017

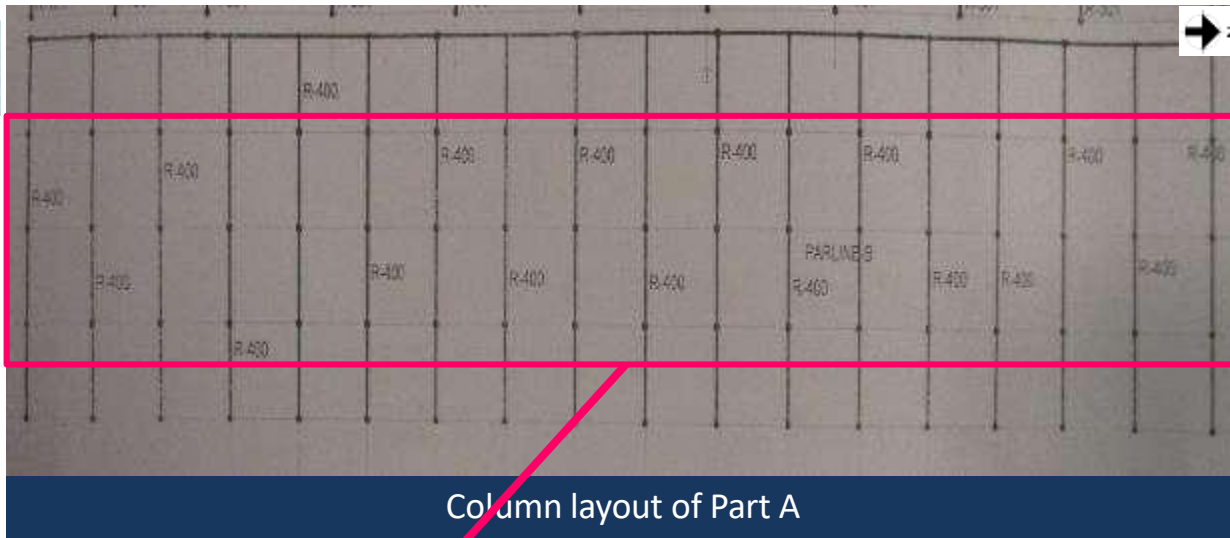
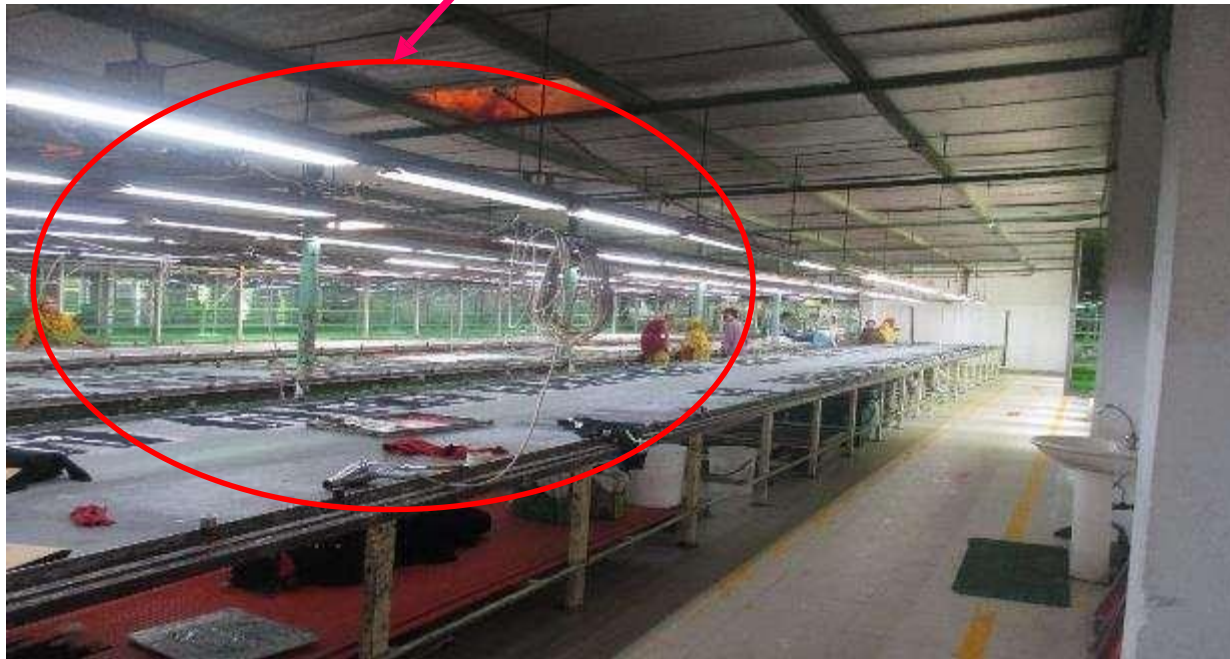
Column layout of Part A

In the marked zone, two steel pipe columns had found instead of three steel pipe columns. Factory is required to update the as-built drawing and assess the stability against vertical and horizontal load.

| Item No. | Observation | Recommended Action Plan | Recommended Timeline |
|---|---|---|---|
| 01 | Discrepancies between provided drawing and on site condition (Shed-2: Screen Printing And Embroidery Unit) | Factory engineer to survey the whole building and produce as-built documentation reflecting the as constructed condition. | 6-weeks |
| 02 | Discrepancies between provided drawing and on site condition (Shed-2: Screen Printing And Embroidery Unit) | Factory engineer to check the stability of the steel shed under lateral and vertical loads. | 6-weeks |
| 03 | Discrepancies between provided drawing and on site condition (Shed-2: Screen Printing And Embroidery Unit) | Carry out remedial works resulting from engineering assessment if necessary. | 6-months |

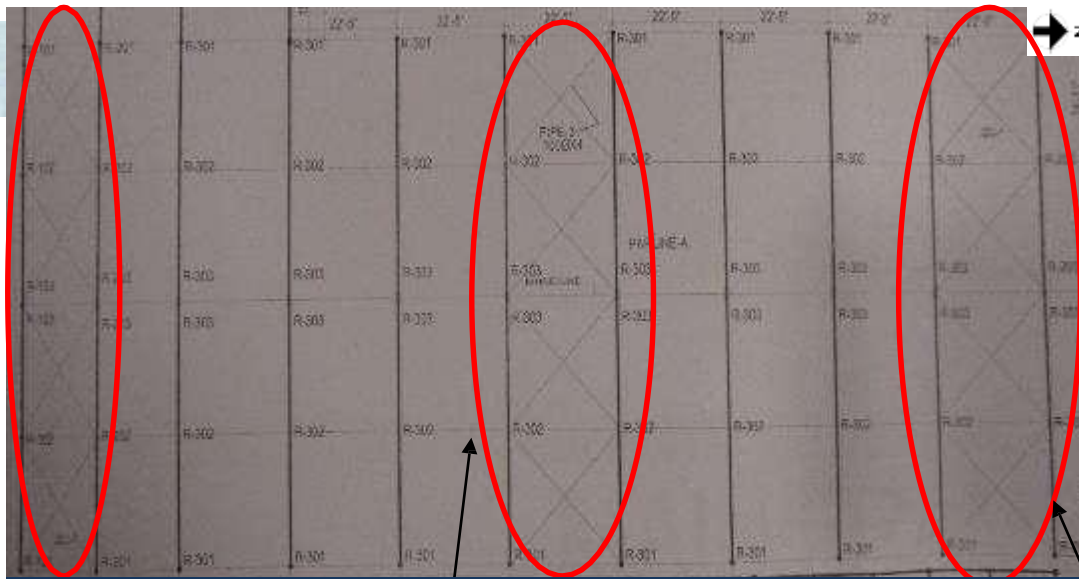
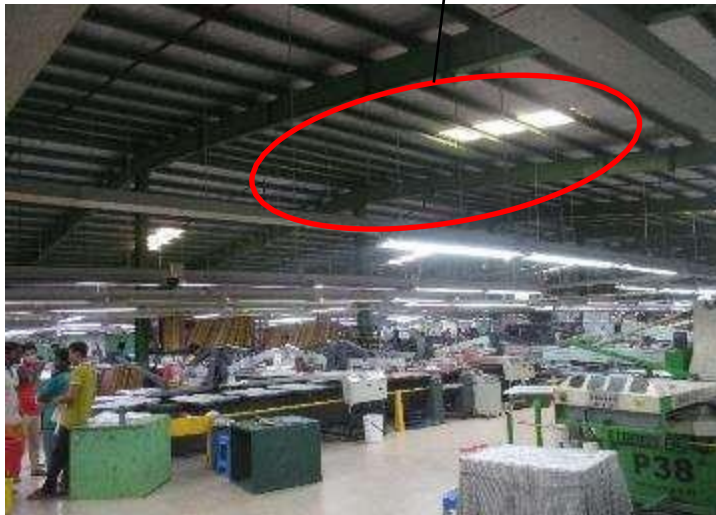
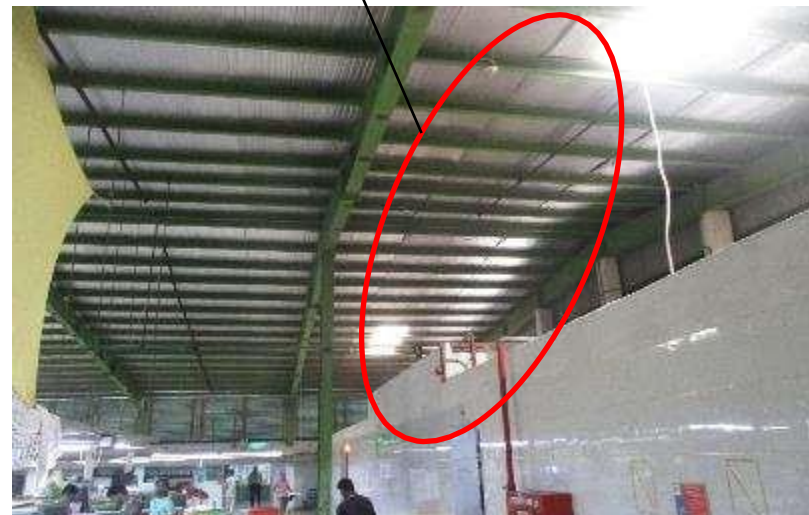
Bracing layout of Part B

No horizontal bracing was found on site where as in provided drawing, the horizontal pipe bracings were shown. Factory is required to install the bracing according to structural drawing.

No horizontal pipe bracing was observed

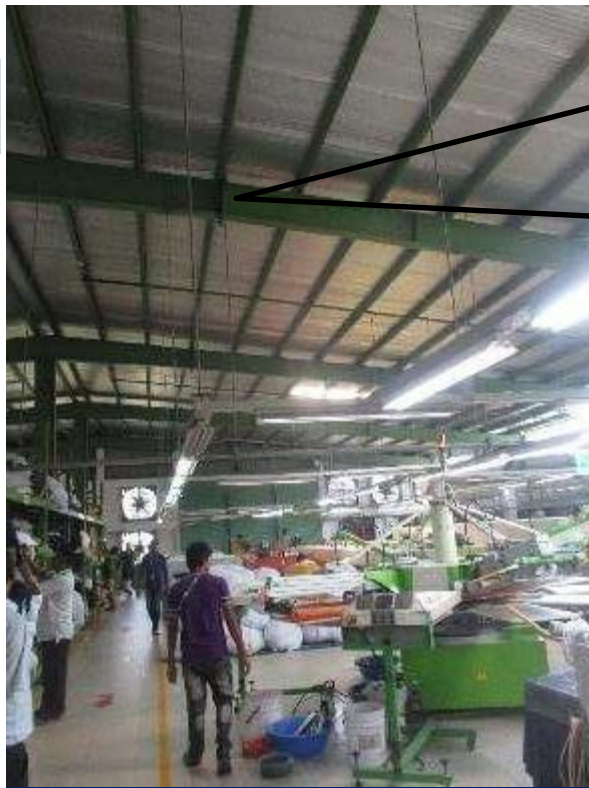
Loose connections were found in several locations in Part B which may produce excessive shear stress in the bolt. The factory is required to take necessary steps for tightening the connection.

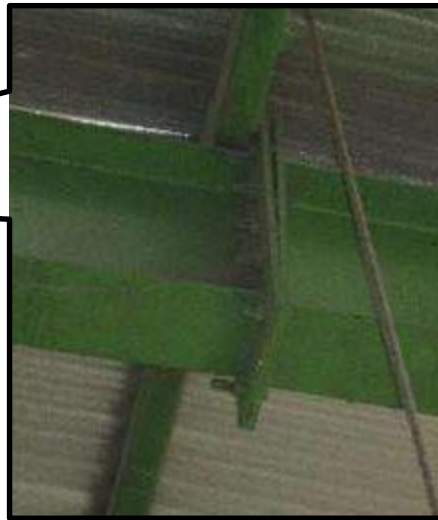
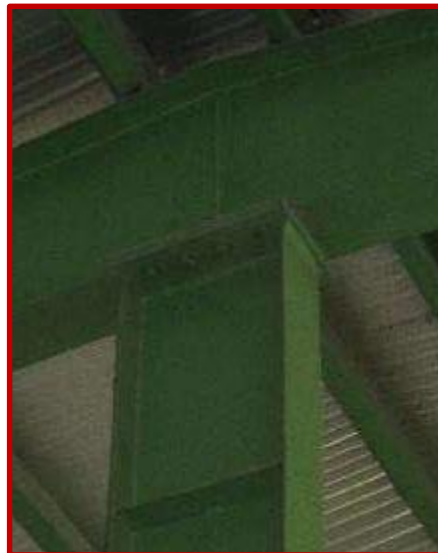
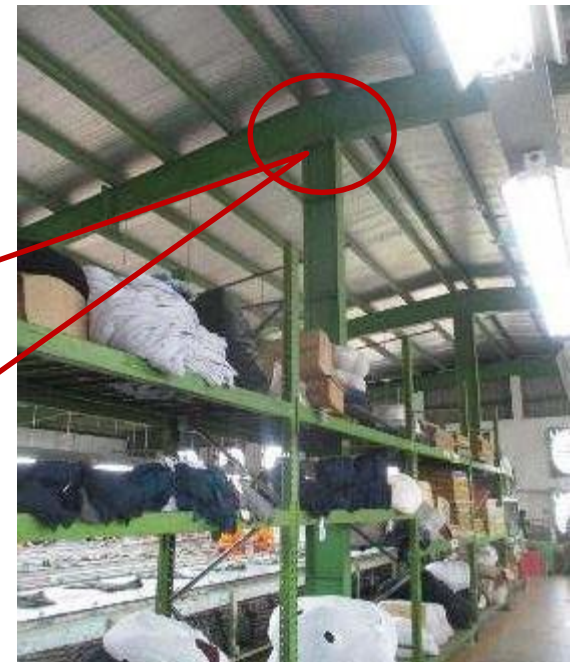
Missing bolts were found in column rafter joint.

| Item No. | Observation | Recommended Action Plan | Recommended Timeline |
|---|---|---|---|
| 04 | Missing bolt and loose connection on Part B (Shed-2: Screen Printing And Embroidery Unit) | Reinstated the missing bolts with appropriate ones according to the suggestion of factory engineer. | Immediate - Now |

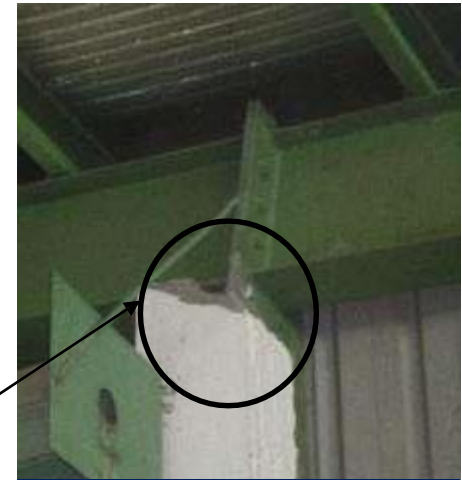
Column top broken at the joint of rafter at north end bay

On the end bay, some portion of the top of RCC column was found broken. The factory engineer is required to assess the capacity of the column and rafter against vertical and lateral load as rafter not properly rested on column.

| Item No. | Observation | Recommended Action Plan | Recommended Timeline |
|---|---|---|---|
| 05 | Distorted column at end bay on Part B (Shed-2: Screen Printing And Embroidery Unit) | The factory engineer is required to assess the capacity of the column and rafter against vertical and lateral load as rafter not properly rested on column. | 6-weeks |

| Item No. | Observation | Recommended Action Plan | Recommended Timeline |
|---|---|---|---|
| 06 | Distorted column at end bay on Part B (Shed-2: Screen Printing And Embroidery Unit) | Carry out remedial works resulting from engineering assessment if necessary. | 6-months |

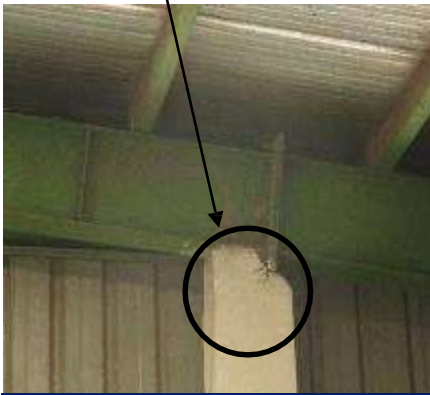
Column top broken at the joint of rafter at south end bay

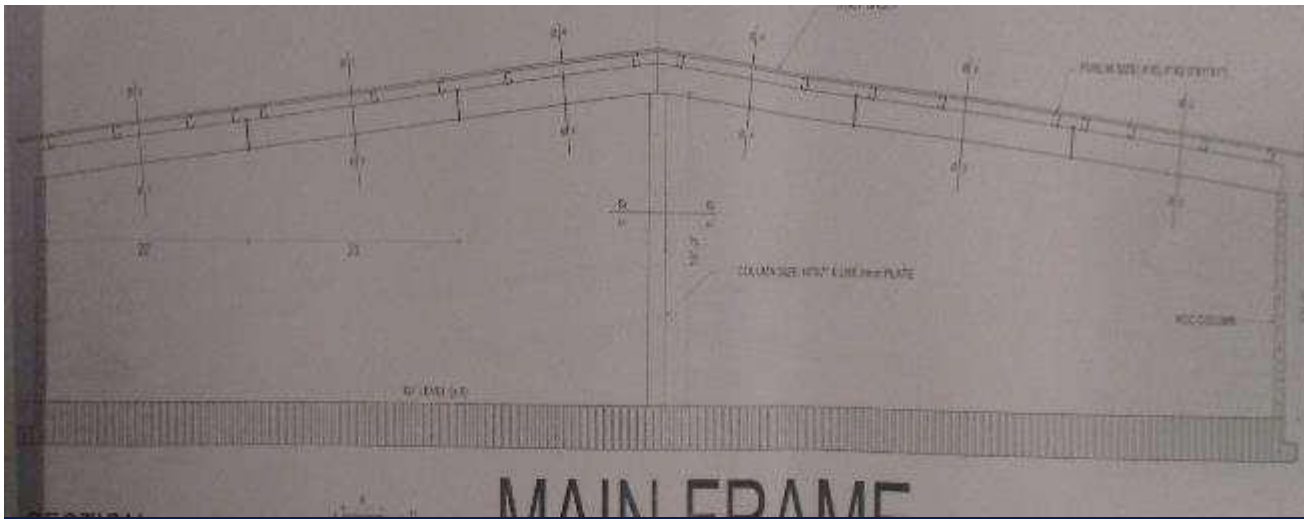
Main frame of part B

No joint detail was found in provided drawing. Factory engineer is required to update the as-built drawing.

| Item No. | Observation | Recommended Action Plan | Recommended Timeline |
|---|---|---|---|
| 09 | Missing information in as-built drawing (Shed-2: Screen Printing And Embroidery Unit) | Factory engineer to survey the whole building and produce as-built documentation reflecting the as constructed condition. | 6-weeks |

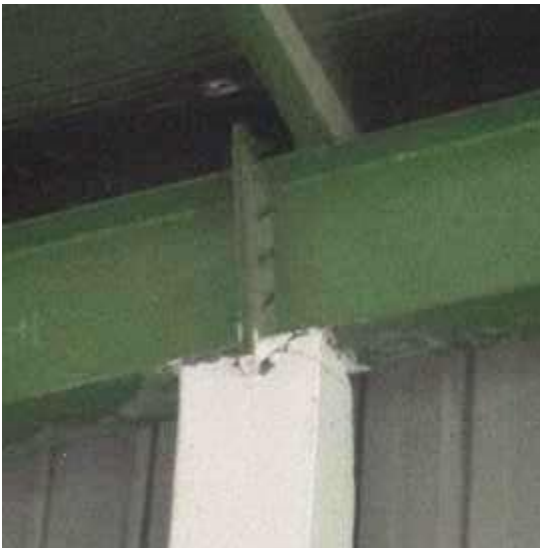
RC column and rafter joint on end bay

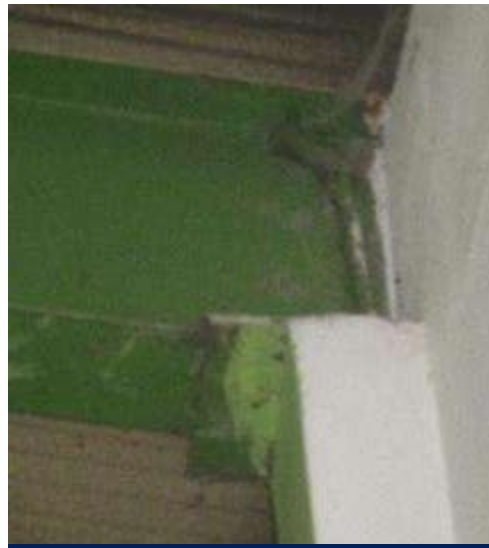
RC column and rafter joint on edge

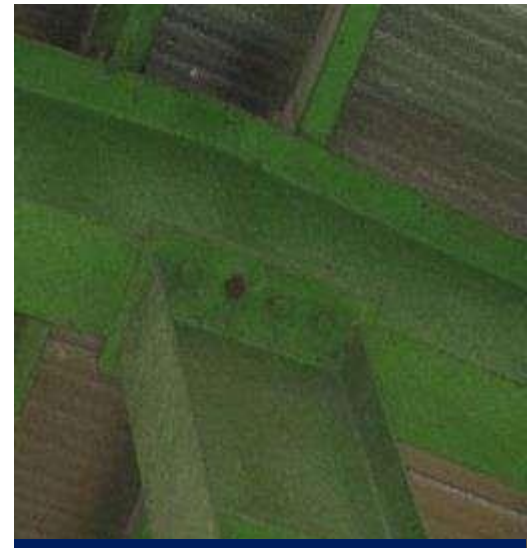
Steel column rafter joint at middle

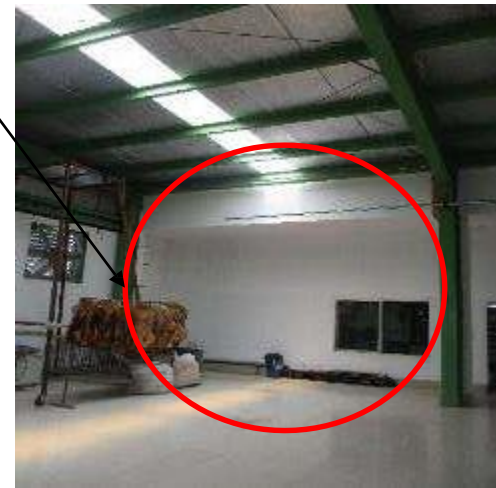
No vertical bracing was observed on east side

| Item No. | Observation | Recommended Action Plan | Recommended Timeline |
|---|---|---|---|
| 12 | Discrepancies between provided drawing and on site condition Shed-2: Printing And Embroidery-Extension) | Factory engineer to survey the whole building and produce as-built documentation reflecting the as constructed condition. | 6-weeks |

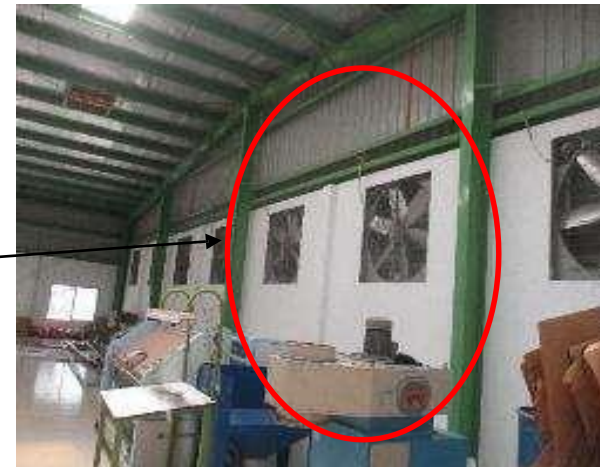
The location of vertical bracing was not matched with provided drawing.

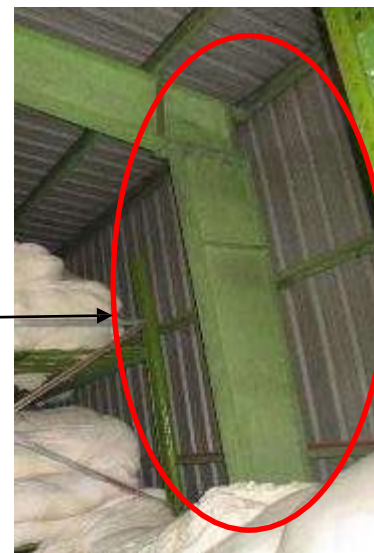
Edge columns were found tapered whereas in provided drawing, those column were shown as straight section.

| Item No. | Observation | Recommended Action Plan | Recommended Timeline |
|---|---|---|---|
| 18 | Discrepancies between provided drawing and on site condition (Shed-3 (Yarn And Grey Fabrics Warehouse) | Factory engineer to survey the whole building and produce as-built documentation reflecting the as constructed condition. | 6-weeks |
| 19 | Discrepancies between provided drawing and on site condition (Shed-3 (Yarn And Grey Fabrics Warehouse) | Factory engineer to check the stability of the steel shed under lateral and vertical loads. | 6-weeks |
| 20 | Discrepancies between provided drawing and on site condition (Shed-3 (Yarn And Grey Fabrics Warehouse) | Carry out remedial works resulting from engineering assessment if necessary. | 6-months |

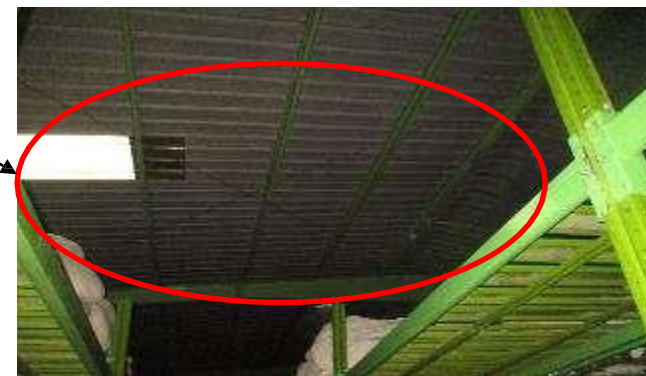
Roof bracing were found installed different location and not as per provided drawing.

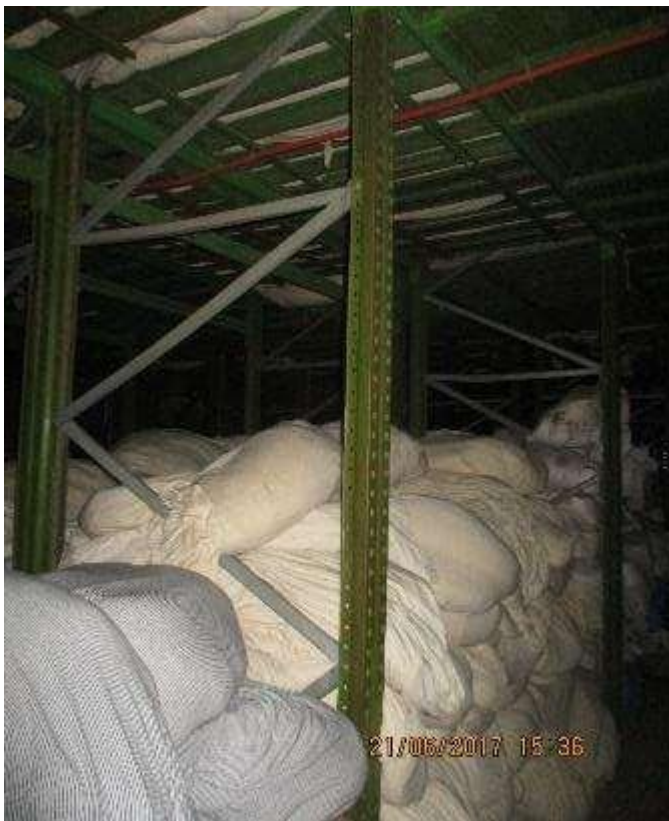
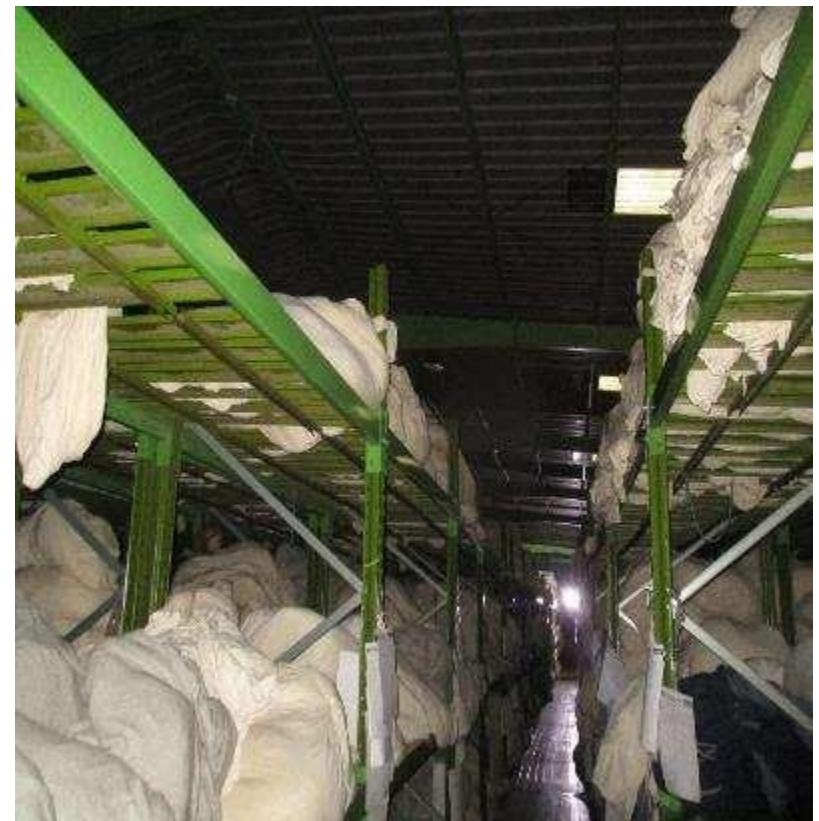
Customized steel racking system is used for storage with an upper platform over the entire area. A capacity check should be carried out.

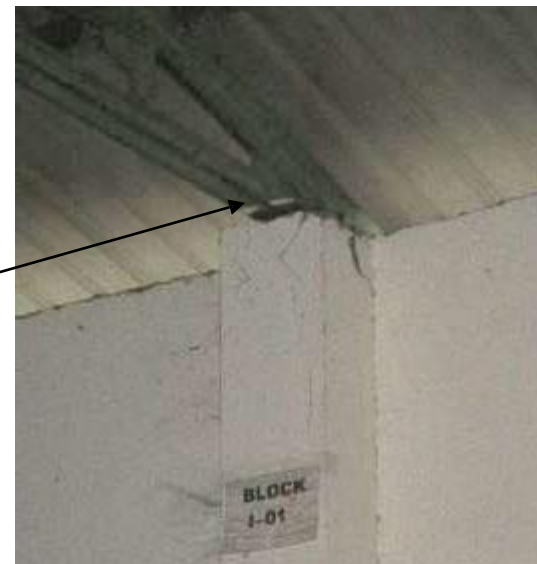
Edge of truss is supported by  
RCC column

Section of steel truss frame was not present in provided drawing. Also, no joint detail and column section was observed in the drawing. Factory is required to update as-built drawing and check the capacity against lateral and vertical load.

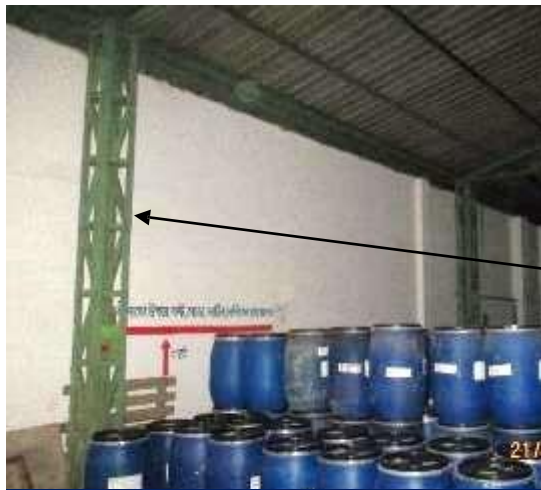
Truss is supported by steel lacing  
column

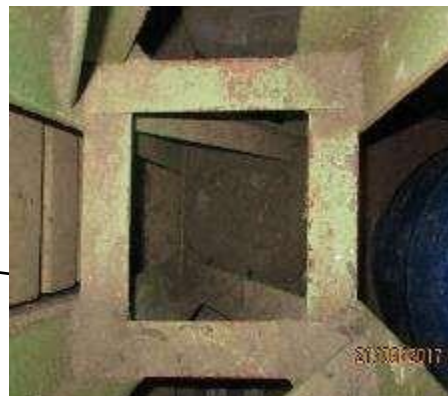
Cross section of steel  
column on site which is  
different than provided  
drawing

| Item No. | Observation | Recommended Action Plan | Recommended Timeline |
|---|---|---|---|
| 23 | Missing information in as-built drawing (Shed-4 (Knitting Process Unit And Chemical Warehouse)) | Factory engineer to survey the whole building and produce as-built documentation reflecting the as constructed condition. | 6-weeks |
| 24 | Missing information in as-built drawing (Shed-4 (Knitting Process Unit And Chemical Warehouse)) | Factory engineer to check the stability of the steel shed under lateral and vertical loads. | 6-weeks |
| 25 | Missing information in as-built drawing (Shed-4 (Knitting Process Unit And Chemical Warehouse)) | Carry out remedial works resulting from engineering assessment if necessary. | 6-months |

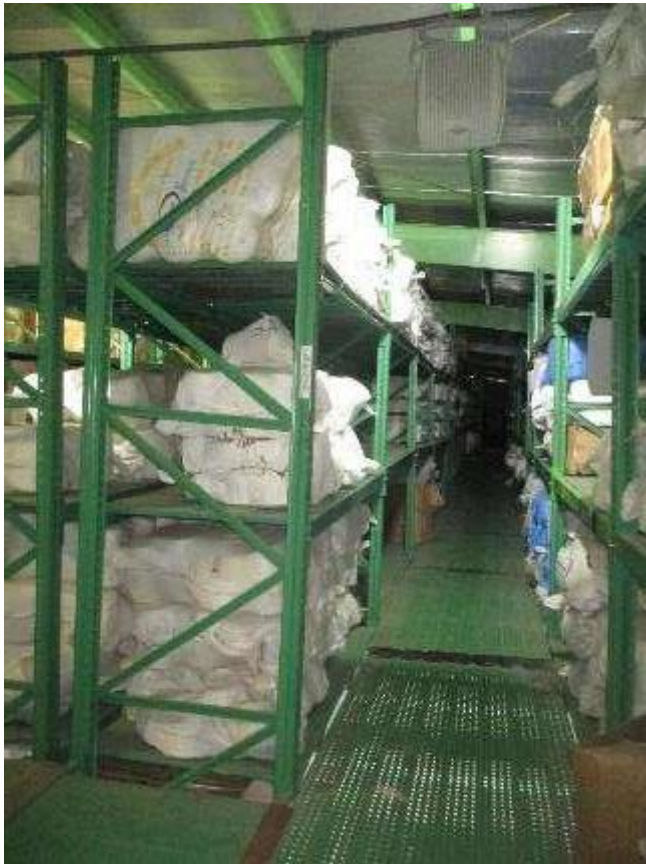
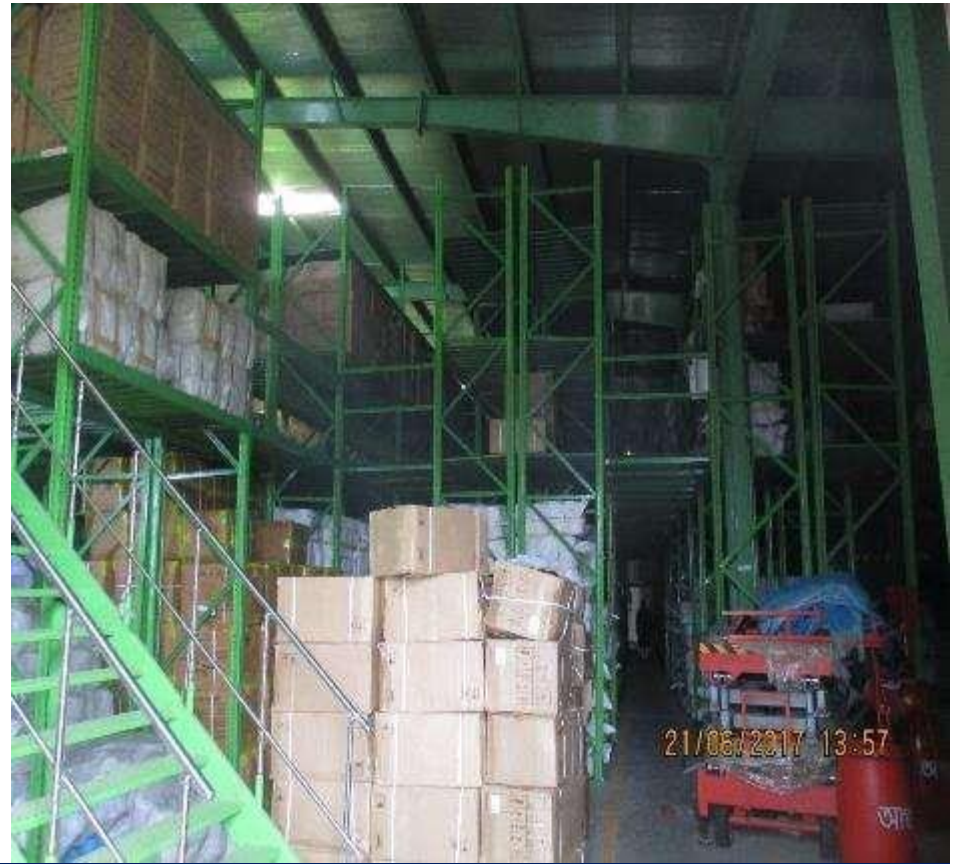
Customized steel racking system is used for storage with an upper platform over the entire area. There was no specific loading plan for the rack supported floors. A capacity check should be carried out for a specific live loading limit.

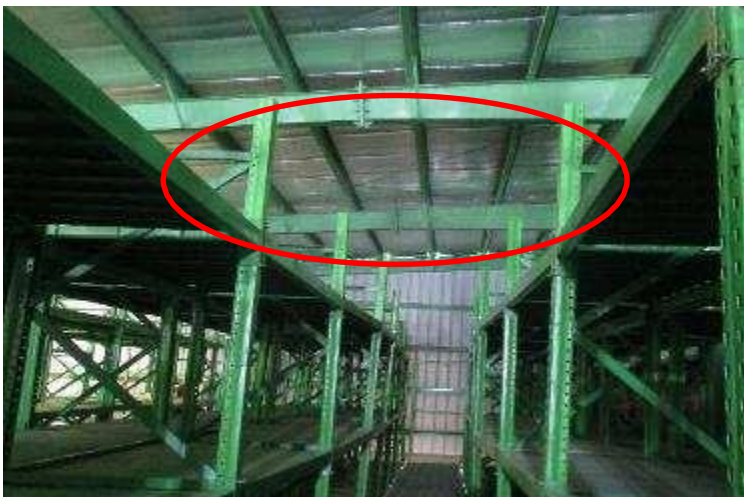
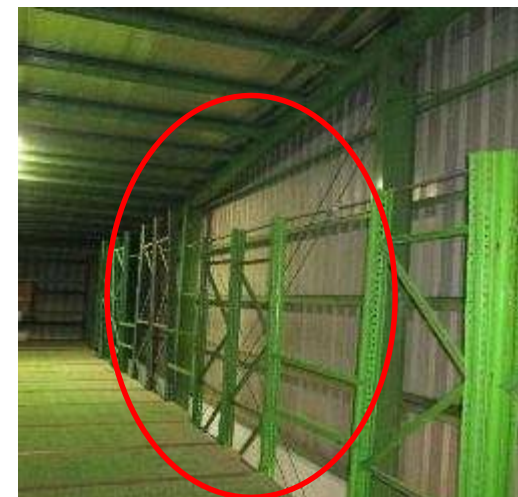
Most of the vertical and roof bracings had found loosely tied. The loose bracings are required to be tighten for acting as a part of stability system.

| Item No. | Observation | Recommended Action Plan | Recommended Timeline |
|---|---|---|---|
| 30 | Loose and missing bracing (Shed-10 (Warehouse-Yarn)) | Loose bracings are required to be tighten. | Immediate - Now |

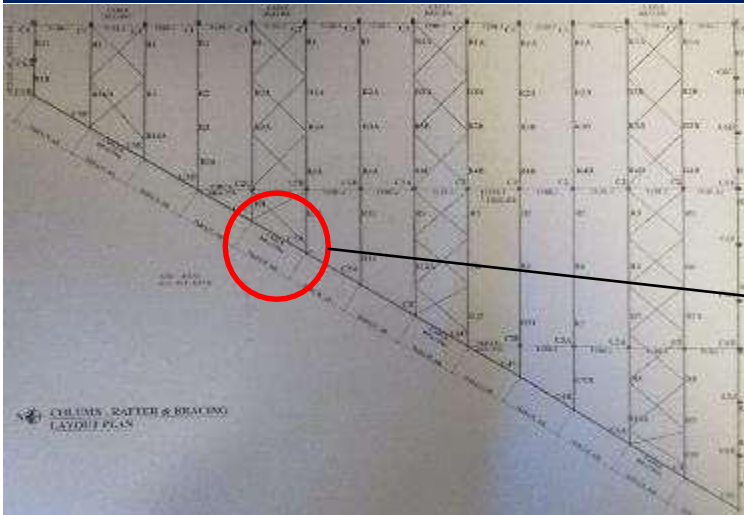
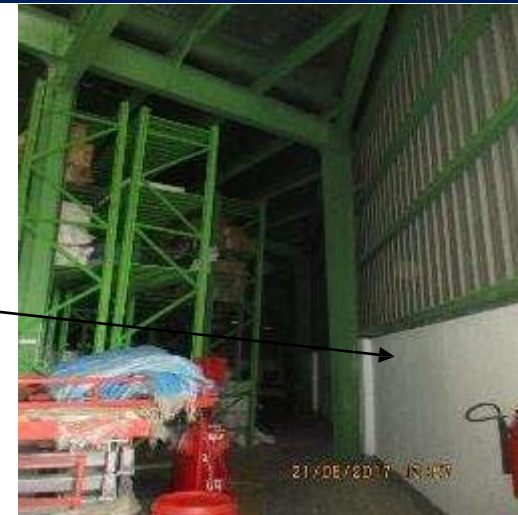
Vertical bracing was found missing in one location. Factory is required to install the bracing according to the drawing.

| Item No. | Observation | Recommended Action Plan | Recommended Timeline |
|---|---|---|---|
| 31 | Loose and missing bracing (Shed-10 (Warehouse-Yarn)) | Install the missing bracing according to drawing | 6-weeks |

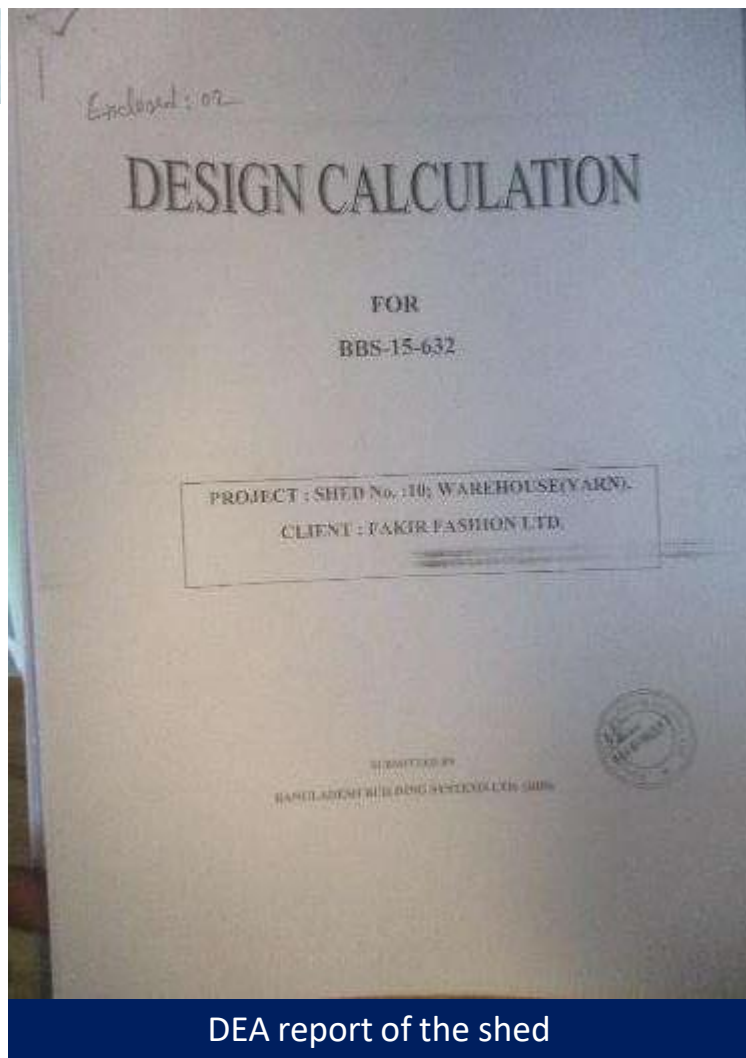
DEA report of the shed

According to the provided DEA report, considering mezzanine floor, the angle bracing and addition of stiffener with the main beam is recommended. But retrofitting drawing was not provided along with the report. For that, DEA report is required to review by ACCORD. Factory is required to revise the report according to earlier mentioned discrepancy and submit to ACCORD for further review.

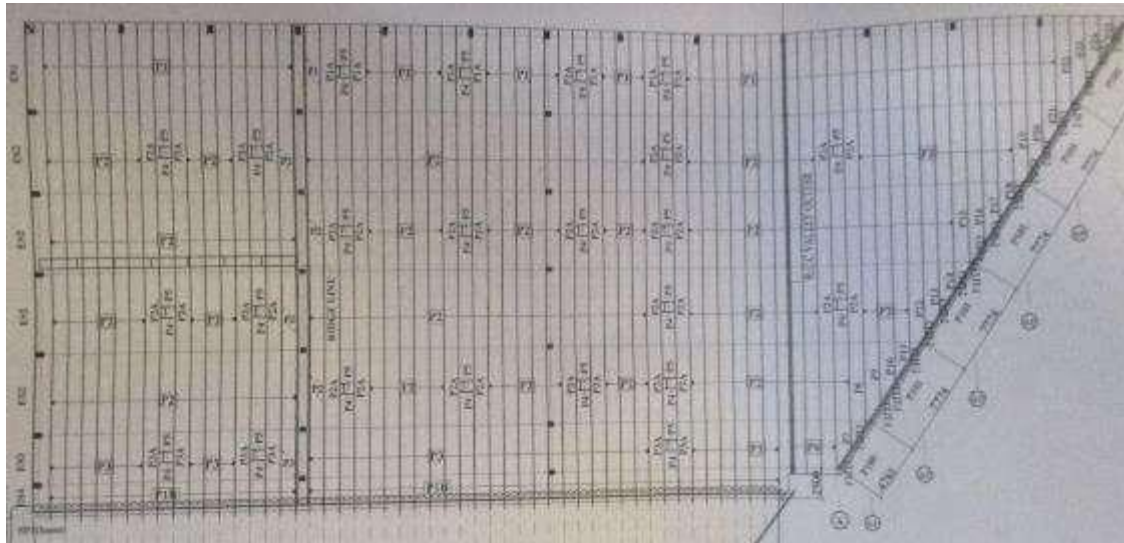
No bracing layout was found in the provided drawing

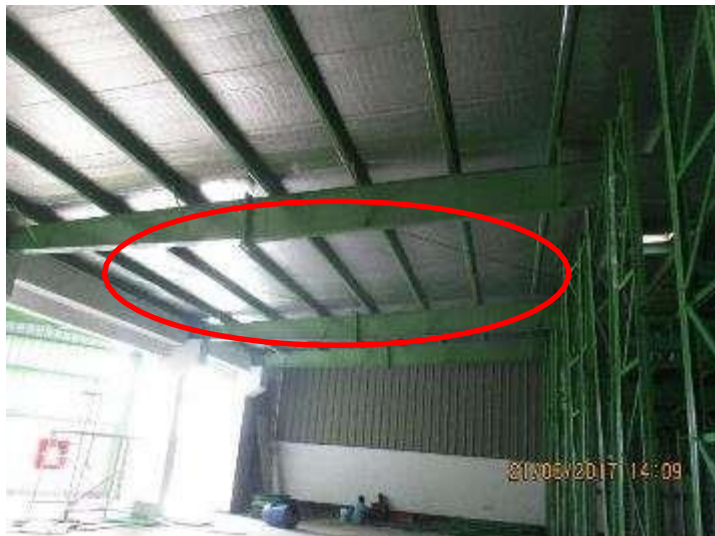
Roof bracing was observed on several location

Roof bracing was observed on site which were not present in provided drawing. Factory is required to update the drawing and check the stability against lateral loading.

| Item No. | Observation | Recommended Action Plan | Recommended Timeline |
|---|---|---|---|
| 34 | Discrepancies between provided drawing and on site condition (Shed-10 (Warehouse-Yarn Extension)) | Factory engineer to survey the whole building and produce as-built documentation reflecting the as constructed condition. | 6-weeks |
| 35 | Discrepancies between provided drawing and on site condition (Shed-10 (Warehouse-Yarn Extension)) | Factory engineer to check the stability of the steel shed under lateral and vertical loads. | 6-weeks |
| 36 | Discrepancies between provided drawing and on site condition (Shed-10 (Warehouse-Yarn Extension)) | Carry out remedial works resulting from engineering assessment if necessary. | 6-months |

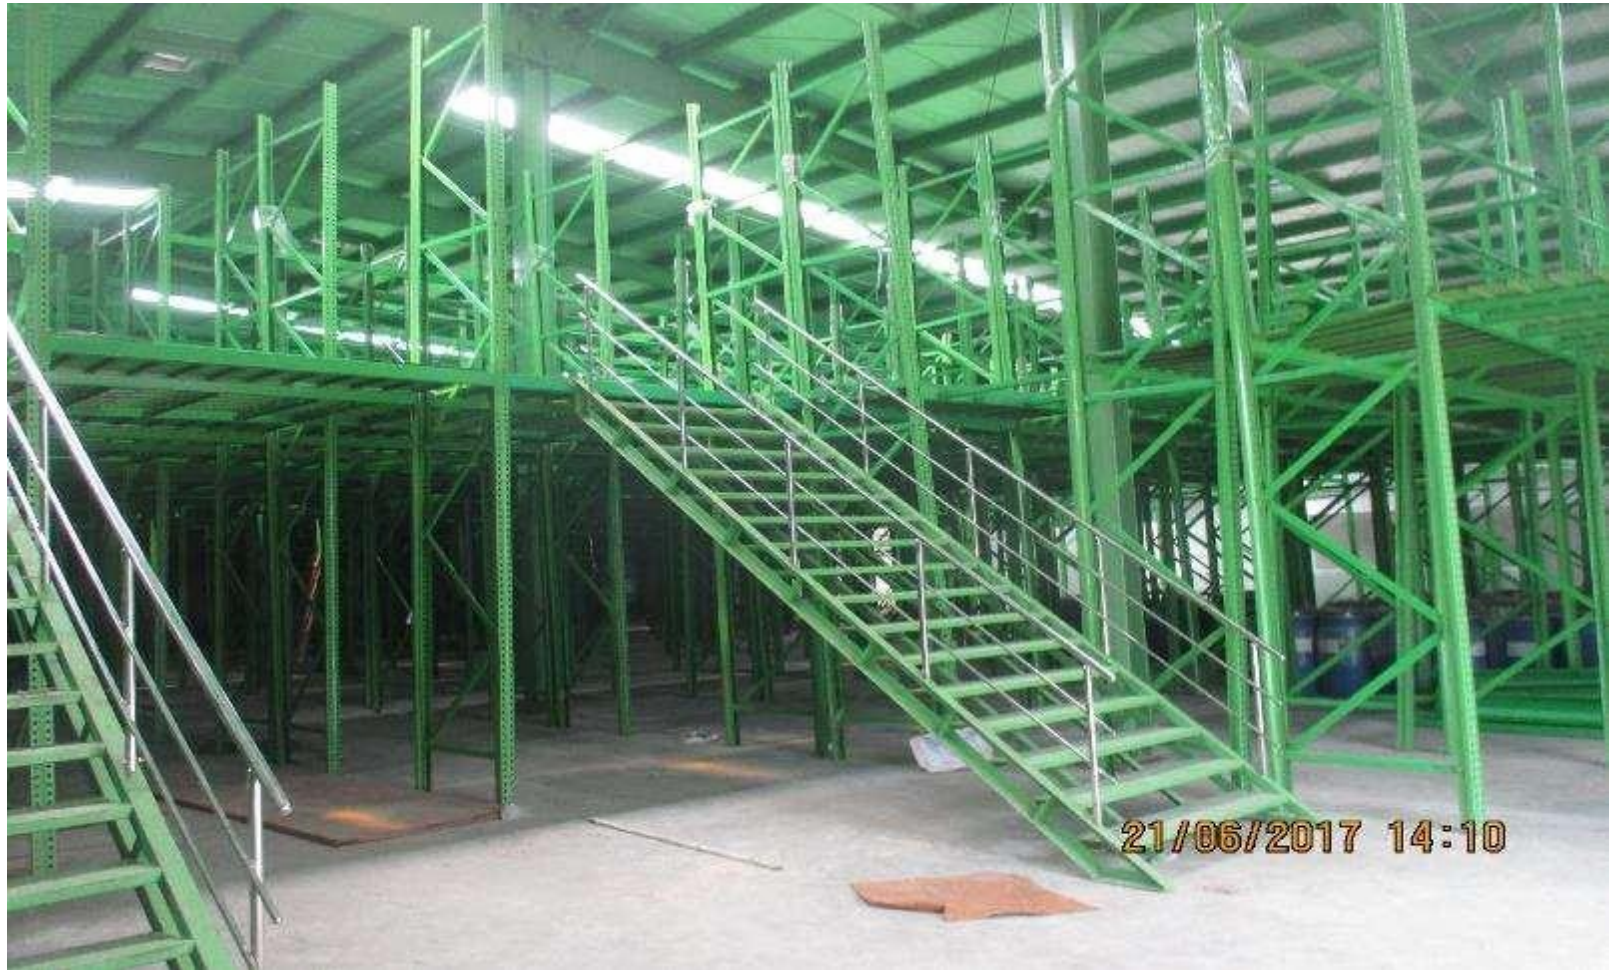
Customized steel racking system is used for storage with an upper platform over the entire area. There was no specific loading plan for the rack supported floors. A capacity check should be carried out for a specific live loading limit.

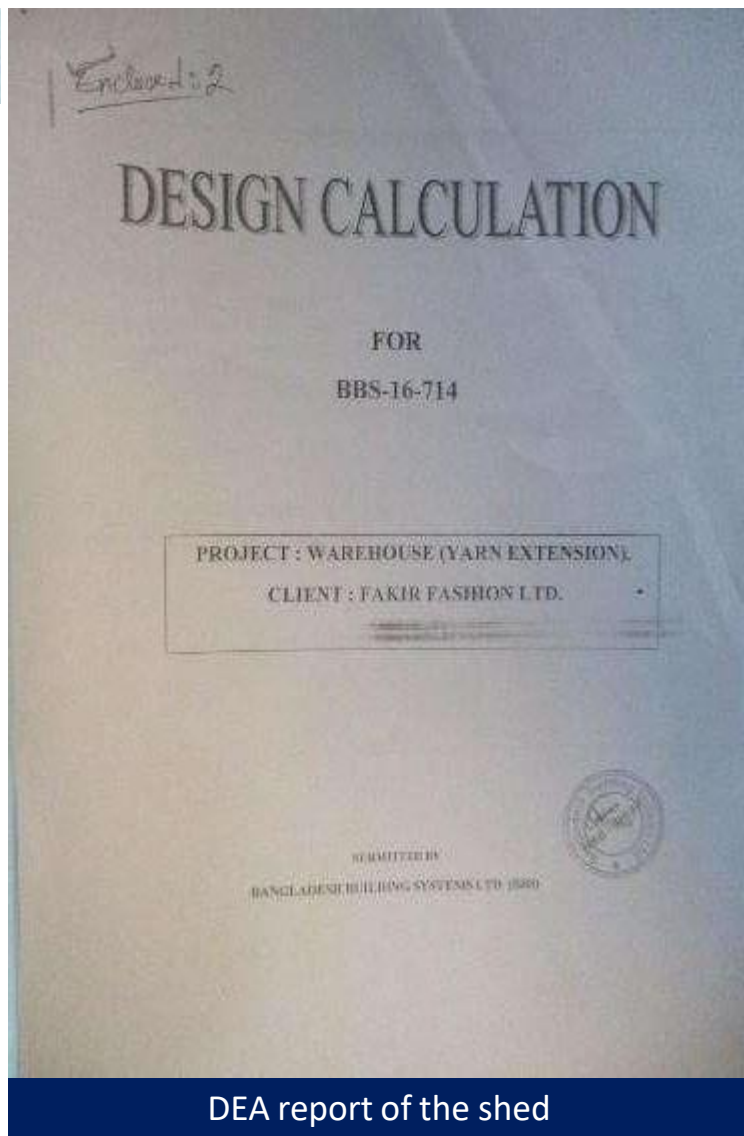
DEA report of the shed

According to the provided DEA report, considering mezzanine floor, the angle bracing and addition of stiffener with the main beam is recommended. But retrofitting drawing was not provided along with the report. For that, DEA report is required to review by ACCORD. Factory is required to revise the report according to earlier mentioned discrepancy and submit to ACCORD for further review.

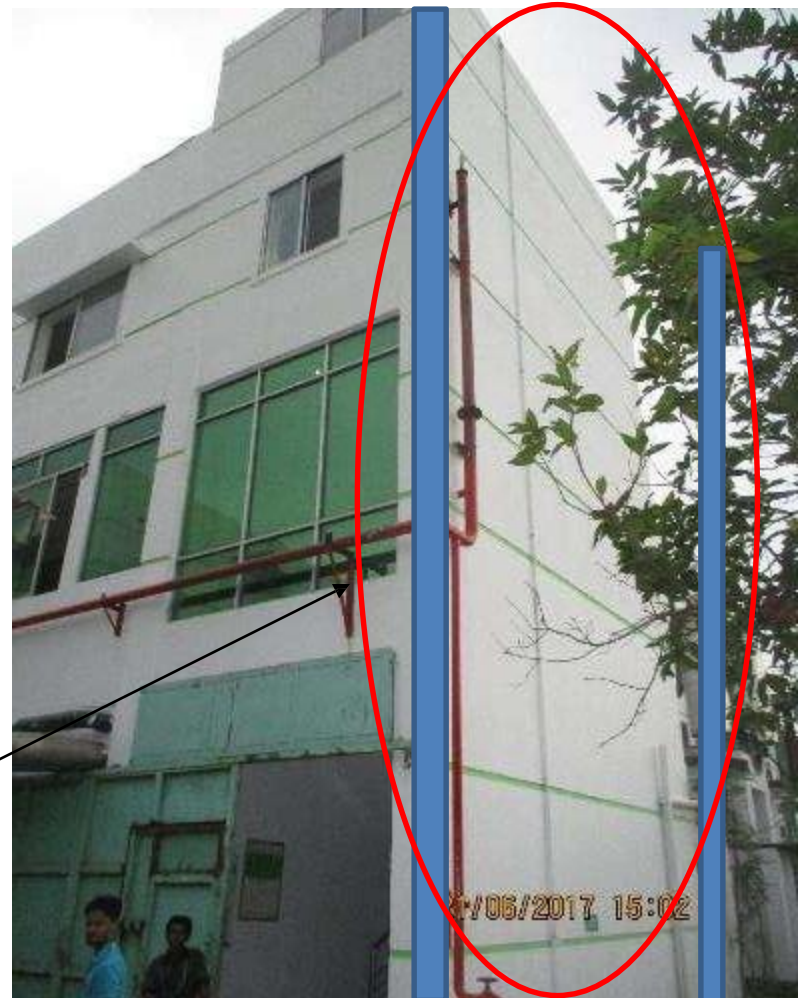
Two column of the south side stair case were not mention in provided drawing . Factory is required to update the as-built drawing

| Item No. | Observation | Recommended Action Plan | Recommended Timeline |
|---|---|---|---|
| 41 | Discrepancies between provided drawing and on site condition (Building-5 (Utility building)) | Factory engineer to survey the whole building and produce as-built documentation reflecting the as constructed condition. | 6-weeks |

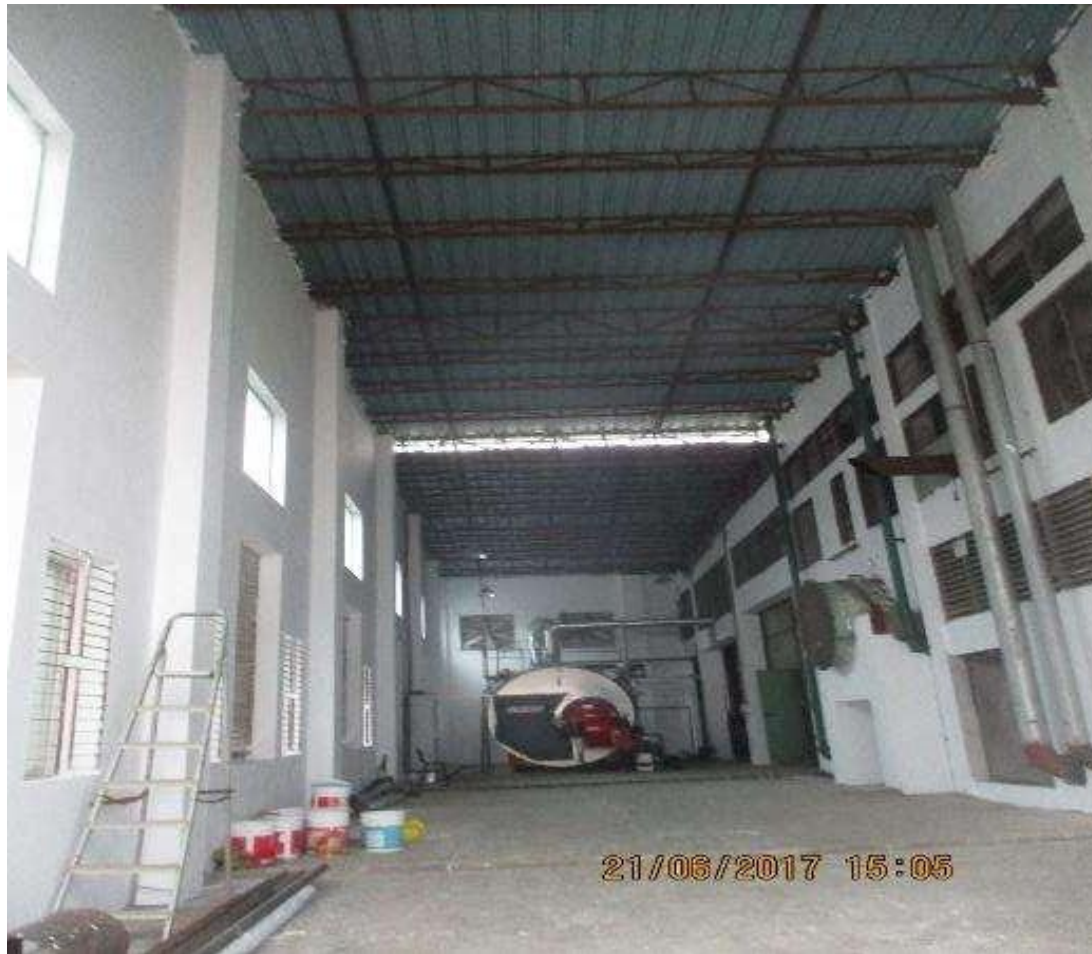
No as-built drawing was provided during inspection. Factory is required to produce as-built drawing for the building.

| Item No. | Observation | Recommended Action Plan | Recommended Timeline |
|---|---|---|---|
| 42 | Lack of as-built documentations (Utility: (Extended For Boiler And Generator)) | Factory engineer to survey the whole building and produce as-built documentation reflecting the as constructed condition. | 6-weeks |
