# Essential Clothing Ltd

24<sup>th</sup> October 2015

# Observations

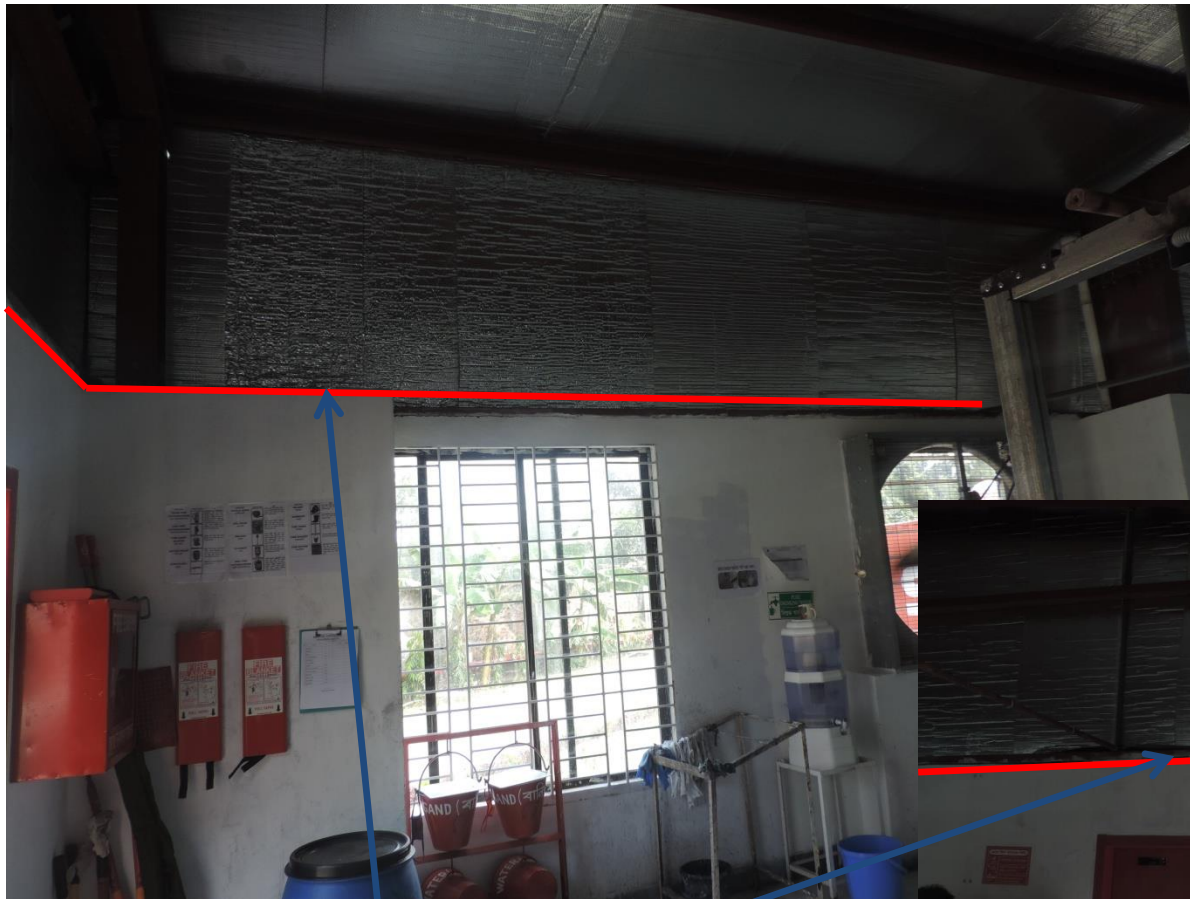
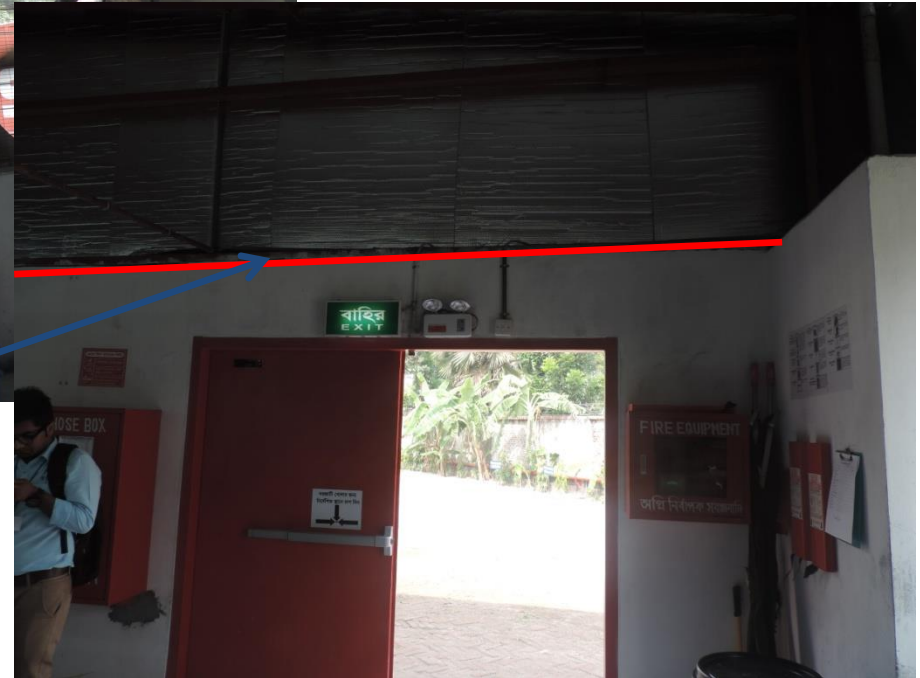
Lack of head restraint to external wall

**ITEM 1:** Lack of head restraint to external walls

| Item No. | Observation | Recommended Action Plan | Recommended Timeline |
|---|---|---|---|
| 1 | Lack of head restraint to external walls | Factory Engineer to review the design by calculation the external walls for wind loading, and the need or otherwise for head restraint to the top of the external masonry walls | 6-weeks |
| 2 | Lack of head restraint to external walls | Carry out any remedial works required from the above review. | 6-months |

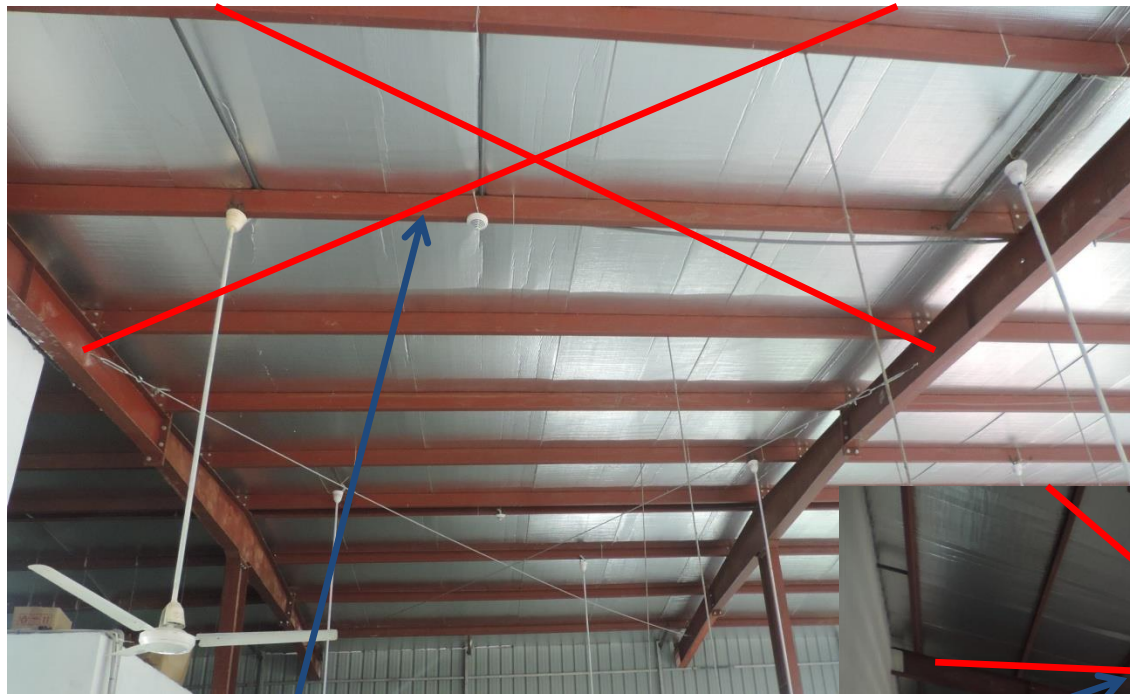
Missing roof bracing

**ITEM 2:** Missing roof bracing.

| Item No. | Observation | Recommended Action Plan | Recommended Timeline |
|---|---|---|---|
| 3 | Missing roof bracing | Engineer to review the roof bracing and its effectiveness to transfer horizontal loading and by calculation justify a suitable system | 6-weeks |
| 4 | Missing roof bracing | Implement all remedial works arising from the structural review | 6-months |

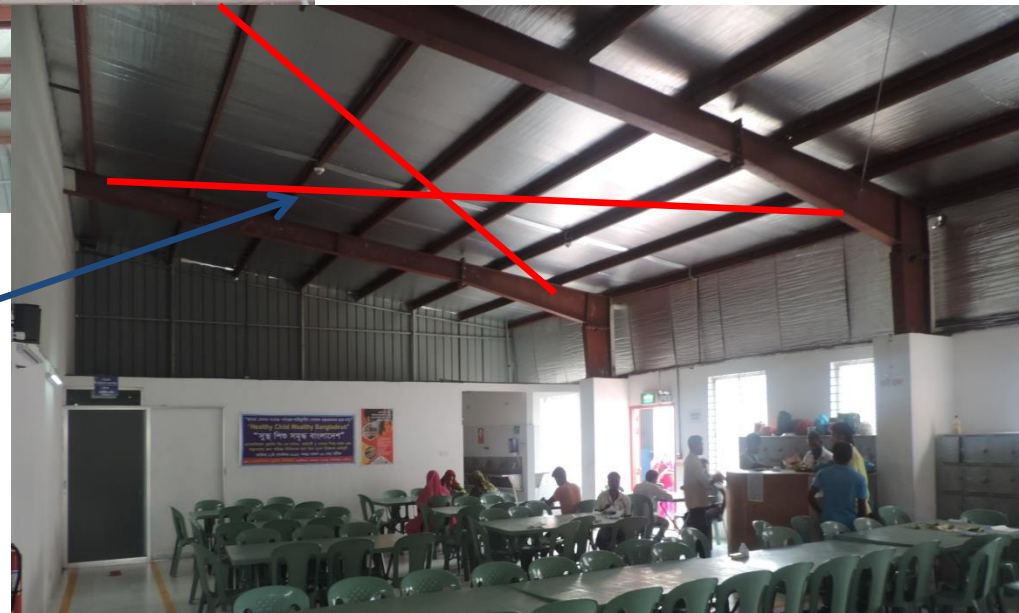
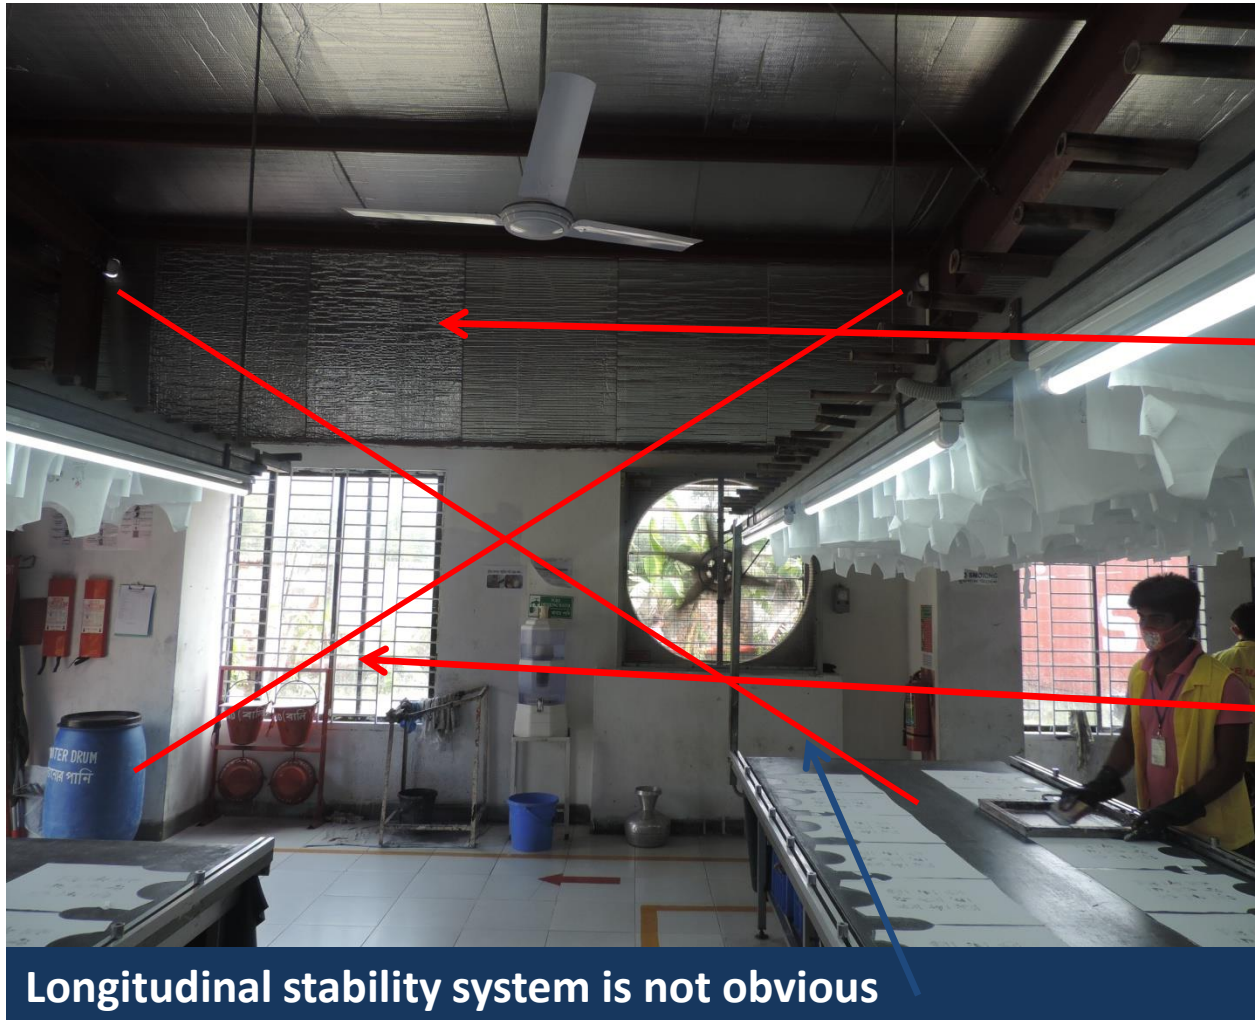
Steel facade sheeting

Large opening is external wall

Longitudinal stability system is not obvious

**ITEM 3:** Longitudinal stability system not obvious

| Item No. | Observation | Recommended Action Plan | Recommended Timeline |
|---|---|---|---|
| 5 | Longitudinal stability system not obvious | Engineer to review the longitudinal lateral system of the building and justify by calculation. | 6-weeks |
| 6 | Longitudinal stability system not obvious | Carry out any remedial actions from the above review. | 6-months |

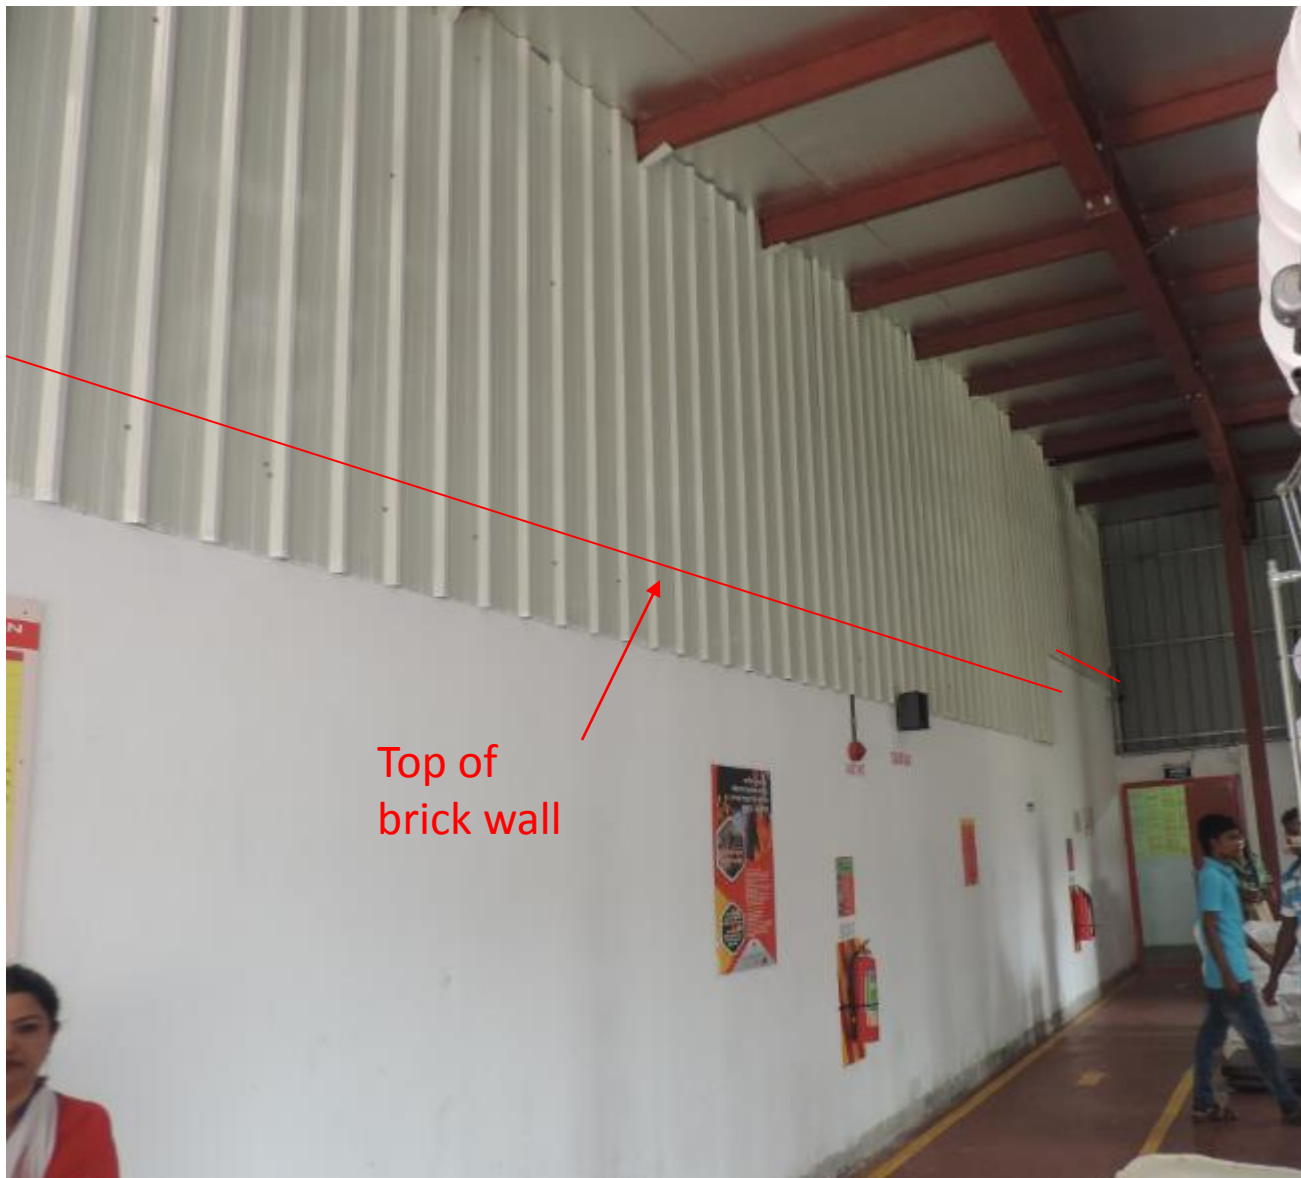
**Full height dividing wall appears non-engineered.**

**1000 litre water tank is placed directly on slab over toilet**

**ITEM 4:** Full height dividing wall appears non engineered

**ITEM 1:** 2000 litre tank on roof slab to toilets

| Item No. | Observation | Recommended Action Plan | Recommended Timeline |
|---|---|---|---|
| 7 | Full height dividing wall appears non engineered | The dividing wall comprises masonry wall half height and cladding for the upper height. Engineer to carry out review of the wall by calculation and design any strengthen works required | 6-weeks |
| 8 | Full height dividing wall appears non engineered | Carry out any stiffening works required from the above review | 6-months |

| Item No. | Observation | Recommended Action Plan | Recommended Timeline |
|---|---|---|---|
| 9 | 2000 litre tank on roof slab to toilets | Building Engineer to carry out a review and design calculations to verify that slab and columns have sufficient capacity to support the 2000 litres water tank over the toilets | 6-weeks |
| 10 | 2000 litre tank on roof slab to toilets | Carry out any actions arising from review. | 6-months |

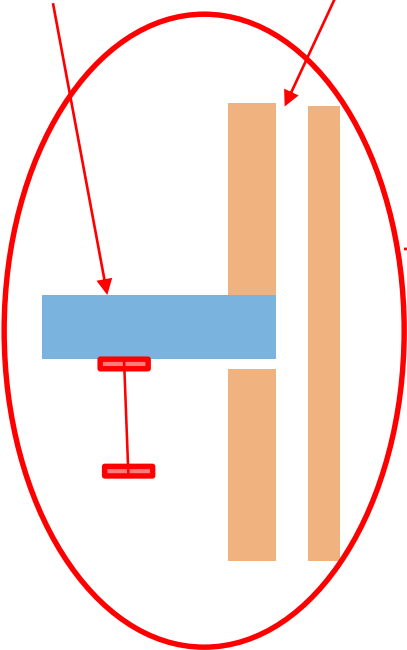
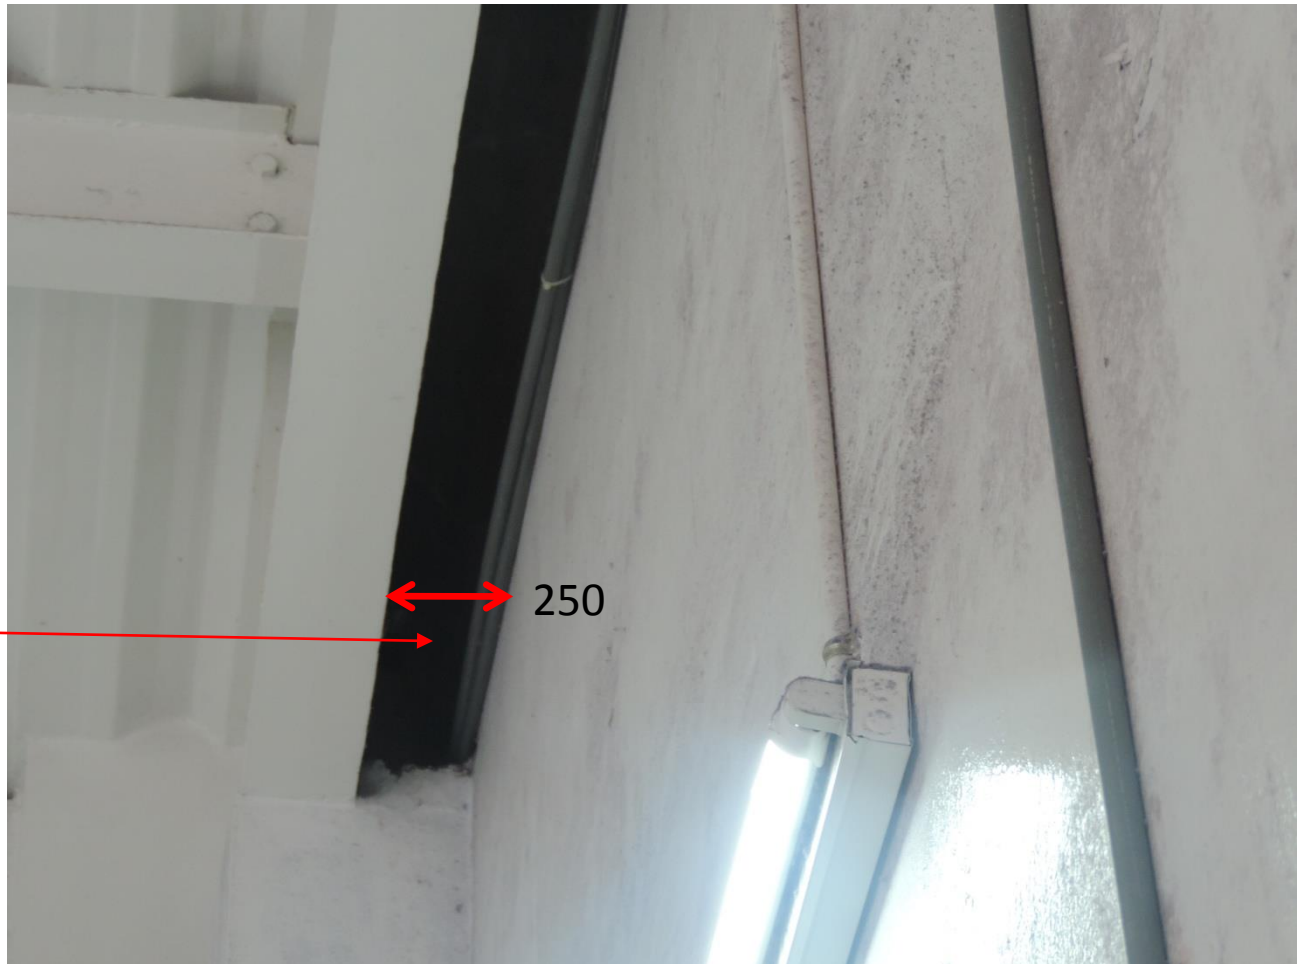
Front elevation inner leaf of external wall is supported on  
cantilever on 1st floor

High internal partition  
wall of 125 mm  
thickness (lateral  
stability a concern)

**ITEM 3:** Front elevation: inner leaf of external wall supported off cantilever 1<sup>st</sup> floor slab

**ITEM 4:** High internal partition wall (lateral stability)

| Item No. | Observation | Recommended Action Plan | Recommended Timeline |
|---|---|---|---|
| 13 | Front elevation: inner leaf of external wall supported of cantilever 1st floor slab | Building Engineer to review by design calculations 1st floor slab capacity to carry the external front wall on the cantilever. | 6-weeks |
| 14 | Front elevation: inner leaf of external wall supported of cantilever 1st floor slab | Carry out remedial actions if required from above review. | 6-months |
| 15 | High internal partition wall (lateral stability) | The dividing wall comprises masonry wall 125 full height Engineer to carry out review of the wall and its ability to resist lateral pressure by calculation and design any strengthen works required | 6-weeks |
| 16 | High internal partition wall (lateral stability) | Carry out remedial works if required by above study | 6-months |

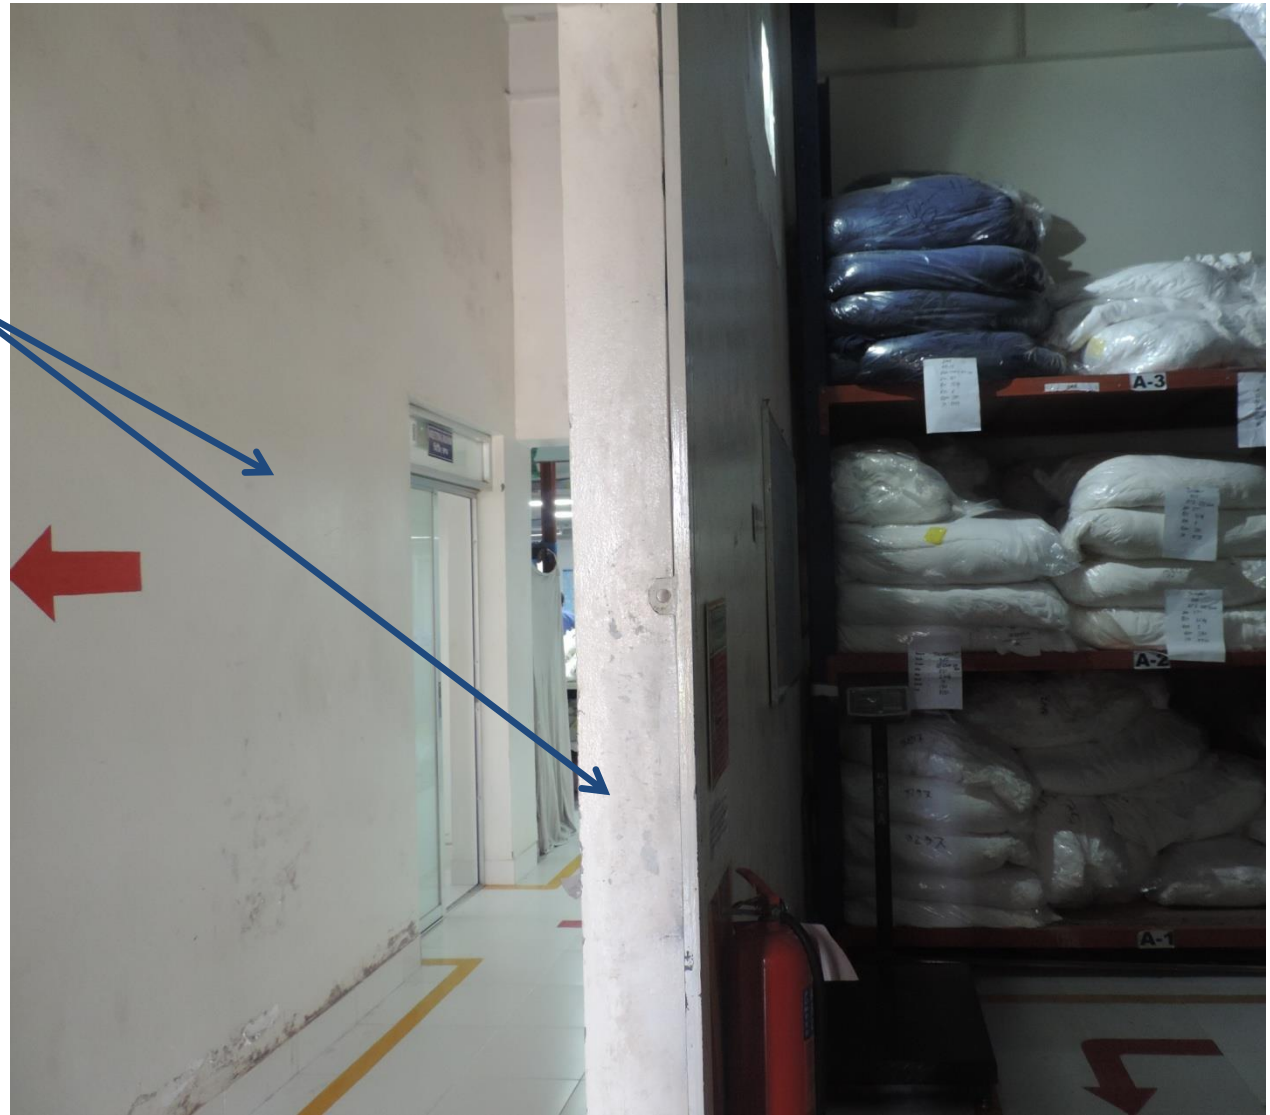
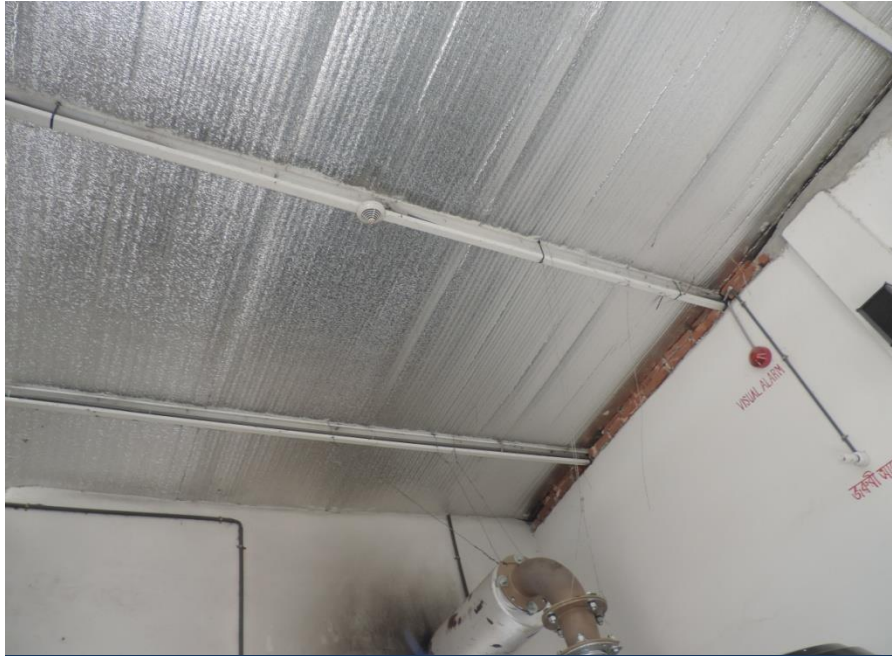
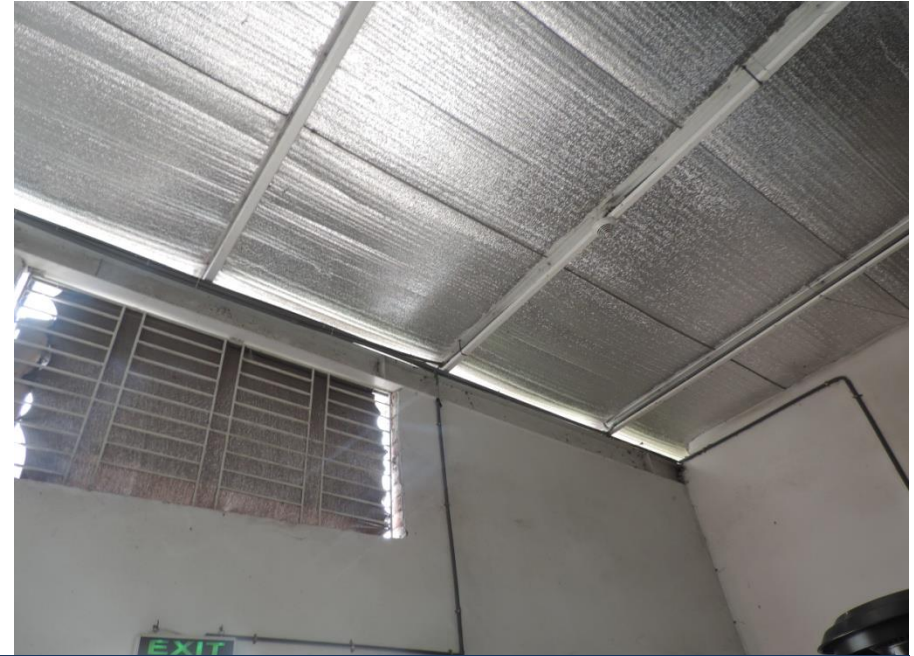
No lateral roof bracing system is observed

**ITEM 1:** Lack of lateral roof bracing

| Item No. | Observation | Recommended Action Plan | Recommended Timeline |
|---|---|---|---|
| 17 | Lack of lateral roof bracing | Engineer to review the roof structure and its effectiveness to transfer horizontal loading and by calculation justify a suitable system | <b>6-weeks</b> |
| 18 | Lack of lateral roof bracing | Carry out works as required from above review | <b>6-months</b> |

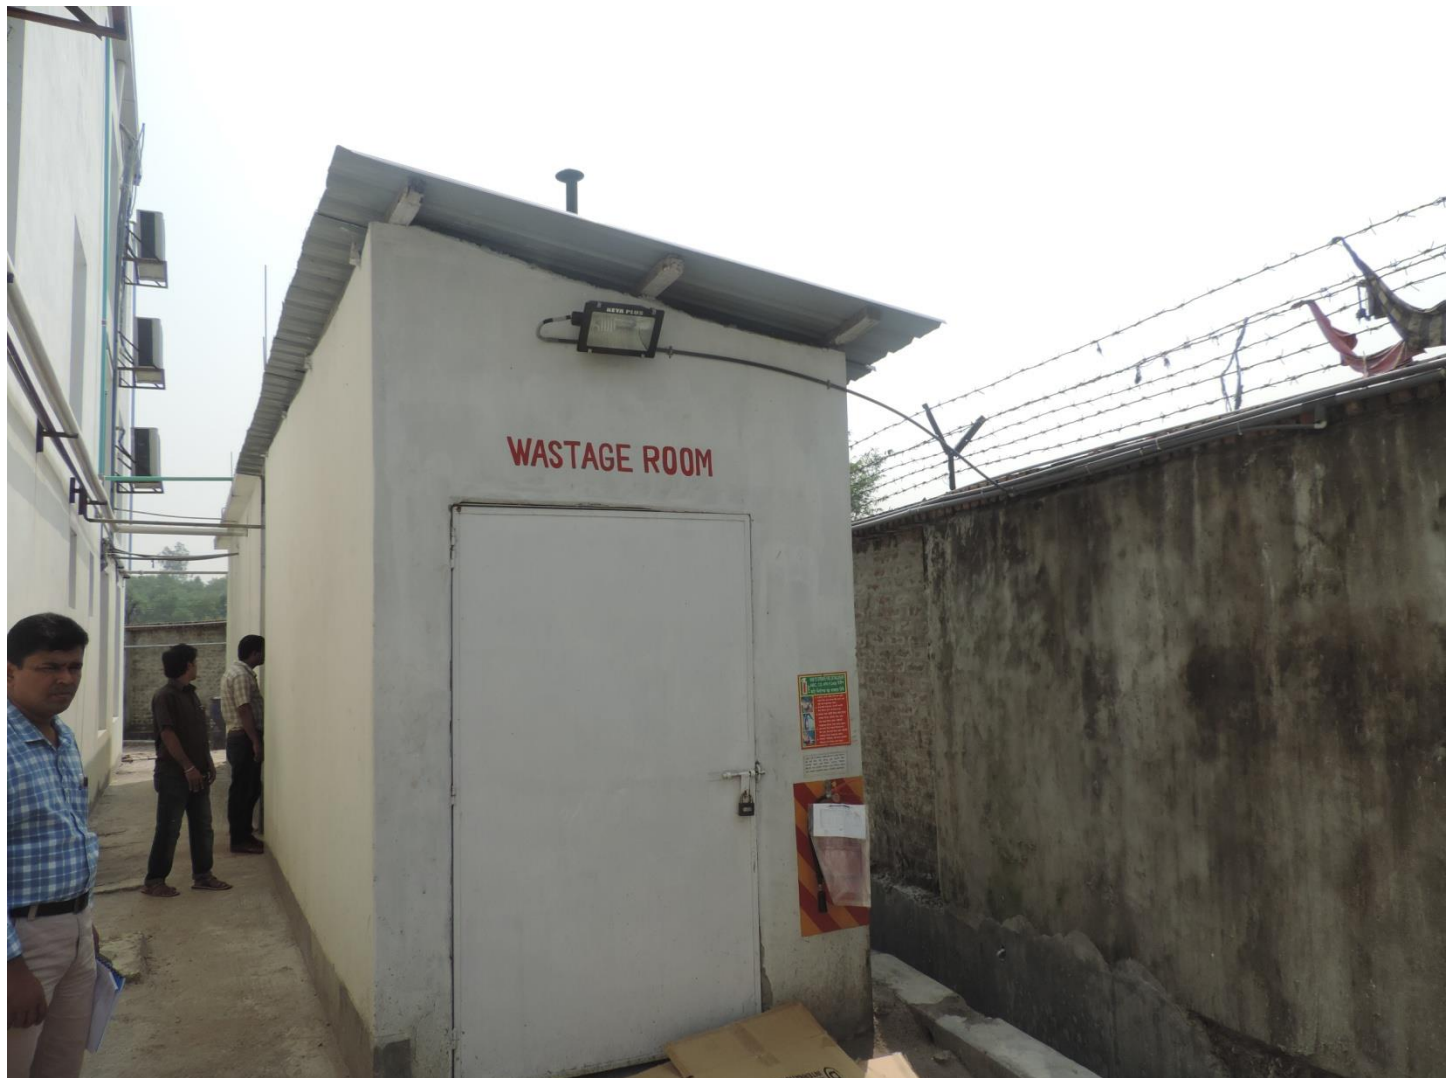
**Non engineered roof**

**ITEM 1:** Non-Engineered Roof

| Item No. | Observation | Recommended Action Plan | Recommended Timeline |
|---|---|---|---|
| 19 | Non-Engineered Roof | Engineer to review by calculation the roof structure to conform to the local building codes | 6-weeks |
| 20 | Non-Engineered Roof | Carry out works as required from above review | 6-months |

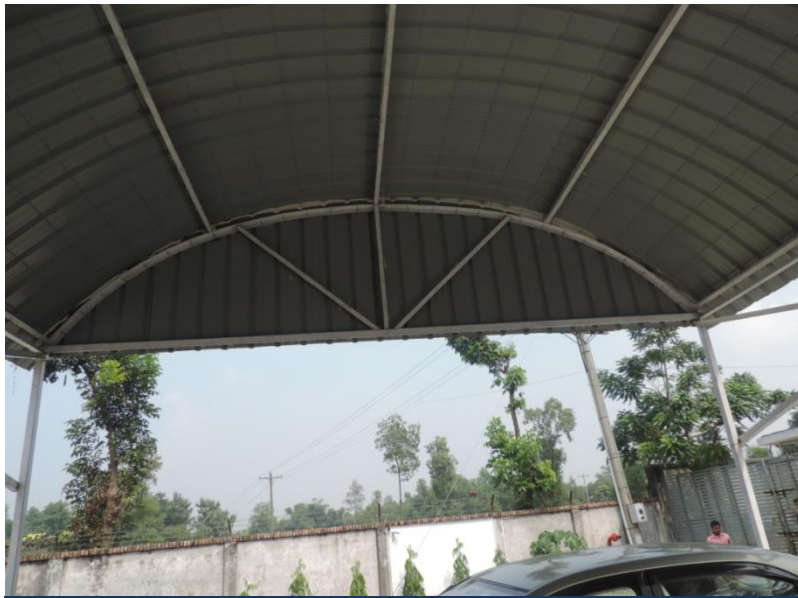
**Non engineered structure**

**ITEM 1:** Non-Engineered structure

| Item No. | Observation | Recommended Action Plan | Recommended Timeline |
|---|---|---|---|
| 21 | Non-Engineered structure | Engineer to review the structure by calculation and propose alterations as required. | 6-weeks |
| 22 | Non-Engineered structure | Carry out works as required from above review | 6-months |

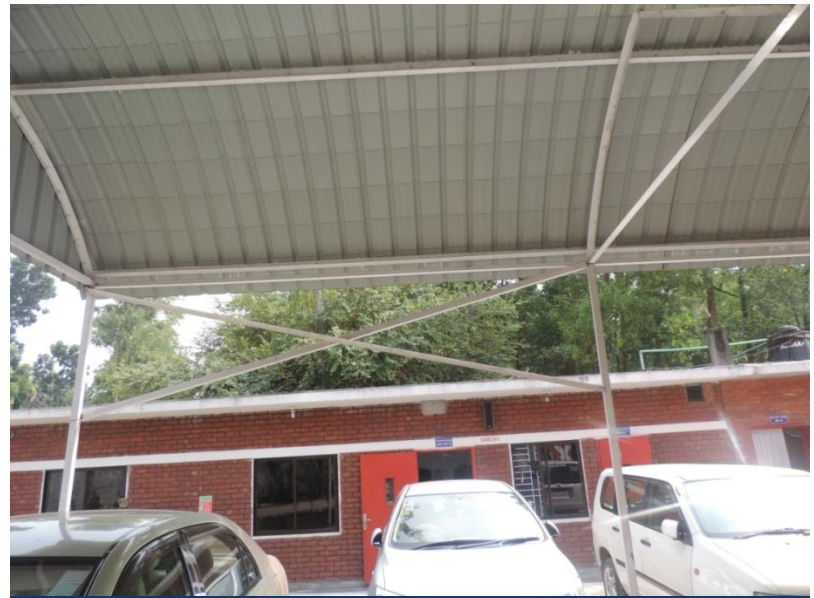
**Non engineered structure**

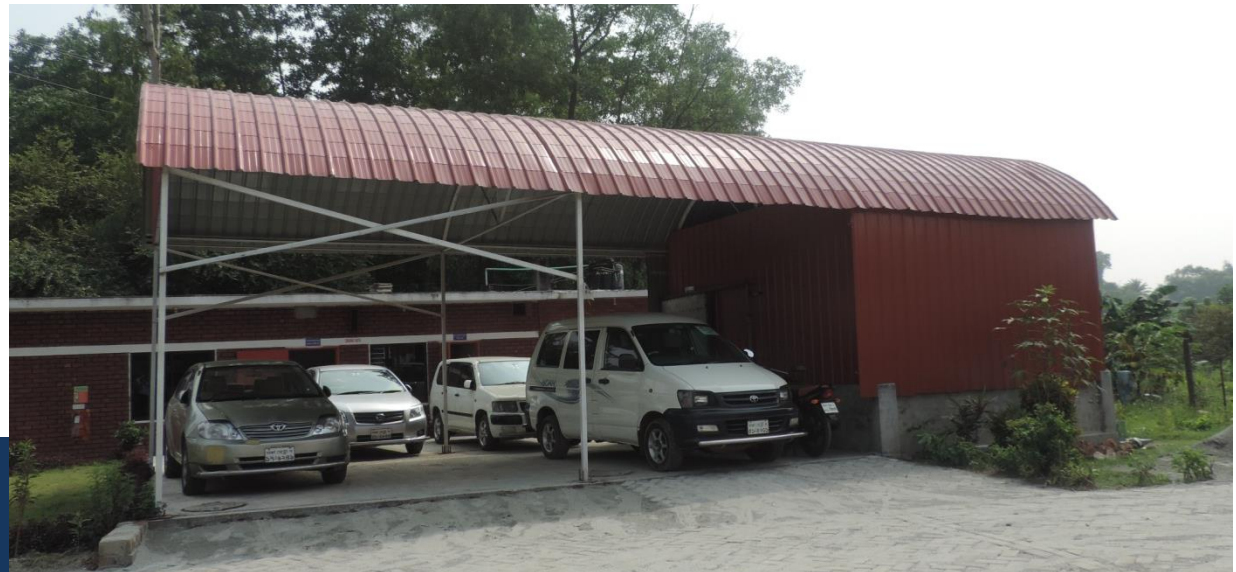
**Structure is open to impact by cars**

**ITEM 2:** Structure open to impact by vehicles

| Item No. | Observation | Recommended Action Plan | Recommended Timeline |
|---|---|---|---|
| 23 | Structure open to impact by vehicles | Engineer to review the possibility and consequence of the columns being impacted by a vehicle. | 6-weeks |
| 24 | Structure open to impact by vehicles | Carry out works as required from above Review | 6-months |
