Topway Industries Limited

Plot no: 19-20, sector: 04, CEPZ, Chattogram, Bangladesh.

27 September 2023

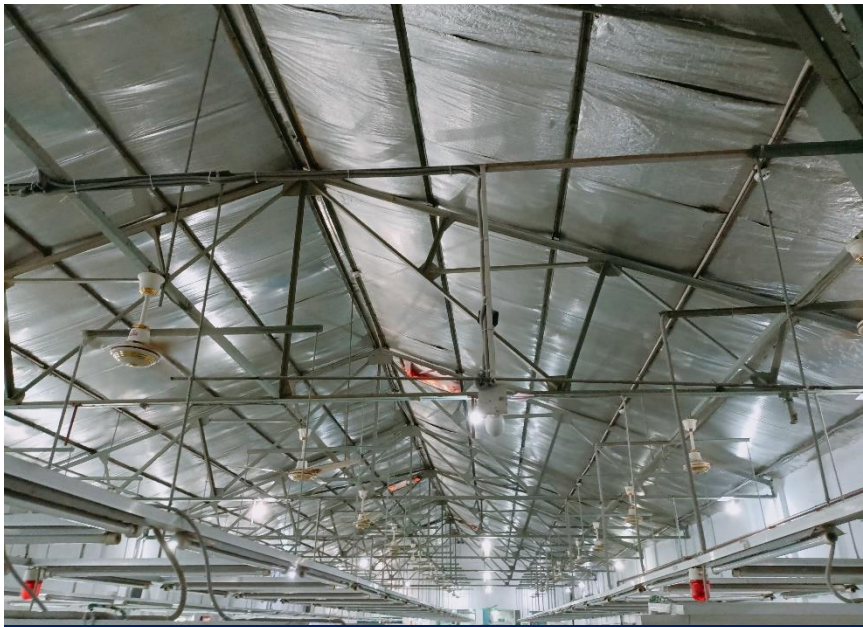
Typical truss frame without bracing

Lack of lateral stability system

Load transfer media is not provided along long direction for this shed. Therefore, lateral stability system of the shed is apparently incomplete. The building engineer is required to check the stability system of the existing structure.

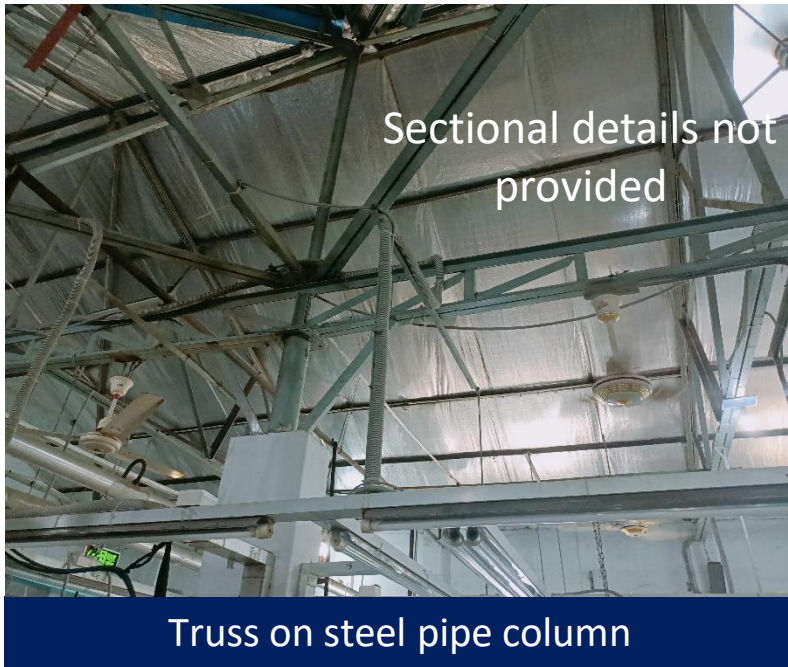
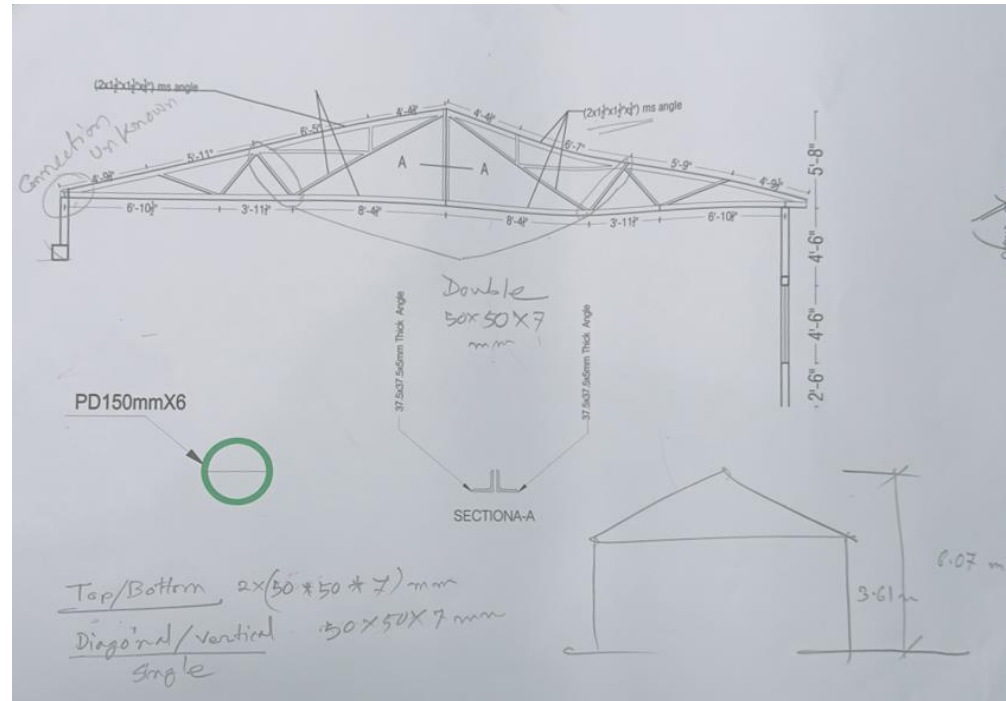
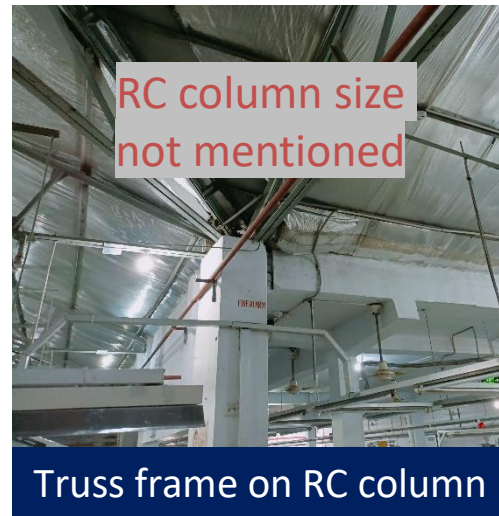
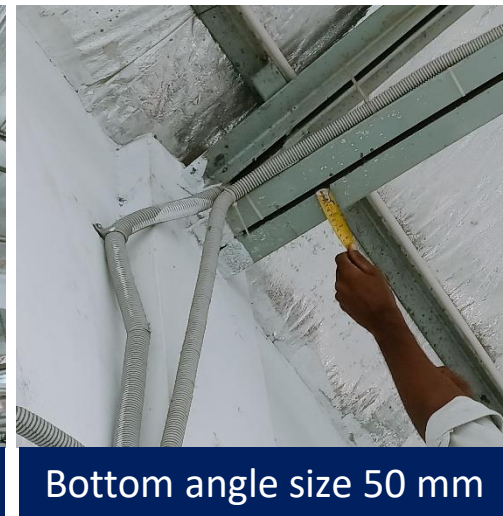
Paucity in as-built drawing

Bottom & top member of truss was found 50 mm instead of 38mm. Also, RC column size, connection details and all section details were not found in the provided drawings. Building engineer is required to revised the abovementioned information and incorporate the details in the as-built drawing.

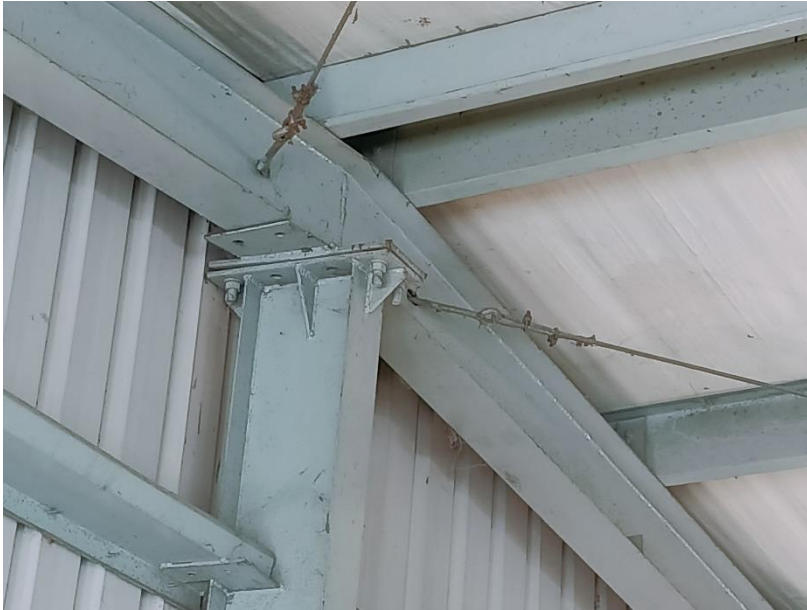
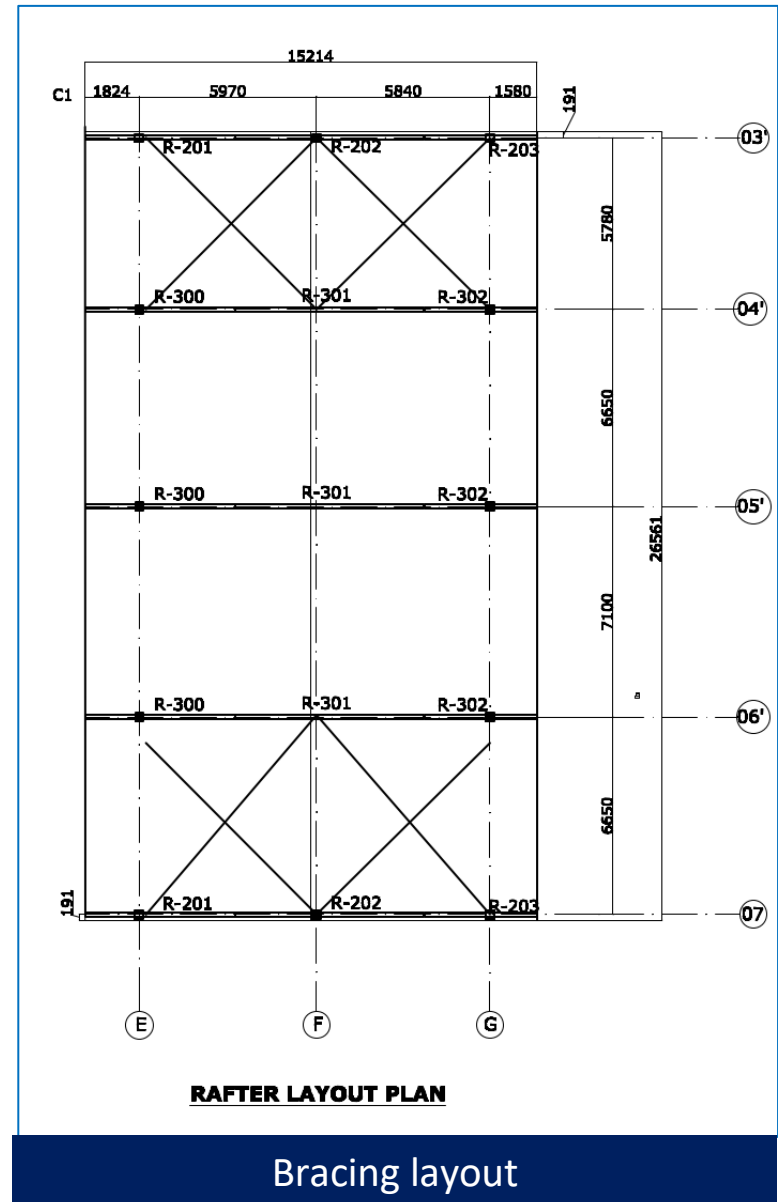
Lateral stability system required review

No compression strut was found along the long direction. Also, bracings were found missing as per drawings. So lateral stability in the long direction is incomplete. The building engineer is required to check the stability system of the existing structure.

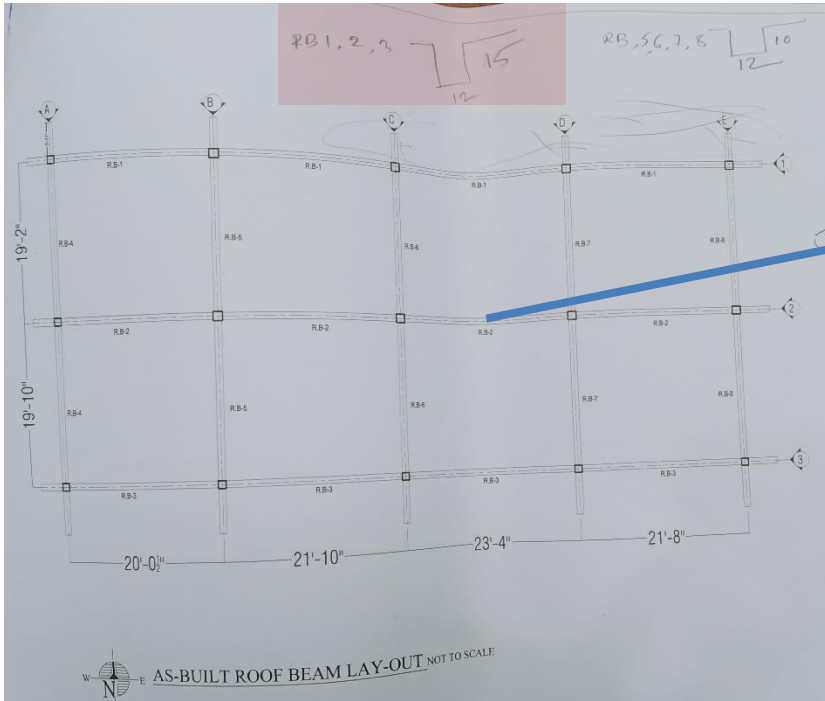
Beam Layout Plan

Discrepancies in as-built drawing

Longitudinal beam down stand was found 375 mm instead of 250 mm. Also slab and cantilever beam layout did not match fully with as built condition. Building engineer is required to survey the structure and prepare accurate as-built drawings.

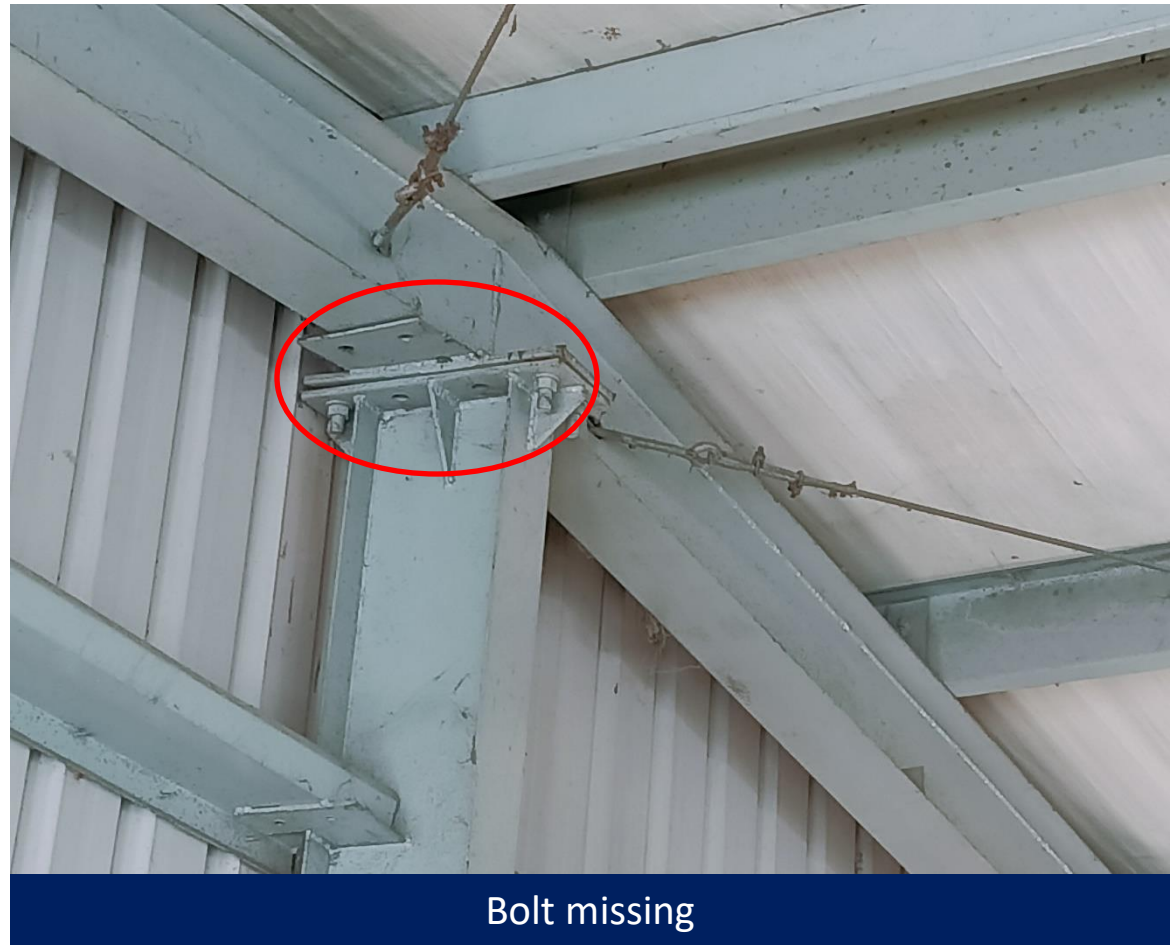
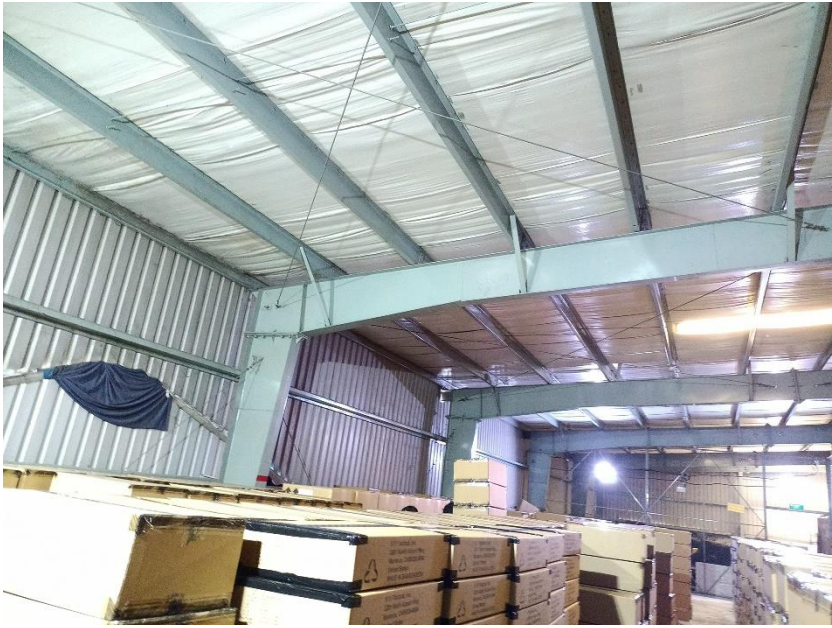
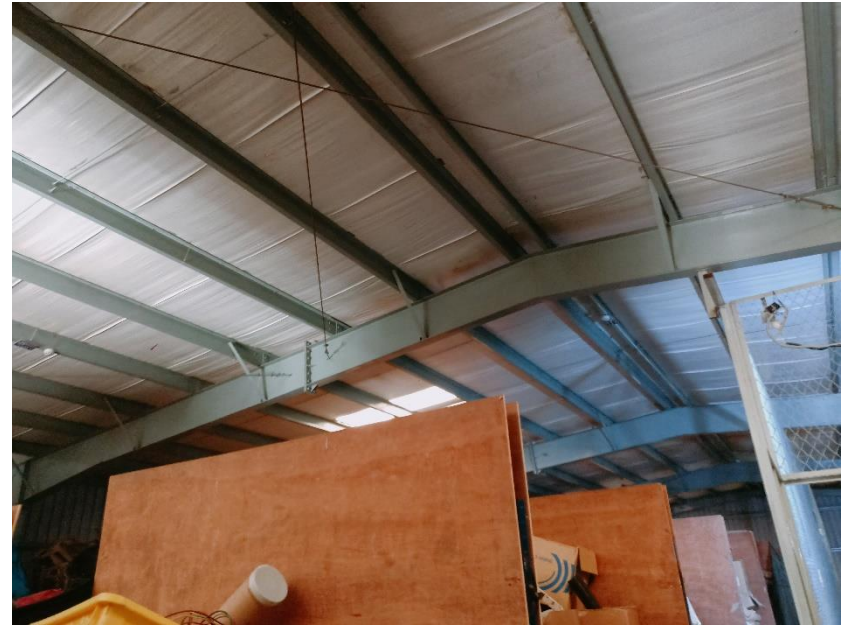
Incomplete lateral stability system

No compression strut was found along the long direction. Only cable bracings were found provided. So lateral stability in the long direction is incomplete. The building engineer is required to check the stability system of the existing structure.

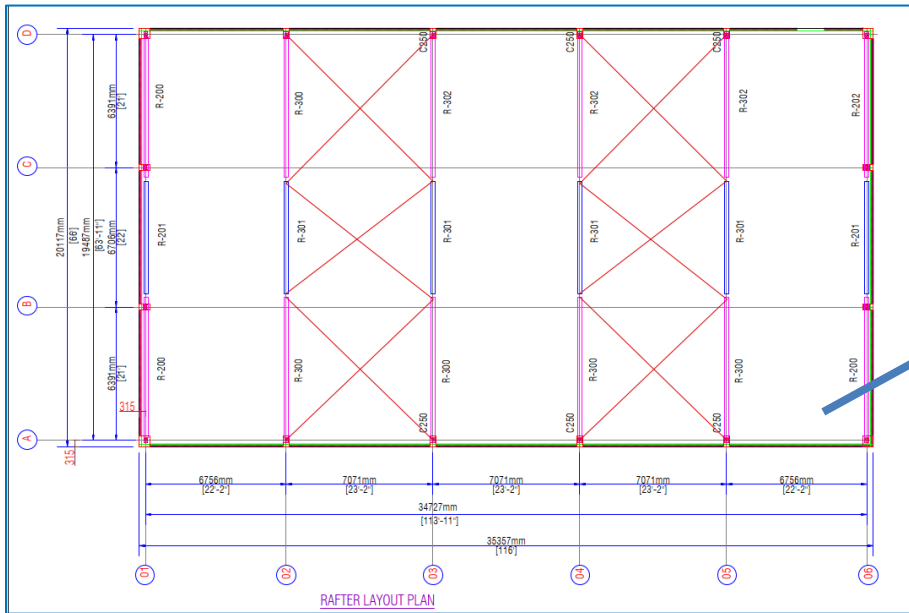
Bracing layout

Inconsistencies in as-built drawing

On site bracings were not matched with layout. Also, no drawing was available for the RC portion on ground floor.

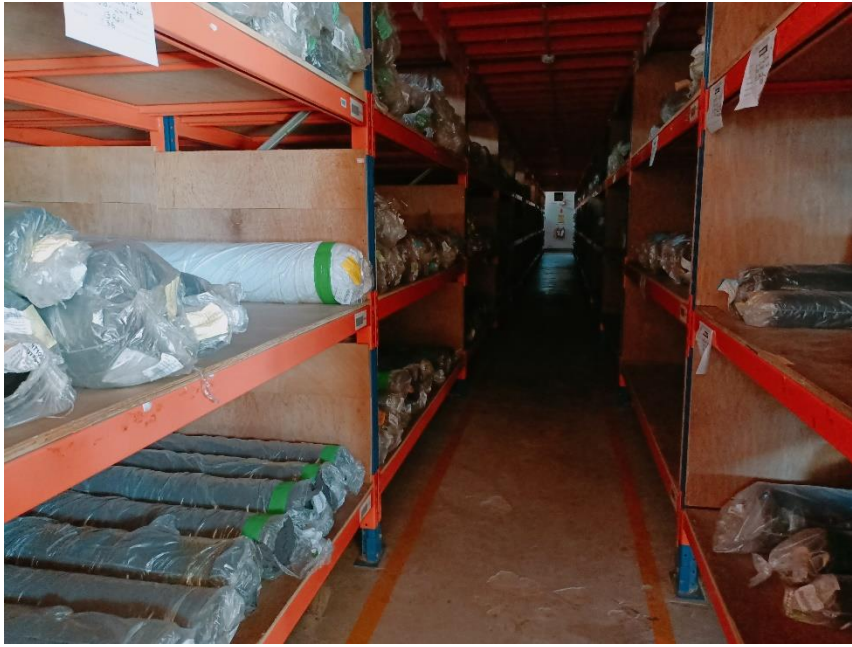
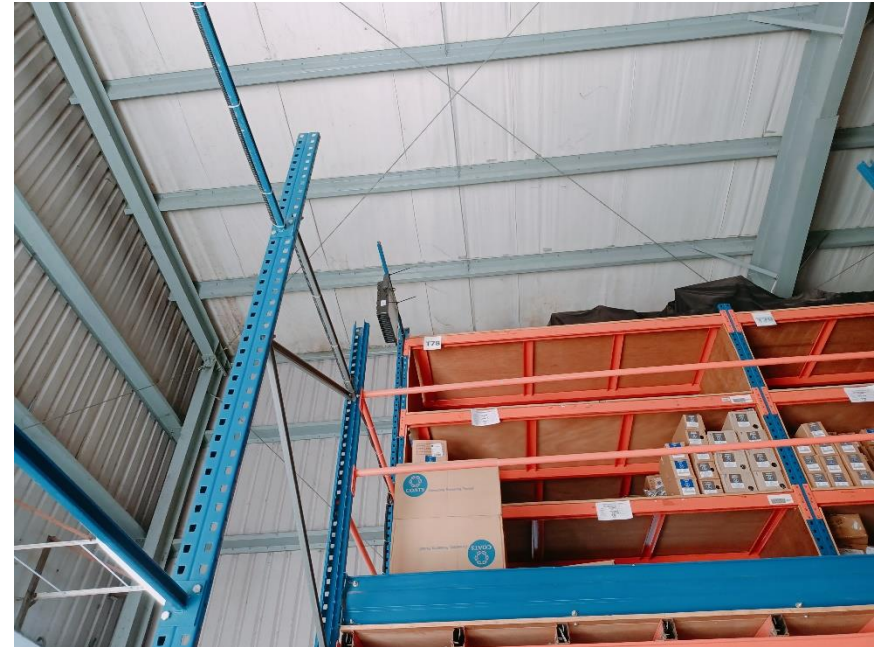
Non-anchored storage rack at several floors

Some racks on floors are not anchored or braced to resist lateral (earthquake) forces. The factory is required to anchor/brace all non-structural elements adequately to resist earthquake forces.

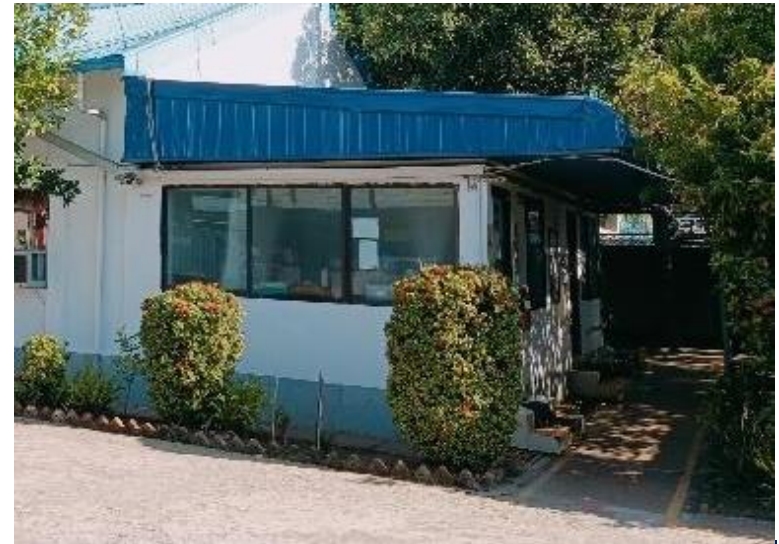
Childcare Room

As-built drawings were not found for the Generator Shed, Chemical Room, Childcare room. The factory has provided a set of drawings which did not match fully with the structures. The building engineer is required to survey the whole structure and prepare a full set of as-built drawings in compliance with section 1.9, part 6 of BNBC.

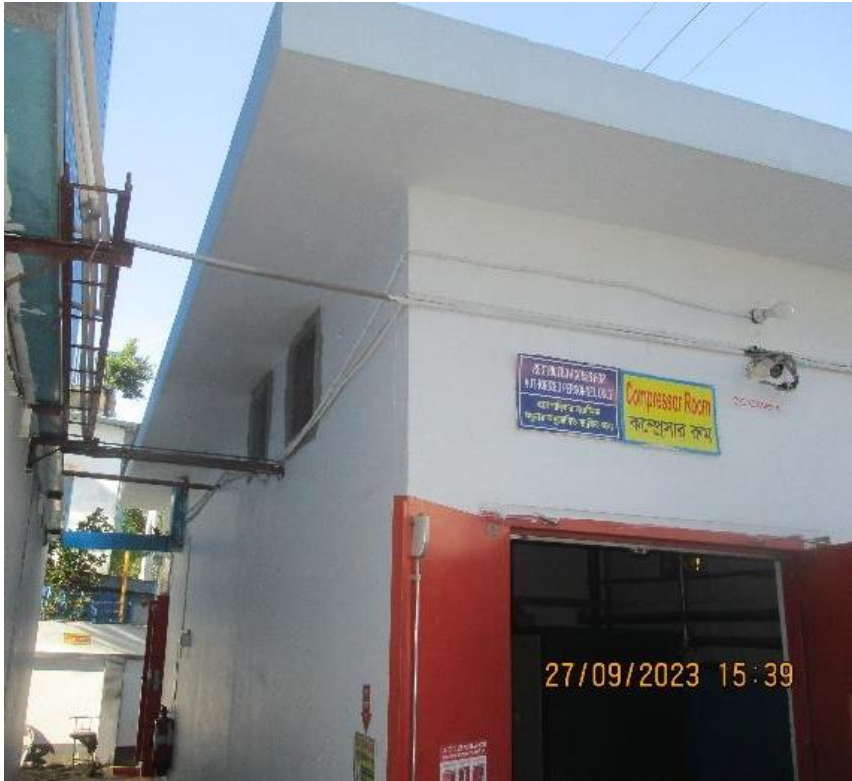
Compressor & Boiler Room

As-built structural drawings were not found for Compressor & Boiler Room, Security Room. Provided as-built drawings did not match with as-built condition. Brick columns were found instead of RC column on site. The building engineer is required to survey the whole structure and prepare a full set of as-built drawings in compliance with section 1.9.1.2, part 6 of BNBC.

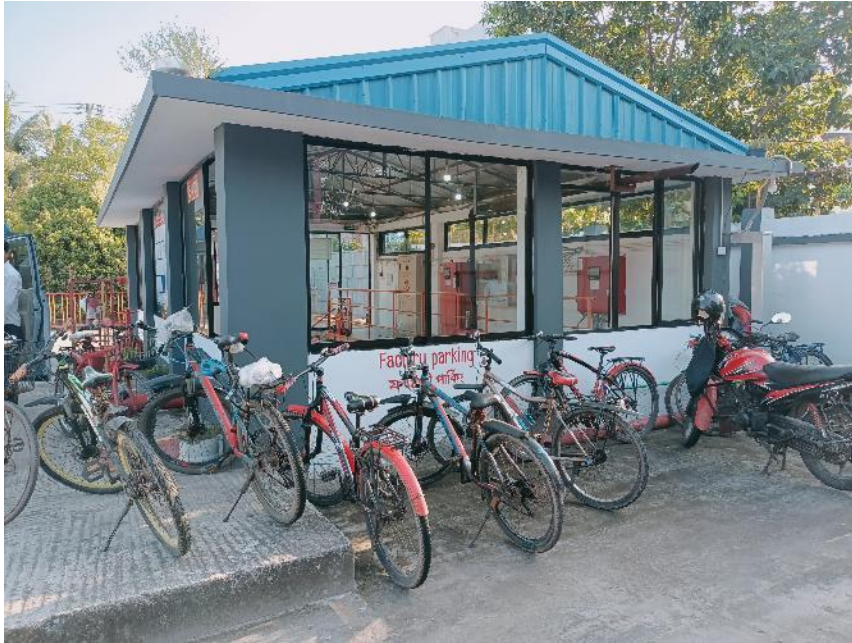
Fire hydrant pump room

Full set of as-built structural drawings were not found for Fire hydrant pump room, Wastage Shed. Sectional details (truss & Rafter) were not found. Moreover, grid dimension and steel column size not match with as-built condition. The building engineer is required to survey the whole structure and prepare a full set of as-built drawings in compliance with section 1.9.1.2, part 6 of BNBC.

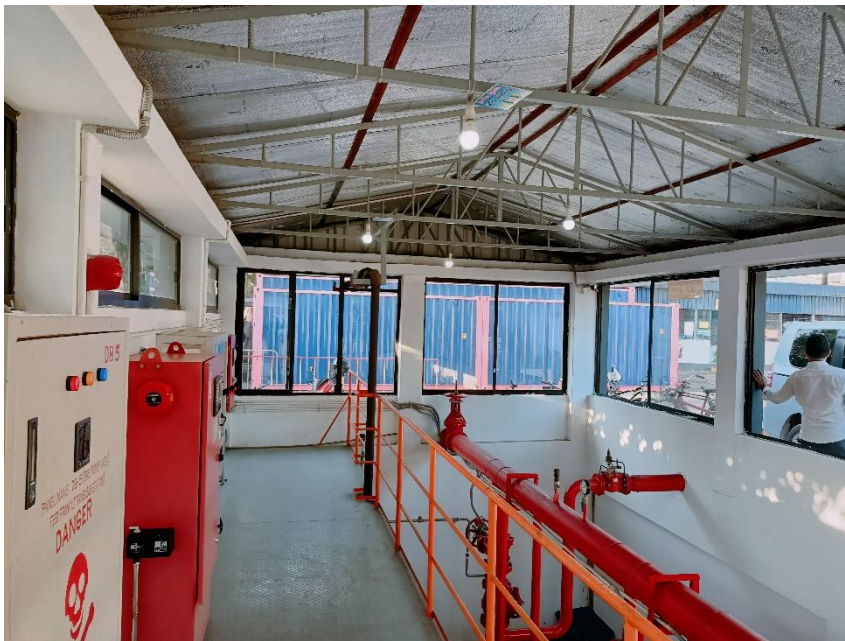
Fire Hydrant Pump Room

Truss and angle connected with the brick wall. No connection details were found in the drawings. The building engineer to checks the connection adequacy of the lightweight roof against the uplift pressure of the wind.

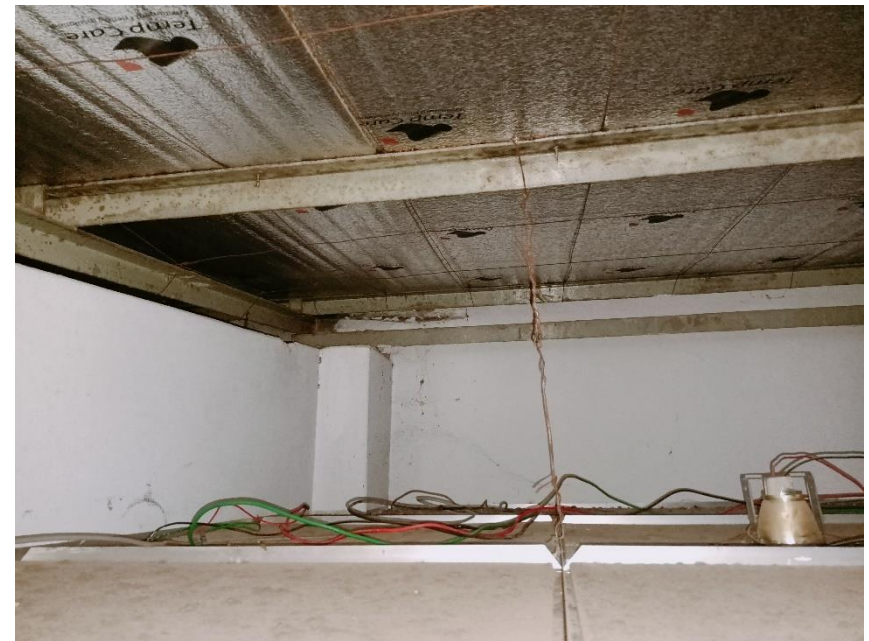
Childcare

Apparently inadequate connections were observed at the lightweight roof of the single storied Sheds. The building engineer to check the connection adequacy of the lightweight roof against the uplift pressure of wind and suggest suitable remedial method. Otherwise replace with an engineered shed.

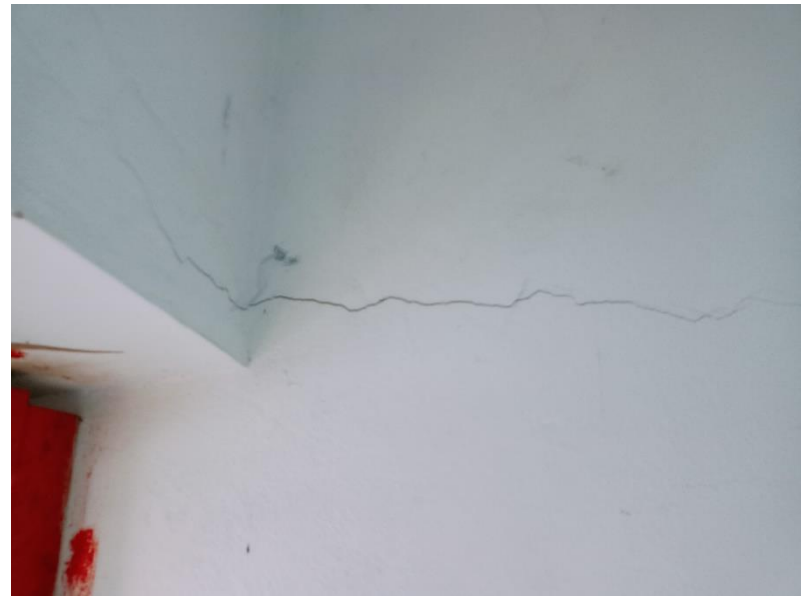
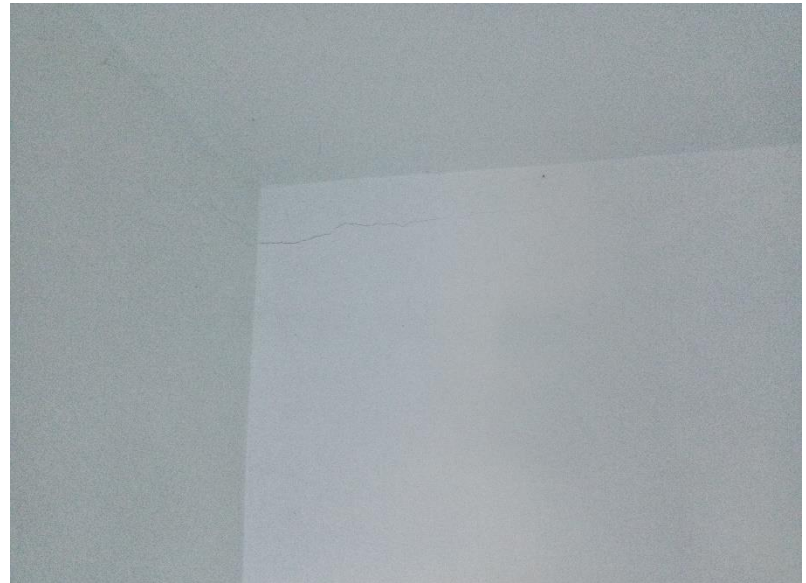
Compressor & Boiler Room

Cracks on brick wall

The buildings were made of brick pier. During the inspection, cracks found on the brick walls both Boiler & Compressor, Chemical Room. Building engineer is required to investigate and repair the with a suitable method.
