# INITIAL FIRE SAFETY INSPECTION REPORT

**Vision Garments Ltd. (New Building)**

**RSC ID: 24674**

**Date: 25 September-2023**

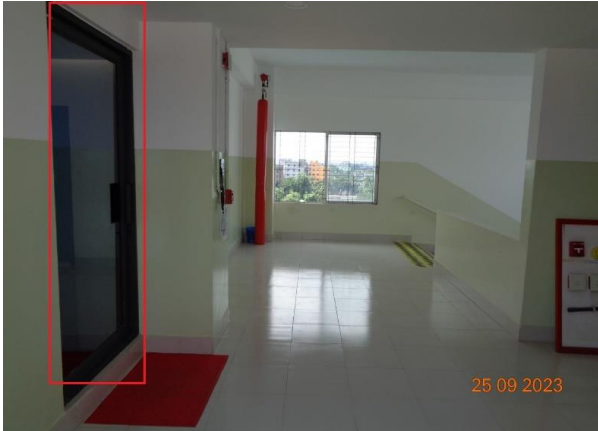
| SI No. | Category | Findings | Required Action | Remediation Time Frame |
|---|---|---|---|---|
| F-1 | Fire Rated Construction | <p>The exit stairs are separated from work areas &amp; other spaces on each floor by fire rated construction.</p> <p><b>Location:</b> 6th floor from conference room.</p> | <p>Stair shall be enclosed with a minimum 2-hr fire-rated construction. Seal all unprotected openings and provide minimum 1.5 -hr. fire rated doors to separate the exit stairs from work areas and other building spaces on all floor levels. Ensure that the fire doors are self-closing, positive latching and that they are provided with fire exit (panic) hardware where serving production floors.</p> <p>Provide a fire-resistive rated assembly between the exterior exit stairs and the building up to 10 ft. beyond the end of the stair to achieve the required separation. The rated assembly shall be</p> | Within 3 Months |

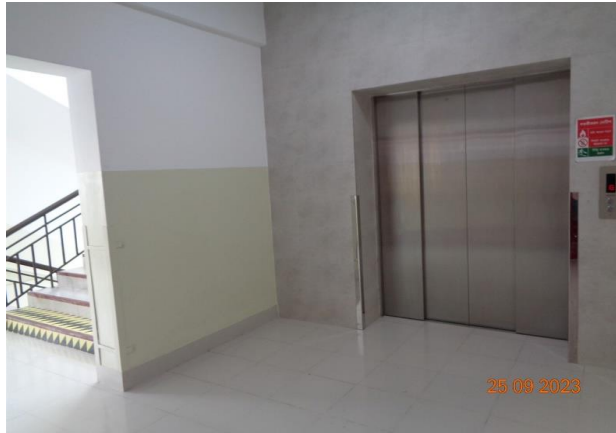
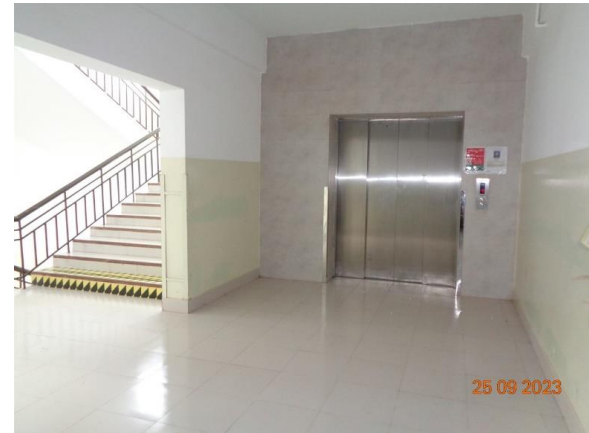
| SI No. | Category | Findings | Required Action | Remediation Time Frame |
|---|---|---|---|---|
| F-2 | Fire Rated Construction | Elevator shafts are directly open into the inside of Stair-1. | For new construction, elevators shall not open into an exit enclosure as per RSC-6.14.3. So, separate the stair enclosure from elevator shaft throughout the building. | Within 3 Month |

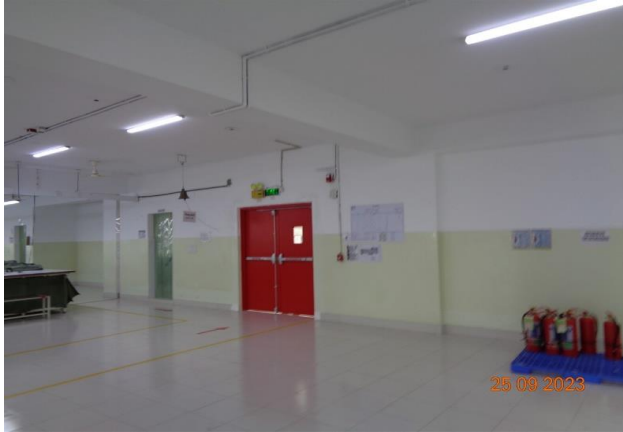
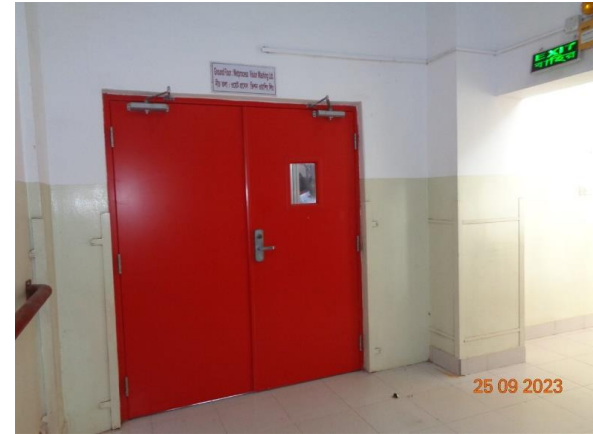
| F-3 | Fire-Rated Construction | Openings from exit enclosures to storage areas was not provided with vestibules on ground and 5th floors. | Openings from exit enclosures to storage areas, basements, transformer rooms, generator rooms, boiler rooms, and similar normally unoccupied spaces shall be provided with vestibules in accordance with RSC Technical Guideline (Standard)-6.14.3. | Within 3 Months |

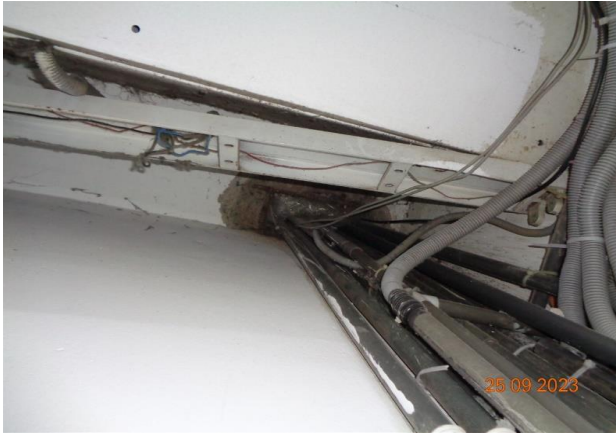
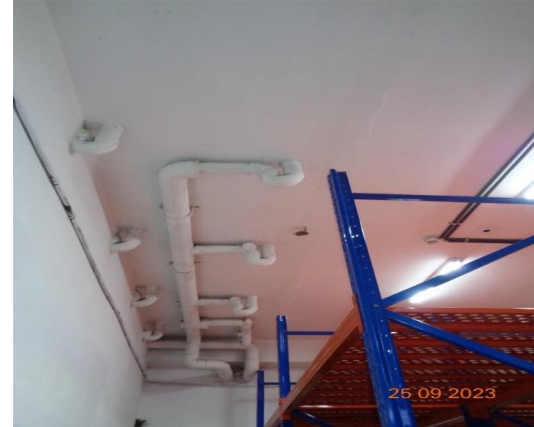
| F-4 | Fire Rated Construction | Penetrations through floor/ceiling assemblies are found unsealed. Location Electrical cable riser, PVC piping and expansion joint. | Seal all penetrations and openings in floor/ceiling (full thickness of the floor/ceiling: minimum 3 hr.) assemblies by third-party certified fire rated materials to maintain the fire resistance rating. or, Provide a minimum 2-hr fire rated shaft to separate the utility risers from each floor if required. | Within 3 Months |

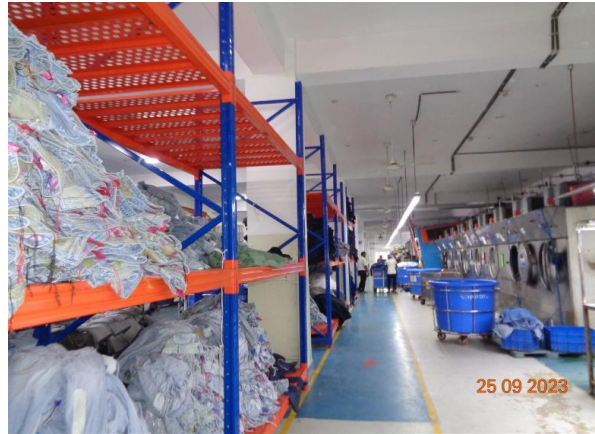
| F-5 | Fire Rated Construction | Areas used for combustible storage are not separated by fire-rated construction on ground floor. | <p>Provide dedicated storage rooms separated by minimum 1-hr fire-rated construction.</p> <p>Where separate storage rooms are not feasible, provide defined storage areas and limit the storage arrangement as follows:</p> <ul style="list-style-type: none"> <li>- Maximum height of <b>2.4m</b> and maximum area of 23m<sup>2</sup></li> <li>- If sprinkler protected: maximum height of 3.66 m and maximum area of 93m<sup>2</sup></li> </ul> <p>Separate areas of unenclosed combustible storage by a minimum clear distance of 3m</p> | Within 3 Months |

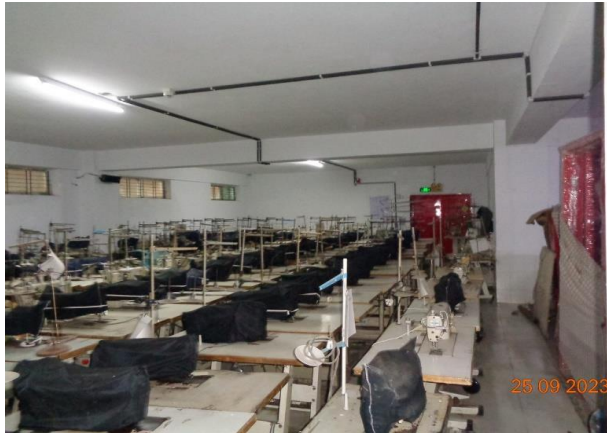
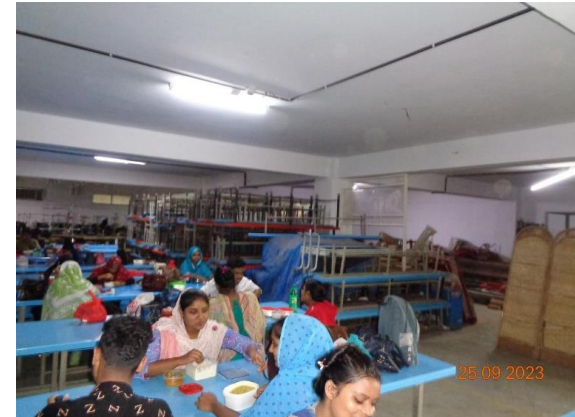
| F-6 | Fire Rated Construction | Dining area is not separated from storage area on basement. | Separate the dining room by a minimum 3-hr fire-rated construction as per BNBC 2006, table:3.2.1. Seal and/or protect all openings to maintain the required fire separations. Also follow RSC Technical Guidelines StandardV1.0 article 3.3.4 Occupancy E: Assembly Buildings for capacity. | Within 3 Month |

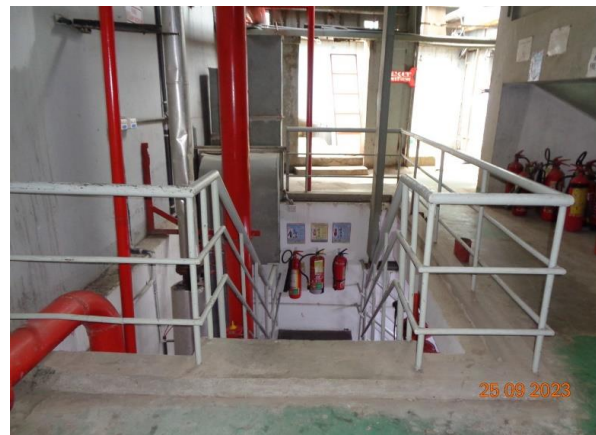
| F-7 | Fire Rated Construction | The fire pump room are not provided with adequate fire separation. Location: Utility Shed | Provide fire pump room with 2 hr. rated fire separation when not sprinklered and 1 hr. rated fire separation when provided with automatic sprinklers, in accordance with NFPA 20. | Within 3 Month |

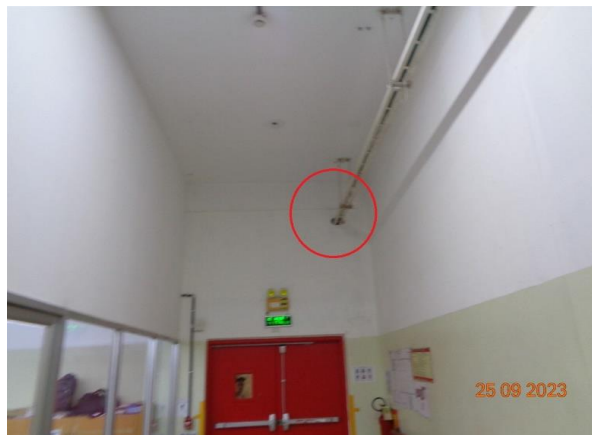
| F-8 | Fire Rated Construction | Unsealed penetrations and openings are located in the exit stair enclosures. Location ground floor at stair-1. Also, electrical cable passing is not permitted in the staircase. | Seal all penetrations and openings in exit stair enclosure walls to maintain the fire separations. | Within 3 Month |

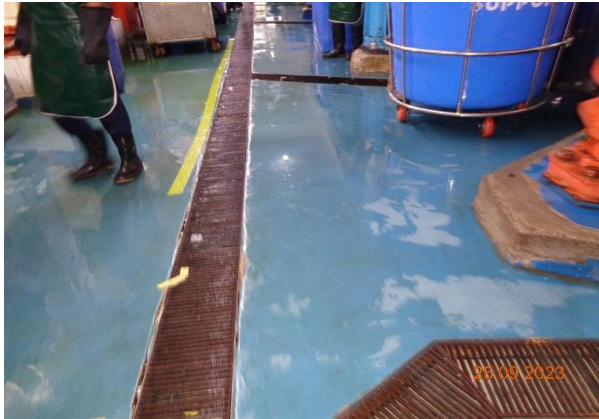
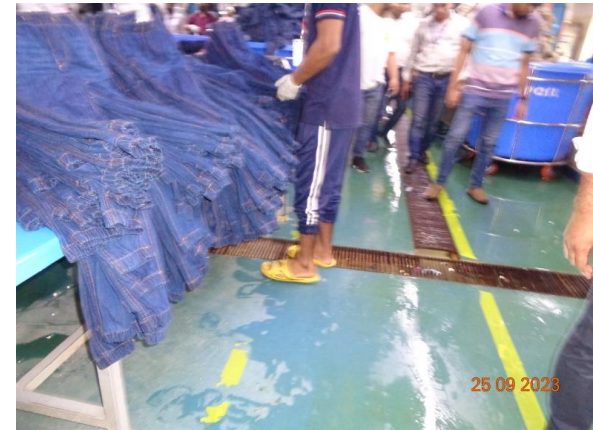
| F-9 | Means of Egress | Aisles are not provide with a minimum unobstructed clear with of 36 in. Location: ground floor | Aisles shall be provided with a minimum unobstructed clear- with of 0.9m (36 in). | Within 1 Month |

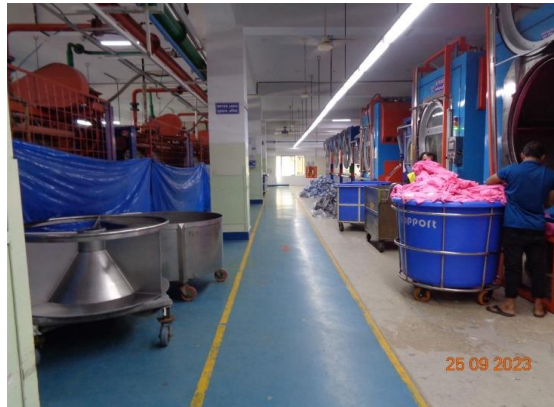
| F-10 | Means of Egress | Dead end corridor was more than 50 feet on ground floor. | For existing and interim construction, dead end corridors shall not exceed 50 feet in accordance with RSCTechnicalGuidelinesStandardV1.0 Table 6.13.3. | Within 1 Month |

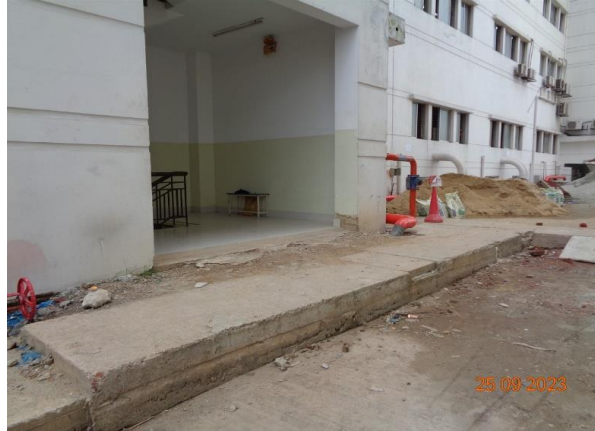
| F-12 | Mean of Egress | Changes in elevation of walking surfaces do not exceed 6.35 mm (1/4 in) unless provided with a beveled slope of 1 in 2 that does not exceed 12.7 mm (1/2 in). Location from stair-2 and stair-3 to the public way. | Resurface the change in elevation to provide a slope that is less than 1 in 48 in. | Within 3 Months |

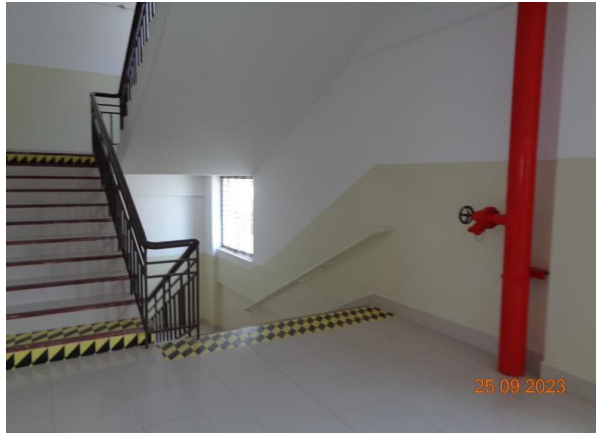
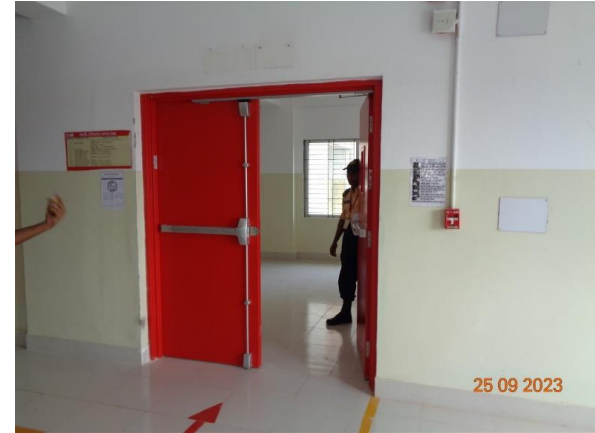
| F-13 | Egress Lighting | Based on the number and location of emergency lights observed, adequate illumination levels are not anticipated along egress routes. | Test the emergency lighting system on each floor and provide additional emergency fixtures to provide adequate illumination along the means of egress. Provide a minimum illumination of 10 lux at the floor level within exit stairs and exit discharge paths and minimum 2.5 lux along exit access aisles. | Within 1 Month |

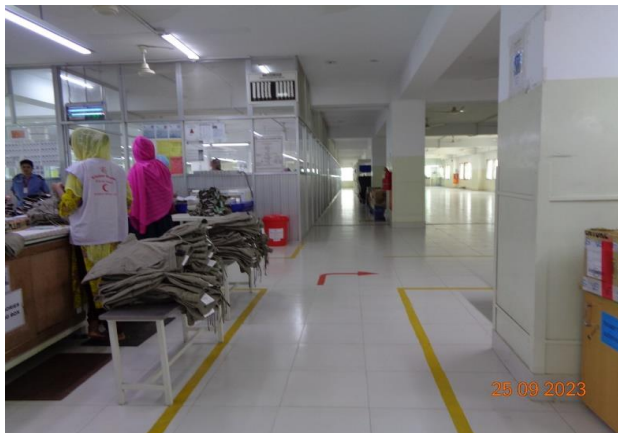
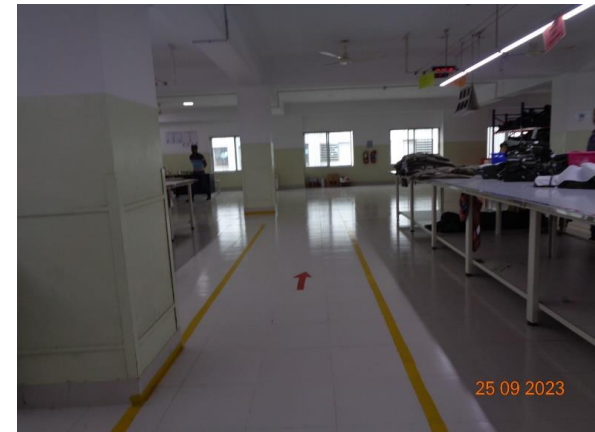
| F-14 | Egress Lighting | <p>Illuminated directional signs are not provided where direction of the path of travel to an exit has changed.</p> <p><b>Location:</b> several floor</p> | <p>Illuminated directional signs shall be provided where there is a change in the direction for the path of travel and the direction to an exit is not obvious.</p> | Within 1 Month |

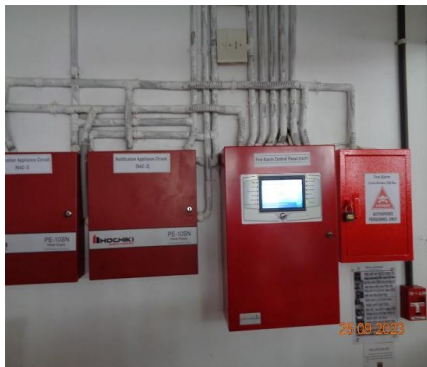
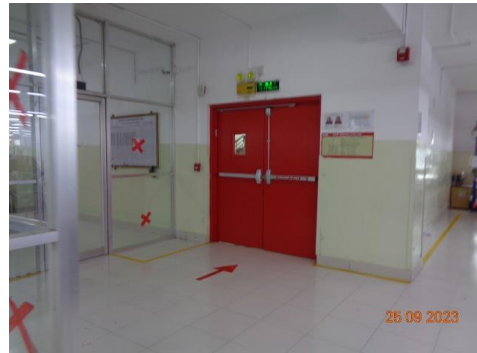
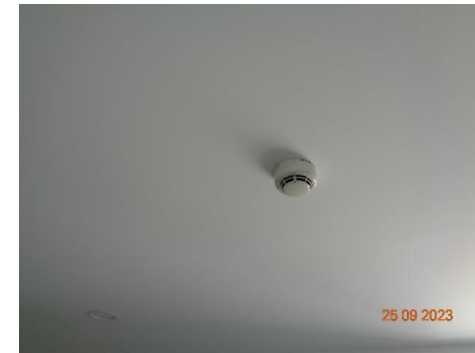
| F-16 | Fire Alarm & Detection System (FADS) | Automatic fire alarm & detection system installation requires detailed review to confirm compliance with NFPA 72 and RSC standards. | <p>Design &amp; Installation of Fire Alarm &amp; Detection system shall be in accordance with RSC standard and NFPA 72. Submit as-built design, documents and calculations to RSC for review prior installation/modification.</p> <p>After installation, the owner shall contact the RSC for witness of conducting the final acceptance testing of the fire detection &amp; alarm system installation.</p> <p>Also inspect, test and maintain the fire alarm system, and keep written records on-site, in accordance with NFPA 72.</p> | Within 3 Months |

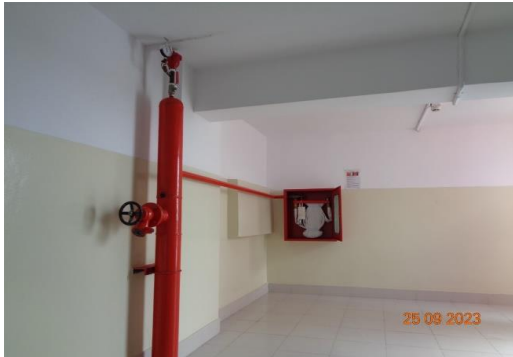
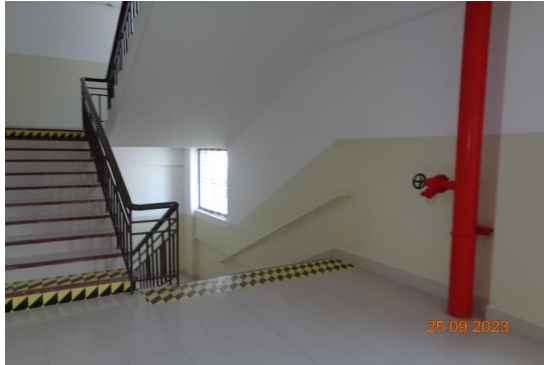
| F-18 | Fire Protection System(Standpipe) | Standpipe system installation requires detailed review to confirm compliance with NFPA 14 and RSC standards. | Submit as-built drawings, testing records, equipment certification and other relevant documentation to the RSC for review and approval. | Within 3 Months |
