# Mondol Fabrics Ltd. (Extension)

Nayapara, Kashimpur, Gazipur

7 November 2023

## 1. Building Information

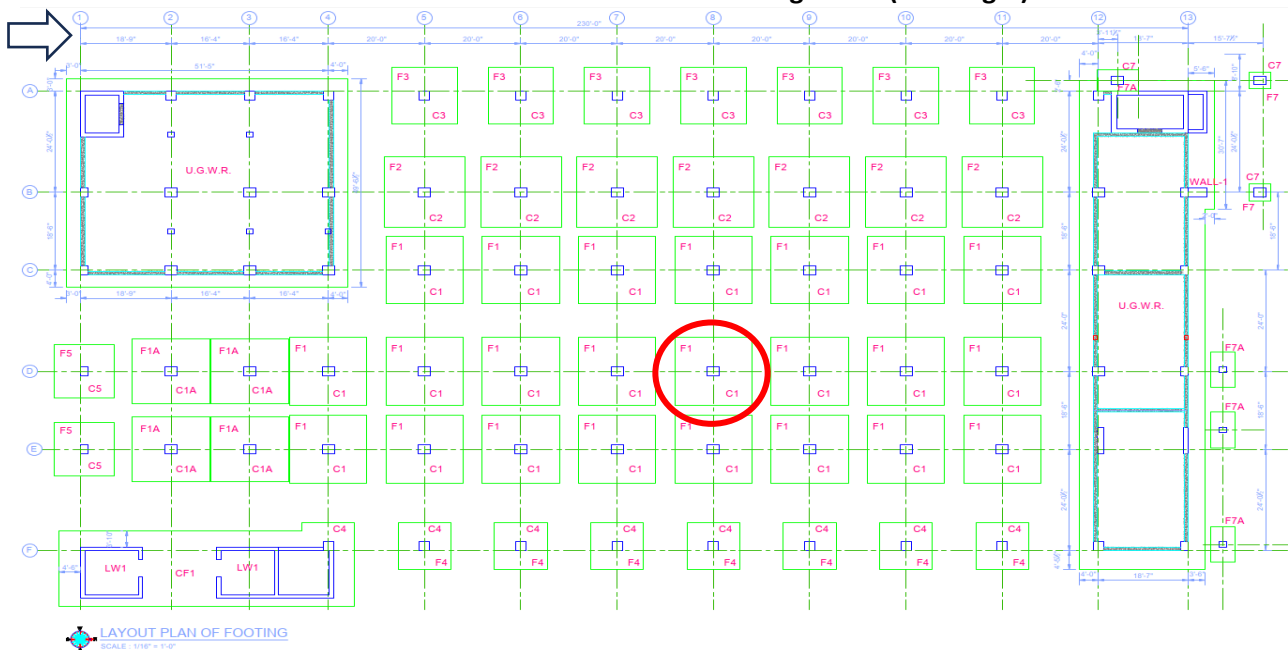
### Observation 2: Stress in the foundation exceeds the normal design limit (Building-8).

The normal design limit exceeds for the isolated footing grid-D-8

**Description:** A cursory calculation shows that the normal design limit exceeds the isolated footing. The foundation capacity has been checked considering a floor live load of 5 kPa & 4 kPa for the production floors, 6 kPa for the storage area & 1.5 kPa for the roof. Considering minimum concrete strength 16.3 MPa and re-bar strength 415 MPa from the available re-bar test report and available bearing capacity from boreholes of the soil test report and grid location of the column footing. The building engineer is required to review the design, loads and column stresses in the area identified above. Produce and actively manage a loading plan for all floor plates.

| Observation | Action Plan | Timeline |
|---|---|---|
| Stress in the foundation exceeds the normal design limit. | The building engineer is required to review the design, loads and column stresses in the area identified above. | within 6 weeks |
| | Produce and actively manage a loading plan for all floor plates. | within 6 weeks |

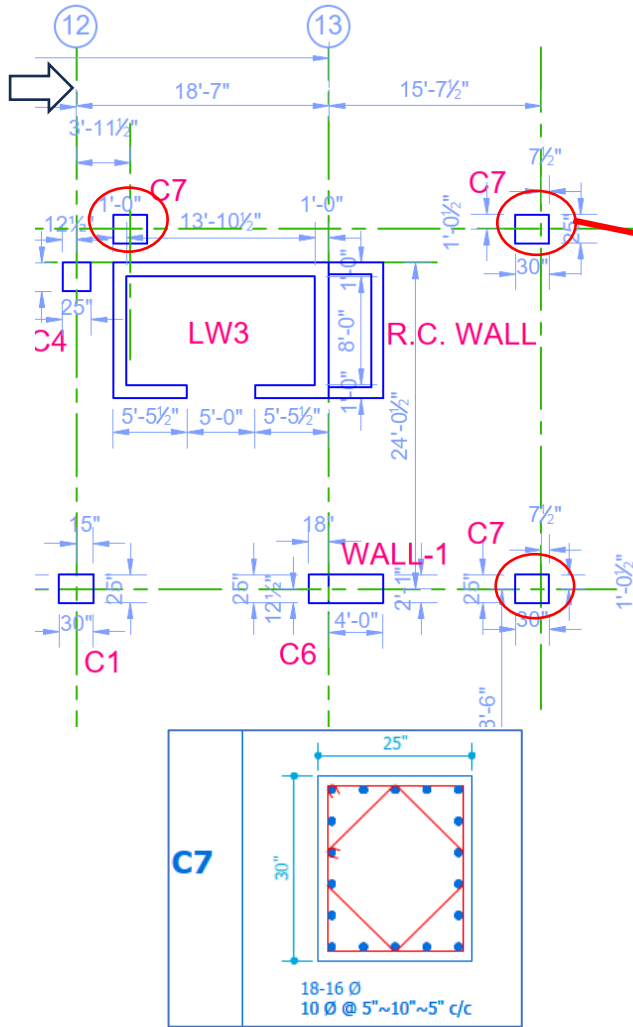
Column C7 (750X675) in drawing

**Description:** Column C7 dimensions are different from the on-site condition. Also, beam layout and detail mismatches were observed. A building engineer is required to survey the whole structure and prepare the as-built drawing reflecting the on-site condition as well as update the design report.

| Observation | Action Plan | Timeline |
|---|---|---|
| Inconsistencies in the provided drawing. | A building engineer is required to survey the whole structure and prepare the as-built drawing reflecting the on-site condition as well as update the design report. | within 6 weeks |

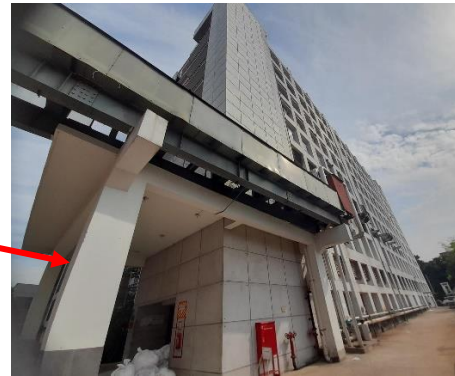
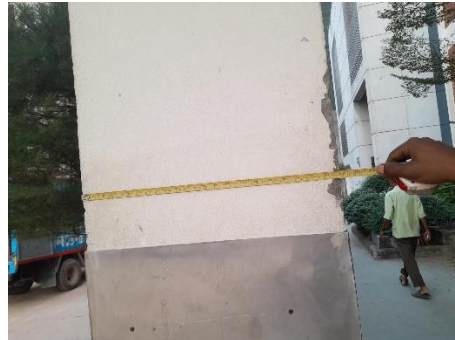
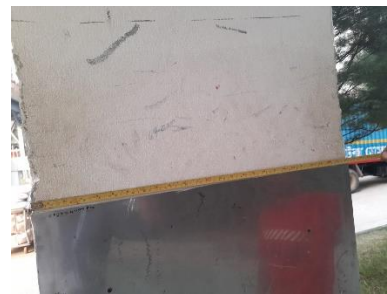
With plaster, 500X650 found on site

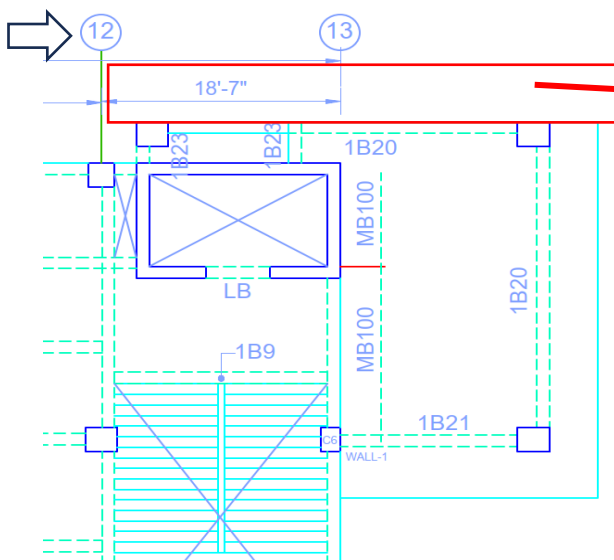
The extended corbel beam is not shown in the provided drawing

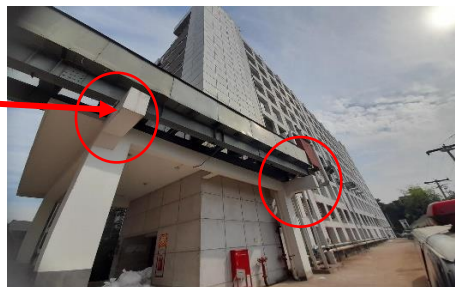
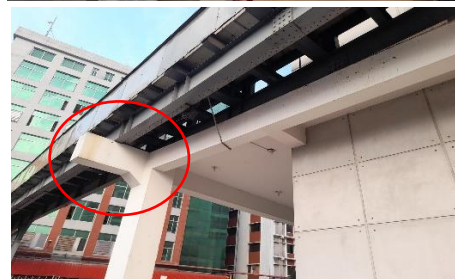
Extended corbel beam was found on the 1<sup>st</sup> floor on-site with a concentrated loading steel bridge

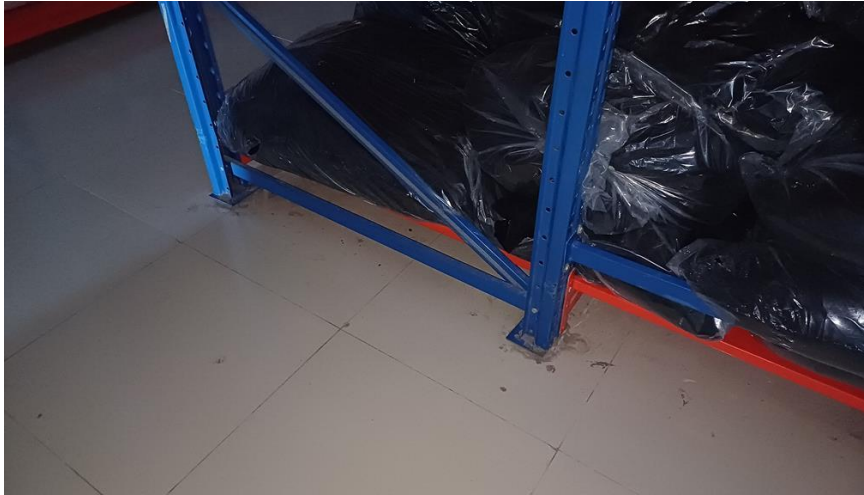
**Observation-5: Racks are not anchored or braced (Building-08).**

**Description:** Some racks on floors are not anchored or braced to resist lateral (earthquake) forces. The building is required to adequately anchor/brace all non-structural elements to resist earthquake forces to comply with the BNBC.

| Observation | Action Plan | Timeline |
|---|---|---|
| Racks are not anchored or braced (Building-08). | The building is required to adequately anchor/brace all non-structural elements to resist earthquake forces to comply with the BNBC. | within 6 months |

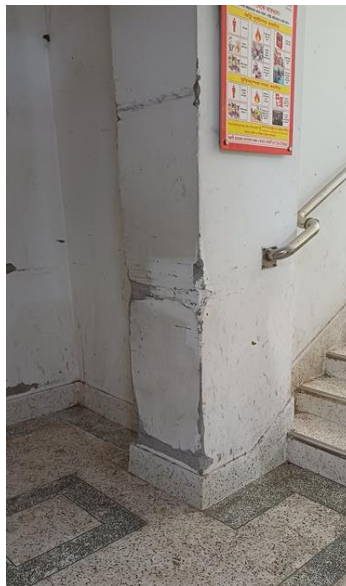
**Observation-6: Column susceptible to trolley impact (Building-8).**

**Description:** Some columns had the sign of vehicle impact. The building engineer is required to provide guard around the column/Shear walls to prevent trolley impact.

| Observation | Action Plan | Timeline |
|---|---|---|
| Column Susceptible to trolley impact (Building-08). | The building engineer is required to provide guard around the column/ Shear walls to prevent trolley impact. | within 6 months |

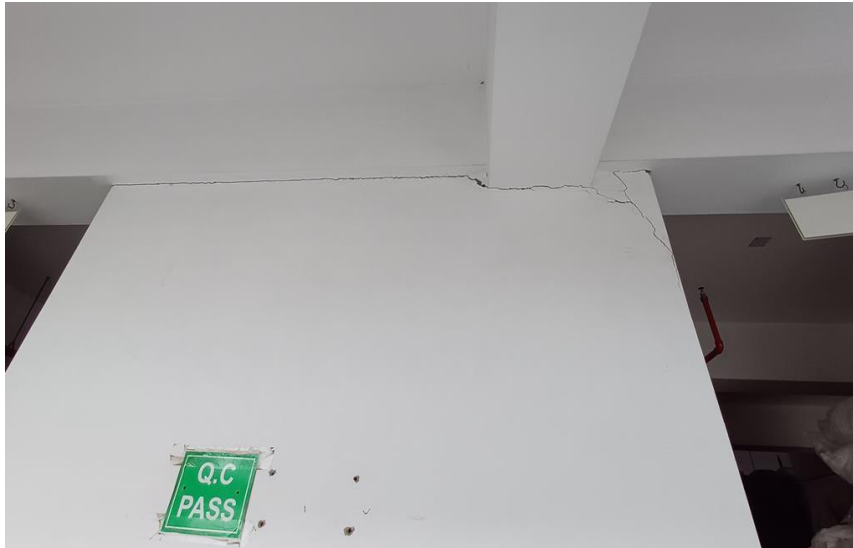
**Observation-7:** Cracks were found in the brick wall (Building-8).

**Description of observation:** Some cracks were found in an internal brick wall. A building engineer is required to repair the cracks with a suitable method.

| Observation | Action Plan | Timeline |
|---|---|---|
| Cracks were found in the brick wall (Building-08). | The Building Engineer is required to repair the cracks with suitable methods. | within 6 months |
