# Tropical Knitex Ltd (Extension)

Chandra, Kaliakoir, Gazipur- 1751

24-Sep-2023

# Observations

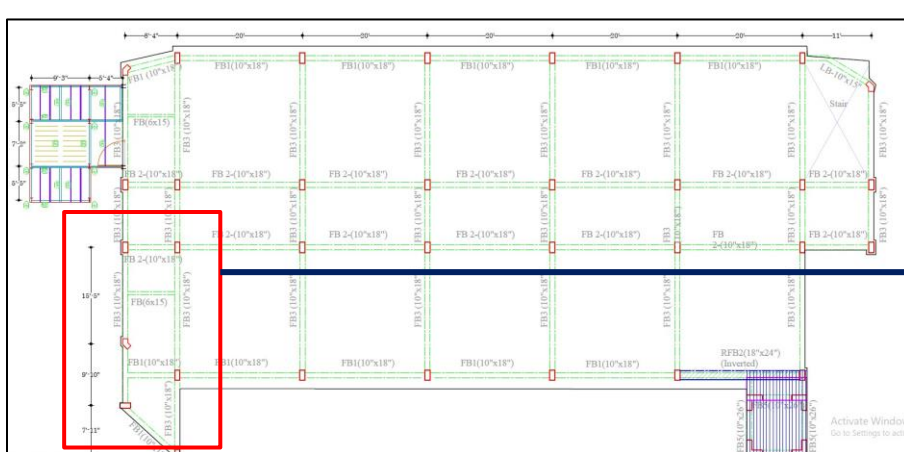
Beam layout plan

The Beam was not found at site

The Beam was found at site

Mismatch found between as-built drawing and actual site condition. Beam was not found at red marked location. Besides, beam was found at green marked location. Also, in FEA model the same mis-match observed.

Factory Engineer is required to survey the whole structure and update as-built drawing. Revise the Detail Engineering Assessment based on actual site condition.

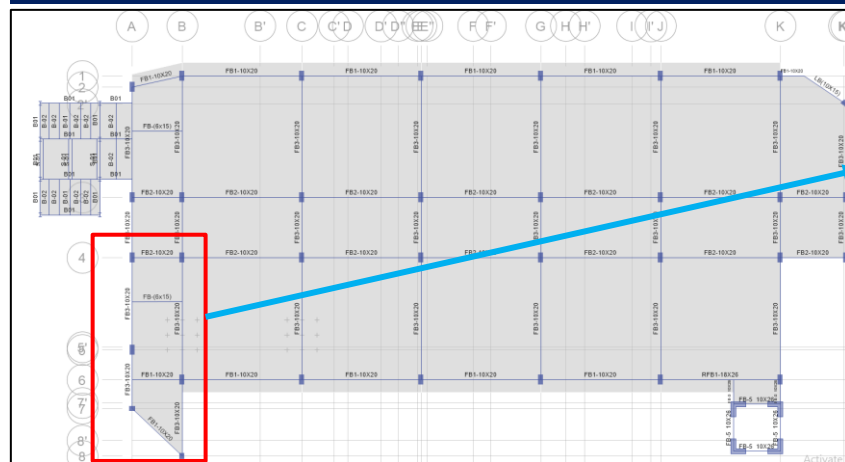
Beam Assignment in FEA model

Beam assignment in FEA model do not match with site condition

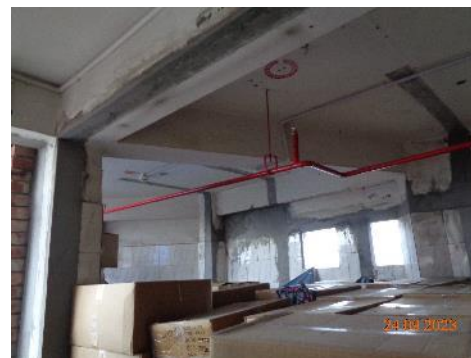
Beam layout mismatch

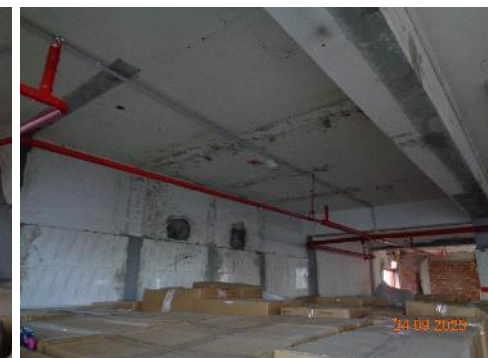
Beam not found at site

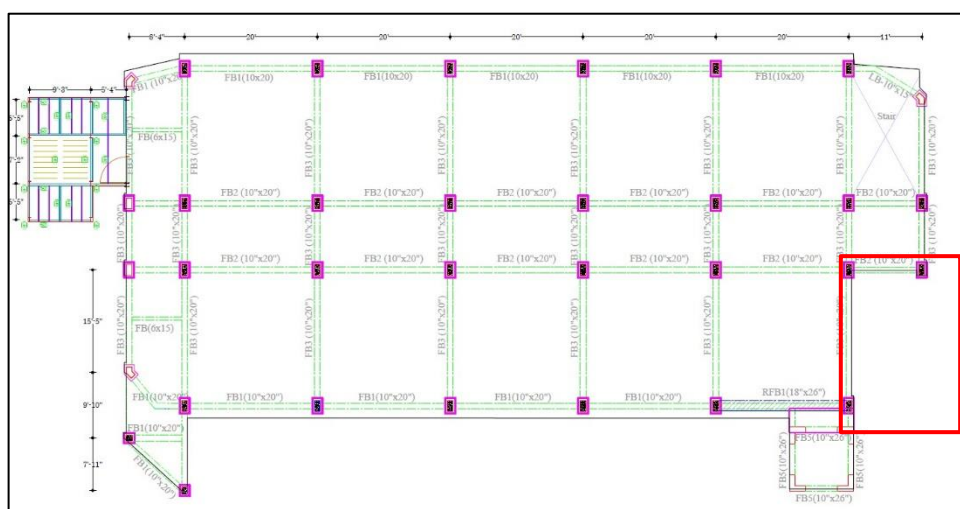
4<sup>th</sup> floor Beam layout plan

Additional panel with beam-slab and column was found at 4<sup>th</sup> floor which has not been shown in as-built drawing.

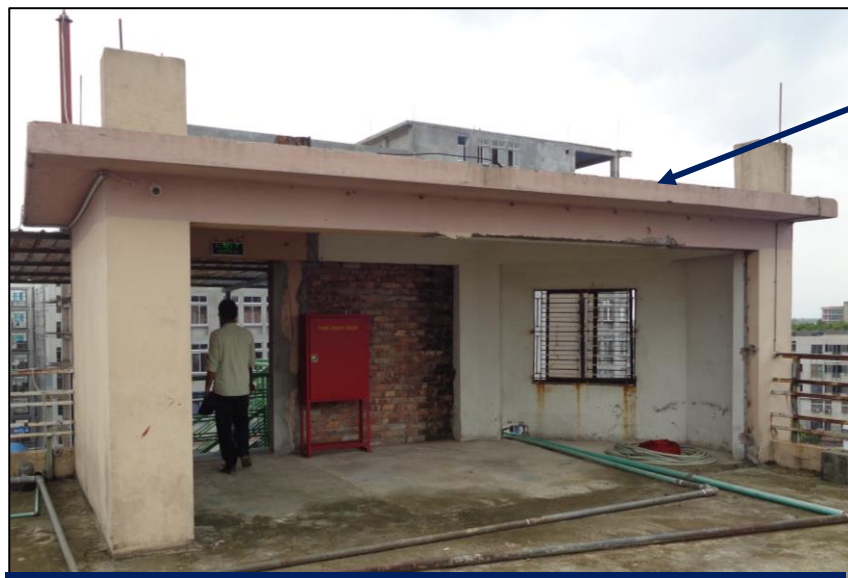
Stair top beam column framing

Stair roof top details of the roof top has not been provided in as-built drawing.

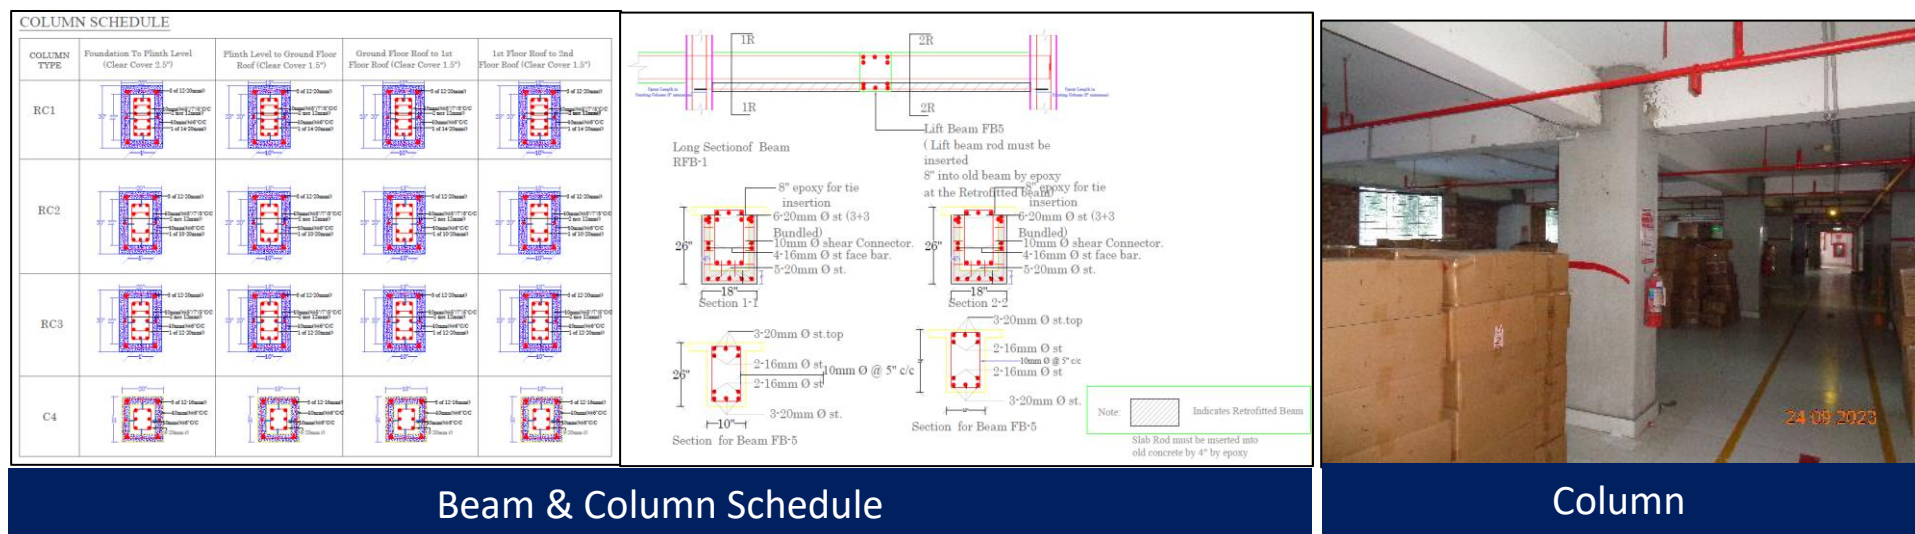
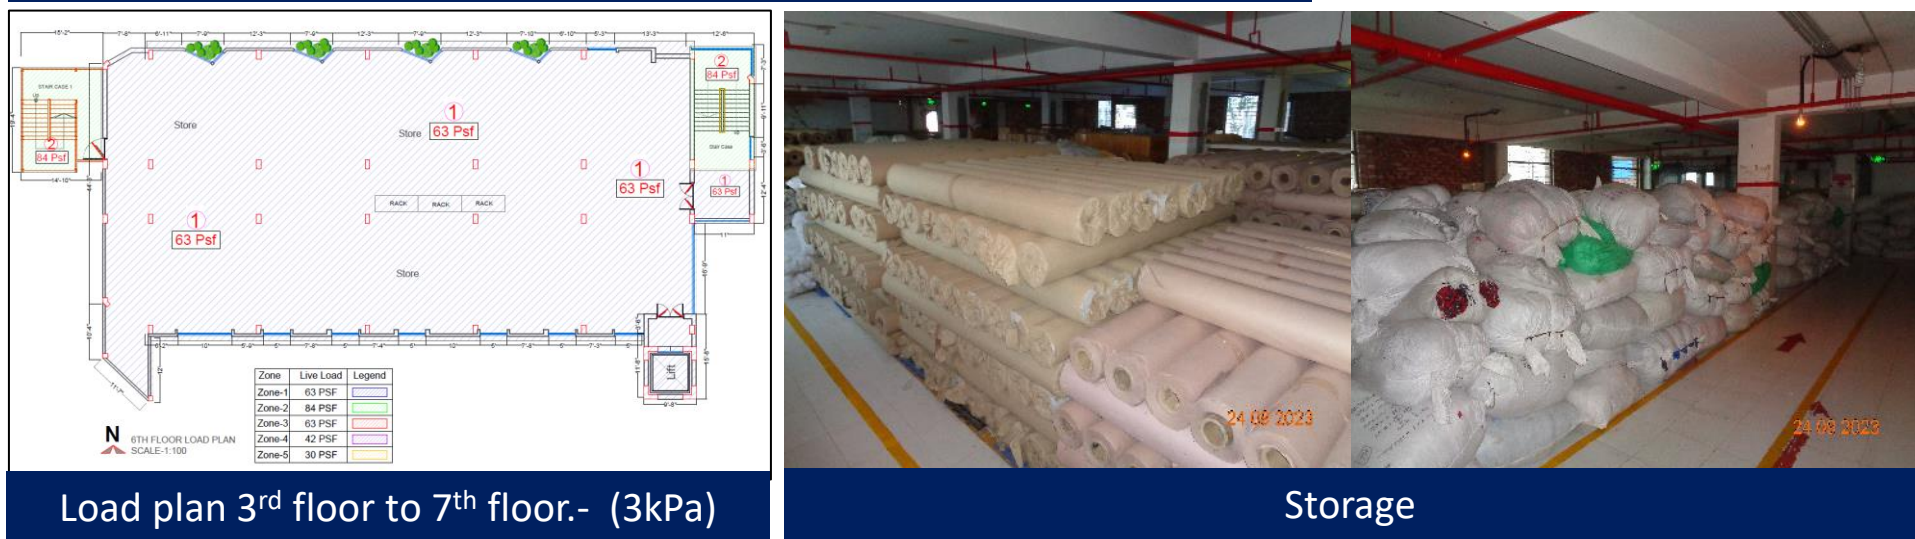
Factory performed the details engineering assessment (DEA) for the structure and completed the retrofiting works. The live load has been considered 3 kPa for the storage area instead of 6 kPa as per BNBC-2006. Factory is required to submit the DEA to RSC for the further review.

| Item No. | Observation | Recommended Action Plan | Recommended Timeline |
|---|---|---|---|
| 06 | Load plan does not comply with BNBC requirement. (Building-01) | Implement the recommendations of DEA report | 6-months |
| 07 | Load plan does not comply with BNBC requirement. (Building-01) | Implement the floor load management plan. | 6-months |

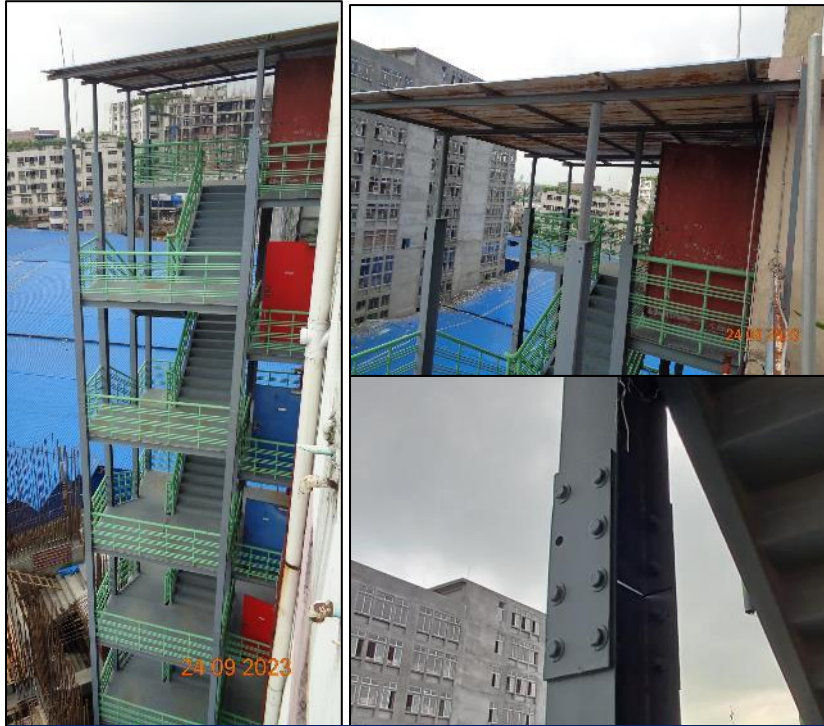
Light weight non-engineered roof shed over the steel stair-1.

Building Engineer is required to verify the lateral stability of the stair-1 including the connection adequacy.

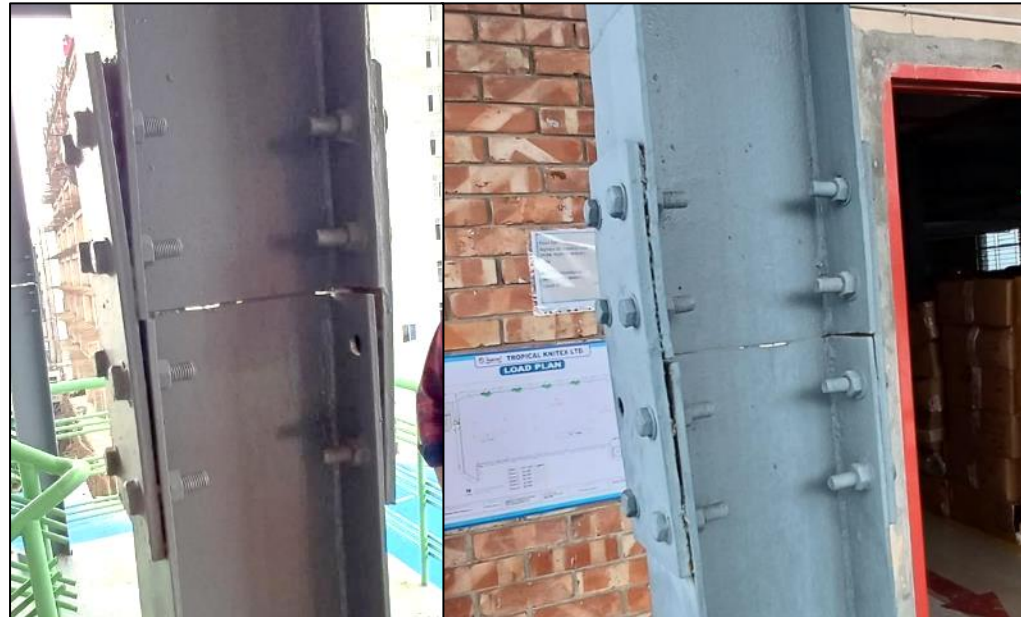
The poor connection found in steel stair-1

| Item No. | Observation | Recommended Action Plan | Recommended Timeline |
|---|---|---|---|
| 08 | Lateral stability needs to be verified for the both steel stairs. (Building-01) | Building engineer is required to check the adequacy of the stair for gravity and lateral forces. | 6-weeks |

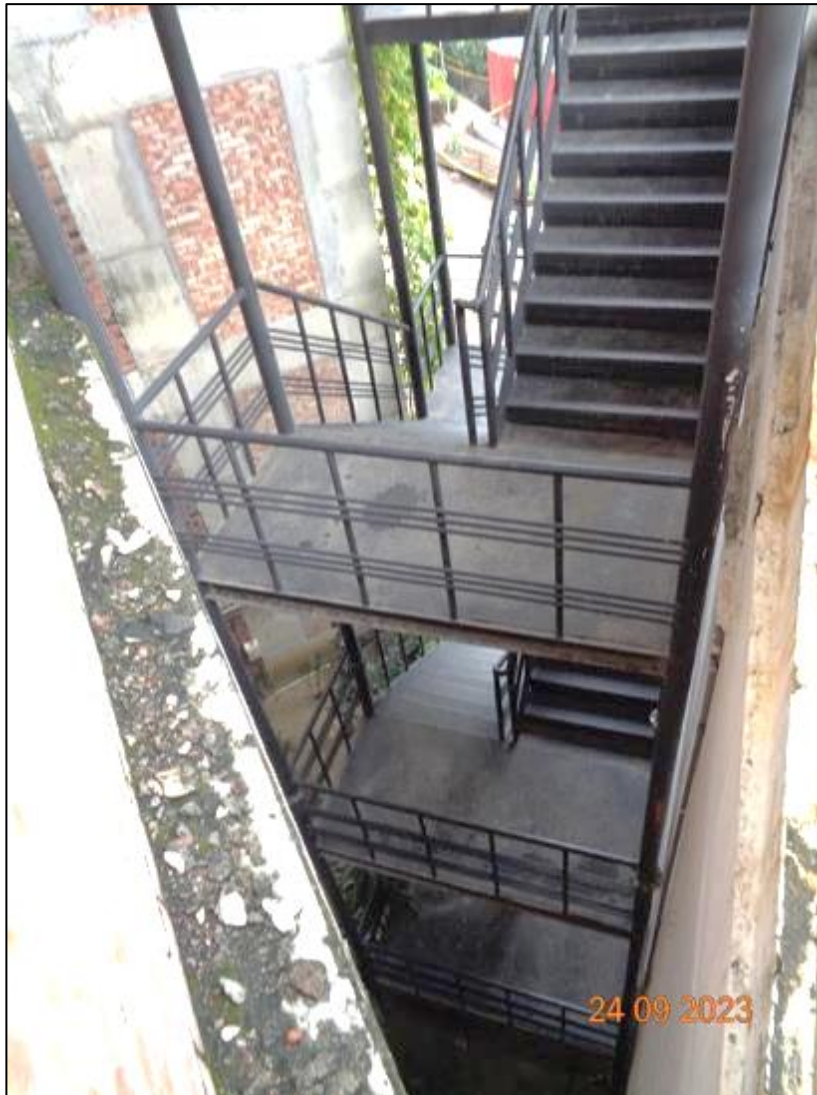
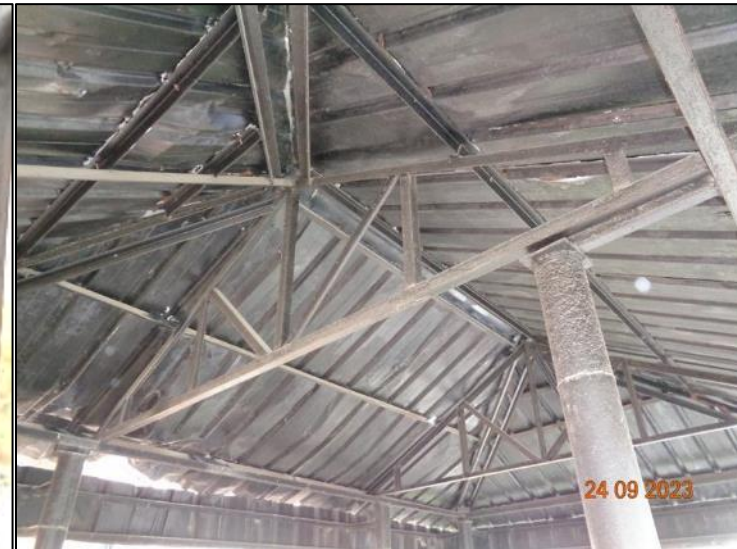
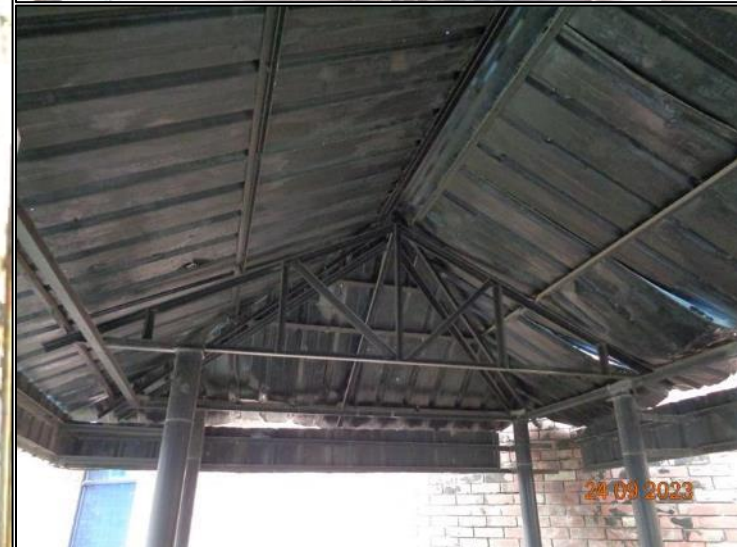
The stair-2 is supported by pipe column. The roof is supported by steel truss. There is no lateral load resisting system. Building Engineer is required to verify the lateral stability of the stair-2.

| Item No. | Observation | Recommended Action Plan | Recommended Timeline |
|---|---|---|---|
| 10 | Lateral stability needs to be verified for the both steel stairs. (Building-01) | Carry out remedial works where required. | 6-months |

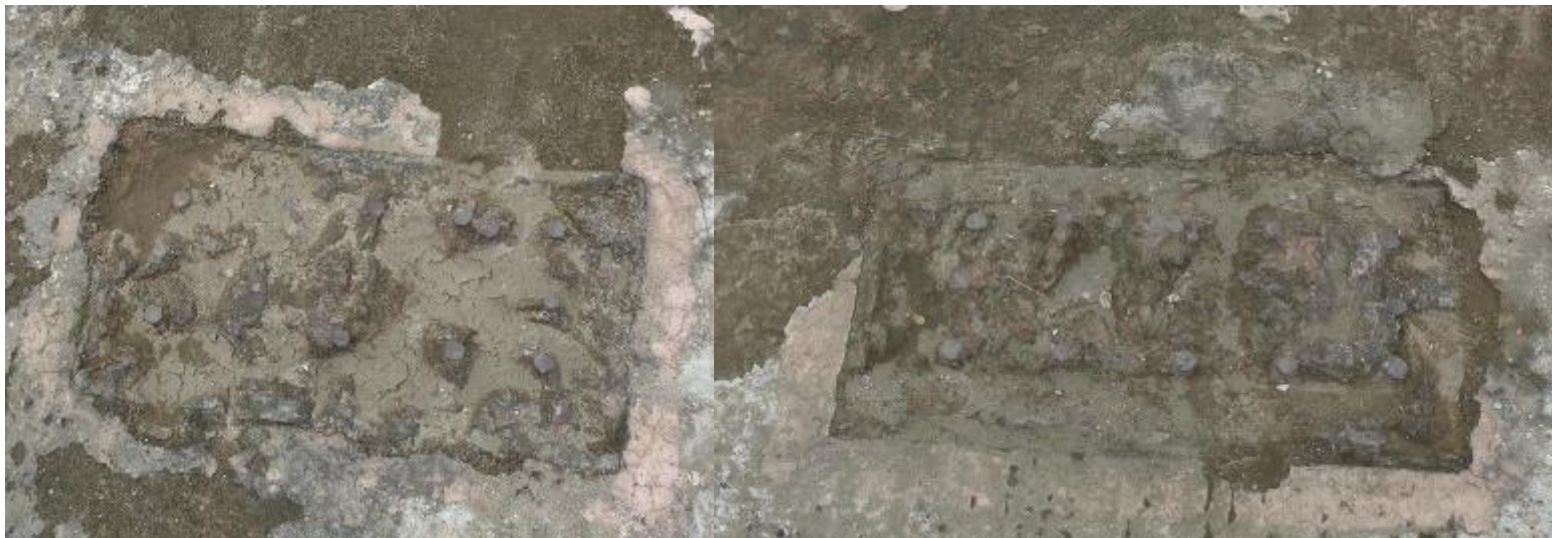
Exposed re-bar head of column at roof susceptible to corrosion and potential to damage of the structural members. Factory is required to take necessary measures to protect the re-bar from corrosion.

| Item No. | Observation | Recommended Action Plan | Recommended Timeline |
|---|---|---|---|
| 11 | Exposed re-bar at roof and corrosion in steel stair (Building-01) | Factory is required to take necessary actions to protect the re-bar from corrosion. | 6-weeks |

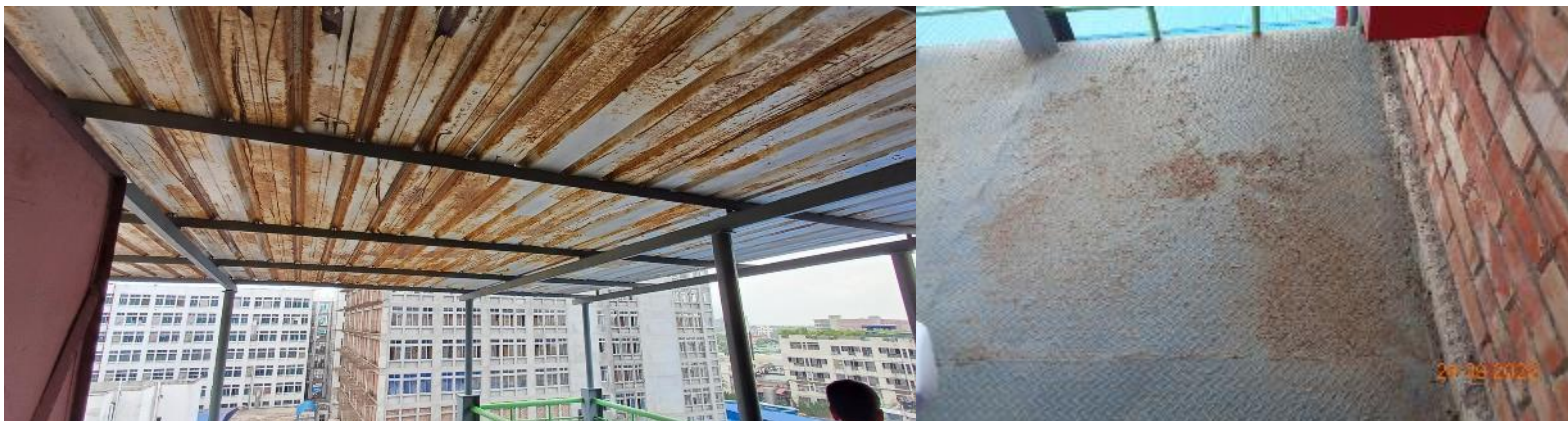
Appearance of corrosion was found in the steel stair. Factory is required to repair the corrosion and apply rust proofing on the corroded areas to protect the steel members from corrosion.

| Item No. | Observation | Recommended Action Plan | Recommended Timeline |
|---|---|---|---|
| 12 | Exposed re-bar at roof and corrosion in steel stair (Building-01) | Factory is required to take necessary actions to protect the steel members from corrosion. | 6-weeks |

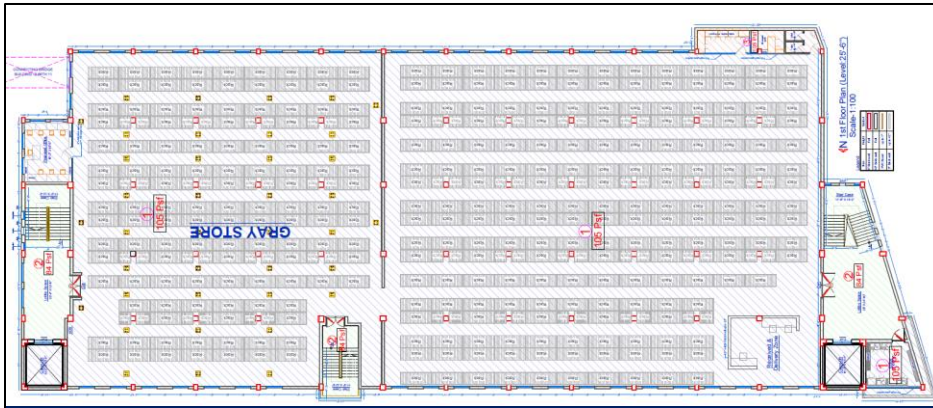
Floor Loading has been considered 5kPa for the 1<sup>st</sup> floor

The live load of the storage area has been considered 5kPa. As per BNBC, minimum loading 6kPa is required for the the storage live load. Also, electrical duct was found in columns of the ground floor.

Factory engineer is required to prepare full set of design documents for the structure in accordance with the provision of Section 1.9.1. The design document shall include a design report, and a set of structural drawings, which shall be prepared in compliance with section 1.9.1.1 and section 1.9.1.2 as per BNBC. Factory engineer is required prepare the design documents including architectural drawing and design report based on FEA model in compliance with section 1.9.1 (part-6, BNBC).

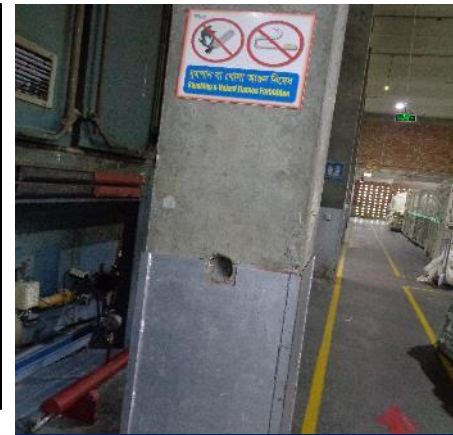
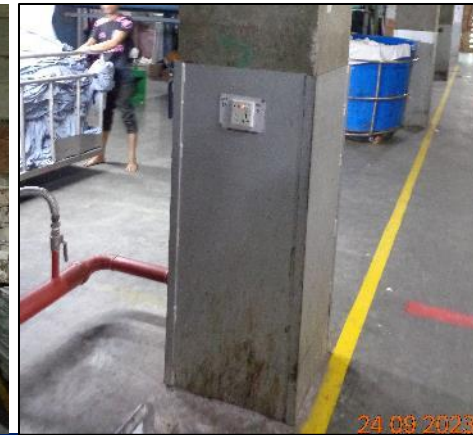
Electric duct in RC Column at Ground floor

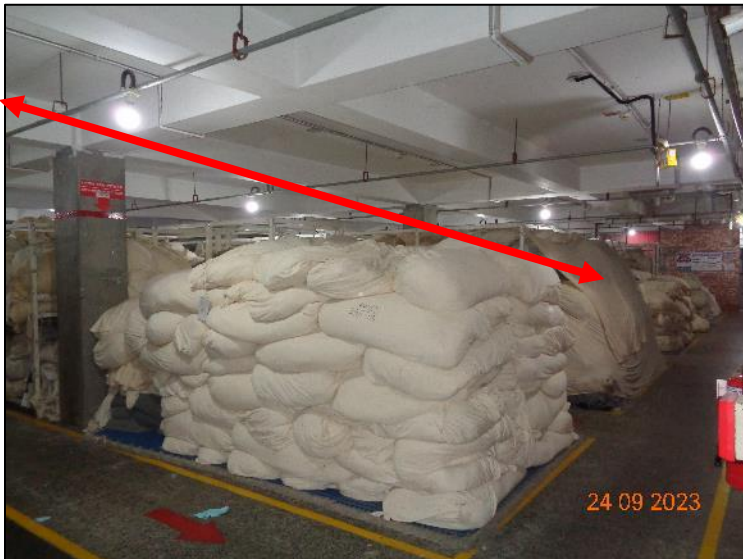
Storage at 1<sup>st</sup> floor

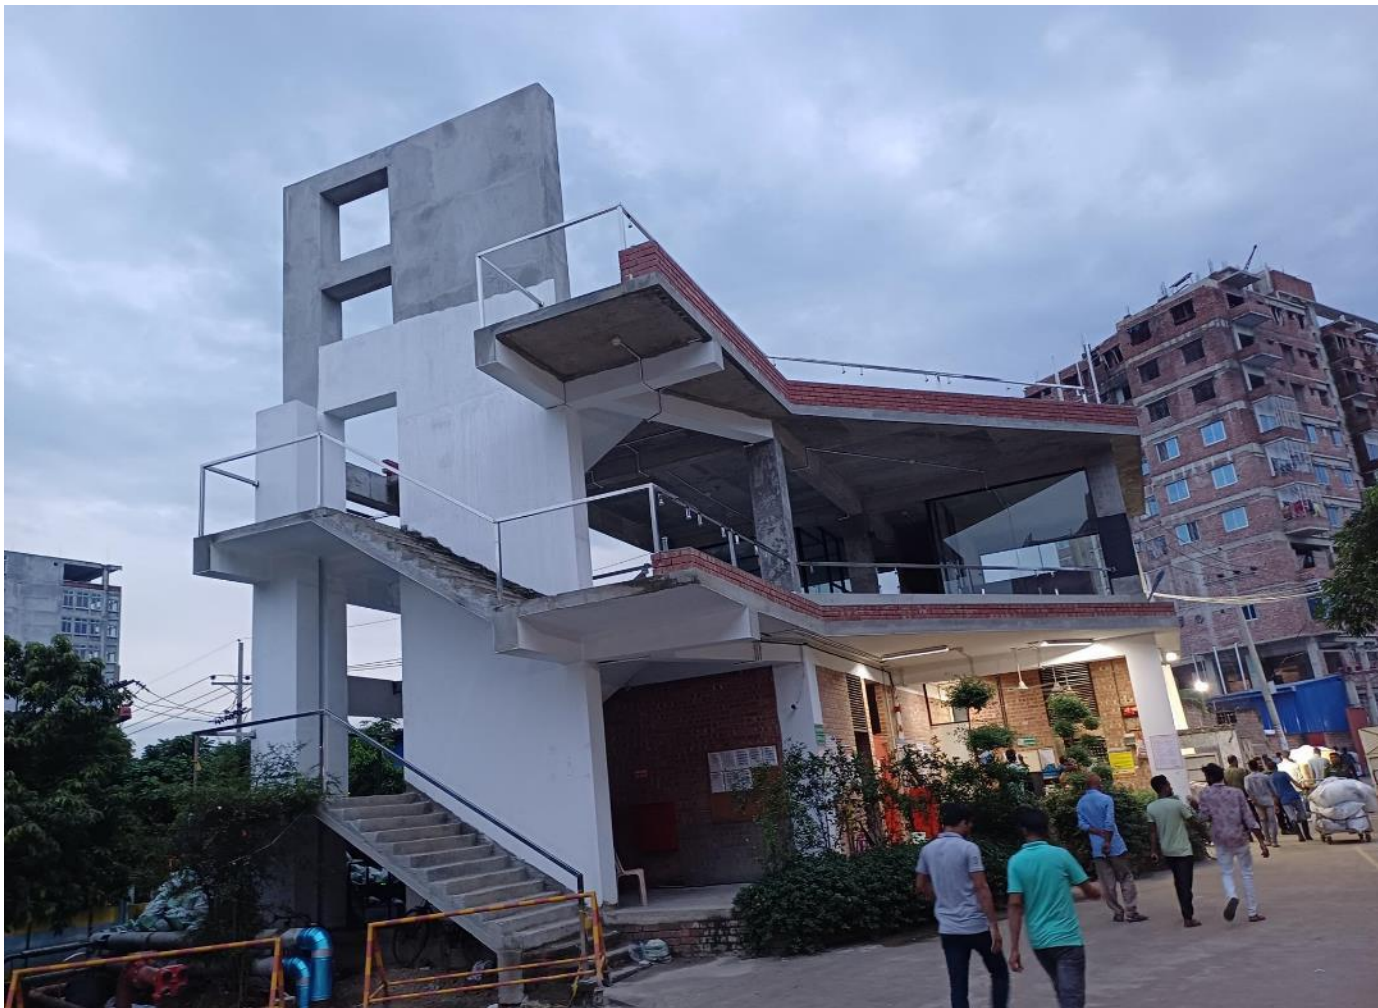
The structure is being used for Surveillance room, RMS Room & office. The building engineer is required to check the structural members against lateral loading considering the in-situ material strength, and the design report to be revised with all the information indicated in section 1.9 of the BNBC and submitted to RSC for review.

| Item No. | Observation | Recommended Action Plan | Recommended Timeline |
|---|---|---|---|
| 16 | Design report need to be reviewed by RSC. (Building-21) | Submit the design documents to reviewed by RSC. | 6-weeks |
