Sisal Composite Limited (Relocated)

Purbohati, Natunpara, Hemayetpur, Savar, Dhaka, Bangladesh.

8 November 2023

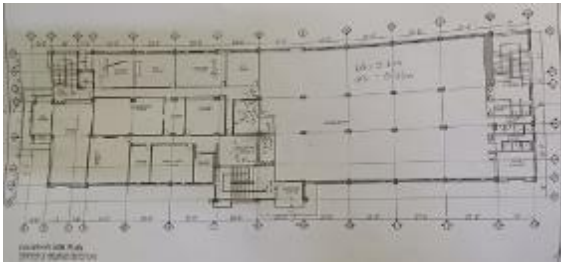
Floor buildup, false ceiling and partition wall height missing in architectural drawing

Description: Toilet floor buildup, false ceiling and partition wall height not mentioned in the architectural drawing. Column orientation mismatch found at GL-4A. Also, marked C12 column not found above 4th floor. Building engineer is required to update the as built drawings.

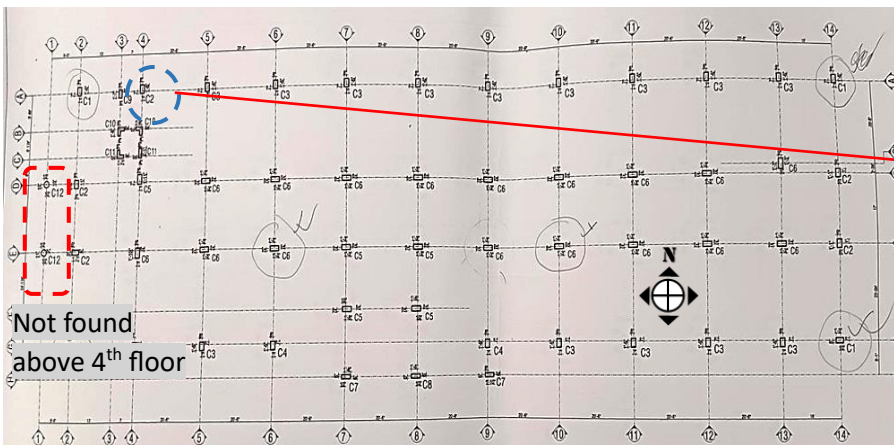
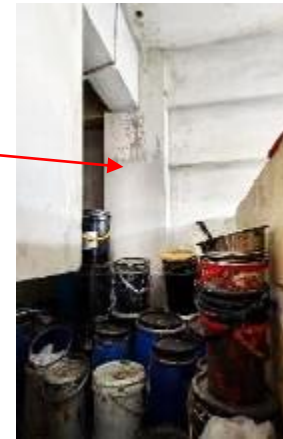
Column orientation mismatch

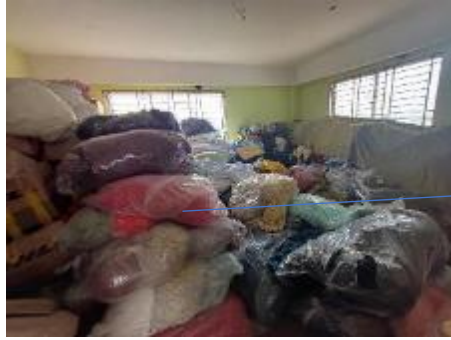
Fabric store

Description: According to BNBC 2006, a minimum of 6 kPa live load required to be considered for light storage. In the load plan and design report, 1.5 kPa & 4.8 kPa live load is considered for storage at roof and 3rd floor respectively. The building engineer is required to revise the load plan for storage area based on the BNBC live load requirement, update the design report accordingly.

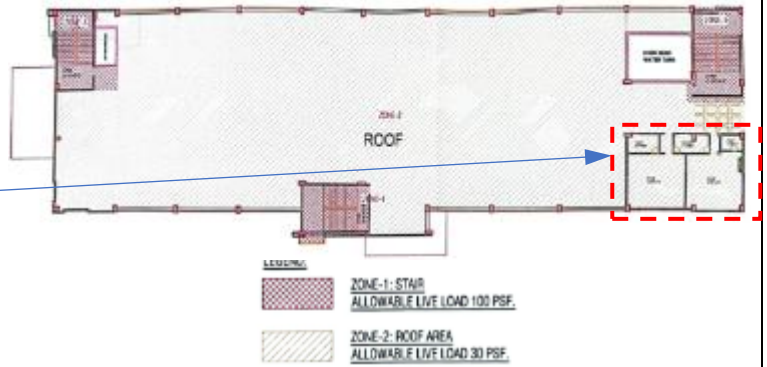
Load plan of storeroom at roof (1.5kPa)

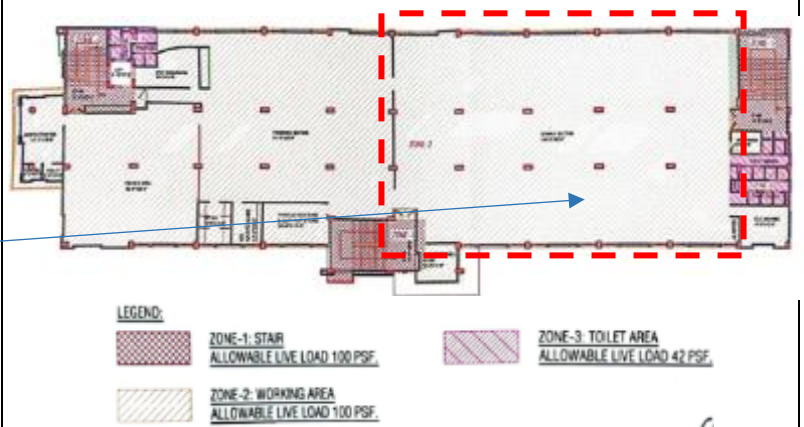
Load plan of finished fabric store at 3rd floor (4.8 kPa)

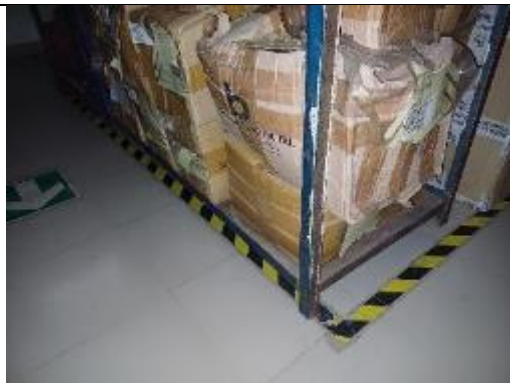
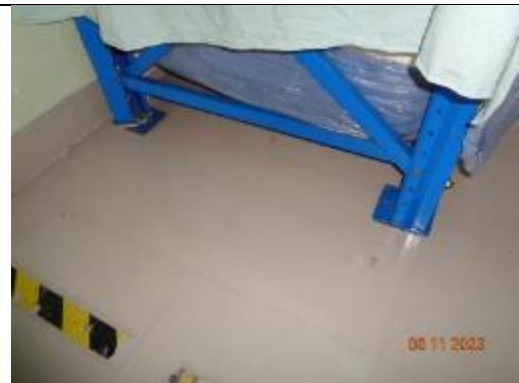
Description: Storage rack found within the building without braced/anchored All non-structural elements including storage racks in the building shall be adequately anchored or braced to resist earthquake forces.

6	Lack of anchorage of nonstructural elements. (Main Building)	All non-structural elements including storage racks in the building shall be adequately anchored or braced to resist earthquake forces.	within 6 months
7	High stress in foundation. (Main Building)	Building engineer is required to carry out Detailed Engineering Assessment (DEA) based on in-situ material strength, minimum floor live loads as per BNBC and submit to RSC for review.	within 6 weeks
8	High stress in foundation. (Main Building)	Carry out remedial works if required.	within 6 months
9	Mismatches in as-built drawings. (Utility Building)	Building engineer is required to prepare accurate as-built drawing.	within 6 weeks
10	Frequency of testing doesn't comply with BNBC requirement. (Utility Building)	The building engineer is required to verify the mentioned design strength of concrete by taking adequate core samples. After verification of material strength, the building engineer is required to revise the design documents.	within 6 weeks

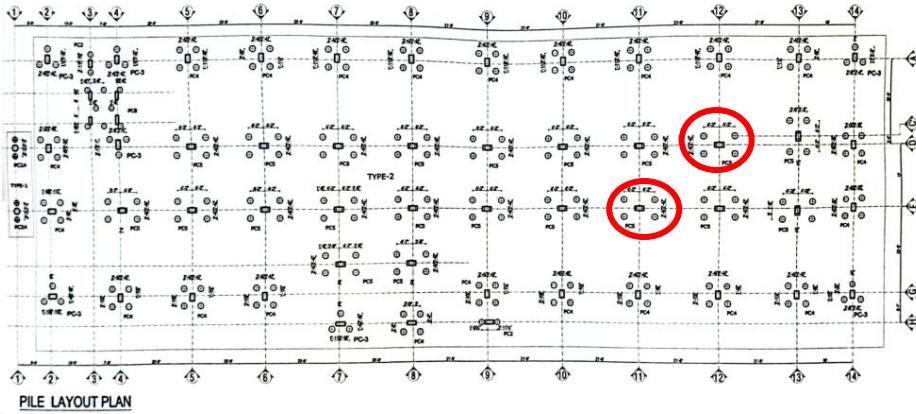
Pile layout plan

Description: Cursory calculation indicates that the marked pile foundations are marginally overstressed based on 5kPa typical floor live load, 6kPa storage live load and observed water load considering allowable pile capacity 58 ton (FoS-2.5) based on soil test report (Table-1). Building engineer is required to carry out Detailed Engineering Assessment (DEA) based on in-situ material strength, minimum floor live loads as per BNBC and submit to RSC for review.

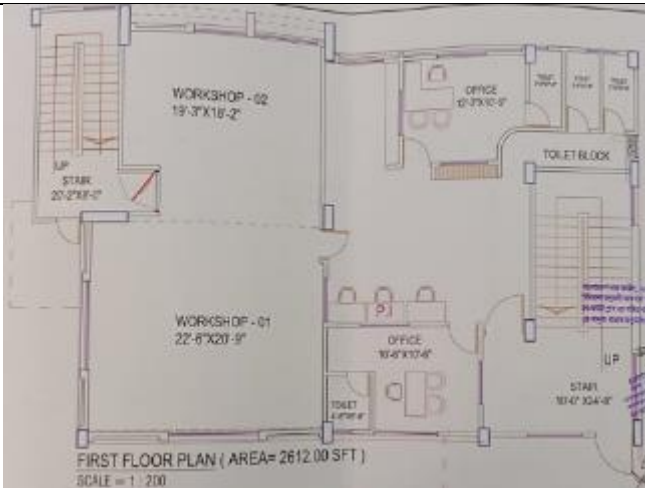
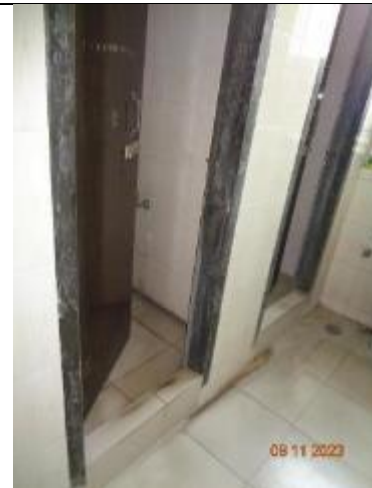
Description: Floor Buildup, false ceiling and partition wall height missing in as-built drawing. Building engineer is required to prepare accurate as-built drawing.

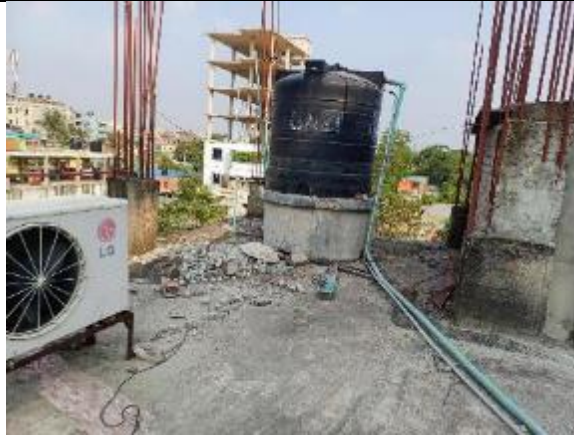
Possible falling hazard

Description: The building engineer is required to provide barrier for open area to prevent falling hazard at roof.

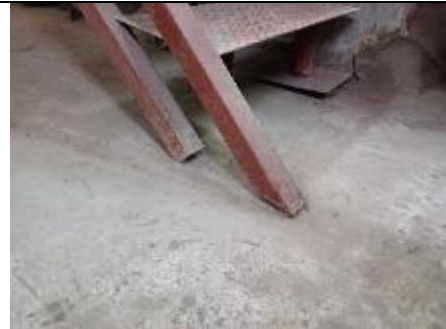
Apparently non-engineered steel stair

Description: Apparently inadequate steel member & lack of anchorage were observed for the steel stair at fire pump room. Building engineer is required to check the adequacy of members and connections of the stair.

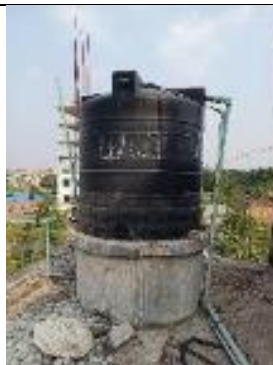
Lack of anchorage of plastic water tank at roof

Description: The plastic water tank was not laterally braced. All non-structural elements including plastic water tanks in the building shall be adequately anchored or braced to resist earthquake forces.

17	Lack of anchorage of nonstructural elements. (Utility Building)	All non-structural elements including plastic water tanks in the building shall be adequately anchored or braced to resist earthquake forces.	within 6 months
18	Non-engineered shed. (Doctor & Daycare Shed)	The building engineer is required to replace the non-engineered shed with an engineered shed.	within 6 months
19	Lack of anchorage for uplift forces. (Security Shed)	The building engineer is required to provide necessary anchorage for the roof to resist uplift forces.	within 6 weeks
20	Lack of anchorage for uplift forces. (Security Shed)	Carry out remedial works if required.	within 6 months

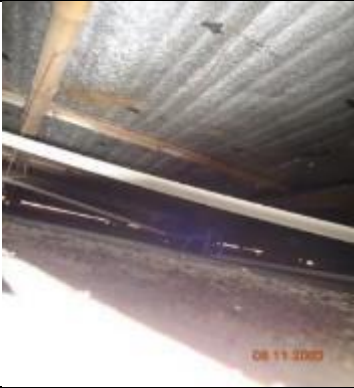
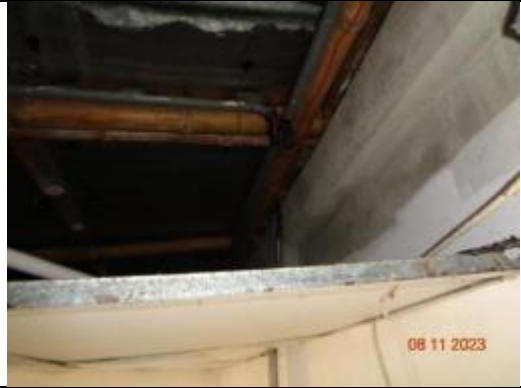
Bamboo rafter with tin roof supported by brick wall

Description: Non-engineered roof observed for the shed. The building engineer is required to replace the non-engineered shed with an engineered shed.

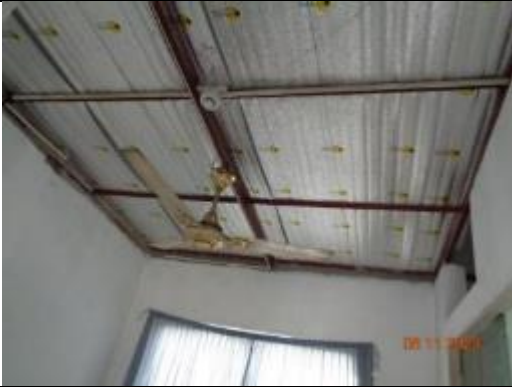
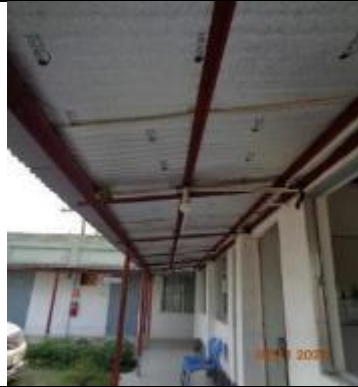
Lightweight steel roof supported by periphery brick wall

Description: Anchorage was not found between roof & brick walls. The building engineer is required to provide necessary anchorage for the roof to resist uplift forces.
