Union Sportswear Ltd. (Extension)

116, Pagar-Morkon Link Road, Pagar, Gazipur
Geographic Coordinates: 23.898500, 90.421014
17 October 2023

Executive Summary

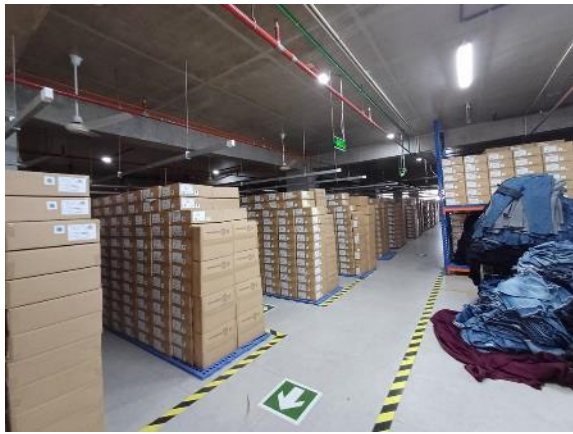
Storage live load not comply with BNBC

Storage on 8th floor

Live load on 4th floor and 8th floor are considered as 5 kPa in prepared load plan. As per BNBC-2020, live load for light storage areas is required to be considered minimum 6 kPa. However, the building engineer is required to revise the live load plan as per BNBC requirement and check the design accordingly.

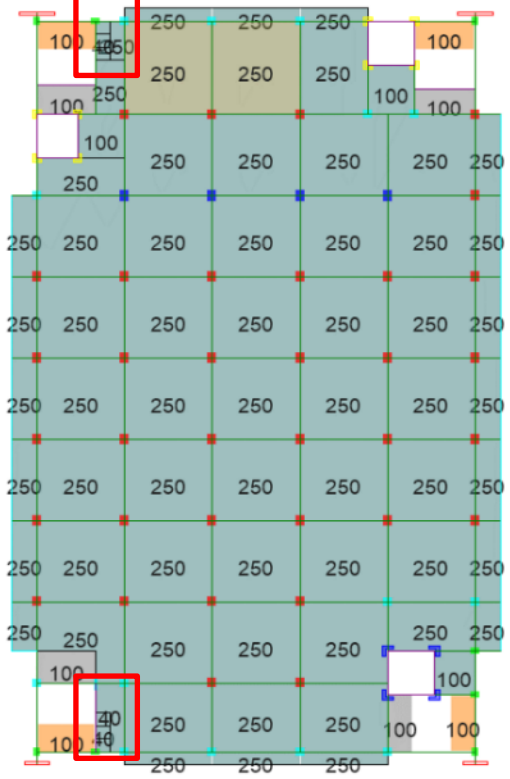
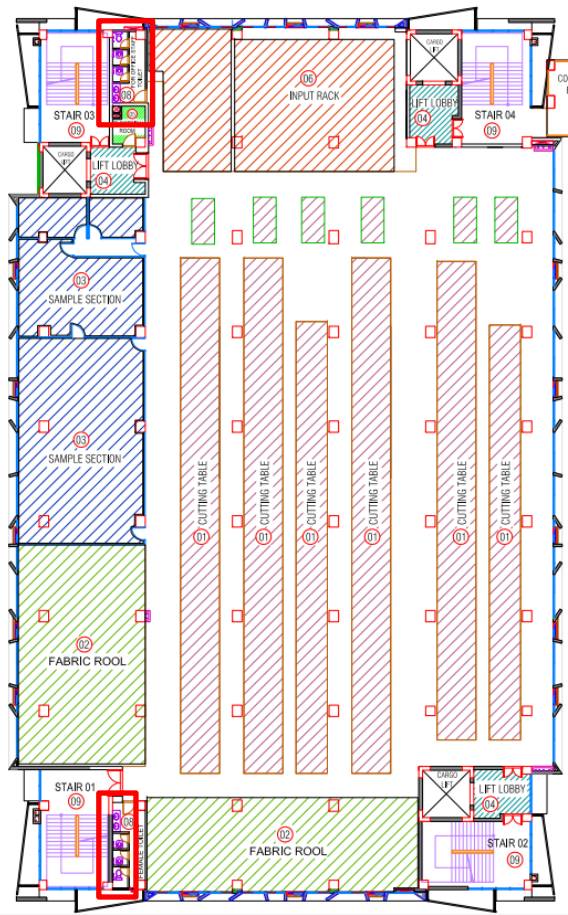
Figure 2.8.3: Applied Live Load on 2nd floor (psf)

Live load: 2nd floor 2 kPa (40 psf) for toilet zone in FEA

Live load plan- 2nd floor 12.5 kPa (250 psf) for toilet zone

Live load on 2nd floor is considered as 12.5 kPa including toilet zone in prepared load plan. But in FEA, live load for toilet areas is considered 2 kPa. However, the building engineer is required to revise the load plan as per BNBC requirement and check the design accordingly.

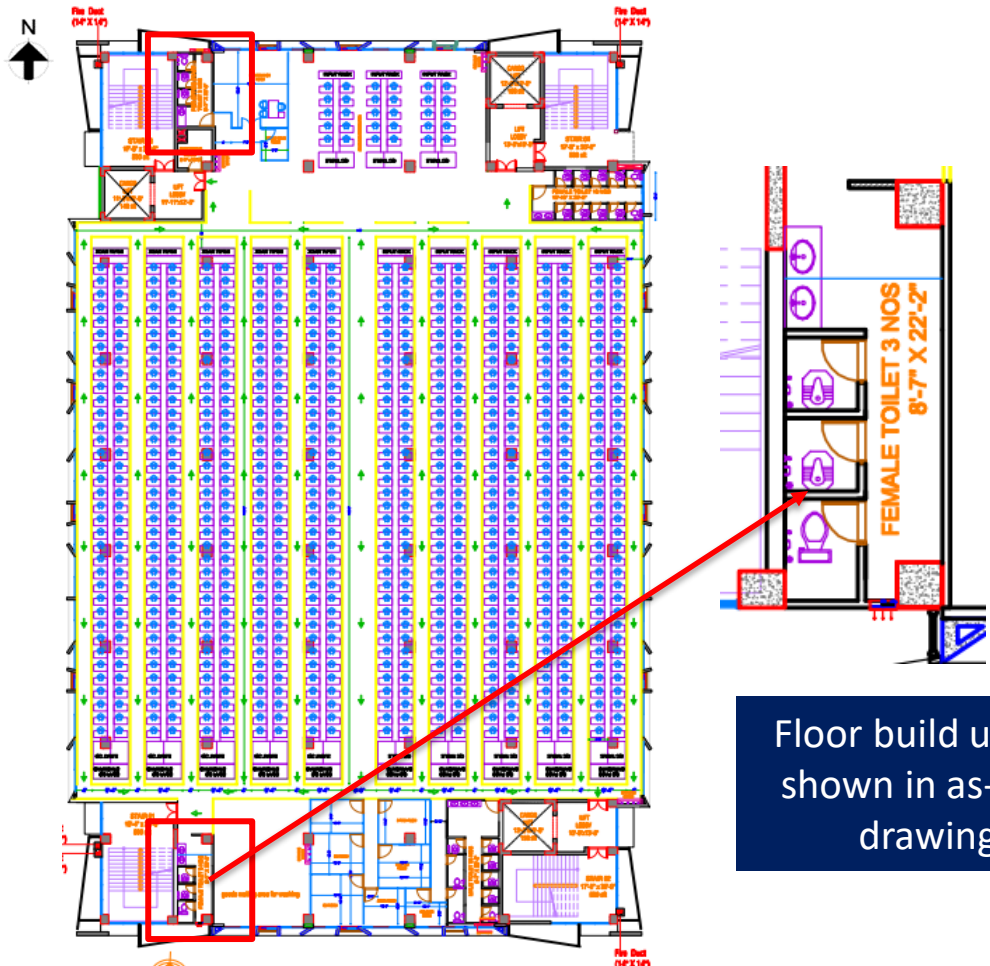
Floor build up not shown in as-built drawing

In as-built architectural drawing, floor build up were not shown. However, floor build up was found 450 mm. Building engineer is required to survey the whole structure and update the as-built drawing accordingly.

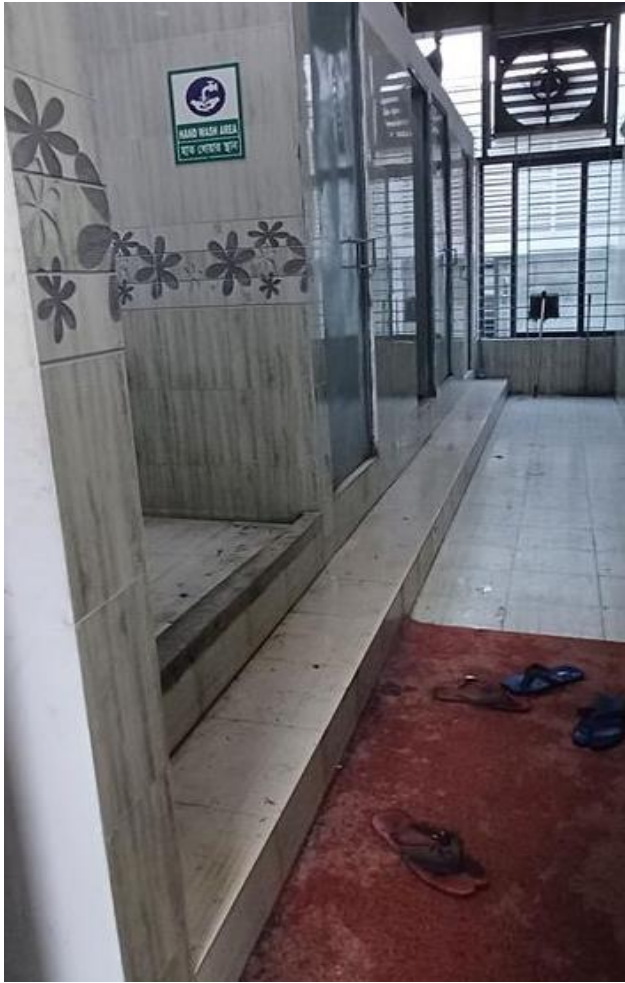
Floor layout plan & blow up of toilet zone area.

Floor build up found 450 mm

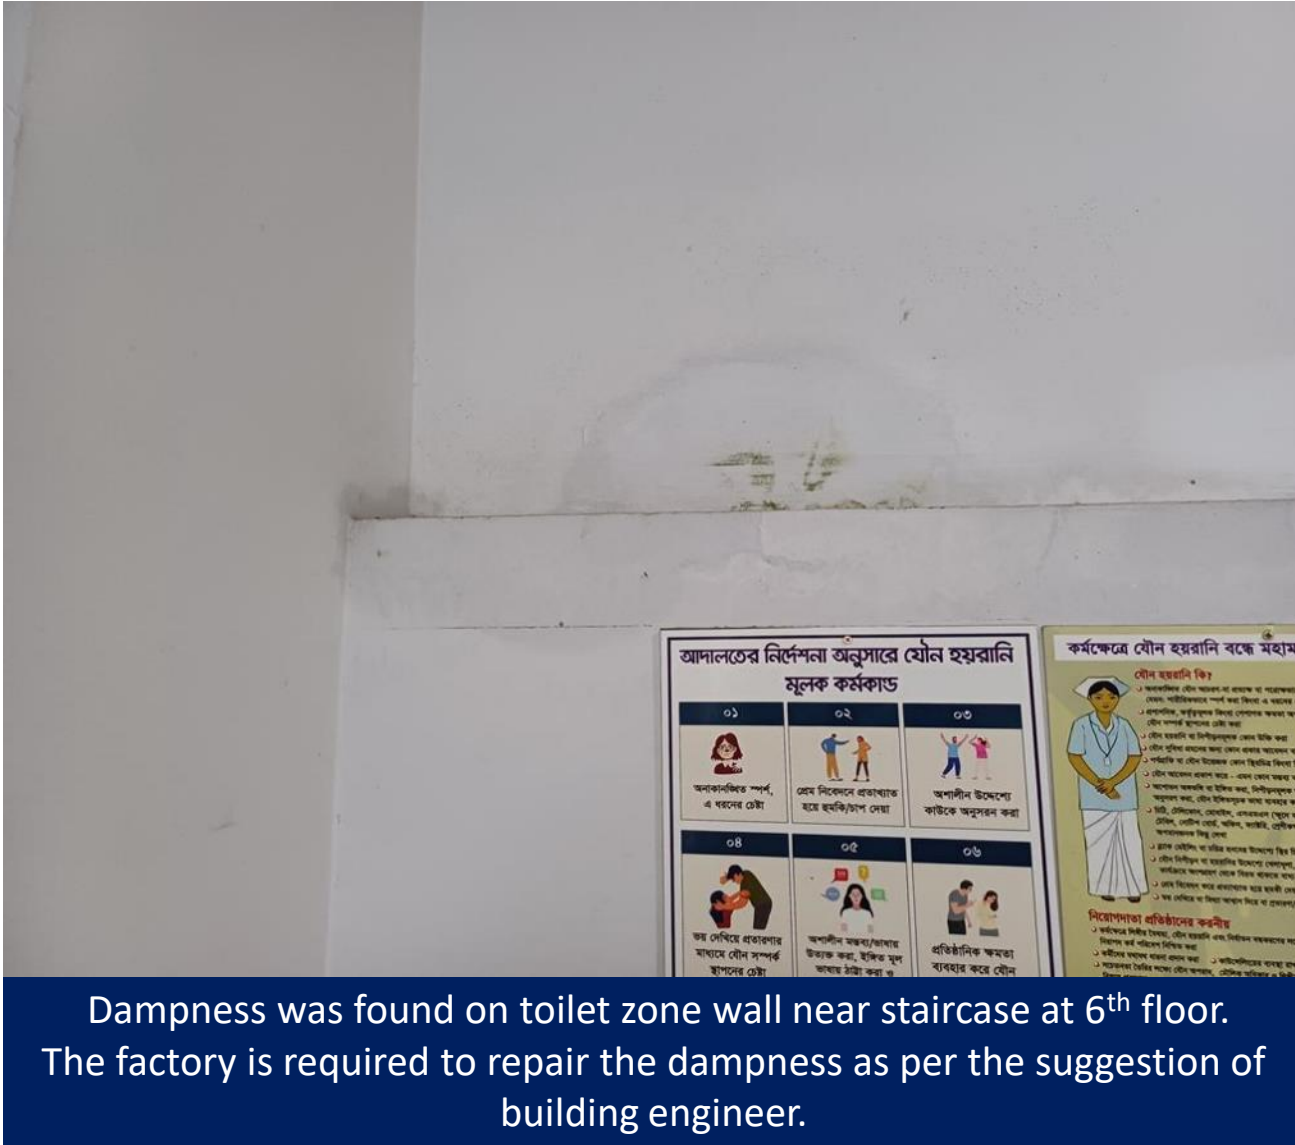
Dampness on toilet zone wall

Dampness was found on toilet zone wall near staircase at 6th floor. The factory is required to repair the dampness as per the suggestion of building engineer.

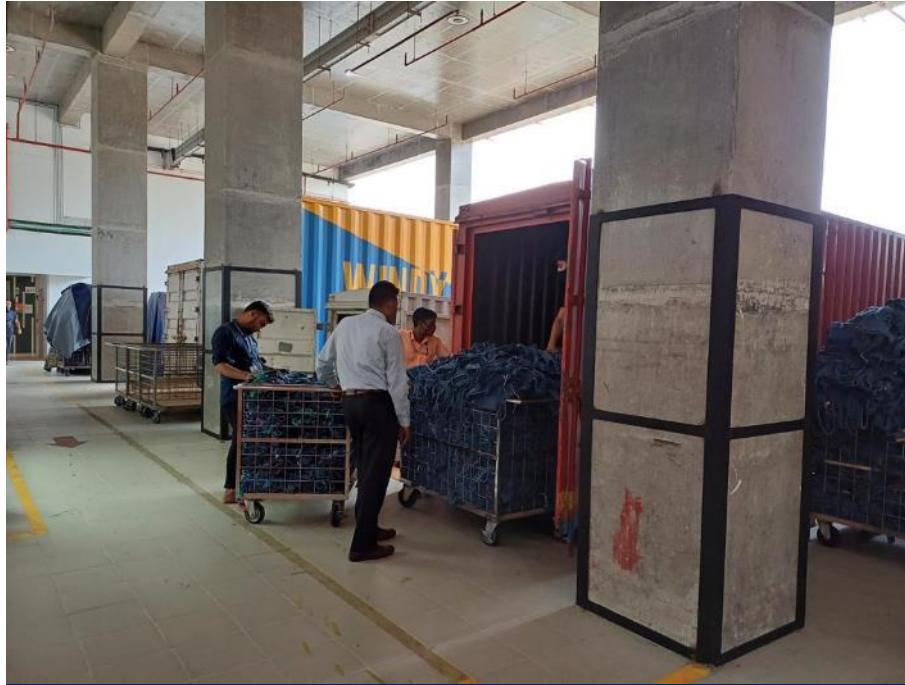
Barrier connected to column directly

Column adjacent of driveway of loading unloading area is susceptible to vehicle impact. The factory has provided light barrier touching the column surface. The building engineer is required to provide sufficient barrier just outside of exposed column to prevent the vehicle impact.

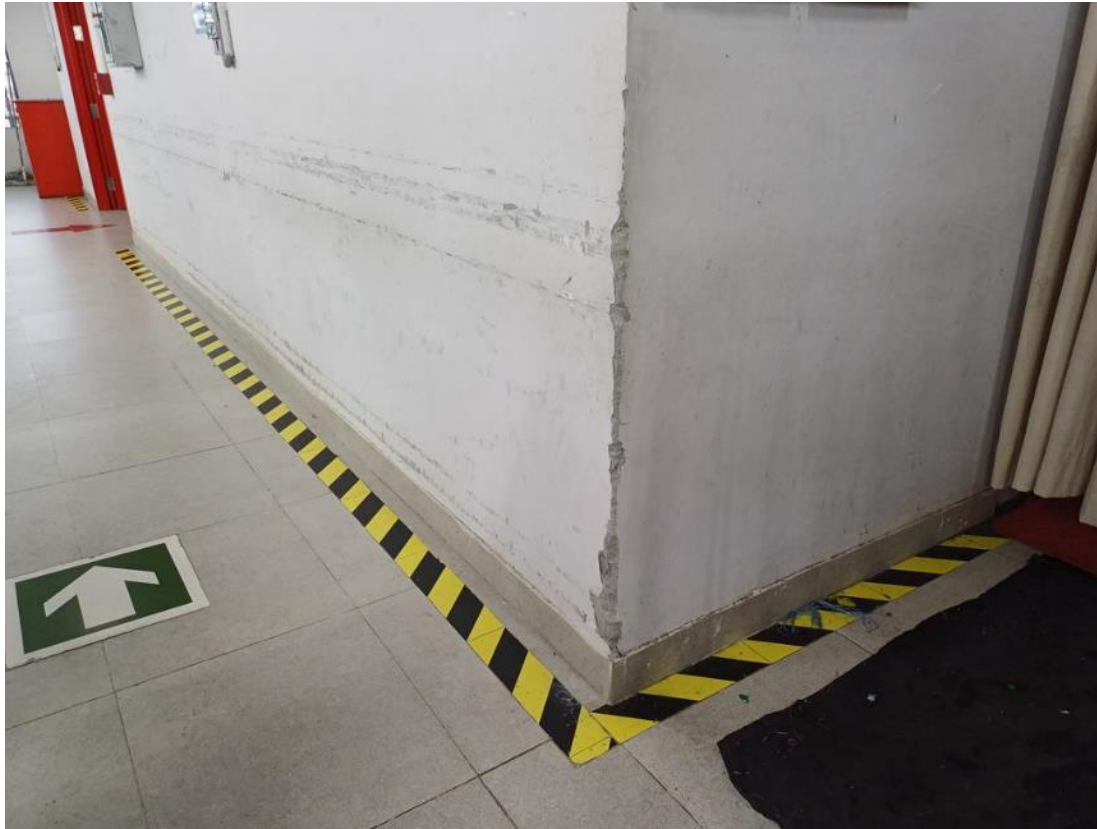
Signage of damage in wall due to trolley impact

The factory is required to provide necessary column/wall guards to resist possible trolley impact.

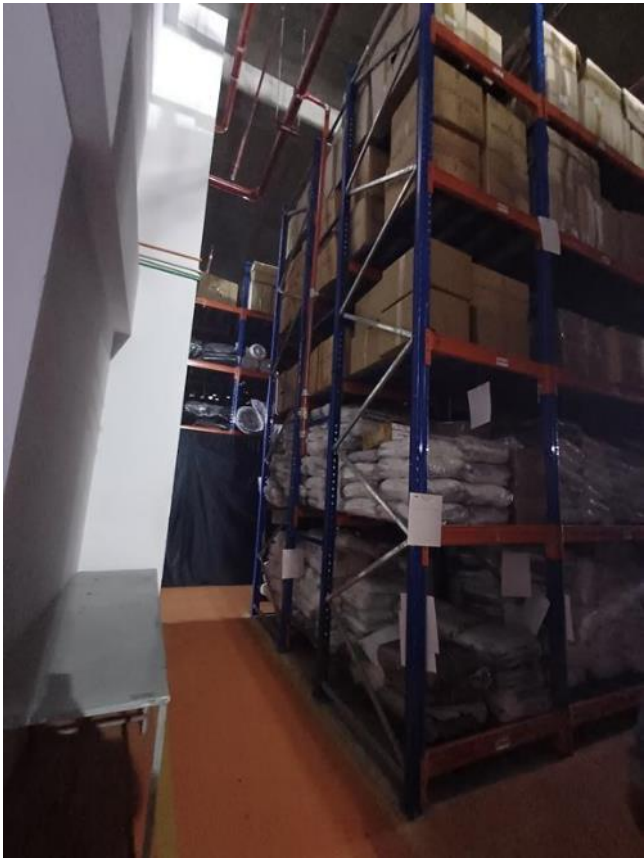
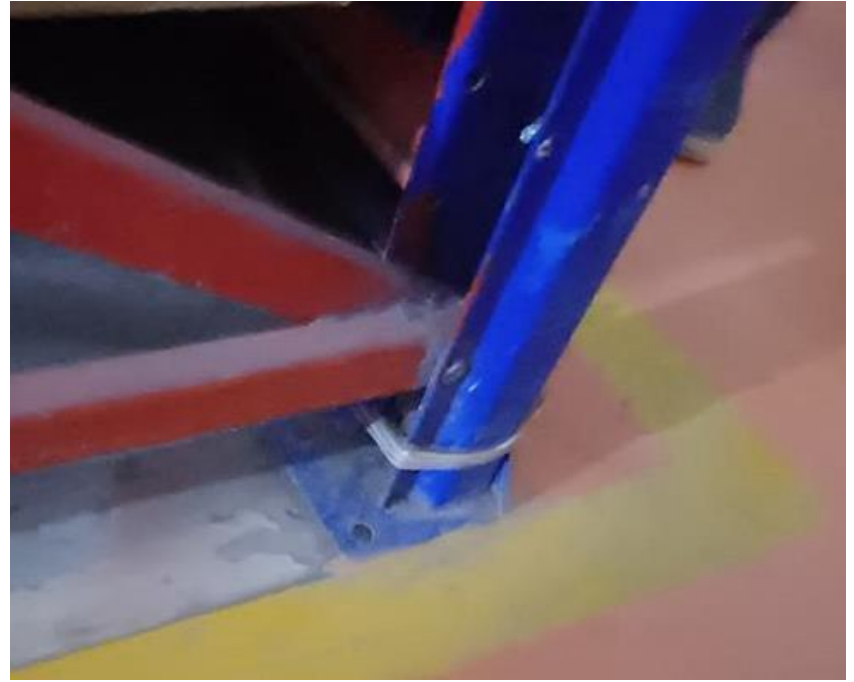
Storage rack found within the building without braced/anchored

All non-structural elements required to be braced/anchored

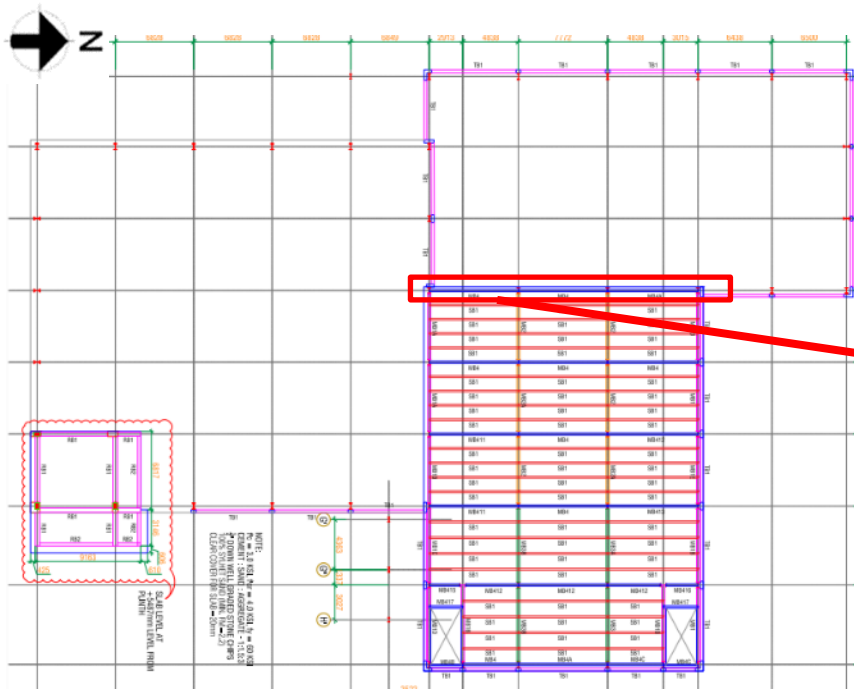
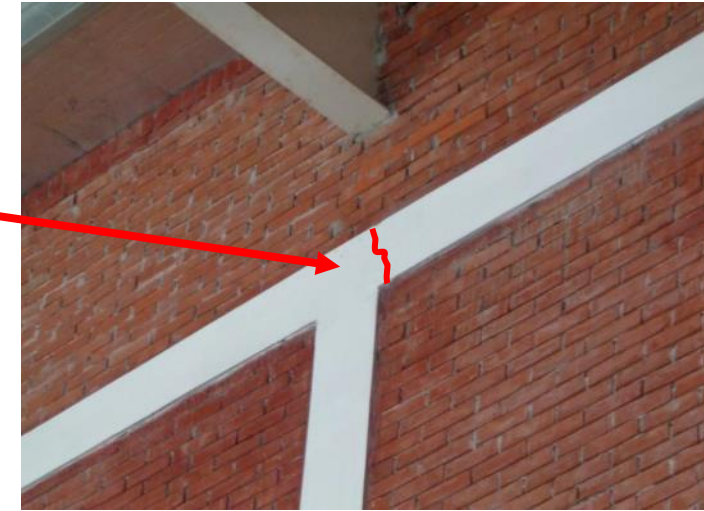
Cracks in beam (ground floor tie beam)

Cracks were observed on ground floor tie beams. The factory is required to repair the crack as per the suggestion of building engineer.

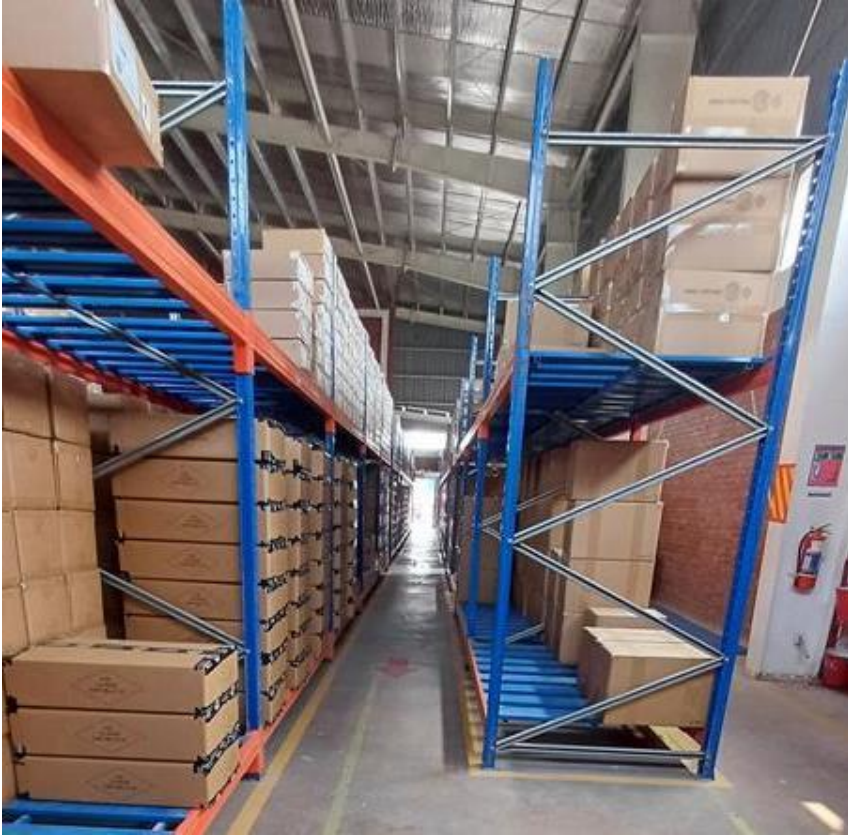
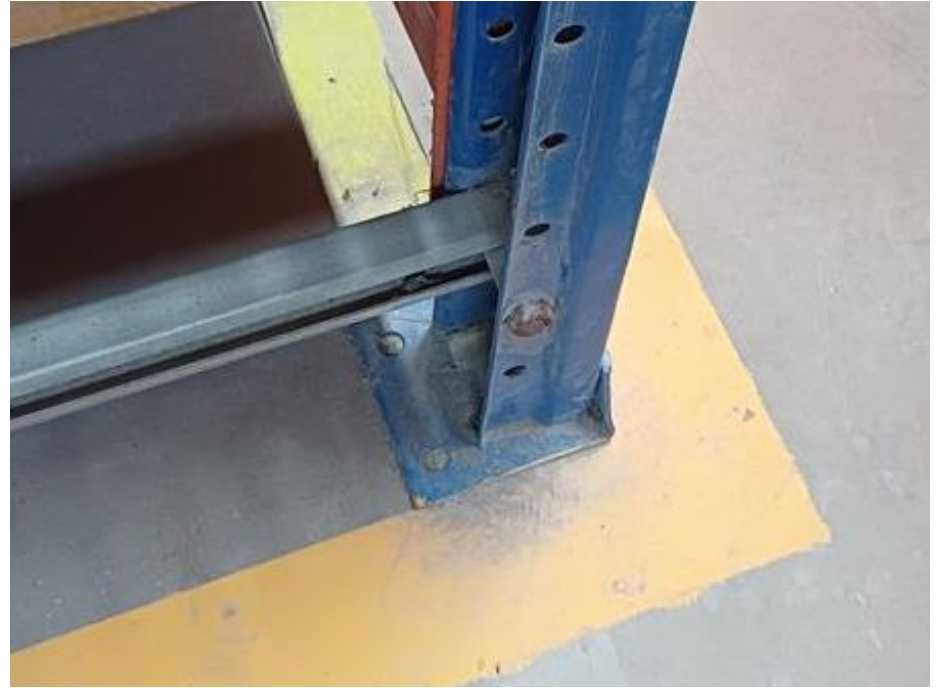
Storage rack found within the building without braced/anchored

All non-structural elements required to be braced/anchored.

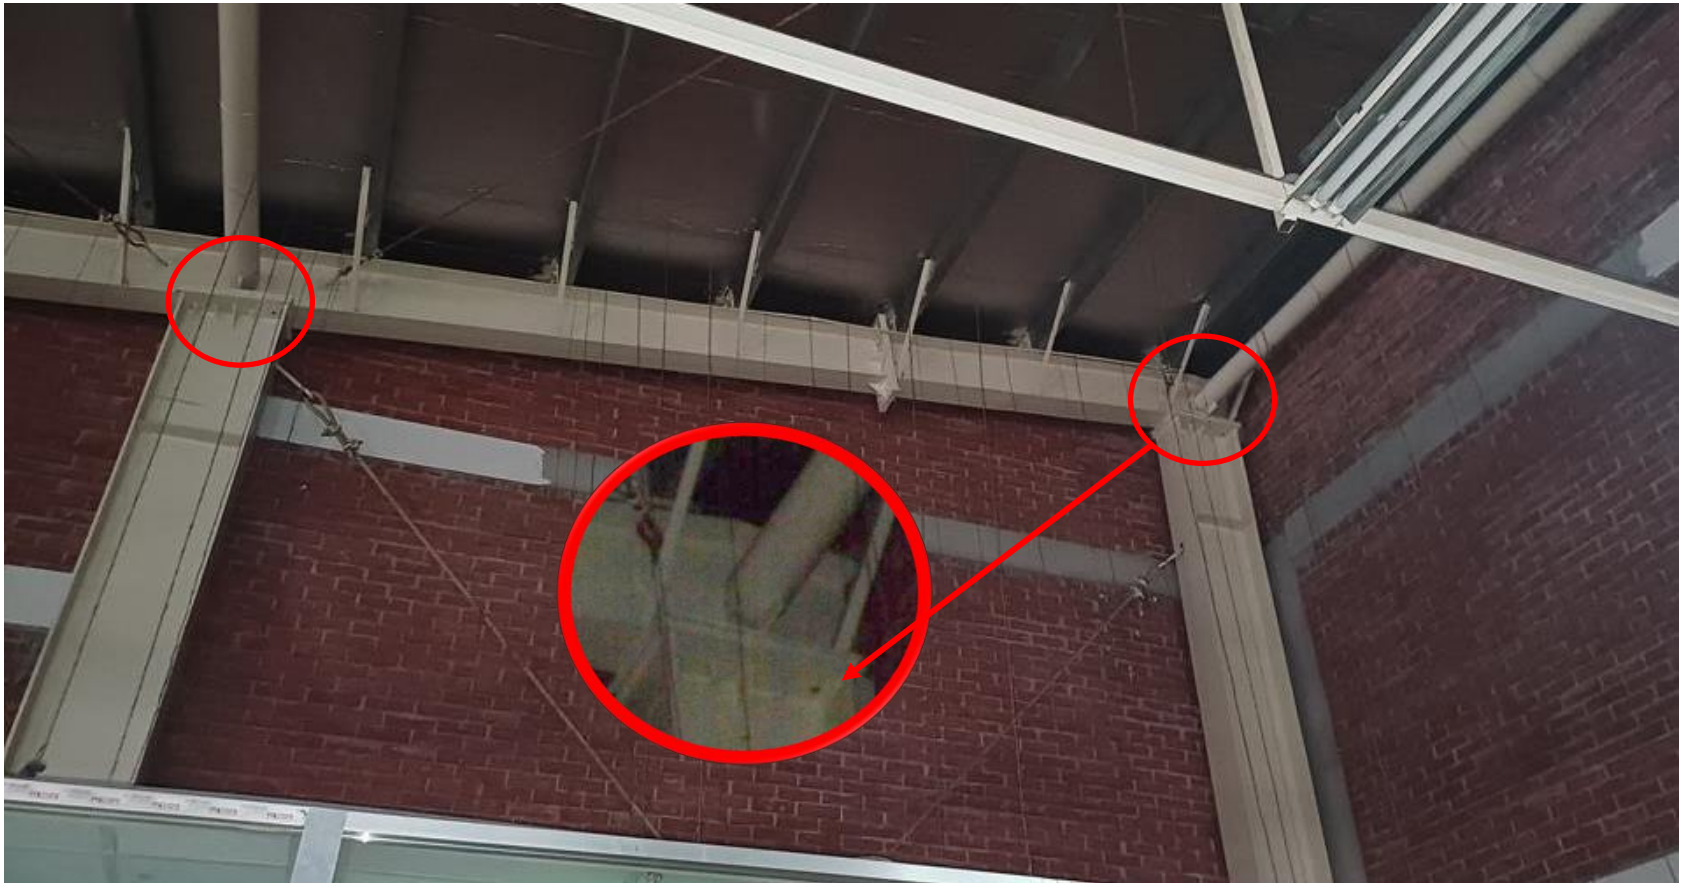
Bolt missing in 1st floor dining Area

Bolt missing in several connection joint. Building engineer is required to identify all locations and install missing bolt accordingly.

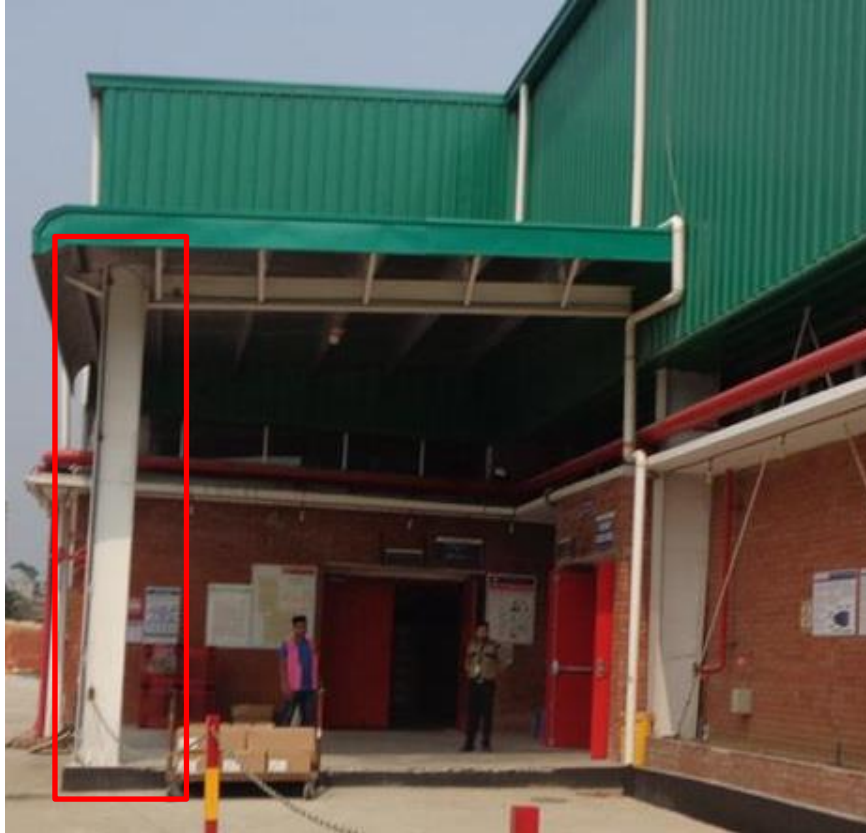
Steel Column susceptible to vehicle impact

Columns at ground floor are prone to vehicle impact. Factory is required to provide barrier for all exposed column at ground floor to avoid possible vehicle impact on column.

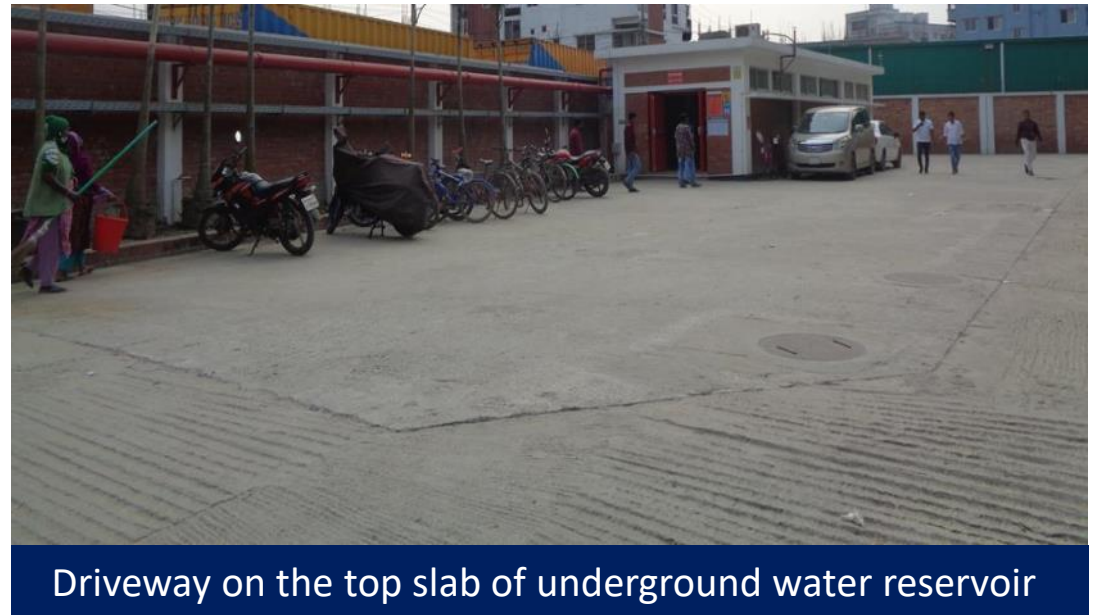
Design Report

The top slab of underground water reservoir is used for driveway of heavy vehicles. The allowable design live load is not mentioned in the report. The building engineer is required to revise the design report for vehicle live load and submit to the RSC for review.

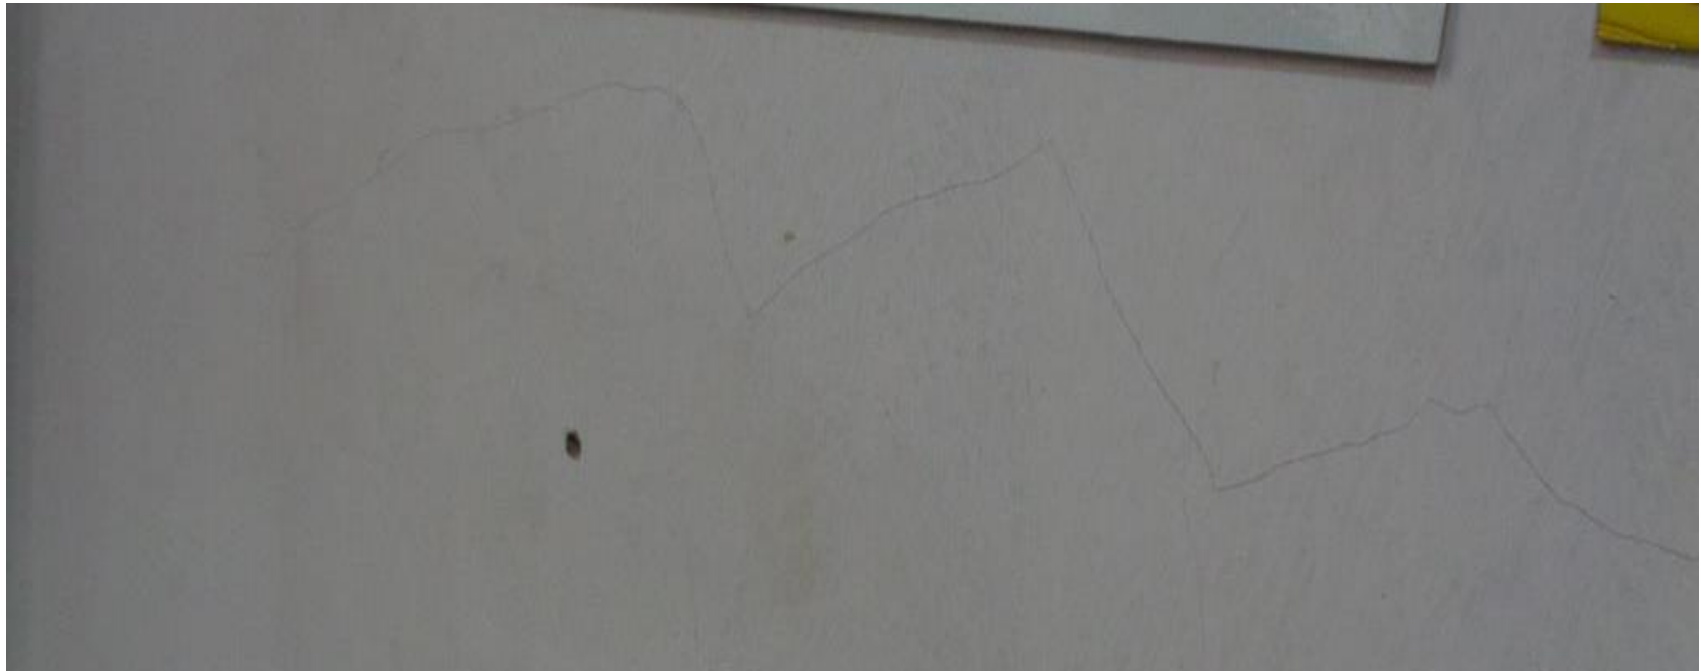
Cracks in retaining wall

Horizontal wavy cracks were observed on retaining wall along the construction joint. The building engineer is required to check the structural impact of the crack and suggest proper repair methodology.

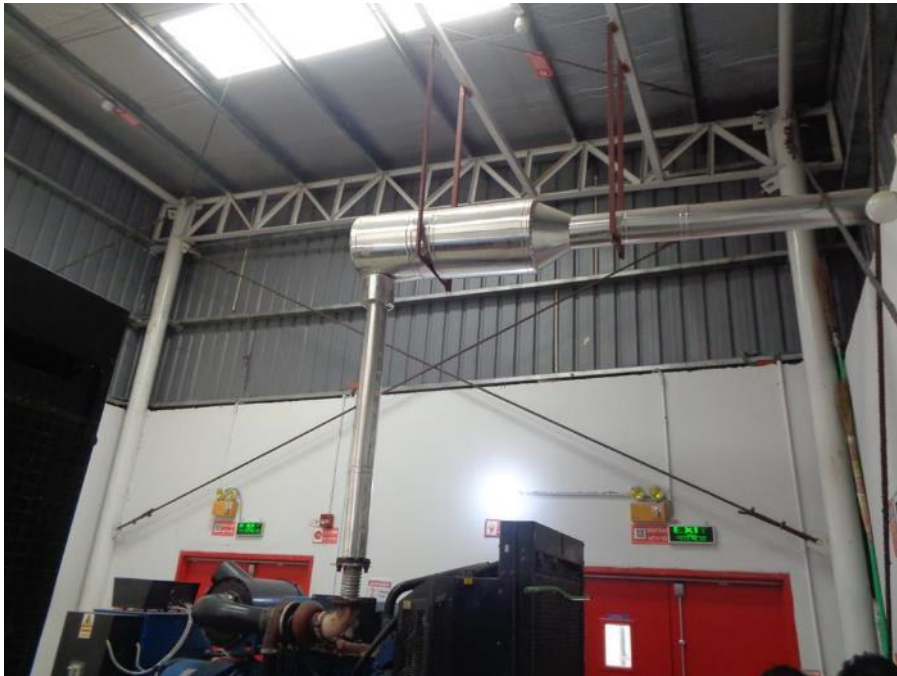
Vertical bracing at half-length of pipe column.

The vertical bracings were connected apart from baseplate. Also, one extra vertical chord member was shown in the provided drawing. The building engineer is required to survey the whole structure and update the as-built drawing and revise the structural analysis & design accordingly.
