# Adury Apparels Ltd (Extension-02)

Karardi, Shibpur, Narsingdi

9 November 2023

## Structural Inspection Report

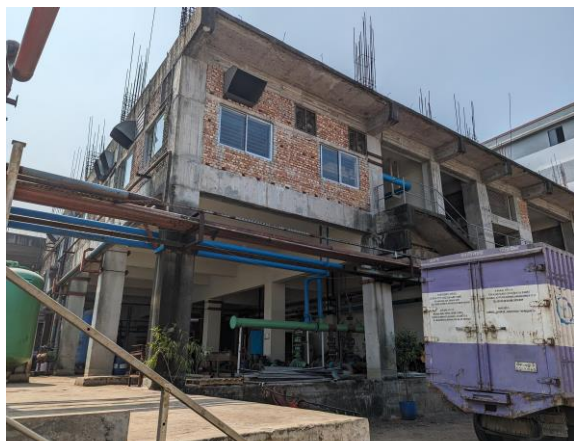
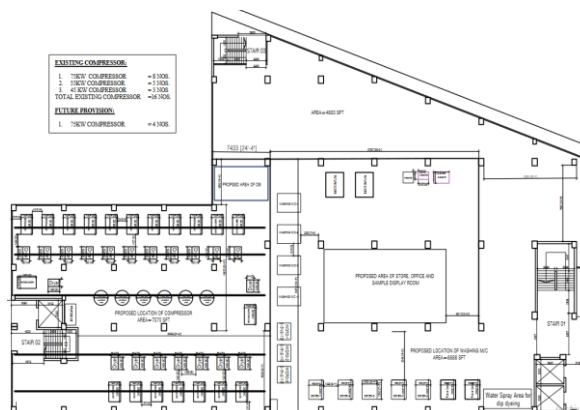
Typical Floor layout plan

### Observation-1: Lack of information in as-built drawing. (Building-5)

**Description:** During inspection, only floor layout plan was provided in available as-built architectural drawing. No elevation view and sectional details were provided. Building engineer is required to update as-built drawing incorporating all architectural details of this Building.

| Observation | Action Plan | Timeline |
|---|---|---|
| Lack of information in as-built drawing. (Building-5) | Building engineer is required to update as-built drawing incorporating all architectural details of this building. | within 6 weeks |

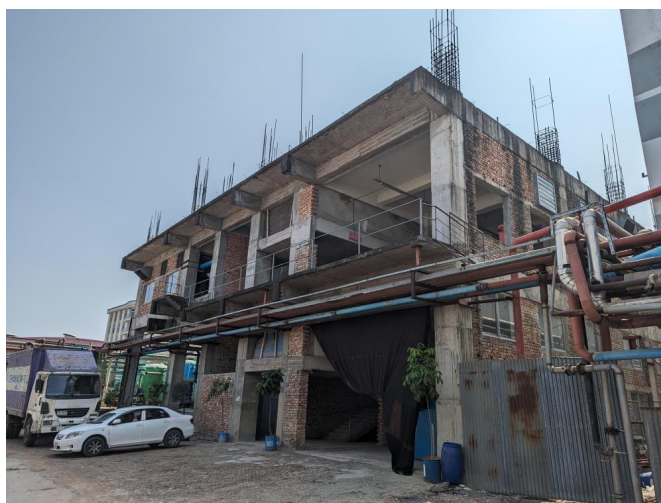
Building-5

### Observation-2: Absence of design documents. (Building-5)

**Description:** As per BNBC, every building or structure designed shall have its design documents prepared in accordance with the provision of Section 1.9.1. The design document shall include a design report, and a set of structural drawings, which shall be prepared in compliance with section 1.9.1.1 and section 1.9.1.2 as per BNBC. At the time of inspection, design report was not available which is required to be prepared in compliance with BNBC 2020.

| Observation | Action Plan | Timeline |
|---|---|---|
| Absence of design documents. (Building-5) | Building is required to prepare a set of design report in compliance with BNBC. | within 6 weeks |
| Absence of design documents. (Building-5) | Implement remediation work if required. | within 6 months |

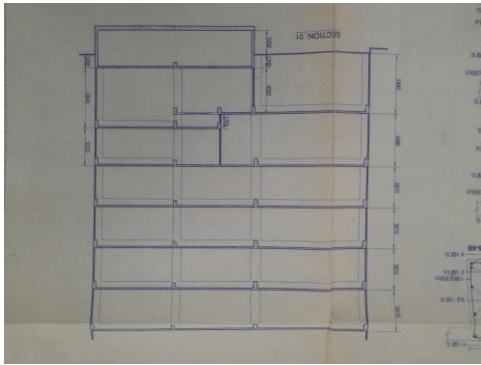
Permit drawing- 6 storey

**Description:** The building has a permit drawing for 6 storied and the factory is intended to conduct vertical extension in future. However, the building is currently existed as two storied. The building engineer is required to prepare a Detail Engineering Assessment (DEA) report prior to the start of vertical extension.

| Observation | Action Plan | Timeline |
|---|---|---|
| Possible vertical extension. (Building-5) | Factory engineer is required to prepare a Detail Engineering Assessment (DEA) report prior conducting any vertical extension. | within 6 weeks |
| Possible vertical extension. (Building-5) | Implement remediation work if required. | within 6 months |

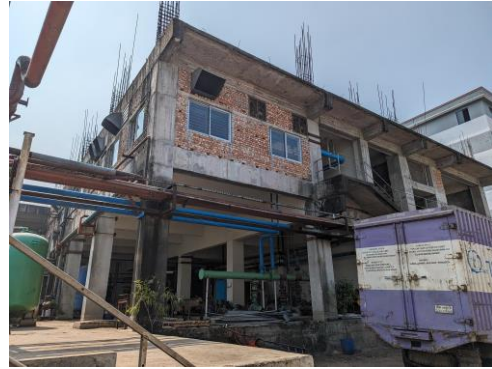
Building-5

**Observation-3:** Possible vertical extension. (Building-5)

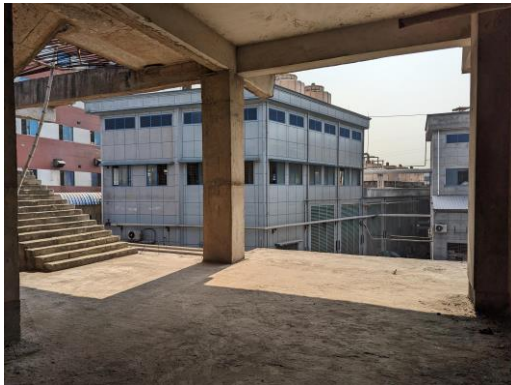
Falling Hazard on 1<sup>st</sup> floor

**Description:** During inspection the barrier was observed in 1<sup>st</sup> floor and roof level. Factory is required to provide parapet/railing at all locations of roof and staircase to avoid possible falling hazard.

| Observation | Action Plan | Timeline |
|---|---|---|
| Possible falling hazard on roof. (Building-5) | Factory is required to provide parapet/railing at all locations of roof and staircase to avoid possible falling hazard. | within 6 weeks |

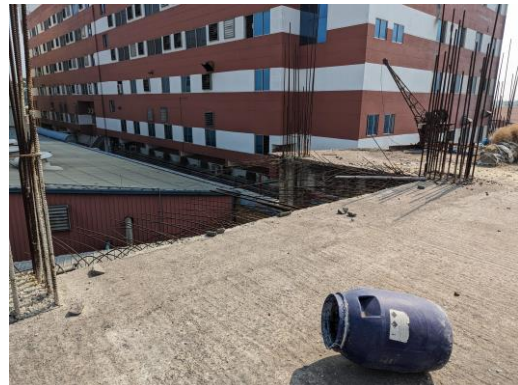
Falling Hazard on roof level

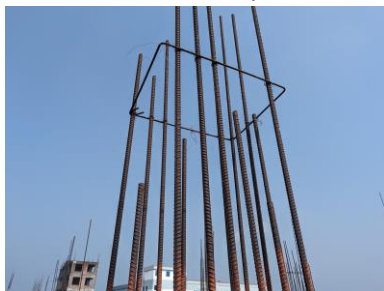
Exposed rebar at roof

**Description:** Corrosion was observed on exposed rebars on roof. Factory is required to provide rust proof paint on exposed rebars to protect from corrosion.

| Observation | Action Plan | Timeline |
|---|---|---|
| Corrosion on exposed rebars on roof. (Building-5) | Factory is required to provide rust proof paint on exposed rebars to protect from corrosion. | within 6 months |

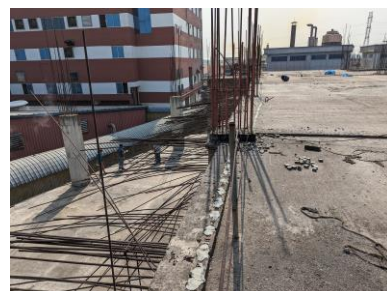
Corrosion in exposed rebars
