# STANDARD GROUP LIMITED

Plot No.-10300, Building -1 and building -2(4,5,6) Floor, Beraiderchala,  
Post-Gilaberaid.; Sreepur PS; Gazipur-1740; Bangladesh.

13 November 2023

## 2. Observations

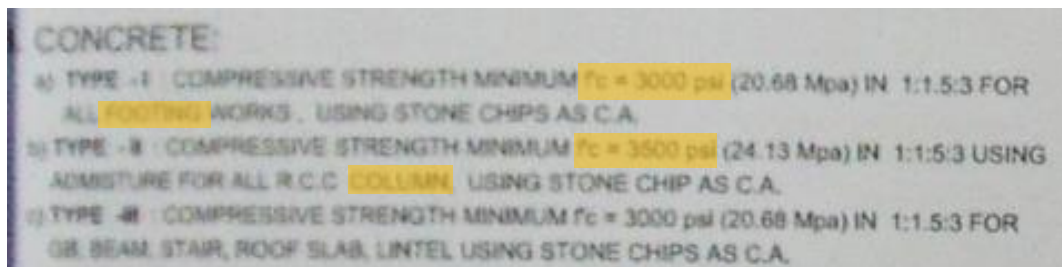
Snapshot taken from construction drawing

**Observation-1:** Inconsistency in compressive strength of concrete (Main Production Building).

**Description:** In design report, compressive strength of concrete has been considered as 4000 psi for footing and column but in construction drawing 3000 psi and 3500 psi were mentioned for footing and column respectively. In addition, the available test results are insufficient to meet the evaluation and acceptance criteria of BNBC. The building engineer is required to evaluate concrete strength as per BNBC, revise design report accordingly and submit to RSC for review.

| Observation | Action Plan | Timeline |
|---|---|---|
| Inconsistency in compressive strength of concrete (Main Production Building). | Verify in situ concrete strength (100mm dia. cores from 4 columns) from lower tier of the building. | within 6 weeks |
| | The building engineer is required to revise the design report for the concrete strength and submit it to RSC for review. | within 6 weeks |

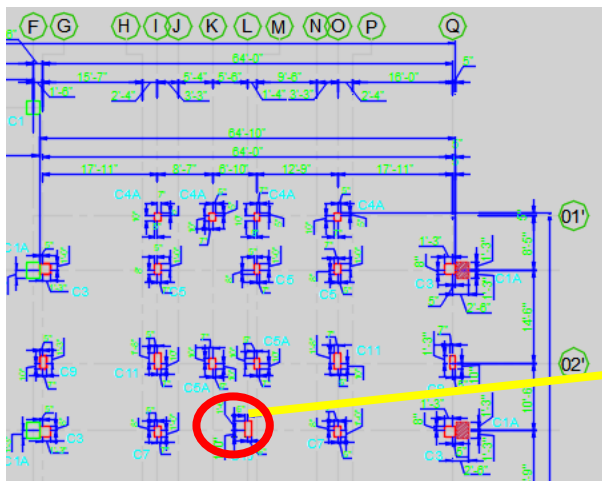
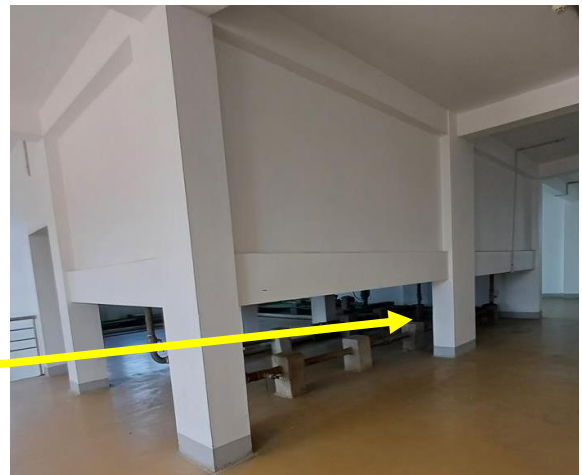
Mismatch in column orientation at grid L-3 (both block A & B)

**Description:** During inspection, some mismatches (column orientation, steel beam instead of RCC beam at roof level, 150 mm buildup at toilet area, partition wall layout etc.) were found between onsite condition and as-built drawing. The building engineer is required to survey the full structure, update as-built drawings as per site condition and incorporate in assessment.

| Observation | Action Plan | Timeline |
|---|---|---|
| Discrepancies in as built drawings (Main Production Building). | The building engineer is required to survey the full structure and produce accurate as-built drawings. | within 6 weeks |

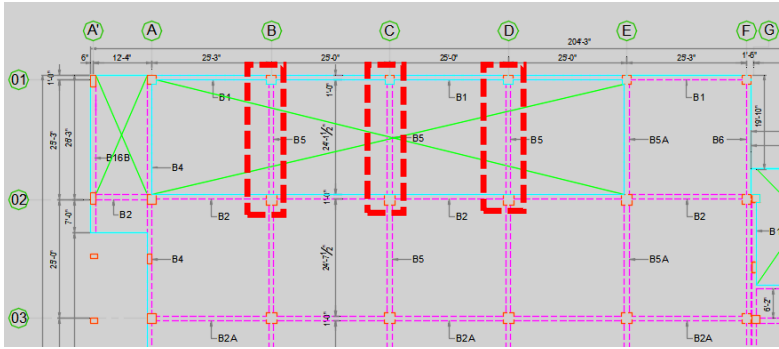
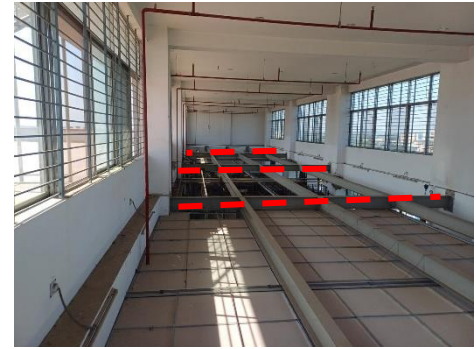
Steel beams instead of RCC beam were found at marked location of roof level (Block A).

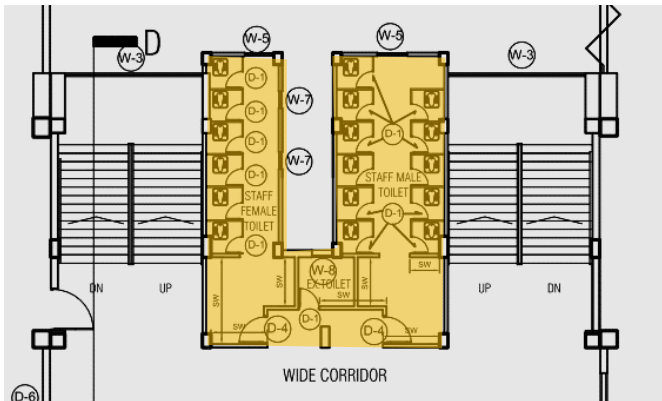
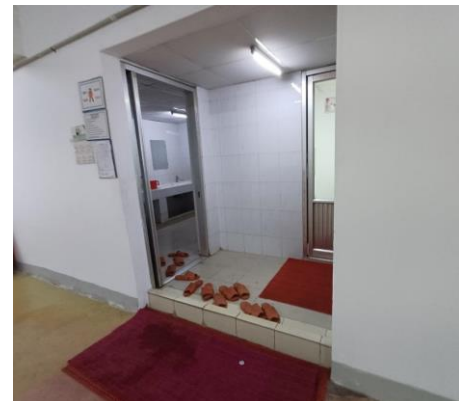
150 mm buildup at toilet area not mentioned in drawing.

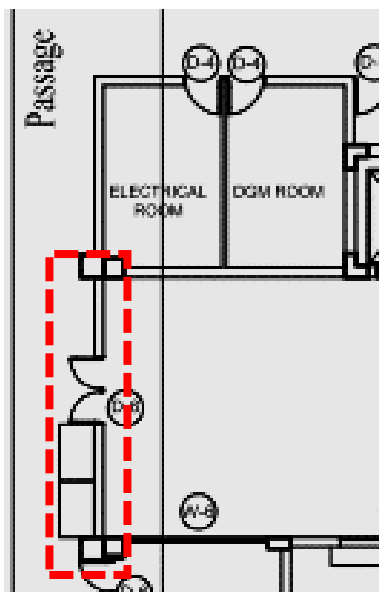
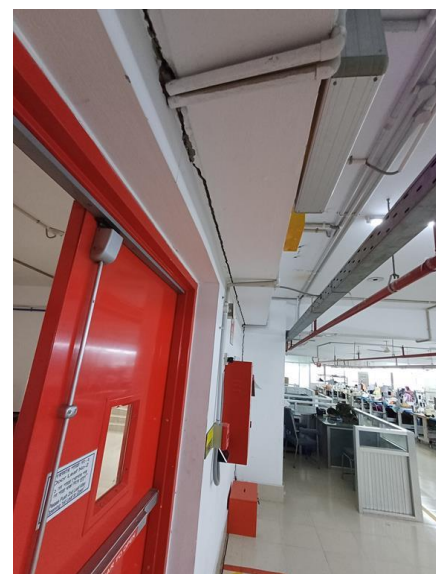
Partition wall was observed at east side of expansion joint instead of west side (Block B).

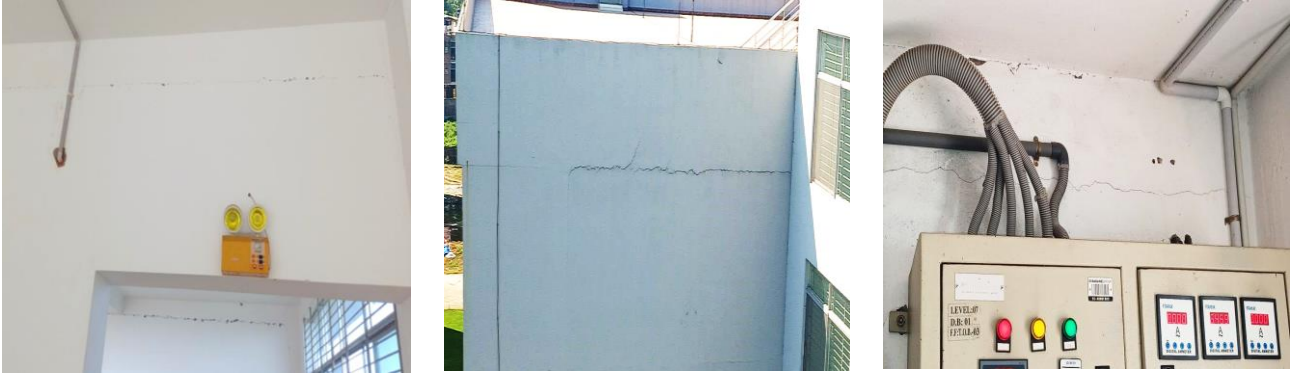
**Observation-3: Horizontal crack on brick wall-beam joint face (Main Production Building).**

**Description:** Horizontal cracks were observed in brick wall-beam joint face at several locations. Factory is required to identify the reason of crack, take necessary remedial measure to repair the wall accordingly.

| Observation | Action Plan | Timeline |
|---|---|---|
| Horizontal crack on brick wall-beam joint face (Main Production Building). | The building engineer is required to identify the reason of crack, take necessary remedial measure to repair the wall accordingly. | within 6 weeks |

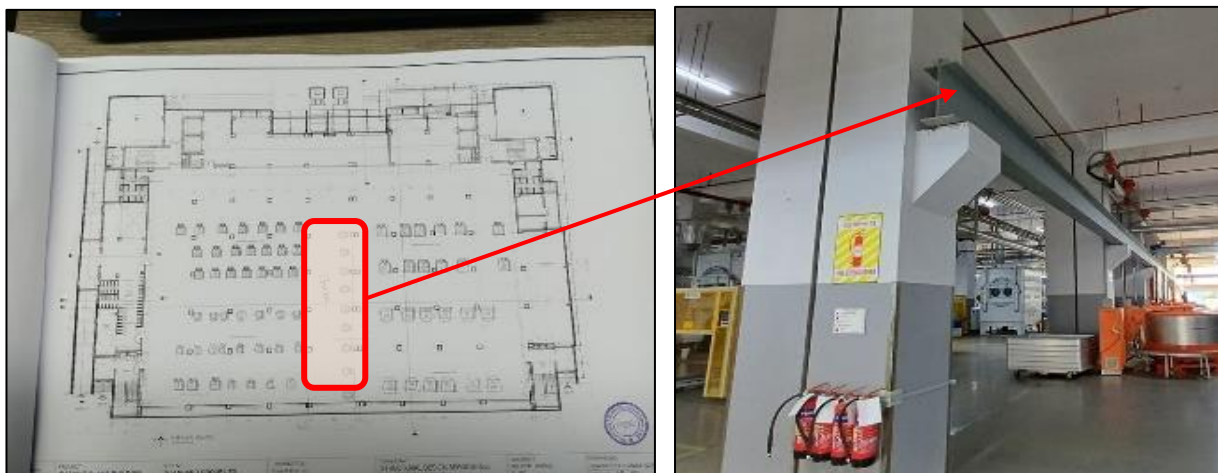
**Observation-5: Discrepancy in as-built drawing (Washing Building).**

**Description:** A monorail crane was found in the ground floor column. But in as-built drawing it was not mentioned.

| Observation | Action Plan | Timeline |
|---|---|---|
| Discrepancy in as-built drawing (Washing Building). | The building engineer is required to update the as-built drawing as per actual site condition. | within 6 weeks |

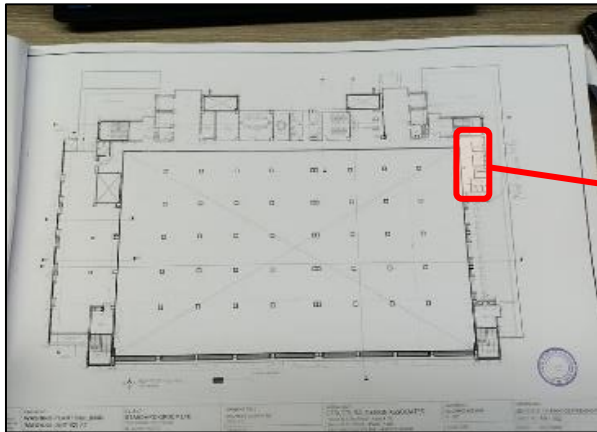
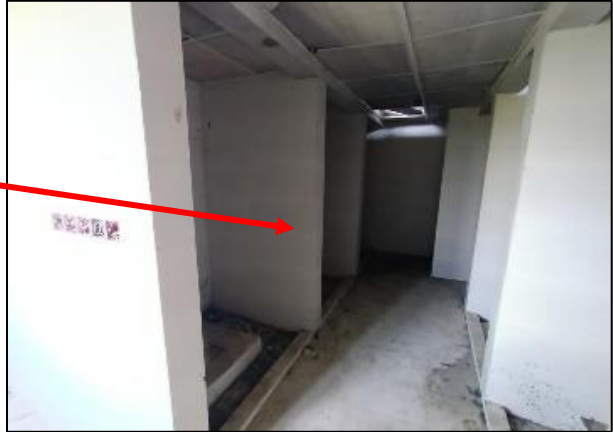
**Description:** Toilet layout at North-East corner was not matched with as-built drawing.

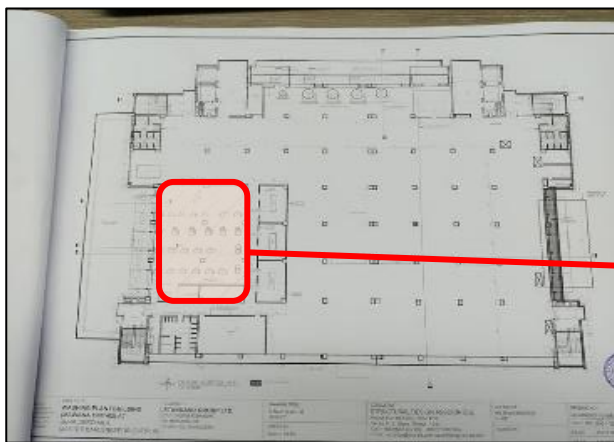
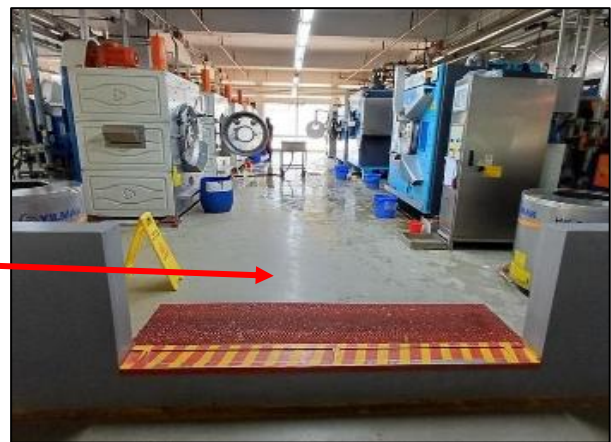
**Description:** 200 mm build-up was found on the 1st floor. But in as-built drawing 125 mm built was mentioned.

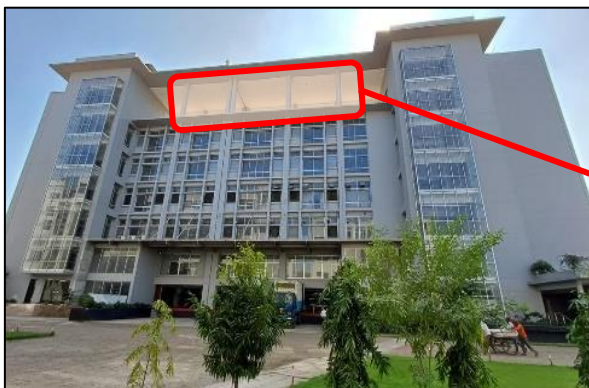
**Description:** 5 nos. circular column was found only on the 5th floor. But in as-built drawing circular column was mentioned from base to roof.

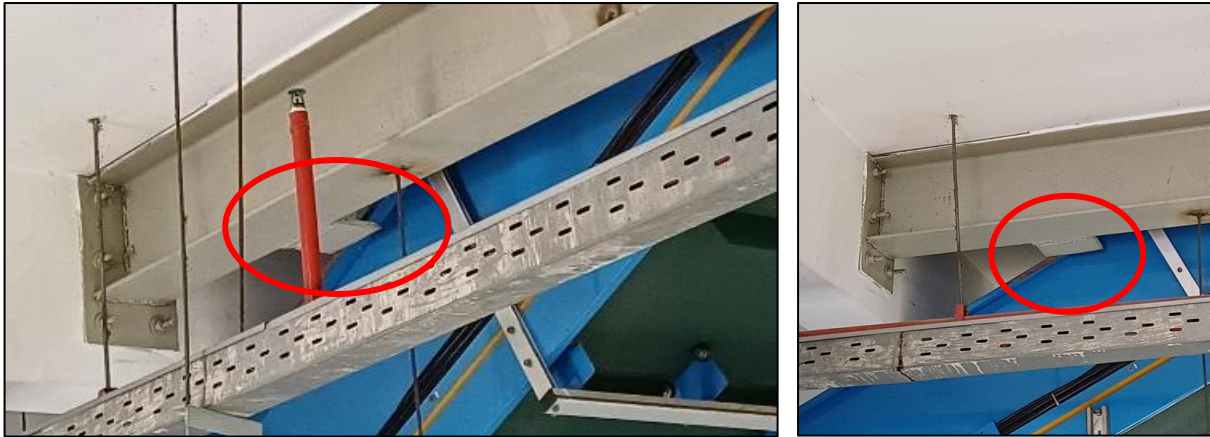
**Observation-6: Discontinued bottom flange of I-beam at 1<sup>st</sup> floor (Washing Building).**

**Description:** During inspection, discontinued bottom flange of I-beam was found at 1<sup>st</sup> floor conveyor belt area. Building engineer is required to check the adequacy of steel I-beam to comply with BNBC.

| Observation | Action Plan | Timeline |
|---|---|---|
| Discontinued bottom flange of I-beam at 1st floor (Washing Building). | The building engineer is required to check the adequacy of steel I-beam in compliance with BNBC. | within 6 weeks |

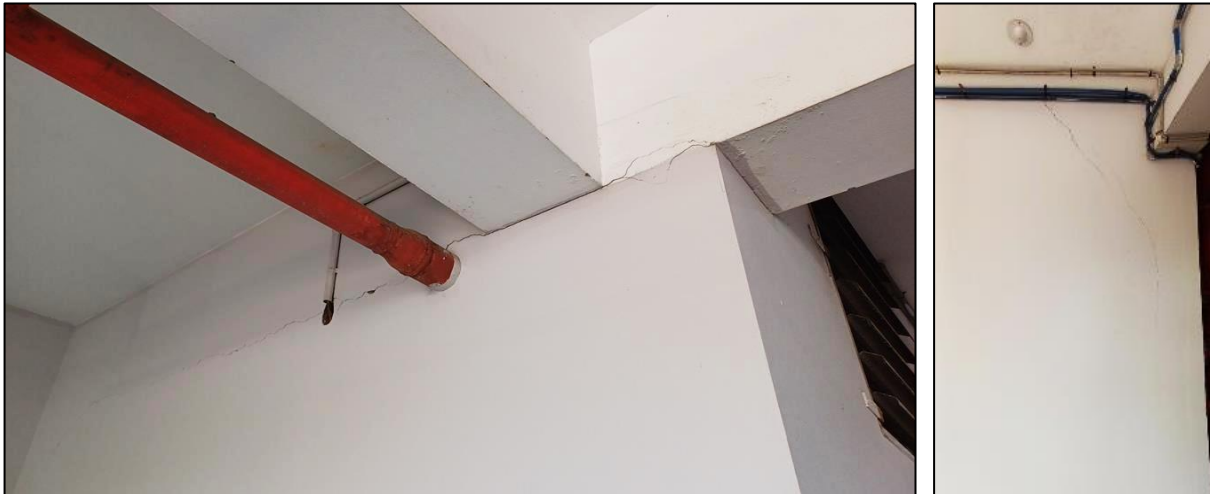
**Observation7: Cracks in brick wall (Washing Building).**

**Description:** Some cracks were found in the brick wall. Building engineer is required to investigate the reason of cracks and repair with suitable method.

| Observation | Action Plan | Timeline |
|---|---|---|
| Cracks in brick wall (Washing Building). | The building engineer is required to investigate the reason of cracks and repair with suitable method. | within 6 weeks |

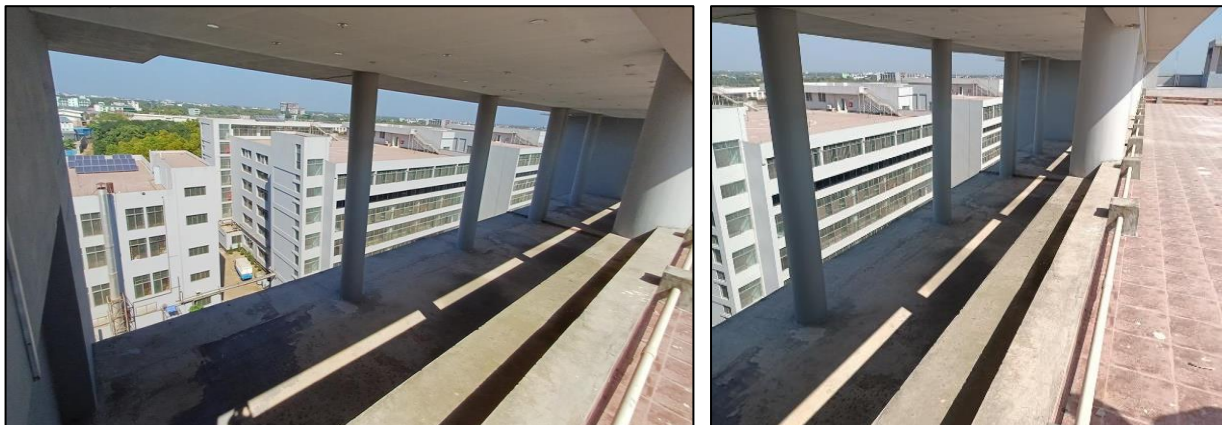
**Observation-8: Falling hazards (Washing Building).**

**Description:** During inspection, no railing or parapet wall was found at 5<sup>th</sup> floor north portion (front side). Building engineer is required to provide railing to mitigate falling hazard.

| Observation | Action Plan | Timeline |
|---|---|---|
| Falling hazards (Washing Building). | The building engineer is required to provide railing to mitigate falling hazard. | within 6 months |

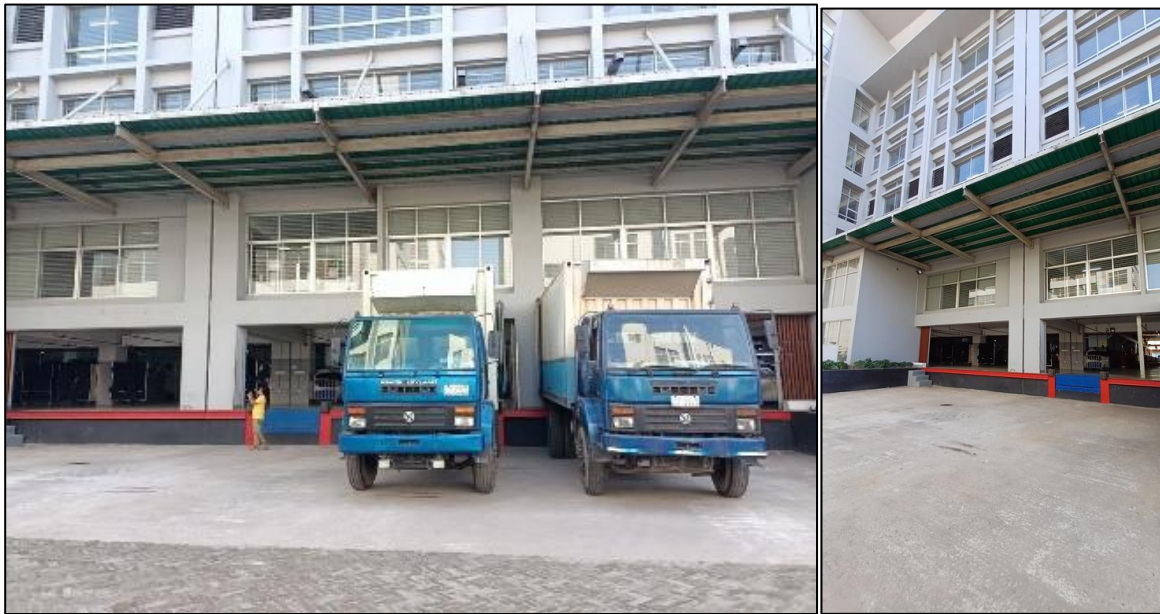
**Observation-9: Column susceptible to vehicle impact (Washing Building).**

**Description:** Some columns on the ground floor were found susceptible to vehicle impact. Building engineer is required to provide barriers around the column to prevent vehicle impact.

| Observation | Action Plan | Timeline |
|---|---|---|
| Column susceptible to vehicle impact (Washing Building). | The building engineer is required to provide barriers around the column to avoid vehicle impact. | within 6 months |

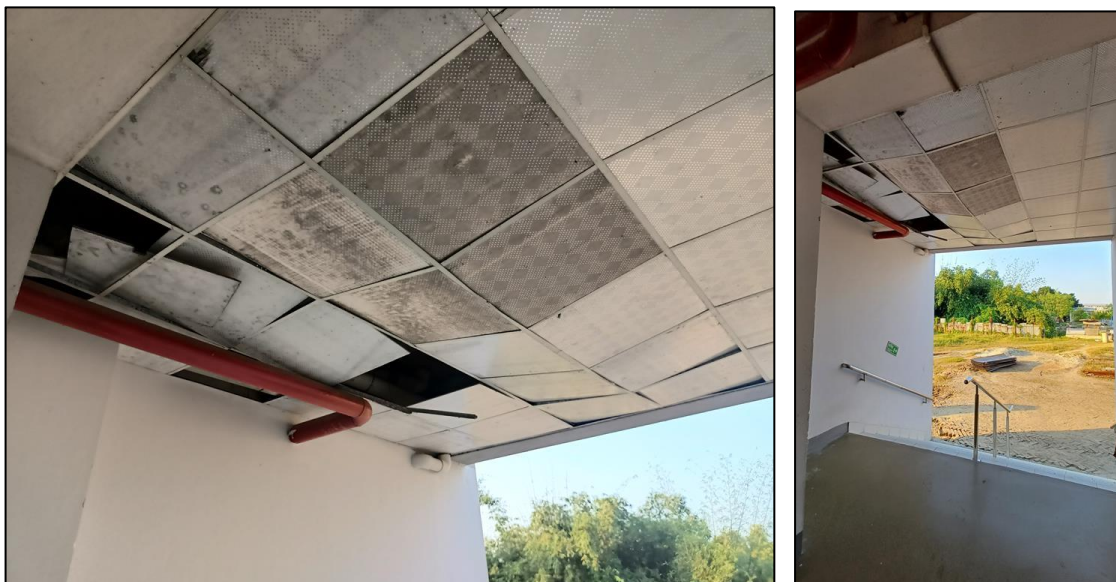
**Observation-10: Falling hazards (Chemical Building).**

**Description:** Ground floor north side ceiling is found to be damaged. Building engineer is required to take proper action to mitigate falling hazard.

| Observation | Action Plan | Timeline |
|---|---|---|
| Falling hazards (Chemical Building). | The building engineer is required to take proper action to mitigate falling hazard. | within 6 months |

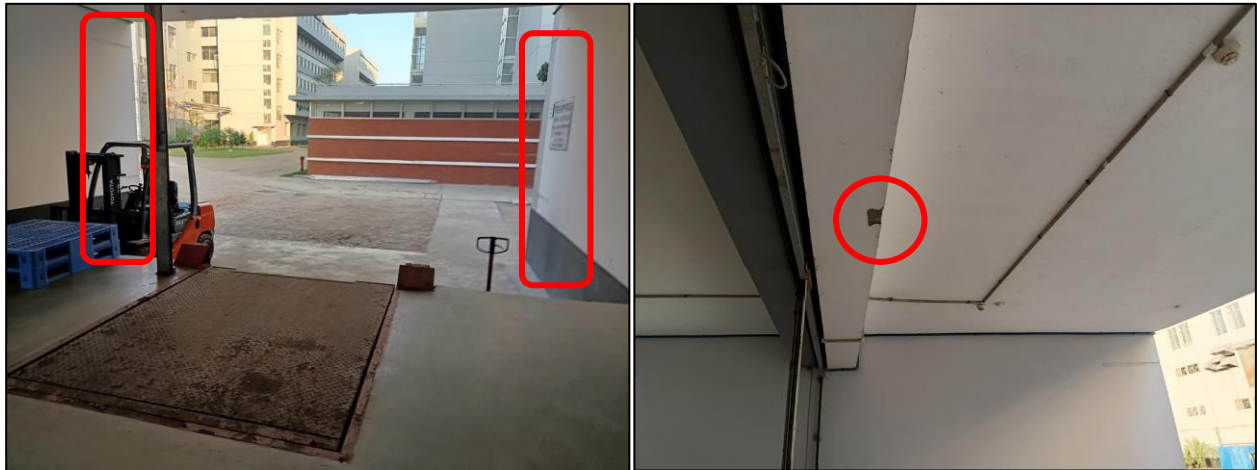
**Observation-11: Column and beam susceptible to vehicle impact (Chemical Building).**

**Description:** Some columns and beams on the ground floor were found susceptible to vehicle impact. Building engineer is required to provide barriers around the column and beam to prevent vehicle impact.

| Observation | Action Plan | Timeline |
|---|---|---|
| Column and beam susceptible to vehicle impact (Chemical Building). | The building engineer is required to provide barriers around the column and beam to avoid vehicle impact. | within 6 months |

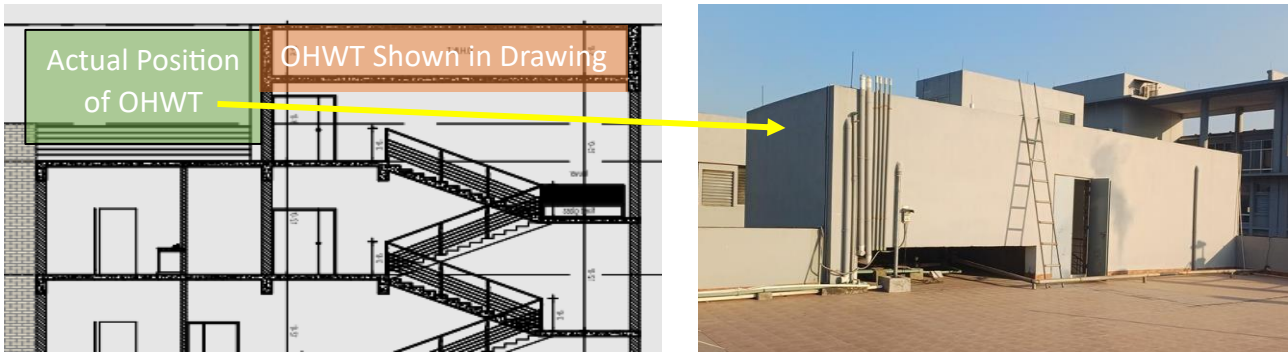
**Observation-13:** Discrepancies in as built drawings (Utility Building).

Location mismatch of Overhead Water Tank

**Description:** During inspection, OHWT was found at different location as shown in picture. The building engineer is required to survey the full structure, update as-built drawings as per site condition and incorporate in assessment.

| Discrepancies in as built drawings (Utility Building). | The building engineer is required to survey the full structure and produce accurate as-built drawings. | within 6 weeks |

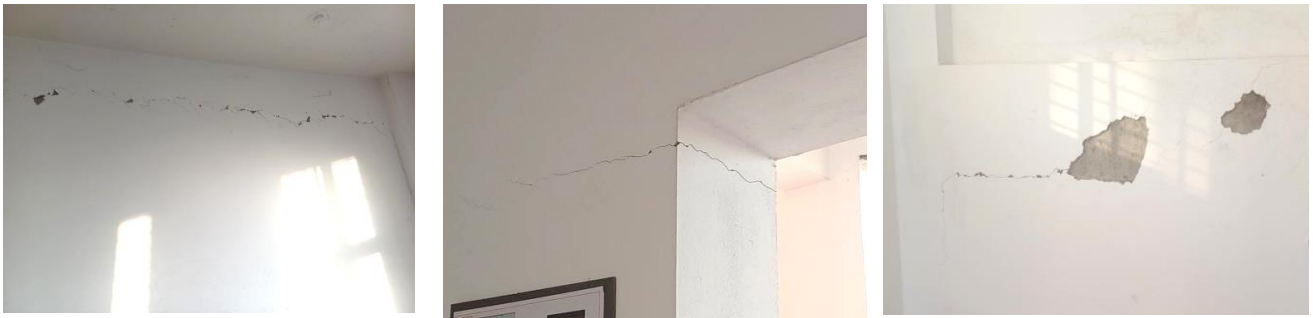
**Observation-14:** Horizontal crack on brick wall (Utility Building).

**Description:** Horizontal cracks were observed on brick wall at several locations. Factory is required to identify the reason of crack, take necessary remedial measure to repair the wall accordingly.

| Horizontal crack on brick wall (Utility Building). | The building engineer is required to identify the reason of crack, take necessary remedial measure to repair the wall accordingly. | within 6 weeks |

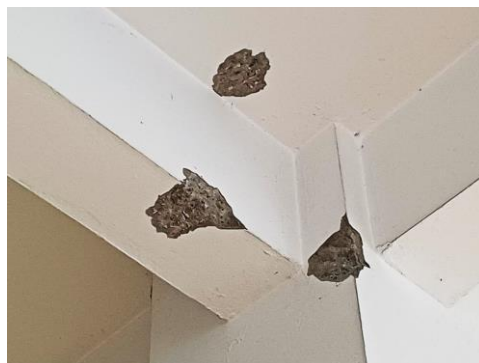
**Observation-15:** Spalling of concrete (Utility Building).

**Description:** During inspection, spalling of concrete was observed at beam, column and slab of 1<sup>st</sup> floor. Factory is required to identify the reason and take necessary remedial measure to repair the damaged portion accordingly.

| Spalling of concrete (Utility Building). | The building engineer is required to identify the reason and take necessary remedial measure to repair the damaged portion accordingly. | within 6 weeks |

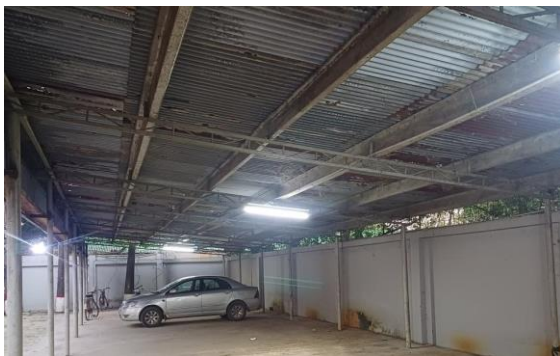
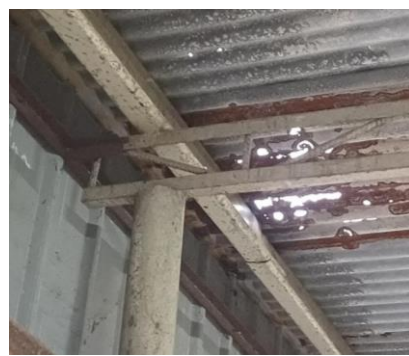
**Observation-17:** Non-engineered structure (Parking Shed).

**Description:** Lack of lateral stability system (strut and bracing), apparent inadequate members and non-engineered connection was observed. The building engineer is required to check the member, connection & stability system of the structure and suggest proper alternatives accordingly.

| Non-engineered structure (Parking Shed). | The building engineer is required to check the member, connection & stability system of the structure and suggest proper alternatives accordingly. | within 6 weeks |
| | Carry out remedial works if required. | within 6 months |
