# Creative Collections Ltd. (Extension)

Nishatnagar, Tongi, Gazipur, Bangladesh.

26 October 2023

## 2. Observations:

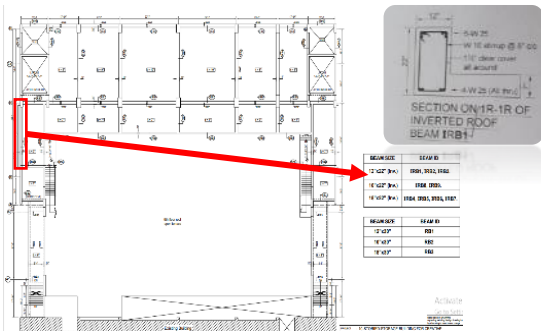
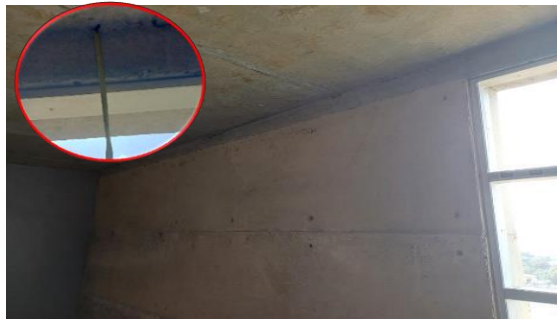
| Main Building (Extension) | |
|---|---|
| Observation 3: Inconsistencies in as-built drawings. | |
| Inverted beam IRB1 in Roof floor beam layout | 163 mm d/s beam found on site |
| <p><b>Description:</b> In as-built drawing, inverted beam IRB1 is mentioned. But, instead of an inverted beam, a beam with a down stand 163 mm was found on site. Building engineer is required to survey the whole structure and update the as-built drawing.</p> | |

| Observation | Action Plan | Timeline |
|---|---|---|
| Inconsistencies in as-built drawings | The building engineer is required to survey the structure and produce accurate as-built drawings. | within 6 weeks |

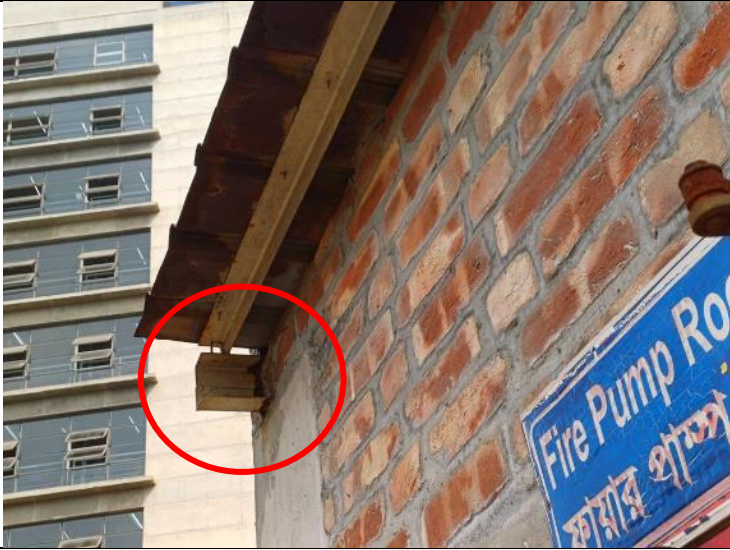
| <b>Observation-4: Apparently inadequate connection.</b> | |
| Improper Connection | |
| <b>Description:</b> Inadequate structural connection details were found. Building engineer is required to check the adequacy of the steel connection for uplift forces. | |

| Observation | Action Plan | Timeline |
|---|---|---|
| Apparently inadequate connection | Building engineer is required to check the adequacy of the steel connection for uplift forces. | within 6 weeks |
| | Carry out remedial work where required. | within 6 months |

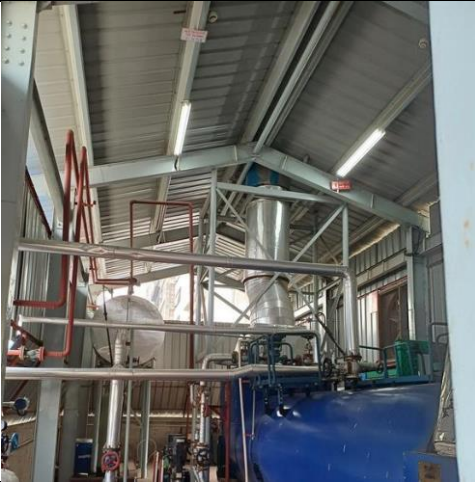
| <b>Observation 5: Lack of stability system.</b> | |
| Portal frame | |
| <b>Description:</b> Roof bracing and wall bracing system was not observed in the roof shed of the EGB Boiler. Building engineer is required to requirement of bracing at the roof and suggest necessary alternatives accordingly. | |

| Observation | Action Plan | Timeline |
|---|---|---|
| Lack of stability system | Building engineer is required to check the lateral stability of the shed as part of the Engineering Assessment (EA). | within 6 weeks |
| | Carry out remedial work where required. | within 6 months |
