Vintage Denim Ltd. (Extension)

13 November 2023

Structural Inspection Report

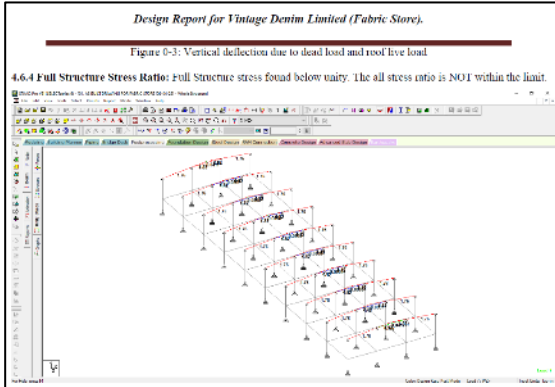
The stress ratio for steel rafters is more than 1.0 in the software analysis.

Description: As per the software output, stress ratio for steel rafters is more than 1.0 (unsafe) but in the design report stress ratio for those members is declared less than 1 (safe). Also, improper connections and lack of lateral load transfer media along eave & ridge was observed on-site which has not been considered in the software based structural analysis. In addition,

Item No.	Observation	Action Plan	Timeline
1.	Inconsistencies between software output and design report. (Fabric Store Shed)	The building engineer is required to revise the design report based on in-situ material strength & software-based analysis and submit the documents to RSC for review.	within 6 weeks

2.	Inconsistencies between software output and design report. (Fabric Store Shed)	Carry out suggested remedial works if required.	within 6 months
3.	Mismatch between drawing & on-site condition. (Fabric Store Shed)	The building engineer is required to survey the full structure and produce accurate as-built drawings.	within 6 weeks

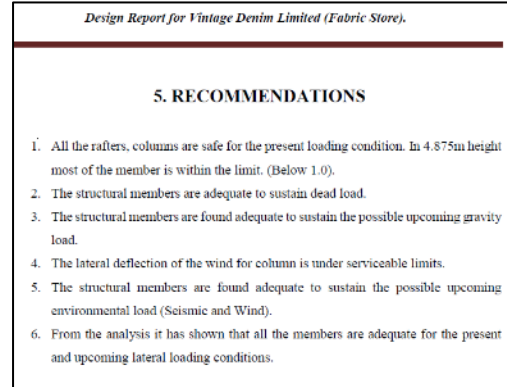
Declared as safe in the recommendation of design report.

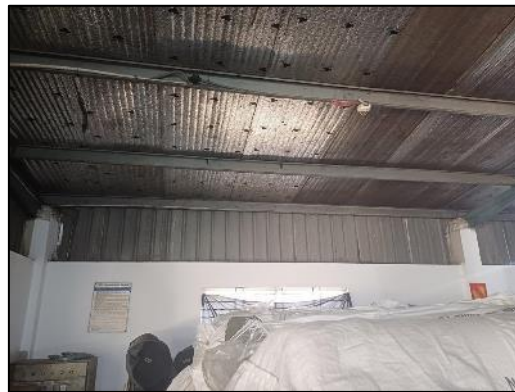
Lack of lateral load transfer media in eave & ridge

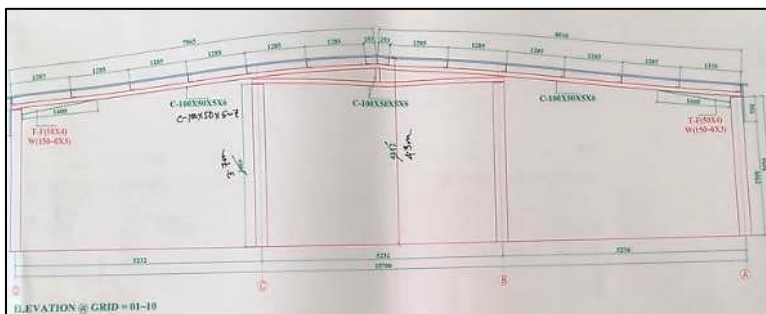
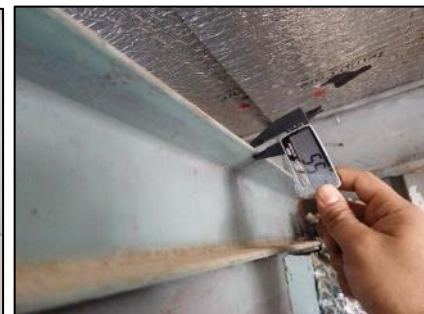
Observation-2: Mismatch between drawing & on-site condition. (Fabric Store Shed)

Description: The height of the building found more than as-built drawing. Also, the thickness of rafter (channel) was found varies from 5 mm to 7 mm where average 6mm is shown in the drawing.

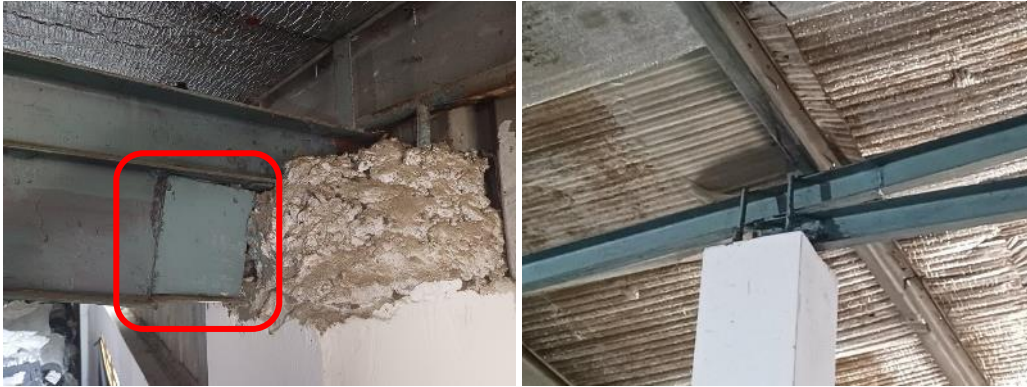
Observation-3: Improper connection & steel sections. (Fabric Store Shed)

Description: Discontinuation of web & flange was observed in end portion of the steel rafter. The thickness of marked plates was thinner than the main rafter section. Also, the connection between steel rafter & RC columns were not proper.

4.	Improper connection & steel sections. (Fabric Store Shed)	The building engineer is required to check the connections and suggest proper remedial action accordingly.	within 6 weeks

5.	Improper connection & steel sections. (Fabric Store Shed)	Upgrade the connections where required.	within 6 months
6.	Vehicle impact on steel canopy (Store Building). (Fabric Store Shed)	The factory is required to restrict the vehicle access by providing barrier in front to the shed keeping safe distance and repair the damaged steel canopy.	within 6 months

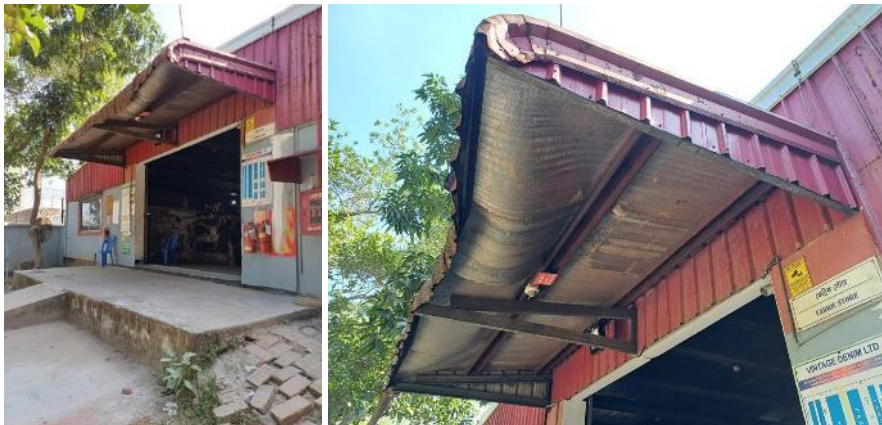
Observation-4: Vehicle impact on steel canopy (Store Building). (Fabric Store Shed)

Description: Distress steel angle was found due to impact of vehicle in the steel canopy.

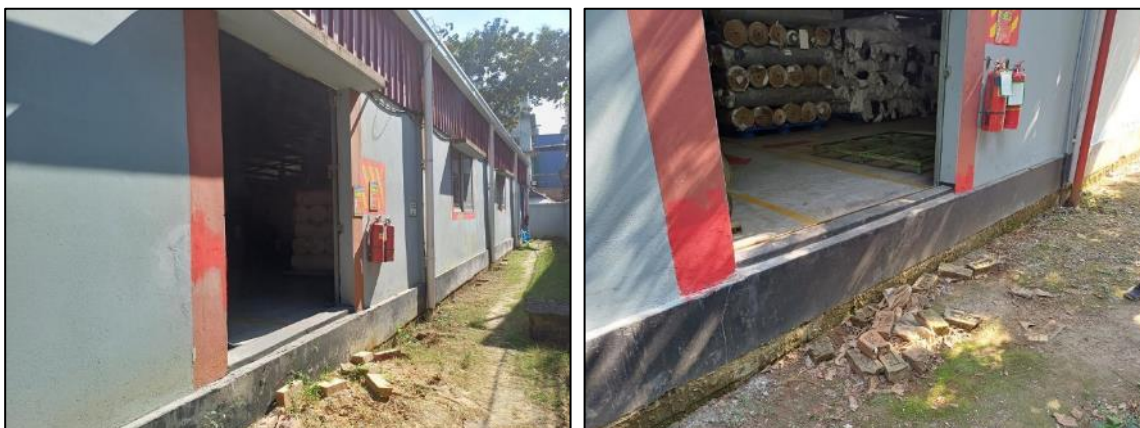
Observation-5: Falling Hazard (Fabric Store Shed)

Description: Falling hazard at the entry/exit of the shed was observed due to lack of steps.

7.	Falling Hazard (Fabric Store Shed)	The building engineer required to build necessary steps in front of exit ways.	within 6 weeks
8.	Structural crack in beam & slab of mezzanine floor (Gas Generator Building).	The factory must immediately engage a consultant to investigate the cracks & existing prop support. Any safety measures, if required as suggested by the consultant, must be taken immediately to ensure safety. The investigation report along with the repair methodology must be submitted to RSC by 20 November 2023.	Immediate

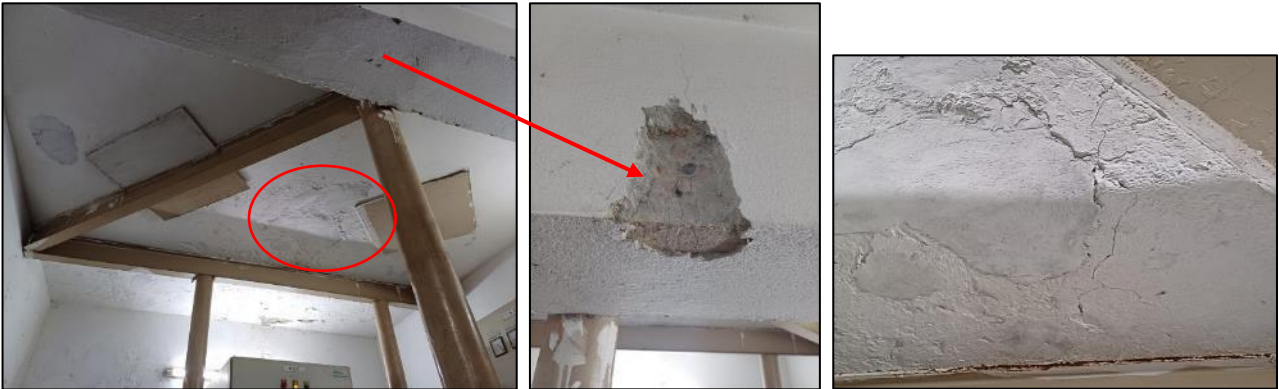
Observation-6: Crack in beam & slab of mezzanine floor (Gas Generator Building).

Description: Structural Crack observed in beam & slab of mezzanine floor of single storied Gas Generator Building which require immediate investigation & action. The factory already provided some props support for slab.

9.	Structural crack in beam & slab of mezzanine floor (Gas Generator Building).	Required remediation work must be completed within 7 days of receiving acceptance from RSC. RSC must be updated with pictorial evidence on work progress.	within 6 weeks

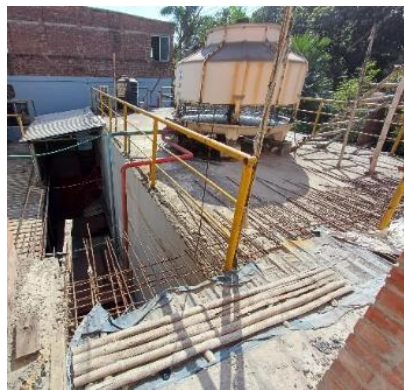
Observation-7: Lack of design documents (Gas Generator Building).

Description: As per BNBC, every structure should have design documents in compliance with section 1.9.1. Design documents consist of design reports, drawings, and software-based analysis. During inspection no design report and as-built drawings were found on-site.

10.	Lack of design documents (Gas Generator Building).	The building engineer is required to prepare design documents in compliance with section 1.9.1 of BNBC (part 6).	within 6 weeks

11.	Lack of design documents (Gas Generator Building).	Carry out suggested remedial works if required.	within 6 months
12.	Dampness on wall (Gas Generator Building).	Seal the source of water and repair the damp areas.	within 6 weeks

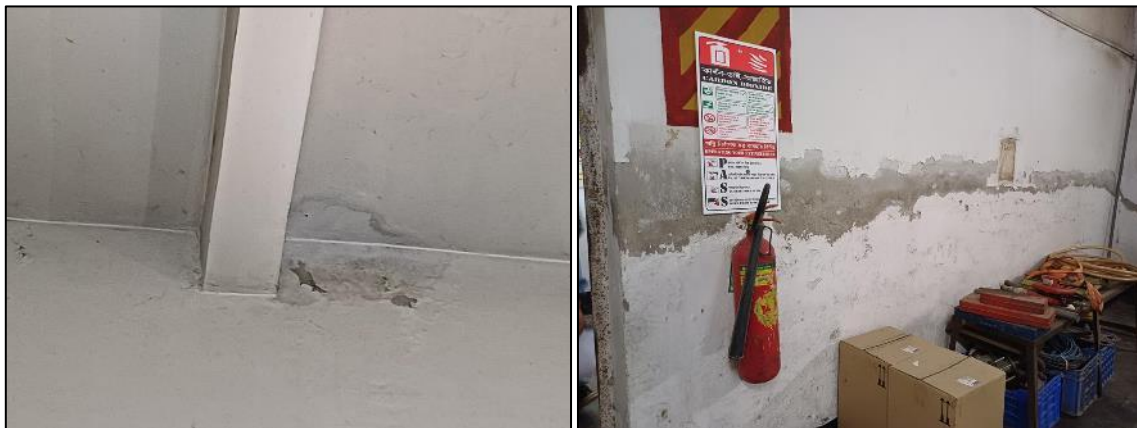
Observation-8: Dampness on wall (Gas Generator Building).

Description: Dampness found on load bearing brick walls.
