# ALIB Composite Ltd. (Extension)

Vannara, Mouchak, kaliakoir, Gazipur

14 November 2023

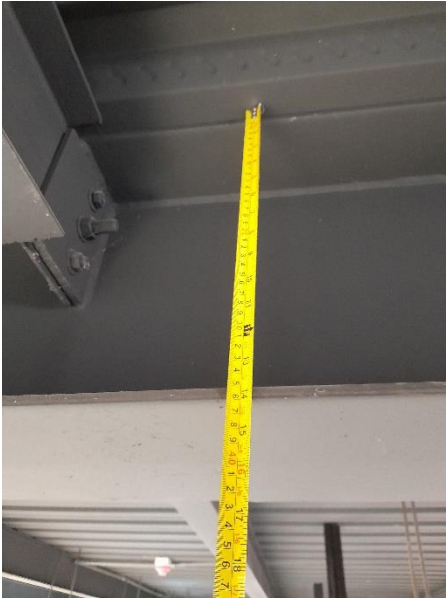
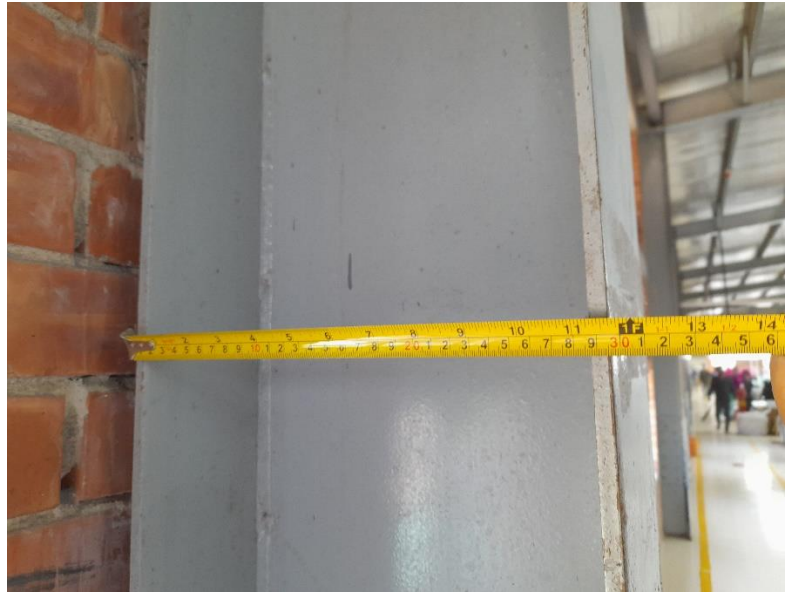
### Observation-1: Lack of Design Documents (Main Building)

**Description of observation:** During inspection, a set of as-built drawings was found but full set of design documents was not available. Mismatch found between the as-built drawing and actual site condition. The depth of the main beam was found 360mm instead of 375mm at several locations. Also, the size (depth & thickness) of the steel columns were found less in size than as-built drawing in few locations.

As per BNBC, every building or structure designed shall have its design documents prepared in accordance with the provision of Section 1.9.1. The design document shall include a design report, and a set of structural drawings, which shall be prepared in compliance with section 1.9.1.1 and section 1.9.1.2 as per BNBC. Building engineer is required to survey the whole structure and prepare accurate as built drawing as well as the design documents including design report based on FEA model in compliance with section 1.9.1 (part-6, BNBC).

| Observation | Action Plan | Timeline |
|---|---|---|
| Lack of design documents.<br>(Main Building) | Building engineer to prepare the design document including a design report, and a set of structural drawings in compliance with section 1.9.1.1 and section 1.9.1.2 as per BNBC. | within 6 weeks |
| | Carry-out remedial works where required. | within 6 months |

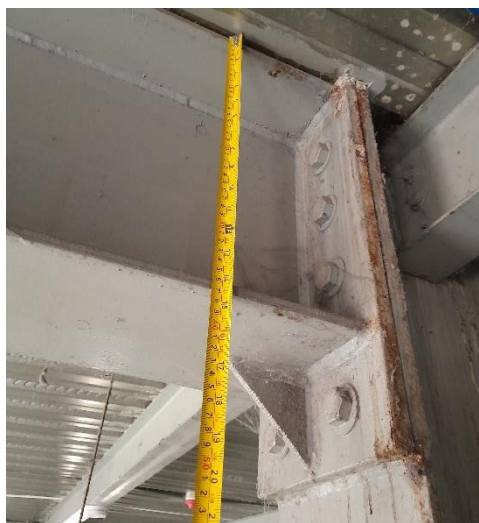
### Observation-2: Corrosion in steel section (Main Building)

**Description of observation:** Corrosion was found in the steel members. Building Engineer is required to repair the corroded areas and take necessary actions to protect the steel members from corrosion.

| Observation | Action Plan | Timeline |
|---|---|---|
| Corrosion in steel section.<br>(Main Building) | Factory is required to take necessary actions to protect the steel members from corrosion. | within 6 weeks |

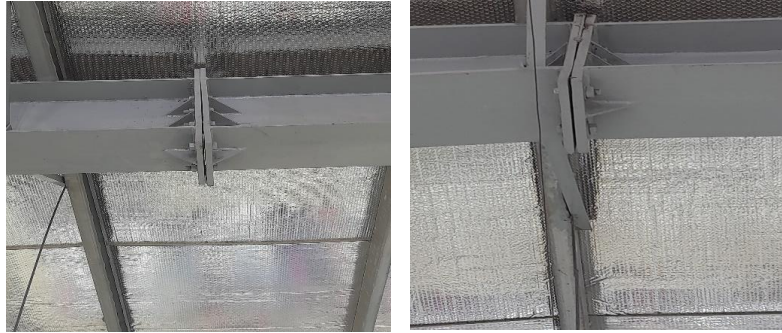
**Observation-3: Connection Gap in Steel joints (Main Building)**

**Description of observation:** Significant gaps was observed at column-rafter, Rafter-Rafter and other joints at several locations. Building engineer is required find out all the locations and carry out suitable remedial works.

| Observation | Action Plan | Timeline |
|---|---|---|
| Connection gap at steel joints.<br>(Main Building) | Identify the locations and carryout suitable repair works where necessary. | within 6 weeks |

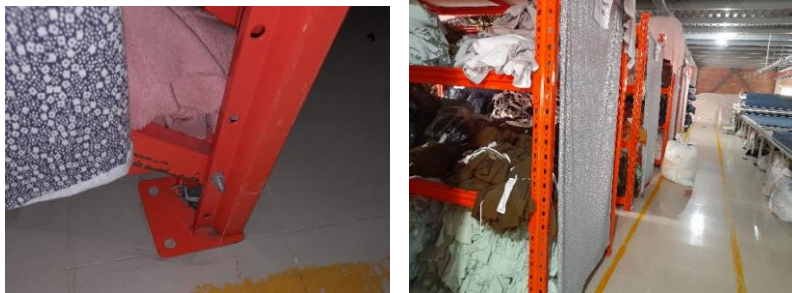
**Observation-4: Non-structural elements not anchored or braced (Main Bulidng)**

**Description of observation:** Racks on different floors are not adequately anchored or braced to resist lateral (earthquake) forces. Building is required to adequately anchor and brace all non-structural elements to resist earthquake forces to comply with the BNBC.

| Observation | Action Plan | Timeline |
|---|---|---|
| Non-structural elements not anchored or braced.<br>(Main Building) | Building engineer is required to adequately anchor and brace all non-structural elements to resist earthquake forces to comply with the BNBC. | within 6 weeks |

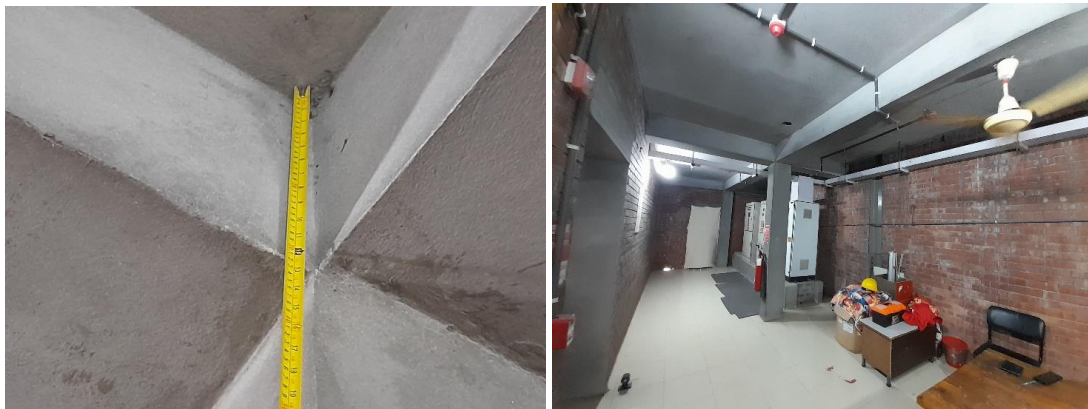
**Observation-5: Lack of Design Documents (Utility Building)**

During inspection, a set of as-built drawings was found but full set of design documents was not available. Mismatch found between the as-built drawing and actual site condition. The down-stand depth of the beam was found 300mm instead of 250mm at several locations.

Also, an adequate number of the cylinder test report was not available.

As per BNBC, every building or structure designed shall have its design documents prepared in accordance with the provision of Section 1.9.1. The design document shall include a design report, and a set of structural drawings, which shall be prepared in compliance with section 1.9.1.1 and section 1.9.1.2 as per BNBC. Building engineers are required to survey the whole structure and prepare accurate as built drawing as well as the design documents including design report based on FEA model in compliance with section 1.9.1 (part-6,BNBC).

| Observation | Action Plan | Timeline |
|---|---|---|
| Lack of design documents.<br>(Utility Building) | Building engineer to prepare the design document including a design report, and a set of structural drawings in compliance with section 1.9.1.1 and section 1.9.1.2 as per BNBC. | within 6 weeks |
| | Provide adequate cylinder test report to satisfy the frequency of test as per BNBC verify in-situ concrete stresses by 100mm dia. cores from minimum of 4 columns & beam. | within 6 weeks |
| | Carry-out remedial works where required. | within 6 months |

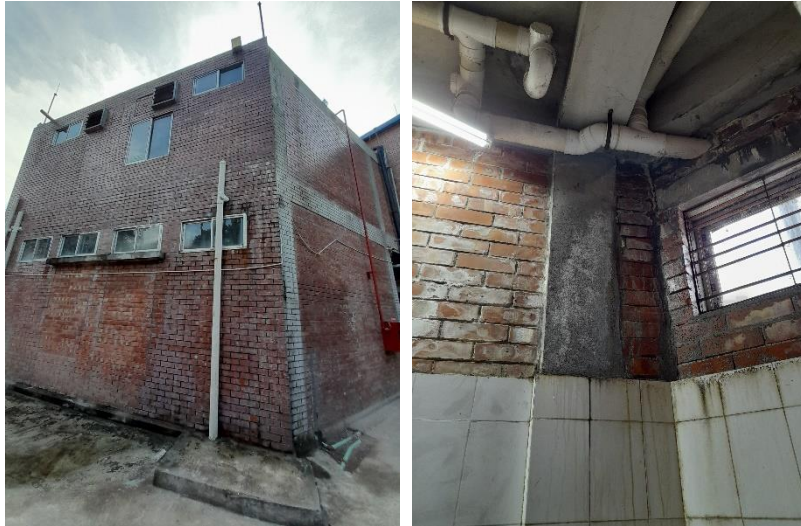
**Observation-6:** Dampness at several locations (Utility Building)

**Description of observation:** Dampness and vegetation were found at several locations of the structures. Factory is required to investigate the source of the dampness, repair dampness and take necessary action to avoid dampness.

| Observation | Action Plan | Timeline |
|---|---|---|
| Dampness at several locations.<br>(Utility Building) | Building Engineer is required to investigate the reason of dampness & apply suitable method to repair dampness. | within 6 weeks |

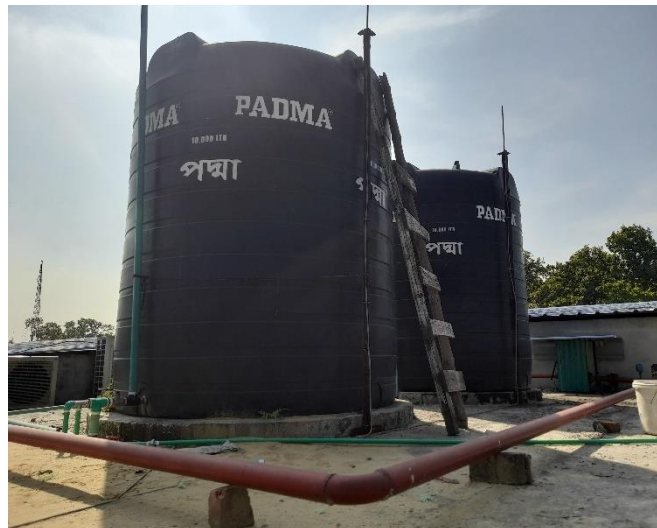
**Observation-7:** Non-structural elements not anchored or braced (Utility Bulidng)

**Description of observation:** PVC water tank at roof of Utility building are not adequately anchored or braced to resist lateral (earthquake) forces. Building is required to adequately anchor and brace all non-structural elements to resist earthquake forces to comply with the BNBC.

| Observation | Action Plan | Timeline |
|---|---|---|
| Non-structural elements not anchored or braced.<br>(Utility Building) | Building engineer is required to adequately anchor and brace all non-structural elements to resist earthquake forces to comply with the BNBC. | within 6 weeks |
