# GMS Textiles Ltd. (Extension)

Tansutrapur, Kaliakoir, Gazipur

14 November 2023

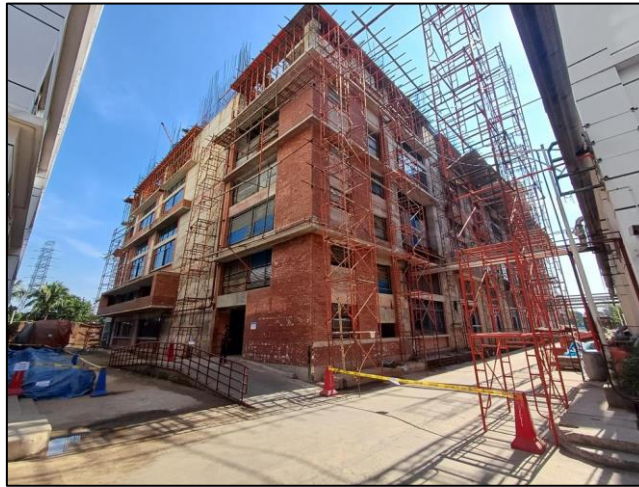
### Observation-1: Lack of design report (Dyeing Building -02).

**Description:** As per BNBC, every building or structure designed shall have its design documents prepared in accordance with the provision of Section 1.9.1. The design documents shall include as-built drawings and a design report which shall be prepared in compliance with section 1.9.1, part-6 of BNBC.

During inspection, the design report was not available on site. The building engineer is required to prepare a design report based on in-situ material strength & software-based analysis and submit it to RSC for review.

| Observation | Action Plan | Timeline |
|---|---|---|
| Lack of design report. (Dyeing Building -02) | The building engineer is required to prepare a design report based on in-situ material strength & software-based analysis and submit it to RSC for review. | within 6 weeks |
| Lack of design report. (Dyeing Building -02) | Carry out suggested remedial works if required. | within 6 months |

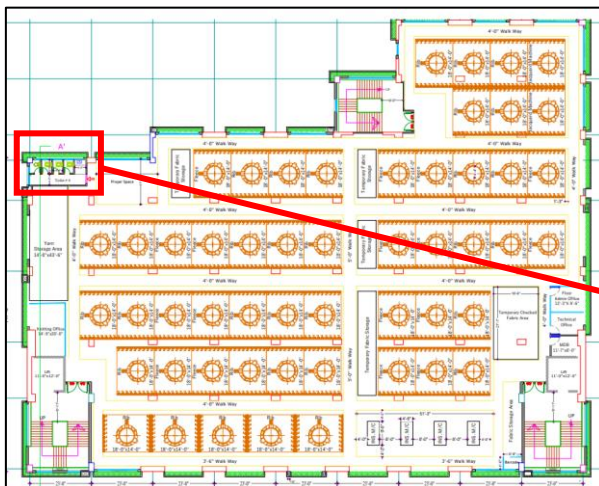
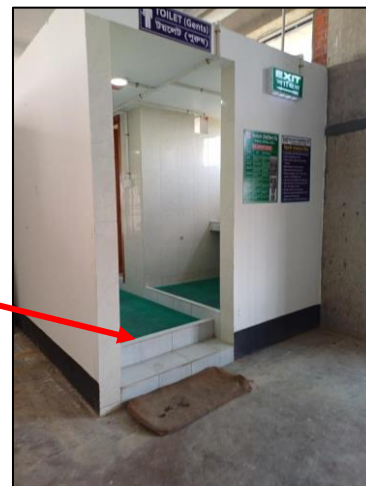
### Observation-2: Discrepancies in as-built drawings (Dyeing Building -02).

**Description:** During the inspection, mismatches were found between the onsite condition and the as-built drawing. On-site, 337 mm build-up was found in the toilet zone which is not mentioned in the drawing. The building engineer is required to survey the full structure and produce accurate as-built drawings.

| Observation | Action Plan | Timeline |
|---|---|---|
| Discrepancies in as-built drawings. (Dyeing Building - 02) | The building engineer is required to survey the full structure and produce accurate as-built drawings | within 6 weeks |

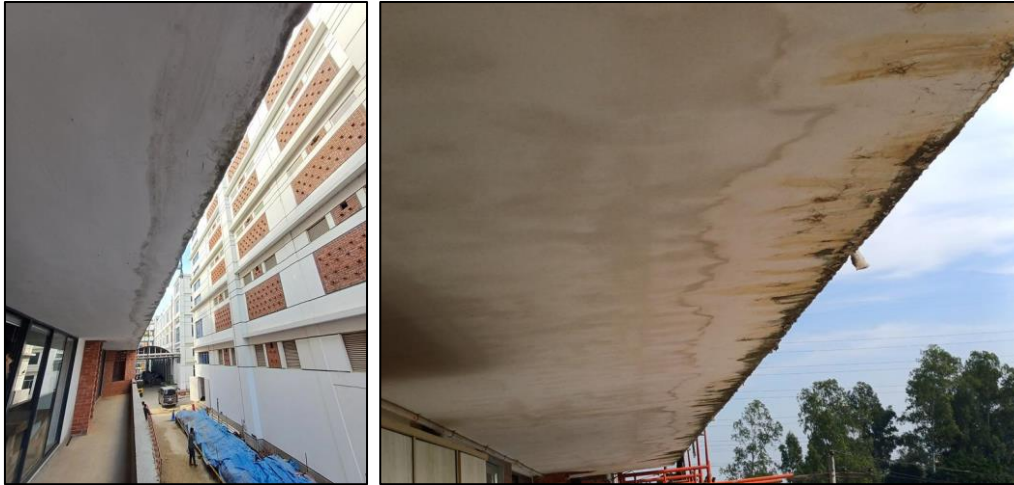
**Observation-3:** Dampness on cantilever slab. (Dyeing Building -02)

**Description:** Dampness found on the cantilever slab of the mezzanine floor. The building engineer is required to identify the source of dampness, and take remedial measures to repair the slab accordingly.

| Observation | Action Plan | Timeline |
|---|---|---|
| Dampness on cantilever slab. (Dyeing Building -02) | The building engineer is required to identify the source of dampness and take remedial measures to repair the slab accordingly. | within 6 weeks |

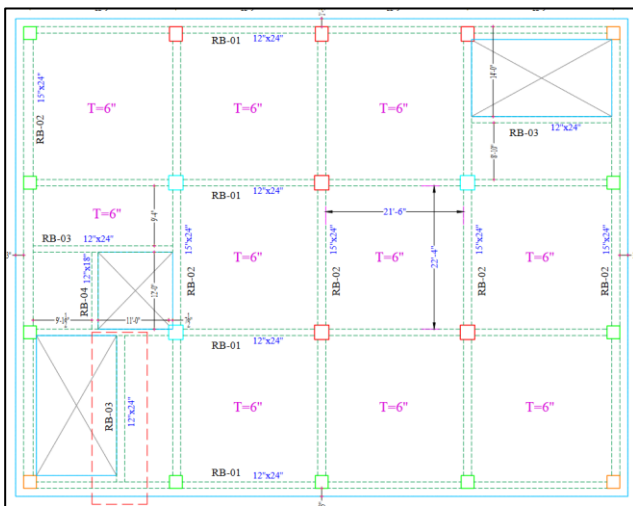
Typical Floor beam layout plan

**Description:** During the inspection, only a typical floor slab and beam layout plan was provided in the available as-built structural drawing. However, no slab and beam details for rooftop structures were provided. The building engineer is required to update the as-built drawing incorporating all structural details of this Building.

| Observation | Action Plan | Timeline |
|---|---|---|
| Lack of information in as-built drawing. (Chemical Building) | The building engineer is required to survey the full structure and produce accurate as-built drawings | within 6 weeks |

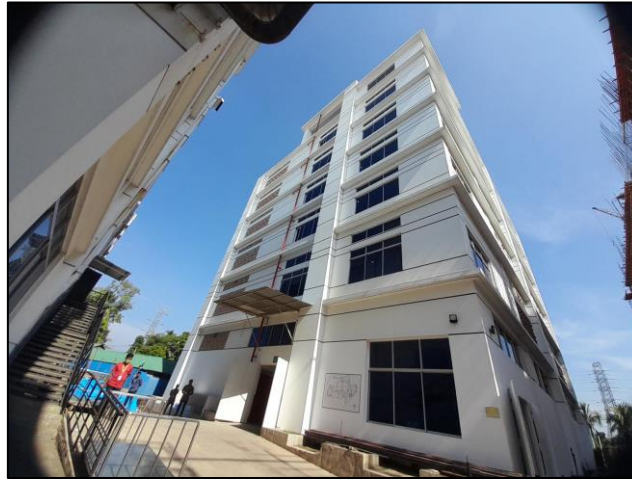
Chemical Building

**Description:** As per BNBC, every building or structure designed shall have its design documents prepared in accordance with the provision of Section 1.9.1. The design document shall include a design report, and a set of structural drawings, which shall be prepared in compliance with section 1.9.1.1 and section 1.9.1.2 as per BNBC. At the time of inspection, design report was not available which is required to be prepared in compliance with BNBC 2020.

| Observation | Action Plan | Timeline |
|---|---|---|
| Lack of design report. (Chemical Building) | The building engineer is required to prepare a design report based on in-situ material strength & software-based analysis and submit it to RSC for review. | within 6 weeks |
| Lack of design report. (Chemical Building) | Carry out suggested remedial works if required. | within 6 months |

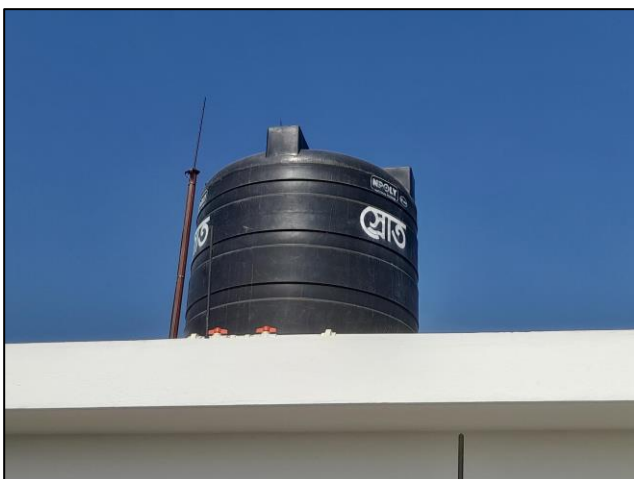
Unbraced PVC tank on the roof

**Description:** During inspection, an unbraced PVC tank on the roof and storage racks on different floors were observed. The building engineer is required to brace/anchor all nonstructural elements to avoid falling hazards during lateral loading.

| Observation | Action Plan | Timeline |
|---|---|---|
| Unbraced nonstructural elements. (Chemical Building) | Building engineer is required to brace/anchor all nonstructural elements to avoid falling hazards during lateral loading. | within 6 weeks |

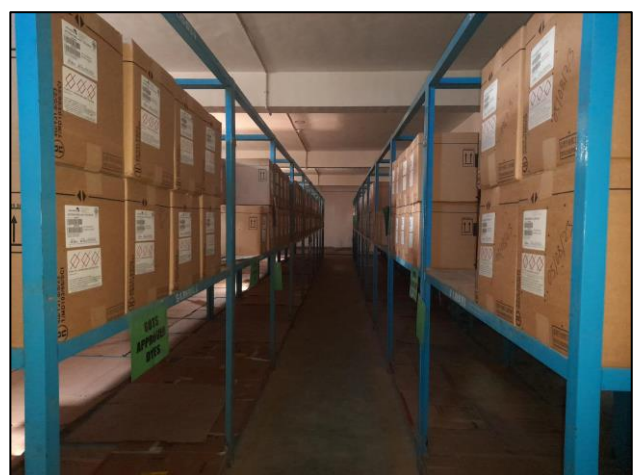
Unbraced storage racks on floors

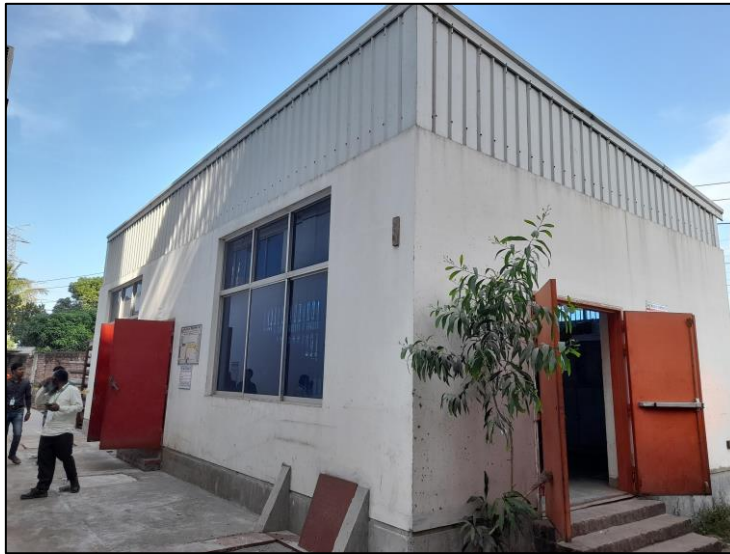
**Observation-7:** Lack of information in as-built drawing. (Mechanical workshop)

**Description:** During the inspection, no foundation details for the Mechanical workshop were provided in the available as-built structural drawing. The building engineer is required to update the as-built drawing incorporating all structural details of this Building.

| Observation | Action Plan | Timeline |
|---|---|---|
| Lack of information in as-built drawing. (Mechanical workshop) | The building engineer is required to survey the full structure and produce accurate as-built drawings | within 6 weeks |
