# KNIT PLUS LTD (10342)

Plot # 2036, Mouchak, Kaliakoir, Gazipur

04.APRIL.2014

# Site Observations

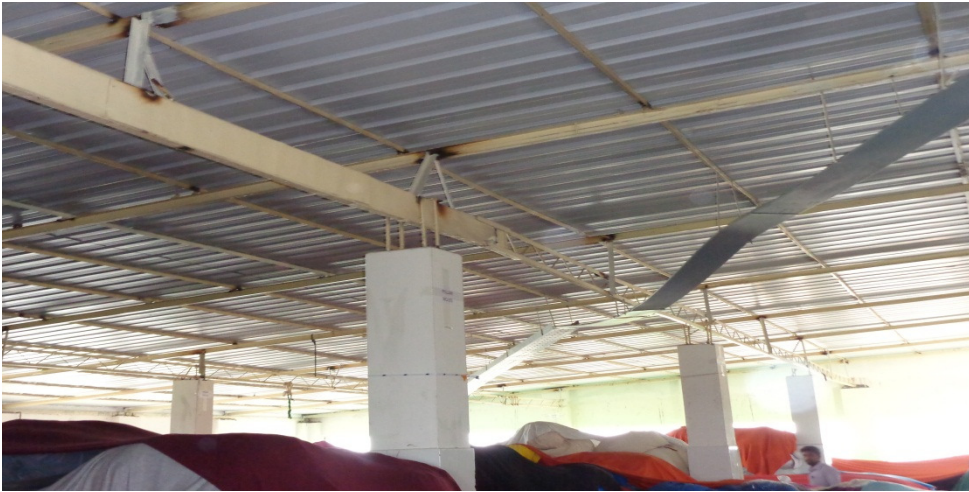
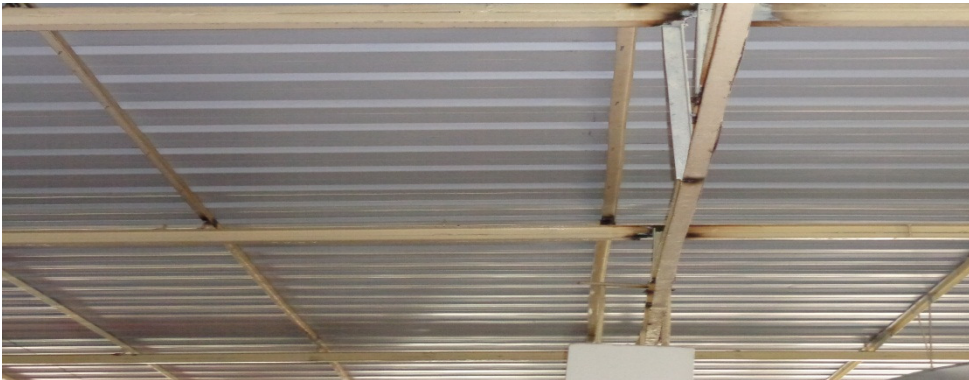
At the garments building, roof made of structural **steel**. Building engineer to validate steel deck, joist and column capacity.

Roof at the garments building

- Building engineer to validate existing structure steel roof at the garments building.

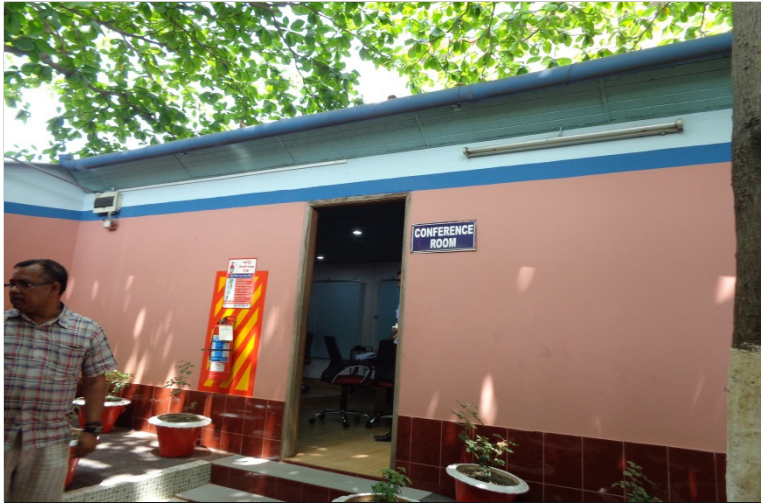
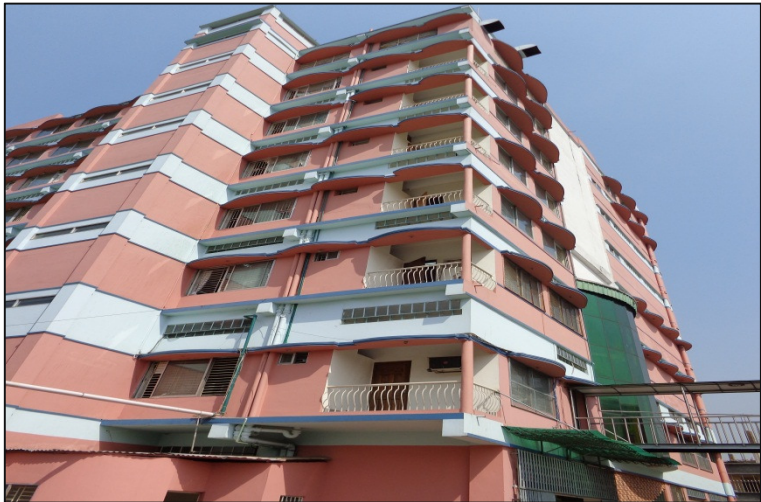
Demolition of the conference room building for the future extension for the garments building. Building engineer to validate beams and column capacity.

**Future extension of the garments building**

- Building engineer to validate existing structure capacity before construction of the future extension

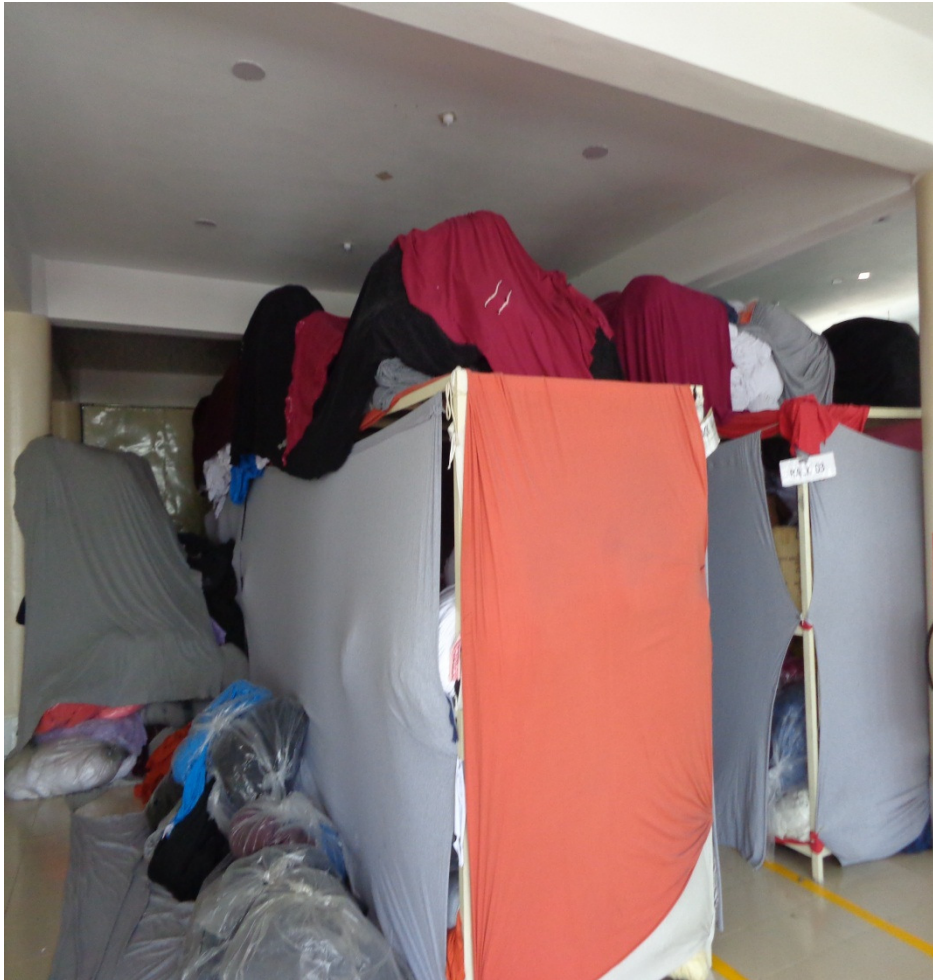
No loading plan in place on the upper floors to insure full compliance with specified design loads.

**No loading plan in place**

- Produce and actively manage a loading plan, ensuring maximum height of storage is adhered to in the long-term.

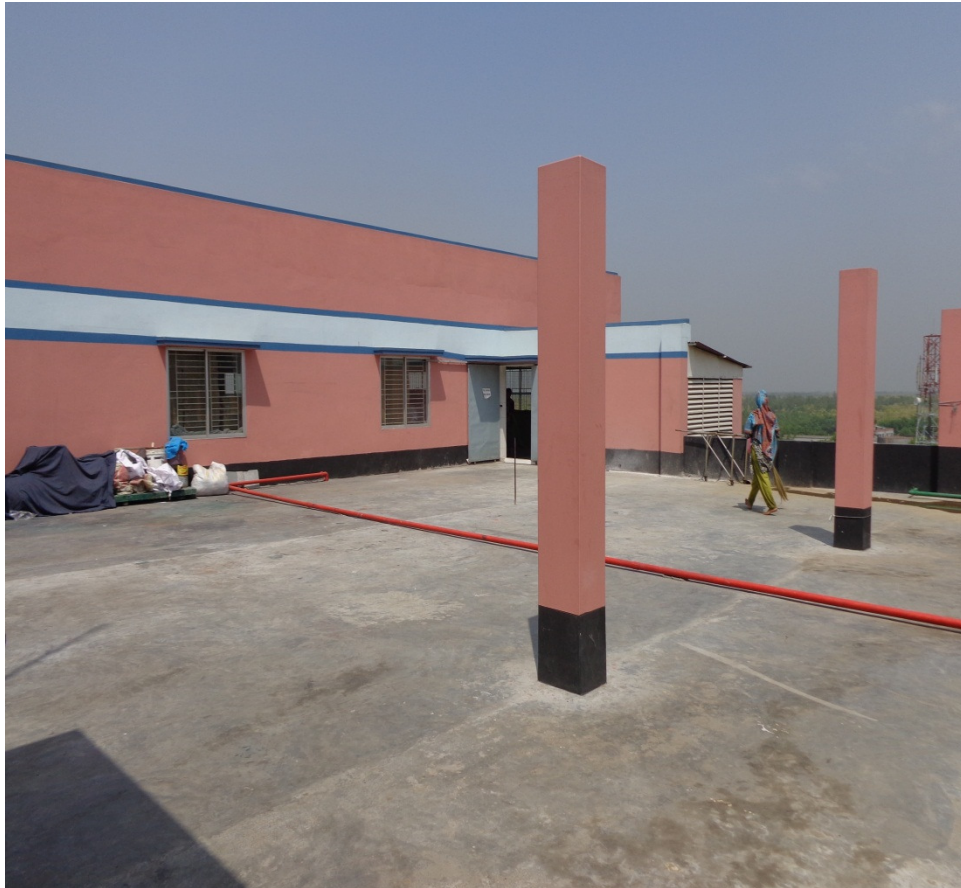
No waterproofing membrane was visible on the roof of the building. This means that any cracks in the surface finishes on the roof will allow water to seep into the concrete slab beneath the finishes, and cause long-term soaking of the slab.

**Roof Floor does not appear to have any waterproof membrane to protect lower floor from water damage**

- Consider applying a new waterproofing membrane.
